U.S. Department  
of Transportation  
**Federal Aviation  
Administration**

## ADVISORY CIRCULAR

# AVIATION MAINTENANCE ALERTS

**MAY  
2005**

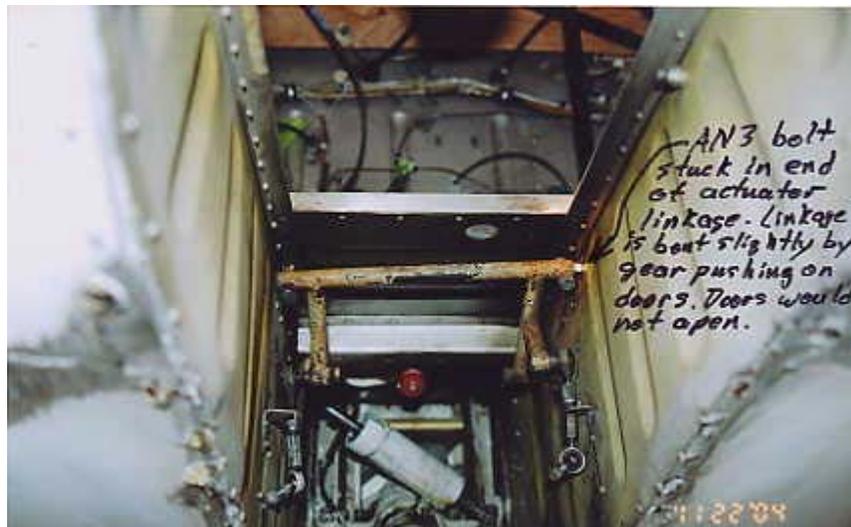
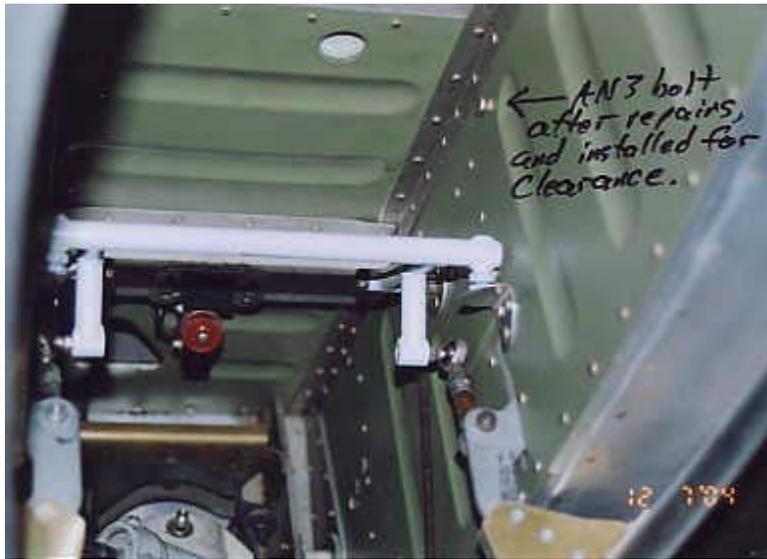
### **Cessna; R182; Nose Gear Extension Failure; ATA 3230**

"On October 6, 2004 this aircraft sustained nose damage due to the failure of the nose gear to extend for landing. The propeller linkage runs down the outside of the nose landing gear tunnel, and is attached (*there*) in two places with Adel clamps, stand-offs, and AN-3 bolts. The aft attach hole is directly in line with the nose door actuator arm which is hollow...(*welded steel tubing: P/N 2213022-14*)." "This aircraft had the aft AN-3 bolt installed with the threads and nut protruding **into** the wheelwell..." The writer describes how the hollow actuator arm impacted the protruding bolt, causing it to loosen with each gear cycle. The moment arrived when sufficient *play* allowed the bolt's end "...to pop over into the end of the hollow actuator's arm tube. This now locked the actuator arm into (*its retracted*) position, and locked the gear doors closed, preventing gear extension. During repairs, the L/H tunnel side was replaced with a factory part (P/N 2213001-3), and the (*above described*) bolt's hole comes pre-drilled in the same location. (*Neither the Cessna*) maintenance manual or the parts catalog have reference to prop cable routing. This problem could easily repeat itself on similar aircraft." (*Two of five submitted photos are shown below: the first demonstrates the problem; the second, a very nice repair!*)

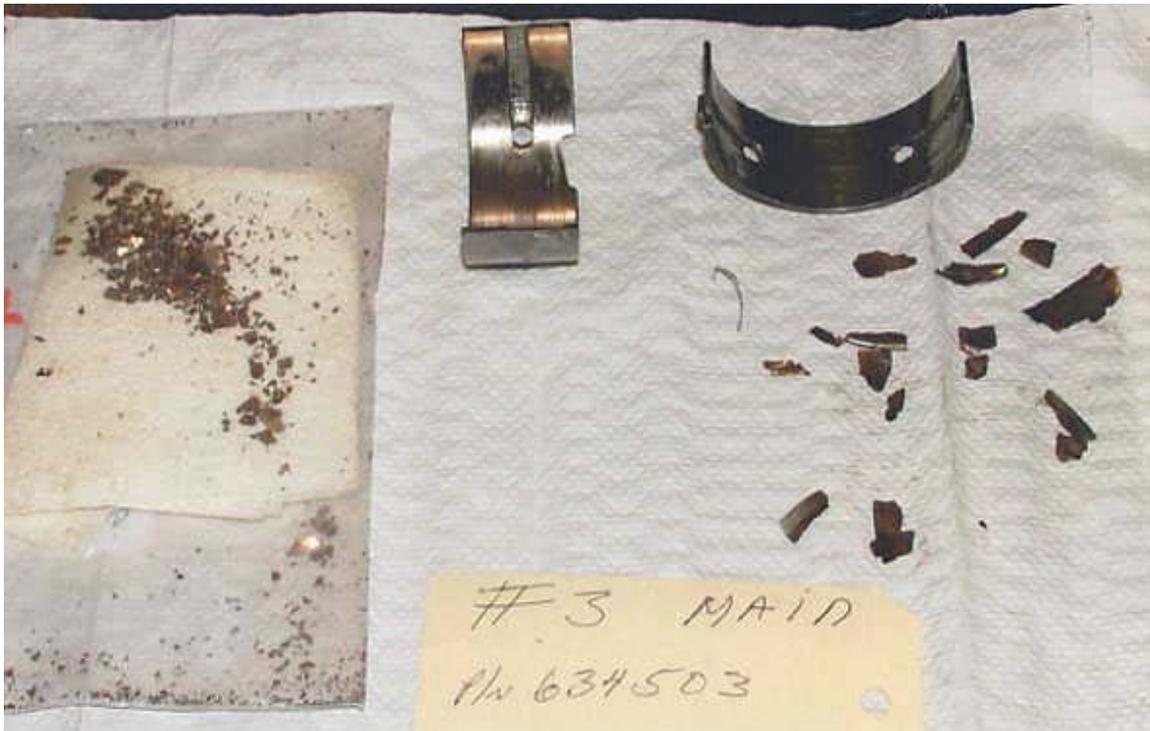
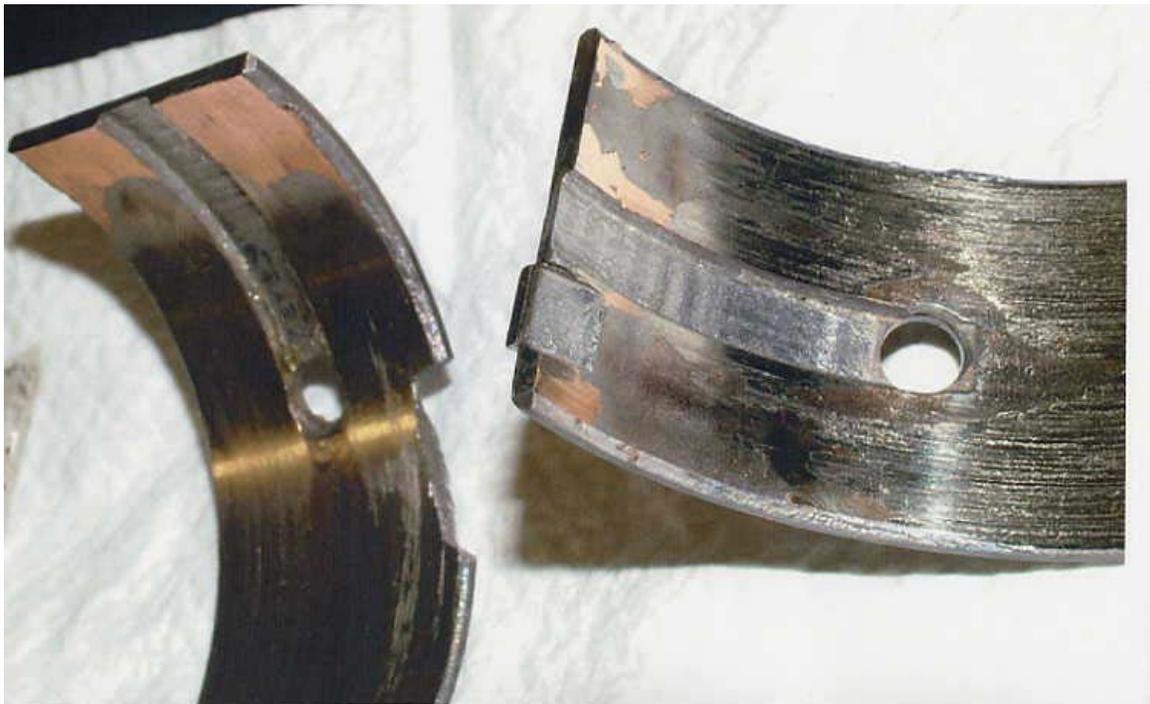
#### **Continental; GTSIO-520; Main Bearing Delamination; ATA 8520**

This mechanic has contributed excellent photographs documenting apparent delamination for his engine's number three main bearing (P/N 634503). He states, "All the brass or bronze separated from the bearing shell. The crankshaft number three journal does not show signs of oil starvation." (No description of this engine's operational circumstances was provided in this report. Two of the submitted photographs are shown below. The SDR data base provides six returns on this part number since 1996. One submission describes, "P/N 630571 (BEARING FOR PROP DRIVER GEAR IN ENGINE CRANKCASE) MARKED ON PACKAGING AS P/N 630571. BEARING ITSELF MARKED AS P/N 634503. P/N 634503 IS CRANKSHAFT MAIN BEARING. PURCHASED NEW FROM TELEDYNE CONTINENTAL MOTORS. BEARINGS WILL FIT IN CRANKCASE SADDLES WHEN SWITCHED, BUT OIL HOLES DO NOT LINE UP AND BEARING OIL GROOVES ARE DIFFERENT WIDTHS. COULD CAUSE BEARING FAILURE/OIL STARVATION. ")
