**Federal Aviation
Administration**

ADVISORY CIRCULAR

AVIATION MAINTENANCE ALERTS

**ALERT
NUMBE
R
323**

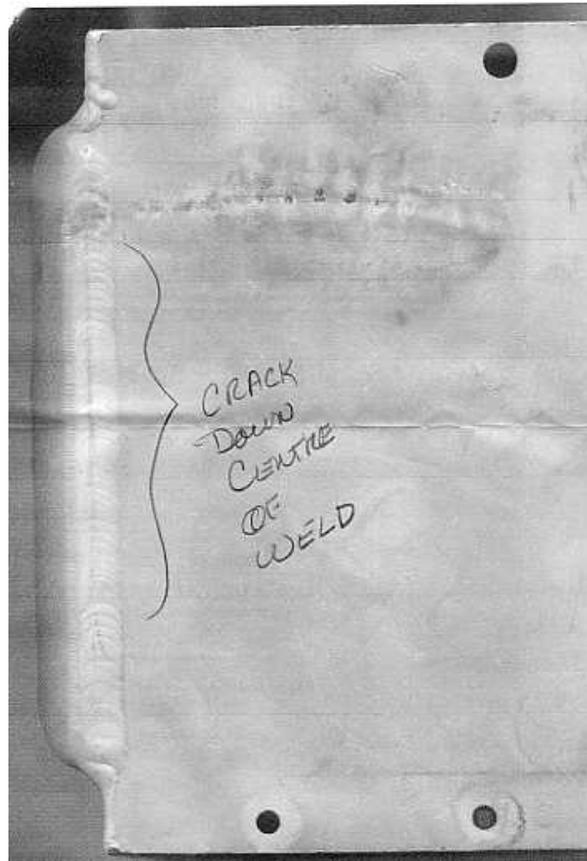
Beechcraft; B60; Cracked Weld on Oil Cooler; ATA 7921

A mechanic found a 2-inch crack down the center of a weld on an oil cooler (P/N 10046A) for a Lycoming TIO-541. *(No other pertinent written data accompanied this submission, but the black and white electronic photo says a great deal.)*

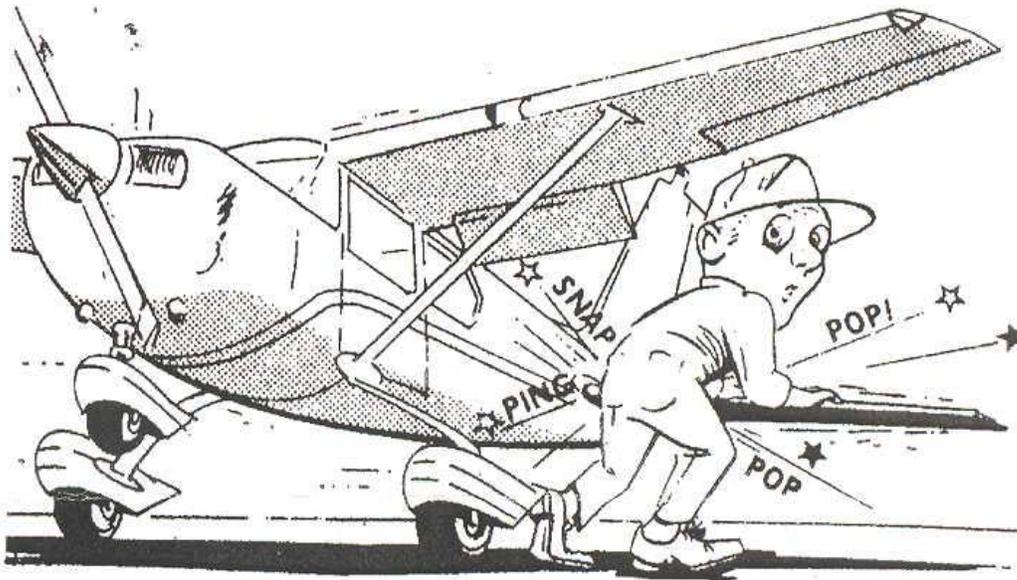
Horizontal Stabilizer Attach Stiffeners

Cessna; All Single-Engine Models; Improper Ground Handling; ATA 5510

“Service experience and engineering tests show damage can be caused by excessive loads being imposed on the horizontal stabilizer when improper procedures are used during ground handling. It is important that pushing forces be applied close to the fuselage when moving an aircraft by the horizontal stabilizer. Check the procedures given in your Cessna Service Manuals. The best procedure for ground handling would be to use a tow bar. Note: This article has been published in previous Alerts. Reports indicate improper procedures are still being used.”

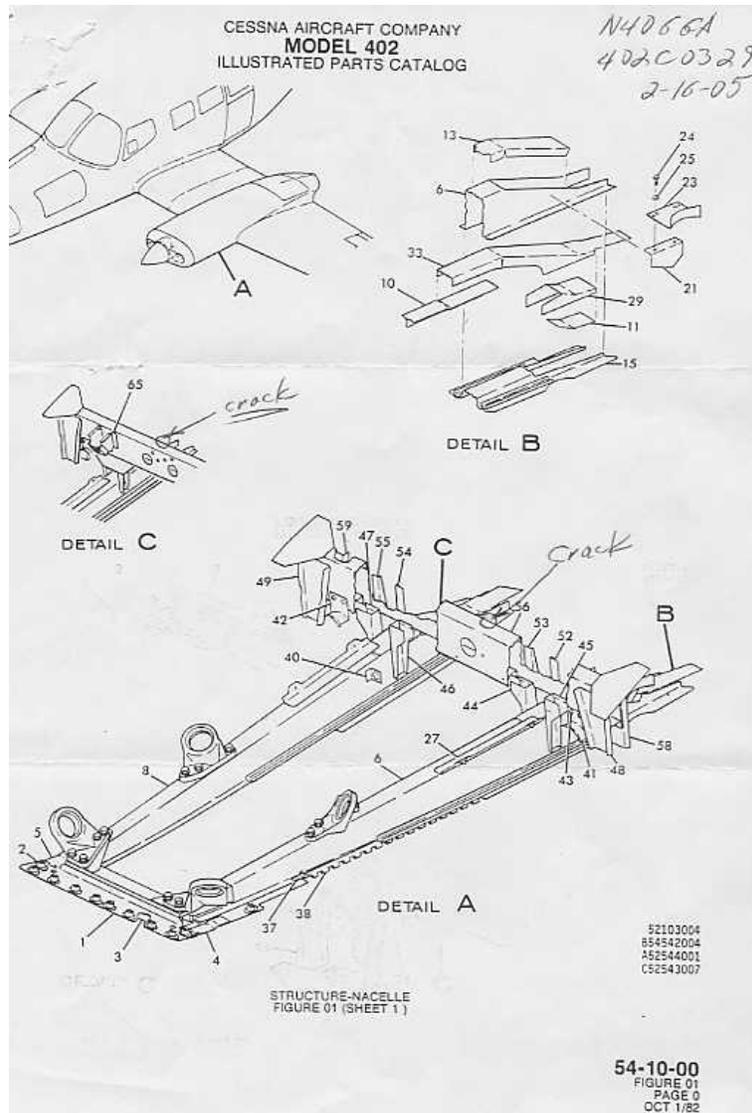
Cessna; 402C; Cracked Engine Nacelle Crossover Beam; ATA 5411

A mechanic found a 1.5-inch crack in the top rear radius of this aircraft's L/H engine nacelle crossover beam (P/N 5654104-11). Repair was affected by part replacement (*see below copy of Cessna Parts Catalog*).

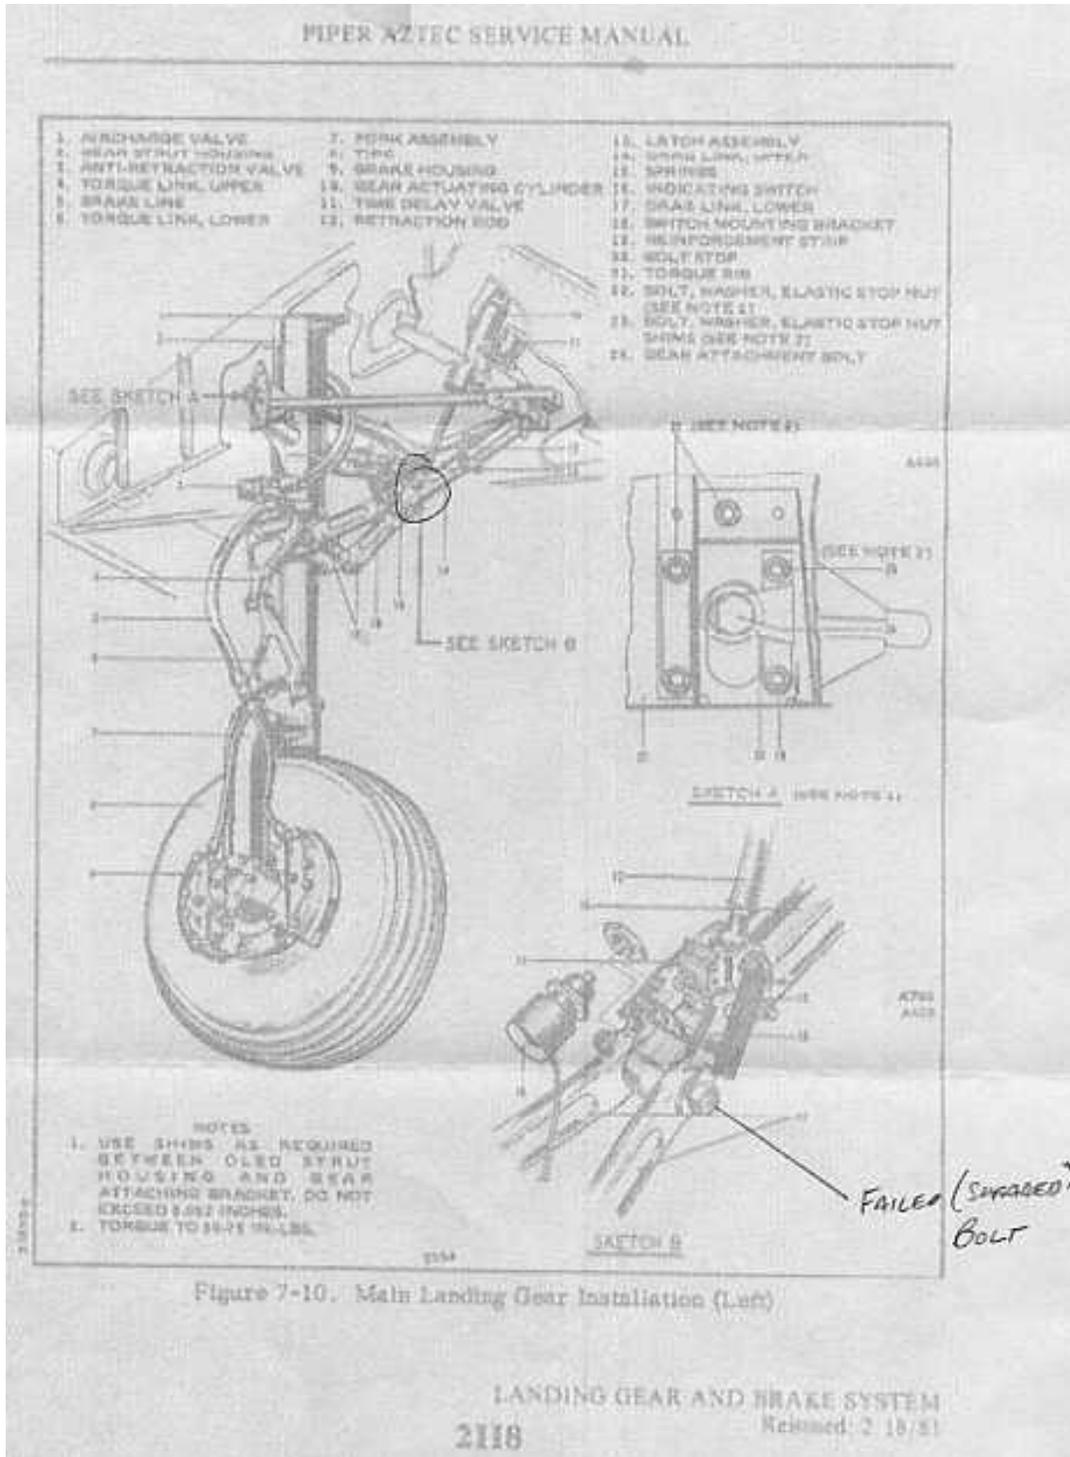
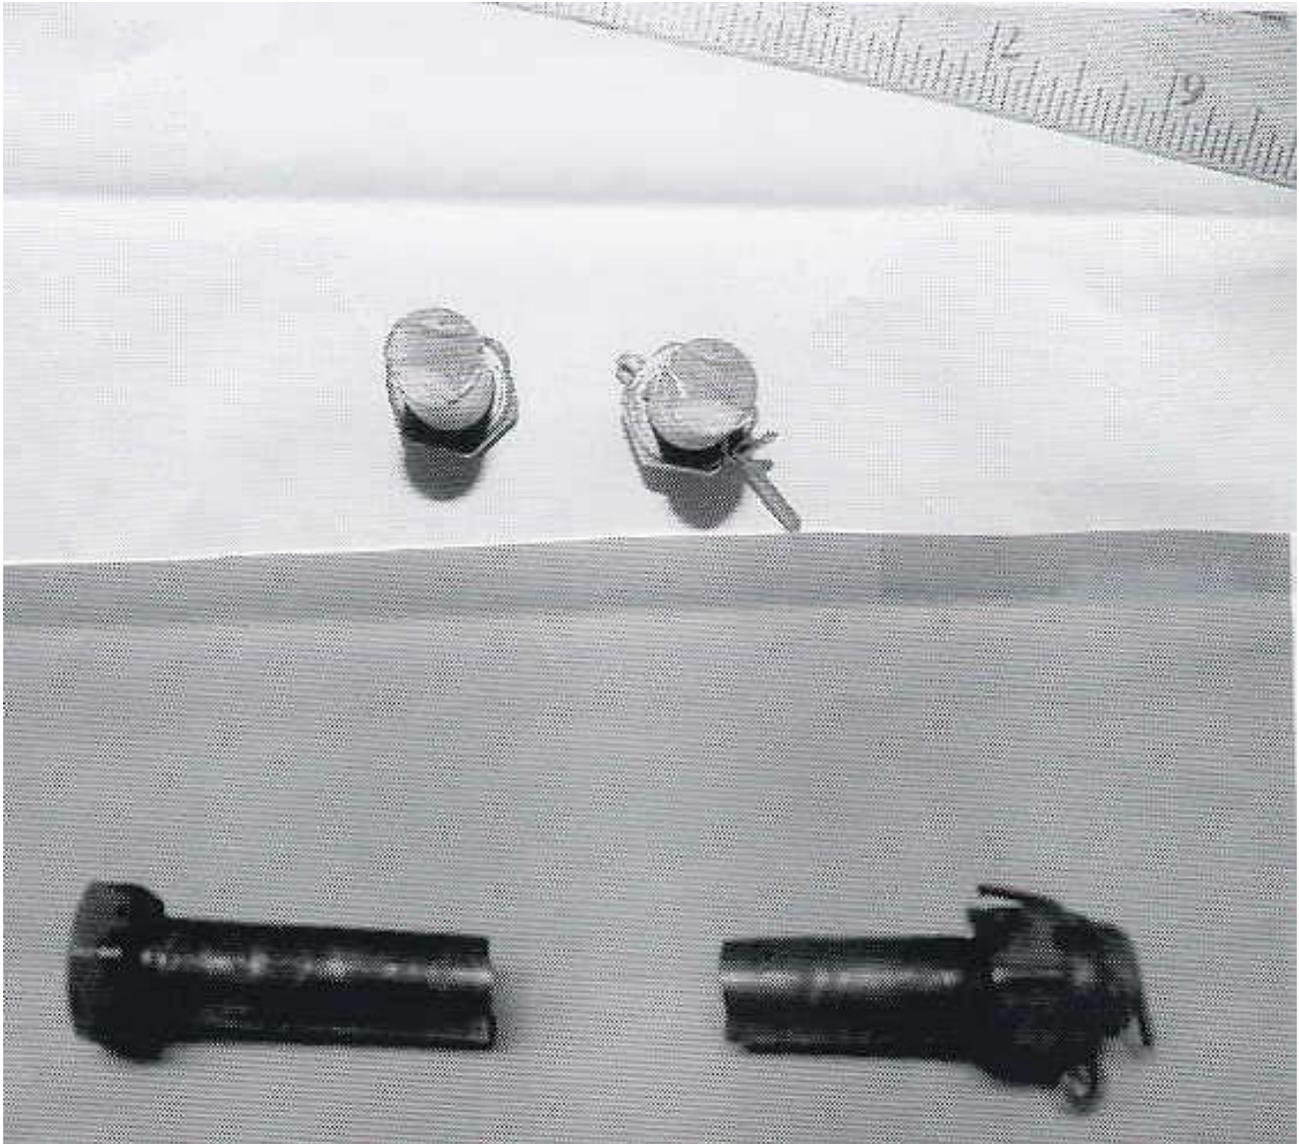
Piper; PA 23-250; Sheared Main Gear Drag Link Pin; ATA 3213

This "...Piper Aztec was on roll out after landing when the L/H main landing gear drag link assembly separated between upper link assembly (P/N 16190-00) and the lower link assembly (P/N 16240-05)," states the writer. "This allowed the L/H main landing gear strut assembly to fold aft, allowing the aircraft to collapse on the runway. When the aircraft was recovered, the L/H main landing gear center drag link attach bolt (P/N 402-427 and/or AN177-27) was found sheared in the center of the bolt shank. Both halves of the bolt were still in the L/H lower drag link leg and were able to be removed for inspection. Visual inspection of the bolt's fracture indicated an existing crack across approximately 3/4 of the bolt's shank, with a new crack through the remaining 1/4 of the bolt's shank. A replacement bolt was installed to facilitate recovery of the aircraft...*(and it)* was subsequently turned over to the owner for repairs to be completed." *(A copy of the pertinent page in Piper's Service Manual was included with this submission, and two pictures of the sheared bolt.)*

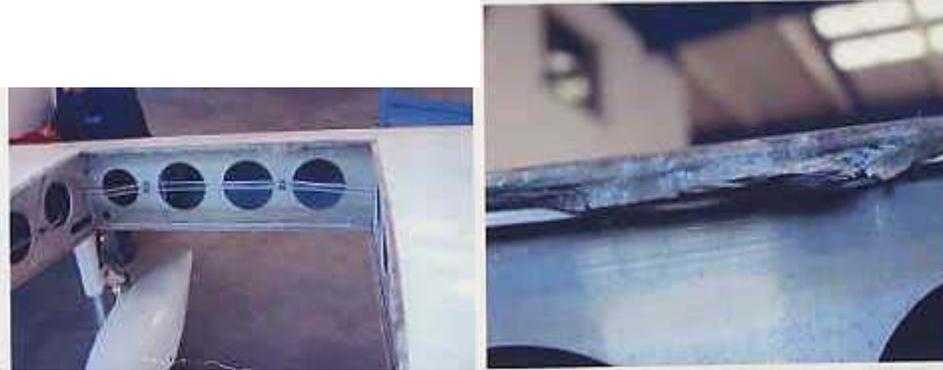
Piper; PA 28-140; Spar Cap Corrosion; ATA 5711

This submission describes severe exfoliation corrosion in the L/H wing spar cap (P/N 67070-02) just behind the fuel tank. Piper Service Bulletin 1006 requires this tank to be removed for inspection. “There was no indication of corrosion swelling on the surface of the wing,” states the technician. “The area where the corrosion occurred is not visible from the inspection panel access and requires the fuel tanks be pulled for inspection of this area.” (*Two of six submitted photographs are shown below.*)

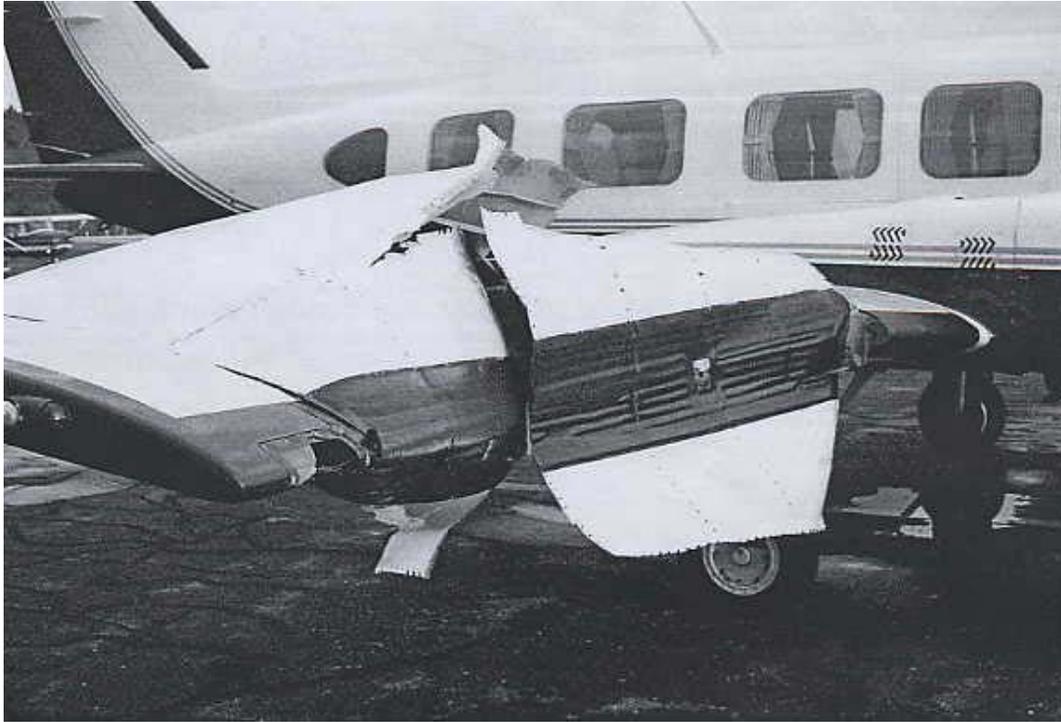
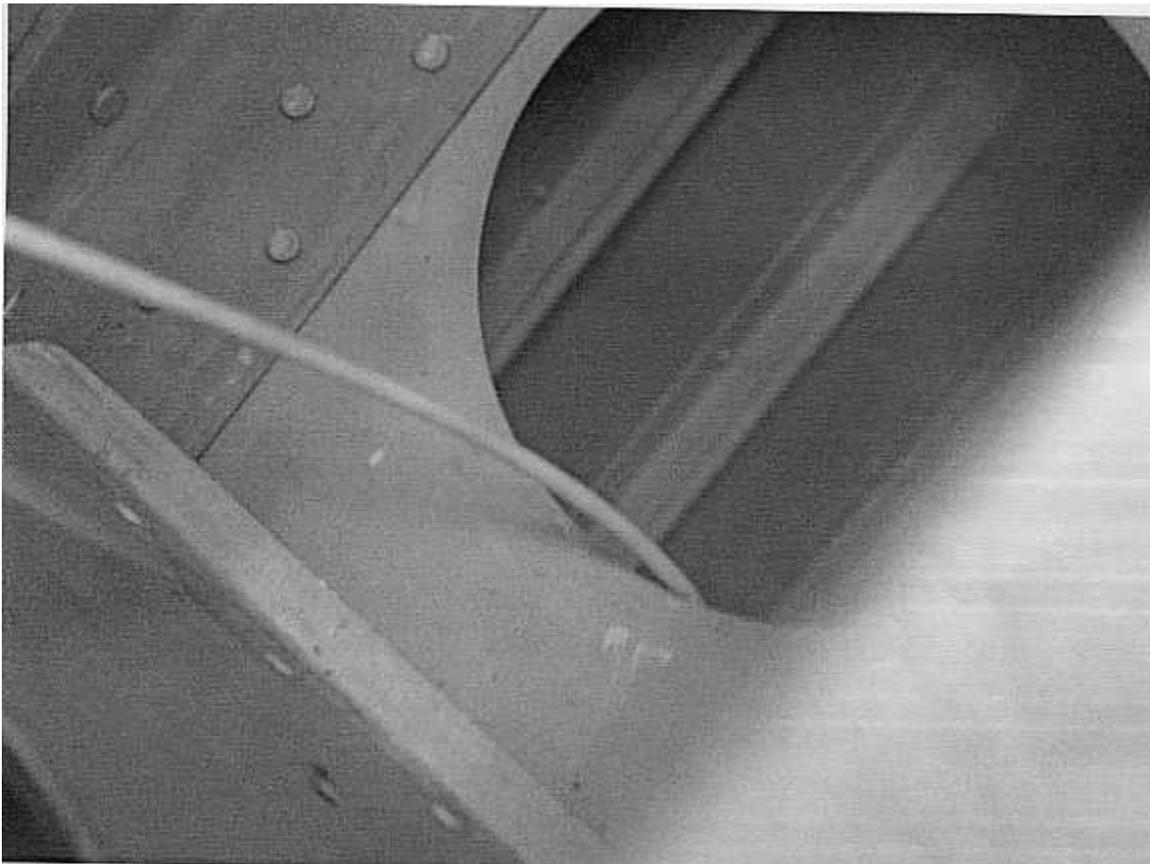
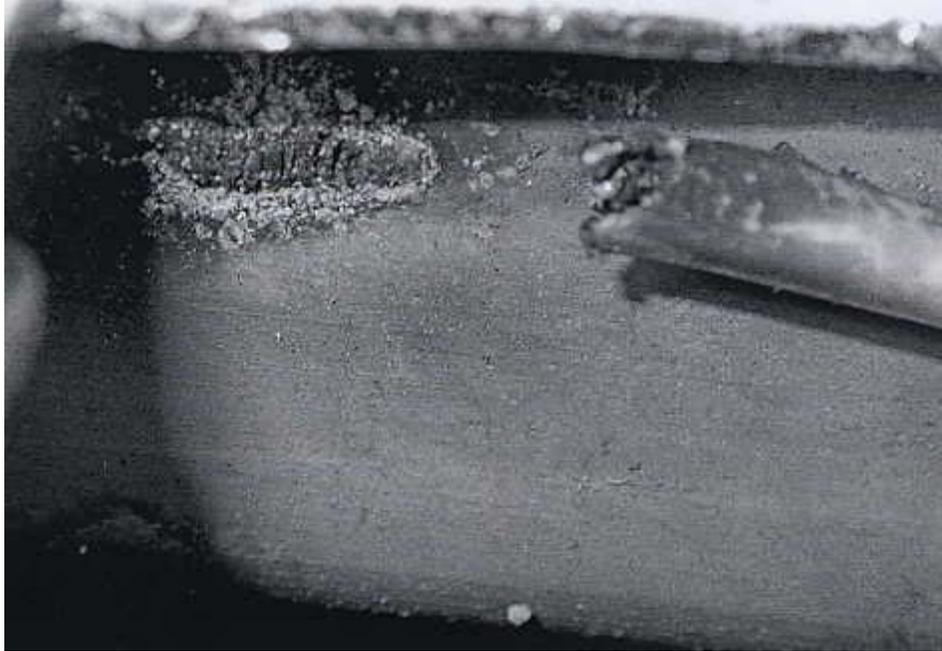
Piper; PA 31-350; Improper Electrical Wiring of Wing Lights; ATA 3340

This aircraft's "...R/H wing exploded on take-off roll," states the submitter, "...due to ignited fuel vapors trapped in the empty wing cavity outboard of the fuel cells." Investigators determined about 700 feet into the takeoff roll the left engine began to loose manifold pressure and the pilot began to abort the takeoff. While the pilot was decreasing power, the outboard section of the right wing exploded. The aircraft was stopped on the runway and the pilot and his six occupants evacuated the aircraft without injury. This submitter goes on to state, "Further inspection revealed the R/H main fuel cell vent nipple was broken off and very brittle and deteriorated, allowing fuel vapors to accumulate in this cavity." The submitter also points out "...the aircraft was previously fitted with Colemill wingtip and landing light modifications." The modification was done in accordance with STC SA1151SO. The 28-volt power wire for the wingtip and landing light assemblies "...had been routed from root to tip following an aft stringer and passing through ribs via stringer cutouts--with no protection. This wire was found to be shorted and burned off with evidence of arcing at the approximate wing station number 148...causing ignition of the above fuel vapors." The submitter recommends "...the incident could have been avoided with proper fuel cell (and nipple) inspections (in accordance with the manufacturer's instructions) and routing wires properly using guidance in Advisory Circular 43.13--1B." The subsequent FAA investigation revealed the wing and landing light wiring had not been installed in accordance with the approved STC, which required the wiring to follow existing navigation light wiring along the front spar and not through the rear fuel cell cavity. The Philadelphia FSDO is currently initiating a safety recommendation to require all PA 31 operators incorporating STC'ed Colemill wingtip assemblies to check for proper wiring, electrical protection, and installation conformity. In addition, it is recommended all operators of similar aircraft utilizing rubber fuel cells perform a visual check of the exterior of the aircraft wings and or fuselage for signs of leakage, fuel wetness or color dye stains, especially in the vicinity of vents and compartment drains, and have properly certificated mechanics investigate the source to determine proper corrective action prior to flight. *(Three photographs follow. No times were provided.)*

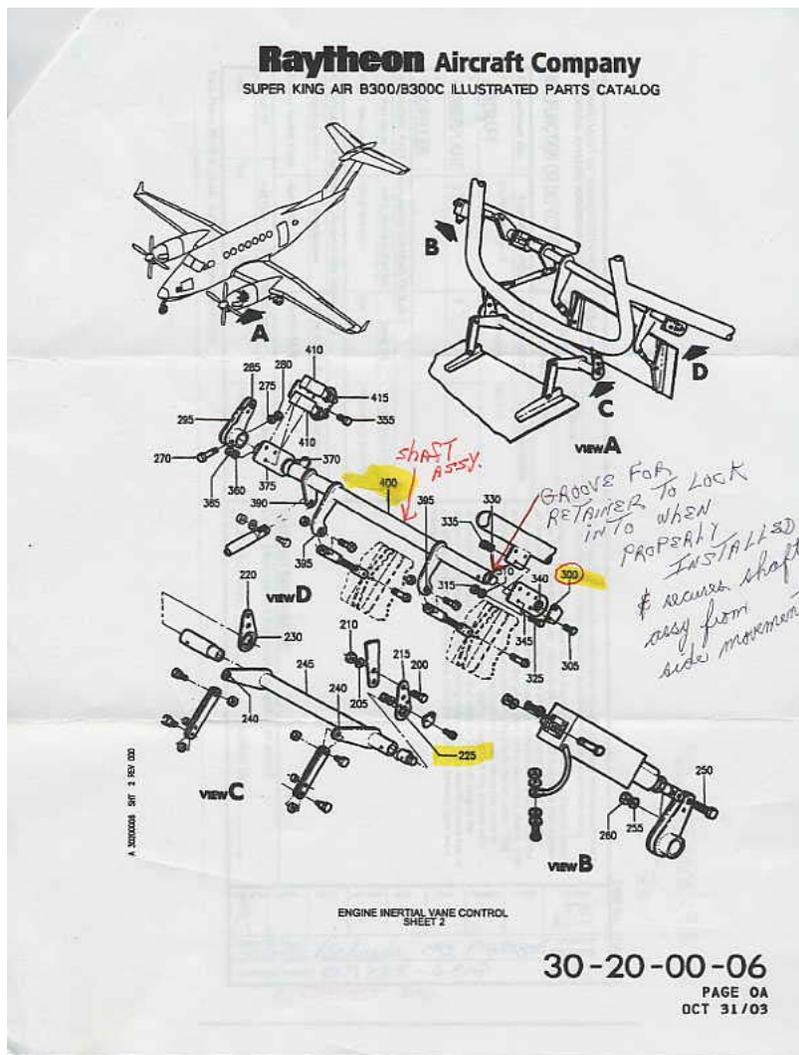
Raytheon (Beech); B300; Improper Installation of Inertial Guide Vane; ATA 5400

A mechanic states, "During a normal phase inspection of the Engine Inertial Vane Control System it was found the retainer plate (P/N 101-910114-35) which locks into a groove on the shaft (P/N 101-910114-129) for the aft inertial vane was not installed correctly. When the retainer plate is correctly installed in the groove on the shaft assembly it would securely hold (*this assembly*) in its mounting plates. This retainer plate is located on the vane shaft end opposite the actuator. This (*improper*) situation allows the shaft assembly to move back and forth when the vane is operated through its (*normal*) range. We have found this excess side movement would also allow the bolt that secures the shaft assembly to the actuator (*to possibly*) catch on the surrounding support. This condition was found on both engines of this aircraft. The shaft assemblies for the forward vanes were found to be correctly installed. (A Raytheon B300 parts drawing is shown below.)

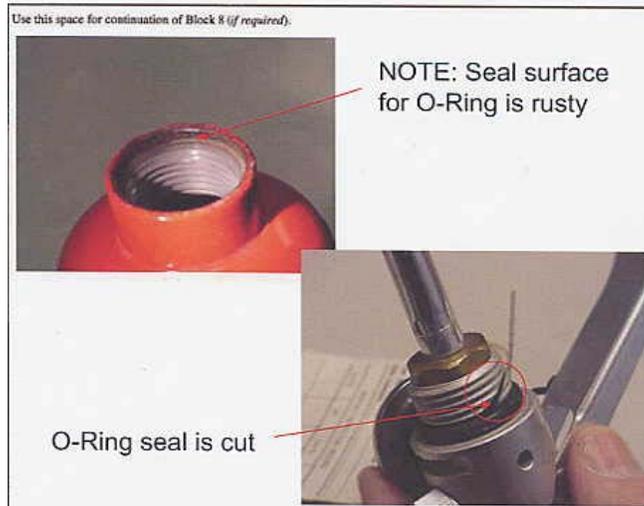
Amerex Fire Extinguisher (*Portable*); Model 344; Depleted Bottle; ATA 2622

The submitter describes this extinguisher to have passed both weight and pressure checks, and then it was stored appropriately (*storage time not provided*) while the host aircraft underwent inspection. Upon reinstallation of this unit into the aircraft, the technician noticed the Halon was depleted, even though all safety seals were intact. Investigation found the cylinder head to be loose and the o-ring damaged. (*Shown below are two photographs that accompanied this submission, followed by another Alert report on the same type of bottle.*)

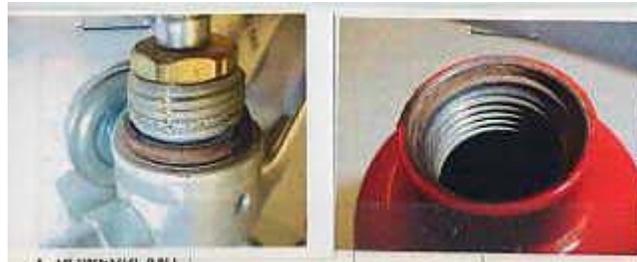
Amerex Fire Extinguisher (Portable); Model 344; Depleted Bottle; ATA 2622

This fire bottle was found completely discharged and its nozzle assembly loose. The inspecting technician describes the unit’s valve threads as being corroded and the o-ring seal deteriorated. Improper valve torque was offered as a possible cause for these discrepancies. (Two accompanying photographs are shown below. The Amerex web site: <http://amerex-fire.com/main.asp> contains excellent information--especially under the “Distributor’s Corner,” on the home page, then select “Technical Tips.” Their discussion makes very clear the specifications for servicing these bottles--specifications not complied with on many units returned to them.)
