U.S. Department
of Transportation
**Federal Aviation
Administration**

ADVISORY CIRCULAR

43-16A

AVIATION MAINTENANCE ALERTS

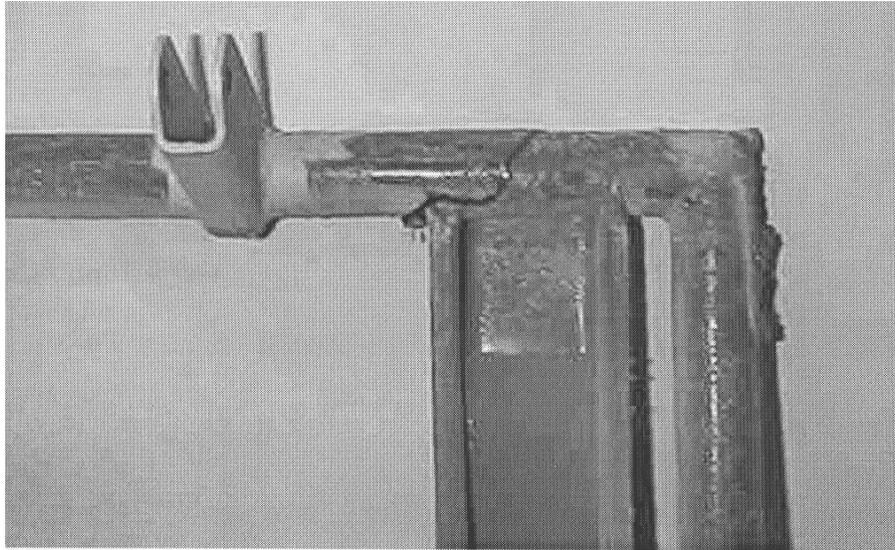
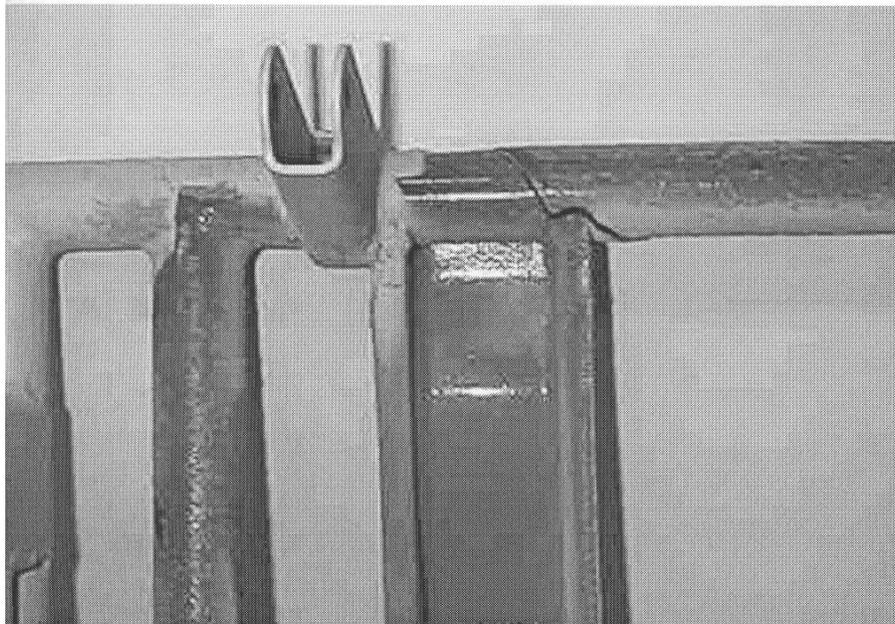
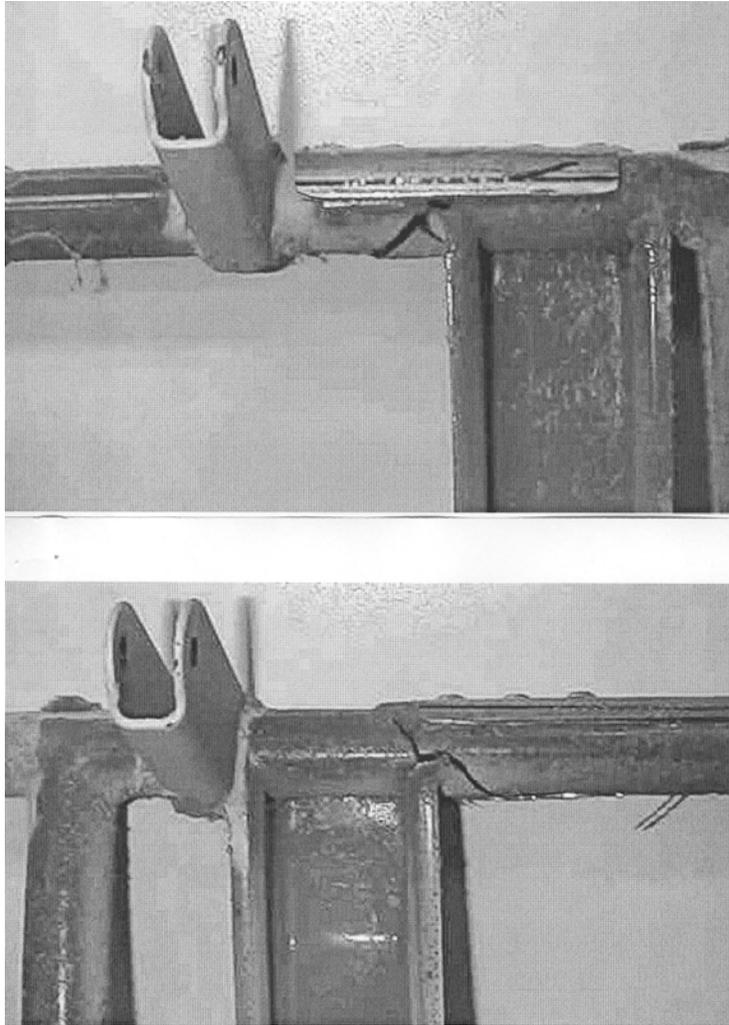
Cessna; 550; Cracked Seat Frames; ATA 2500

(The following description is a composite of three defect submissions on the same aircraft having identical cracks in the same locations on three different seat frames. Four of eight enclosed photos are shown below.)

The repair station technician states, the "...upper chair base assembly cracked at chair back attach points." (*Seat frame P/N 55-19009-21, 55-19009-22, 55-19009-32.*) These chairs were repaired in accordance with "...Aviation Fabricators STC STO1042WI Structural Seat Repair." He notes pictures 3 and 4 (below) show the remnants of a previous, inappropriate repair.

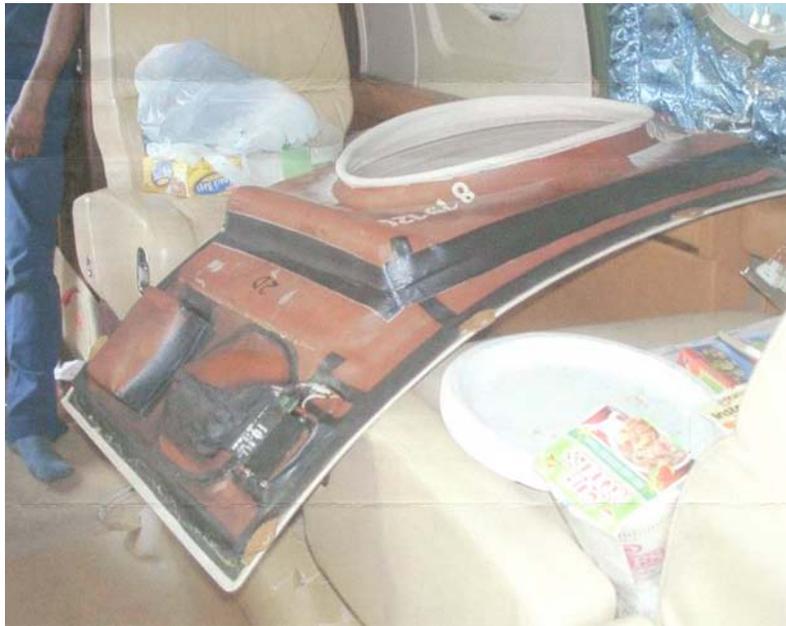
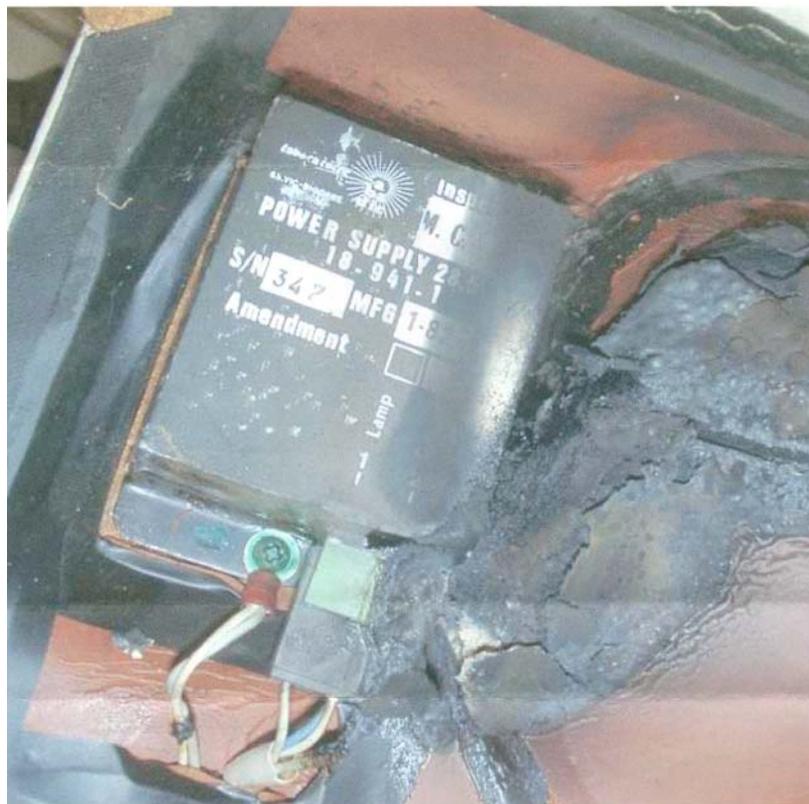
Dassault; DA50; Burned Cabin Lighting Power Supply; ATA 3320

The writer states the "...crew had power on the aircraft and noticed an electrical burning smell from the cabin. After investigating, they found the cabin indirect lighting circuitry breaker popped. The maintenance facility troubleshot the problem to a power supply (P/N 18-941-1) that burned up." This report recommends further inquiry into this particular power supply to determine suitability for its continued use. "Dassault Aviation issued a 'RECOMMENDED' Service Bulletin F50-335 for replacing the power supplies with an improved power supply that incorporates a protection circuit. These lighting systems were installed under Dassault Aviation Modifications F50 M2065 + M2674. This aircraft will have S.B. -335 installed as soon as parts can be procured." *(The following two photographs, slightly cropped, show the power supplies to be located behind the L/H sidewall panel.)*
