U.S. Department  
of Transportation  
**Federal Aviation  
Administration**

## ADVISORY CIRCULAR

# AVIATION MAINTENANCE ALERTS

**ALERT  
NUMBER  
325**

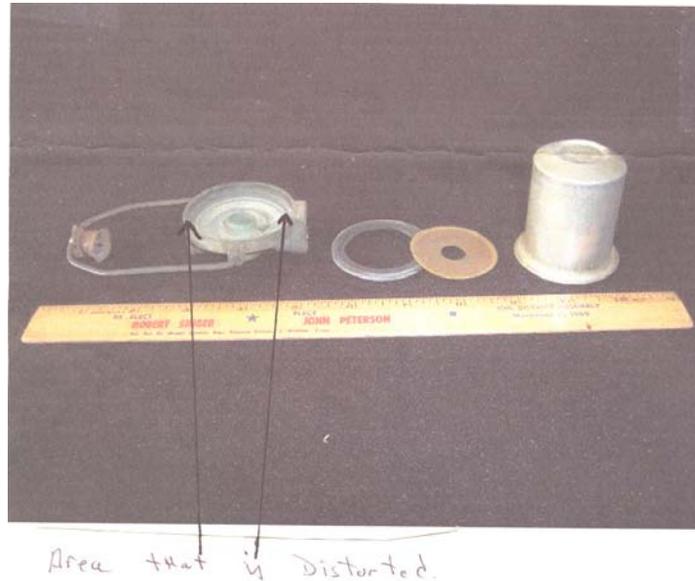
This technician has observed bending deformation in the fuel filter's bowl cover (P/N 14428-00) as result of the wire assembly bail (P/N 494-644) being tightened. "Over the years, the force of the bail actually bends the frame (*to the point*) the gasket will no longer seal, and fuel will seep by the gasket when the bowl is rocked forward and aft -- 90 degrees to the location of the bail assembly. The only option to remedy the situation is to replace (*the gascolator*) with factory new or an STC replacement."

Part Total Time: 2,895.0 hours.

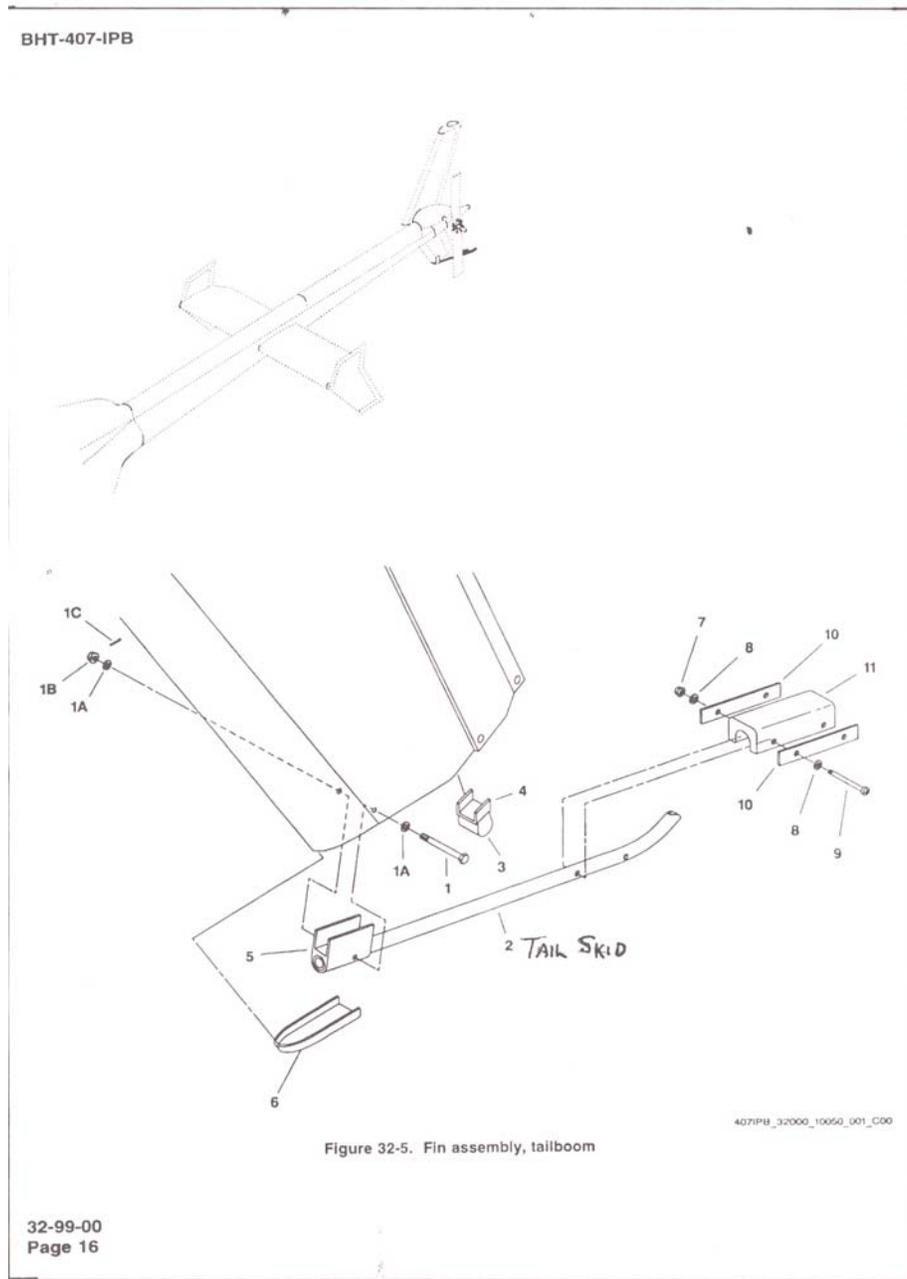
A pilot found the tail skid (P/N 206-020-110-103) to be loose during a preflight inspection. "Upon closer examination, the tail skid pulled out from the fin assembly. The tail skid had cracked completely around and through at the attachment bolt hole. By the appearance of the broken ends of the tube, this crack propagation was slow." (*He notes one occurrence of a hard landing 4 years and over 2,700 hours prior to this defect. The SDR database records another three occurrences of cracked tail skids at this same location.*)

Part Total Time: 4,517.5 hours.
