U.S. Department
of Transportation
**Federal Aviation
Administration**

ADVISORY CIRCULAR

AVIATION MAINTENANCE ALERTS

**ALERT
NUMBER
326**

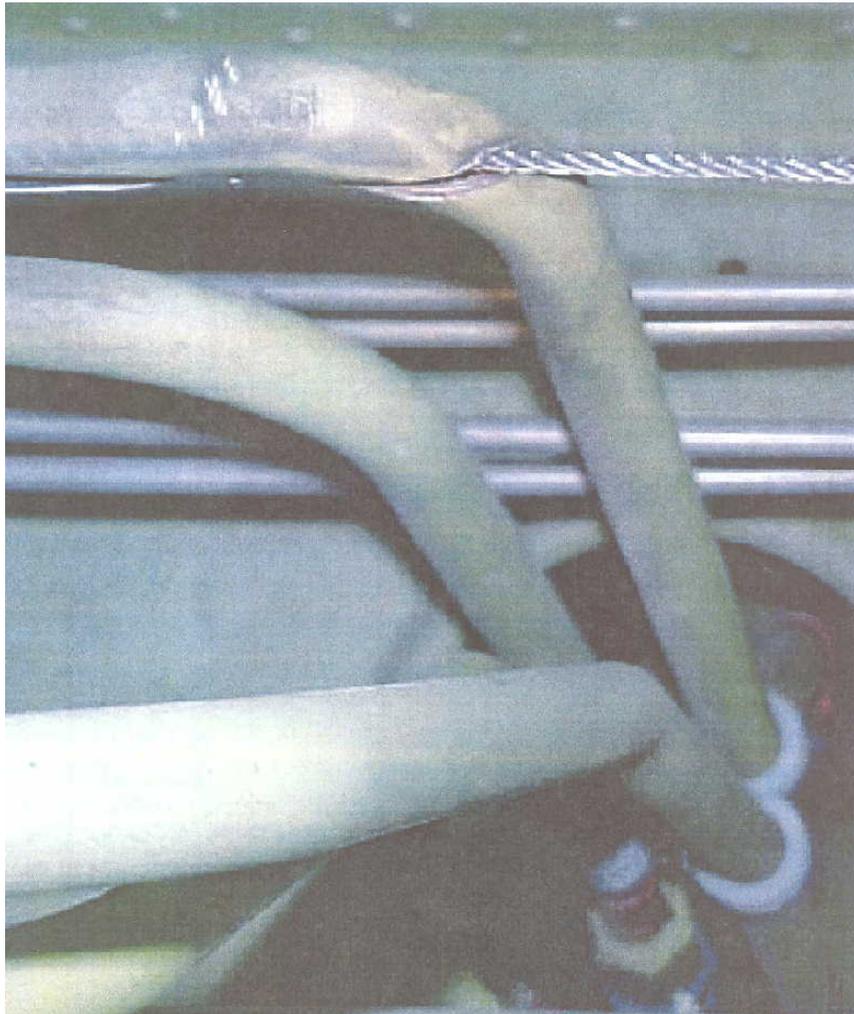
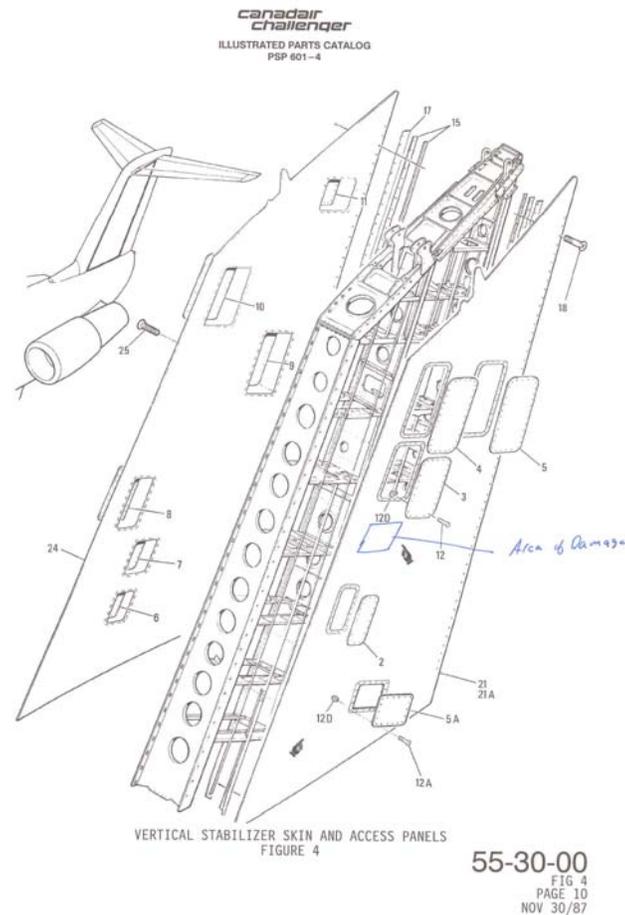
Canadair; CL-600-2B16; Cut (...sawed) Electrical Conduit; ATA 3340

A repair station technician investigates an intermittent circuit breaker fault for this aircraft's upper anti-collision light. "...*(I)* discovered the L/H elevator control cable had torn through the wiring conduit in the vertical stabilizer. The cable wore through the conduit and shorted out the wiring for the upper beacon. *(I)* repaired the wiring conduit, replaced the wiring, and replaced the control cable in accordance with the manufacturer's instructions." He describes ensuring sufficient clearance between the cable and surrounding conduits, but wonders about the origins of this defect. "*(It)* is unclear if the conduit was installed at the factory or at the time of *(aircraft)* completion. *(I)* suggest inspection of this area on other, similar aircraft. *(It is a)* difficult *(defect)* to notice due to the accessibility of this area in the tail." *(The part number for this particular electrical conduit segment was not provided.)*

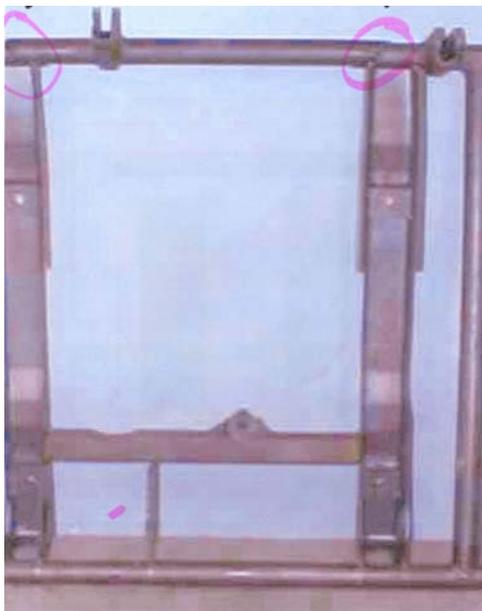
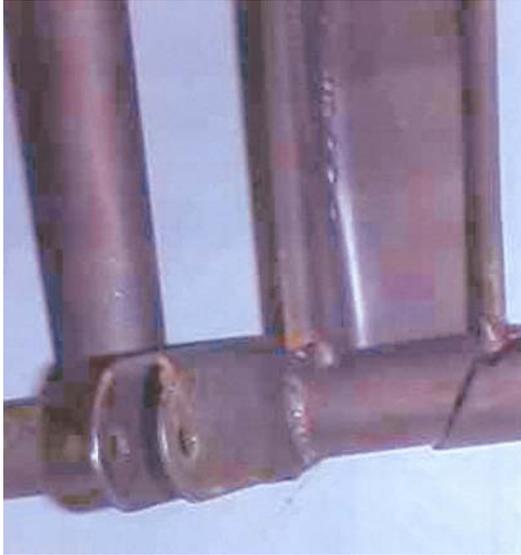
Cessna; 501; Broken Seat Frame; ATA 2510

An upper chair base assembly (P/N 5519015-6) was found cracked at the attach points. The submitter believes stress and metal fatigue are the probable causes. This chair was repaired in accordance with Aviation Fabricators STO1J043WI (supplemental type certificate) structural seat repair. (*Two photographs are shown below. Reference last July’s Alerts for very similar report.*)

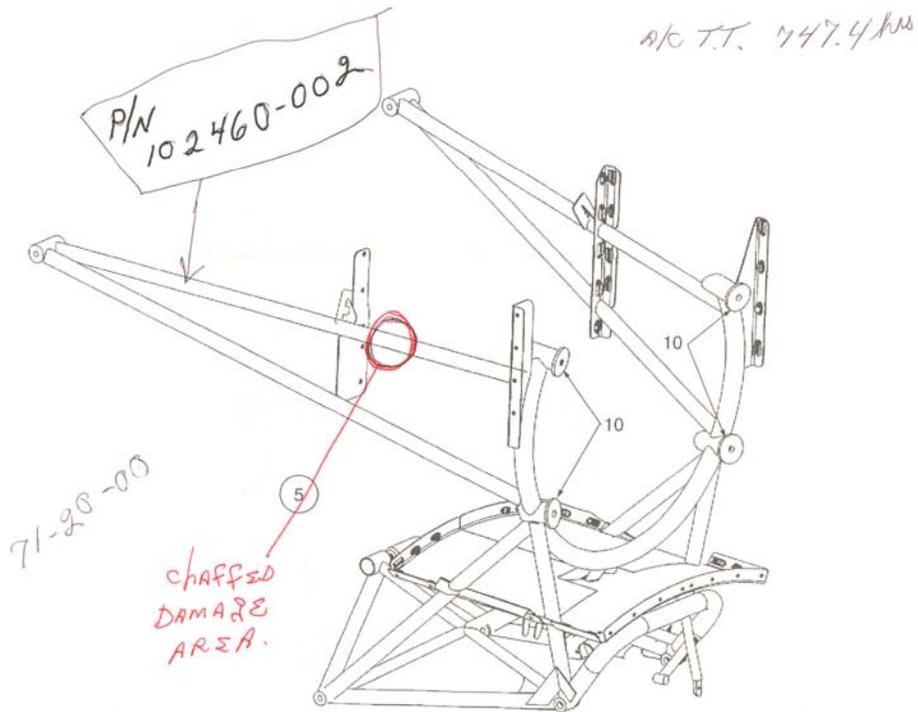
Figure 50. Engine Mount Assembly

A technician writes, "During a normal event inspection, the air shield was found chaffing against the upper R/H engine mount leg where it passes through the baffle shield (P/N 102403-053) for the plenum assembly. This type of a problem has been discovered on other model aircraft, and it is recommended close inspection be given to the area where baffling could be cutting into the engine mount. Both times this (*defect*) was found, the engine mounts had to be repaired by approved welding methods and authorized repair facilities." (*The SDR data base reflects another, very similar chafing discrepancy.*)

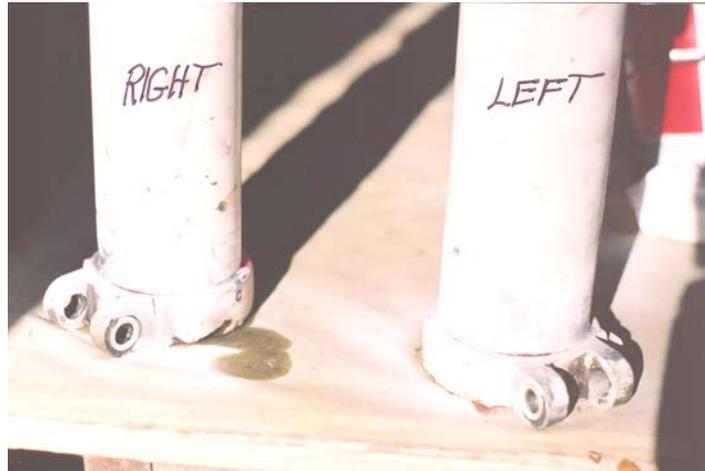
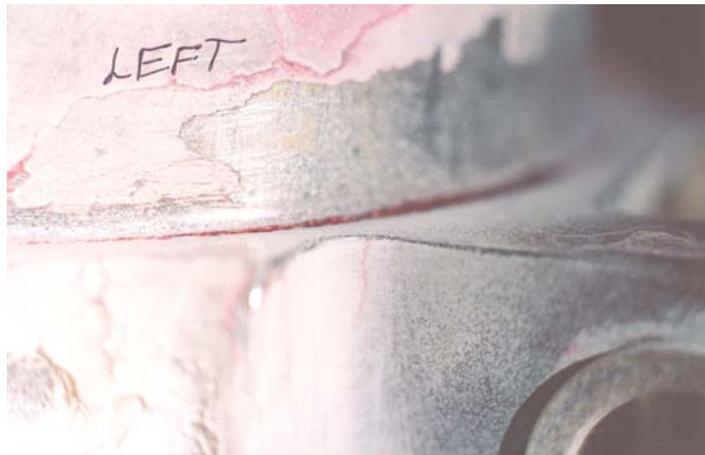
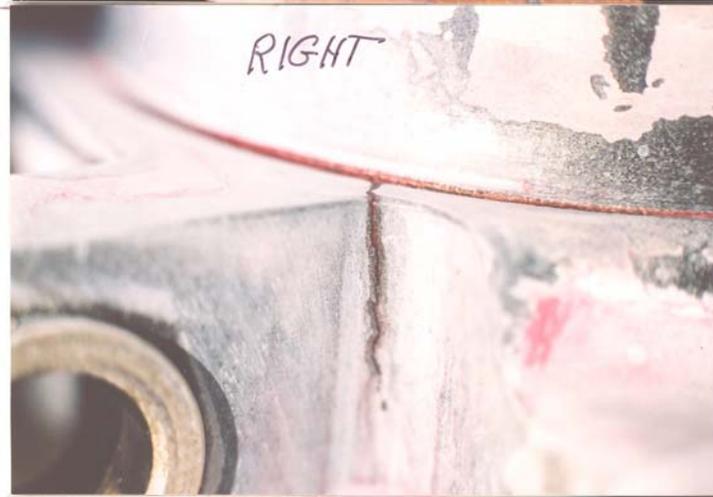
Piper; PA600; Main Landing Gear Strut Cracks; ATA 3213

(The following is a composite description of three submissions from the same mechanic for two aircraft: a PA600 and a PA601.) The left main landing gear strut bottom collar is "...separating from the tube due to insufficient penetration when the part was furnace brazed or silver-soldered together. The working cylinder (P/N 400054-01) collar caused the part to work and crack the boss. (I) recommend inspection of the collar at the bottom of the gear strut for any movement or working between the collar and the strut cylinder assembly. Dye check the collar where the part is machined for clearance on the torque links."

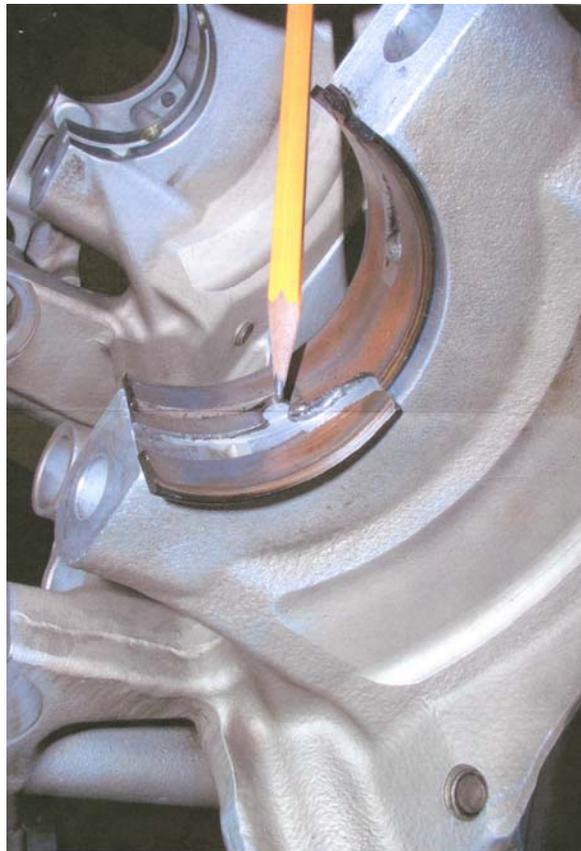
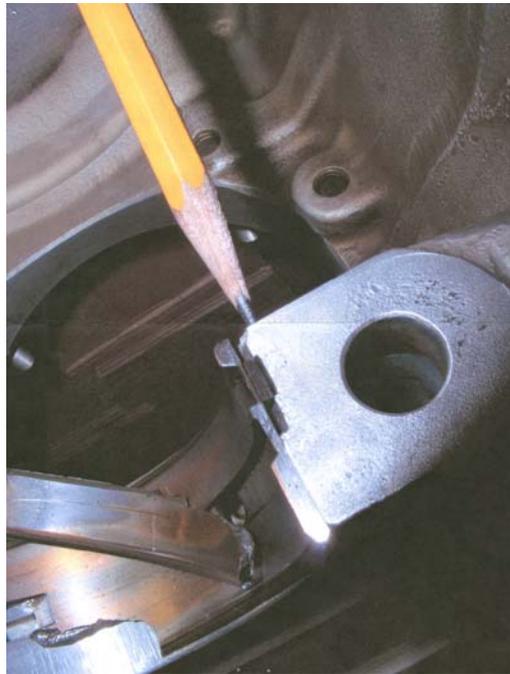
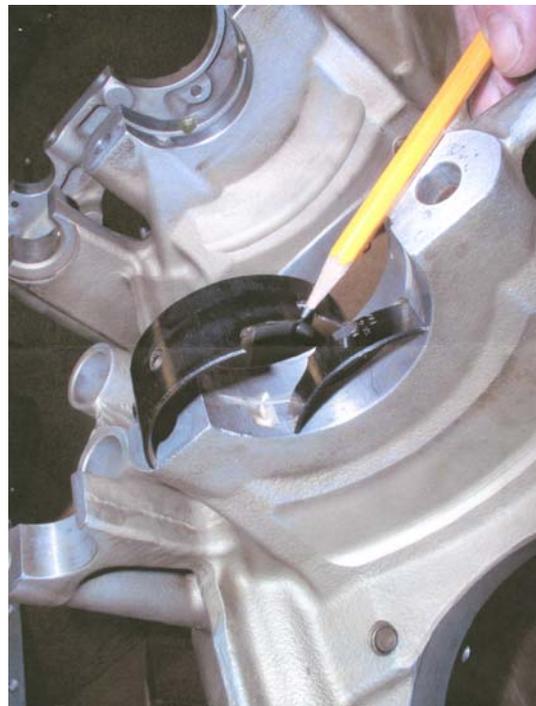
Continental; IO-550-F; Broken Crankshaft Bearing; ATA 8520

A repair station mechanic disassembles this engine and notes a broken bearing shell, number two “...from the rear saddle. It appears the bearing has worked—and is polished as result.” Fretting on the parting surfaces and a malformed bearing tang also provide evidence for a working bearing (P/N SA634503M010). (*Great pictures! Next time, if possible, please “flesh-out” a few more details: TSO, TT, Part Times, operating conditions and earnest speculation—they all provide insight and education. Thanks—Ed.*)

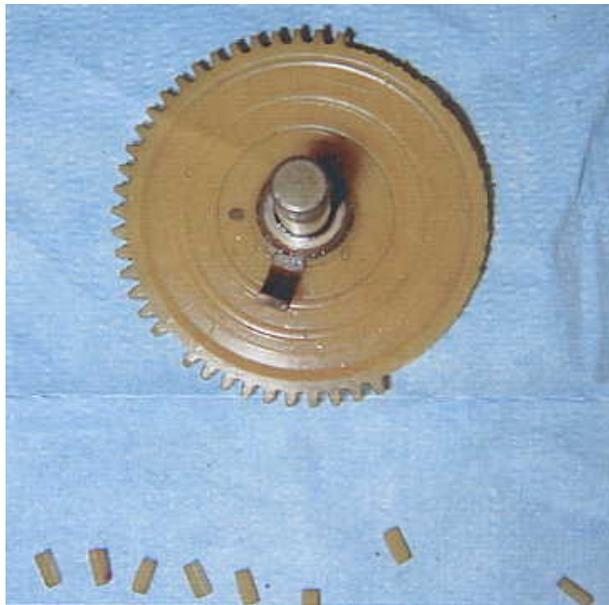
TCM Magneto; 10-500556-1; Teeth Missing--Distributor Gear; ATA 7414

A Piper PA-32R arrived at a mechanic's hangar with a rough running engine. Diagnostics determined one side of the dual magneto was dead. Upon removal and disassembly, this magneto's defect became clear: multiple teeth were missing from the timing gear. The owner described this particular magneto as "...low time," but no specific hours were provided. Aircraft total time was given as 2,289.8 hours. (*Gear part number not provided. See an example in the next Alert item's attached photograph.*)

This failed magneto was removed from a Continental O-470 powering a Cessna 182H. Twenty-four teeth were found missing from the distributor gear (P/N 10-357584). New replacement gear (P/N 10-357586) provided new life for this unit. (*Time since overhaul is estimated at 678.0 hours. The following photograph nicely depicts 'dental' problems with distributor gears.*)

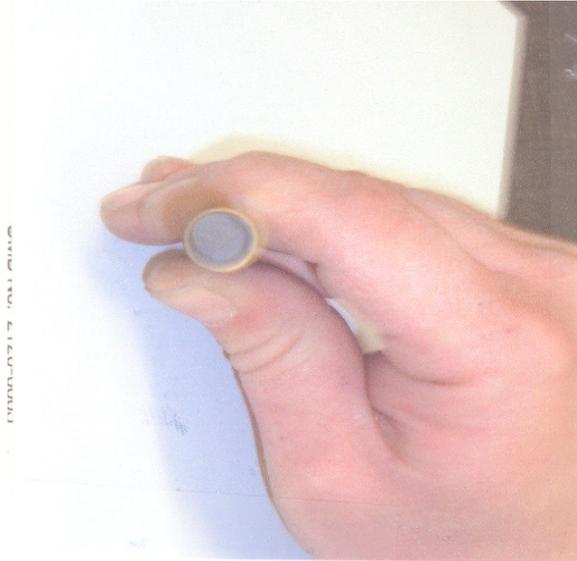
Superior Air Parts; Engine Through-Bolts; Broken Bolts; ATA 8530

A mechanic states, "12.36 hours after installing (*this particular*) through-bolt and torquing it to specifications—the bolt broke (P/N SA641931-10.75; Lot/N B05006996). (*This*) totals five broken bolts on three different engine models." (*Unfortunately, the applied torque for a given application was not provided. Original bolt specifications and their comparison to bench-test results of a couple of new and used bolts would have been very telling.*)

One can increase the “validity” of any concern by describing frequency and method of instrument calibration, and degree of sample control. A necessary condition of validity is “reliability”. Reliability improves for any concern by increasing the number of measures. At what torque values do brand “X” and “Y” fail? How many times out of five tests, does each succeed or fail? Finally, include contact information. Your measures have to be repeatable by others, further increasing “reliability.” Perhaps other mechanics that have experience with these bolts will provide additional detail. See the attached picture.)
