ADVISORY CIRCULAR

43-16A

AVIATION MAINTENANCE ALERTS

**ALERT
NUMBER
327**

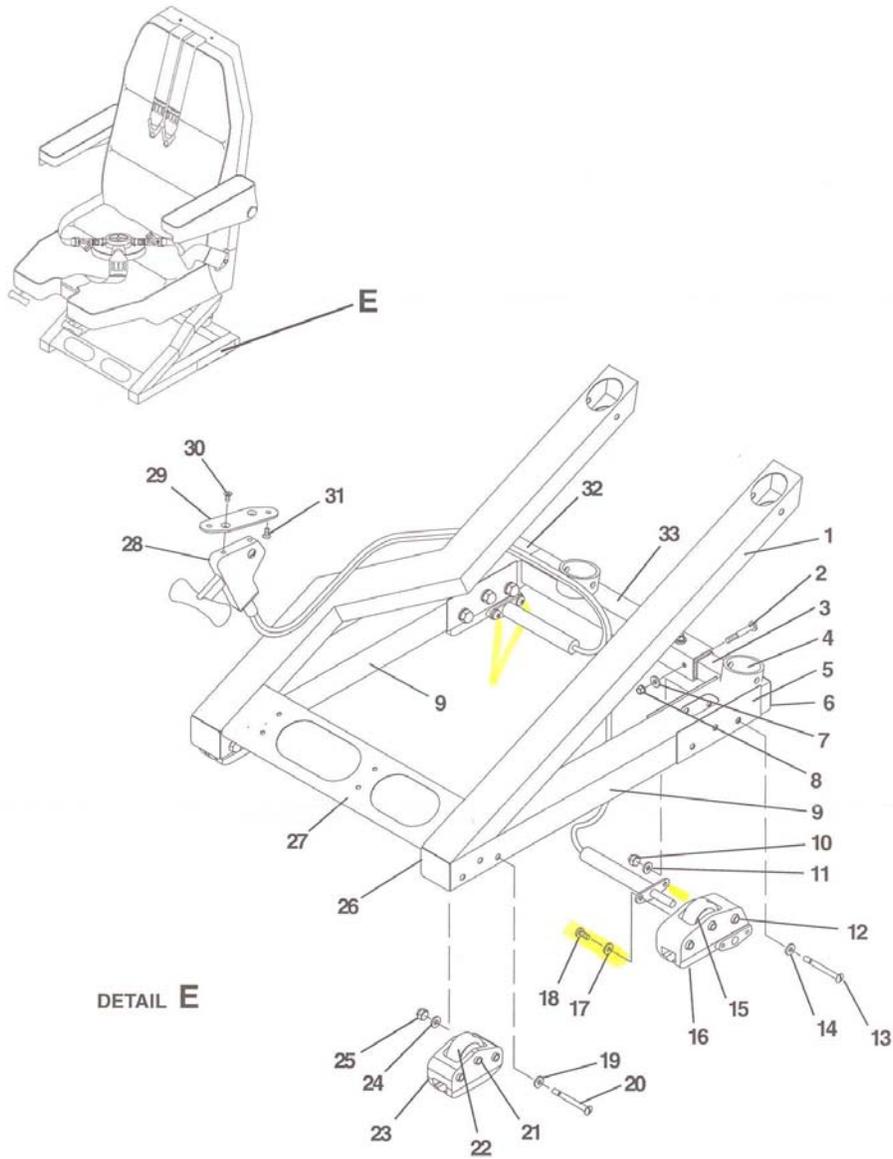
DETAIL E

Cessna; 750; Loose Seat Locking Screws; ATA 2510

A repair station technician writes, “The screw depicted in Cessna 750-0202 Interior Manual 25-10-06 (page 9, reference number 18) was found loose on both the pilot’s and co-pilot’s seats on two separate occasions, six months apart. These screws were retightened on both occasions. I feel this problem is significant due to the fact the possible failure mode could be loss of seat locking capability and the crew seat being free to move fore and aft. It has been recommended to Cessna Aircraft (using their Service Condition Report) some locking feature should be used for this screw, such as a lock washer or Loctite compound.”

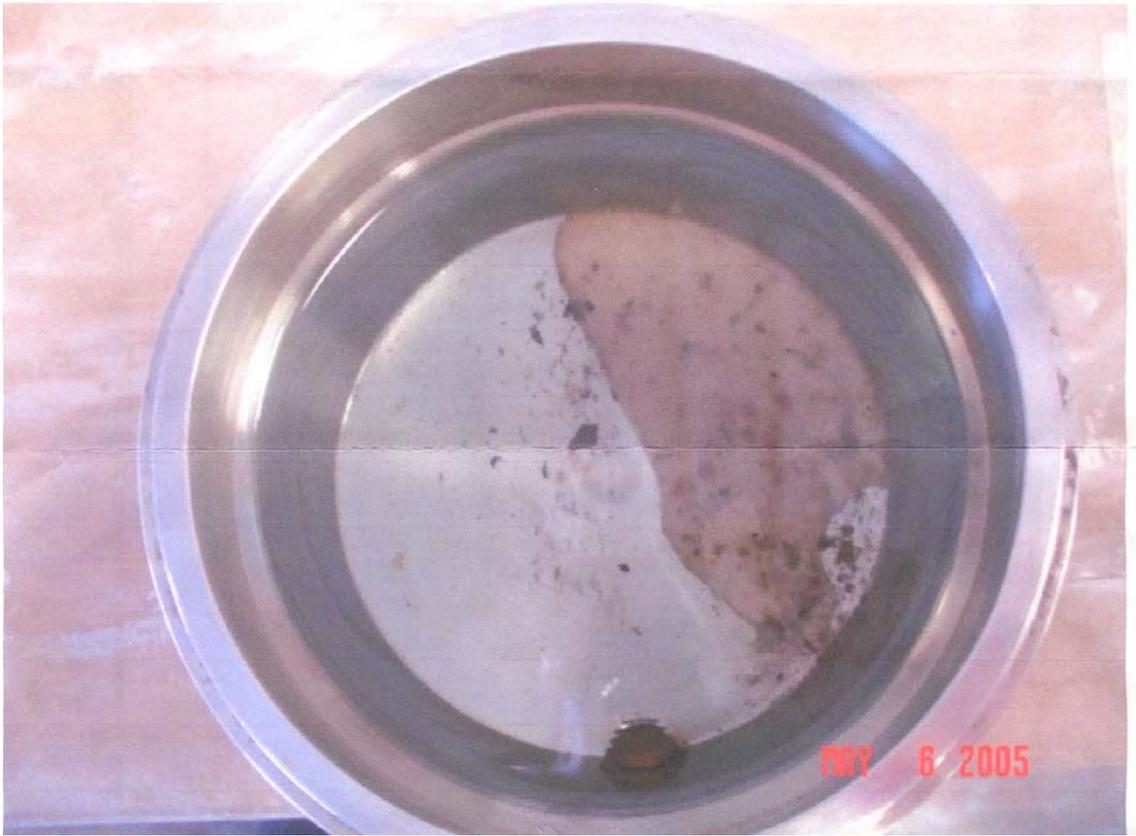
Piper; PA-25; Gascolator Access Difficulty; ATA 2821

A submitting FAA inspector writes, “During an accident investigation, (*this aircraft’s*) fuel gascolator was found with large amounts of water and solid contaminants. It was noticed the part could not be rotated to ensure drainage of contaminants...due to cowl support strut interference. This gascolator could be relocated two inches inboard to ensure clearance of the cowl struts. (*I*) have inspected four other PA-25 aircraft and found the same condition exists: the contaminants could not be drained out effectively. As Piper no longer supports this aircraft, an airworthiness directive may be needed to fix this problem.”

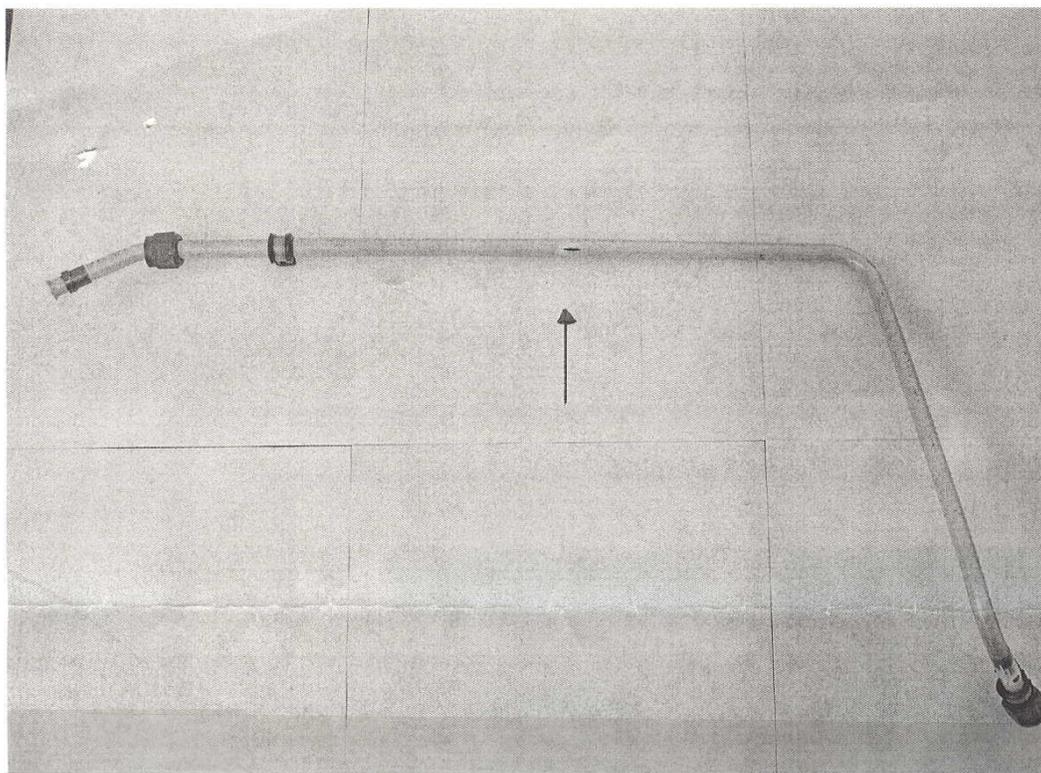
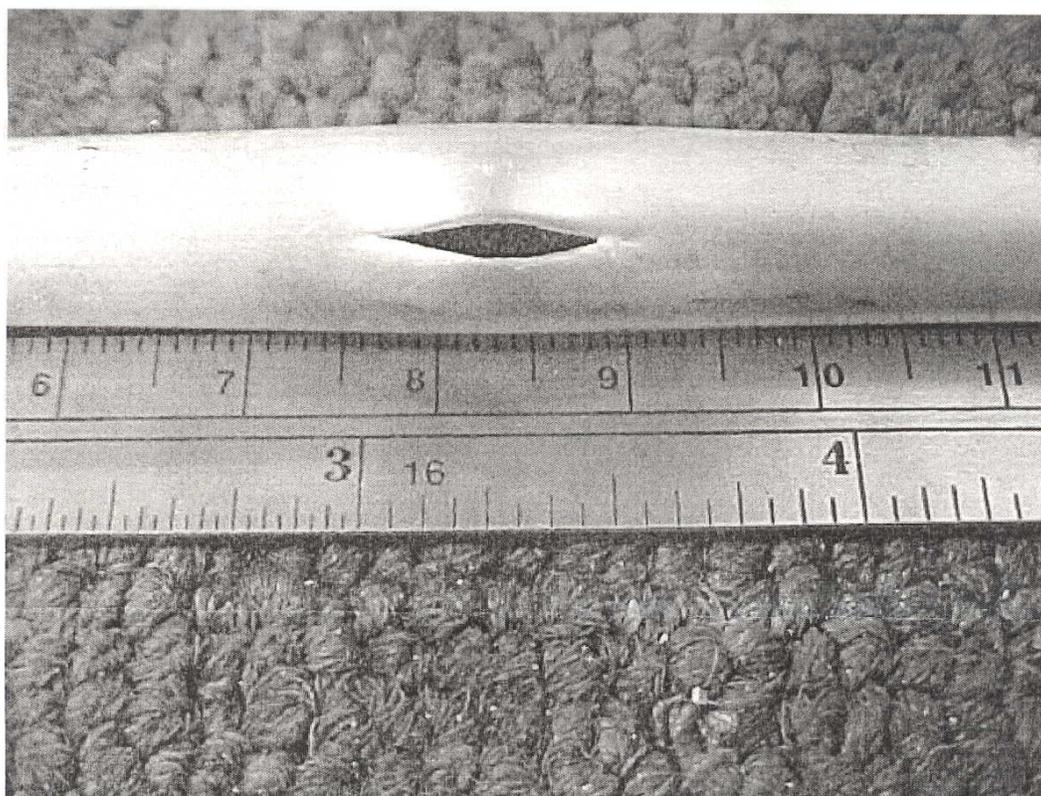
Piper; PA-31T; Split Hydraulic Line; ATA 2910

A submitter describes the pilot of this aircraft as receiving no response from his gear-down selection. He was on final for landing. "He attempted *emergency manual gear extension* and 'felt' the gear coming down...then he lost hydraulic pressure. The pilot was unable to secure the gear in a down-and-locked (*condition*). The aircraft sustained substantial damage during emergency landing. Post accident inspection revealed the hydraulic system's drain/fill line (P/N 46138-00) had ruptured, causing rapid loss the hydraulic reservoir's contents. This failure prevented sufficient hydraulic system pressure (*for either*) normal or emergency extension of the landing gear. The line failed parallel to the grain structure...(its rupture measuring approximately one-half inch in length). It is suspected water contamination in the line froze, causing the rupture. (I) suggest regular purging/draining of line contents during planned maintenance."

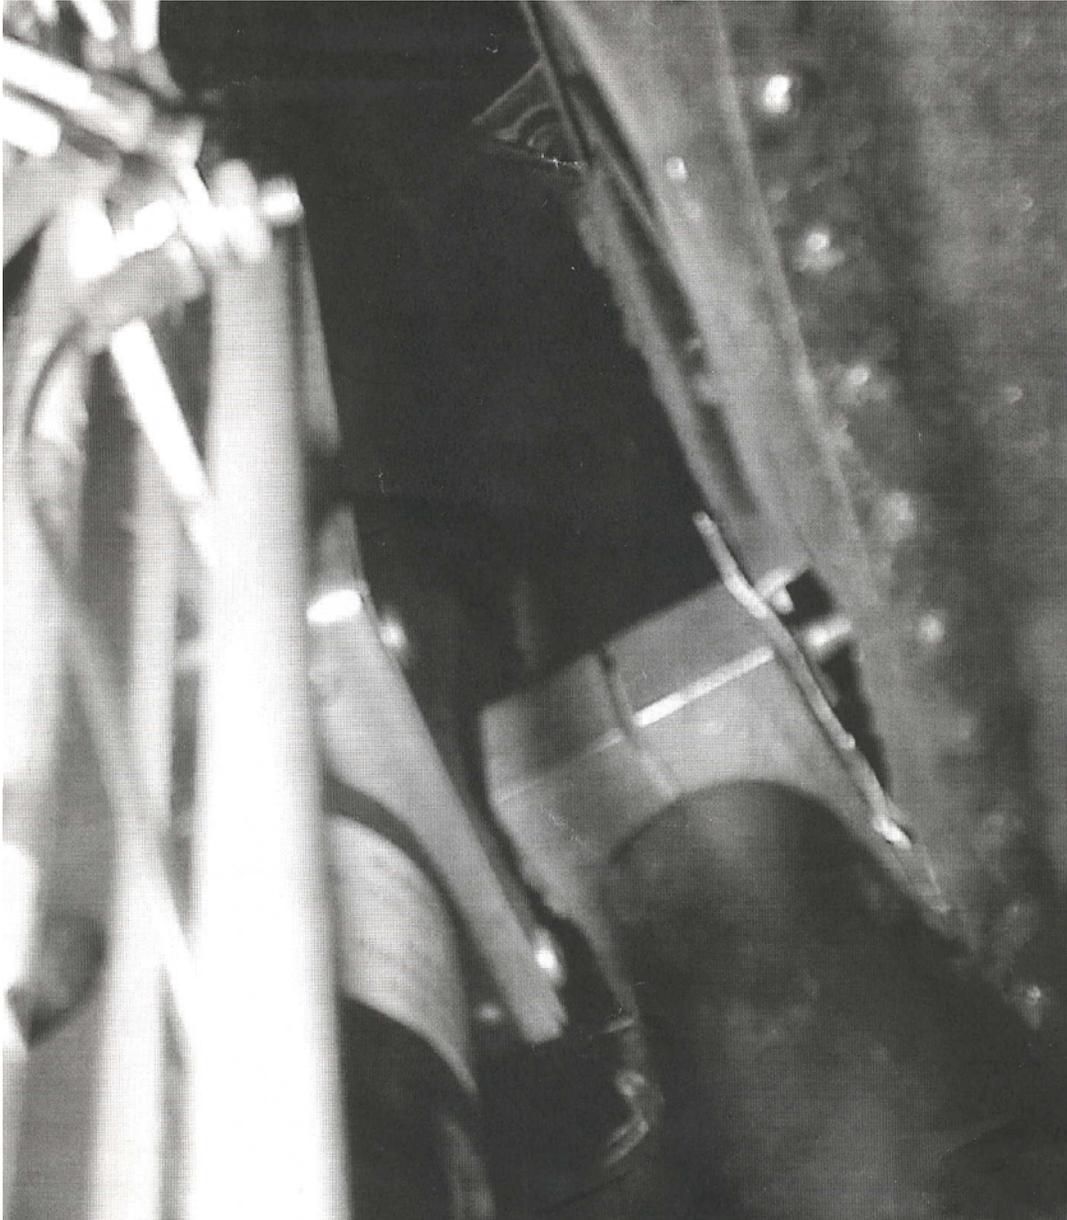
Piper; PA-31T; Rudder Torque Tube Bearing Support -- Cracked; ATA 2720

A pilot reports unusual yaw characteristics in flight (*specificity not provided*). The submitting mechanic describes having previously adjusted the rudder cable tension, and is very surprised to find it loose. Subsequent inspection found the rudder torque tube bearing support flange cracked at the aft bolt on the pilot's side. The mechanic speculates excess rudder pedal force with the aircraft on the ground (and not moving) may have been the cause of this failure. (*No part numbers were provided with this report. Despite the low resolution of the attached black and white photograph, the torn flange segment still attached to the torque tube bearing can be seen.*)

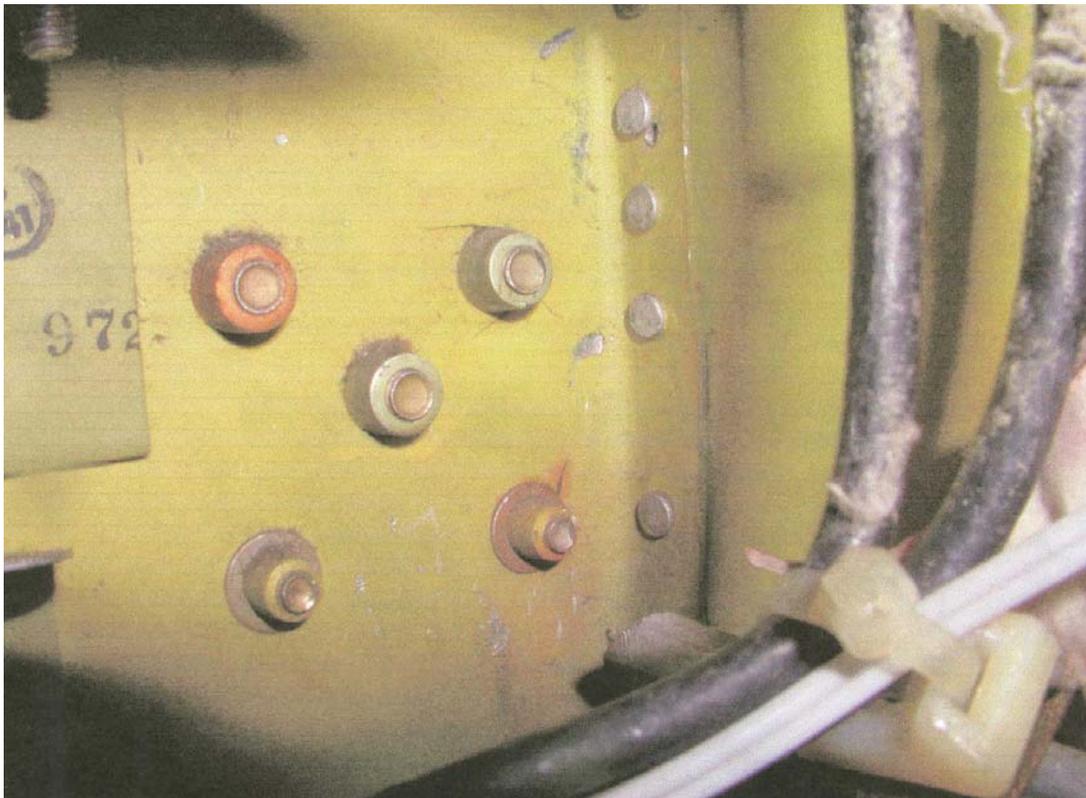
Raytheon Beech; 58; Cracked Forward Spar Web; ATA 5714

The submitter states, "During an Annual inspection, cracks were noted in the forward carry-through spar web (P/N 002-430018-5). They are located at the L/H upper, outboard-most Huck bolt holes (2 ea.) on the forward side of the carry-through assembly. The head end of the upper Huck bolt is inaccessible for viewing without wing removal. The lower Huck bolt is accessible and no movement or cracking was noted.

"It is believed the high aircraft time and damage history were contributing factors to the cracking in this area."
(The following two photographs show the cracked web, and its repair, respectively.)

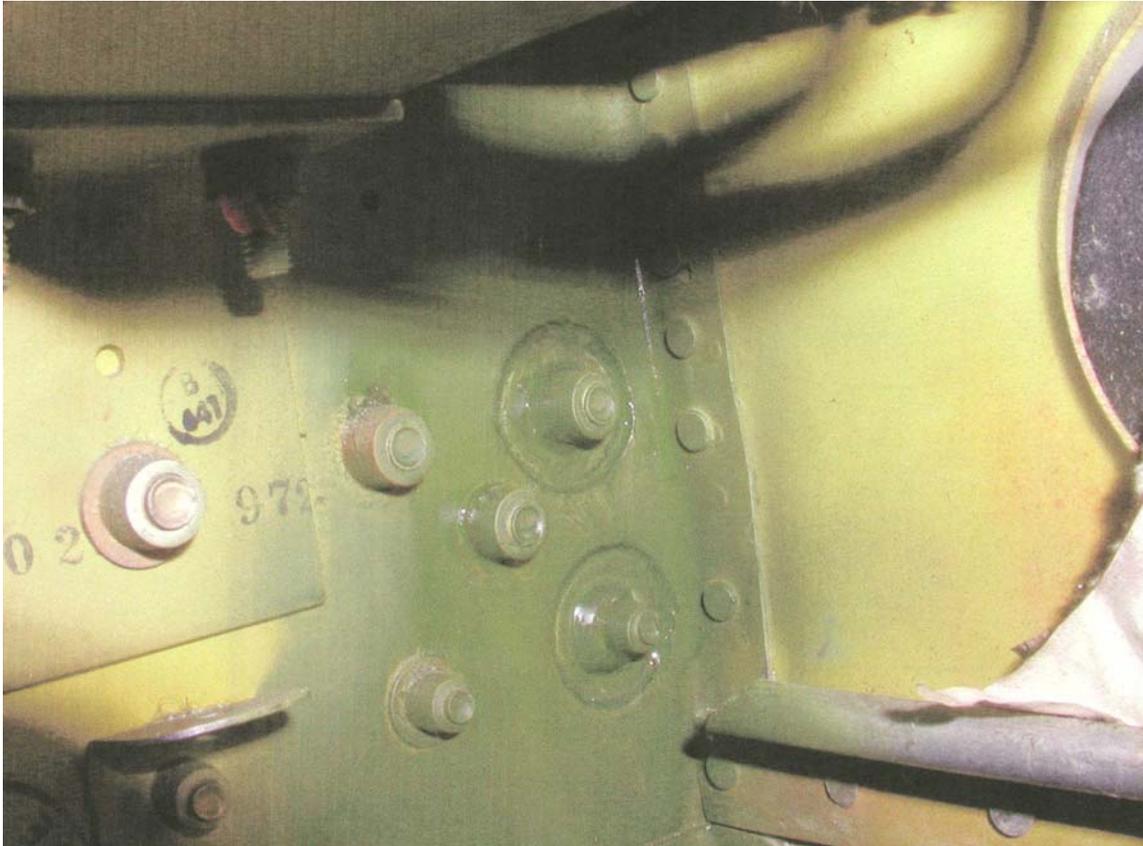
"AD 90-08-14 (*airworthiness directive*) concerns (*itself with*) cracking in the carry-through webs, and limits cracking at the Huck bolts to one per side. The Beech repair kit (P/N 58-4008) is to be installed if more than one Huck bolt (*installation hole*) is cracked. This aircraft has two bolt areas cracked on one side, however, the required repair does not extend into this area -- thus the need for this type of (*DER*) action.

"(In accordance with a Designated Engineering Representative's directions...) the web skin around the Huck bolts was removed down to the underlying web tie plate. The plate was then eddy current inspected for cracks -- none were detected. Per DER instructions, this area will be inspected by fluorescent dye penetrant method every Annual Inspection, and by eddy current method every 500 hours.

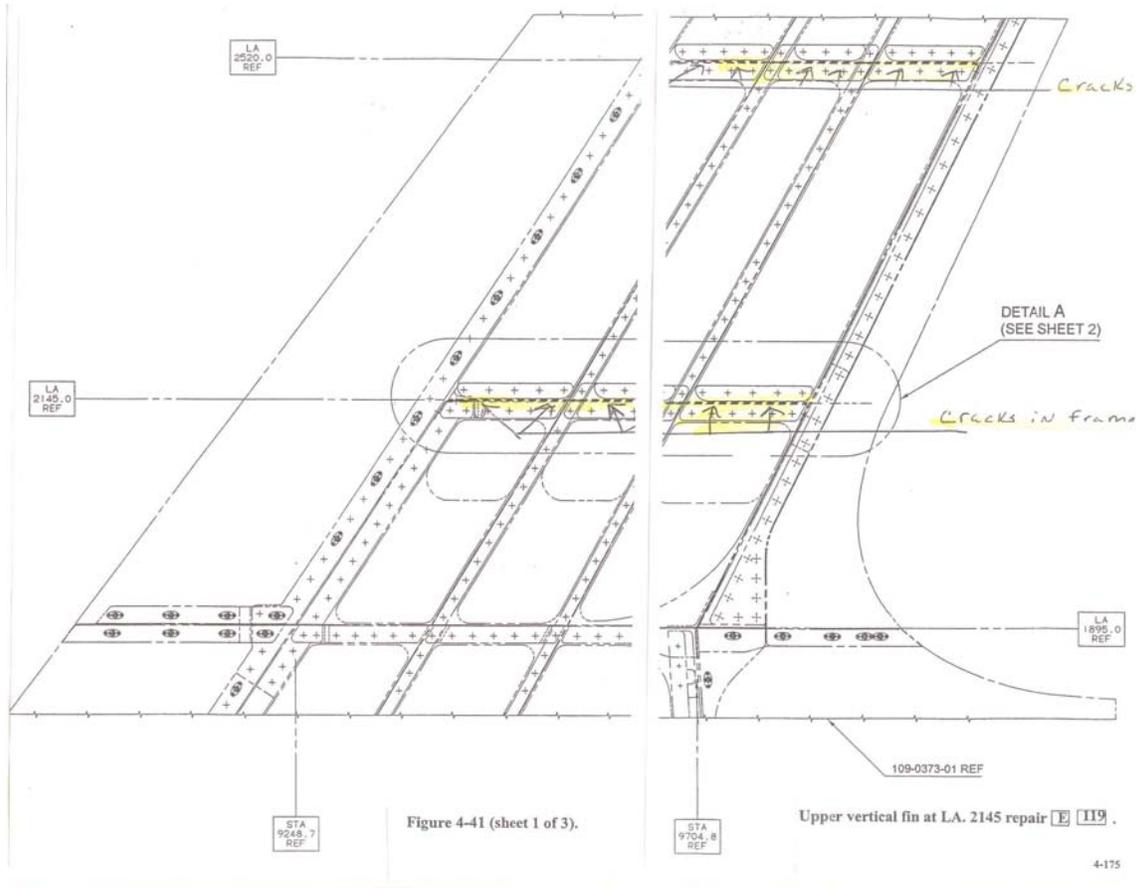
Agusta; A 119; Cracks in Vertical Stabilizer; ATA 5530

A repair station mechanic submitted a similar defect report as the last entry. He states, "This is to report cracks in the frames on the vertical fin (P/N 109-0373-01) in the areas at W.L. 2145.0 and 2520.0. These cracks are occurring approximately between F.S. 9350.0 to 9850.0. Agusta Aerospace has a repair for these cracks referenced in Agusta A119/A109 Series Structural Repair Manual, Chapters 4-2-23 and 4-2-24." *(The report includes two Agusta manual drawings, both of which have been cropped and spliced together to show stabilizer crack locations in one picture.)*

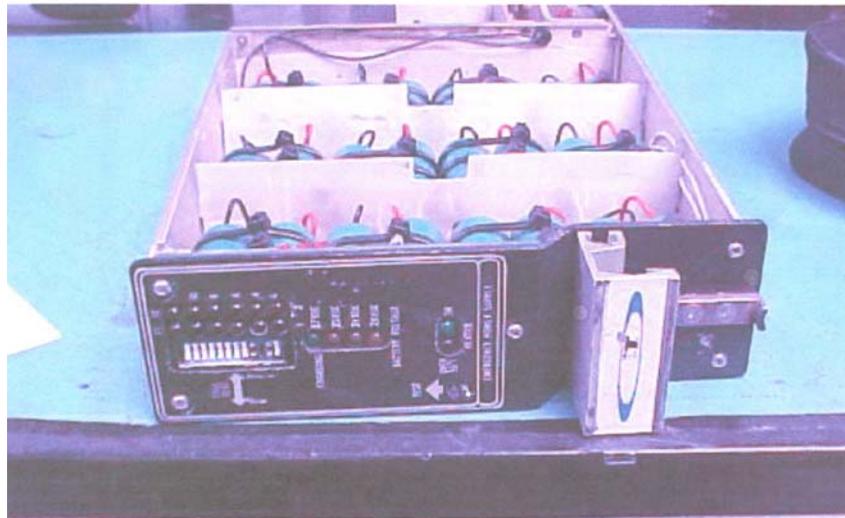
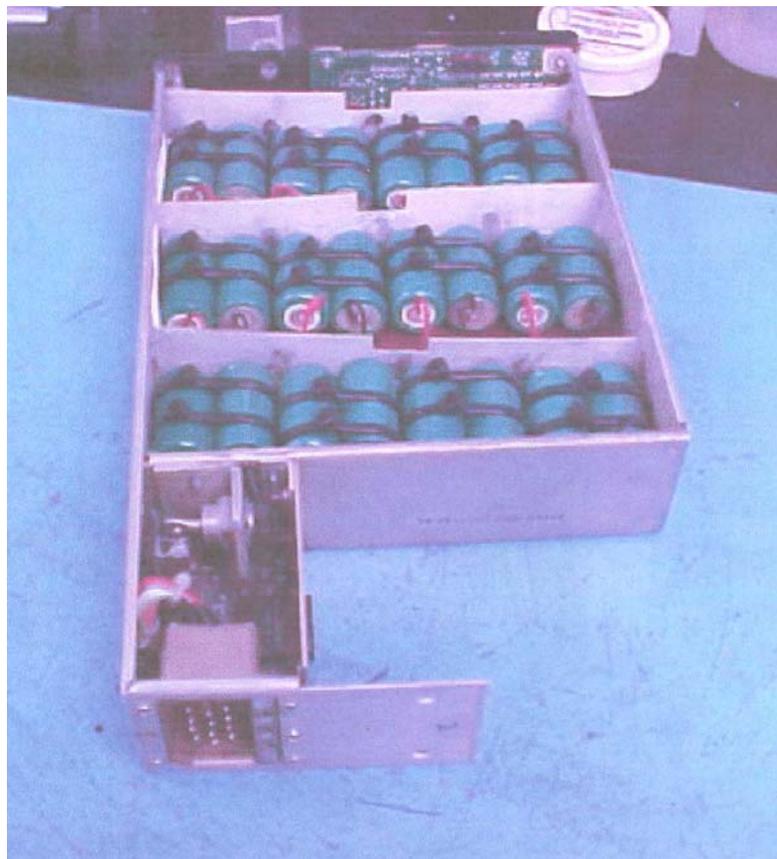
B. F. Goodrich; Emergency Power Supply; Improper Battery Cells; ATA 2400

The submitting repair station technician describes finding this aircraft emergency avionic power supply (P/N 501-1228-03) packed full of cells having both the wrong chemistry and voltage. "This unit contains 24 NICAD (*nickel cadmium*) cells in place of the 12 lead acid cells that belong in it. The higher voltage appears to have burned the cell switch block. NICAD cells are not an approved replacement cell for this unit." (Two pictures of this unit are shown below. No other information accompanied this submission.)
