U.S. Department  
of Transportation  
**Federal Aviation  
Administration**

## ADVISORY CIRCULAR

# AVIATION MAINTENANCE ALERTS

**ALERT  
NUMBER  
328**

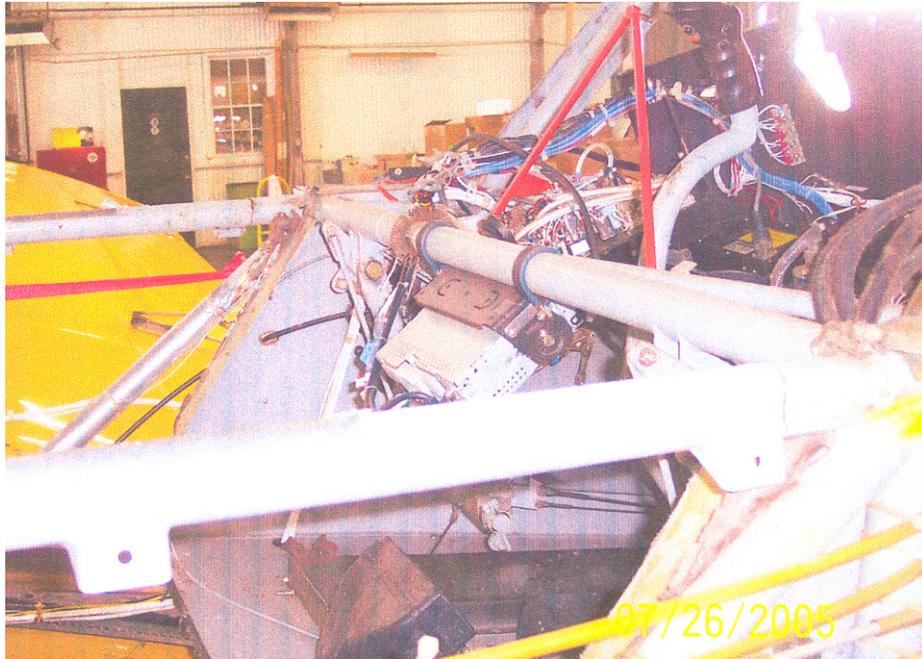
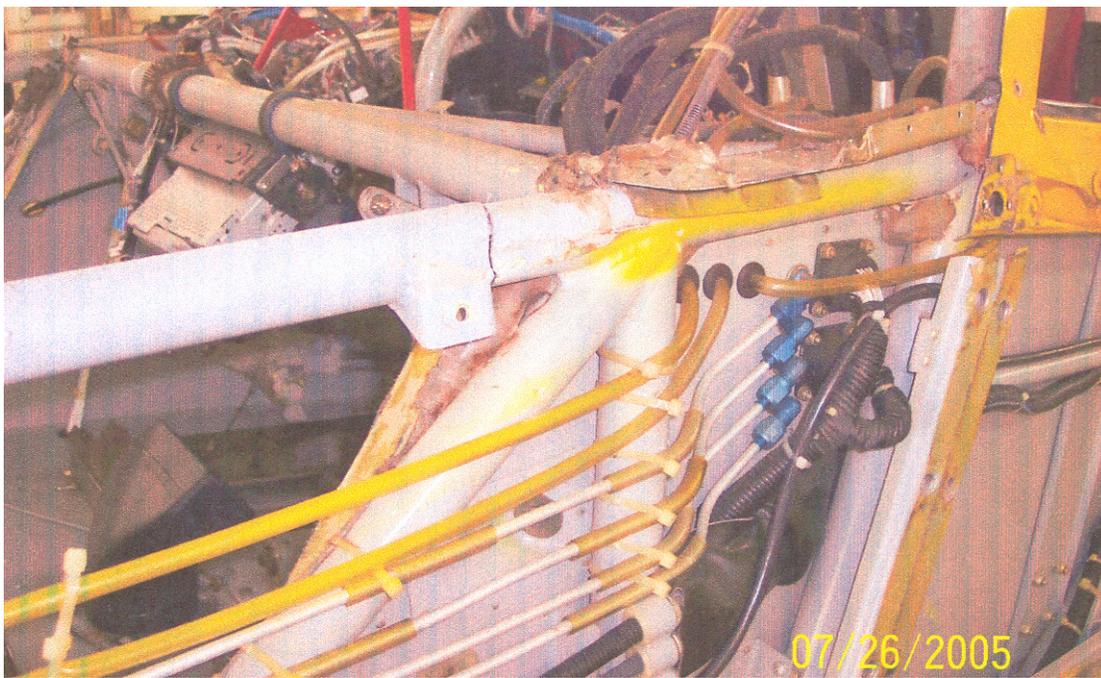
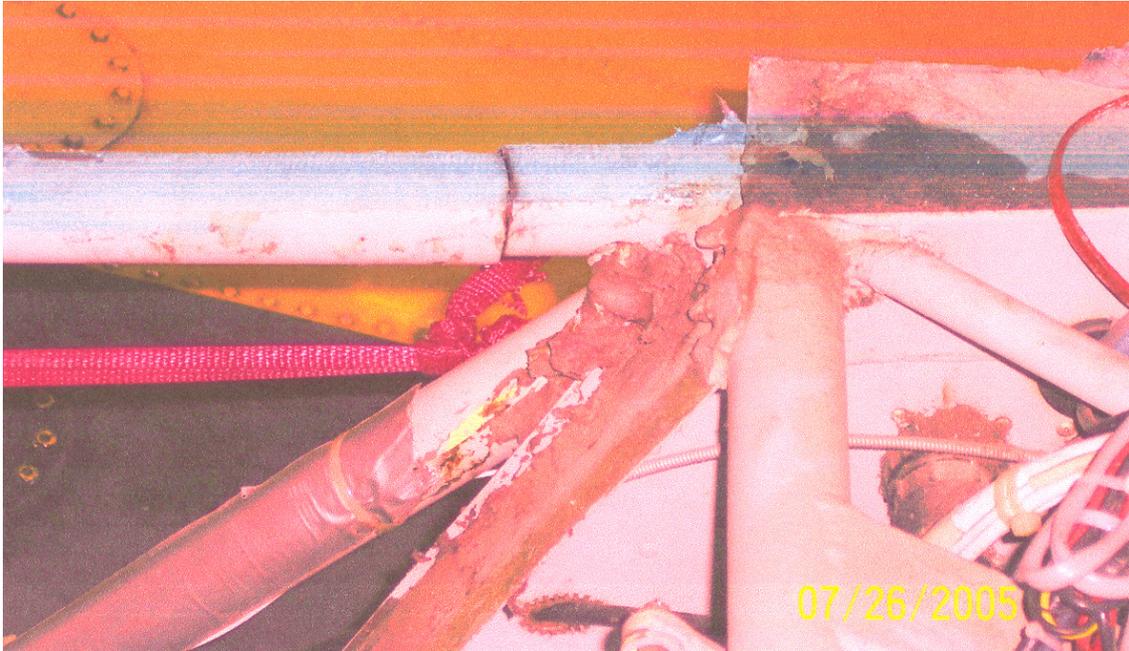
**Ayres: S2R-T34; Cracked Longerons; ATA 5313**

A mechanic's inspection of this agricultural airplane found significant structural failure. “Both upper longerons were cracked approximately 54 inches aft of the datum. The area is difficult to inspect as it is three-fourths covered by the hopper (*tank*). Pictures were taken after the hopper was removed (*see below*). This is a very unusual area to find such a defect. The aircraft has no damage history and has not been abused.” *(Of six submitted scan photos, three are shown. They have been slightly cropped and rotated.)*

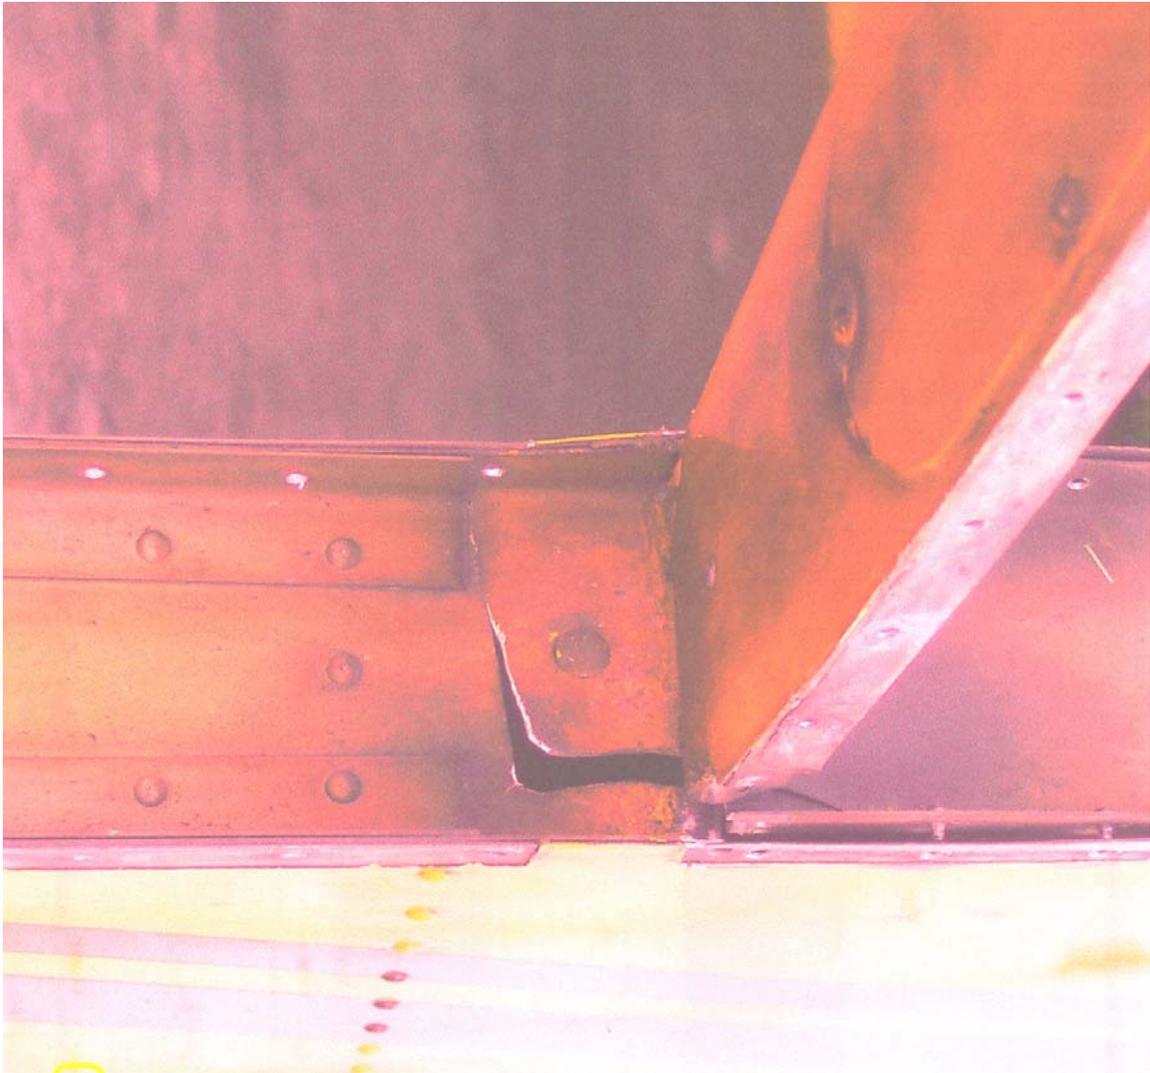
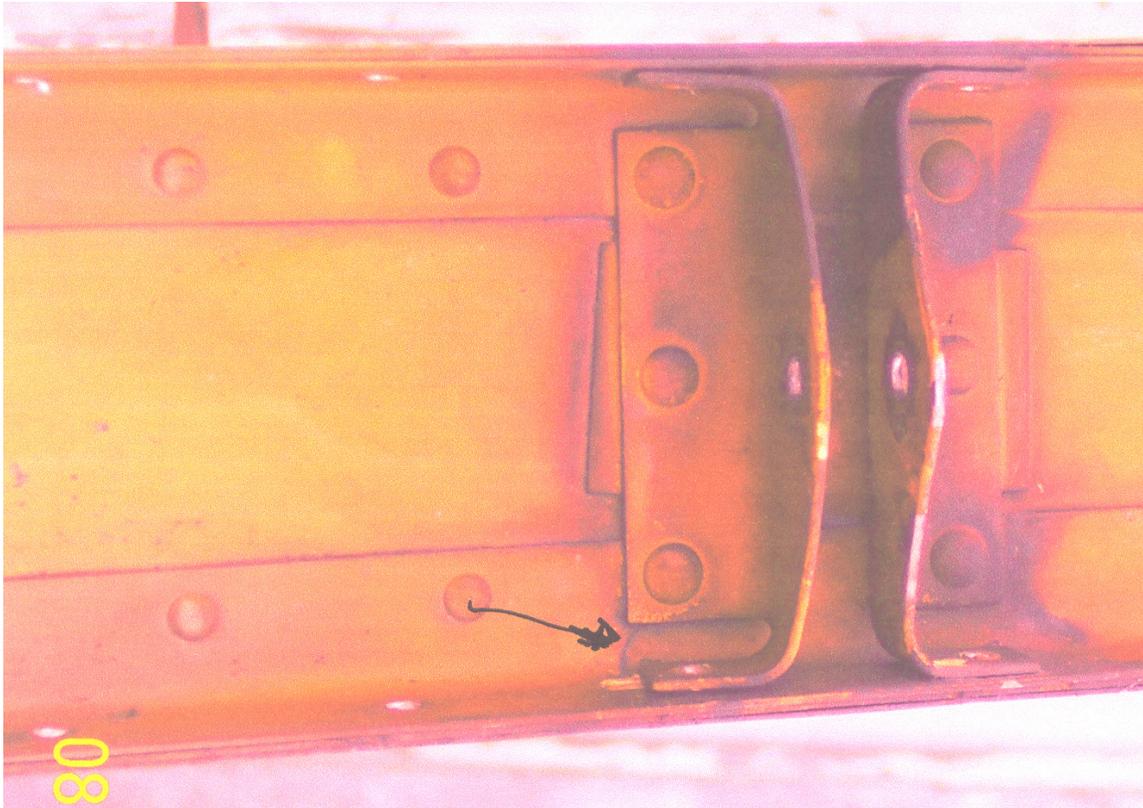
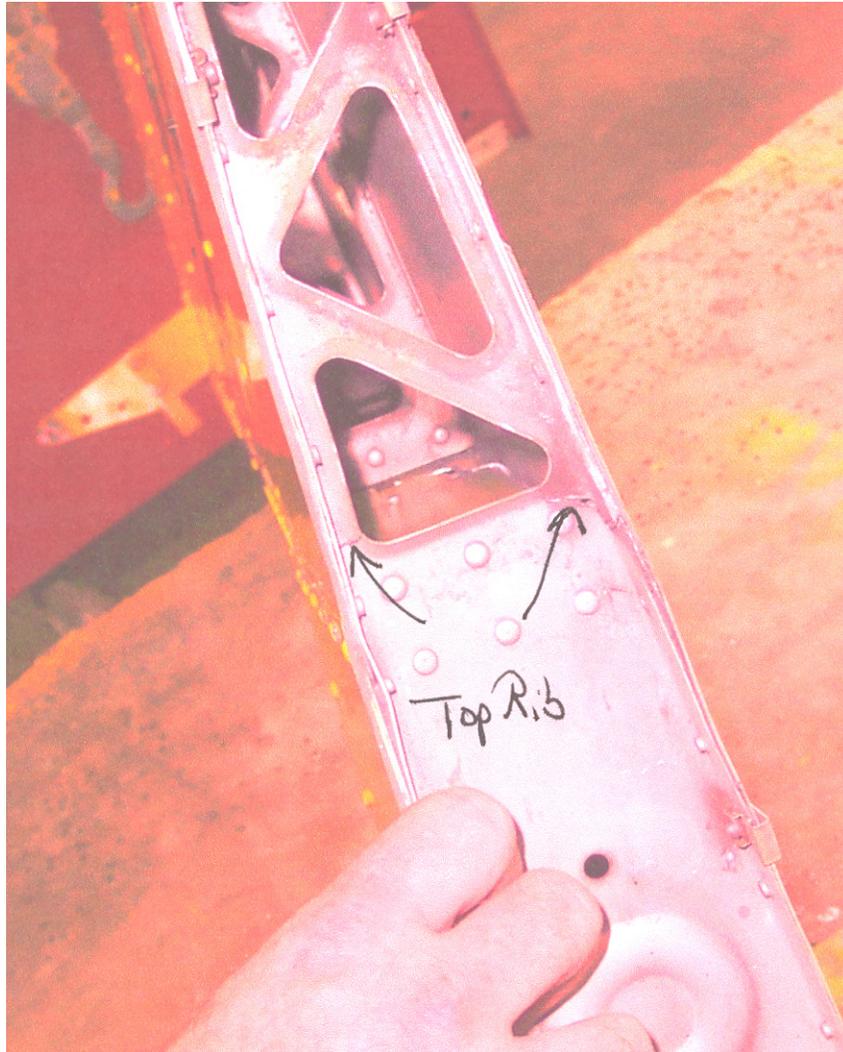
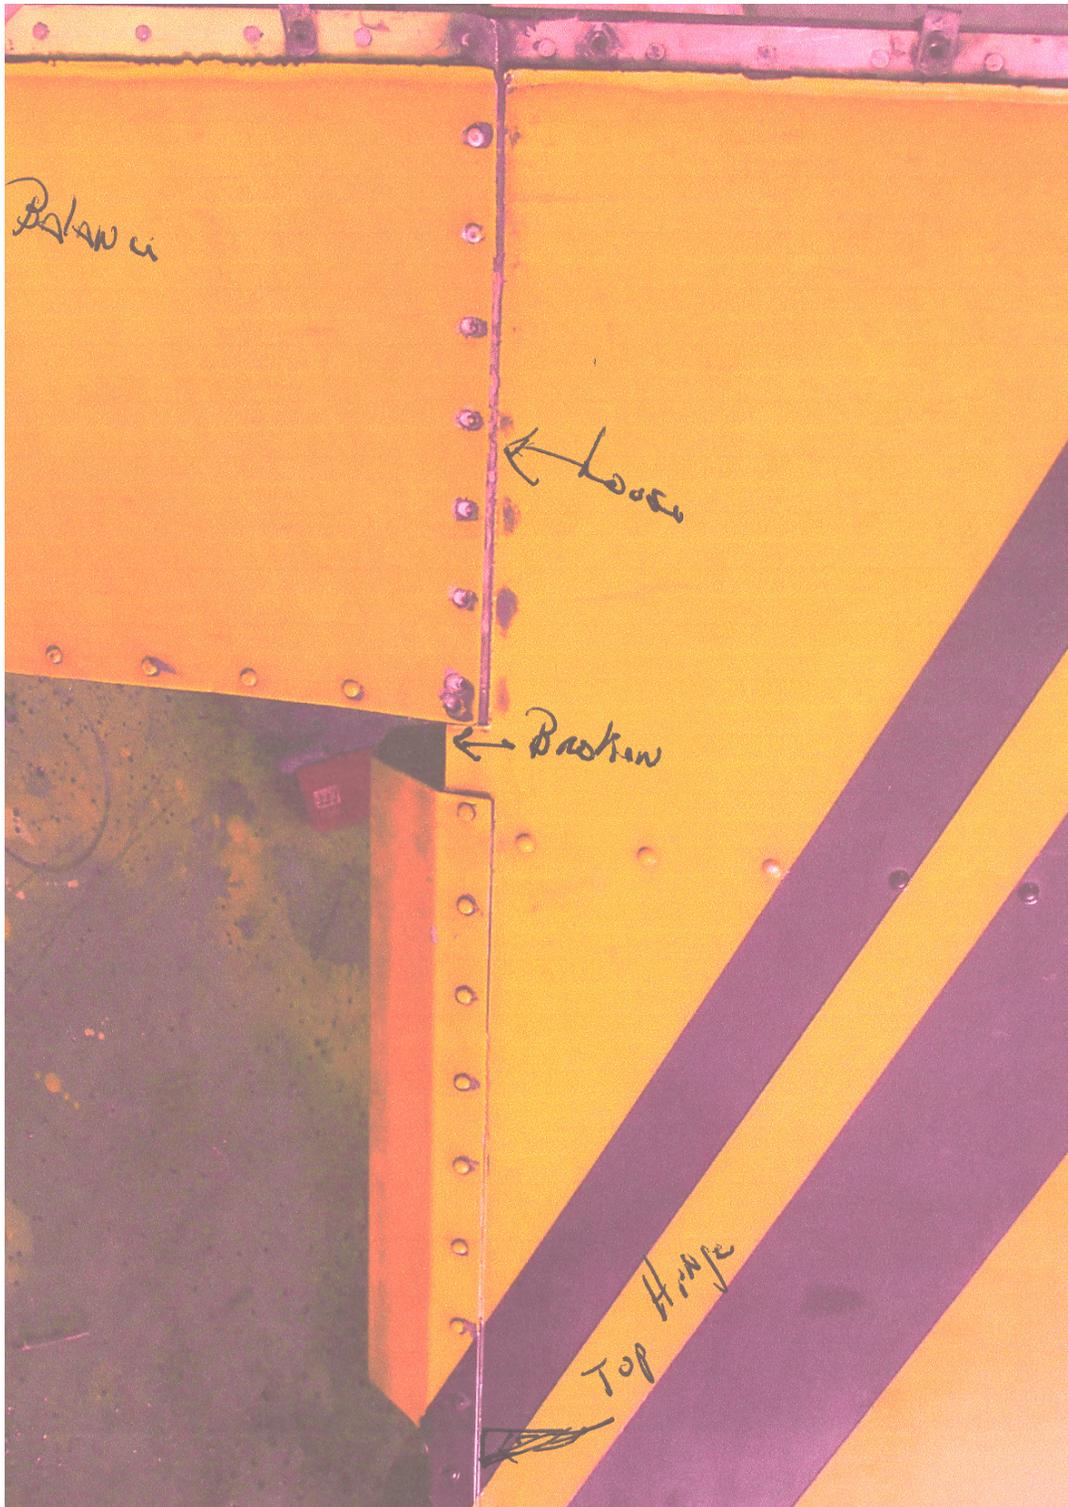
**Ayres: SR-T660; Cracked Rudder Spar; ATA 5541**

The submitter for the preceding report finds another crack. He states, "The upper rudder spar (*was found*) broken 12.5 inches above the upper hinge. In addition, the spar was cracked under the upper hinge fitting. This caused the rudder counter-balance to be loose, resulting in rudder flutter. Further flight could have resulted in loss of rudder control. The spar web is made of .040 inch aluminum channel with very little in the way of stiffeners. The spar needs to be beefed-up. Photos are included." (*Part numbers were not provided. Four of nine submitted photographs are shown below. They have been cropped from their original size.*) (A 1996 SDRS entry for a similar aircraft described multiple cracks found in this rudder spar and its connecting ribs. Submitter believed designed reinforcement was required for this rudder structure.)

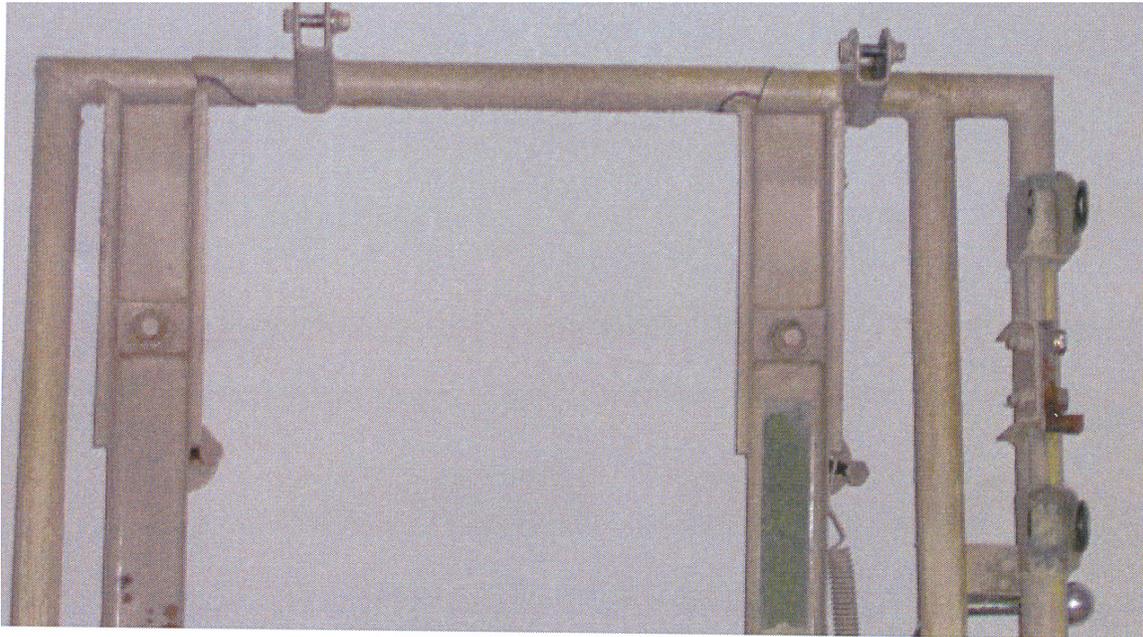
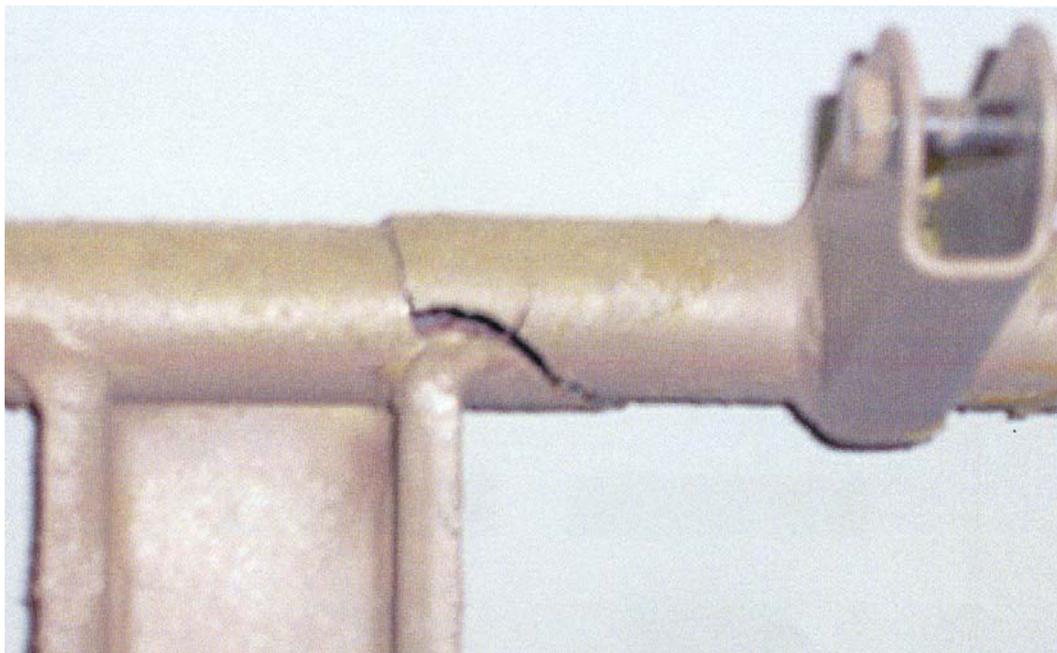
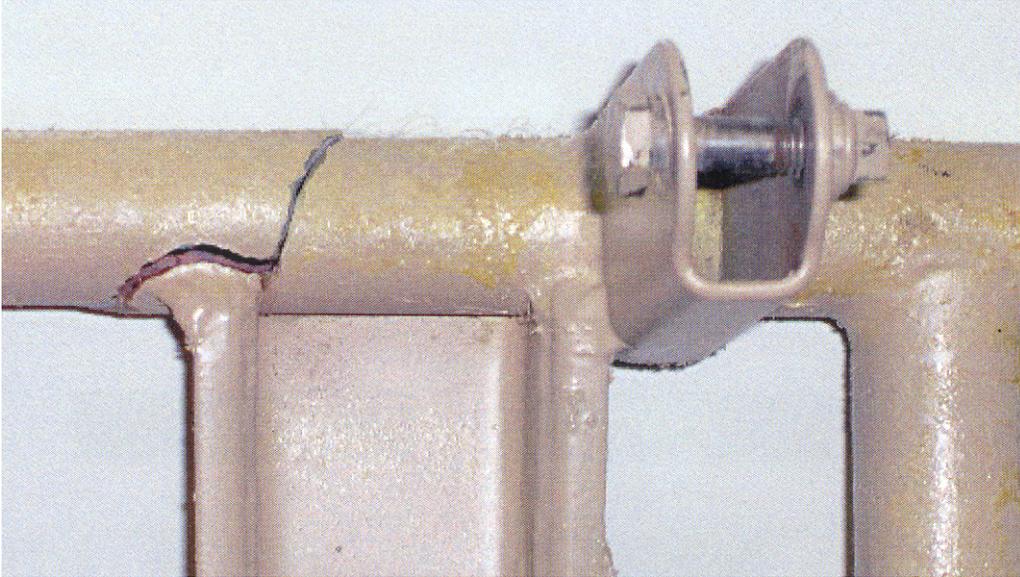
**Cessna: 550; Cracked Seat Frames; ATA 2510**

A repair station technician finds this aircraft's seat structure broken (P/N 5519009-22). "The upper chair base assembly is cracked at the chair back attach points." He speculates stress and metal fatigue are the probable cause of this discrepancy. "The chair was repaired in accordance with Aviation Fabricators STC ST01042WI Structural Seat Repair." (*See also last July and September's Alerts for similar defects. SDRS search yields nine entries. Factoring in repaired frames never reported, it would be wise to inspect these items frequently.*) (Pictures have been slightly cropped.)

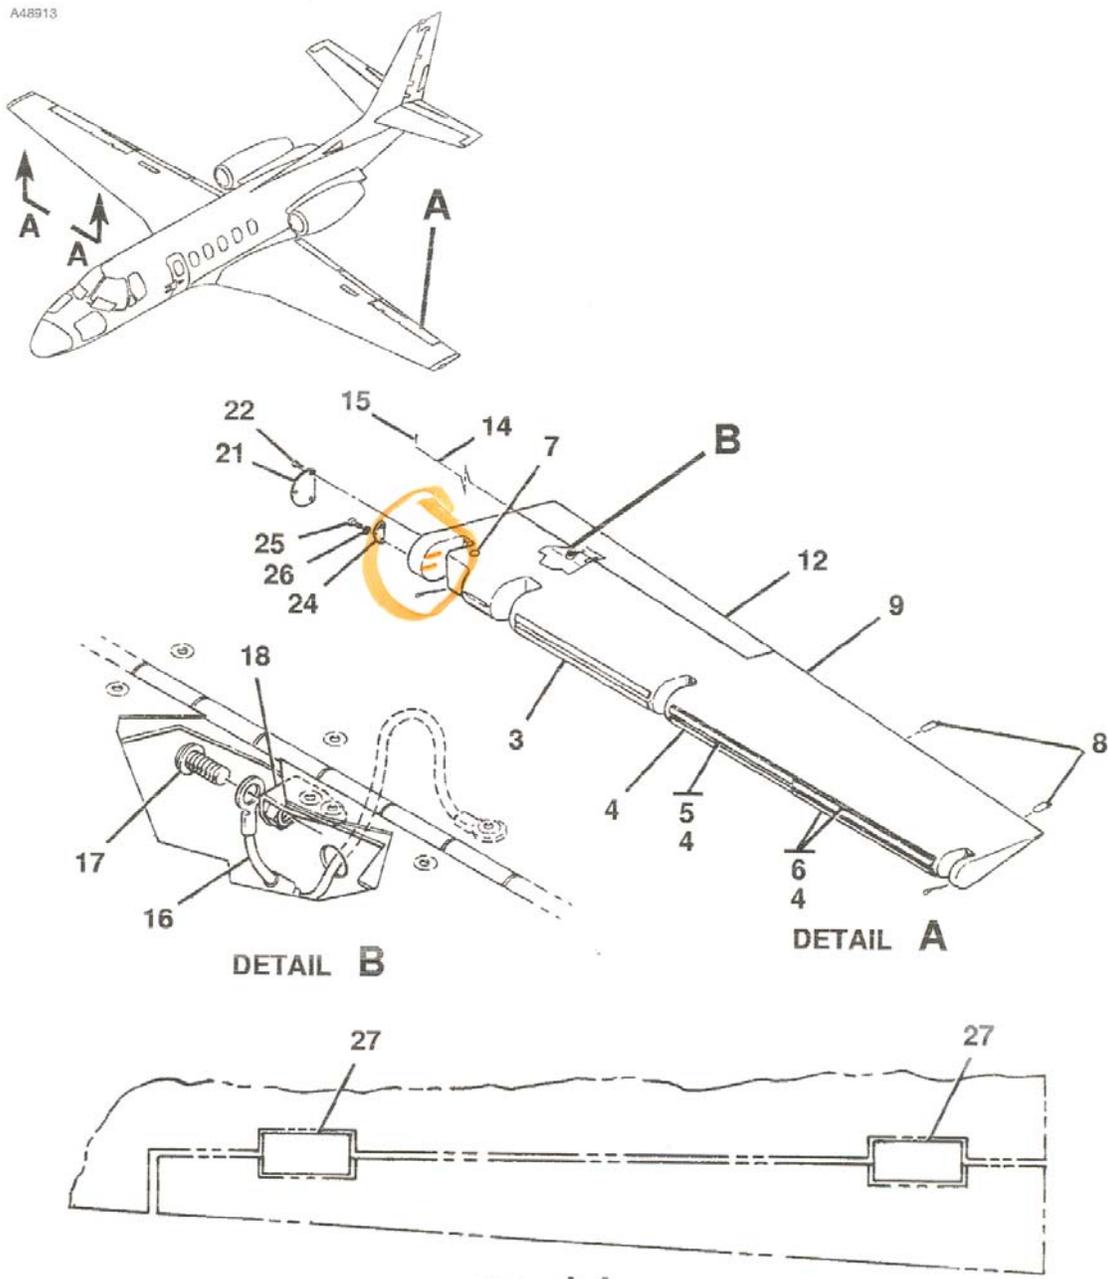
**VIEW A-A**  
BOTTOM SIDE OF RIGHT AILERON TRIM TAB ON  
AIRPLANES -0001 THRU -0092 INCORPORATING SBS550-57-2

#### **Cessna: S550; Loose Aileron Balance Weights; ATA 5751**

A technician notes what appears to be "...cock-eyed" bolt heads on the aileron balance weights during a phase 2 inspection (*P/N 6524004-12*). Further investigation revealed the weight stack had developed significant corrosion, which enlarged the retaining bolt holes. This also allowed the stack to be loose. New parts were installed to fix the discrepancy. "Detailed inspection of this area is not on any inspection form. I suggest operators of this model aircraft remove the ailerons and (*perform*) a complete and detailed inspection of these weights."

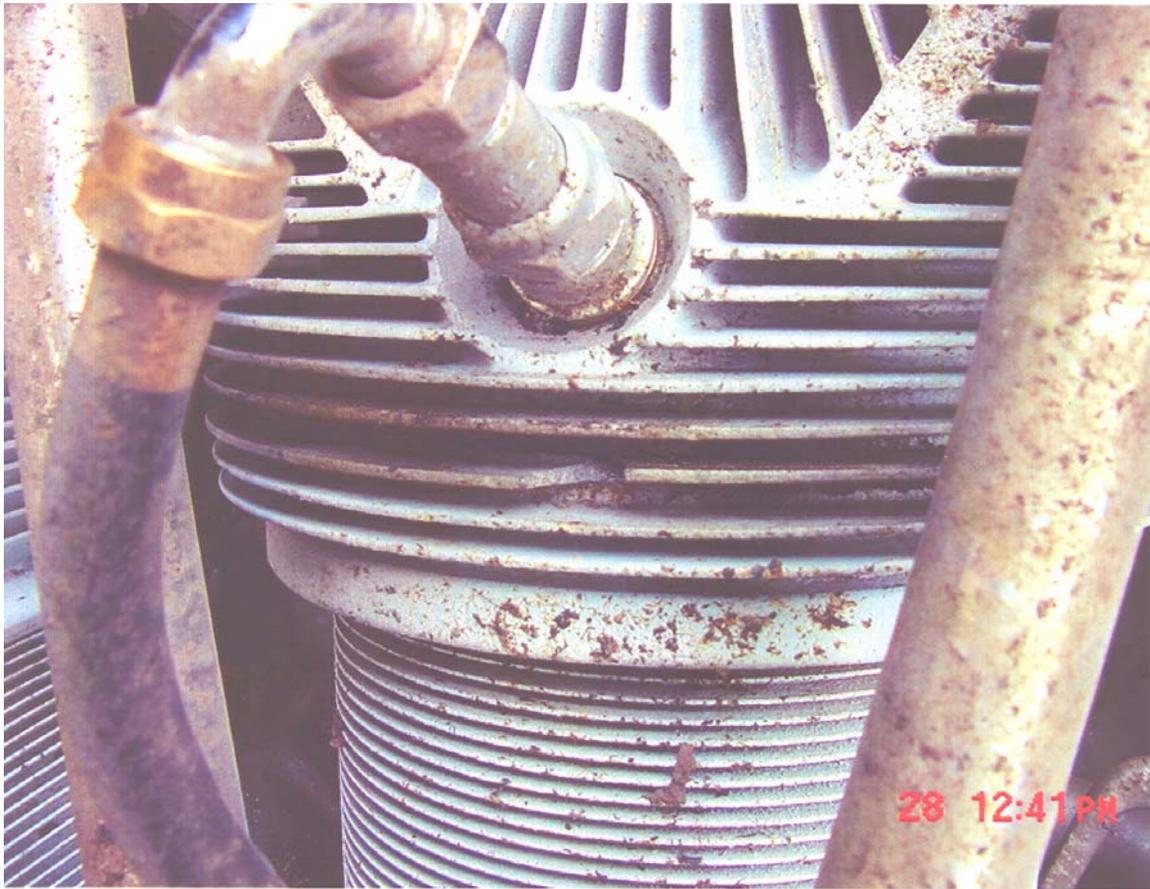
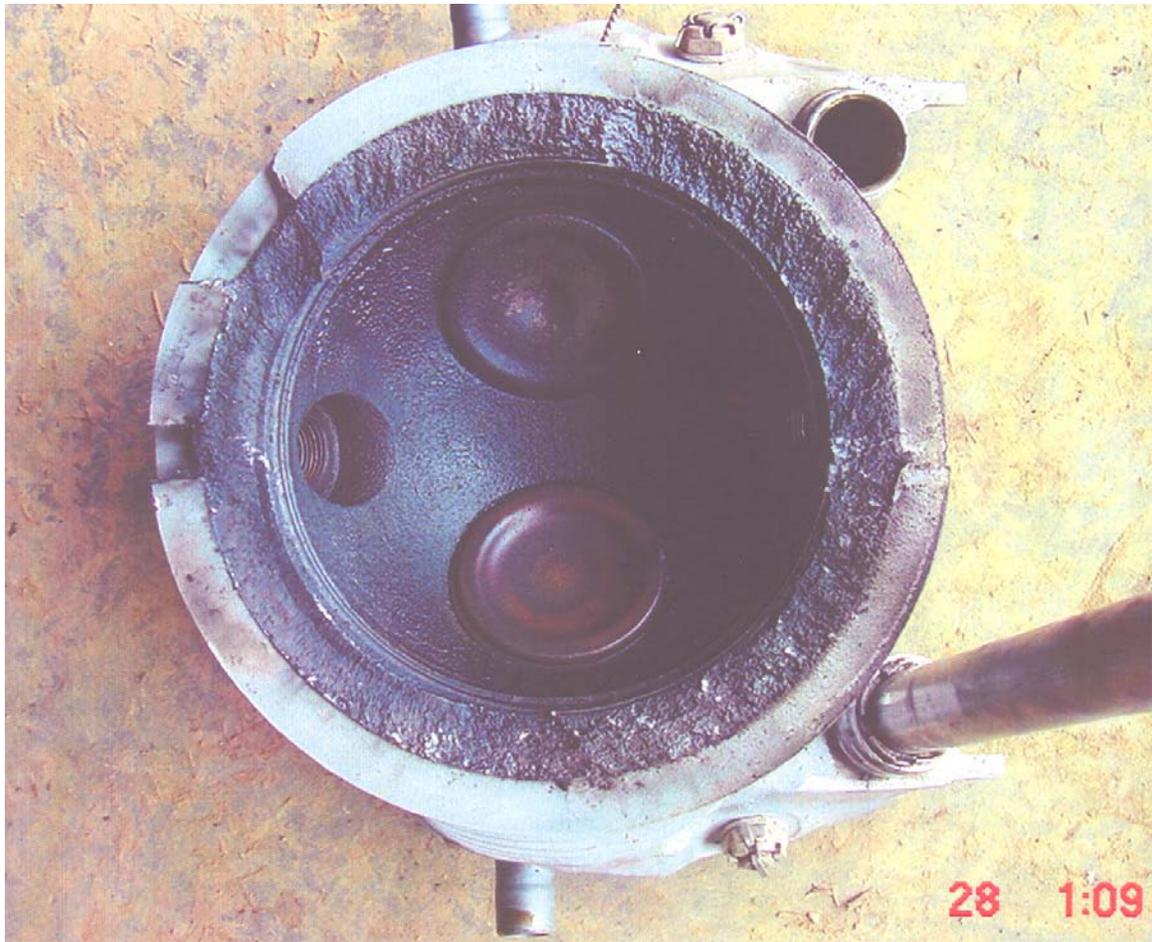
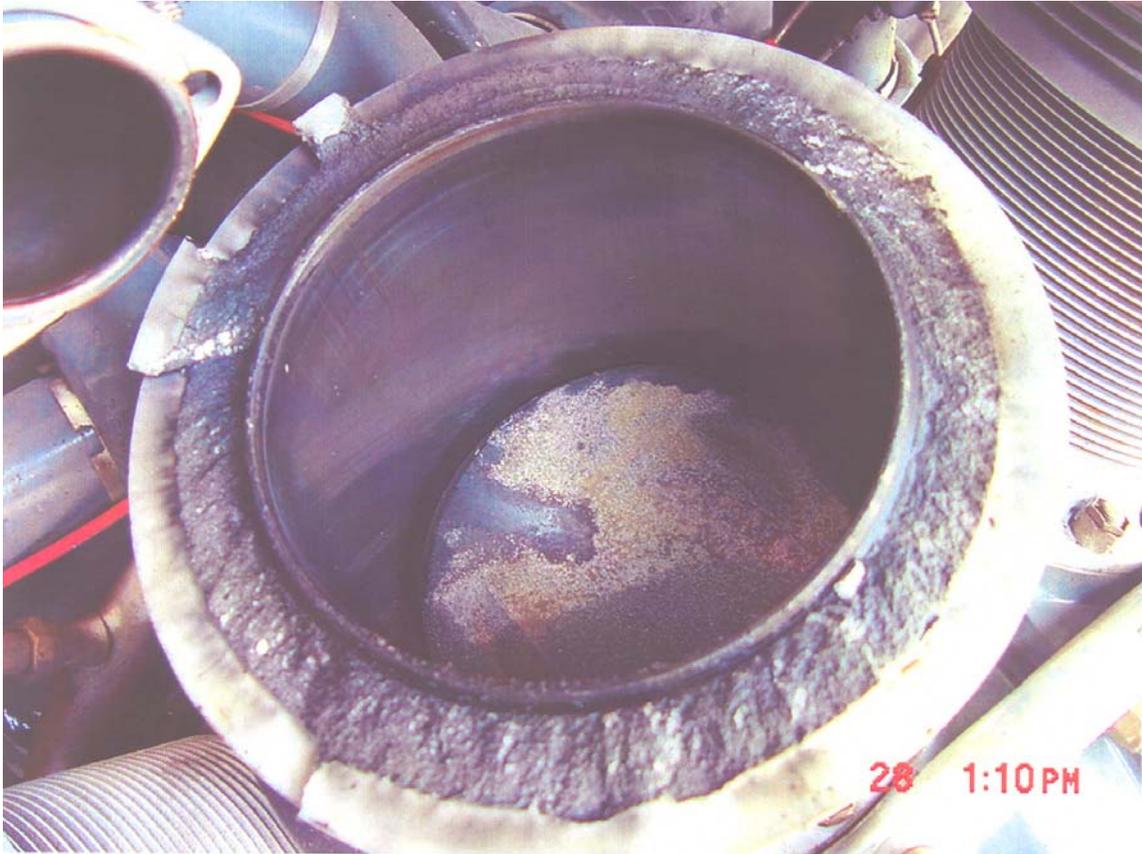
“During spraying operations,” the submitter says, “the aircraft was climbing into a right-hand turn. The pilot heard a loud ‘bang’, then the engine began to run very rough. The aircraft made a forced landing.

“Inspection of the engine found the number two cylinder head (*P/N 399354*) separated from the sleeve at the number three, larger cooling fin from the bottom. Airworthiness Directive 78-08-07 was complied with during the last overhaul, 43 hours earlier.” (*This aircraft is a Weatherly 620B.*) (*Pictures have been slightly cropped.*)
