ADVISORY CIRCULAR

43-16A

AVIATION MAINTENANCE ALERTS

**ALERT
NUMBER
329**

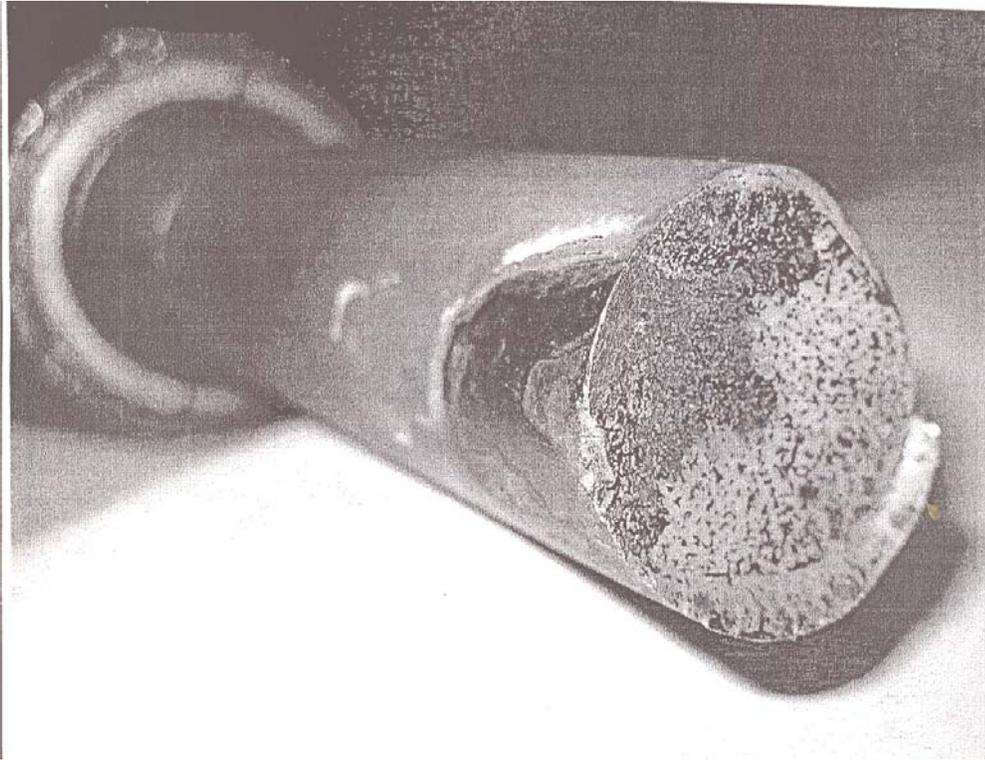
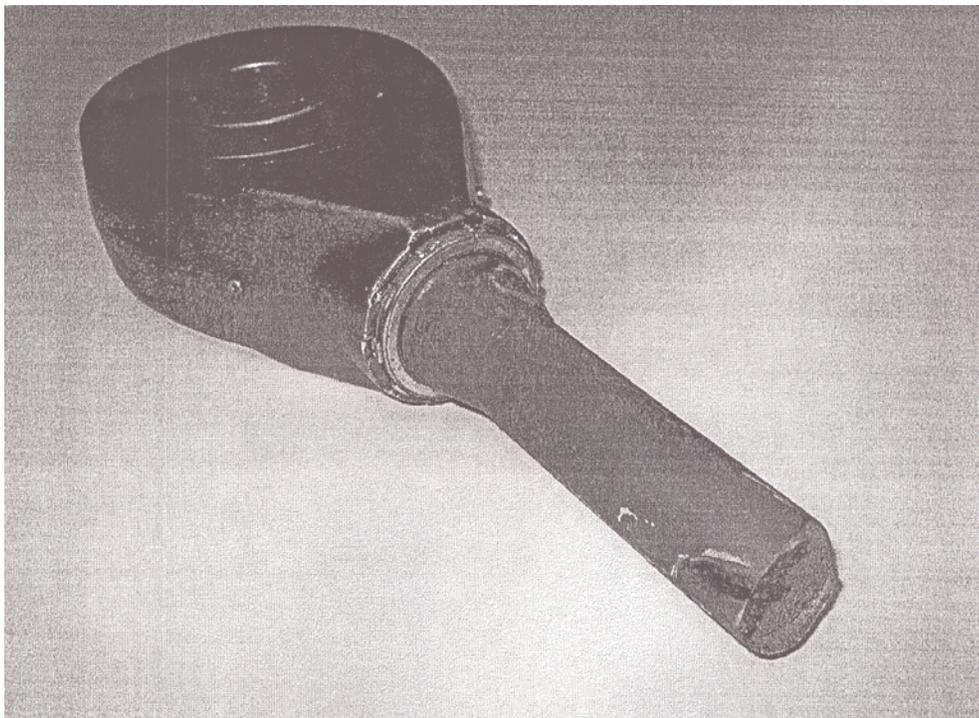
"On August 5th, during the flight control rigging operation, the L/H aileron power control unit's rod-end was found broken," states the submitter. "This rod-end is part of the Bendix PCU (P/N 317012-1) assembly. Evidence of corrosion is apparent at the cracked location. See the attached photo's of the PCU rod end..." *(The part's total time and/or time since last overhaul was not provided. The attached photographs are low resolution, but clearly show the consequences of undetected corrosion.)*

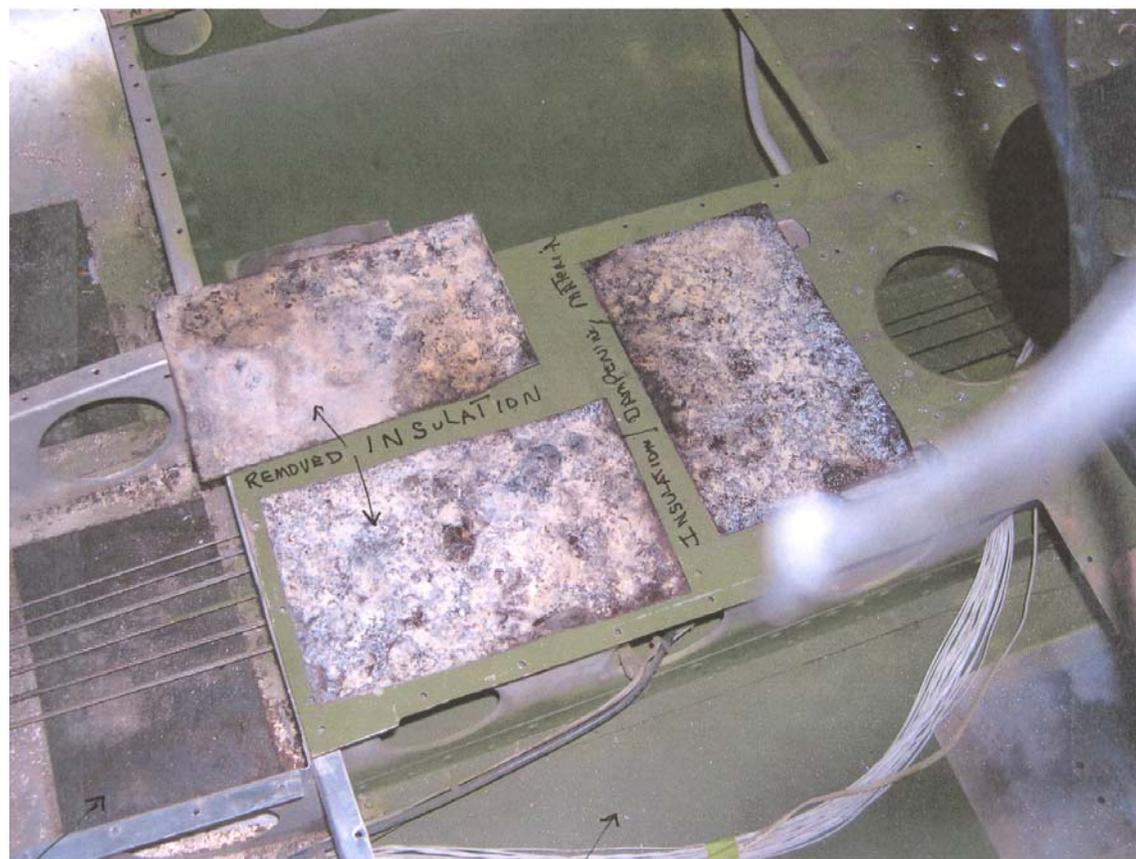
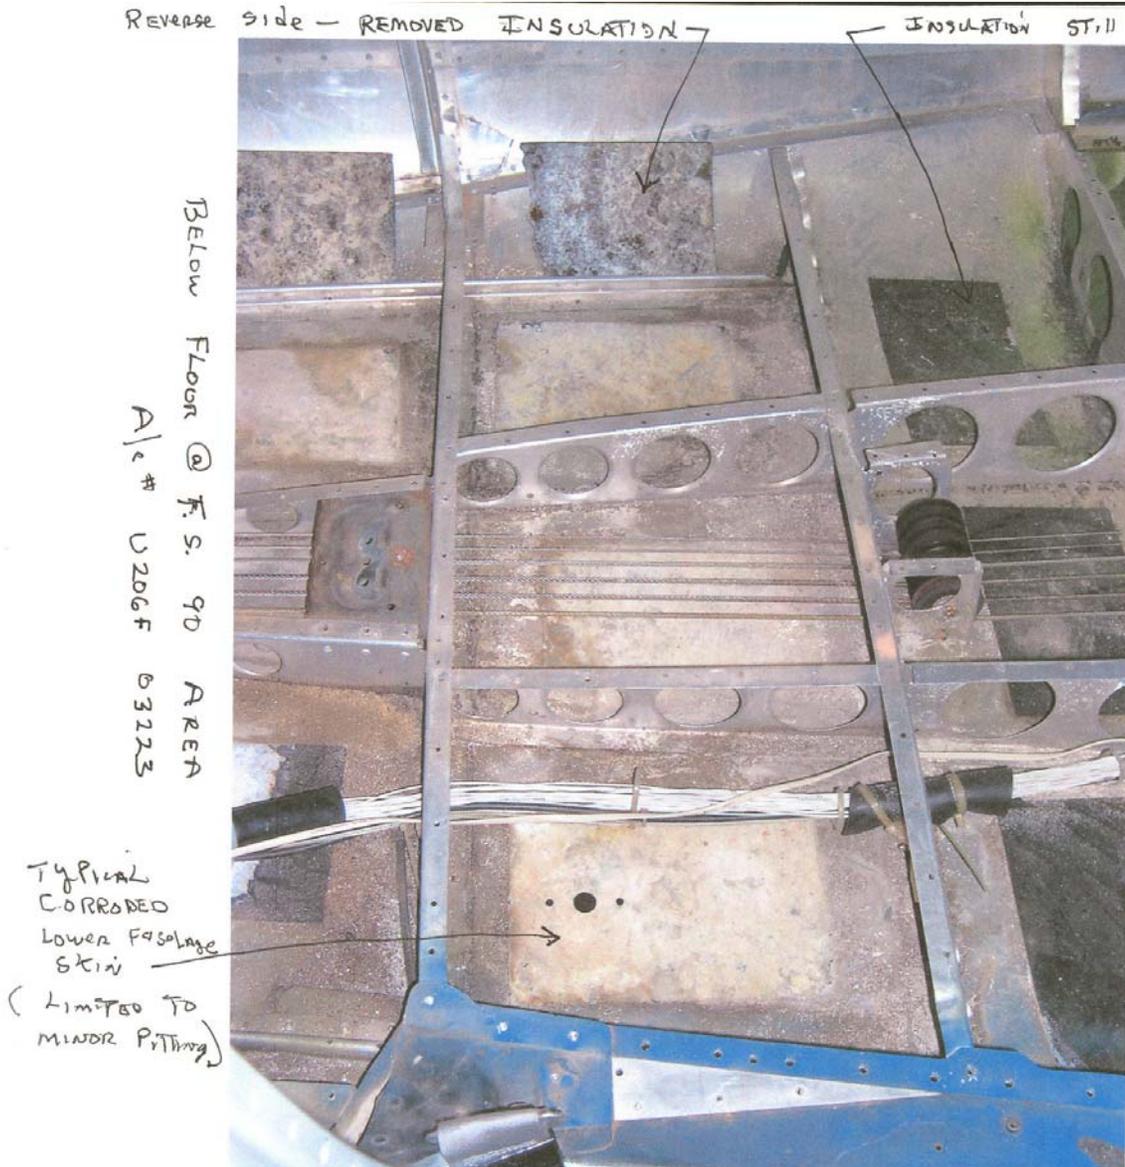
M&D REPORT 7.21.2005

This aircraft was undergoing extensive avionics upgrade installations. During some of the antenna installations "...a technician noticed corrosion under factory installed dampening/installation material," writes the submitter. This corrosion was found on the lower fuselage skins only beneath those pieces of insulating material that were apparently coming loose. He describes removing the minor corrosion and treating the affected areas. (*I*) suggest close inspection of this area in all aircraft. (*This*) problem is more than likely caused by age and moisture accumulation." (*There are two additional internal skin corrosion reports in the SDRS data base.*)

INSULATION STILL
INSTALLED

POST REPAIR AREA

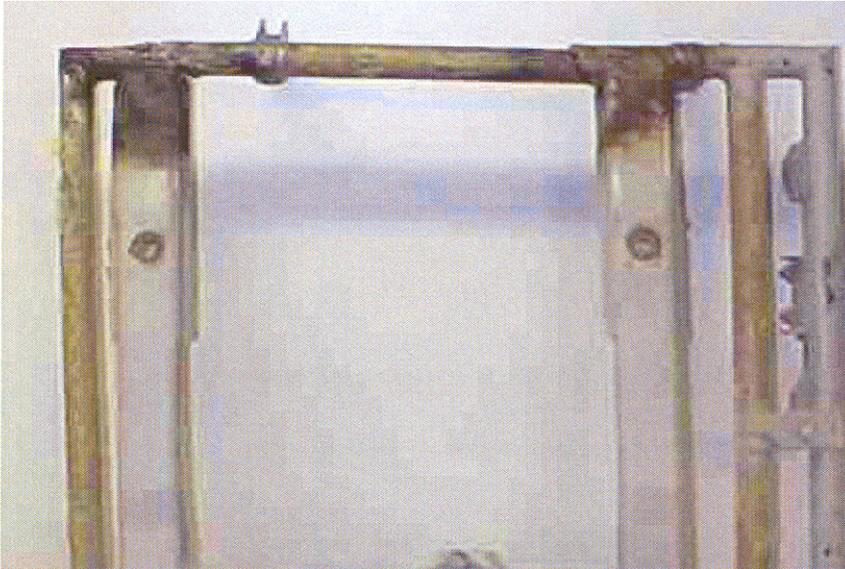
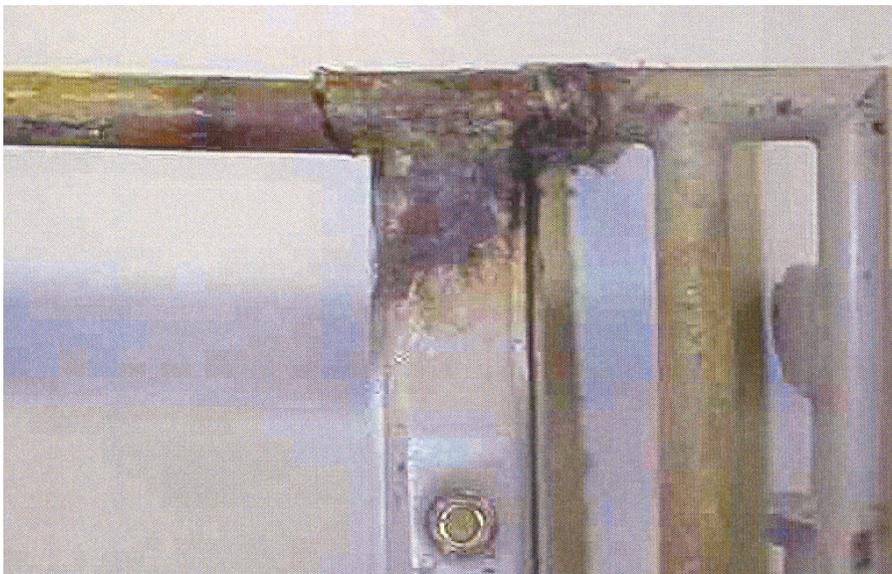
“The upper chair base assembly(s) are cracked at the chair back attach points.” These discrepancies include notations that these assemblies both show previous, inappropriate repairs. The technician references Aviation Fabricators STC (*supplemental type certificate*) ST01042WI structural seat repair as proper guidance. Part numbers for the left and right assemblies were noted as 5519015-13 and -14. *(See also the Alerts for July, September, and November for almost identical reports. From 2002 to the present, the SDRS data base records 19 reports related to this ATA code, 15 of which specifically reference cracks.)*

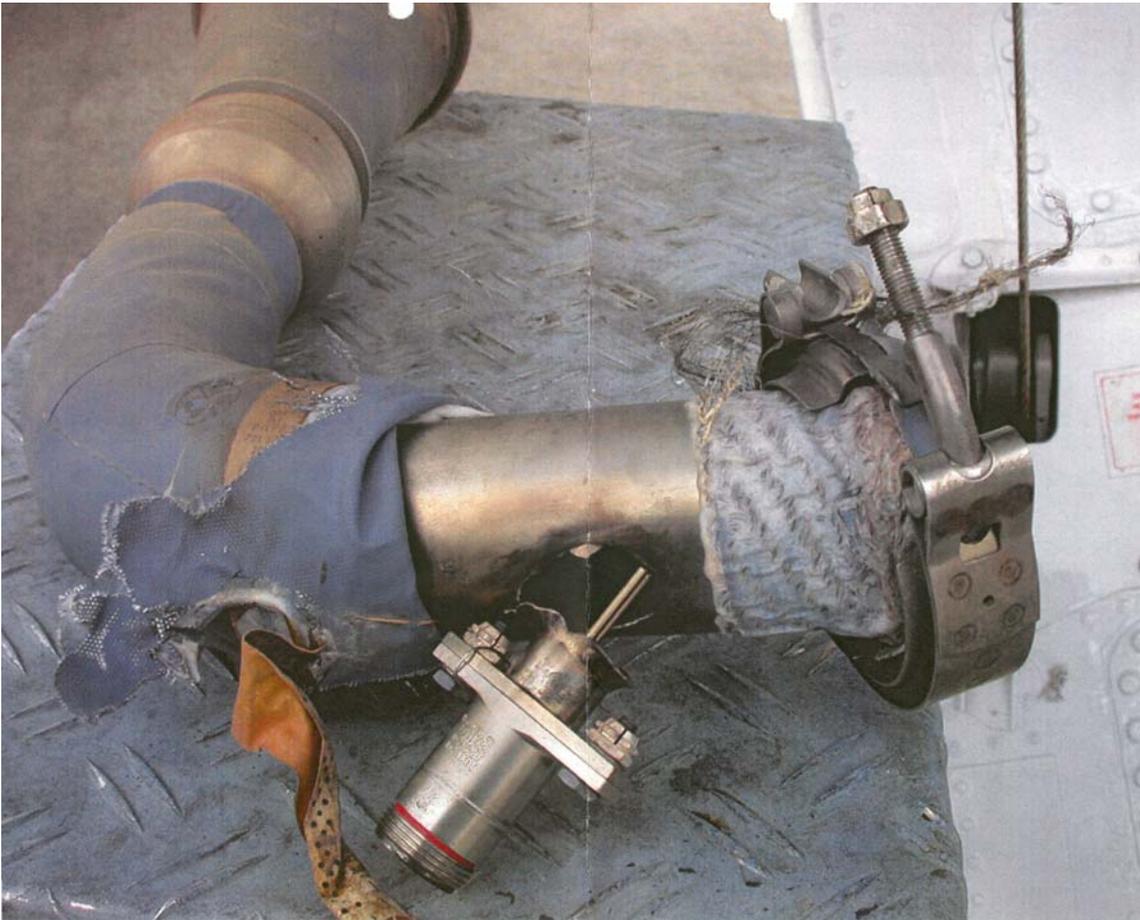
A mechanic's investigation into a problem with an oil pressure transmitter for this aircraft's number one engine led to the discovery of a hot air leak from the supporting pylon. Further observation revealed a large crack in a bleed-air duct around a temperature probe. No secondary damage was found as result of the cracked duct, or speculation offered for its cause. *(One of two photographs is shown below.)*

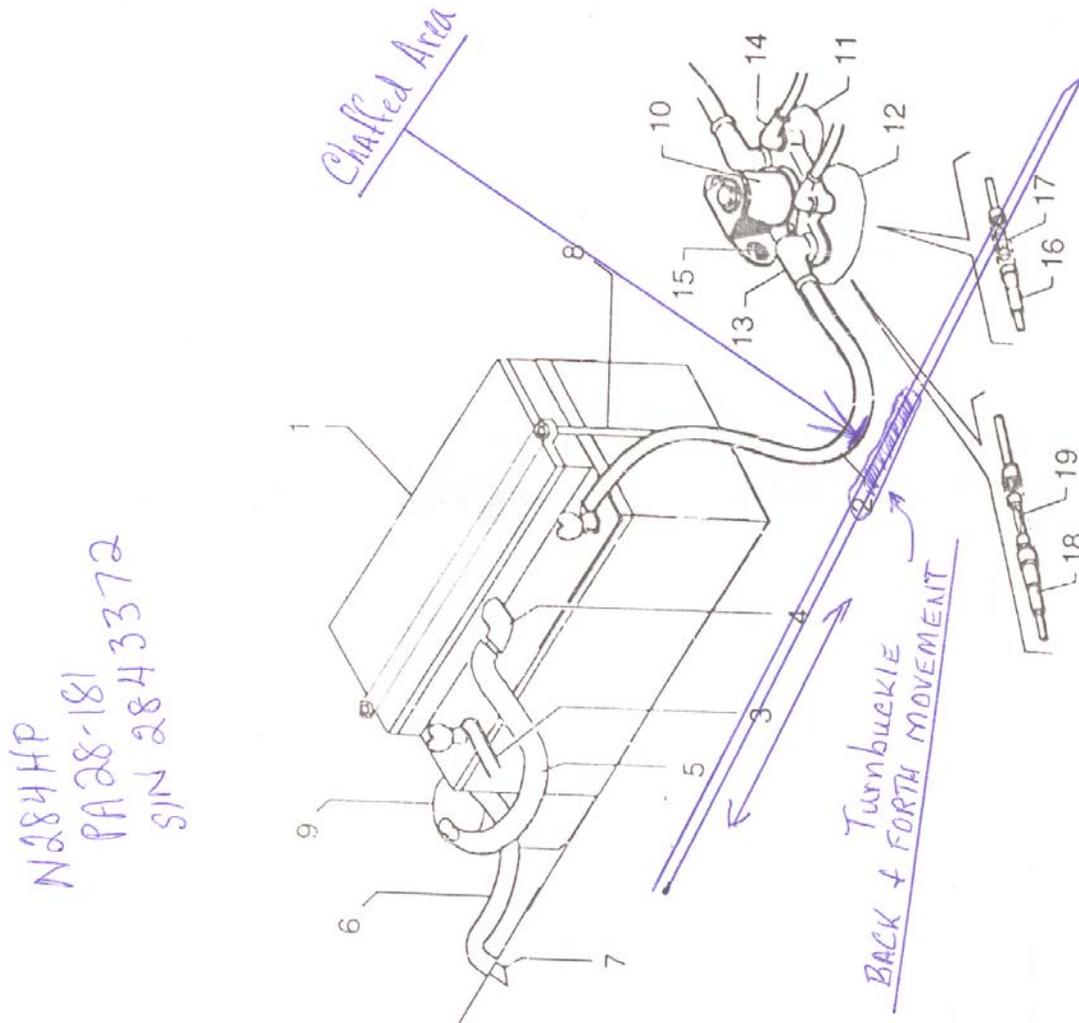
Routine maintenance found this aircraft's positive battery cable (P/N 78140-39) progressively chaffed by a control cable's turnbuckle. "This sawing motion of the turnbuckle almost wore through the battery cable insulation jacket," says a mechanic. "This battery cable was repositioned during the last 100 hour inspection for the same reason. Apparently the cable has taken a 'set'—it keeps returning to its original bend configuration. (*My*) recommendation is to shorten the cable and to crimp the terminal ends 90 degrees to the lay of the cable."

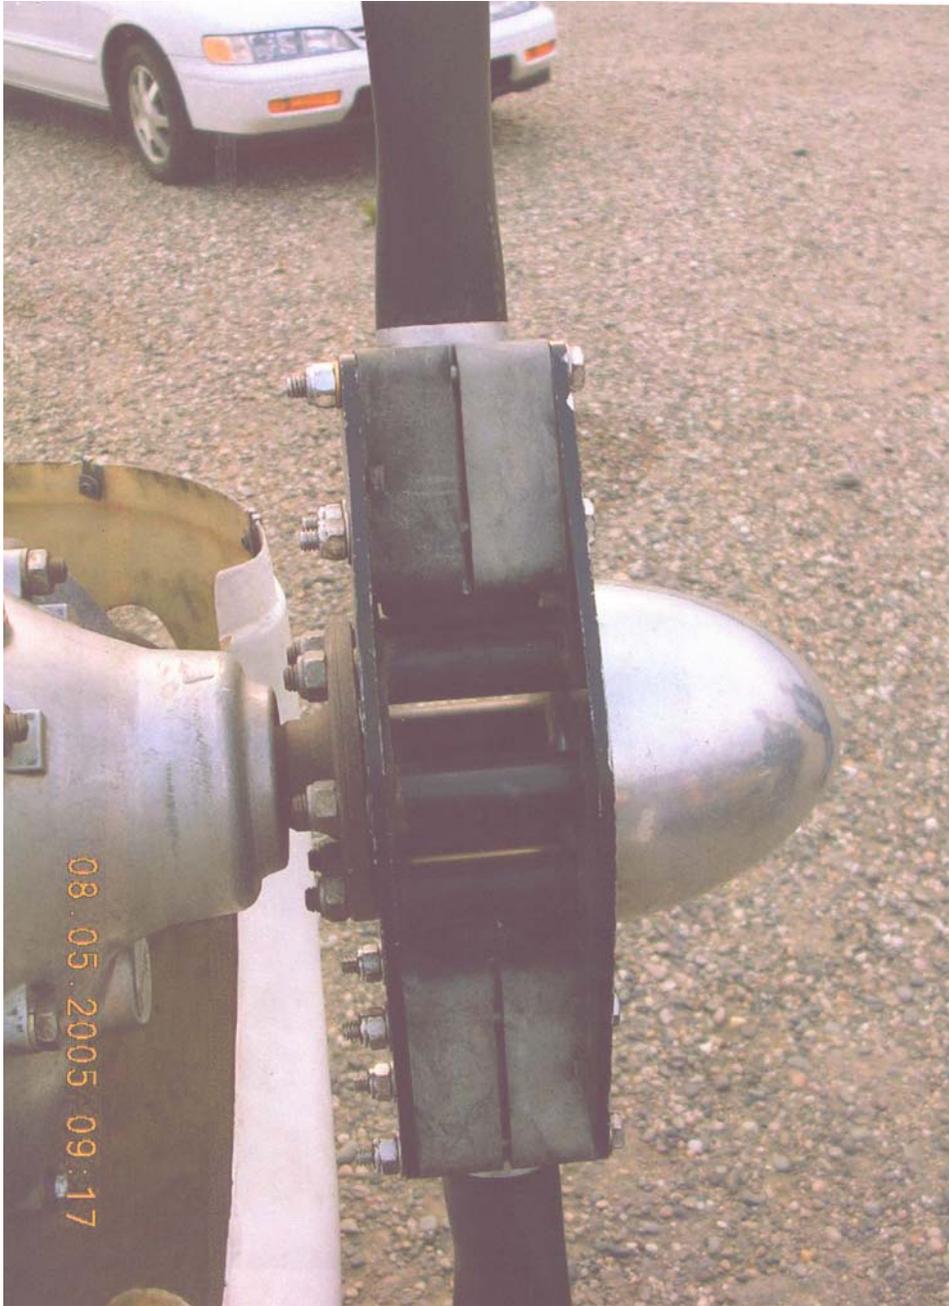
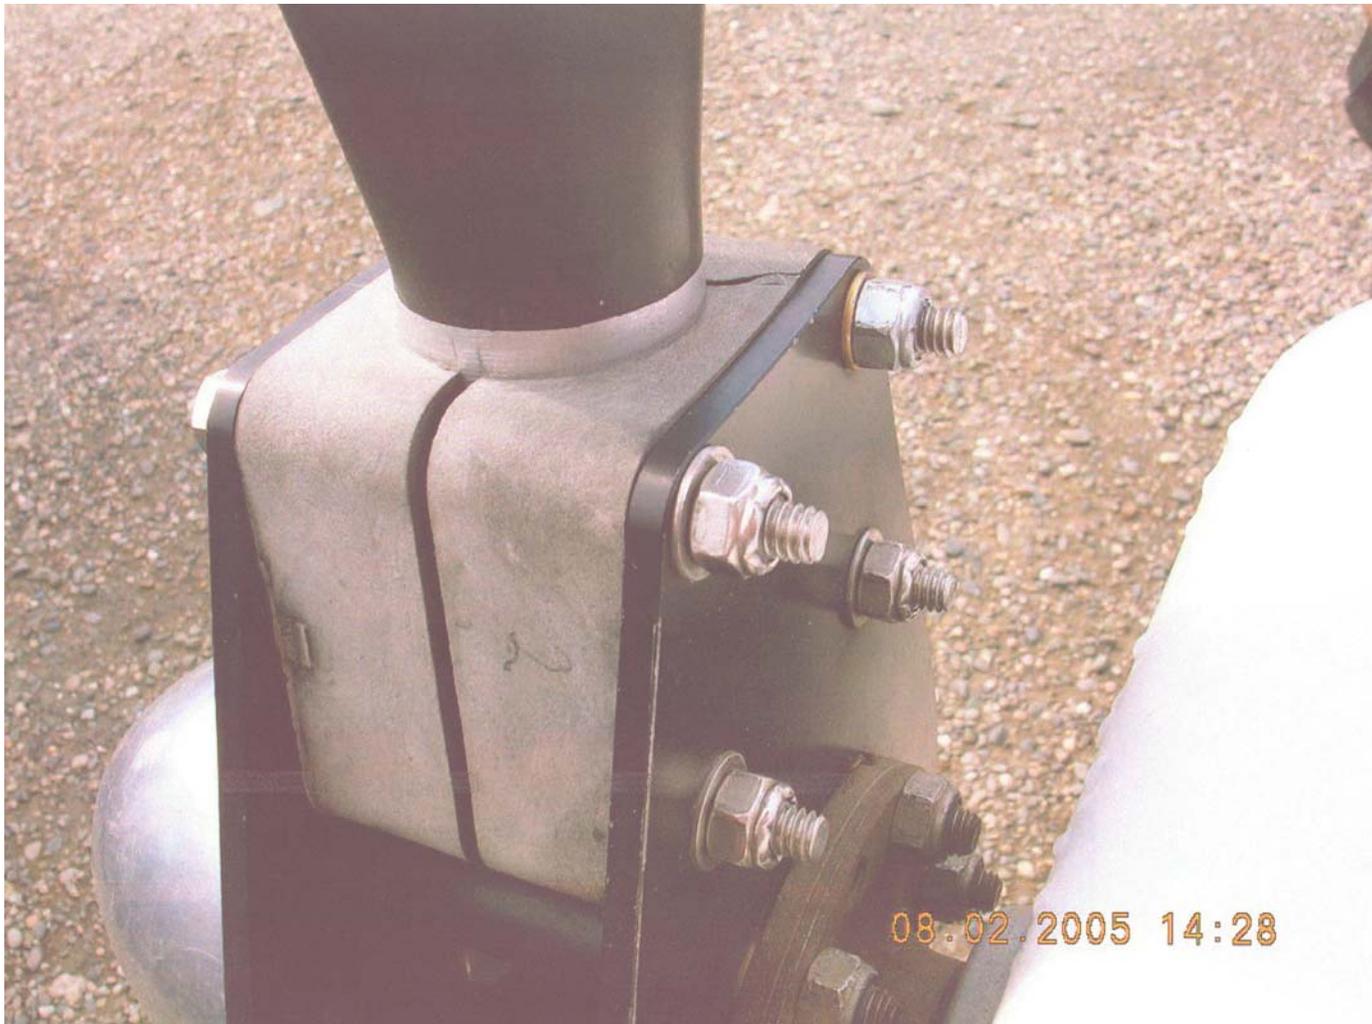
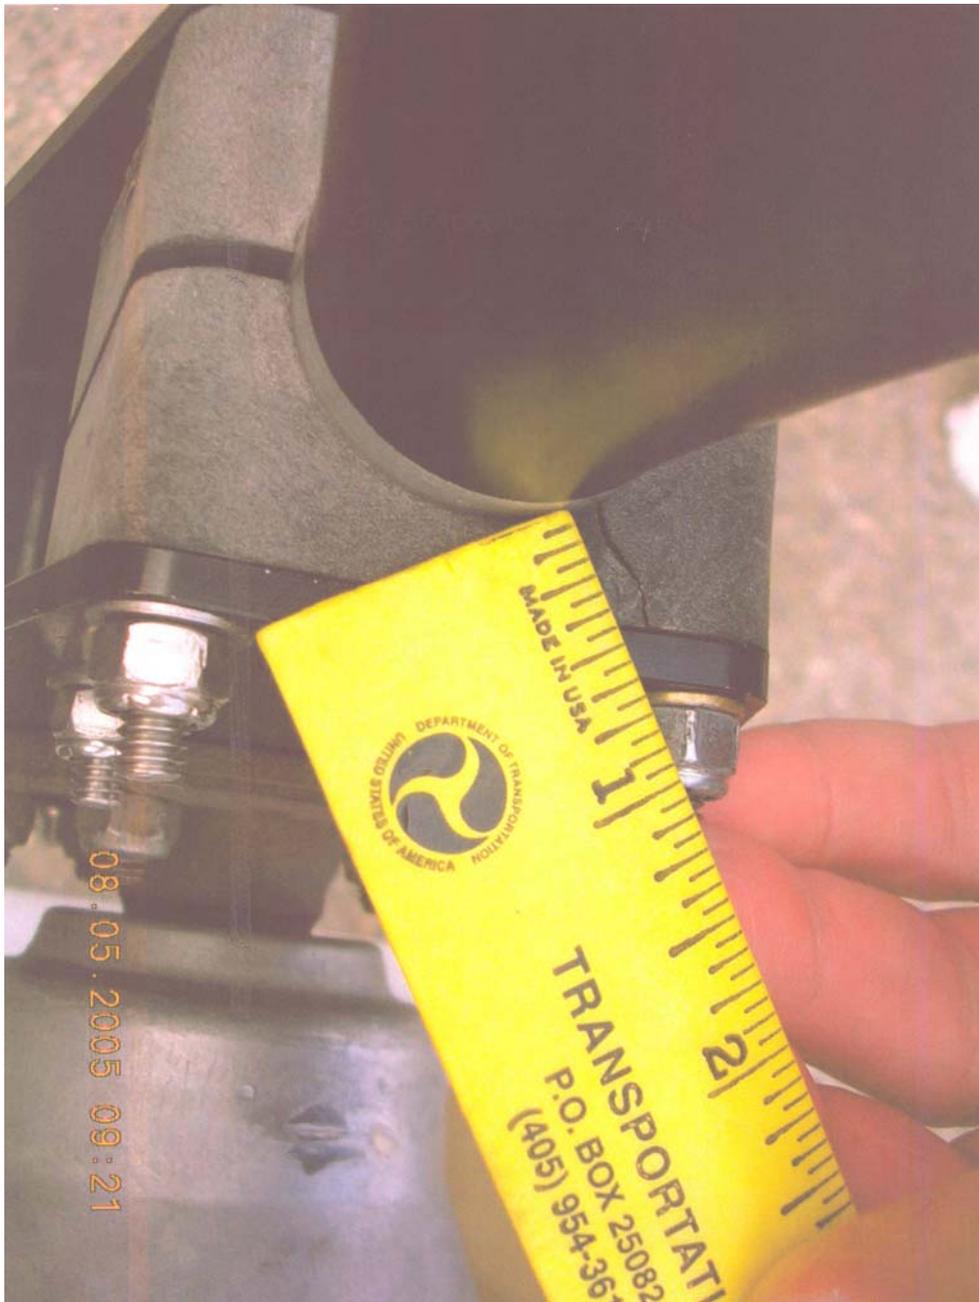
“During an inspection,” states the submitter, “it was noted the Warp Drive, 2 bladed propeller (WD-2B-68) had a crack in the hub (*extending*) from the base of the blade to one of the outer flange bolts. This is the flange that lashes (*mates*) up to the reduction gear box hub on the Rotax 582 installed on this aircraft.” (*At the time of this writing, requisite permissions have not yet been extended for other source references. More on this propeller issue will hopefully follow next month. Relevant discussions may be read at the “www.ultralightnews.ca” website. Look under “advisories”, and then “Warp Drive”.*)

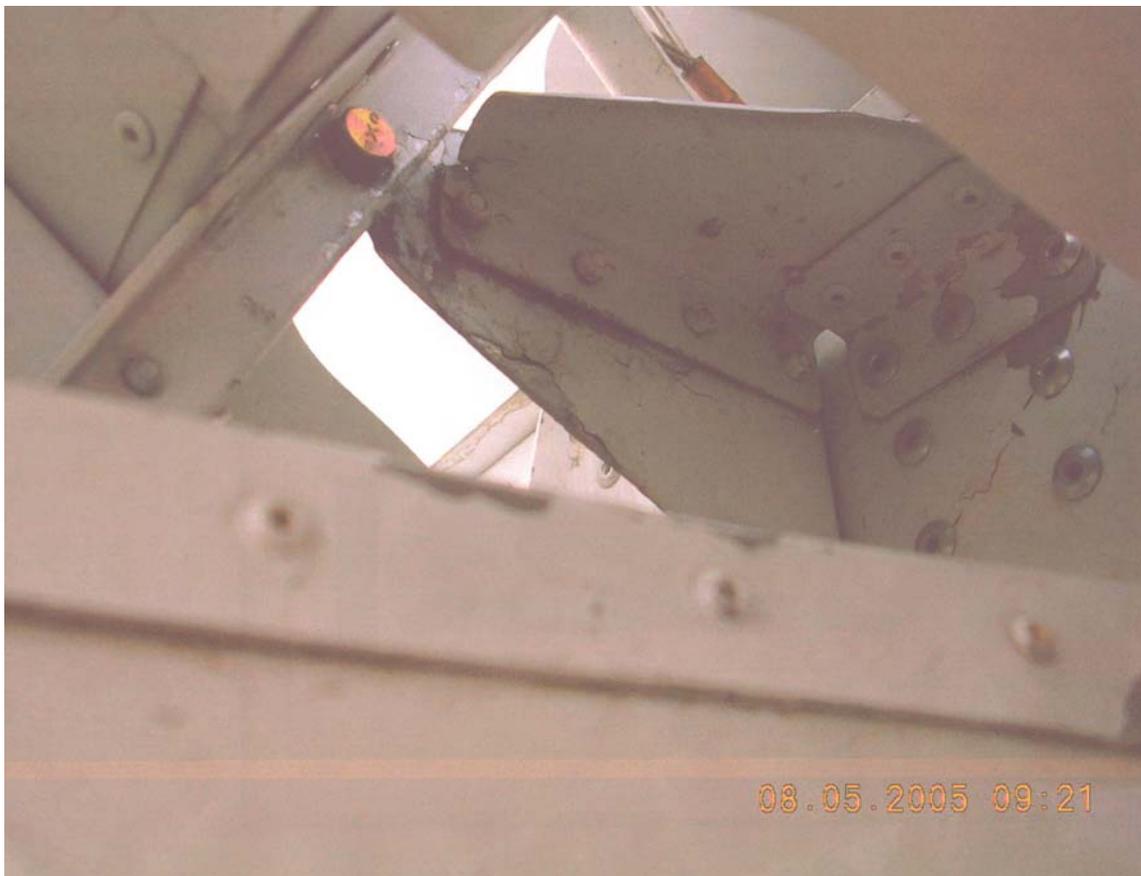
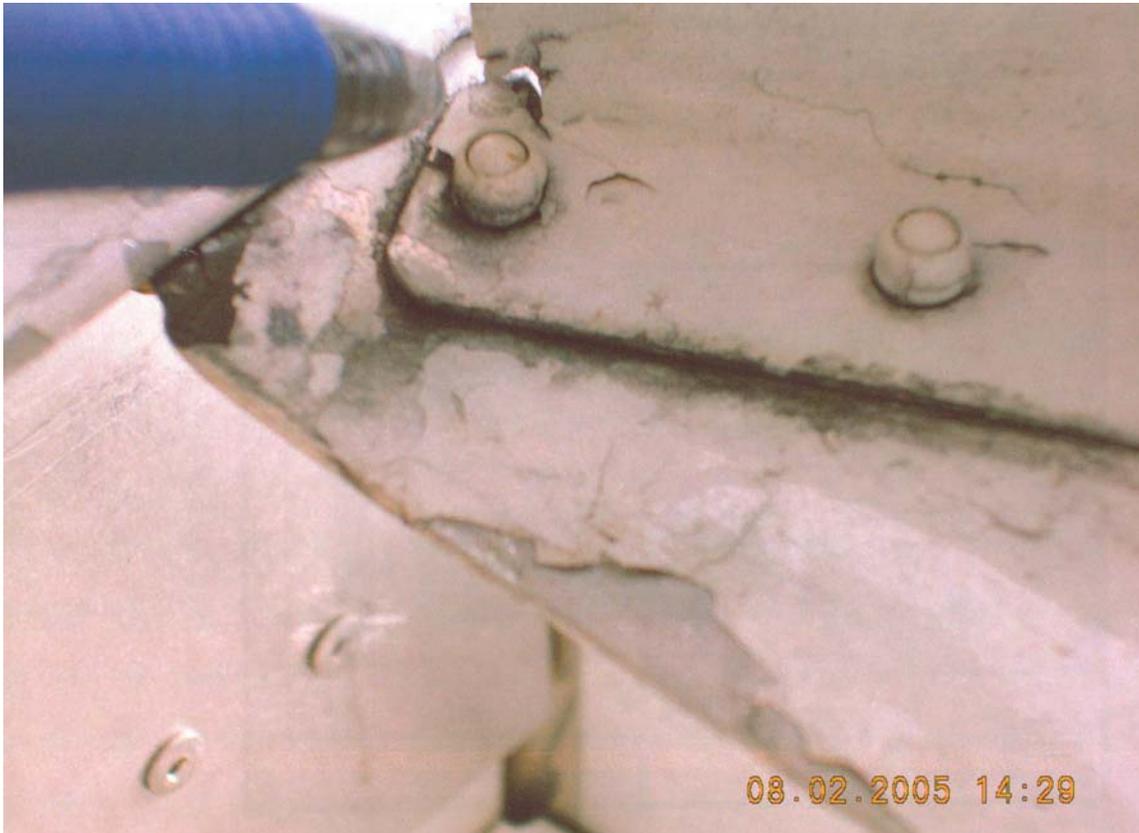
The submitter describes finding the elevator's forward hinge attach bracket "...cracked at the aft bend in the radius near the aft attach rivet. The owner stated this was a common occurrence on these model aircraft and that...*(he knew of two other planes having the same defect).*" No part numbers were provided with this report.

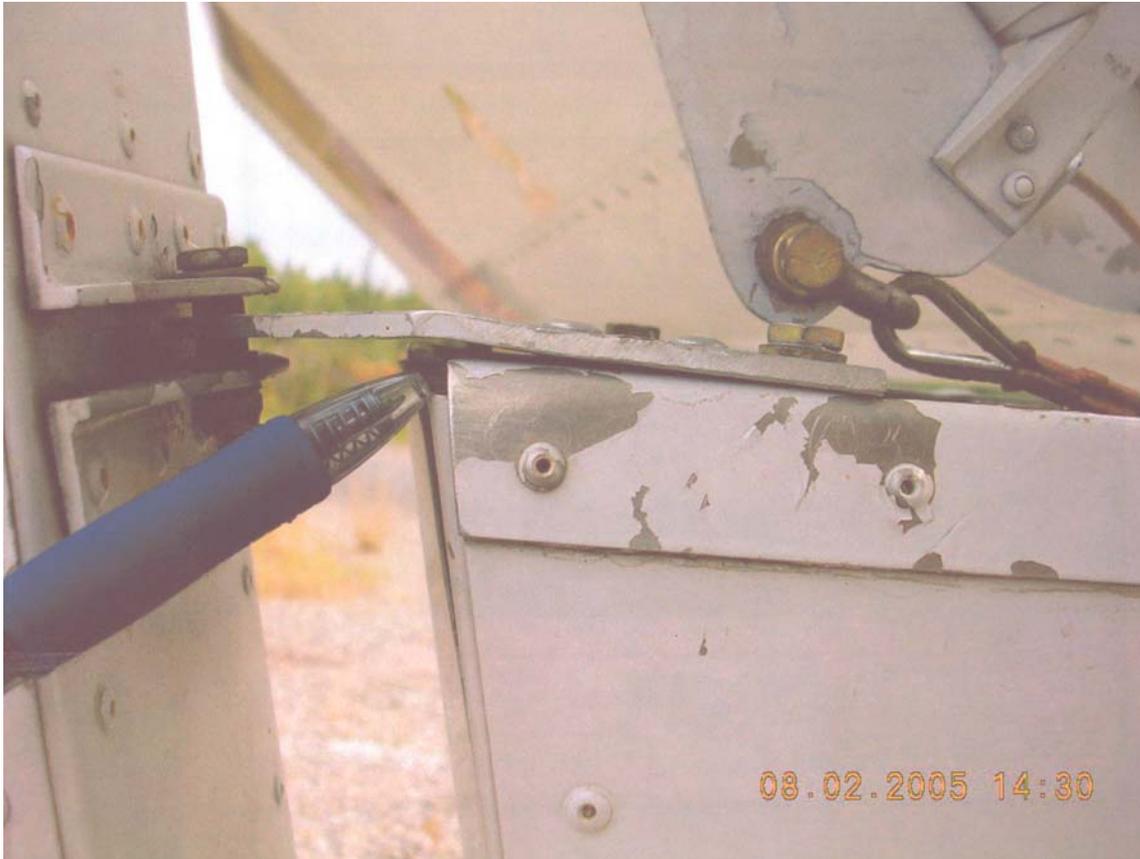
The same submitter from the preceding report found another significant structural defect on the same aircraft and during the same inspection. The rudder lower hinge attach fitting's aft two attach rivets were found pulling free from the reinforcing channels. "It should be noted the rudder is also the vertical fin on this aircraft. (I) recommend these pop-rivet type fastener be removed and aircraft hardware be installed, either bolts or MS screws. Aircraft owners should also consider installing doubler channels on the bottom side of this attach point." No part numbers were provided with this report.

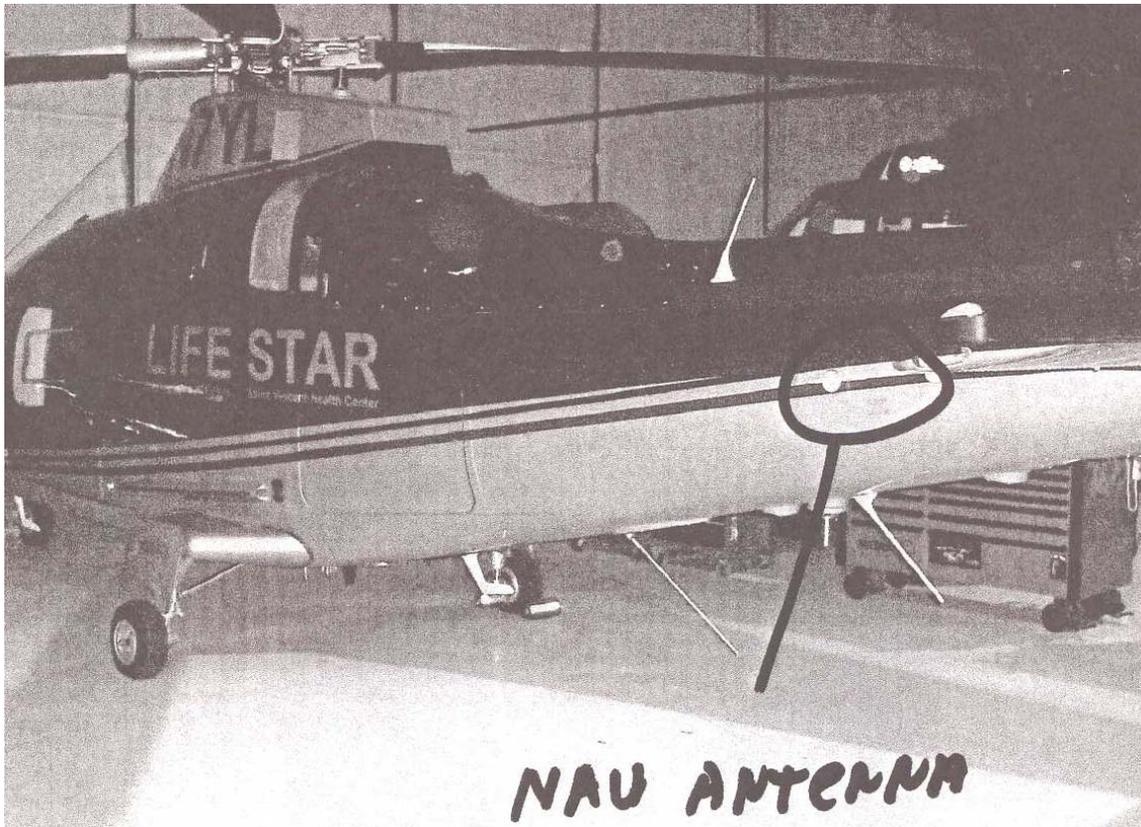
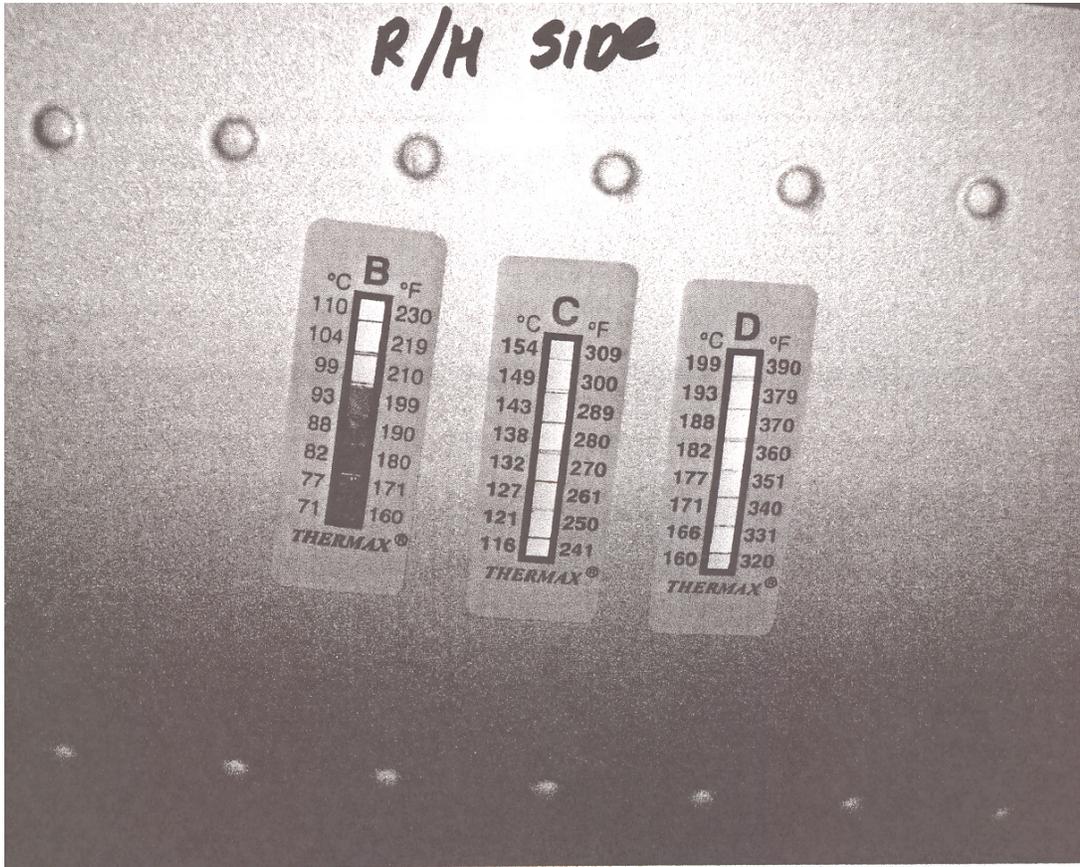
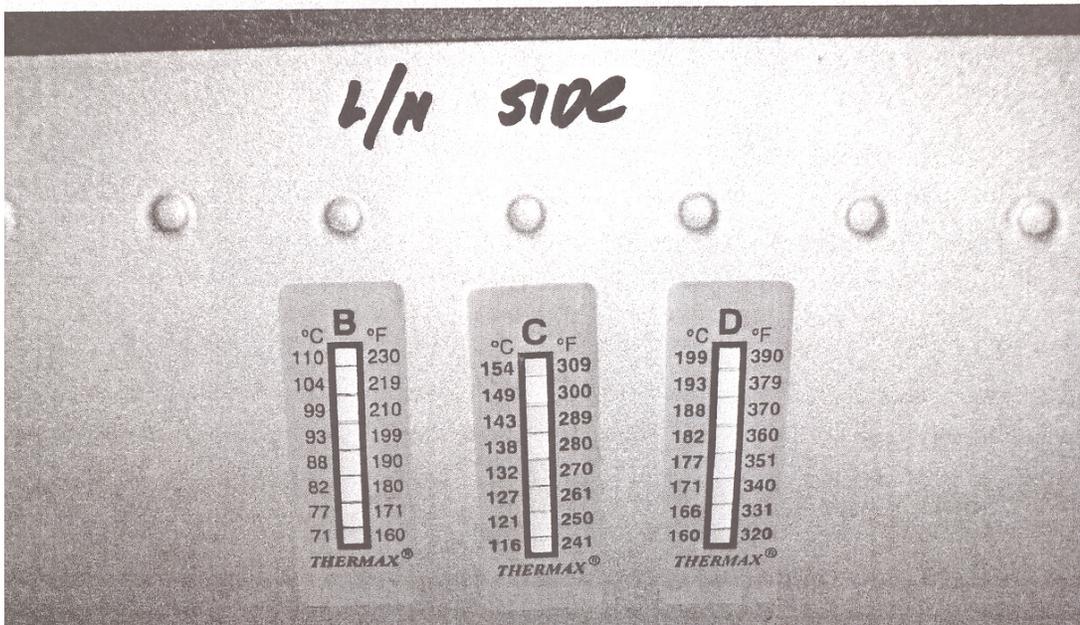
A technician describes having difficulties with the placement of this aircraft's navigation antennas. "Over the past 24 months this aircraft has had four sets of navigation antennas installed. The failure mode of the antenna is 'right hand element becomes extremely weak', which causes navigation indicator display errors of up to 5 degrees. Visual inspection indicates the R/H antenna element is exposed to a much higher temperature than the L/H element. A recent flight performed with temperature strips affixed to the aircraft proved this as fact. The temperature strips on the R/H side of the aircraft indicate an 'in flight' temperature in excess of 199 degrees F. The design limit for this antenna is 185 degrees F (*according to*) the manufacturer. (*My*) recommendations include either using an antenna suitable for higher temperature exposure or re-locating the antennas (*to fuselage positions*) away from the exhaust. (*Antenna part number is DMN48-1.*)
