43-16A

# AVIATION MAINTENANCE ALERTS

**ALERT  
NUMBER  
330**

**JANUARY  
2006**

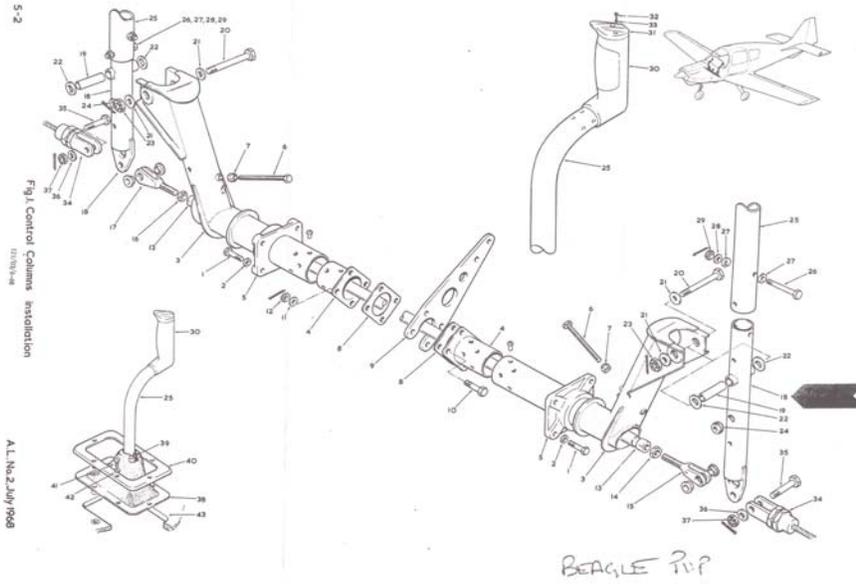
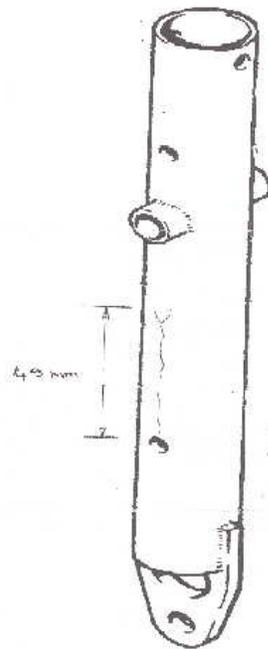
**Beagle: B121; Cracked Flight Control Column; ATA 2701**

An annual inspection visually detected a 2-inch longitudinal crack in one of the cockpit control columns. Magnetic particle inspection was used to confirm the defect. "This component forms part of the aircraft flight control system and is critical to flight," states the attending mechanic. "Both the L/H and R/H fittings (*parts*) are the same part number (*BE45.10057*). The probable cause (*for this defect*) is stress corrosion cracking. It is recommended an airworthiness directive be raised to inspect this component for cracks on the left and right control columns at the next annual—or within 50 flying hours—and then annually as a repeat inspection. (*This report*) has been transmitted to the aircraft type certificate holder: DeHavilland Support in the United Kingdom.... Telephone 44 (0) 1223 830090."

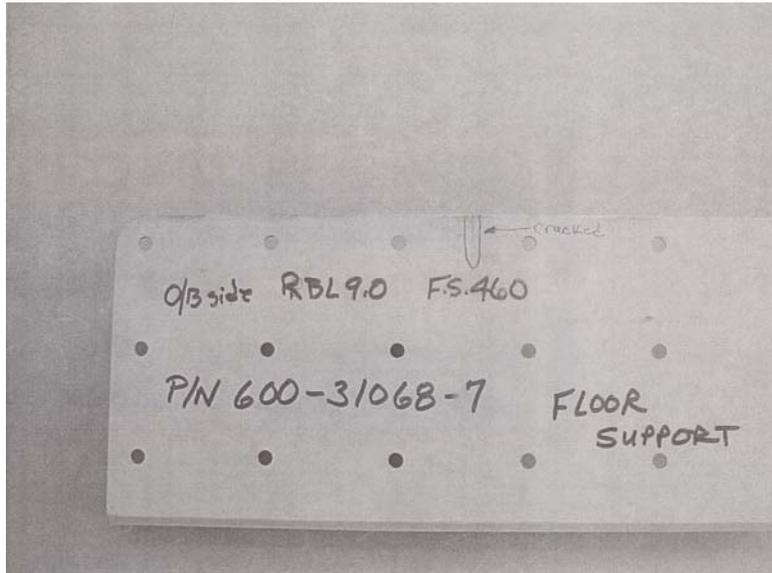
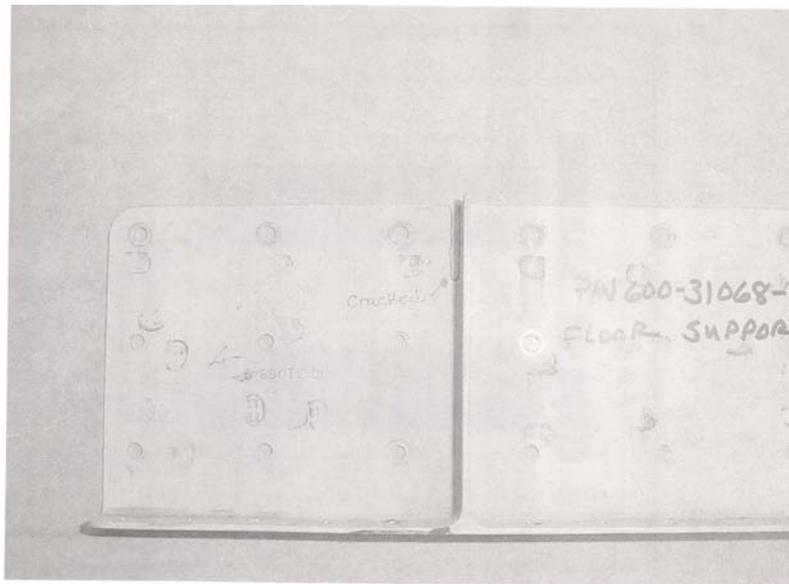
**Canadair: CL-600; Cracked Floor Support; ATA 5315**

This defect report describes a cracked flange found on supporting floor structure (P/N 600-31068-7). It was found by visual inspection during a floor beam replacement and described by the submitter as being included in the 60 month *below floor inspection task*. This cracked floor support was located at RBL 9.0, F.S. 460 (*right buttock line and fuselage station*). Inspection of three additional CL-600 aircraft did *not* find similar cracks. (*Low resolution, black and white photos accompanied this submission, two of which are included.*)

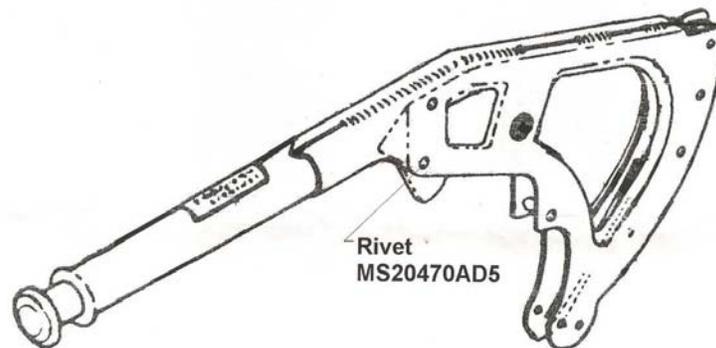
### Cessna: 170B, 172-172E, 180's, 182-182D, 185's: Worn Flap Handle Latch; ATA 2750

“The FAA has received reports of problems associated with a tubular spacer found within Cessna flap handle latch mechanisms (P/N 0510166-0 through -5). Specific models include 172 through the 172E (1964), all 180's, 182 through 182D (1961), and all 185's. The spacer's relative position within the handle can be seen in the attached drawing. It is transfixed by a rivet having washers at each end. Continued use of this latch mechanism causes wear on the handle. Should this occur, the spacer can work itself sufficiently out of the handle to jam the latching mechanism. Wear may be evidenced by paint or surface scrape-type marks found just below the washers on either side of the flap handle. It is recommended this latch joint be inspected for wear during every 100 hours or annual inspection.”

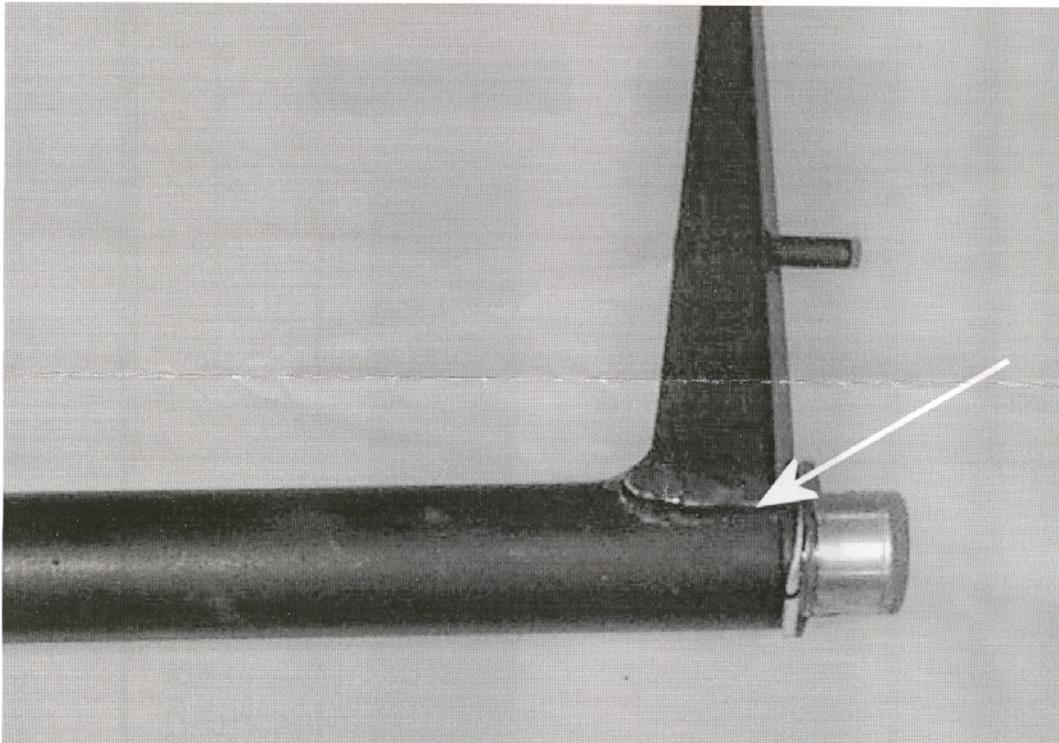
### **Mooney: M20J; Cracked Seat Crank; ATA 2510**

Aft acceleration of the pilot's seat during takeoff provided plenty of motivation for an inspection. Vertically adjusting, the submitter found the left rear bell crank assembly cracked, allowing for sufficient frame distortion the seat lock pins would not fully engage the slide tracks. A new bellcrank and tube assembly were installed (P/Ns 140216-501 and 140216-021). The submitter notes the new bellcrank had reinforcement straps welded at the failure point. The new parts returned the seat to normal operation. *(This vertically adjusting seat is described as optional: P/N 140215-501. Shown below is a picture of the cracked crank assembly.)*

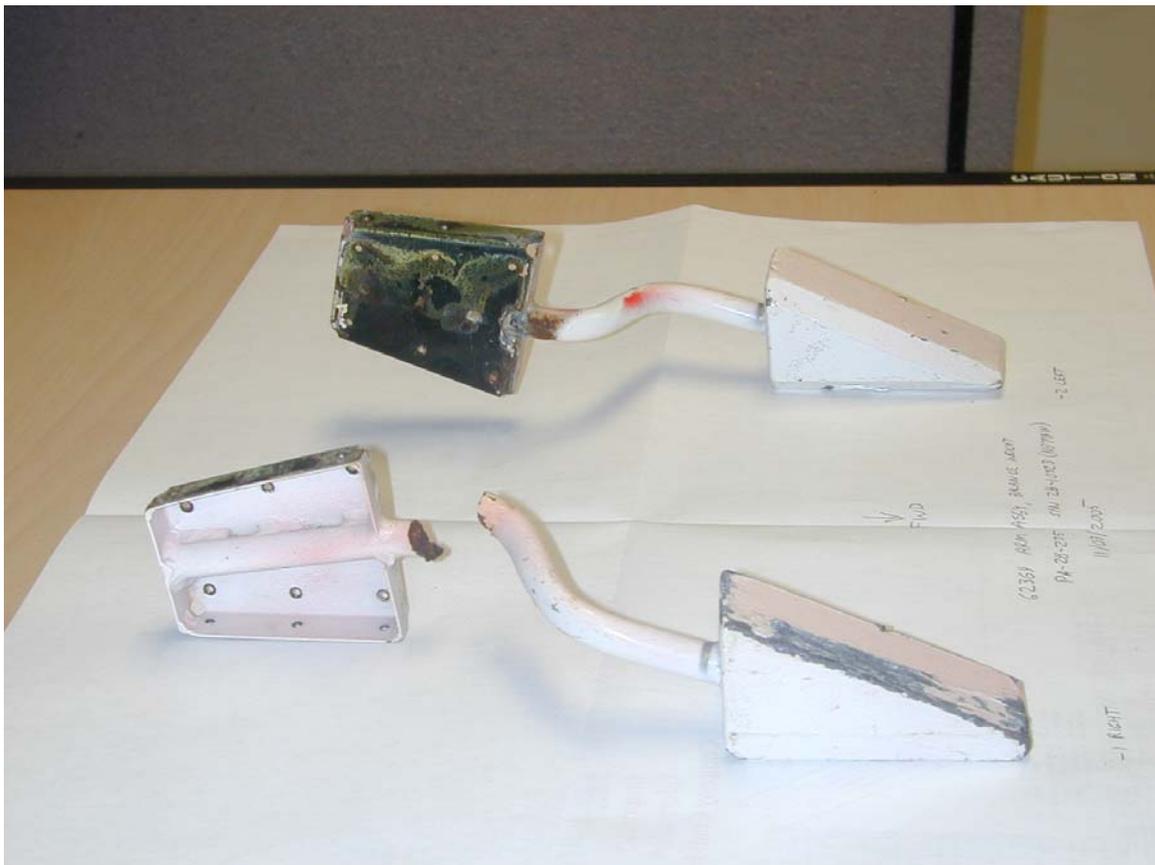
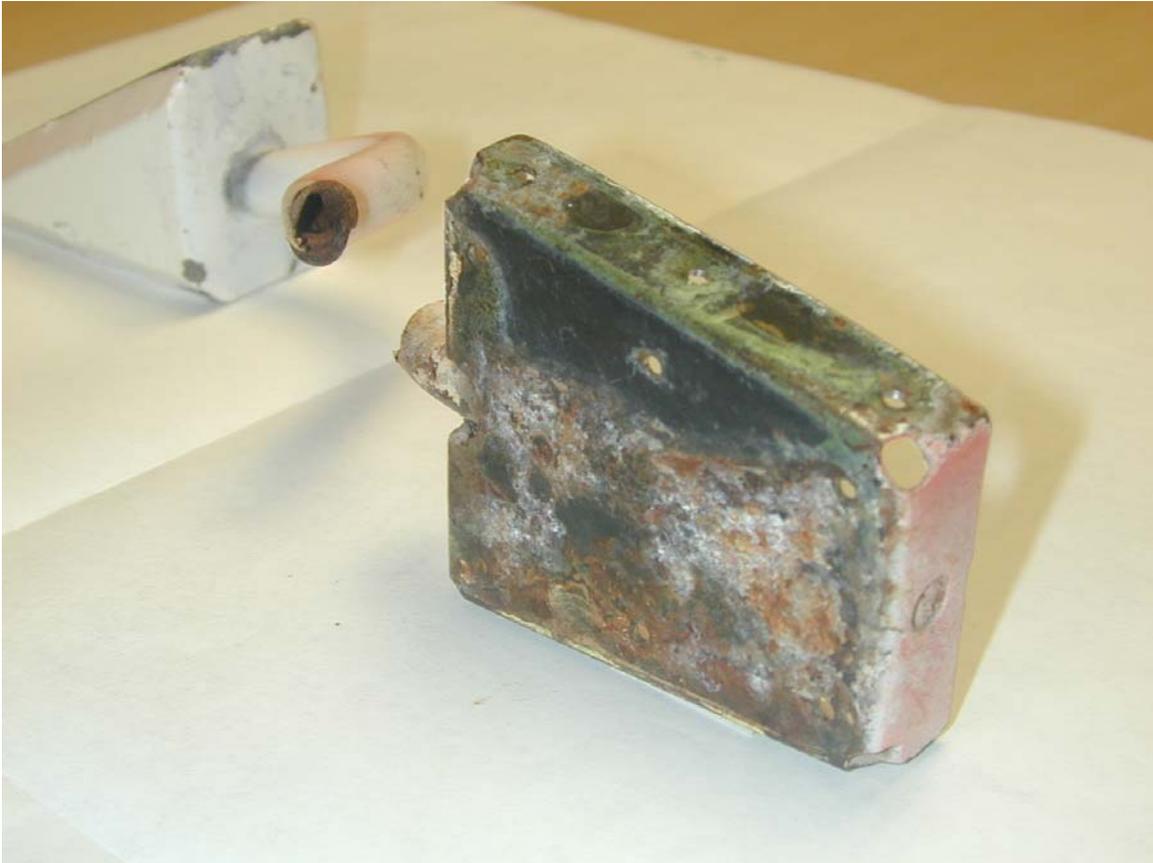
#### Piper: PA28 and-32; Corroded Aileron Balance Weight; ATA 5751

“This office received a report of a corroded aileron balance weight assembly on a 1964 Piper PA-28-235 (P/N 62369-00 or 62369-01). Based on the report and our research, the following is recommended: for those Piper PA-28 and PA-32 model airplanes that meet the applicability requirements specified in Airworthiness Directive (AD) 67-12-06, accomplish the actions specified in paragraphs (a) through (c) of the AD for the aileron balance weight assembly. Do this at the next annual or 100 hour inspection (whichever comes first) and repeat every annual inspection. Consider additional inspection of the faying surface—where the assembly attaches to the aileron end-rib. More corrosion may be found.”

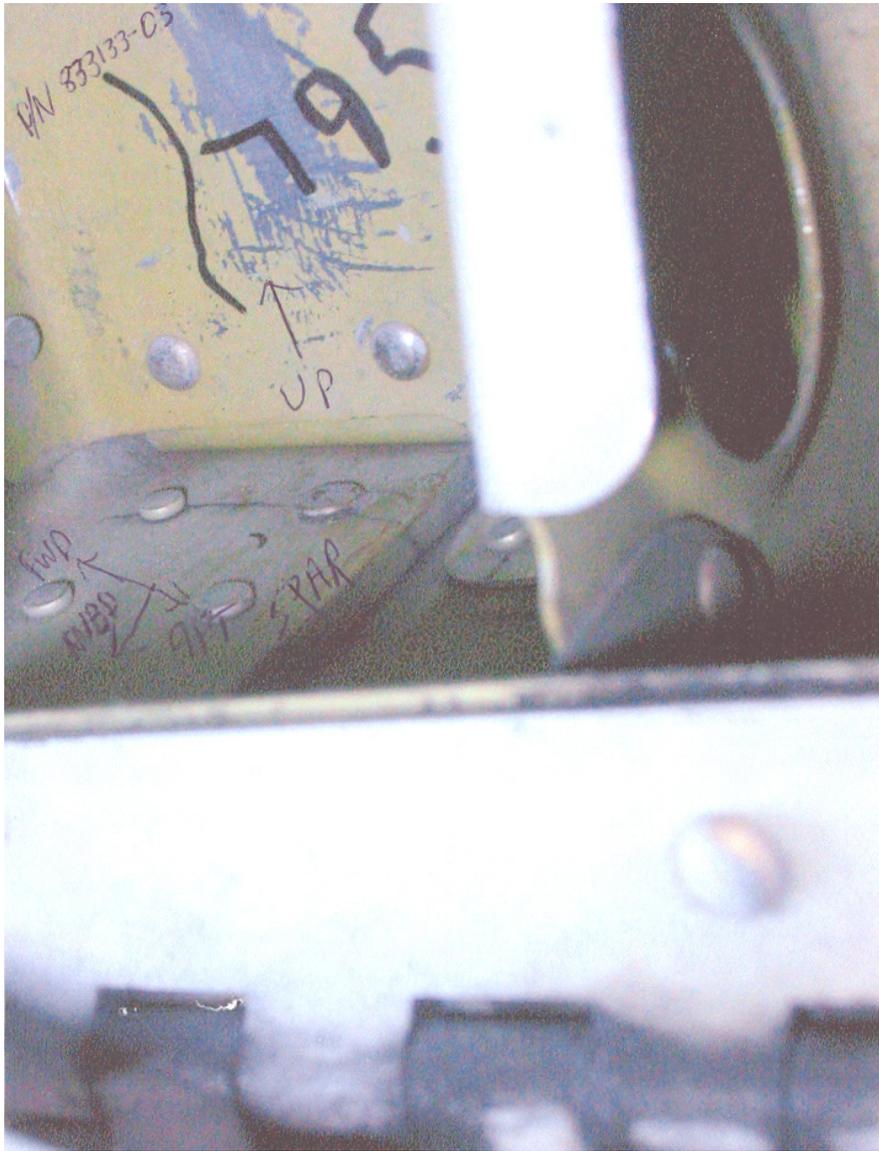
### **Piper: PA46; Cracked Wing Spar; ATA 5711**

A repair station technician writes, "During an annual inspection it was noted several rivets attaching the right wing skin to the lower wing spar were becoming loose (smoking) just outboard of the main gear door and inboard of the rib (P/N 83133-03) at wing station 79.5." A crack was found inside the wing on the bottom aft side of the spar angle (P/N 82200-696), starting at the aft edge and propagating forward through two rivets and beyond (see attached photograph). "It appears the wing flexes considerably in this area, evidenced by loose rivets." He encourages accomplishment of Piper Service Bulletin SB796B, part 1 of which addresses this issue. *(The "smoking rivet" idiom is analogous to the more broadly known "smoking gun." Any number or combinations of dirt, fluids, grease, oil, and the like can readily "work" around a loose fastener. When exposed to the airstream, telltales are generated in the form of long dirty streaks leading back to the source. The SDRS data base reflects seven additional/related lower spar cracks.)*

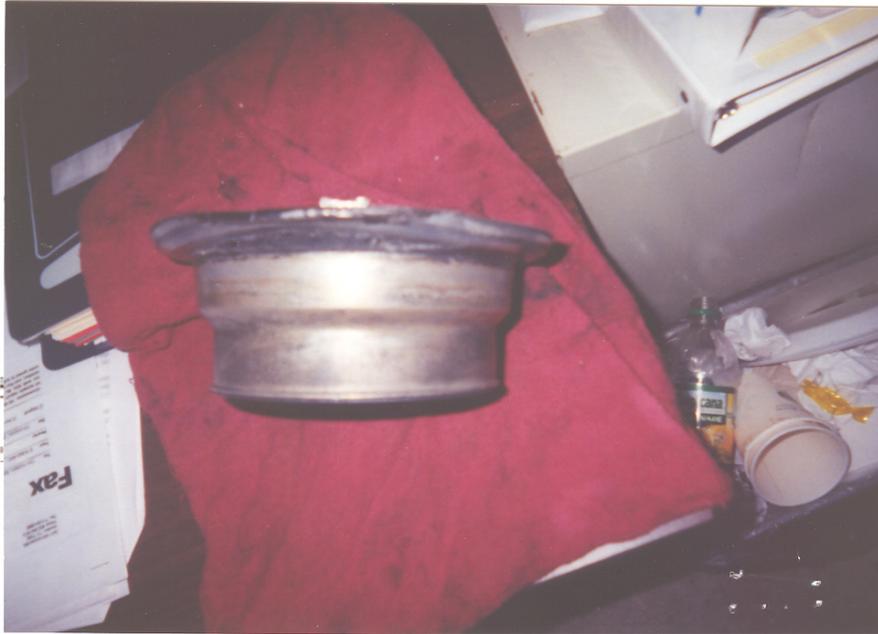
**Piper: PA32; Cracked Wheel Half; ATA 3246**

A mechanic describes this aircraft landing safely, with a subsequent flat tire developed during taxi. Fairing removal revealed the inboard wheel half (P/N 161-47) rubbing on the brakes. After disassembly and removal of the brake disk, "...the inboard wheel half (*was observed*) to be cracked three inches along the bead area and bowed out." The pilot reported this wheel's tire had been changed 6 months previously, leading the mechanic to speculate whether or not close inspection at that time could have detected this defect.

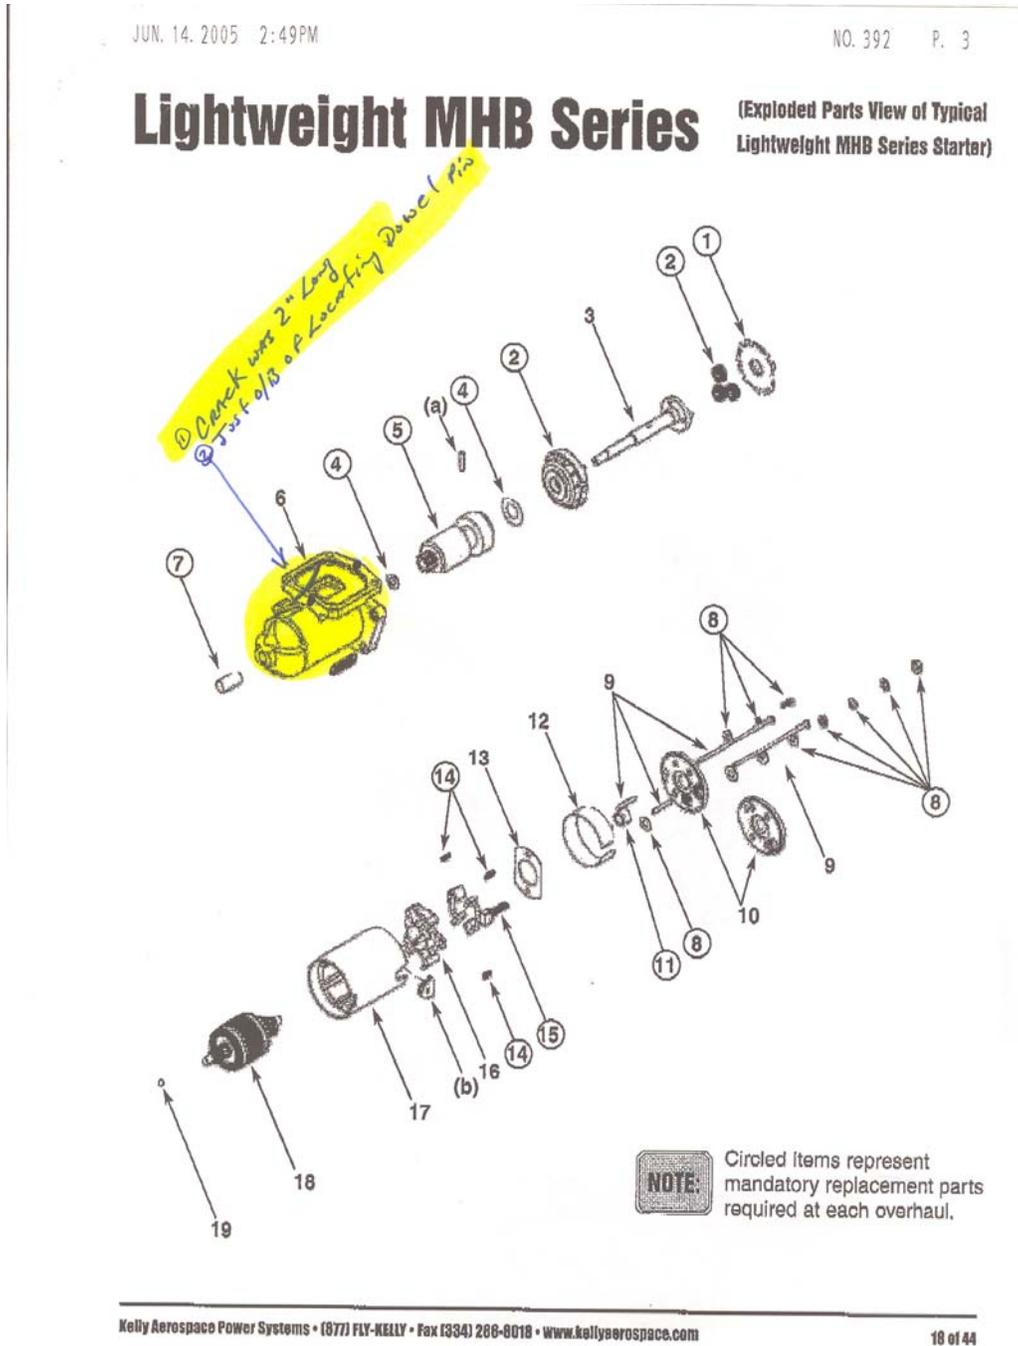
#### Kelly Aerospace (Starter—3 ea.): MHB 6016; Cracked Mounting Plate; ATA 8011

*(Three defect reports from the same mechanic describe identical flaws in the same starter part number (MHB-6016) from two Piper PA-28 aircraft and a third unknown aircraft.)*

“Mounting plate has stress crack identical to (the) other failures,” states the submitter. “See the attached IPC (internal parts catalog) for the (location) area of the crack. Cracks on both units were two inches long.” The third report includes “This is the fifth cracked housing in a two month period. There is a major problem....” (Part times were not included with these reports. All three starters were condemned.)
