ADVISORY CIRCULAR

43-16A

AVIATION MAINTENANCE ALERTS

**ALERT
NUMBER
331**

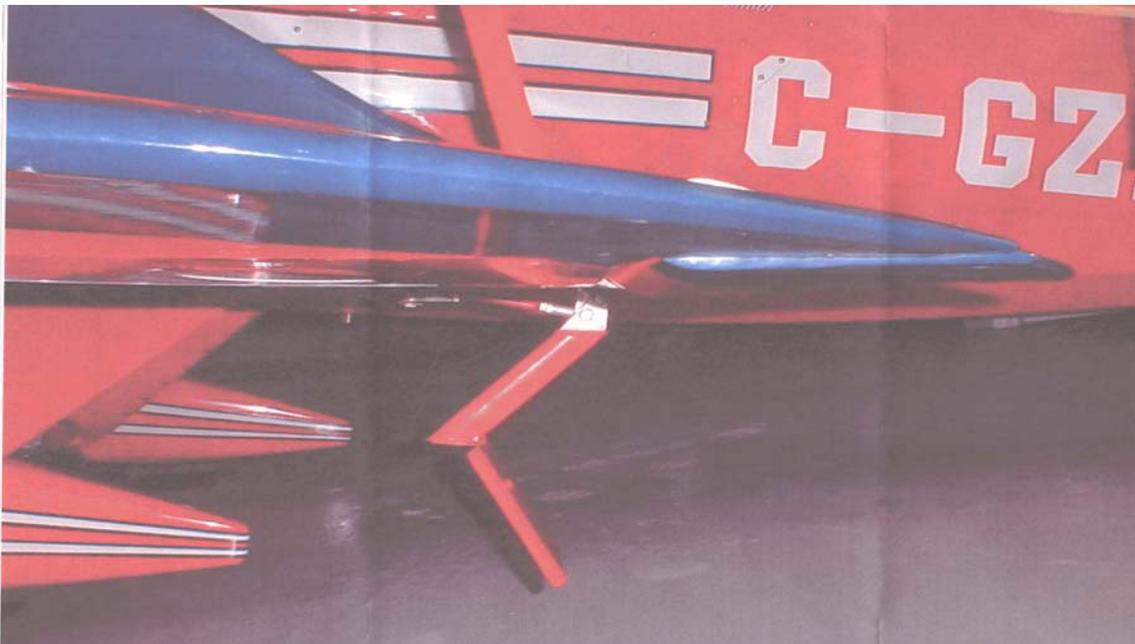
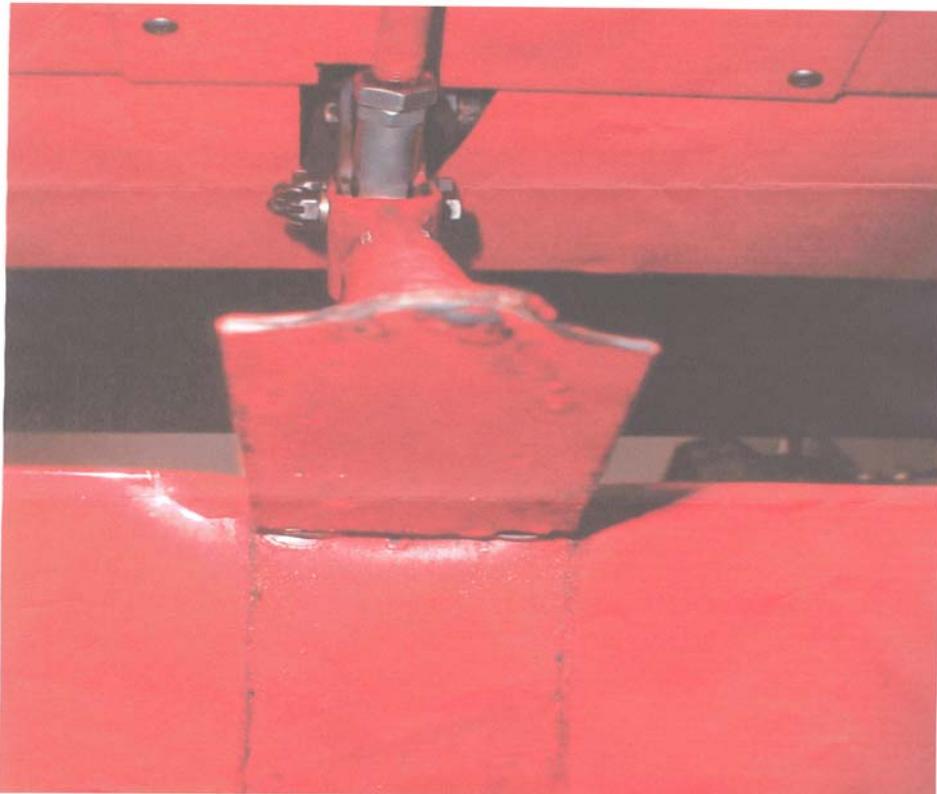
Aviat: S-1T; Broken Spade Plate; ATA 2710

A submitter from the Aviat company states, "At approximately 200 MPH the left aileron spade-plate front attach point broke, allowing the spade-plate to pivot downward to a full vertical position where it stayed until landing. *(The attached photographs indicate...)* signs of previous cracking as shown by rust." "*(There are)* ...indications of aerobatic maneuvers (snap rolls) in excess of recommended limits. A daily and annual inspection of the spade assemblies will be added to the owner's maintenance manual." *(The spade assembly part number provided is: 1-0425-001; the spade plate: 1-0425-002. The following pictures have been slightly cropped.)*

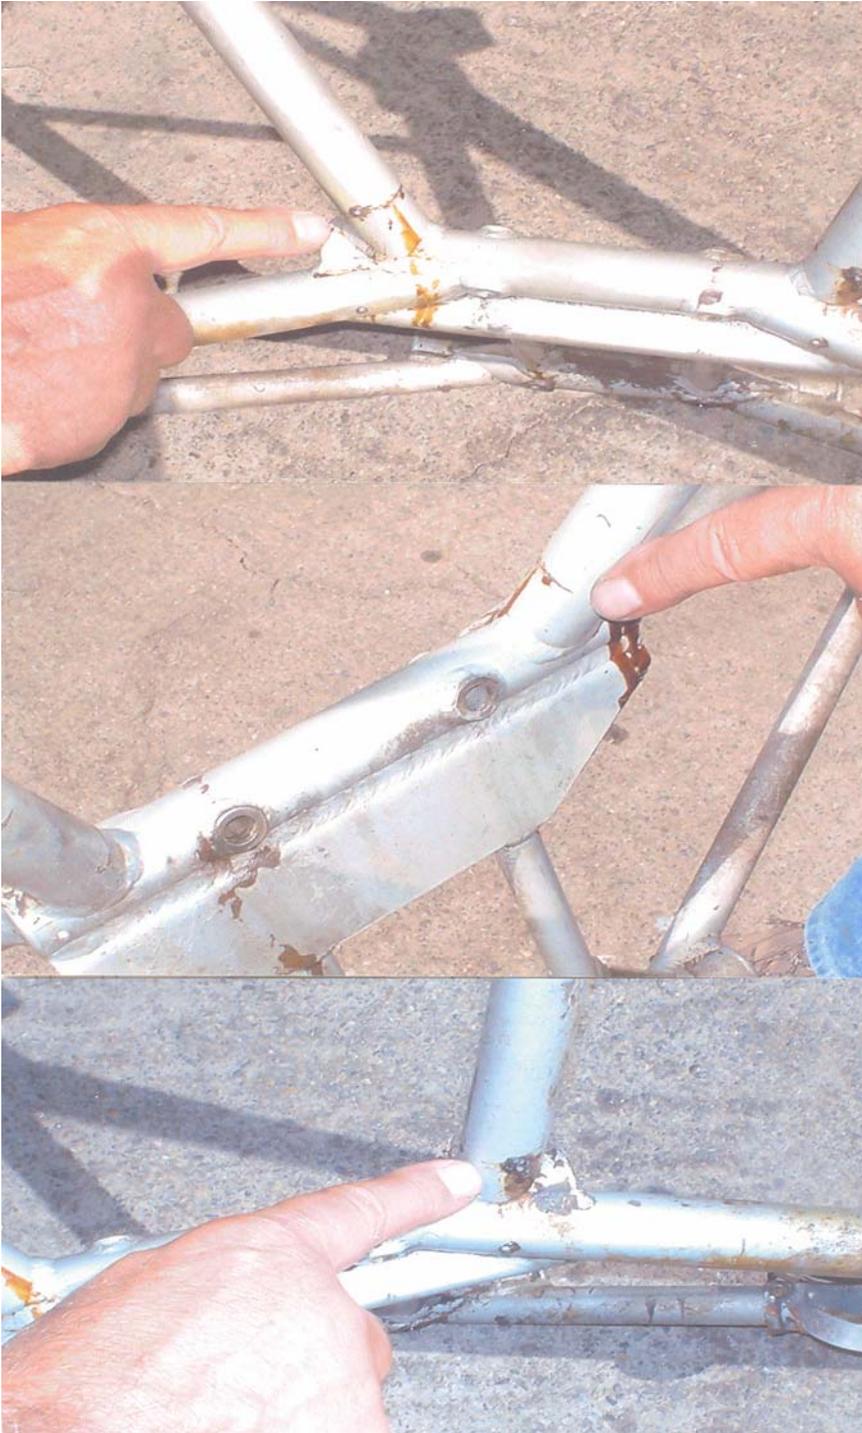
Beech: 77; Cracked Motor Mount; ATA 7120

A mechanic describes finding this aircraft's upgraded motor mount cracked (provided part number included only the last two digits: ...-71). "The plug used to relieve (*tubular*) welding pressure and/or to add (*preserving*) linseed oil appears to be the problem—as a stress riser, etc. The linseed oil escaped and made a perfect crack indication without the use of dye-penetrant. The older style -1 motor mount does not have plugs in this area." (*A data base search yields motor mount part numbers 108-910011-1 and -71.*)

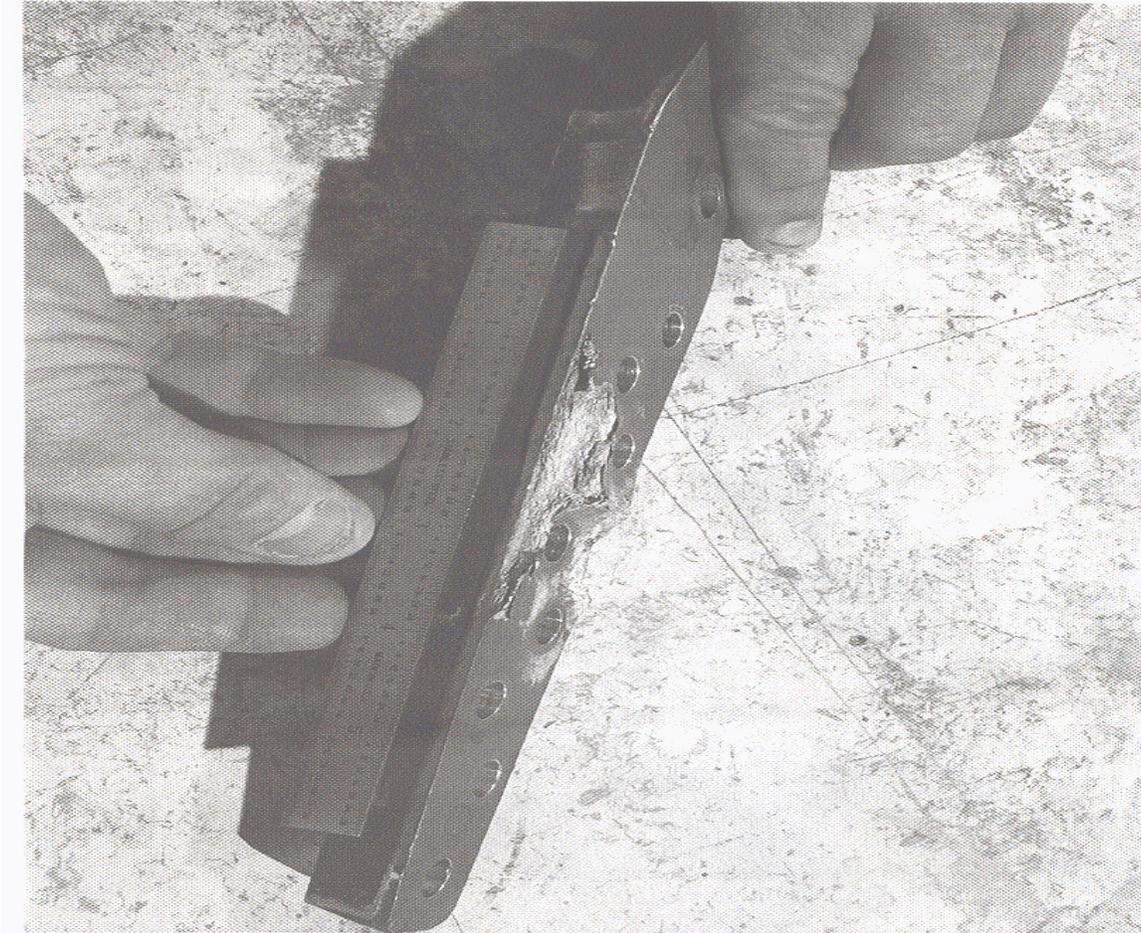
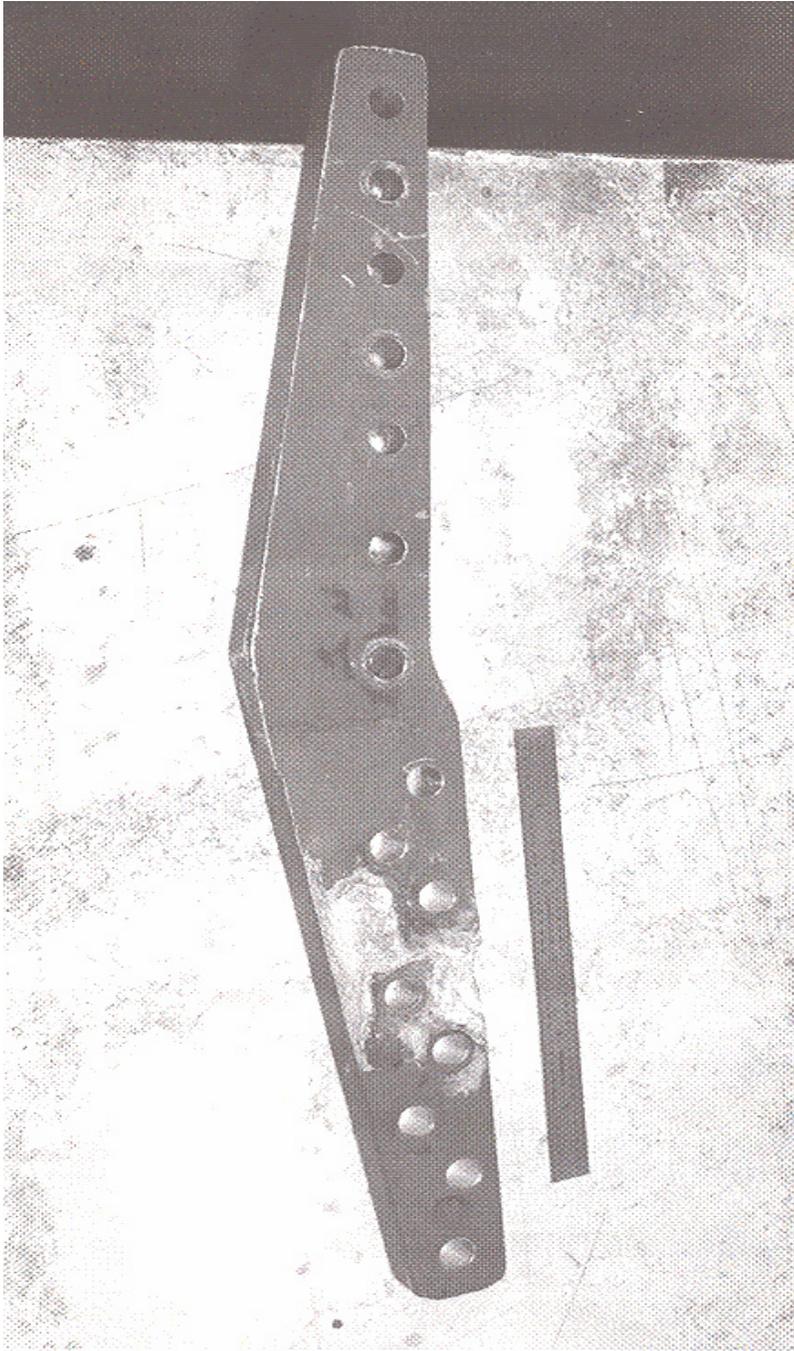
CESSNA**Cessna: 310J; Corroded Wing Attach Fitting; ATA 5741**

A mechanic found severe corrosion on this aircraft's wing attach fitting during an annual inspection (P/N 0811276-3). Its location is described as L/H wing, aft top mount. "...the corrosion was so severe it was almost 1/4th of the way through the fitting," states the submitter. *(No other condition descriptions of the remaining fittings and their related pieces accompanied this report. Four low resolution photographs were provided, two of which are shown here. The SDRS data base reflects two additional entries having this description.)*

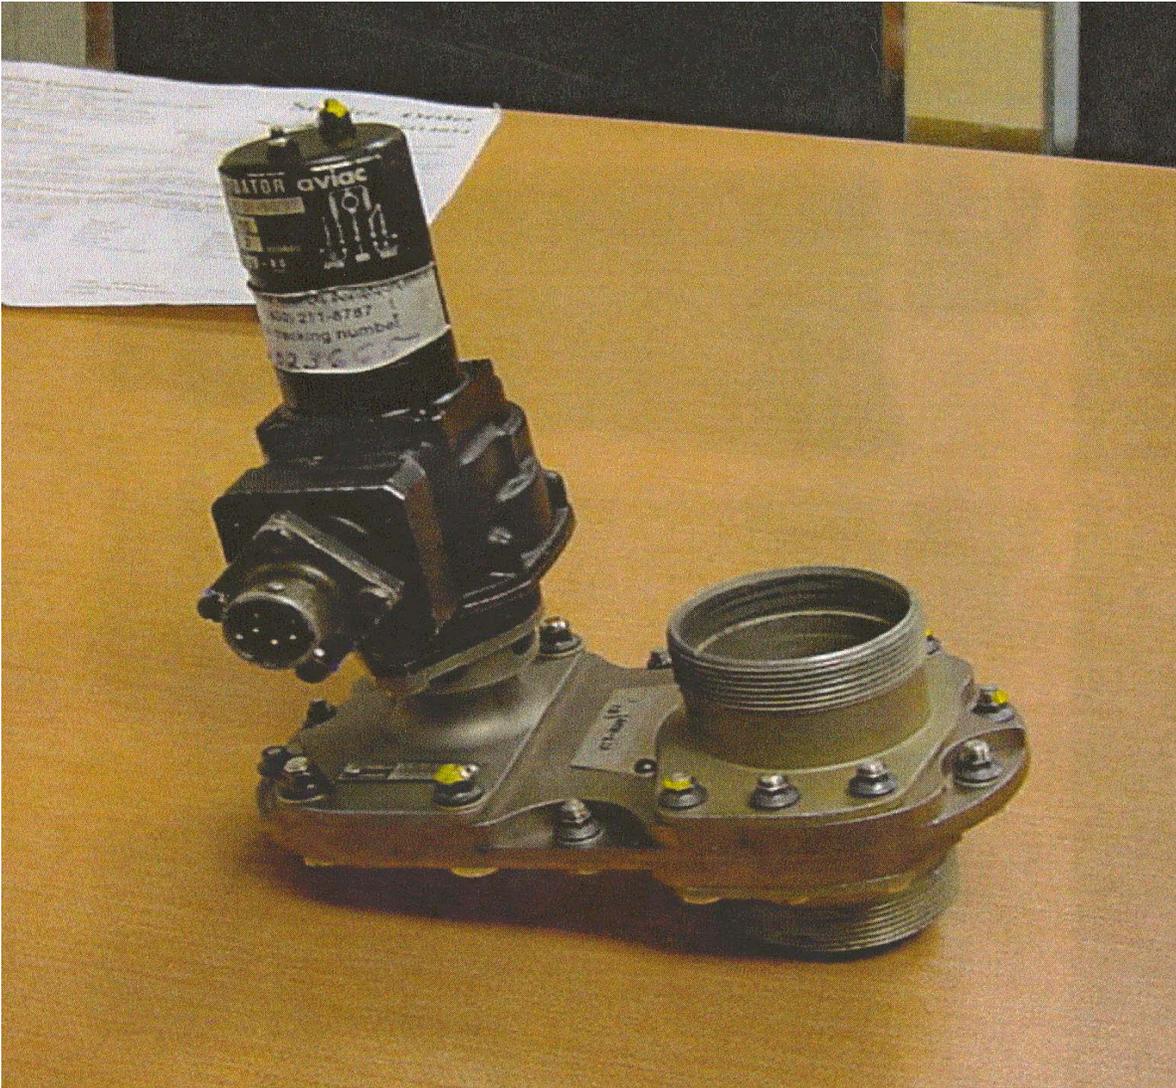
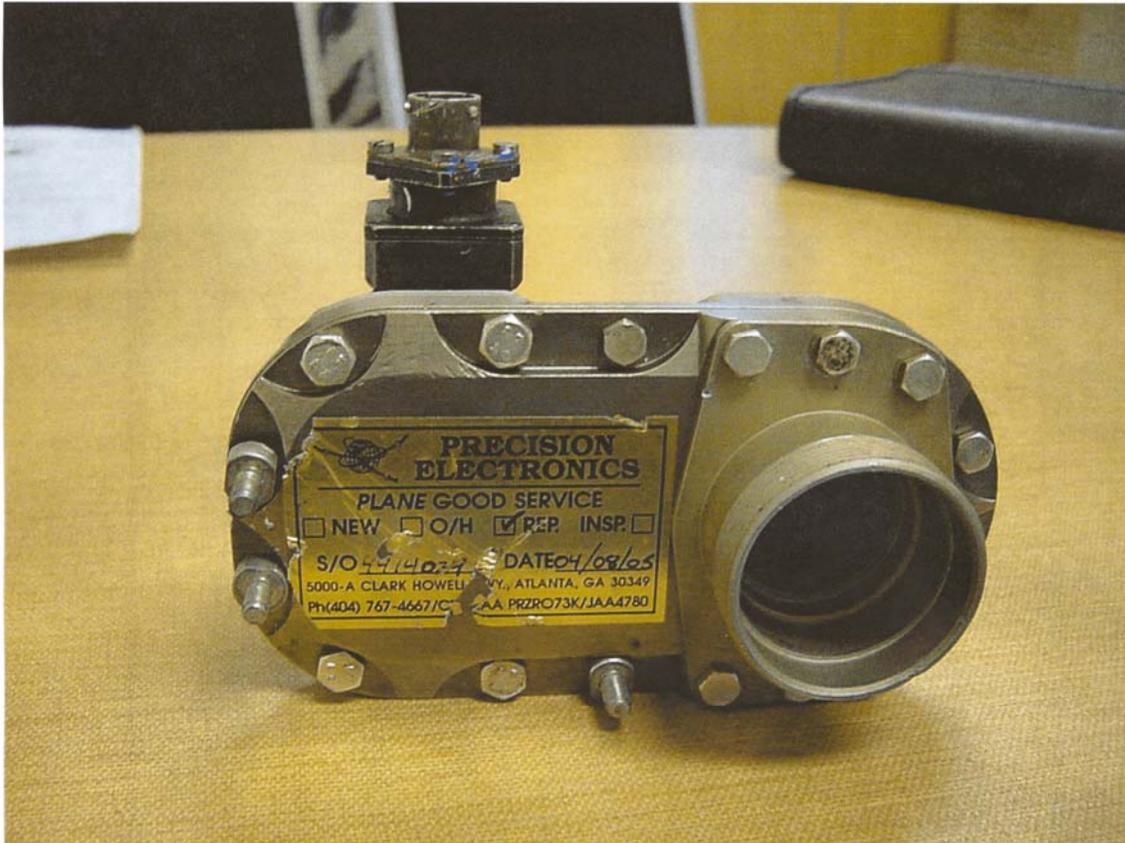
Dassault: Falcon 20-F5; Defective P3 Pressurization Valve; ATA 2130

A cabin pressurization problem gave cause for a mechanic to install an overhauled pressure shutoff valve (P/N 14632-112). Leak checks found no defects, but airflow was noted to be low, and subsequent operational checks of cabin pressurization demonstrated the aircraft would not pressurize. Again this system was troubleshot; again the same valve was determined to be the cause. Specific troubleshooting of the overhauled valve revealed *intermittent valve movement—the same discrepancy for which this valve was originally overhauled*. “I have no recommendations for preventing recurrence,” states the submitter, “...except for a methods and standards review of the repair station that overhauled the part.” The valve was shipped back to the source vendor.

(Photographs and documentation copies of the valve’s work orders and FAA Form 8130-3, Authorized Release Certificate, accompanied this submission. Two of the photographs are shown below, slightly cropped.)

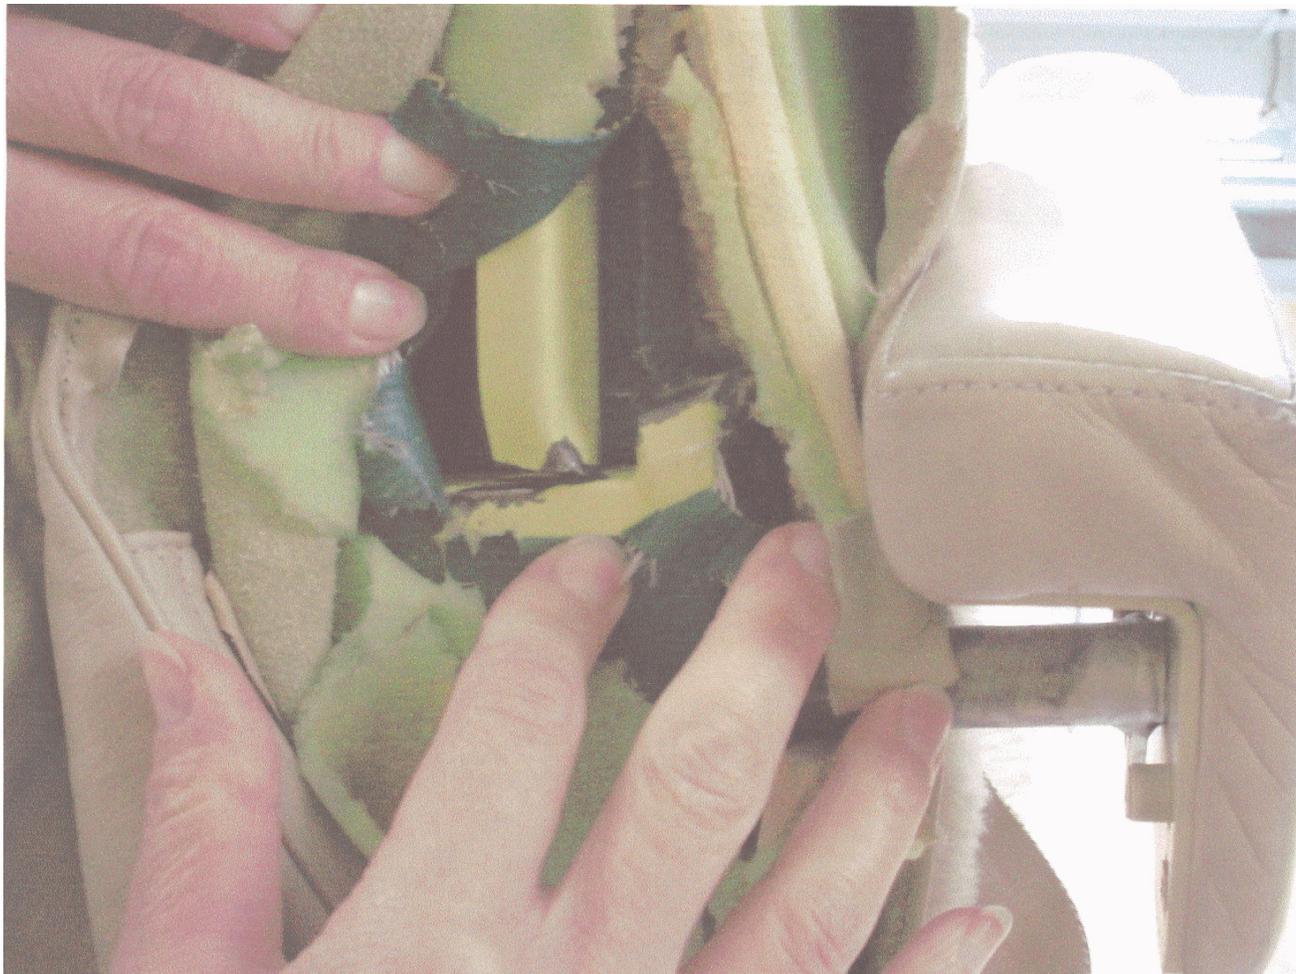
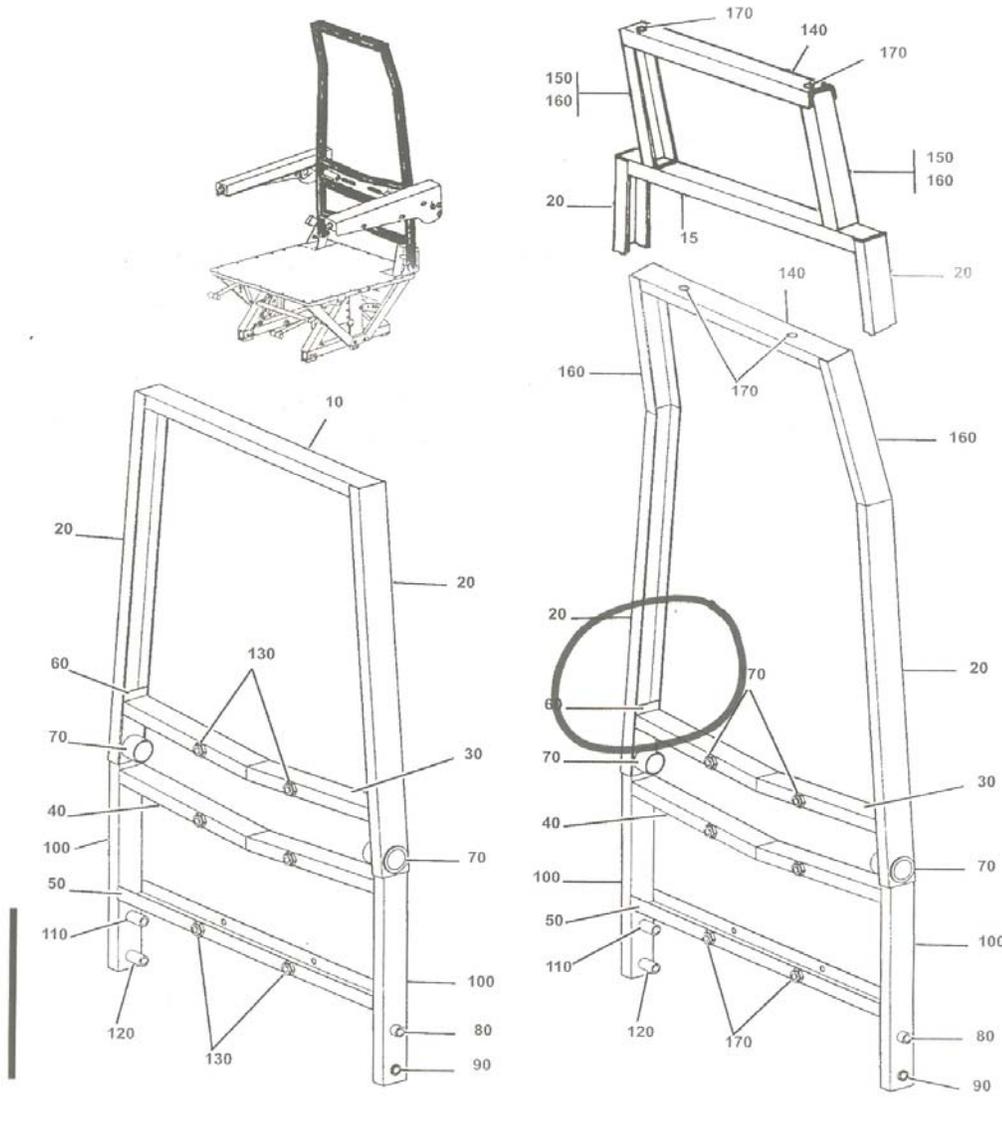
PILOT AND COPILOT SEAT, BACKREST ASSY
FIGURE 6

Gulfstream: G100 (SPX); Broken Seat Frame; ATA 2510

A repair station technician discovered broken back-rest structure while reupholstering this crew seat (P/N 5-1100-23-000). Contact with Gulfstream produced a repair formed with welded doublers. (*Pilot seat listed as Golan Industries: P/N G1-1105-0.*)

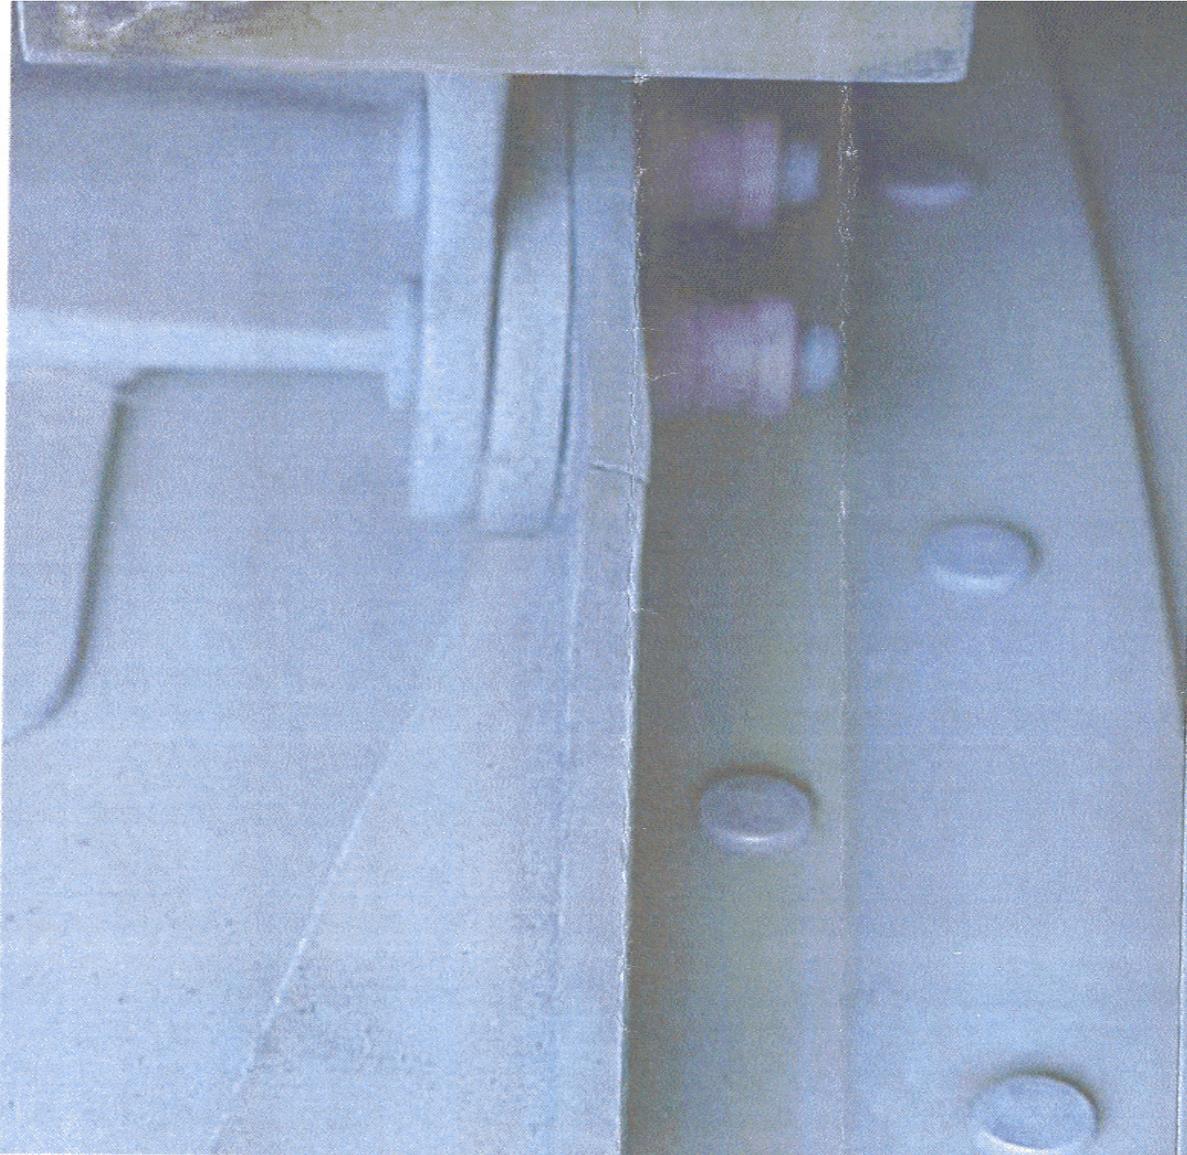
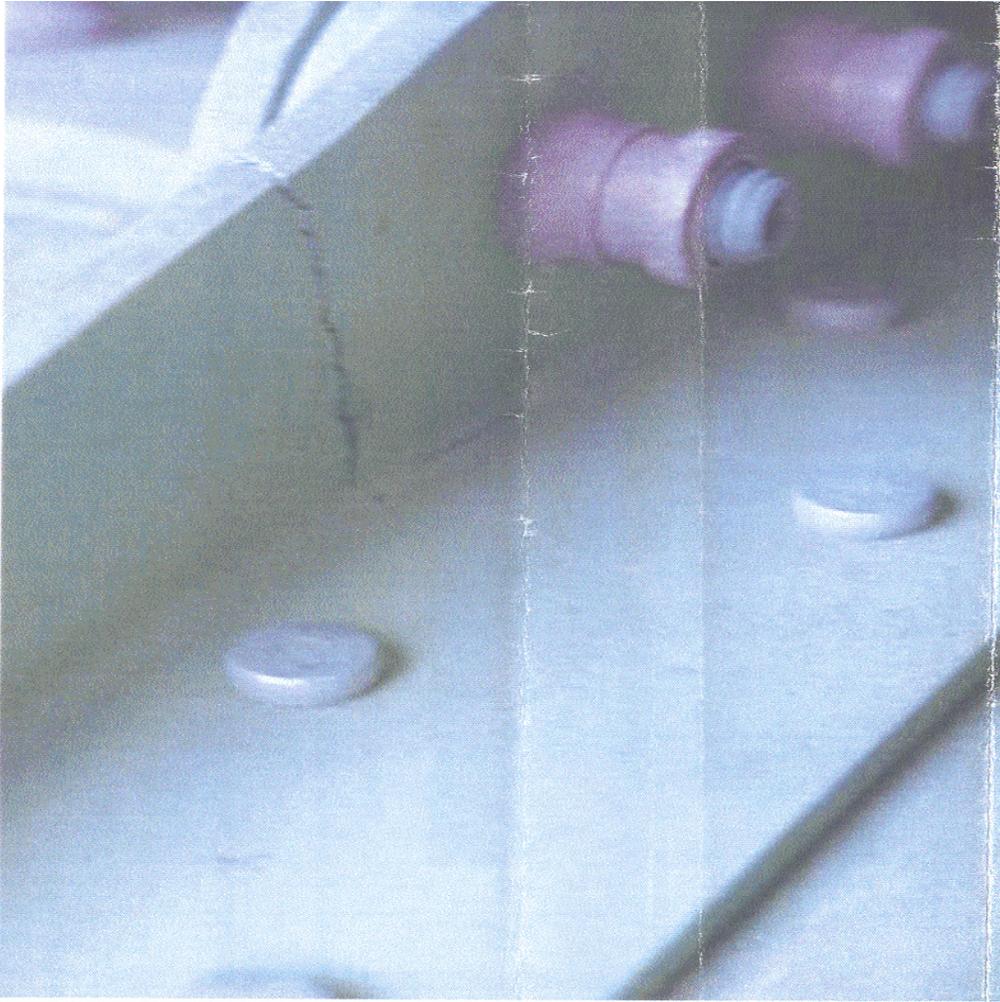
Gulfstream: G200; Cracked Thrust-Reverser Angle; ATA 7830

“The thrust-reverser assembly has stiffener angles that go around the barrel,” states a mechanic. “The point where the angle attaches is cracked at one location. Several other thrust-reverser assemblies were evaluated on aircraft in house and no cracks were noticed. It appears the angle in question was preloaded and drawn down to the carriage rather than being shimmed.” (*The thrust-reverser assembly stated as Nordam; P/N 266-0005-520. Shown below are two pictures of the cracked angle.*)

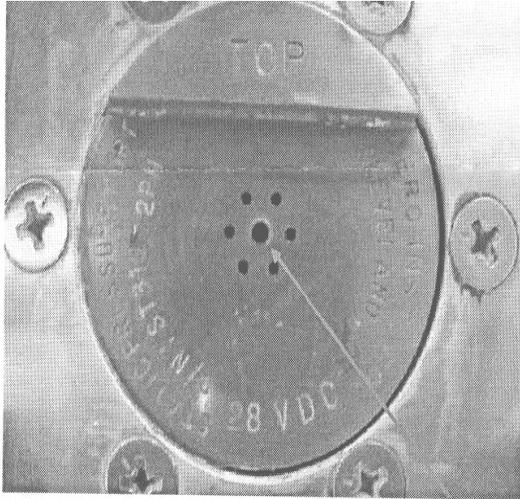
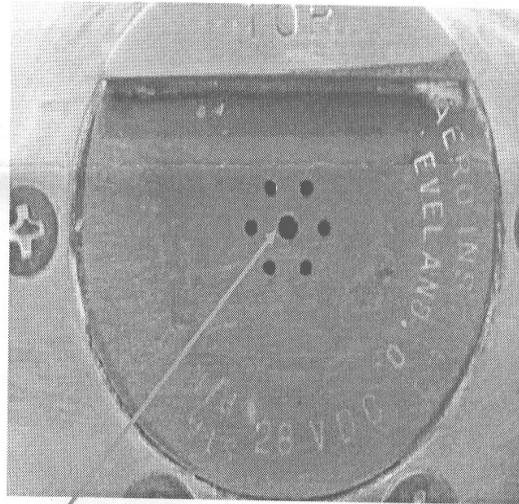
WW s/n 344
Left Static Ports

Israel Aircraft: 1124; Pitot Static-Port Damage; ATA 3411

An inspector at an aircraft repair station writes, “During the accomplishment of the pitot/static system check it was noted the static ports were damaged—the center holes had been opened up. This aircraft has Aeromech RVSM (*reduced vertical separation minimum airspace*) STC# ST01221SE incorporated, meaning any work performed on the pitot/static system must be accomplished in accordance with the Instructions for Continued Airworthiness (AMI-STC-P1124A). Section 2 of this document provides the maintenance instructions for this system, and paragraph 2.1.2.2 provides the ‘Visual Inspection of the RVSM Critical Region.’ It is this criteria, specifically the statement ‘...port orifices must be inspected for abnormal elongation, deformation, and/or obstructions.’ The center holes of all four static ports (*on this aircraft*) have been opened up, meaning the orifice is deformed and elongated.”

The center holes
have been opened

“In my search (of this topic) I found the (IAI) maintenance manual has very little information regarding the serviceability of the static ports. A review of the IAI design drawing (see below) clearly shows that not only are these static ports not RVSM acceptable, but they have been modified from the original type design, making them unacceptable for continued service, and must be replaced before the aircraft can be returned to service. The modified static ports (on this aircraft) were removed and replaced with new static ports.” (The provided part number is ST310-2PH.)

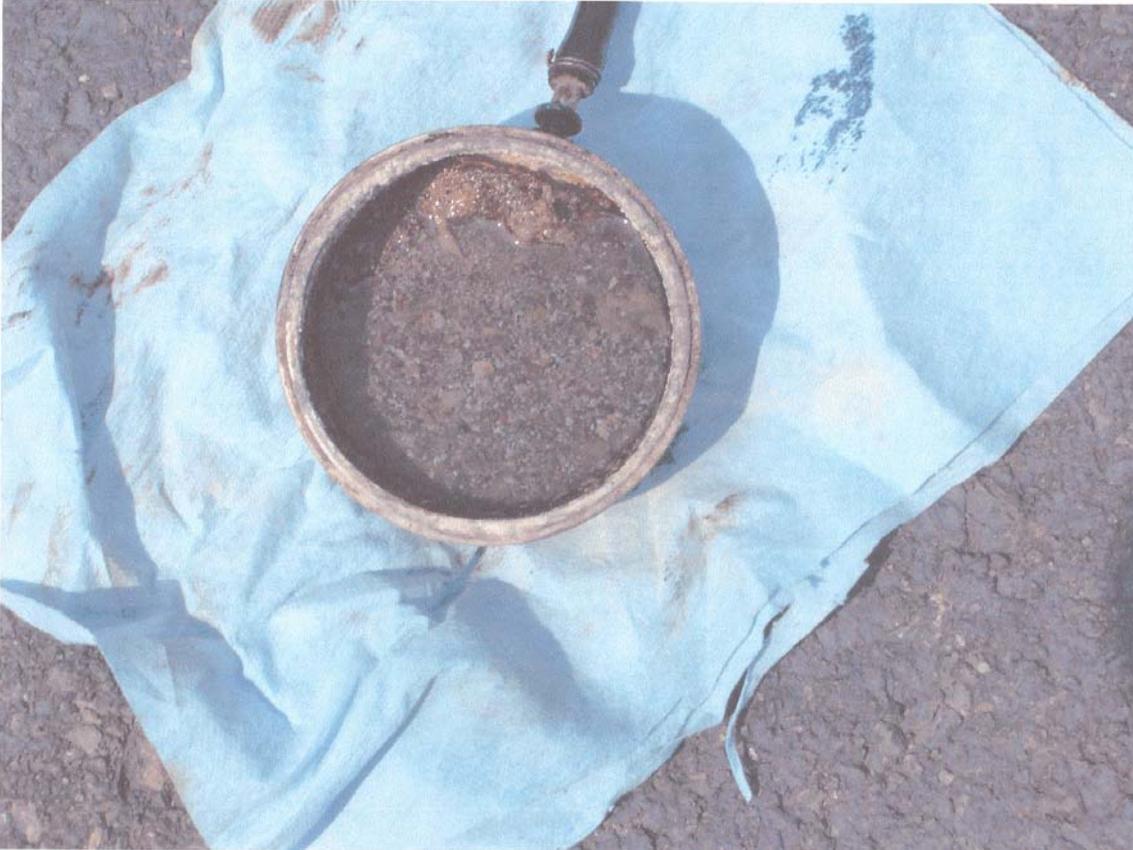
An experienced pilot was engaged to fly a recently purchased aircraft from a remote airfield (*not specified*) to its new owner. During runup he noticed the Lycoming TIO 540 engine failed to make full power, then subsequently quit. He called for maintenance support from a familiar repair station. The submitting mechanic provided the following analysis of this aircraft's defect(s).

"After extensive troubleshooting we found fuel injectors clogged by dirt. The fuel filter screen and filter were removed and found to be badly contaminated (photo attached). (*This*) aircraft had just received a fresh annual inspection." (*The inspection's source and date were not provided. He continues describing maintenance actions.*) "The filters and nozzles were cleaned, the fuel lines purged, and the (*subsequent*) engine run made full power. The filters were then checked again and were clean at this time.

“Very poor maintenance and inspection practice is determined to be the major factor contributing to the malfunction. The maintenance history was mostly unknown to the customer, other than the fresh inspection....”
“Our customer is a professional pilot and has extensive time in this model aircraft. A less experienced pilot may not have recognized there was a problem with the aircraft until it was too late—and the engine quit while airborne.”

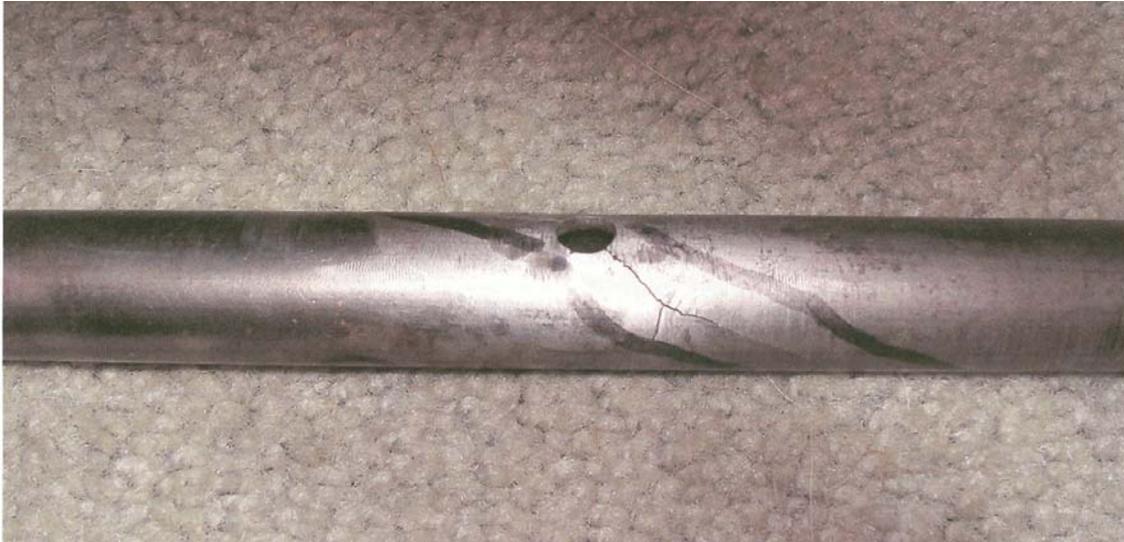
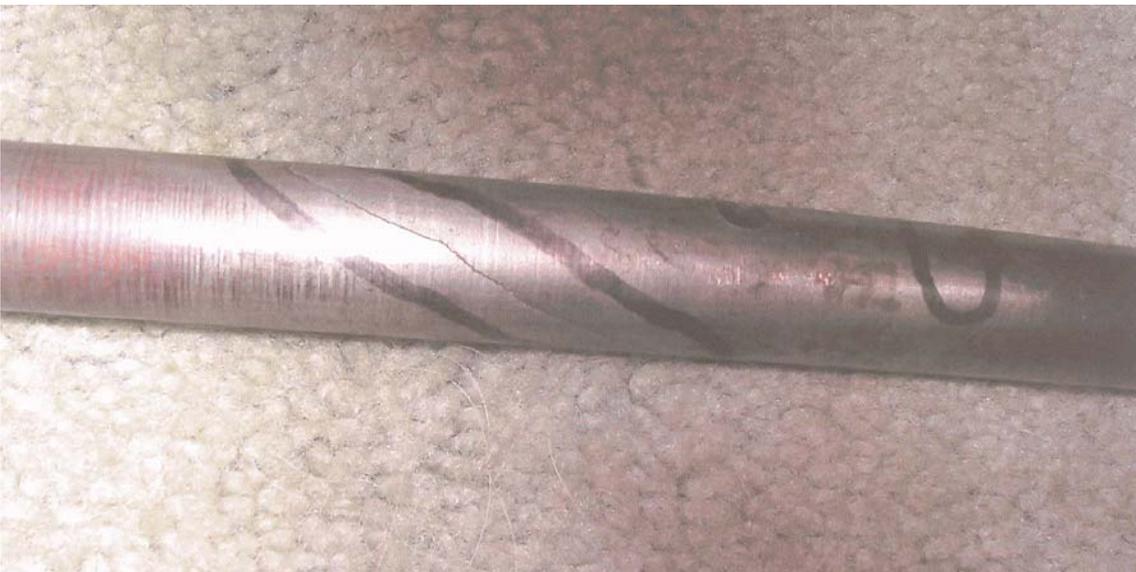
Piper: PA 32-301; Cracked Rudder Bar; ATA 2720

This defect describes excessive play noticed between the left and right rudder pedals by the submitting technician. “Upon disassembly (I) found the tube (P/N 63419-02) to have an extreme crack radiating from the through-bolt hole and radiating around to the back side of the tube and going out to each side in a spiral fracture. It was near total failure.

“This part is impossible to inspect without totally removing and disassembling the rudder bar assembly. (I) believe this (type) of defect is caused by pressing hard on the pedals (to effect turning) of the nose wheel before the aircraft is in motion, (thereby) causing a strong radial force to be applied to the rudder bar.” (Both pictures have been slightly cropped.)

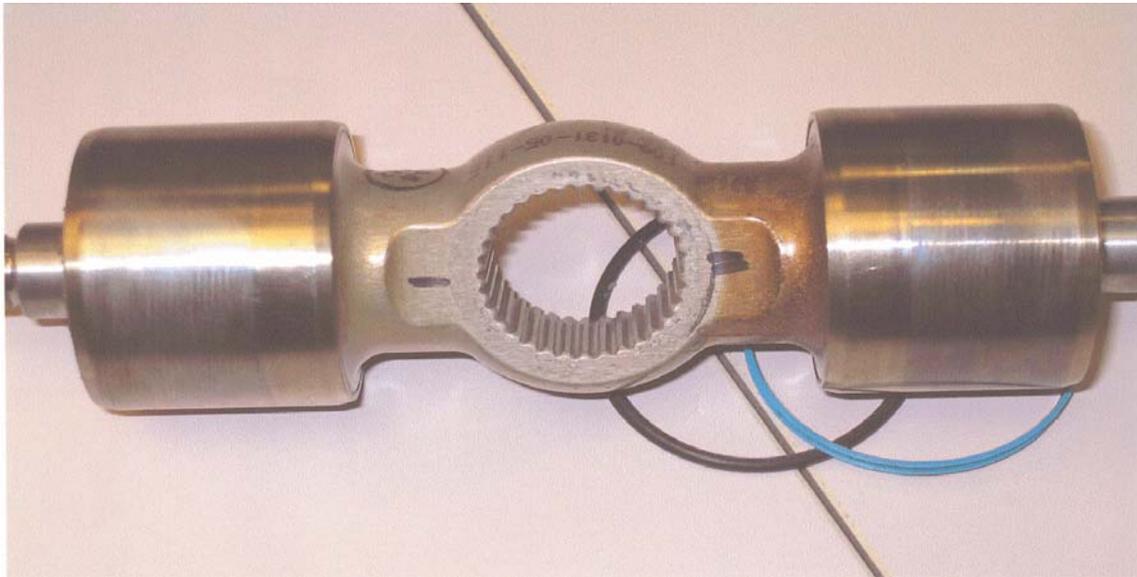
Agusta: A109K2; Tail Rotor Trunnion Overheating; ATA 6420

A helicopter mechanic describes finding heat-generated enamel paint discoloration on the tail rotor trunnion (P/N 109-0131-05-115). It was found during a 25-hour inspection. *(Offsetting the very short description is an excellent photograph clearly depicting the discoloration. Submitters are encouraged to provide relative mechanical histories, details, and free speculation as to a defect's cause and possible solution. This part number generates five additional entries of overheat defects in the SDRS data base.)*

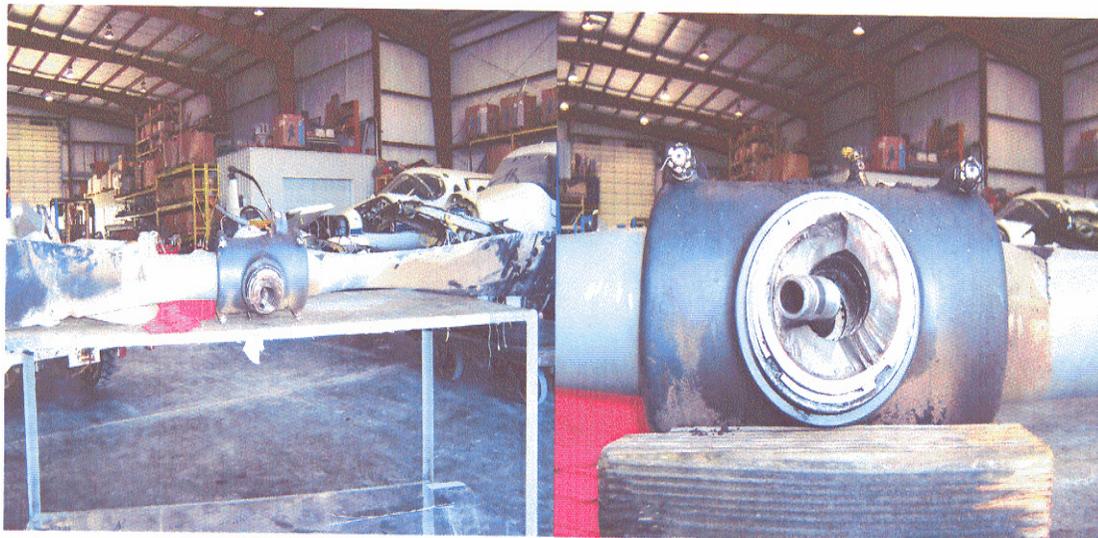
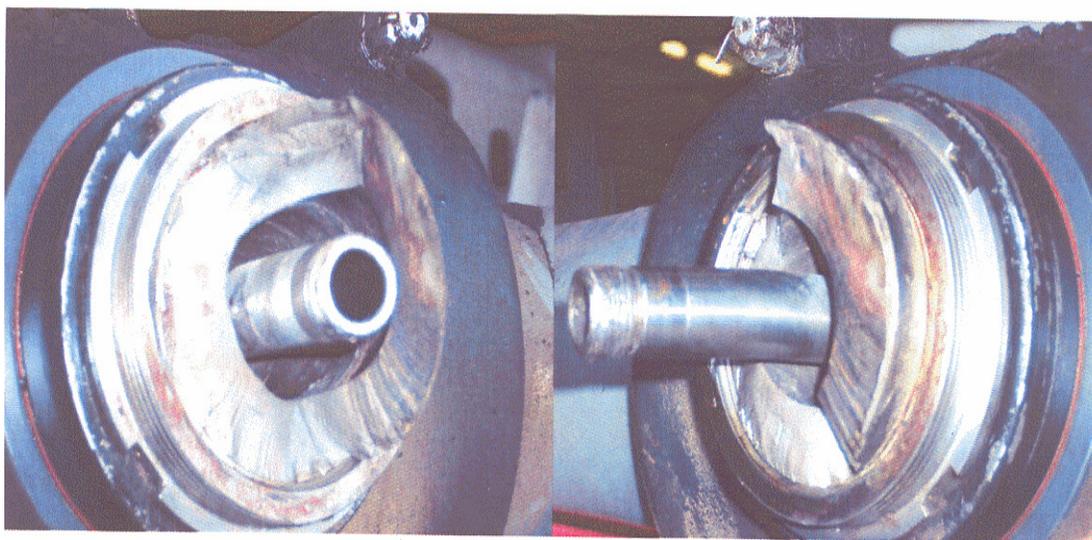
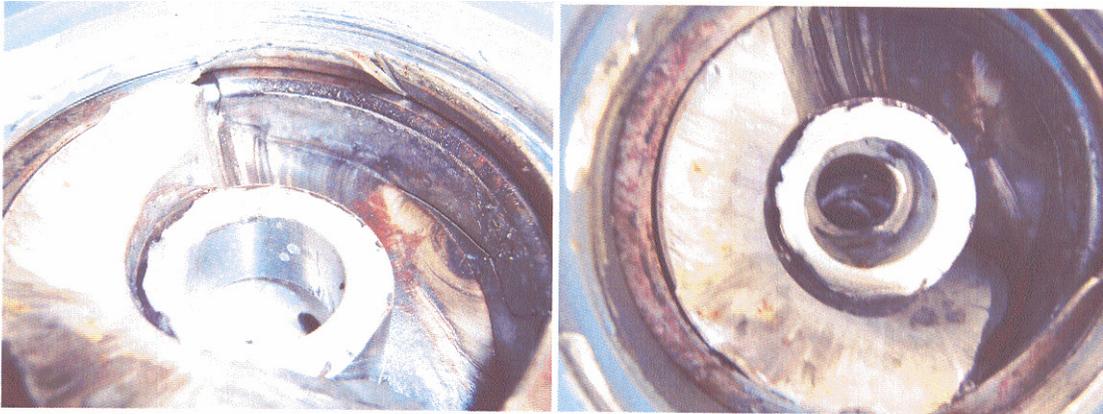
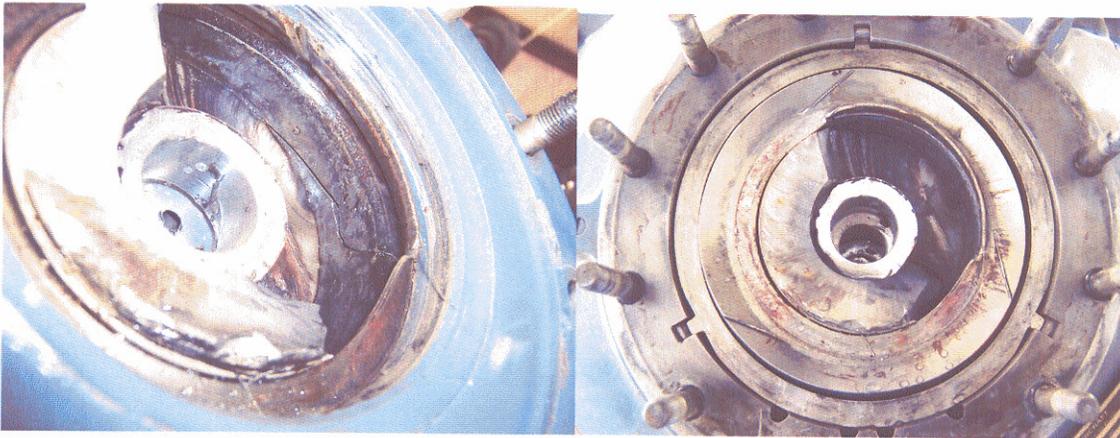
Pratt & Whitney: R1340; Broken Crankshaft; ATA 8520

Twenty-five minutes into a ferry flight the pilot of this AT-301 (Air Tractor) reports oil on the windshield. Within moments oil collection worsens, encouraging the pilot to decrease power—which then caused severe vibration in the aircraft. Further decrease in power resulted in reduced vibration. An unplanted field provided opportunity for landing. At touchdown the aircraft skipped over a terrace as it slowed to a stop, its rollout concluding with a tip-over onto its nose. The propeller separated from the engine after striking the ground.

The subsequent inspection found "...the crankshaft had broken in the propeller thrust bearing area," writes the inspector. "Examination of the crankshaft shows fatigue cracking. There was little (*overt*) damage to the propeller blades." Secondary damage from engine cowling contact was found on the trailing edges 25 inches I/B from the propeller tips. The overhauled propeller had been in service for less than one-half hour before failure of the crankshaft. (*Engine time since overhaul provided as 1,041.9 hours. The crankshaft part number is listed as 270458.*)

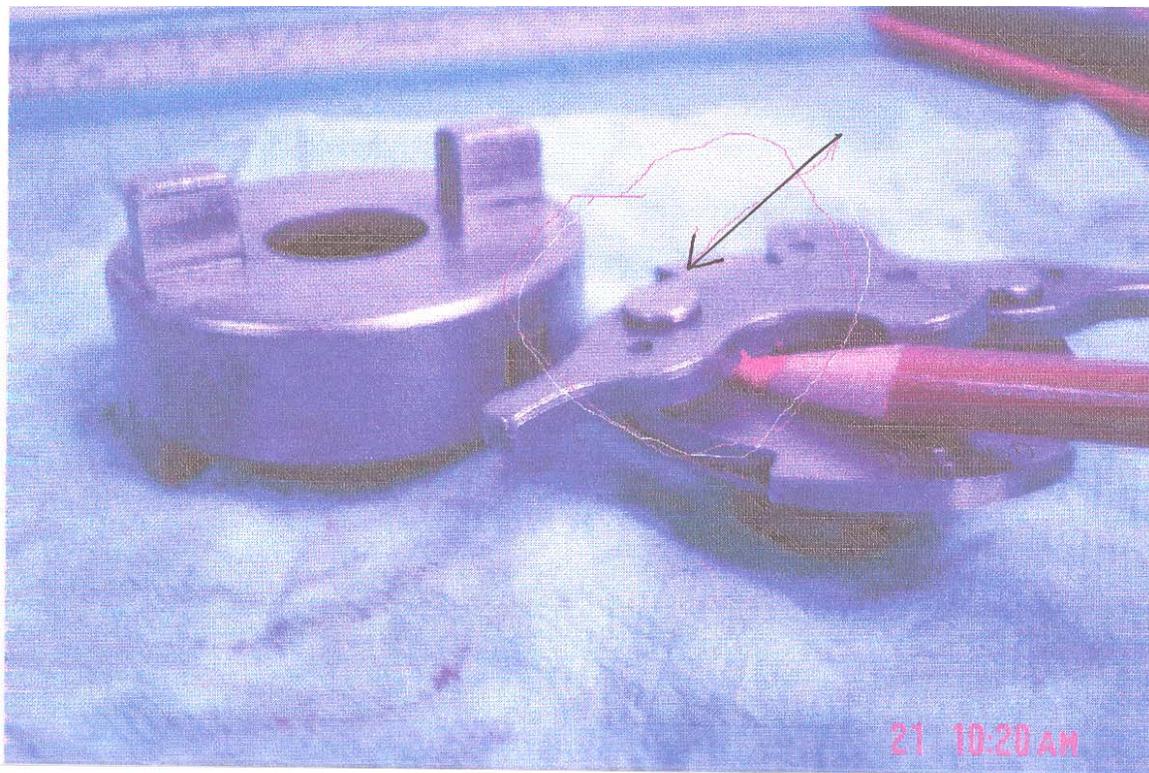
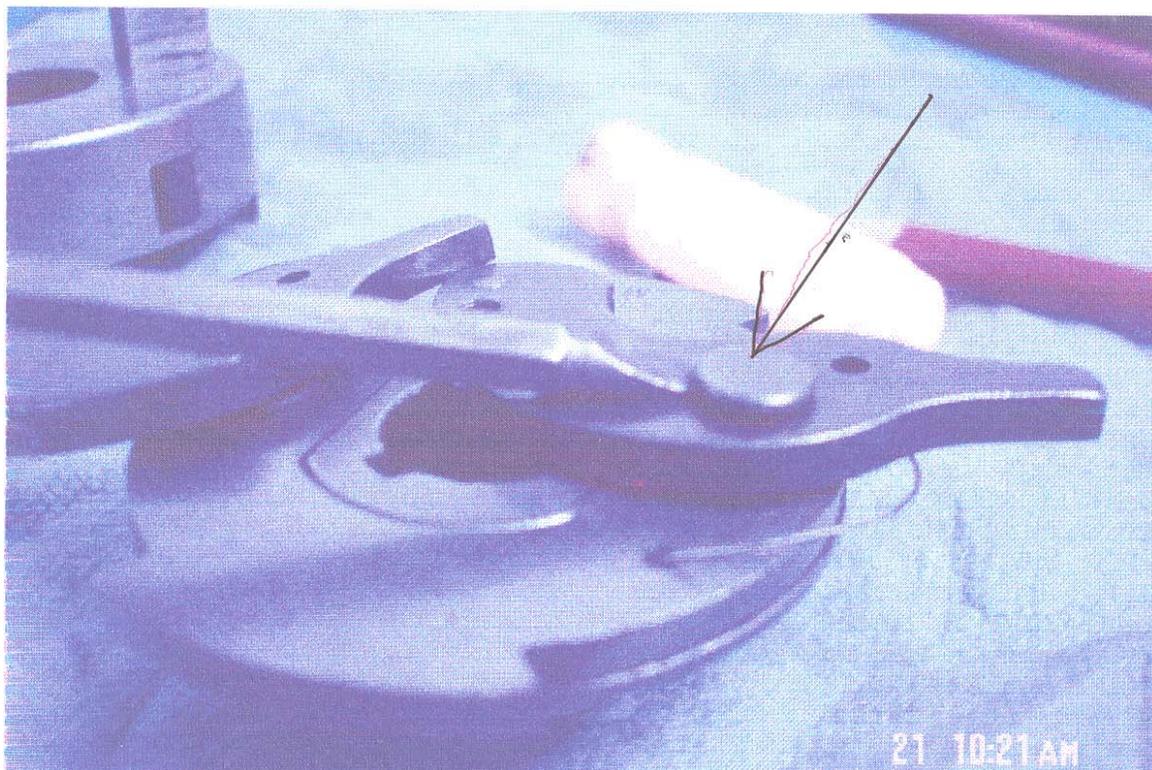
Slick: Magneto; 6310; Worn Impulse Coupling; ATA 7414

A repair station mechanic writes, "During an Annual inspection (*on the Raytheon Beech 58*) the inspection department decided to comply with the 500 hour magneto internal inspection, which includes the impulse coupling per Slick (Unison) Service Bulletin 2-80C. One impulse coupling was found to be very loose—due to loose rivets. It would have failed very soon. A failure of this type can cause extensive damage to the magneto and the engine. The aircraft manufacturer's inspection checklist does not call for detailed inspection of the magneto impulse coupling or other magneto internal parts, other than points. This coupling was replaced with a new part—the old part only had 529 hours time since new. (*I*) suggest compliance with the 500 hour detailed inspections of all magnetos, regardless of the omission (*of said inspection criteria by some airframe manufacturers*). All magneto manufacturer's provide checklists and inspection criteria for their magnetos." "This station adheres to the 500 hour magneto and coupling detailed inspections and have found parts that do not meet magneto manufacturer's airworthiness requirements. Many low time in-service units have been found with parts worn beyond limits. This station considers (*this level of magneto care to be...*) to be another level of safety beyond the airframe manufacturer's checklist requirements." (*P/N listed is M3050, generating nine additional SDRS data base entries with similar defects.*)
