ADVISORY CIRCULAR

43-16A

AVIATION MAINTENANCE ALERTS

**ALERT
NUMBER
332**

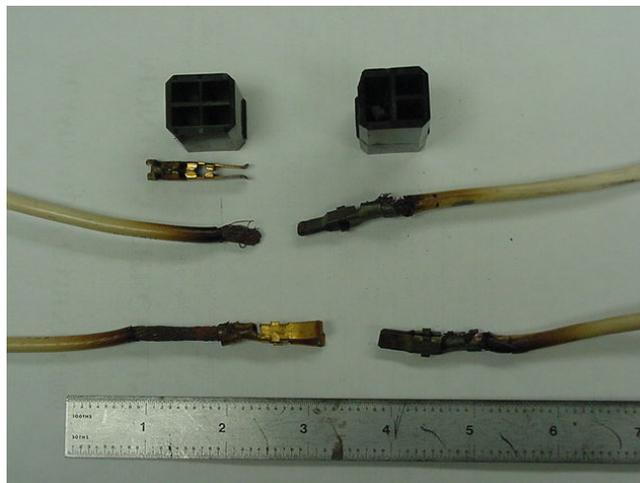
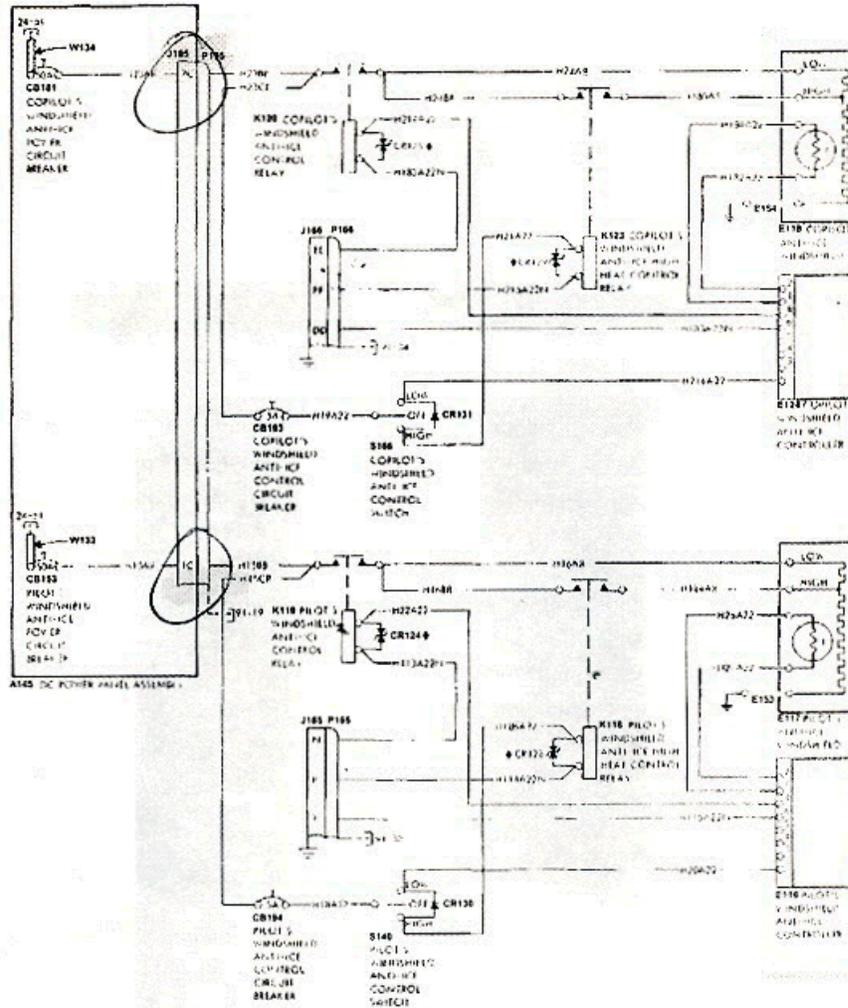
Beech Super King Air 200 and 200T Wiring Diagram Manual
 Windows, Windshields and Doors-Anti-Ice, BB-35 and After; BT-1 and After

An FAA safety inspector submitted this defect report in conjunction with a repair station's manager. A customer's complaint of inoperative windshield heat led to a more significant finding of a connection fault at the DC power distribution panel. "Using REPS Beech Super King Air 20-0 wiring diagram (30-40-02 figure 1) the connections at junction 195 and plug 195 had been subjected to excessive heating..." and burned as result of loose connections. "The strain relief for the plug does not ensure a secure connection for the 8 AWG wire to maintain a positive contact. The end result is the connections work loose and begin to arc. This arcing generates heat to the point of burning the wire and causing the socket connection (P/N 66257) and pin (P/N 66259) to become brittle and weak. Eventually the wire and socket connection failed. This failure of the connection renders the windshield heat system inoperative. The heat generated from connection failure creates a potential fire hazard for the aircraft." Suggestions to fix this defect include "...eliminating the connections at plug 195 (1c and 2c) for the pilot's and co-pilot's windshield heat." The windshield heat wires H15A8 and H158B8, H23A8, and H23B8 could be butt-spliced, completely bypassing the junction and its possibility for loose connections.

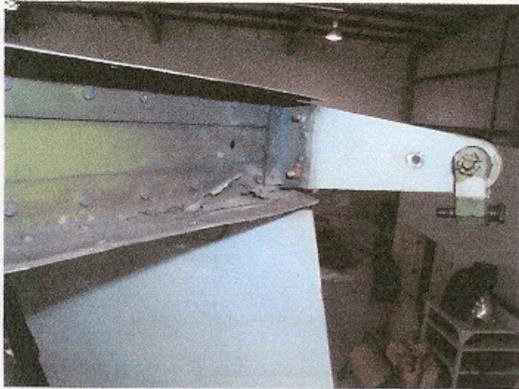
An airframe and powerplant mechanic writes, “During a return from lease inspection, the following areas of the horizontal stabilizer were found to have corrosion and were repaired or replaced...” Noted areas included the L/H and R/H lower aft spar cap, L/H outboard hinge (P/N 101-620011-1), R/H outboard hinge (P/N 101-620011-1), the R/H center hinge (P/N 101-620013-1), the L/H elevator trim tab pushrod tightening device (P/N 101-524095-1), and the R/H elevator trim tab horn. (*The SDRS data base records an additional three entries having similar corrosion difficulties.*)

RH HorStab lower aft spar cap

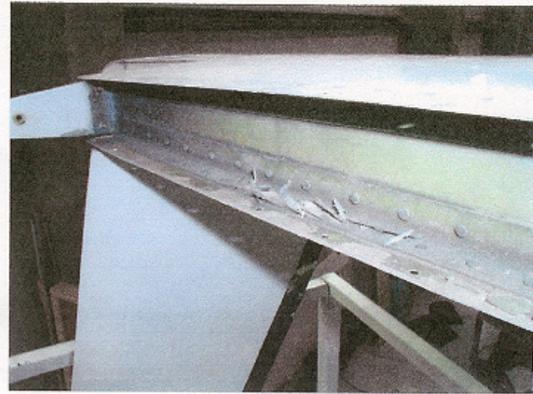
LH HorStab lower aft spar cap

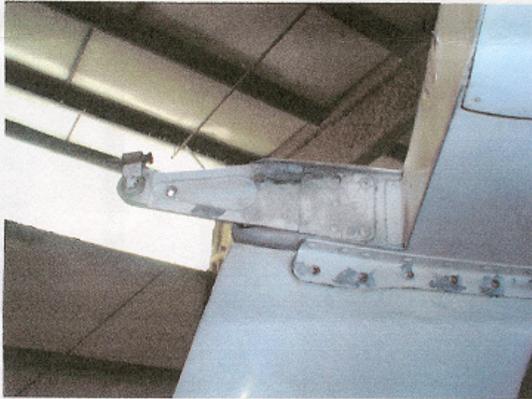
RH OB Elevator hinge

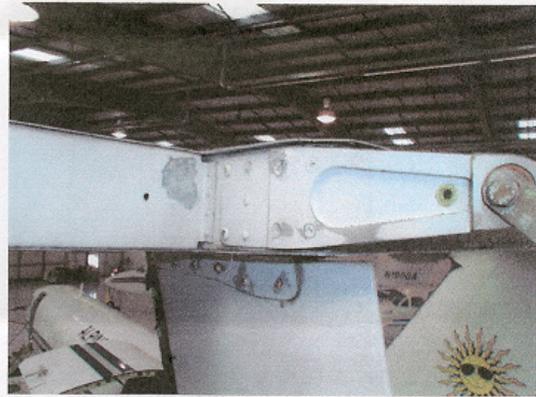
LH OB Elevator Hinge

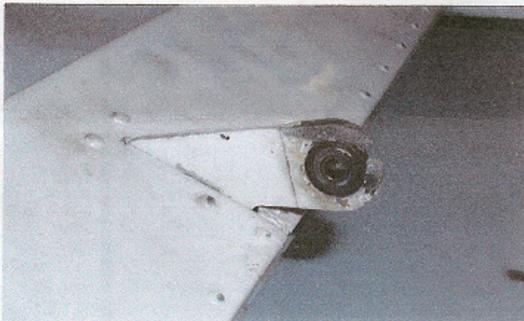
RH Elevator Trim Tab horn

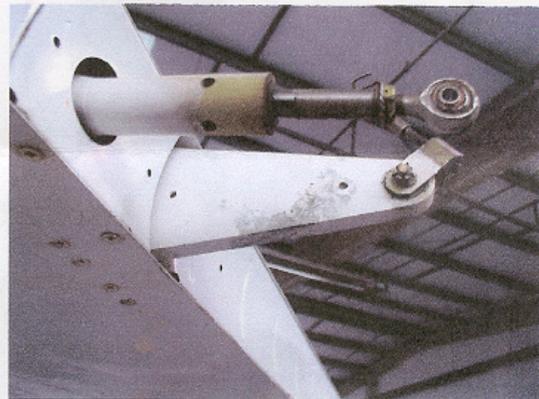
RH Center Elevator Hinge

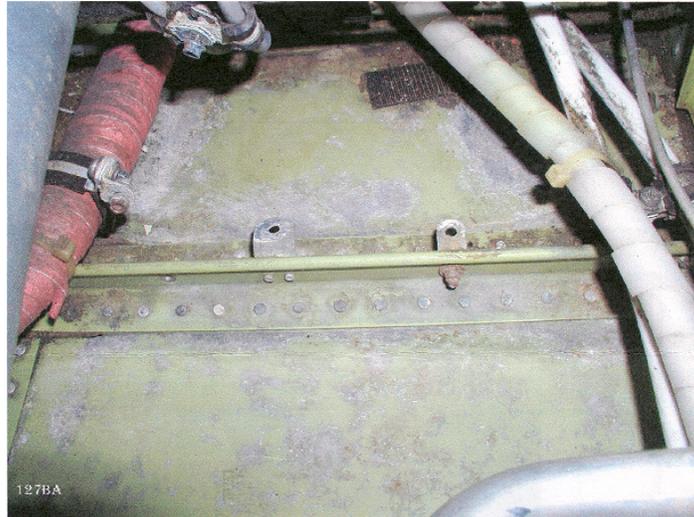
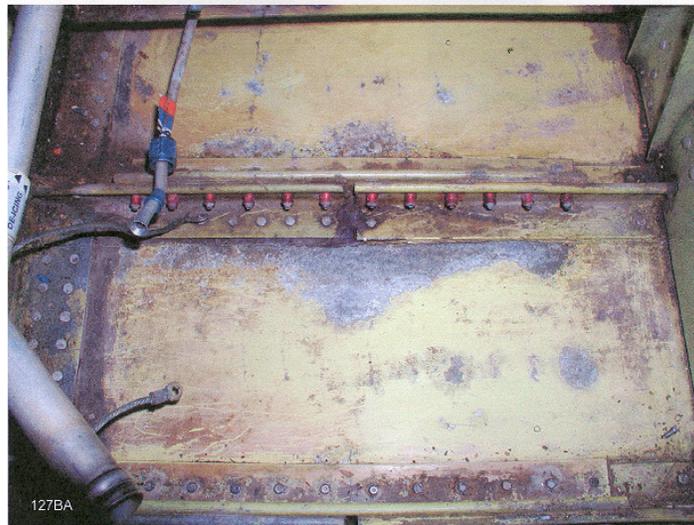
Another Beech 1900 has corrosion problems, this time on lower fuselage skins at stations 243-273 and stringers 14L, 15R, and 15L. (This carrier's submission offered no other data. Two of four pictures are shown below. The SDRS data base records 12 similar entries.)

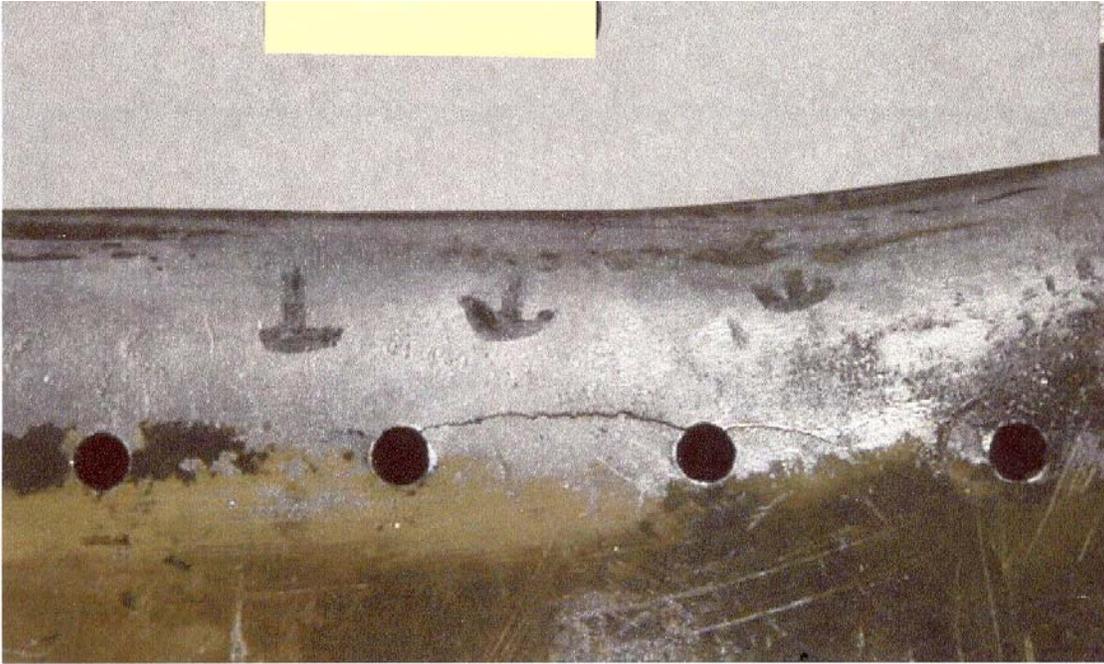
A submitter writes, "Several rivets holding the hinge to the air-stair door assembly had pulled through the lower closure reinforcement. The reinforcement...had been installed 1,374 hours earlier as part of Raytheon designed field repair FR-CO-J01063." (Field Repair Reinforcement kit P/N 114-4023-3; reinforcement P/N 101-430142-64). "A number of the rivets securing the air stair door hinge to the fuselage were found to be 'working'. Further investigation found cracks in the doorframe between the rivet holes in the upper line of rivets towards the aft end of the hinge." (Doorframe P/N is listed as 114-420034-1. Two additional entries of this description can be found in the SDRS data base.)

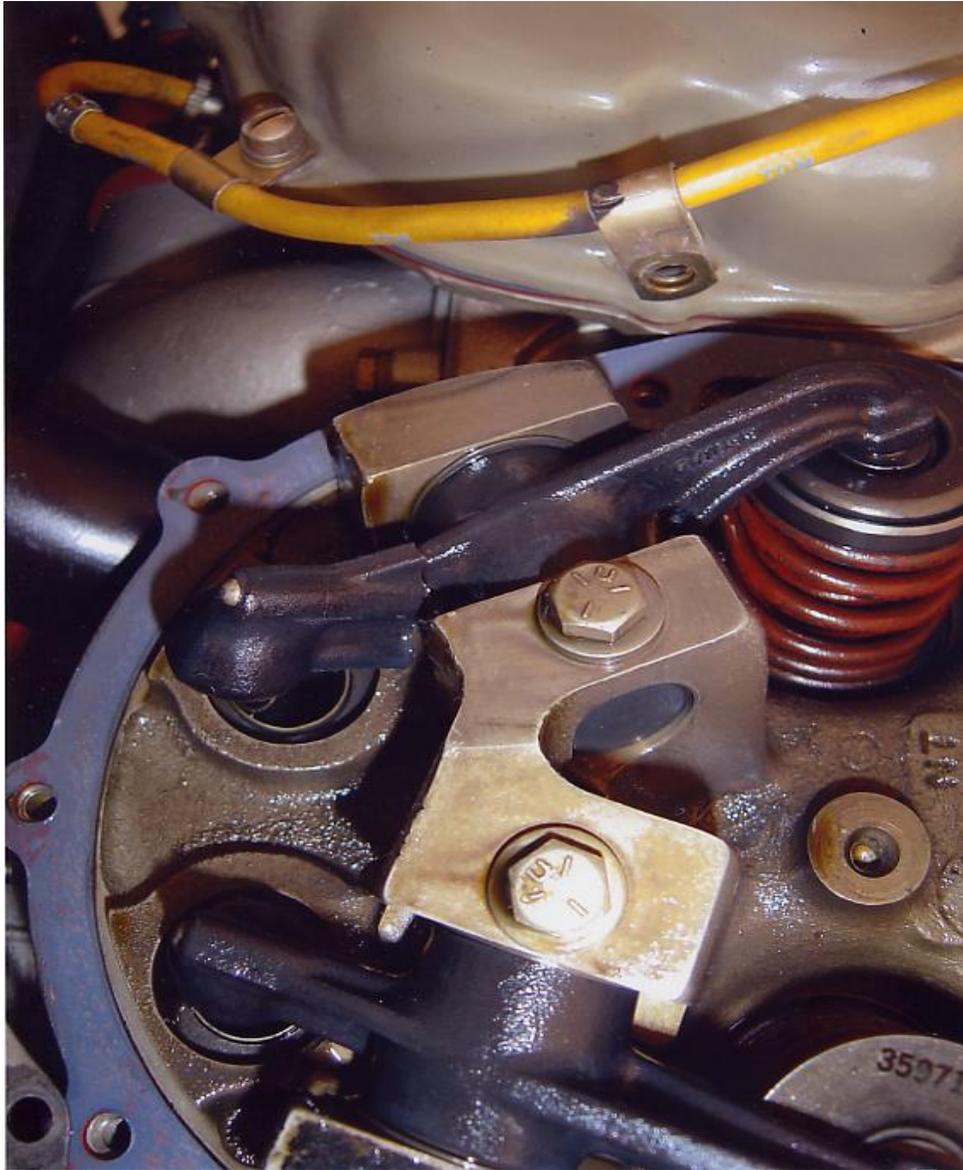
“On take-off roll the pilot lost power to the left engine,” wrote this repair station technician. “Investigation revealed the number five cylinder exhaust valve rocker arm was broken. Additional inspection revealed damage to the number five push rod, housing, and hydraulic lifter assembly. The engine was manufactured on 7/23/01 and has a total time 110.6 hours. Inspection and repair was completed in accordance with instructions from a TCM tech representative. The broken rocker arm was sent to TCM for warranty, per their request and the owner’s approval.” (*Part number for the rocker arm given as 652130. Even at the scanner’s lowest resolution, this photo remains the best of all submissions over the last year. Thank-you!*)
