U.S. Department
of Transportation
**Federal Aviation
Administration**

ADVISORY CIRCULAR

AVIATION MAINTENANCE ALERTS

**ALERT
NUMBER
333**

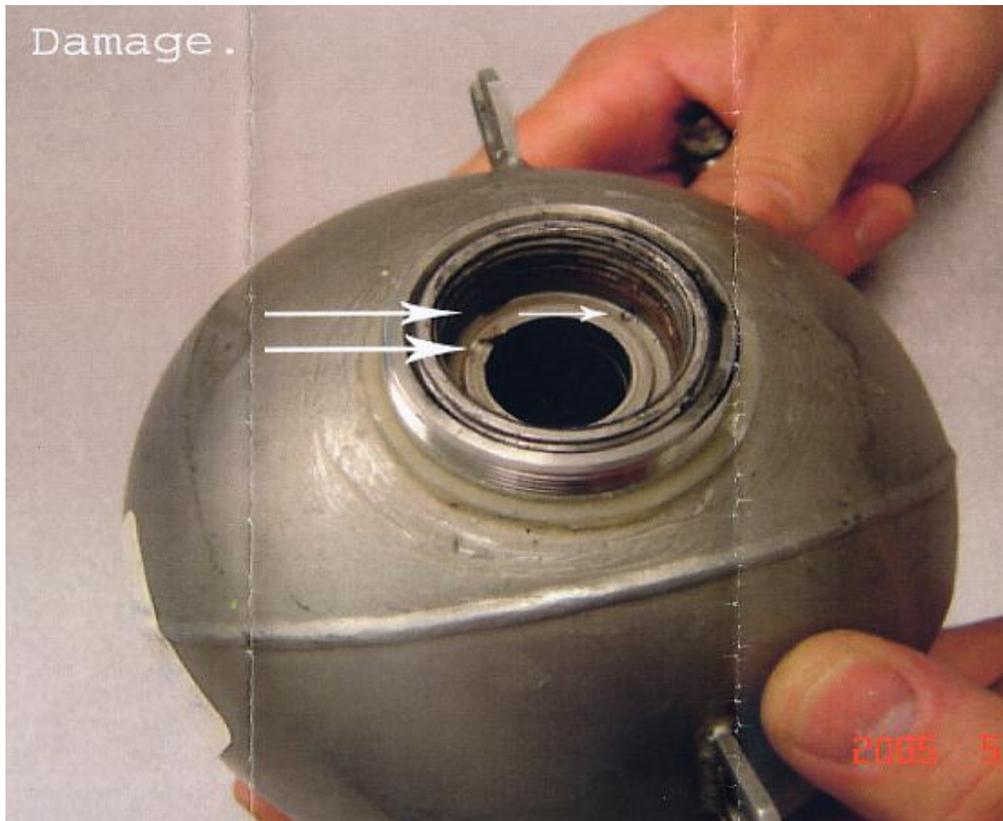
This repair station technician writes, "Pacific Scientific received a Walter Kidde 829700-5 APU fire extinguisher for overhaul after *(its)* firing. During the disassembly it was discovered the pyrotechnic cartridge melted the stainless steel bottle's seat, rendering the pressure vessel *(as)* scrap. This type of damage is consistent with previously reported damage caused by this manufacturer's cartridges.

"Pacific Scientific is very concerned since at least two other unrelated repair stations have reported similar problems with the pyrotechnic cartridges from this manufacturer." The listed cartridge P/N is M805300-44; the fire extinguisher P/N is 829700-5. *(One of four submitted photos is shown below, slightly cropped and compressed.)*

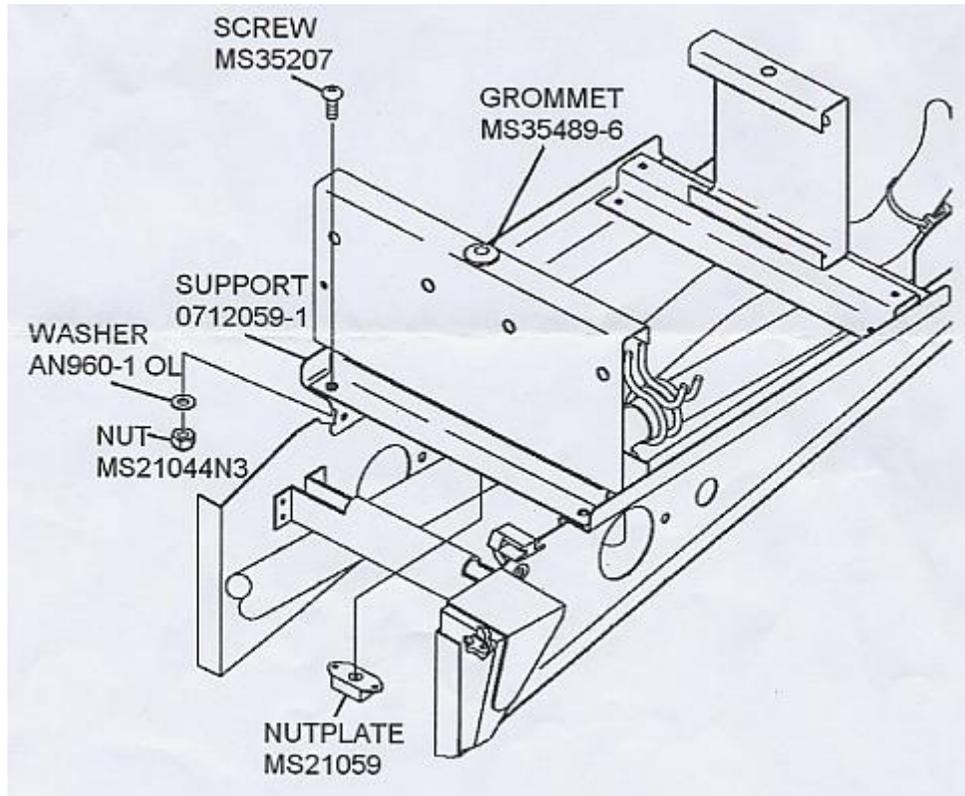
“The FAA has received Service Difficulty Reports (SDR) from the Civil Aeronautics Safety Administration (CASA) Australia regarding failure of the support (P/N 0712059-1) for the installation of 24 volt batteries in Cessna 182 airplanes. In one report, both supports failed at 295 hours flight time since they were new. Beginning in 1989, seven similar reports were found in the FAA SDR database. The tie-downs were changed on the Cessna 182S, 182T, and T182T series airplanes to eliminate this problem.

“A long tie-down bolt runs through the grommet and down to the nutplate in the lower hat section shown in the figure. As the tie-down bolt is tightened, the load force pushes down on the grommet and support (P/N 0712059-1). The reactive forces, pushing upward at the screws to the battery box on each side, will tear the support (P/N 0712059-1).

“The tie-down bolts (not shown in the figure) hold the cover on the battery box. The bolts are to be snugly tightened. The self-locking mechanism used in the battery box does not require a lot of torque. If the bolts are tightened similar to other parts of the airplane as described in the maintenance manual or the FAA AC43.13-1B, change 1 section 3, then the support angles under the battery box will fail by tearing. If this happens, then these parts must be replaced.”

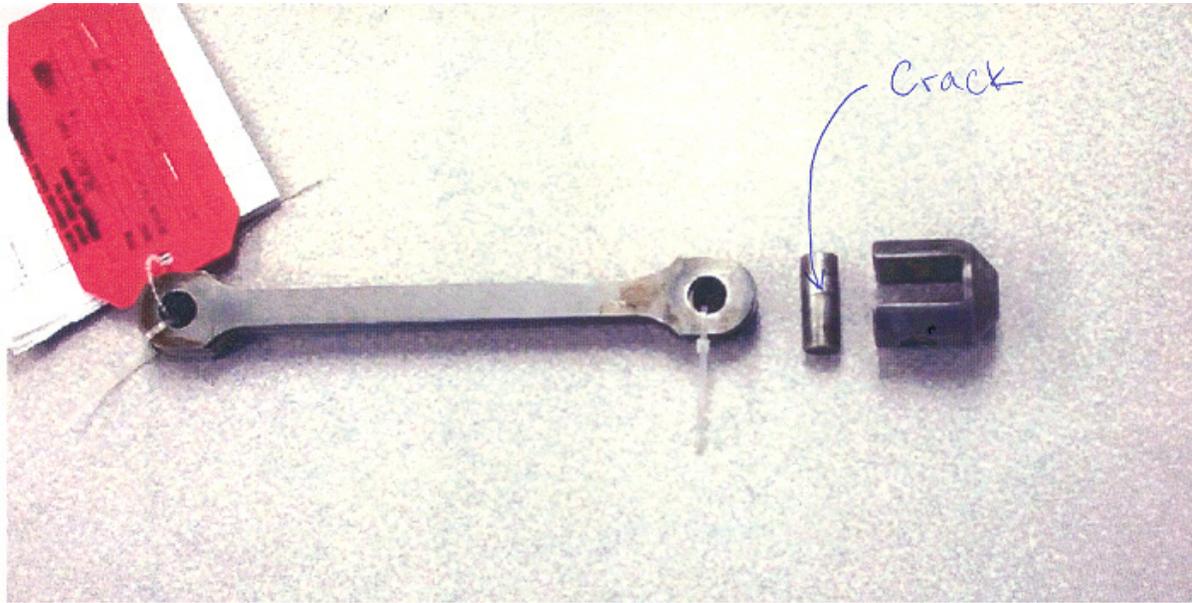
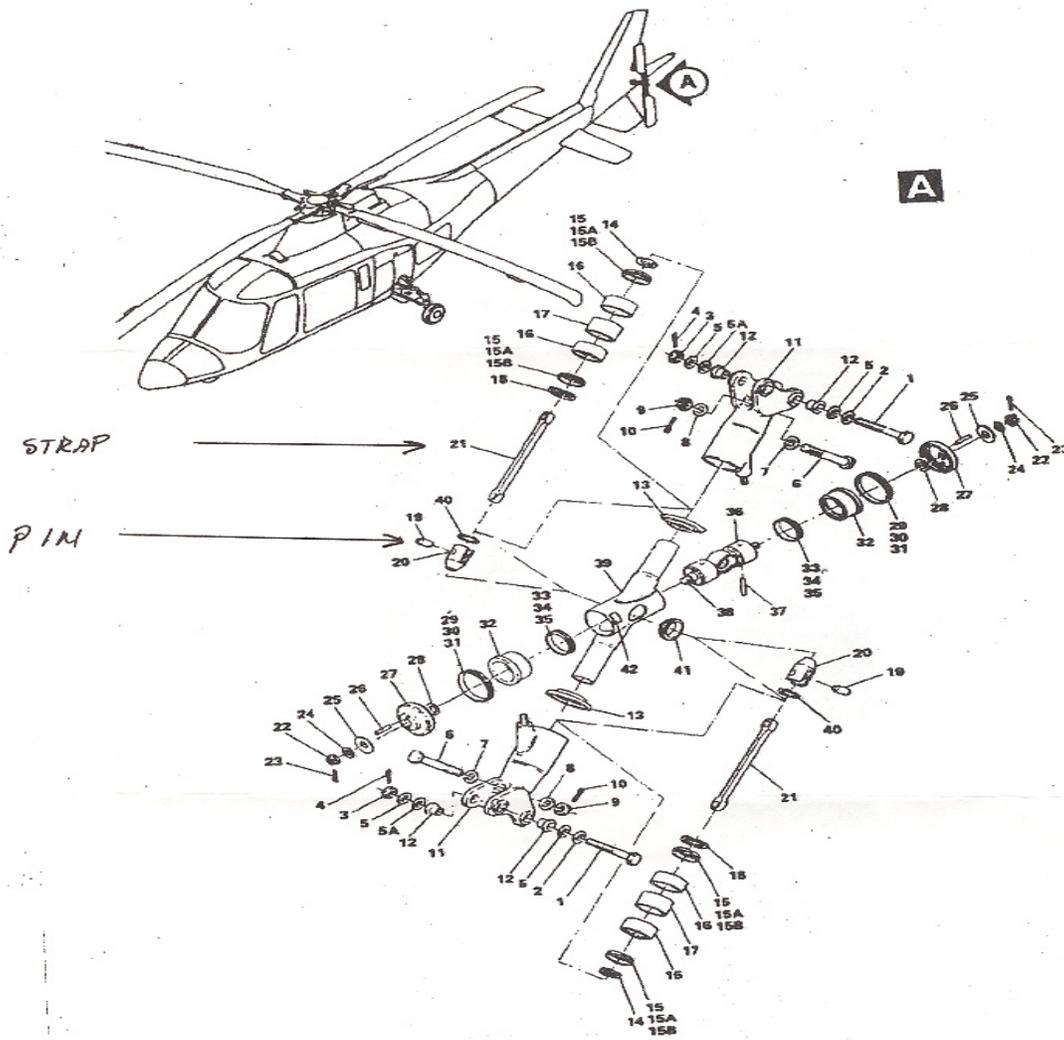
Fig. 1. HUB ASSY, TAIL ROTOR

A helicopter technician describes disassembling the tail rotor hub assembly as part of a scheduled 600-hour inspection requirement. The internal retention strap assembly was close to its service life of 5,000 hours, but this inspection point revealed a crack in the strap’s connecting pin. “(*I*) replaced the cracked strap pin and attaching parts: strap plug P/N 109-8131-06-1 with 4,070.0 hours, and the retention strap P/N 109-8131-07-1 with 1,735.0 hours.” The other assembly was also replaced as it too was close to its service life end. (*The provided tail rotor hub assembly P/N is 109-0131-02-125.*)

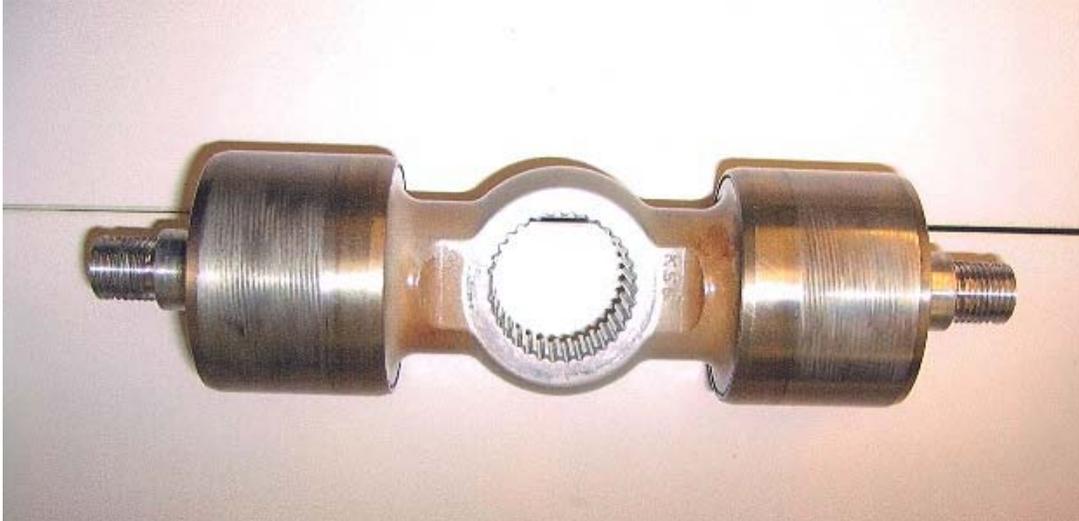
A 25-hour inspection of this helicopter's tail rotor trunnion (P/N 109-0131-05-115) evidenced signs of overheating: the part's enamel paint was discolored. Trunnion serial number K81 was removed after 149.8 hours of operation. A new trunnion was installed, S/N K56.

During a *future* daily inspection the attending mechanic found abnormal play in the tail rotor assembly's trunnion. Further inspection revealed signs of excessive heat to the trunnion's enamel paint described as "brown discoloration." This part (K56) managed 184.4 hours of operational life. *(Both this entry and the next are a bit dated, but the attached photograph—even at low resolution scan—is high quality and shows the brown discoloration. Trunnion discrepancies are reflected at least seven times in the SDRS data base for the A109 series tail rotors.)*
