U.S. Department
of Transportation
**Federal Aviation
Administration**

ADVISORY CIRCULAR

43-16A

AVIATION MAINTENANCE ALERTS

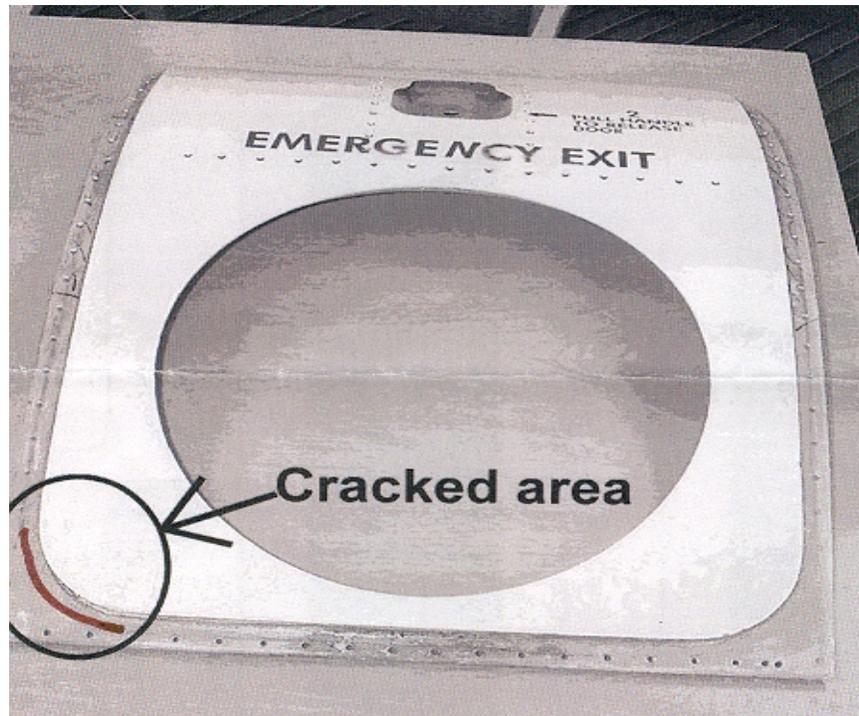
Beech (Raytheon): 200; Cracked Emergency Exit Door Skin; ATA 5220

A mechanic writes "During a phase 1 - 4 inspection, the emergency exit hatch outer skin was found cracked at the inboard surface. (*The crack propagated...*) through the entire ninety degree radius of the lower aft corner of the skin assembly (P/N 115-430100-661A). The crack length (*measured*) approximately six inches." (*Aircraft total cycles: 9,366.*)

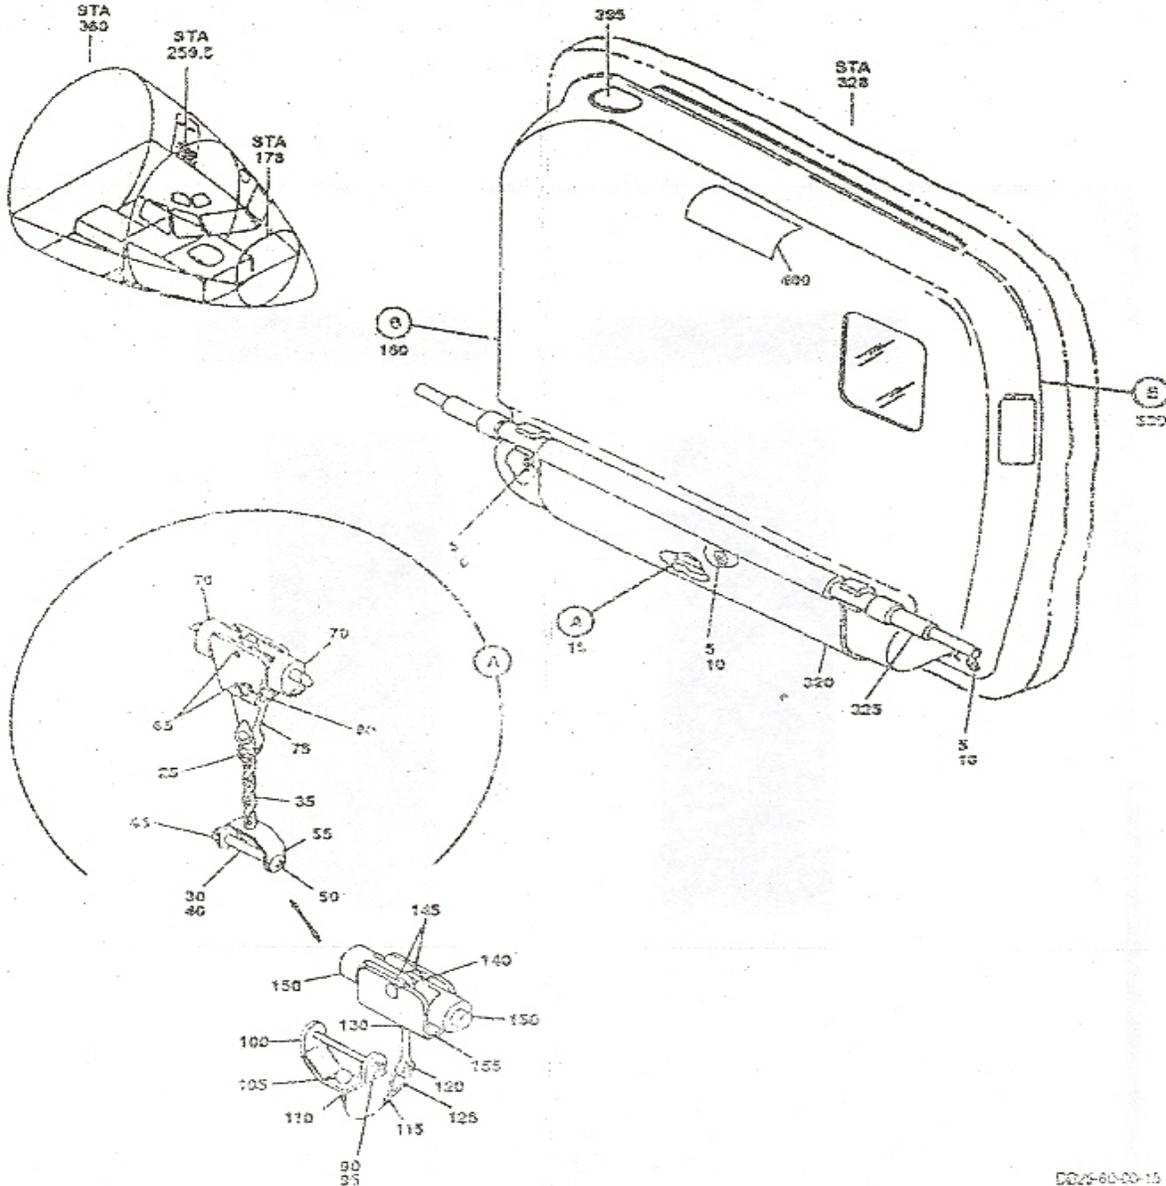
COMPARTMENT INSTL-STA 328 FWD ENTRY DOOR MOUNTED EVACUATION SLIDE
FIGURE 15 (SHEET 1 OF 4)

Boeing: 727-100QF; Emergency Slide Chain Detachment; ATA 2565

An Irish repair station submission reads, “During a ‘C’ check routine inspection of the forward door emergency escape slide, the slide bustle latch chain was found detached from the split ring. *(This)* split ring had become elongated and its ring coils separated—thus allowing the chain to detach *(see drawing item number 25 - next page)*. The slide would not have inflated if required. The chain and ring assembly will be replaced.” *(This editor has zero experience with emergency slides. I'm presuming the split ring elongation occurred through inadvertent/undetected damage from some activity not related to the assembly's function. Speculation as to cause was not provided. P/Ns: Split ring - BACR12BU9B; Chain assembly - 65C19901-21. The SDRS data base holds at least one additional entry of this same discrepancy.)*

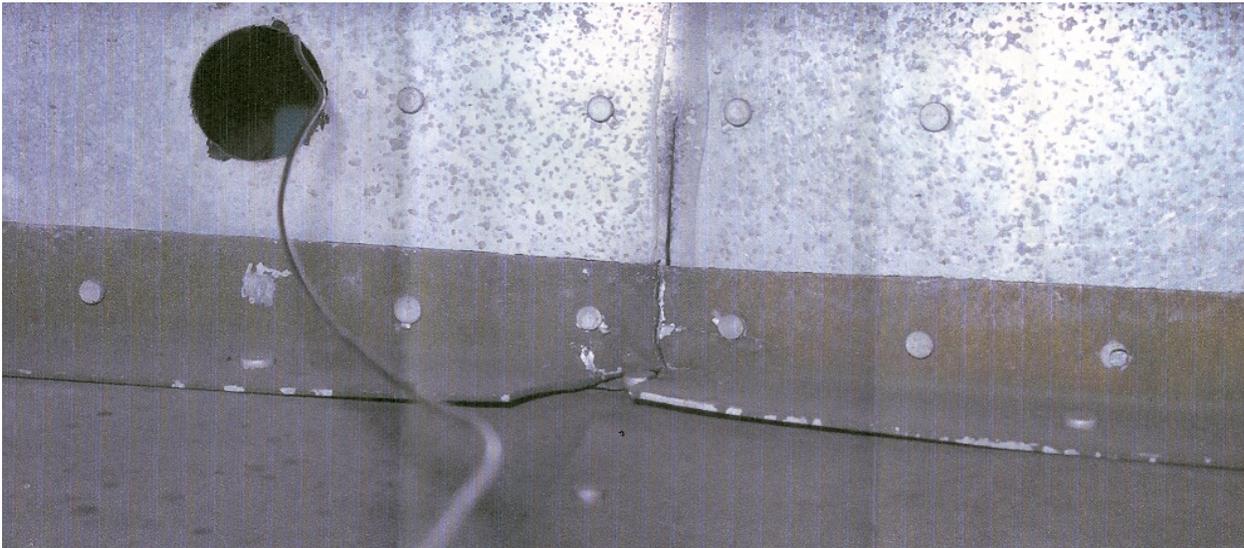
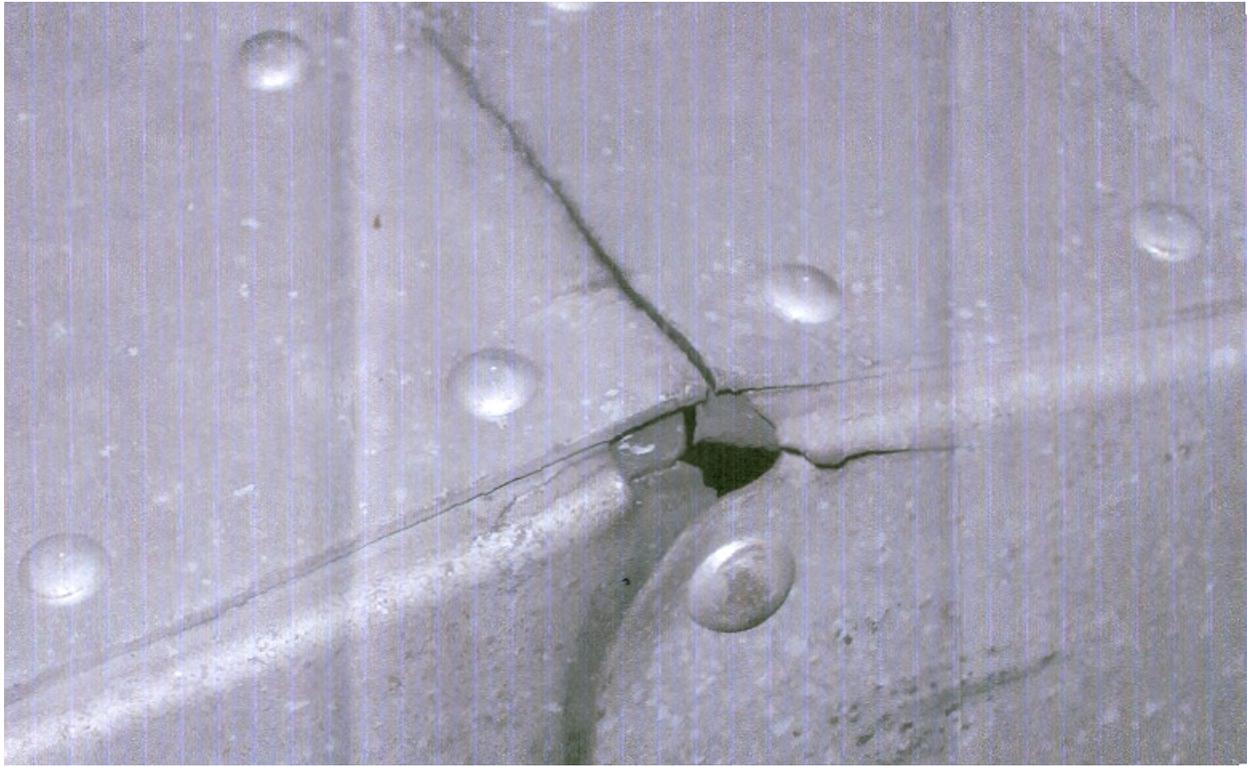
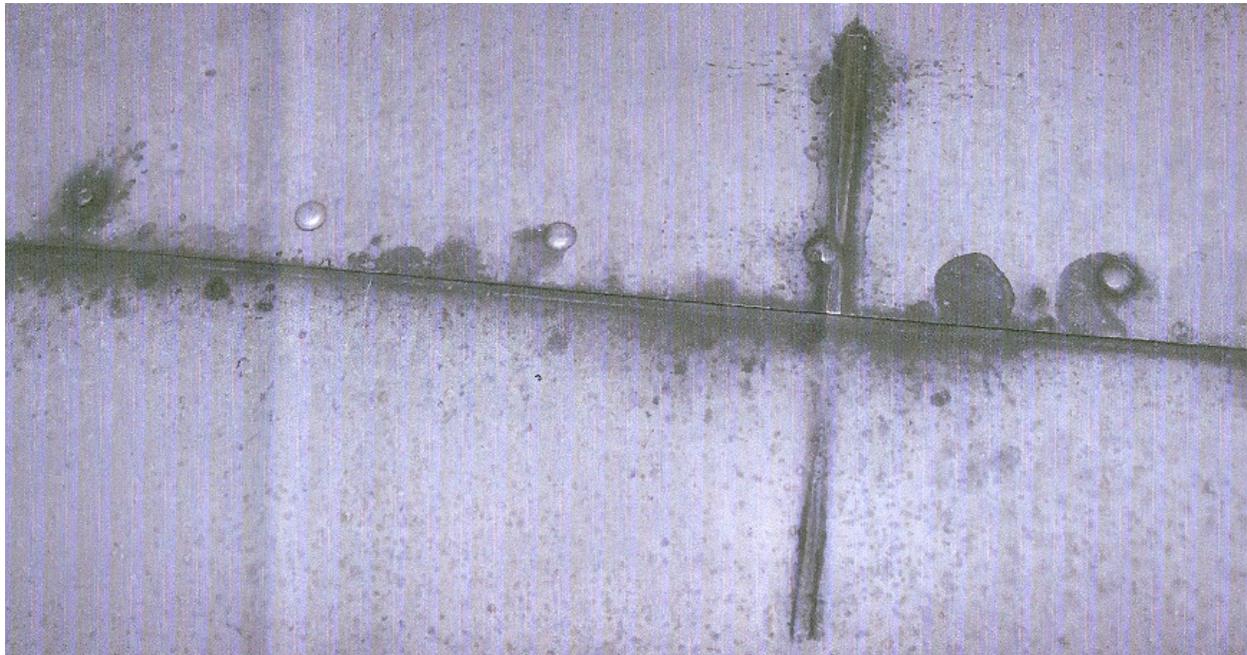
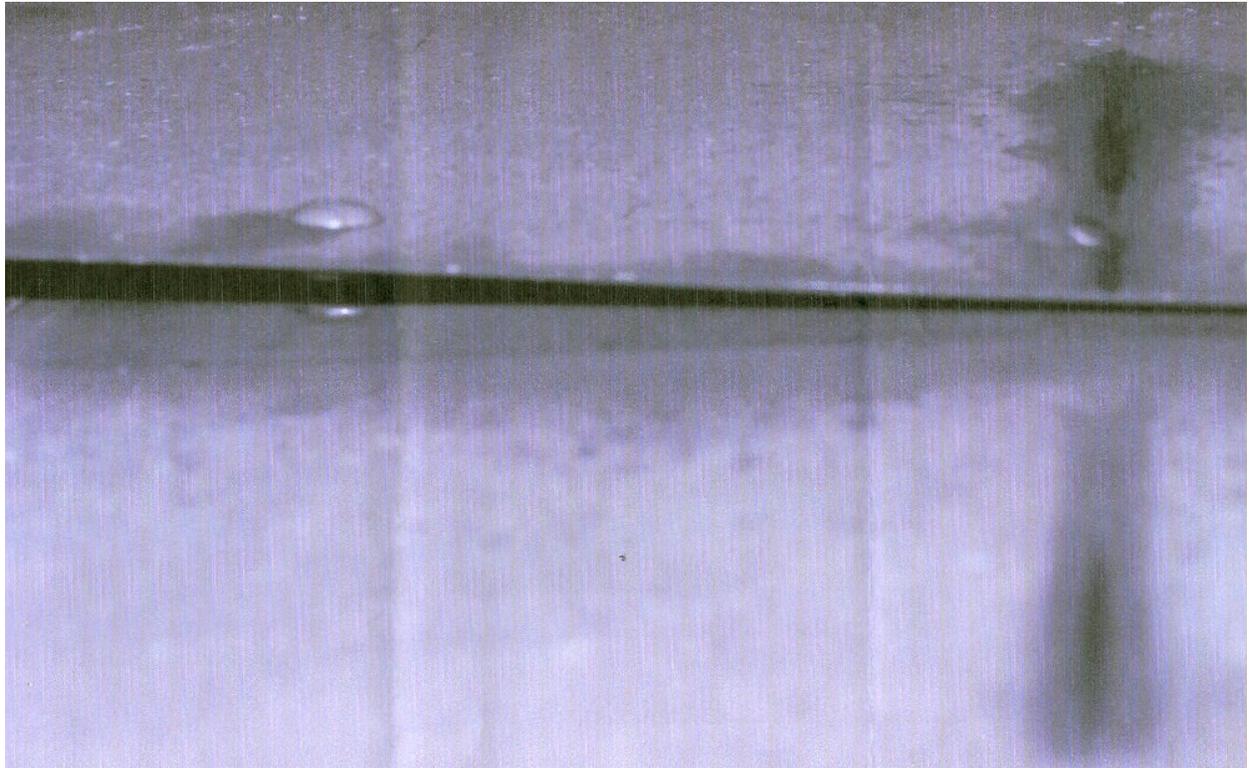
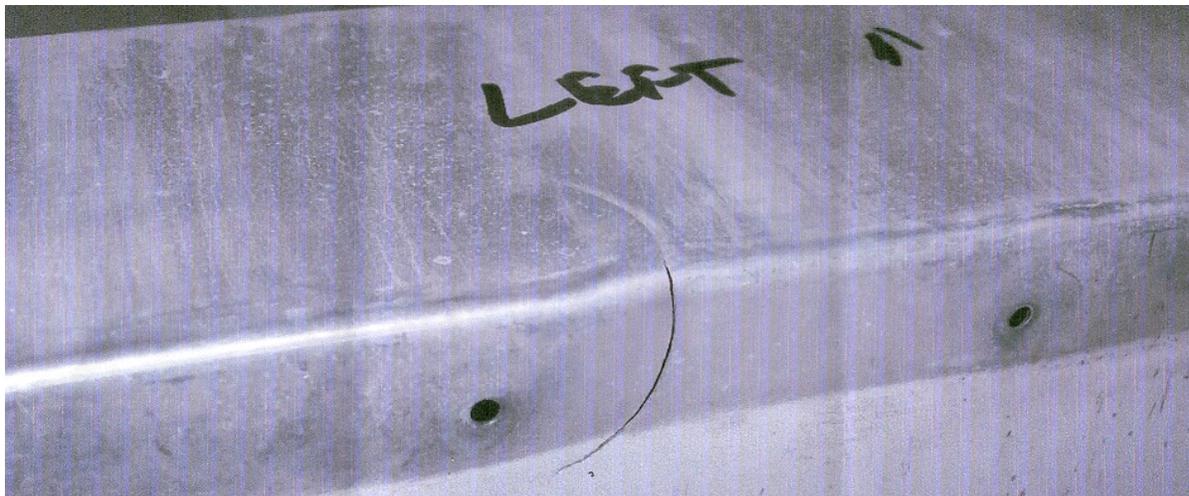
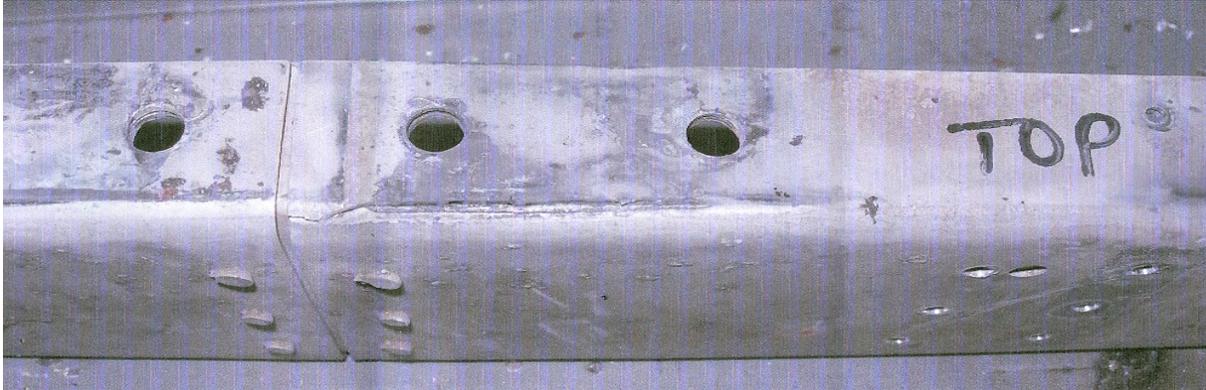
CESSNA**Cessna: 152; Cracked Horizontal Stabilizer Spar; ATA 5511**

A mechanic writes, “On a routine 100 hour inspection a crack was found on the horizontal stabilizer’s front apex: (*specifically*) the lower angle (P/N 0432001-44: see photo number 1) and the reinforcement plate (P/N 0432001-44: photo number 2). The lower skin rivet seam (*was also found*) fretted and loose (photos 3 and 3A.) Upon removal and disassembly (*additional defects*) ...were discovered: cracked skin (P/N 0432001-55: photo 4) and a cracked spar (P/N 0432001-56: photos 5 and 6).

“This is an earlier serial numbered aircraft which apparently did not have the reinforcement angle (P/N 0432007-3) as installed on later serial numbered aircraft. This aircraft also has Bolen’s ‘conversion to tail wheel’—it has spent a portion of its total time (*in this configuration*).” The Supplemental Type Certificate number provided for this conversion is SA 175GL. (*Excellent sequential documentation: thank-you! Of the seven photos, I could rationalize cutting only the close-up number six—but I didn’t. Each tells a piece of this story: the close-up should drive it home. All of these pictures have been cropped and vertically compressed. Some day...soon...we hope to facilitate appending documents and photos to the electronic, defect submission forms—or maybe a separate server/mail account, etc. Currently I have to scan—what you already have scanned—which doesn’t help the “picture,” right?—Ed.*)

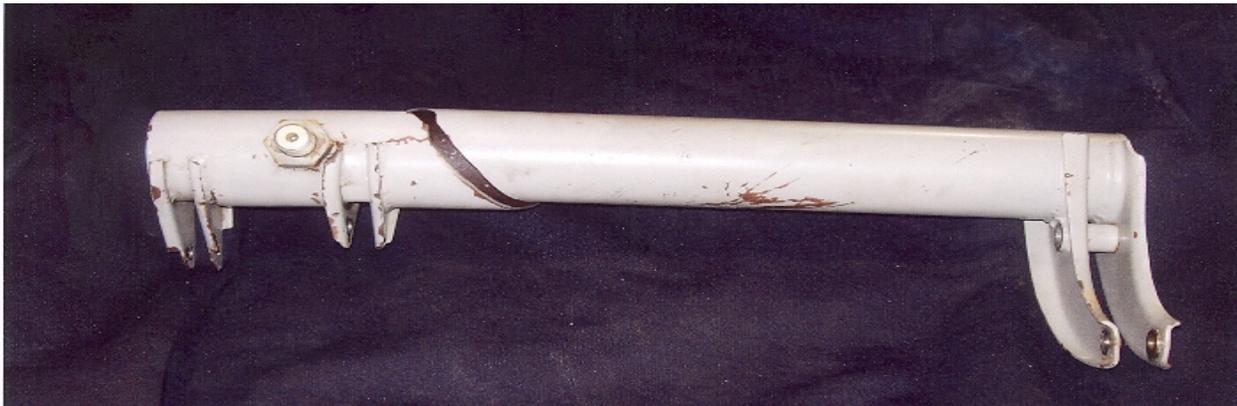
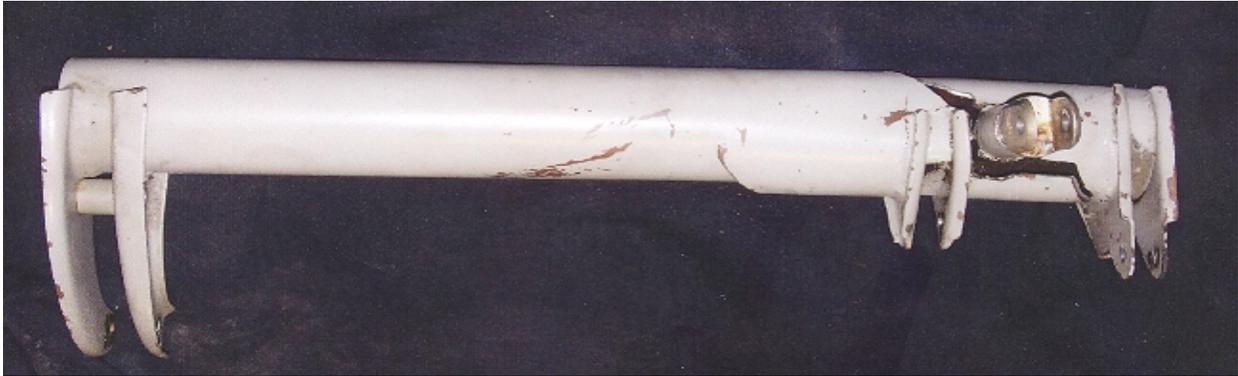
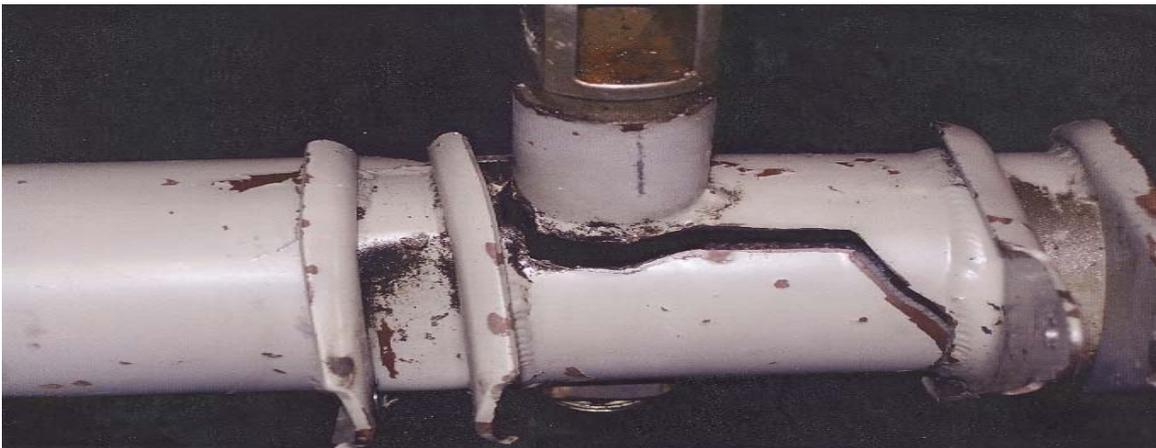
Cessna: 414; Cracked Main Gear Bellcrank Assembly; ATA 3230

A submitter states, “The L/H main gear bell crank assembly (*P/N 5045010-19*) cracked and failed when the gear was selected to ‘up.’ The L/H main gear returned to ‘down and locked.’ The bell crank tube broke and twisted as it failed—the crack radiating from the rear welds to the fork bolt socket and forward.” (*Six beautiful, hi-resolution photos accompanied this discrepancy—which were promptly cropped, compressed, and reduced in resolution.*)

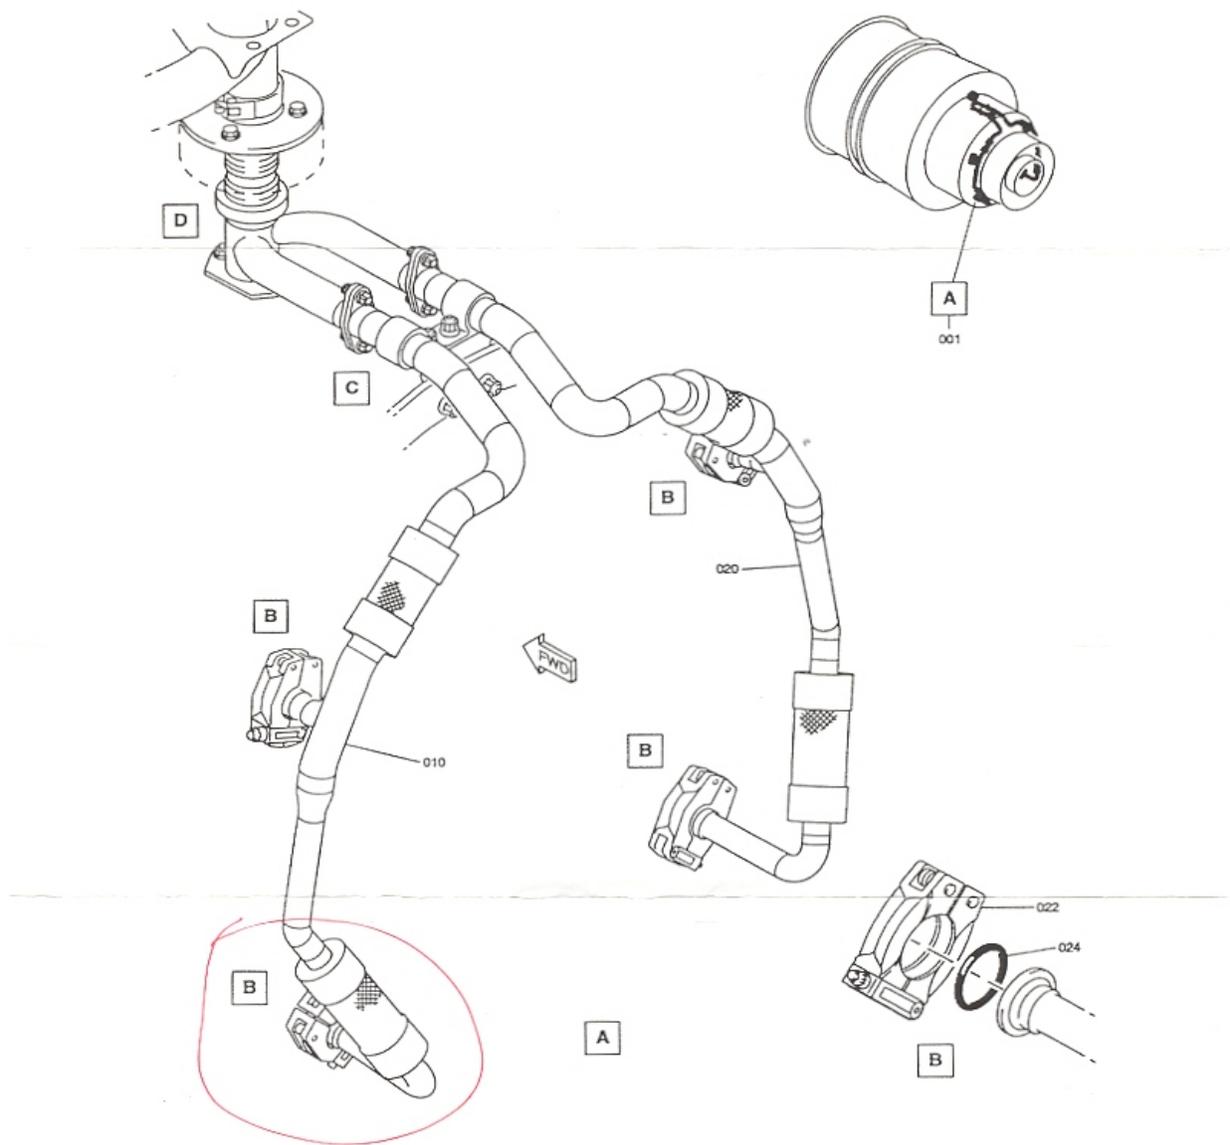
DASSAULT**Dassault: DA-50; Cracked High Pressure Bleed Air Duct; ATA 3610**

A repair station technician writes, "During a scheduled number two engine change inspection noticed the high pressure bleed air duct (*P/N SBJ33057-401*) was cracked at the center, bleed air tap. The crack appeared to originate at the weld and progressed radially approximately 2.25 inches toward the braided flex coupling. A new duct was ordered and installed. The cracked duct will be sent to Dassault for engineering evaluation. This is the second high pressure bleed air duct found cracked during recent engine changes. The first duct found cracked was on number three engine (*P/N SBJ33055-401*) with some difference in configuration, but the same application. (*This duct*) was also replaced with a new part from Dassault Falcon Jet."

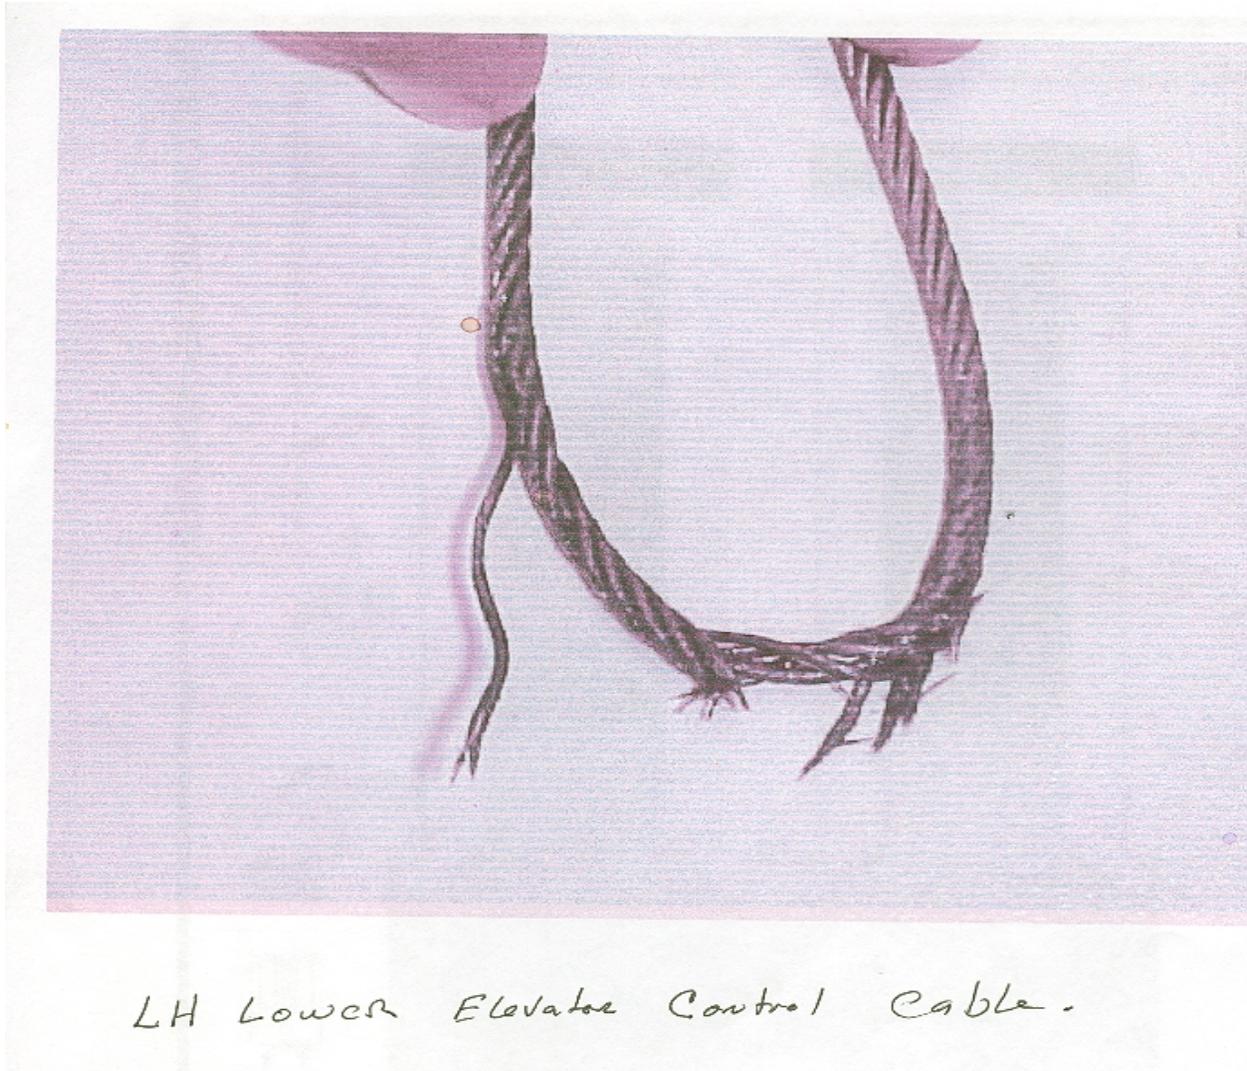
Learjet: 45; Frayed Elevator Control Cable; ATA 2730

A repair station technician writes, "During the initial 5,000 hour cable inspection (I) noted extensive damage to the lower left aft elevator control cable and the pressurization system vacuum line at fuselage station 495 (under the SKI storage box in the rear baggage bay). The pressurization vacuum line was found mis-routed, causing damage to the elevator control cable and the vacuum line. (I) recommend engineering evaluate the need for a one-time inspection of this area on all like aircraft with less than 5,000 accumulated flight hours." *(Elevator Cable P/N 7627302026-001. Aircraft time and cycles: 4,224.68 hours; 3,183 cycles.)*

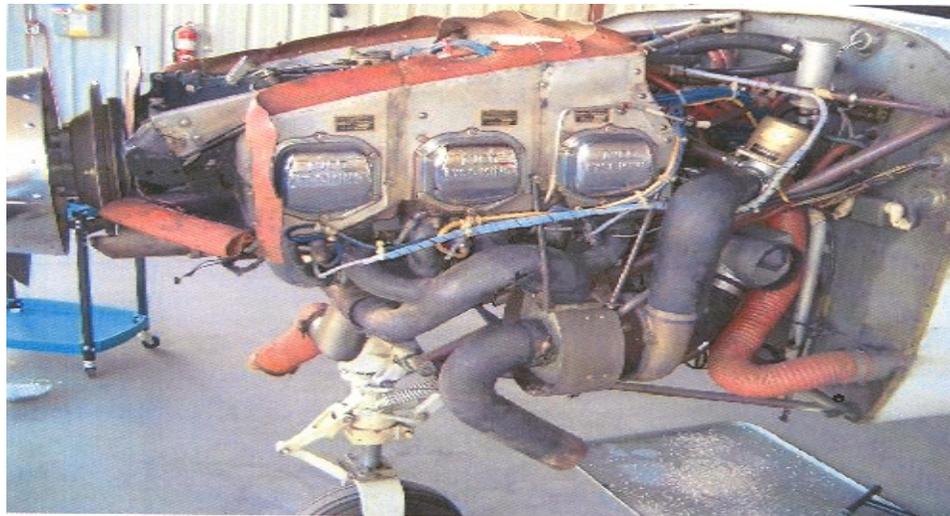
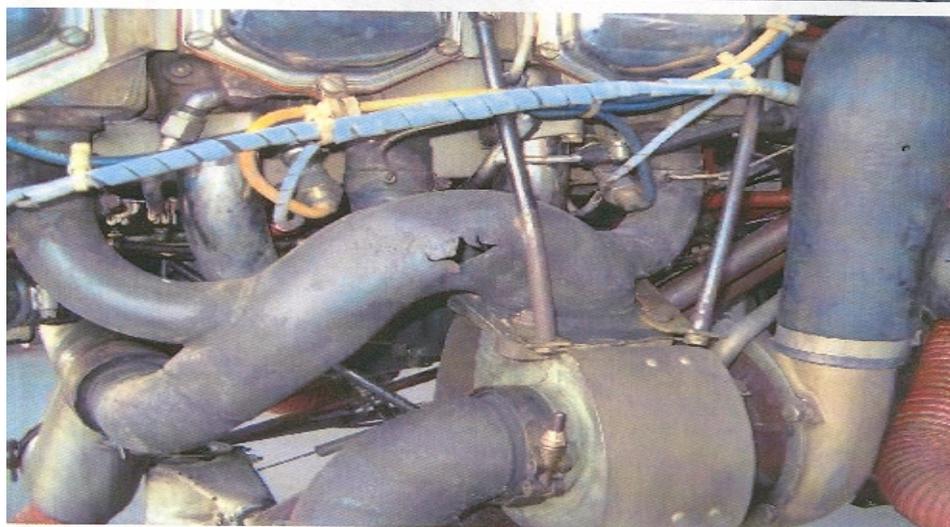
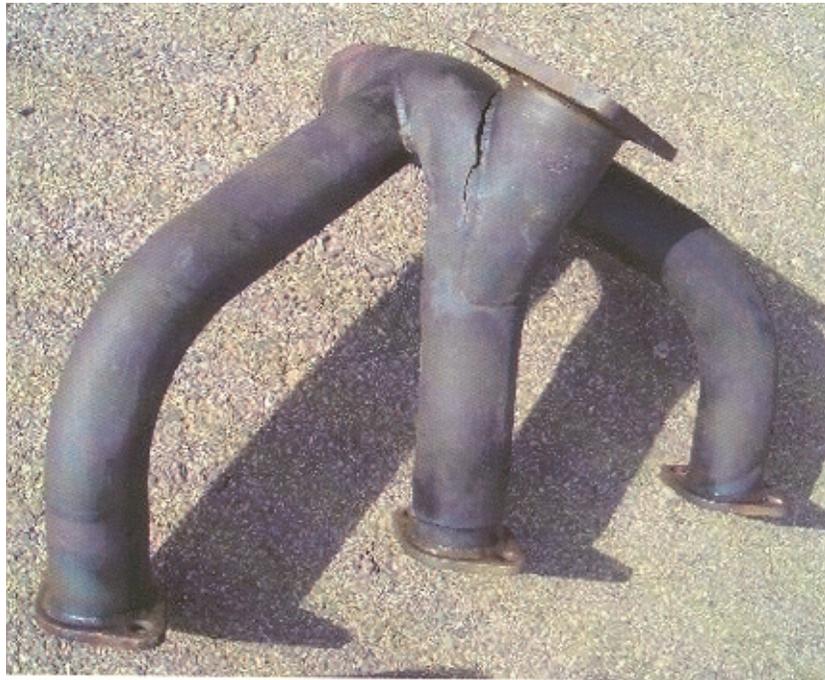
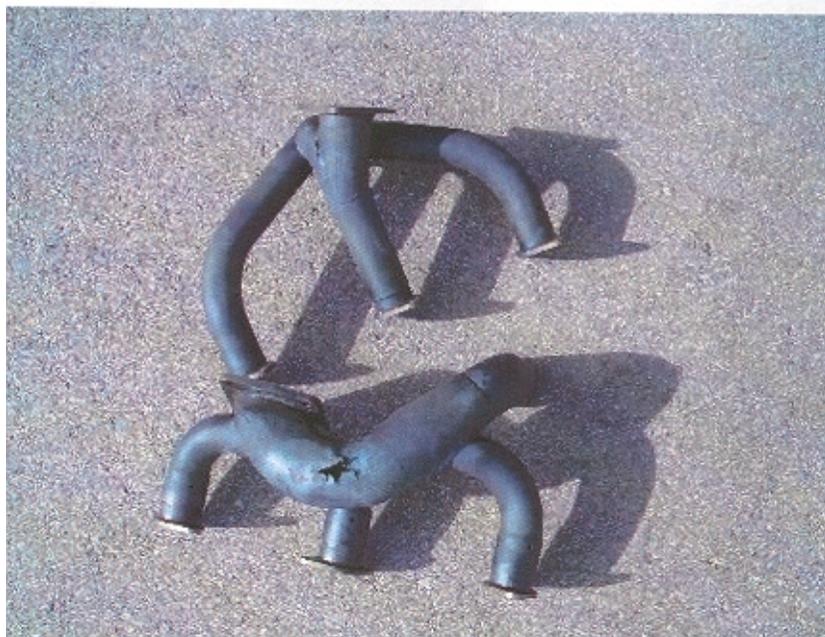
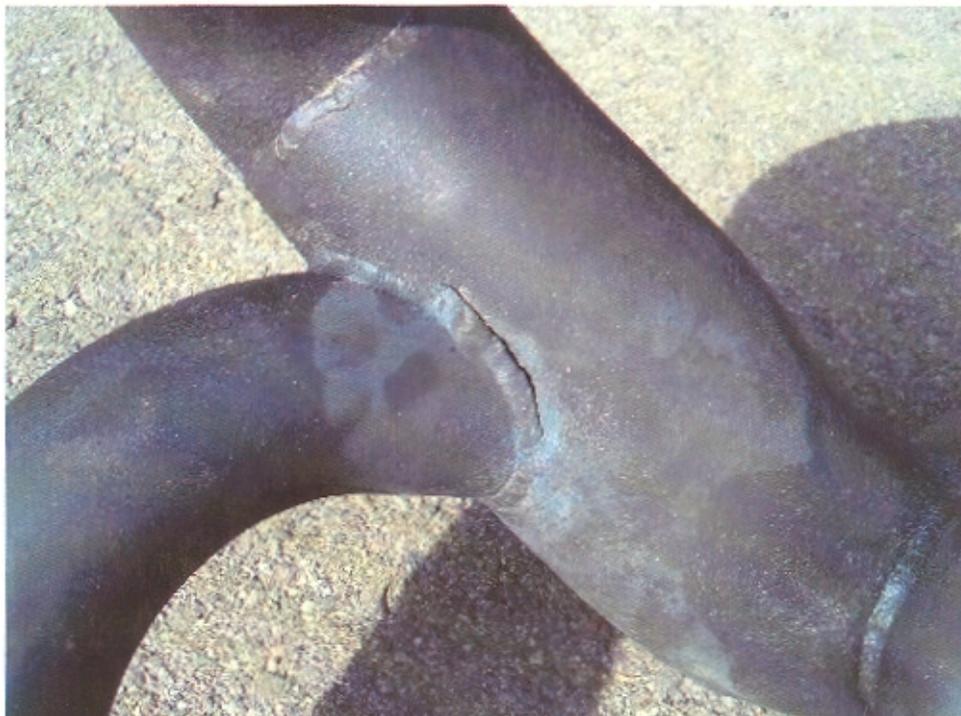
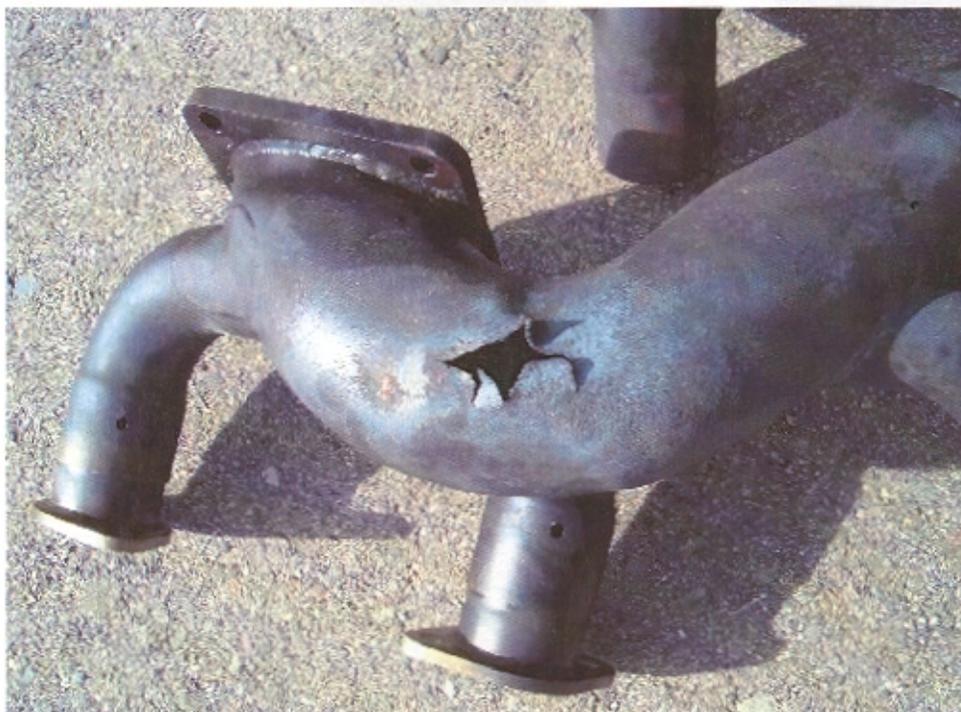
Rockwell: 114; Cracked STC Exhaust Risers: ATA 7810

A submitter describes finding multiple holes and cracks in the exhaust risers of this aircraft's STC turbo system (*supplemental type certificate SA00356DE*). These exhaust units were deemed unserviceable after only 207.8 hours since new. Nineteen photos were attached to this discrepancy, only a few of which are provided here. An added note indicates the new, replacement risers also cracked after just 140.0 hours.
