U.S. Department  
of Transportation  
**Federal Aviation  
Administration**

## ADVISORY CIRCULAR

# AVIATION MAINTENANCE ALERTS

**ALERT  
NUMBER  
342**

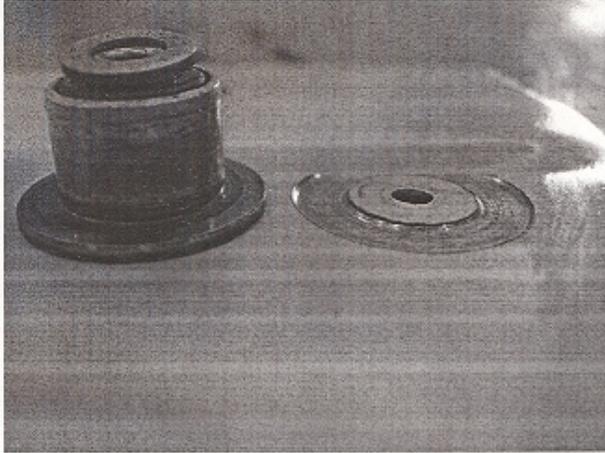
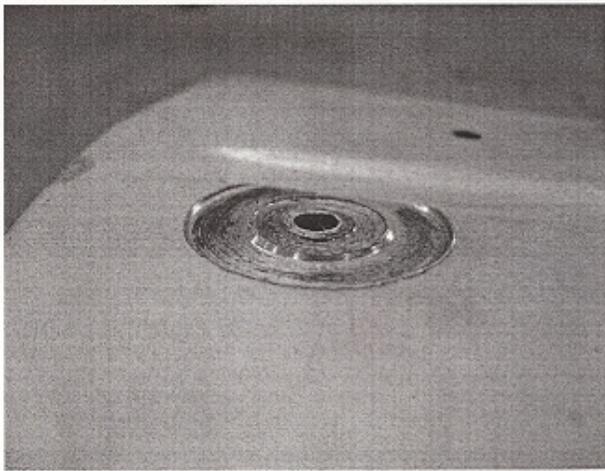
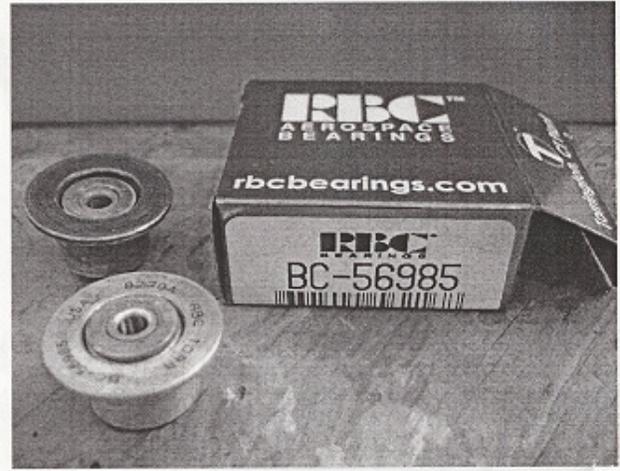
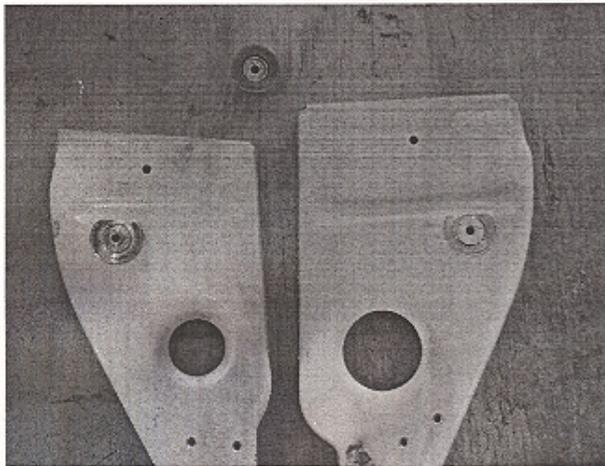
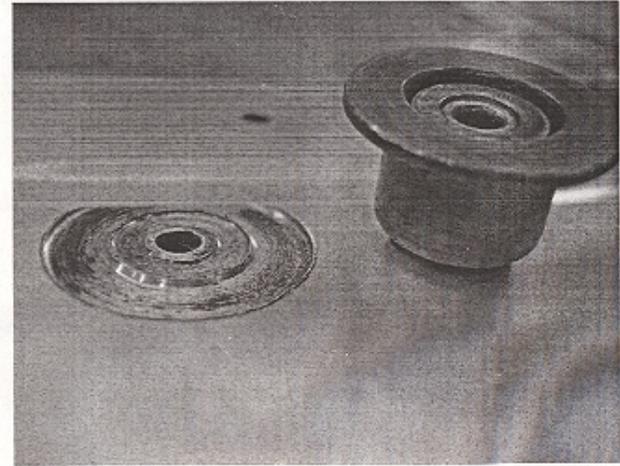
**Beech: C90; Flap Rib & Bearing Damage; ATA 5753**

A mechanic describes a flap problem on this Raytheon King Air. "*(The left flap's aft roller bearings...)* have very little side clearance between the bearing and the flap's rib. As the bearing wears, side play increases to the point where the bearing flange contacts the rib. Raytheon has not provided any chafe protection on this side of the bearing, therefore, the bearing begins to cut into the rib as it rolls fore and aft. A small, thin Teflon washer would prevent contact and allow bearing wear to be detected before damage occurs (*RBC Bearing P/N: BC-56985*)."

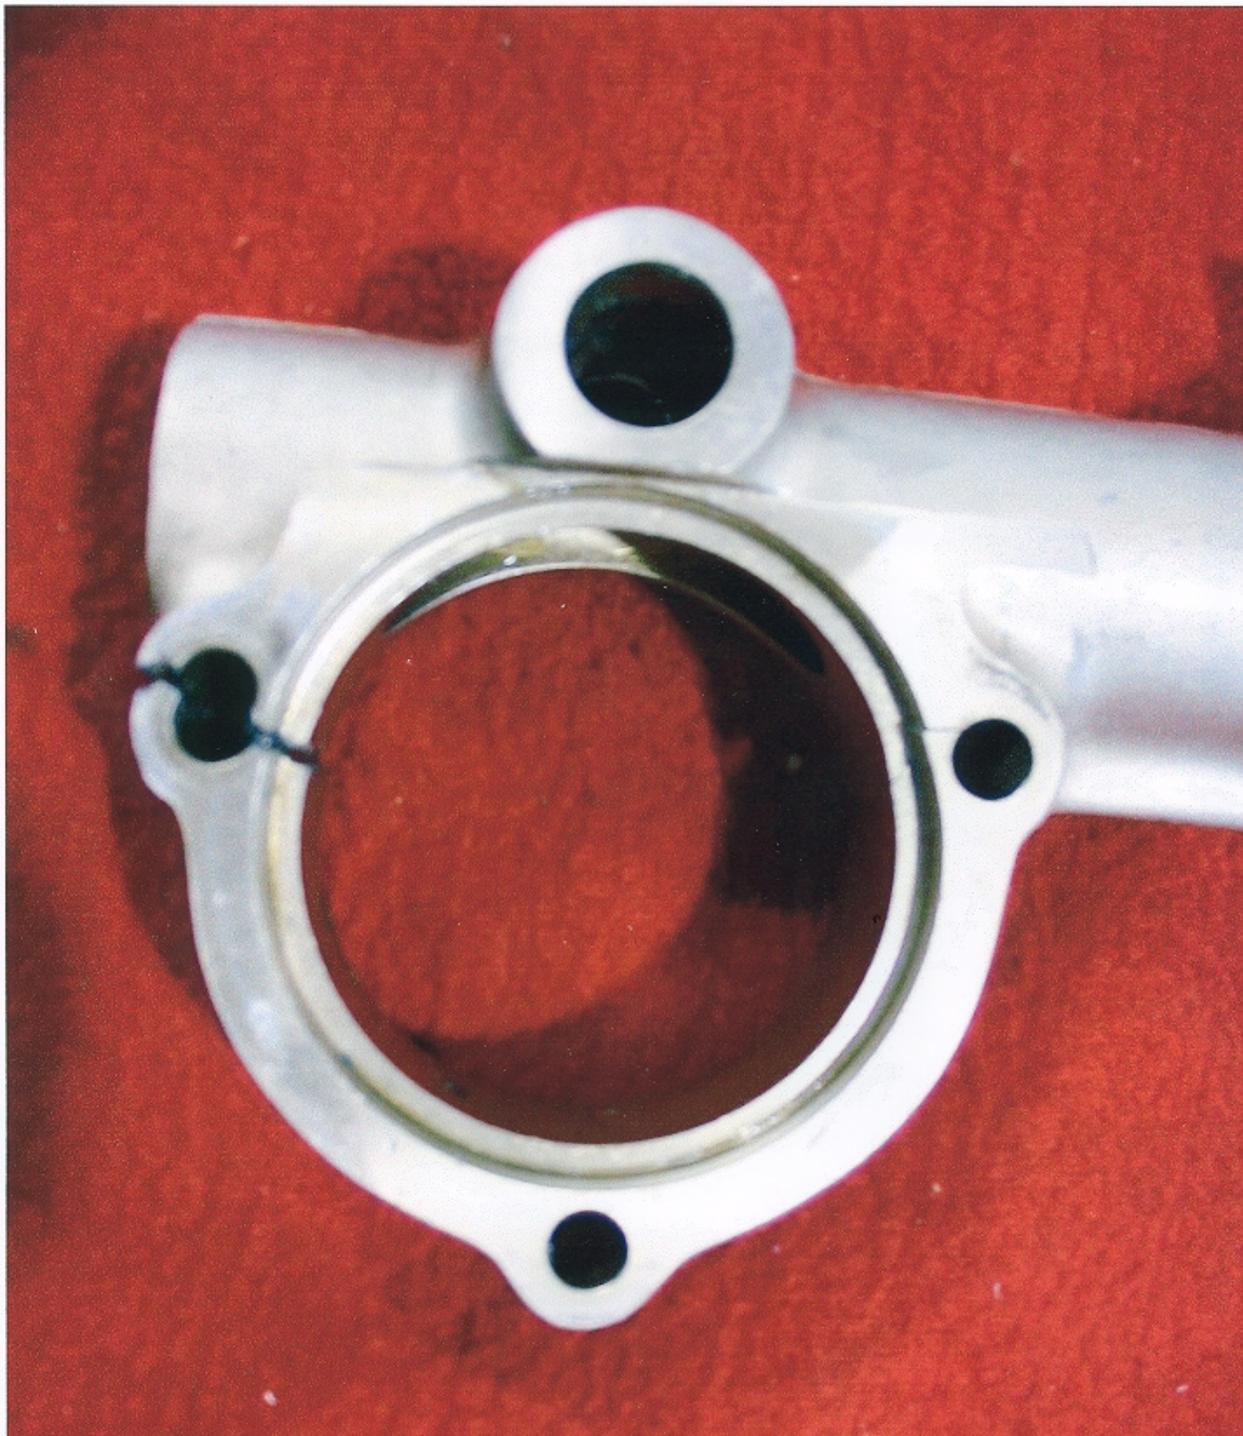
**CESSNA****Cessna: 172RG; Cracked, L/H Landing Gear Actuator; ATA 3233**

Two technicians from a repair station co-authored this discrepancy. “During flight, the L/H main landing gear failed to extend, but trailed—seemingly disconnected from the hydraulic system. The pilot was able to rock (*this L/H gear*) into the down and locked position and make a safe landing. Upon inspection it was determined that the (P/N 1281001-3) actuator body had cracked clear through the forward attach hole and half-way through the aft attach hole. (*This*) caused the actuator to separate when hydraulic pressure was applied, separating the piston gear shaft (P/N 9882004-1) from the sector gear (P/N 9882002-2) mounted to the pivot. The actuator’s attach bolts were found tight and their safety wire undisturbed. The actuator body was replaced with a new part (P/N 1281001-6). The actuator was resealed, reassembled, reinstalled and torqued per the 172RG Service Manual. (*We*) performed a hydraulic pressure switch check (*same ref.*) and found the pressure to be within limits.

“Damage to the actuator body is unrelated to the condition addressed in Cessna (*bulletin*) SEB01-2. (*We*) suspect failure of the actuator body may be attributed to shear stress on (*its*) attach bolt holes due to the high number of gear cycles over the life of the aircraft. Inspection of the R/H gear actuator body yielded no cracks or defects.” (*This actuator assembly, P/N 9882015-2, is located under the floor beneath the cabin’s back seat. A search of the FAA Service Difficulty Reporting System data base reflects 20 entries for this same part number since 1995.*)

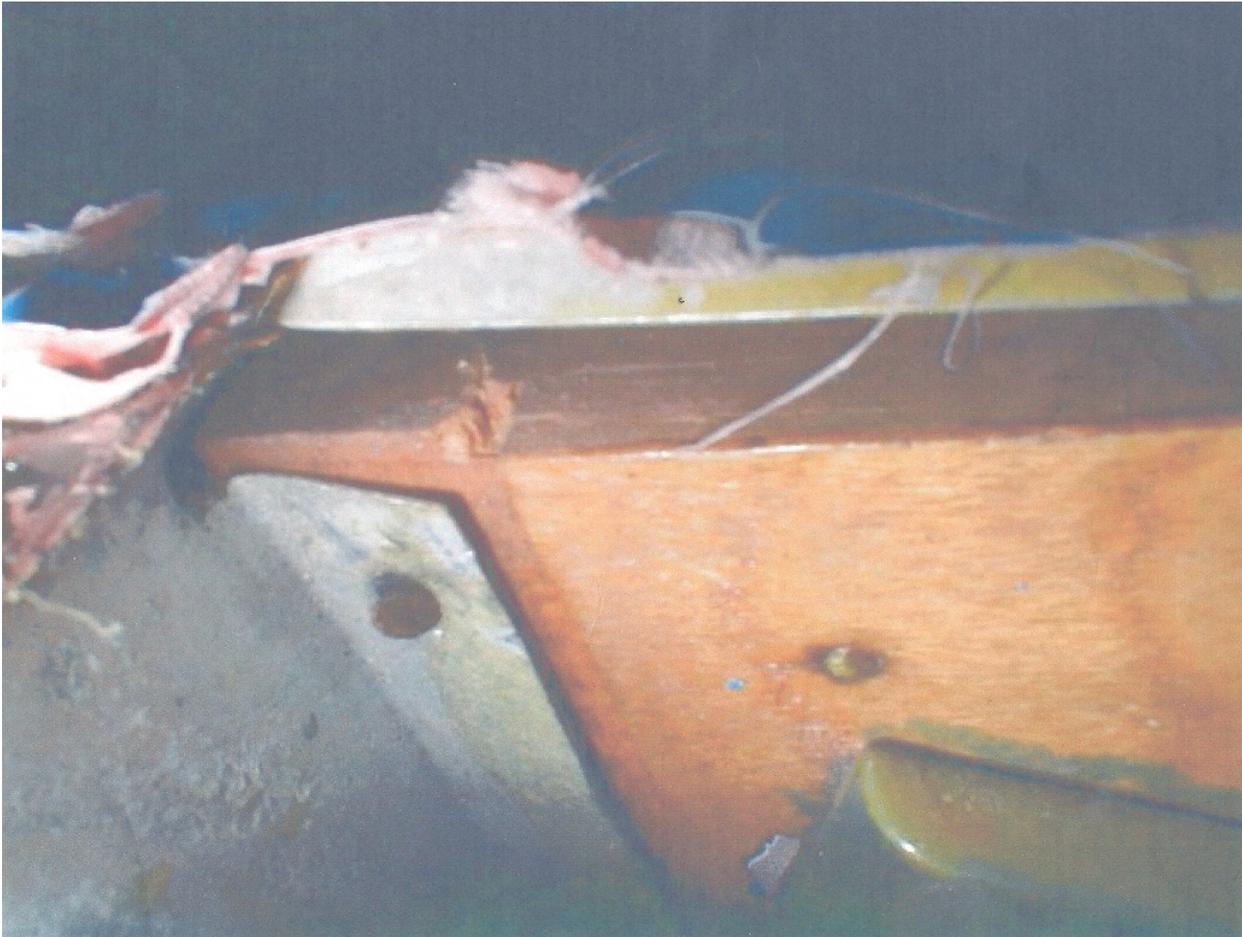
### Champion: 7ECA; Cracked Wing Spar; ATA 5711

A repair station technician writes, “A required inspection of wooden wing spars in accordance with AD 2000-25-02 revealed a compression crack in the left wing forward spar at the top, O/B of the wing-strut attach doubler plate.” (*The part number listed is 5-271L.*)

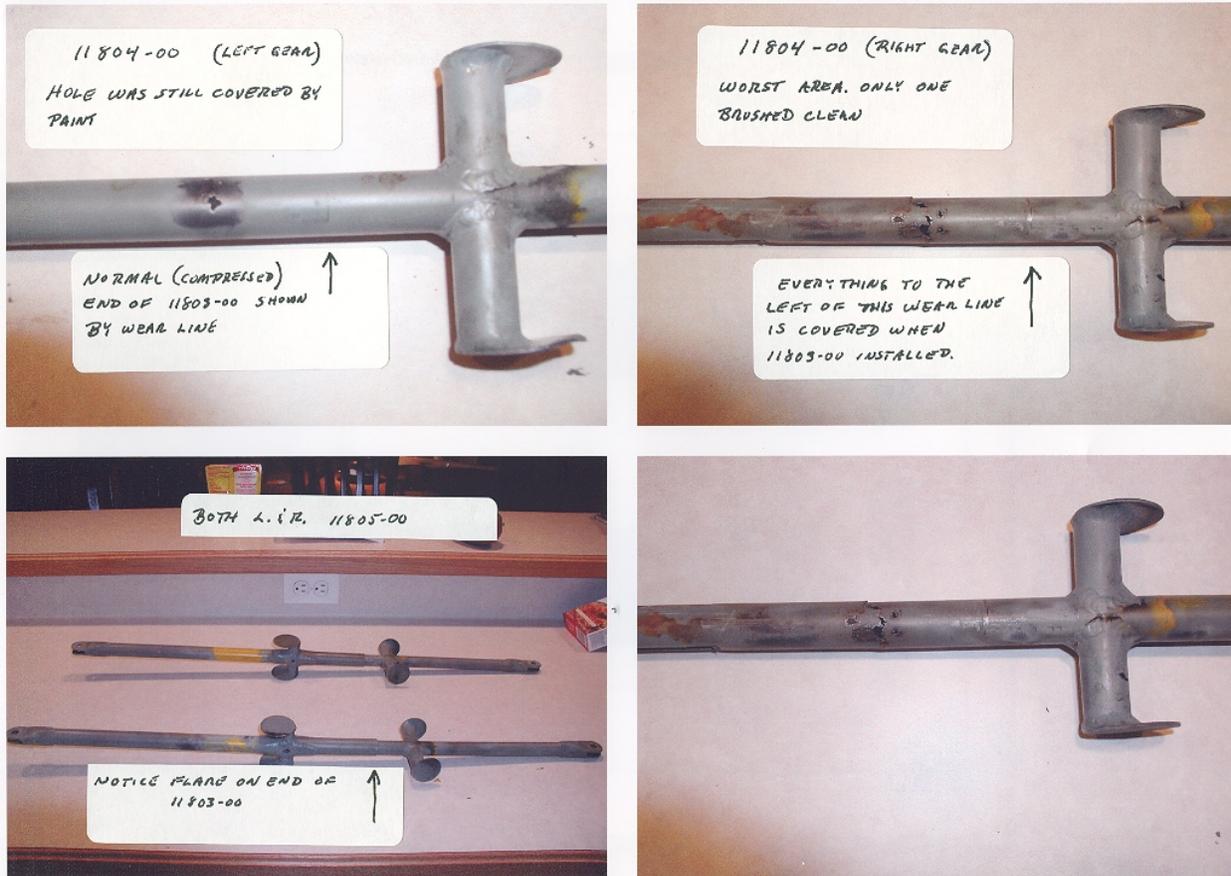
### Piper: PA17; Corroded Bungee Struts; ATA 3210

“While changing shock chords on this aircraft,” says a mechanic, “I noticed a discoloration of the inner strut tube (P/N 11804-00), so I removed it from the outer tube (P/N 11803-00). One of the inner strut tubes was corroded (*through*) approximately 50 per cent of its circumference. The other inner strut tube had multiple corrosion holes through all of the metal. Both short (outer) tubes showed oval elongation at the ends, indicating flexing/bending of the assembly during landing and takeoff. I believe only the relatively new bungee kept this gear from final failure and a resultant ground loop.

“The bungee chords, when installed, cover this area and also (usually) have a cloth or aluminum fairing over them. Detection of this requires removal of the fairings at a minimum, and removal of the bungee to clearly see the outer tube’s circumference. To inspect the area that failed it is necessary to disassemble the unit (P/N 11805-00) and view the inner piece (P/N 11804-00) and outer piece (P/N 11803-00) separately.

“I would recommend whenever bungee (*cords*) are changed, the pieces (*described*) should be removed from the aircraft, disassembled, and inspected for corrosion.”

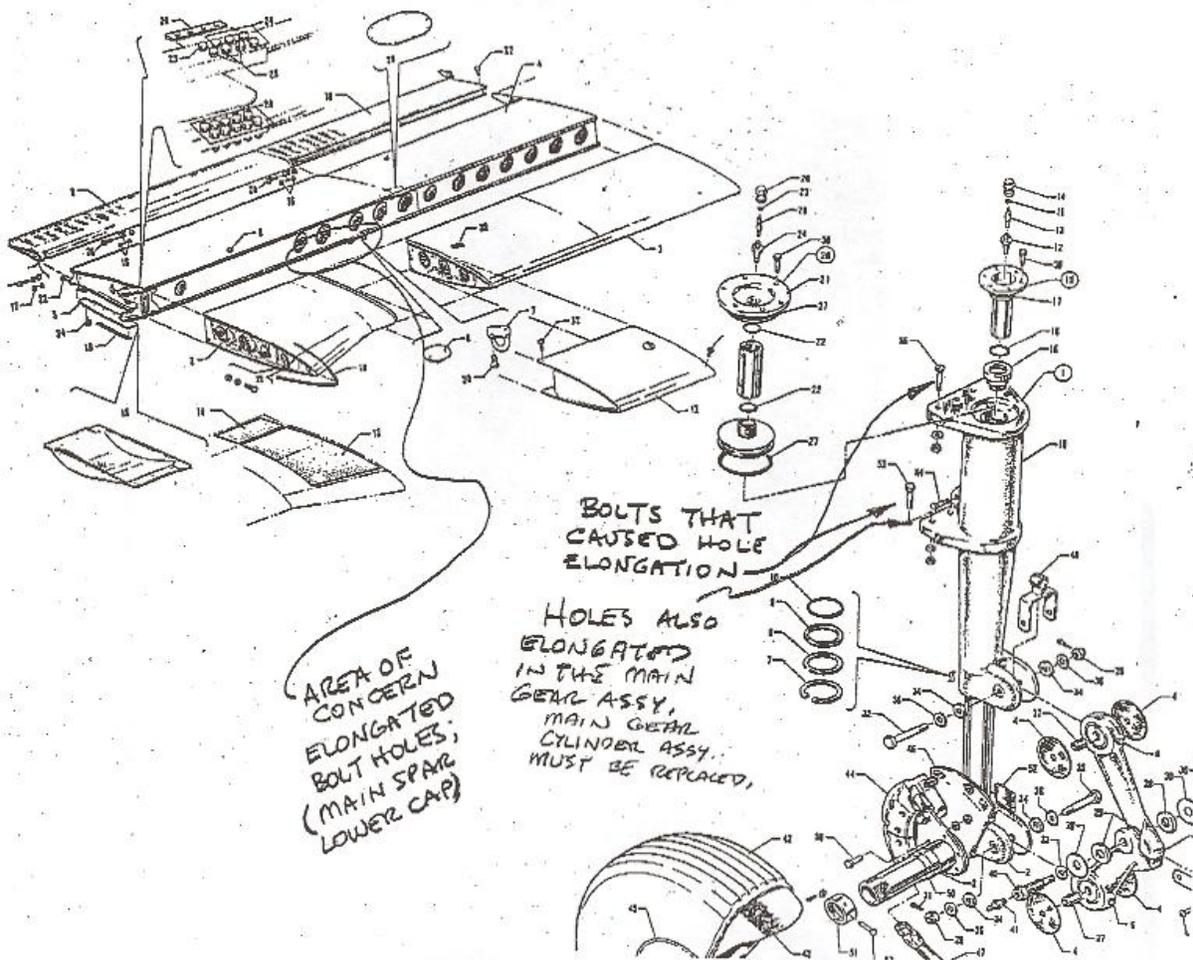
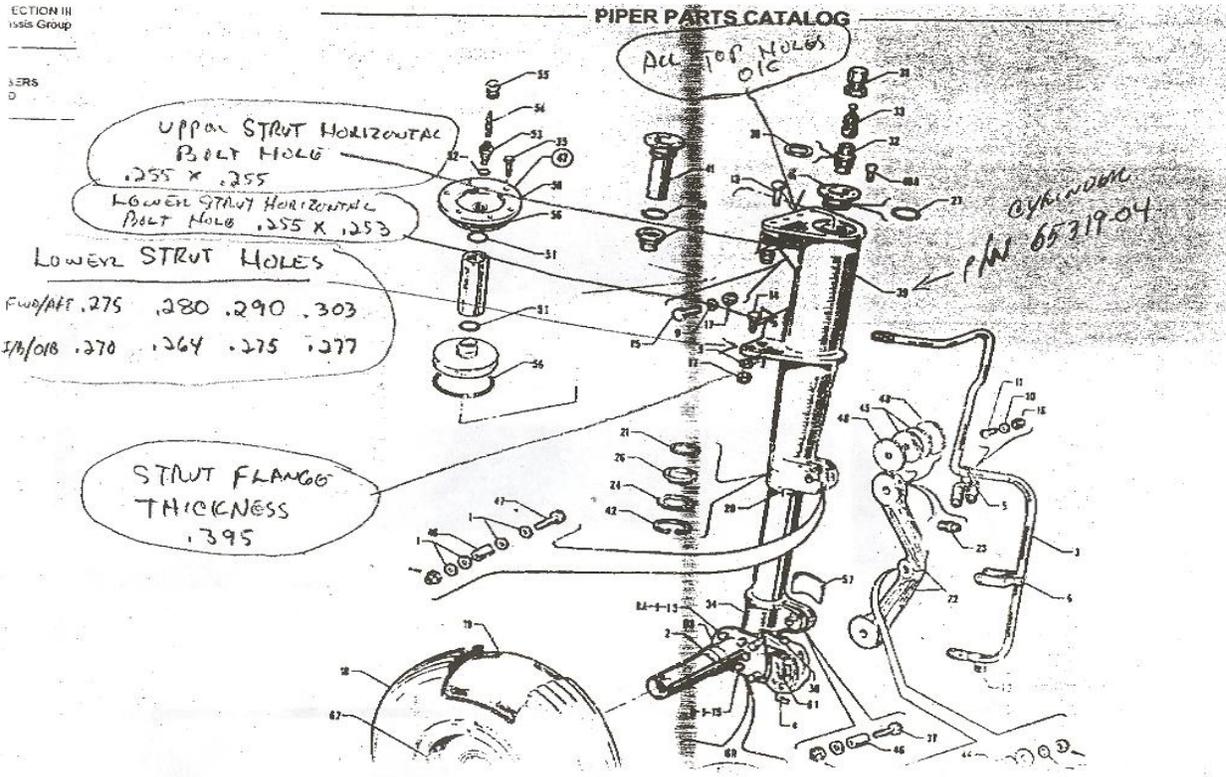
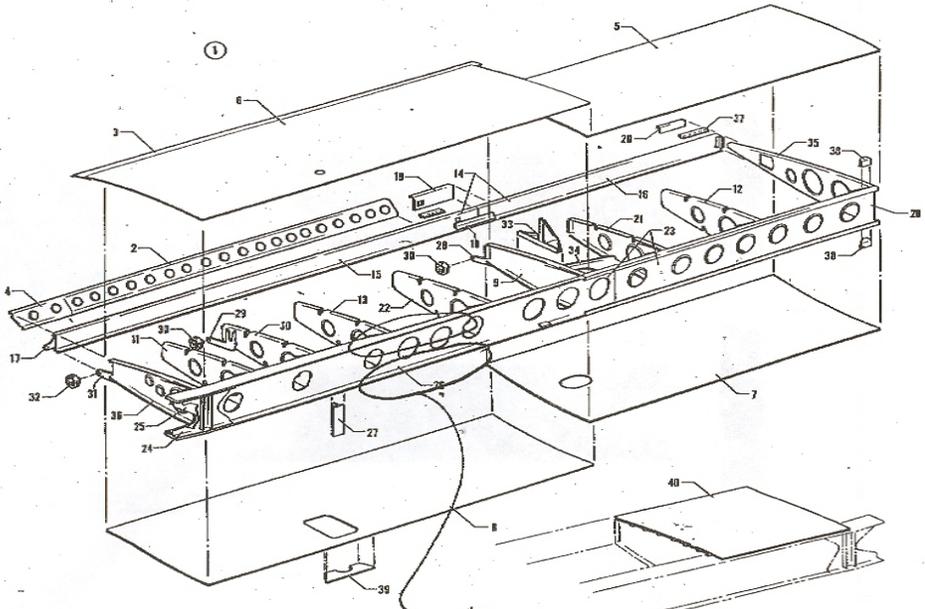
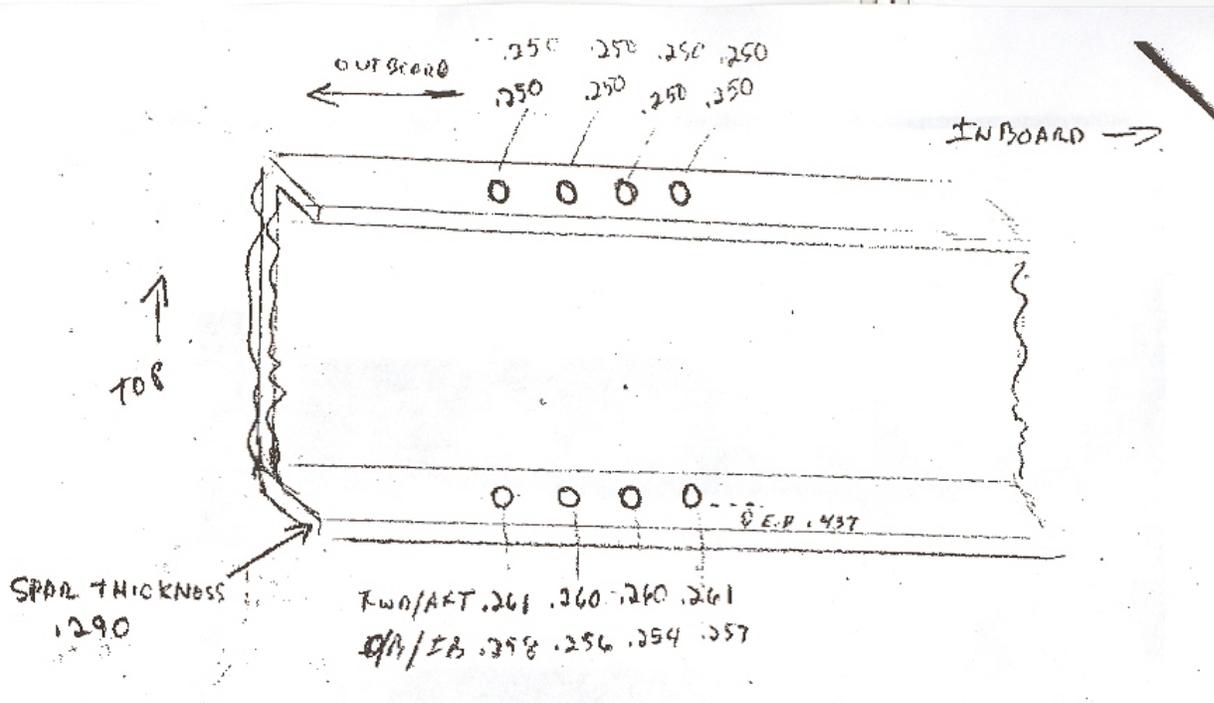
### Piper: PA28-140; Worn Landing Gear Mount Holes; ATA 3211

A Designated Airworthiness Representative (DAR) for a repair station describes the following defect. “During an annual inspection of the L/H main landing gear cylinder assembly (P/N 65319-04), it was found to be loose in the main wing spar. The L/H main landing gear was removed for further inspection of the main wing spar assembly’s gear attaching bolt holes and attach points. Close inspection of the wing spar showed the lower four bolt holes had been elongated. The holes in the landing gear cylinder were also found to be elongated. (Apparently, all the bolts were ‘shanked-out,’ leaving the assembly loose for some time.) The aircraft wing spar was repaired. The L/H main landing gear cylinder was replaced with a later model cylinder assembly from Piper since the original part was no longer available. (I) recommend close inspection of landing gear attach points during all inspections.”

AREA OF ELONGATED MAIN LANDING GEAR BOLT HOLES, MAIN SPAR, LOWER

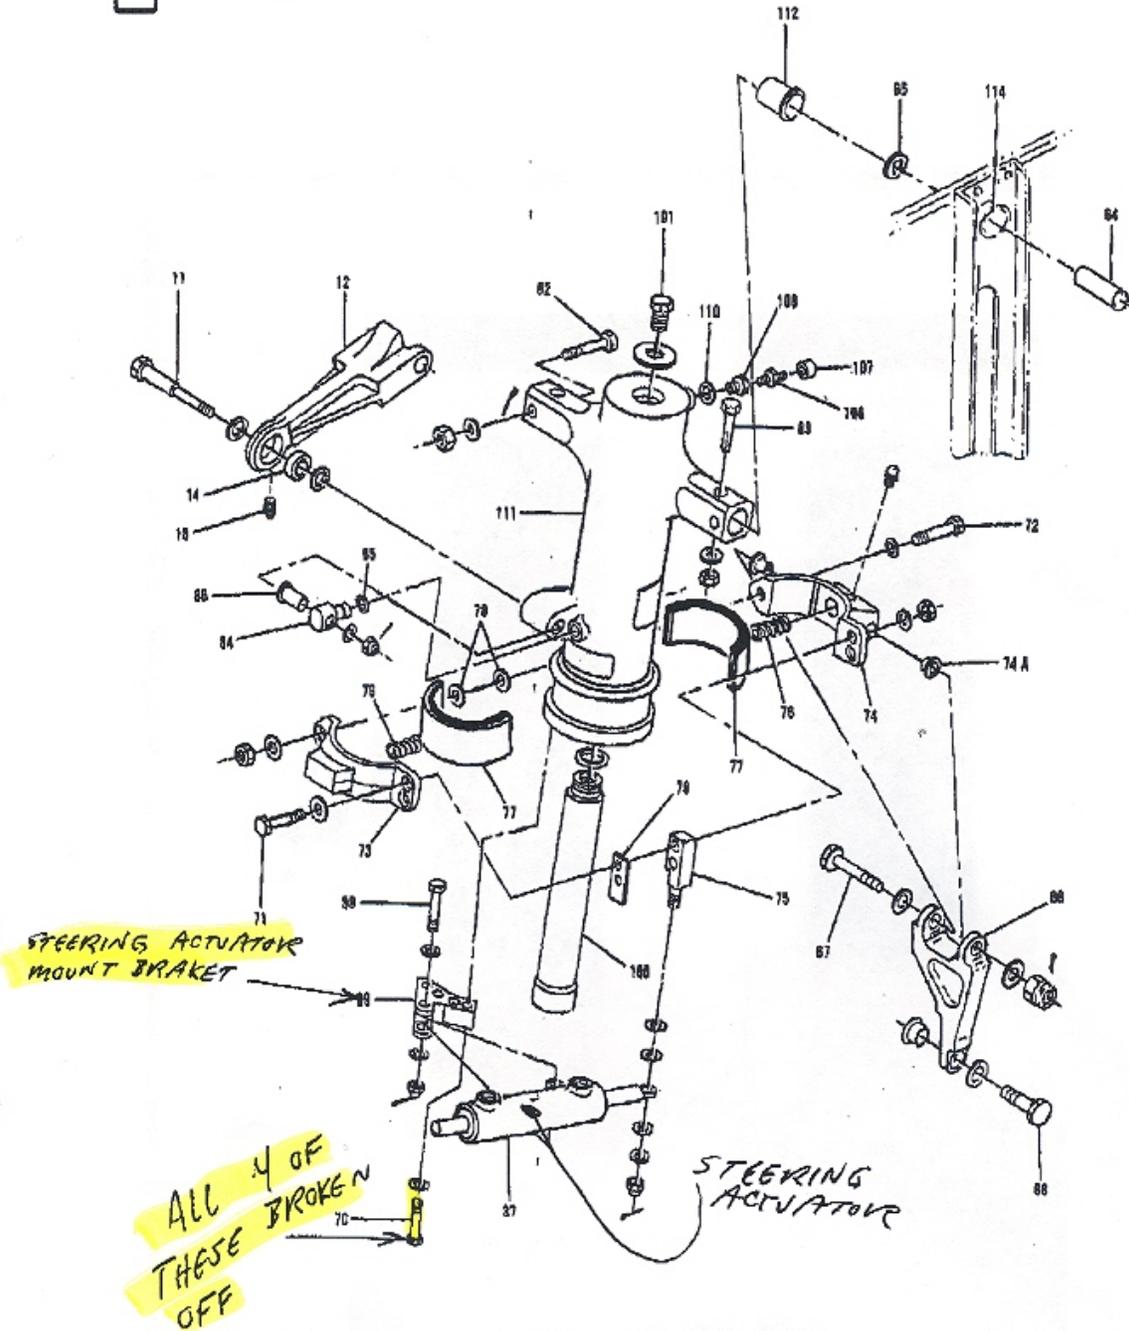
Figure 2-19. Nose Landing Gear Installation (Sheet 2 of 5)

Another repair station submission reads, “During landing gear extension (while on approach) the *gear in transit* light remained on, and the nose landing gear did not indicate *down and locked*. Initial fly-bys indicated the nose landing gear to be only partially extended. After recycling the gear several times, a “clunk” was heard and the nose landing gear extended. Inspection revealed the four AN3 bolts (used to secure the hydraulic steering actuator to the nose landing gear oleo strut) sheared, resulting in the steering actuator hanging only by its hydraulic lines. The unsecured steering actuator had possibly jammed between the nose landing gear strut and the radome, preventing full extension of the nose landing gear. Some radome damage was evident, though no other damage has been found.

“The four broken AN3H11A bolts can be damaged by exceeding the nose landing gear turn limits during towing. It is suspected the bolts were weakened by excessive turning (while towing) sometime in the past, and failed during this flight.”

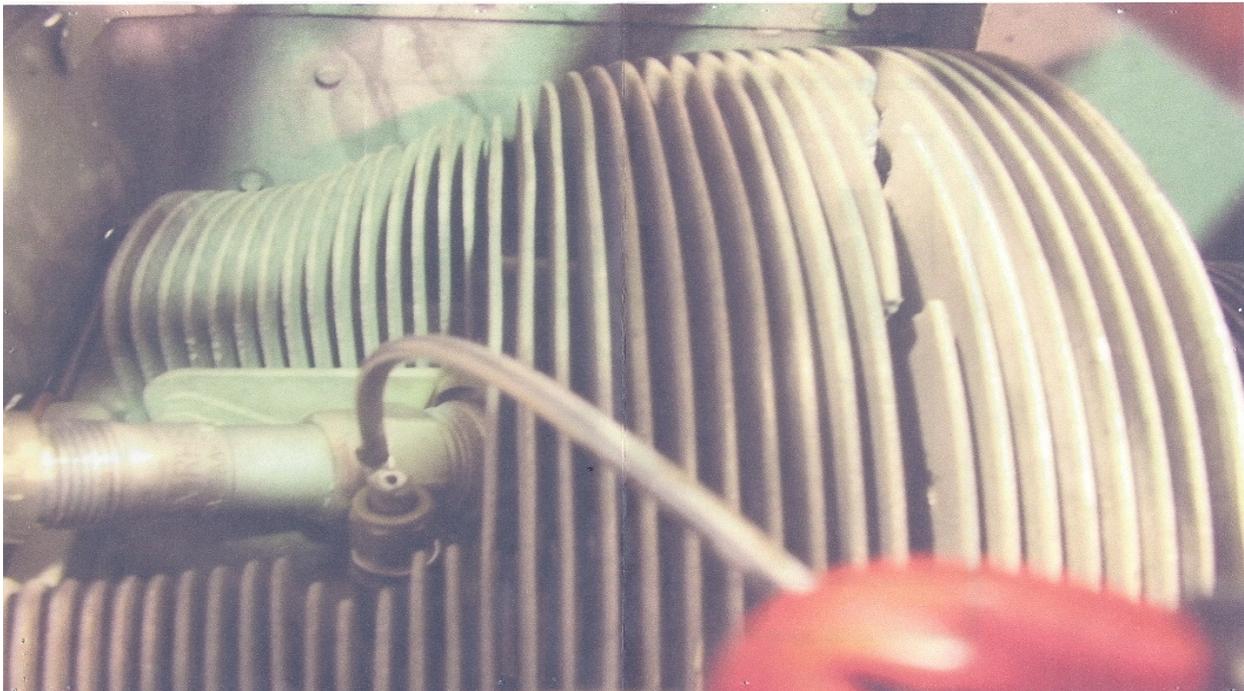
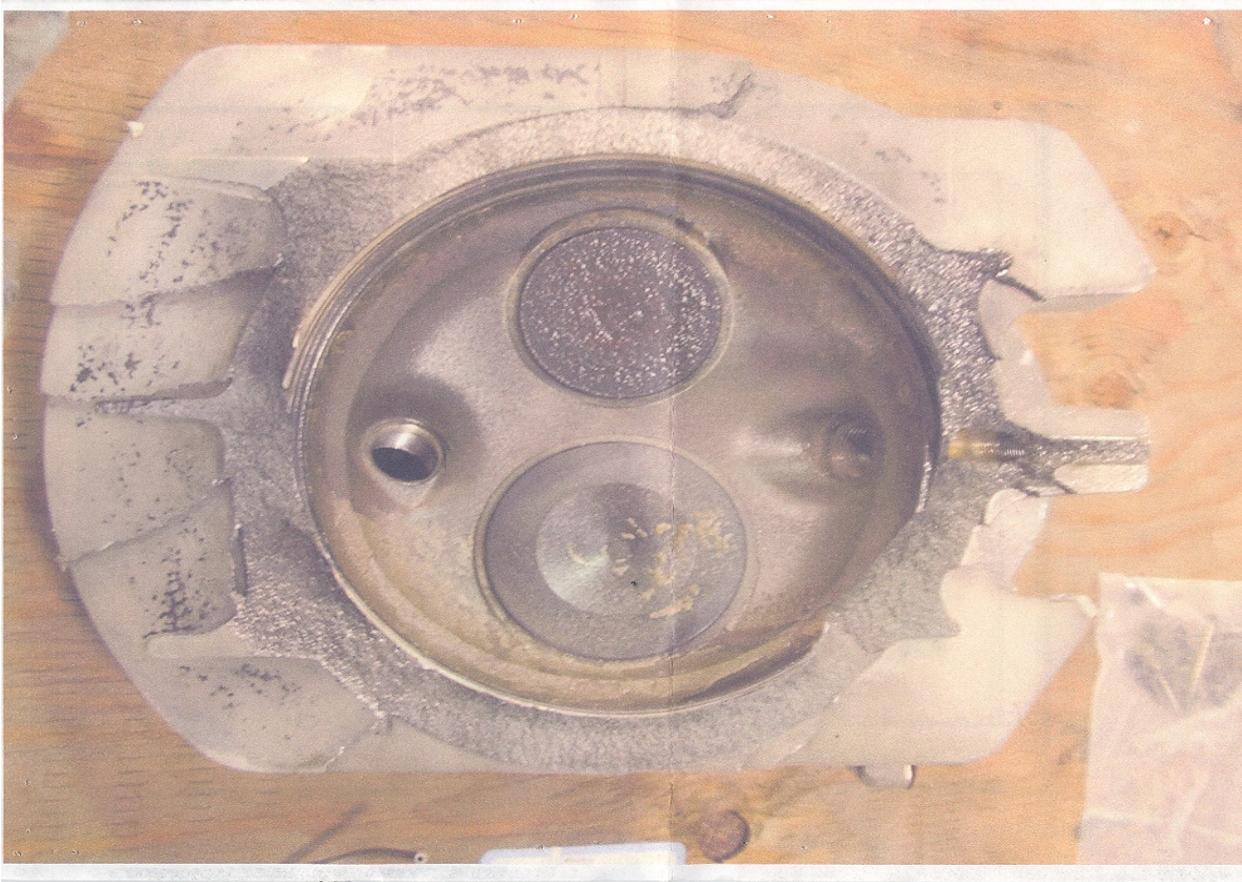
“Both cylinders (P/N SA52000-A20P) failed at take-off power settings within two hours of each other,” states this mechanic. “Failure consisted of complete separation of the head from the barrel, causing *(additional)* damage to the baffling and exhaust collector. *(It also)* severed the fuel injector line.”
