U.S. Department
of Transportation
**Federal Aviation
Administration**

ADVISORY CIRCULAR

43-16A

AVIATION MAINTENANCE ALERTS

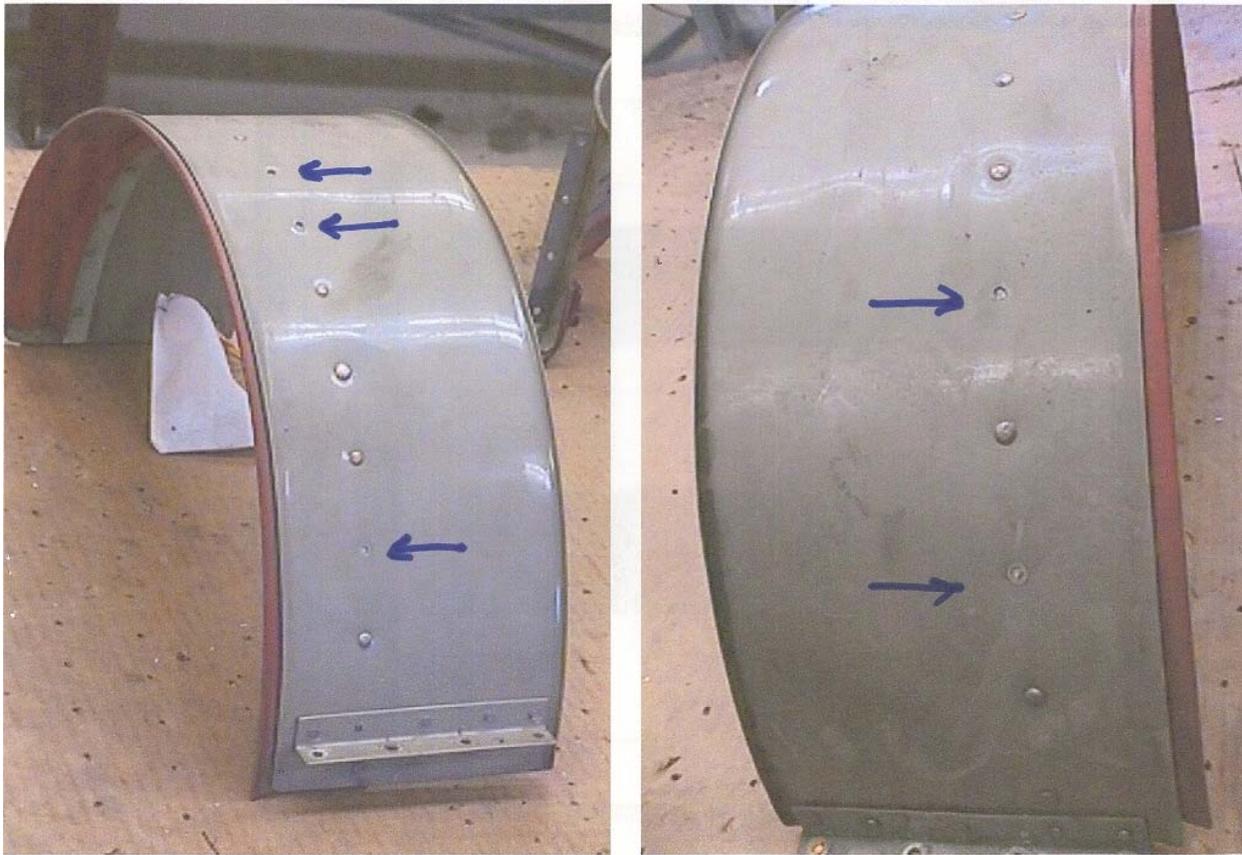
P/N 2658047-1 Top Side

About this Cessna Caravan a mechanic writes, "While removing the engine for a scheduled overhaul we noticed five rivets sheared off the top half of the induction air plenum band assembly (P/N 2658047-1). A sheared rivet head can easily fit through the engine inlet screen and could be ingested by the engine, causing great damage or total engine failure. We hope this information makes owners of Caravans aware of this problem before it happens to them." *(Top plenum assembly part number: 2658047-1; bottom 2658047-2.)*

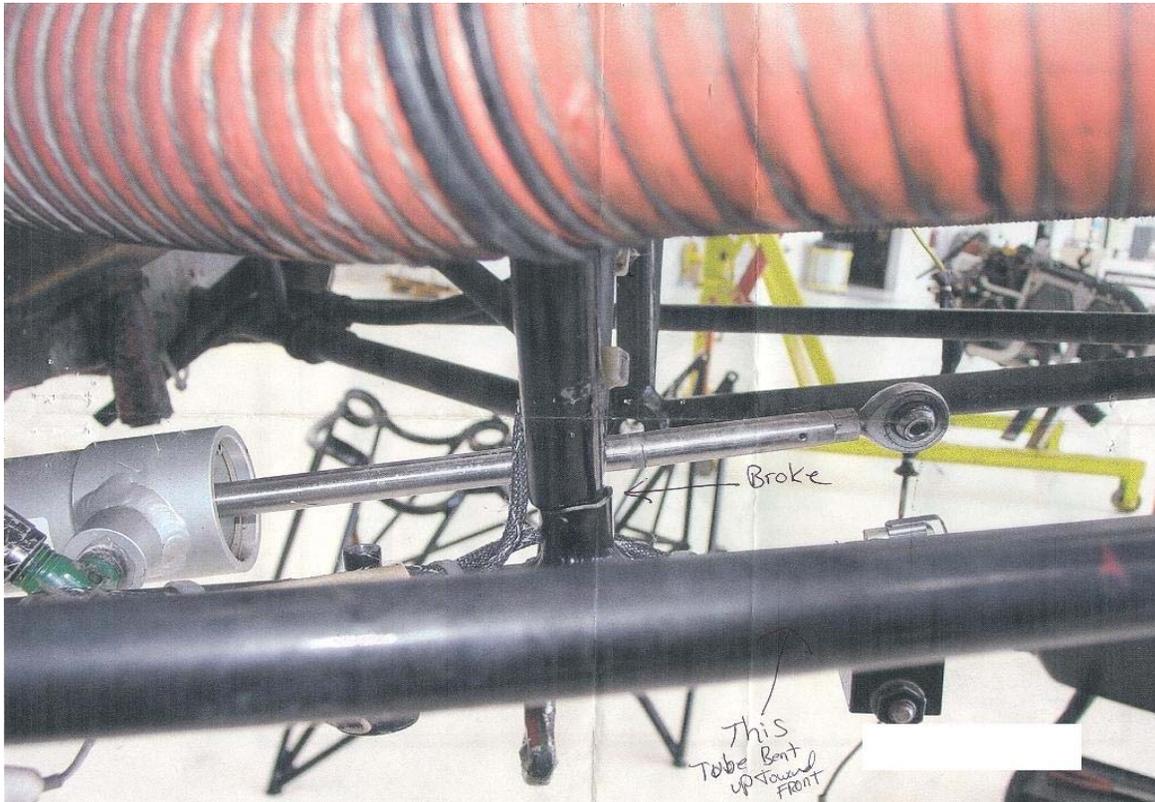
A repair station technician writes, “During a routine scheduled maintenance inspection the engine mount was (*found*) cracked just above the weld on the R/H side of the mount, just above the aft drag link mount point. Upon further inspection the lower horizontal tube most outboard was also (*found*) bent (*in the area*) toward the front part of the mount by the landing gear attach point. No hard landings had been reported.”

(*The engine mount part number listed is 67119-57. Eight additional entries can be found in the FAA Service Difficulty Reporting System data base.*)

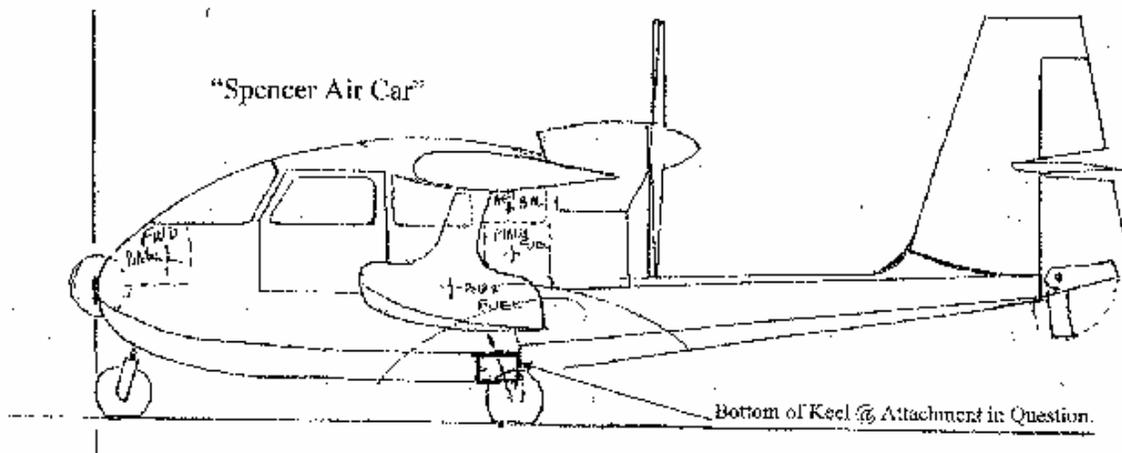
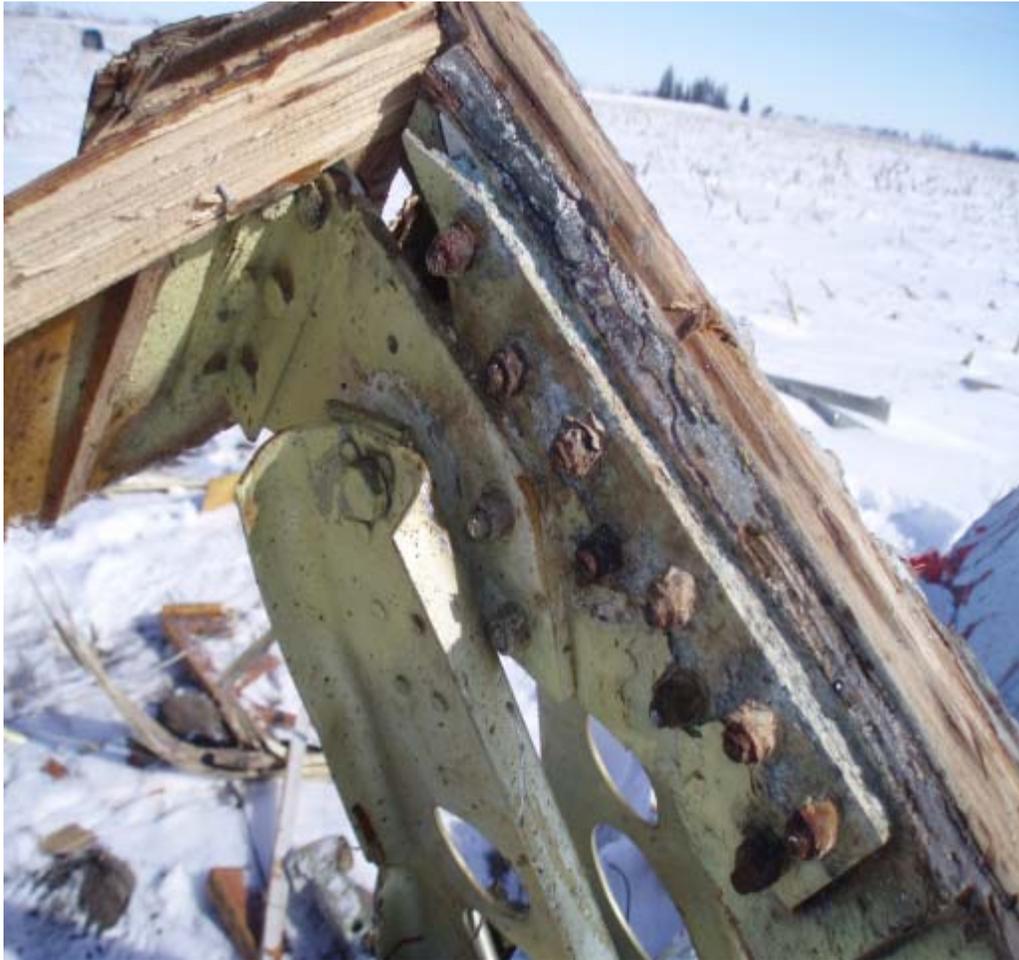
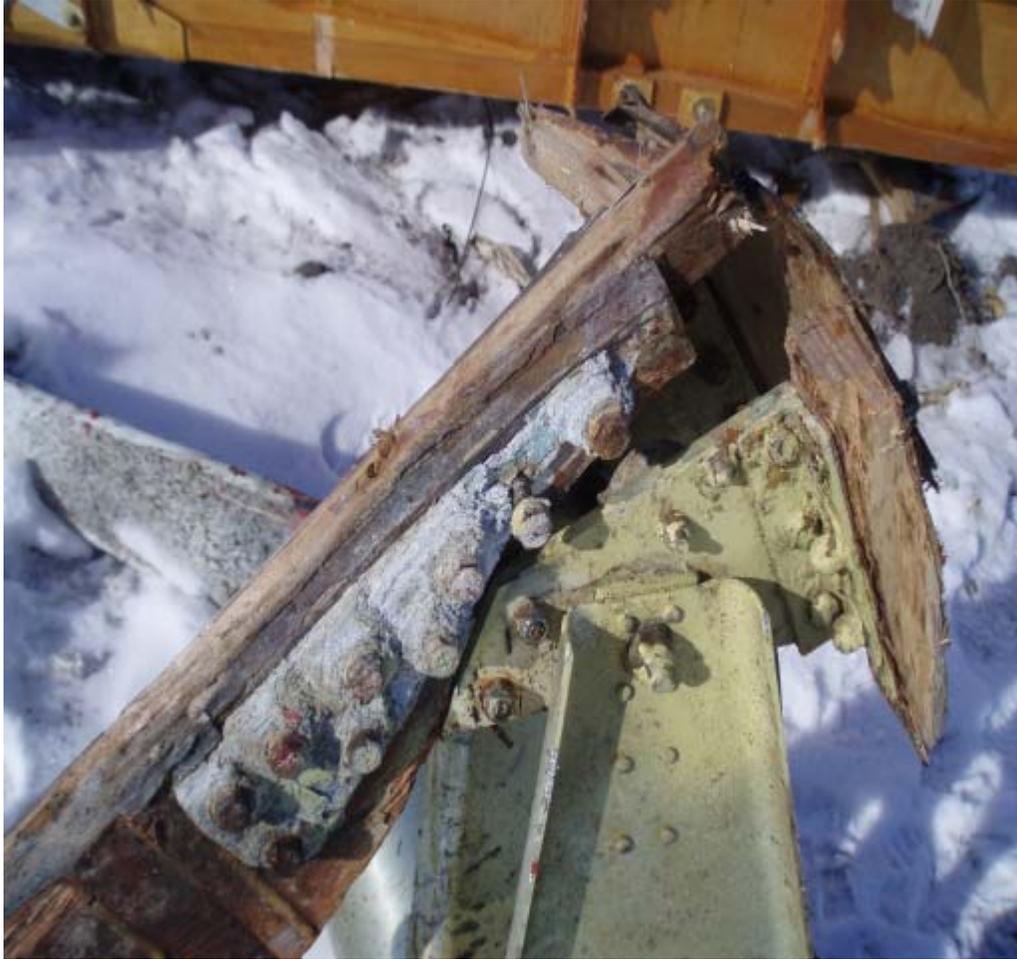
“During an accident investigation of a Spencer S12D, the airframe rear keel support was found to have excessive corrosion and the wooden structure attached to the keel was dry rotted. Although the corrosion is evident, we believe it was not a cause of the accident. This aircraft—built in 1975—was operated in a salt water environment. It had (*recently*) received a condition inspection, (*...however, we observed*) ...there was no access (*provision*) for inspecting the keel support located aft of the passenger compartment. It is recommended an access panel be made to inspect the keel assembly, and for it to be inspected at least (*during*) every condition inspection.”

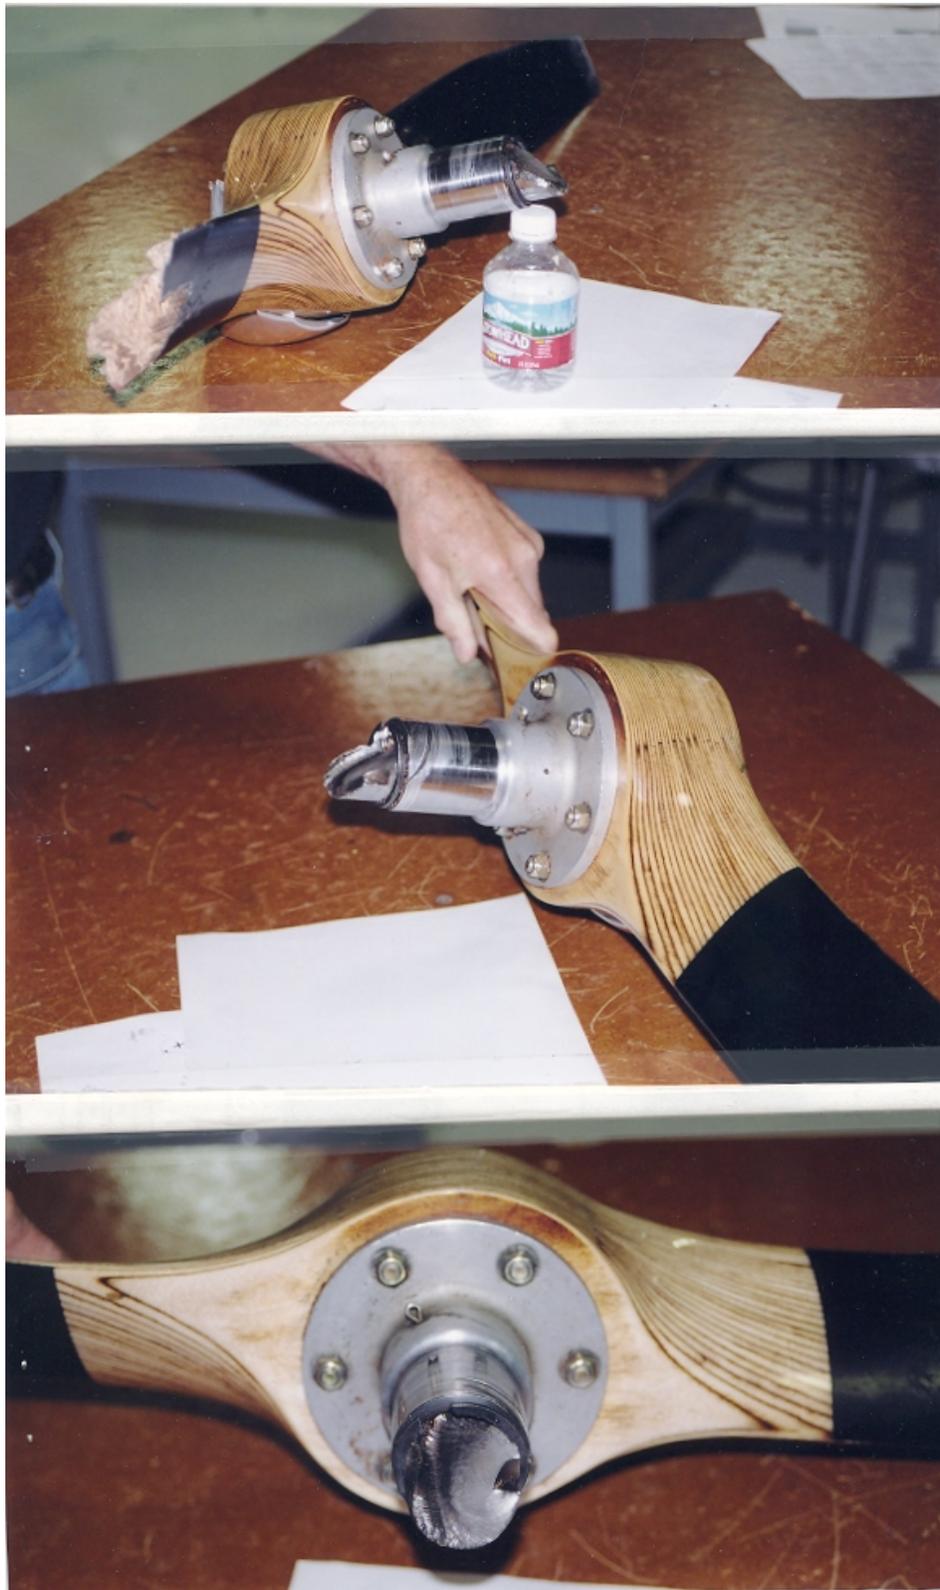
This engine is attached to an experimental airplane known as a Cygnet SF2A. Its owner, a resident of Arizona writes in attached information, “...I departed Ryan Field on runway 24 left. At about 2 miles N.W. and 3700 feet altitude the aircraft nose jolted and the windscreen began oiling up. I executed a 180 degree turn, contacted the tower, and notified them of a problem. A safe landing was effected on runway 15. Upon exiting the airplane I noted the prop and flange were missing....”

Additional information with this report continues: “The engine speed was approximately 3100 RPM...with an airspeed of 104 MPH. Failure (*of the “Scat” brand crank*) occurred about 10 inches behind the propeller and aft of the front bearing (*three inches into the engine case*). The crankshaft failed diagonally with an approximate 45 degree break. The propeller and crankshaft stub departed cleanly with no resulting damage to the airframe.”
