ADVISORY CIRCULAR

43-16A

AVIATION MAINTENANCE ALERTS

**ALERT
NUMBER
357**

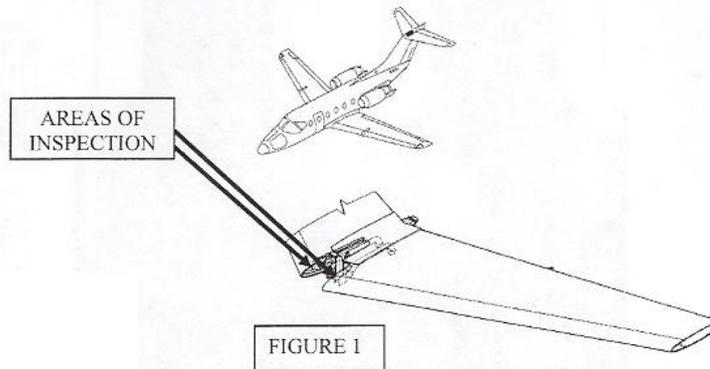
RAC has recently received reports of cracks in the ribs underneath the horizontal stabilizer roller brackets as well as in the adjacent underlying structure. Although Chapter 5 of the MU-300 and 400/400A Maintenance Manuals requires an inspection of roller bracket assemblies and the vertical stabilizer guide rail, **no requirement to inspect the structure behind the roller bracket currently exists.** RAC therefore recommends expanding the scope of the published rail/bracket inspections to include the ribs and structure mentioned above. Utilization of a borescope will be necessary to perform a thorough inspection behind the ribs. Figure 1 illustrates the area of the inspection.

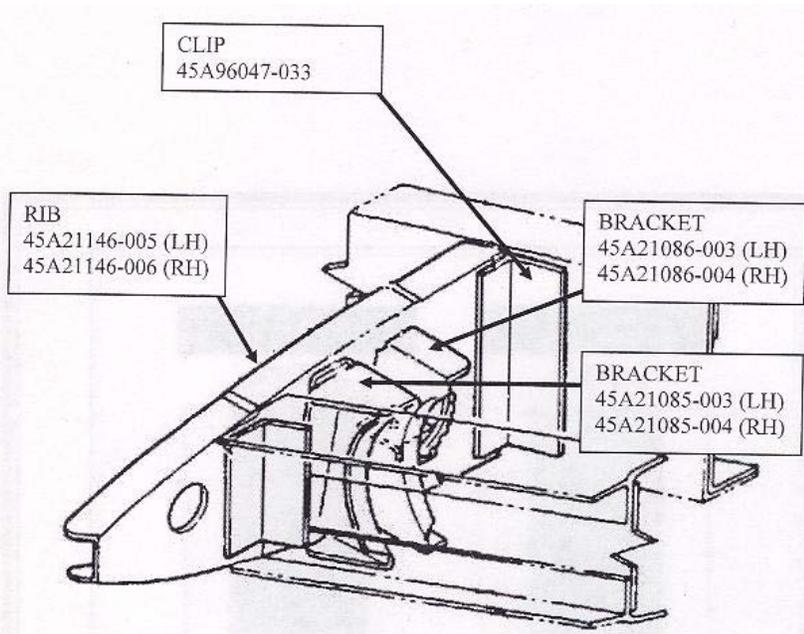
FIGURE 2

If the expanded inspection reveals a crack in a rib or associated part, that item may be replaced individually or as part of an assembly. The part numbers for the rib assemblies are detailed in the chart below. These rib assemblies include the brackets and ribs shown in figure 2.

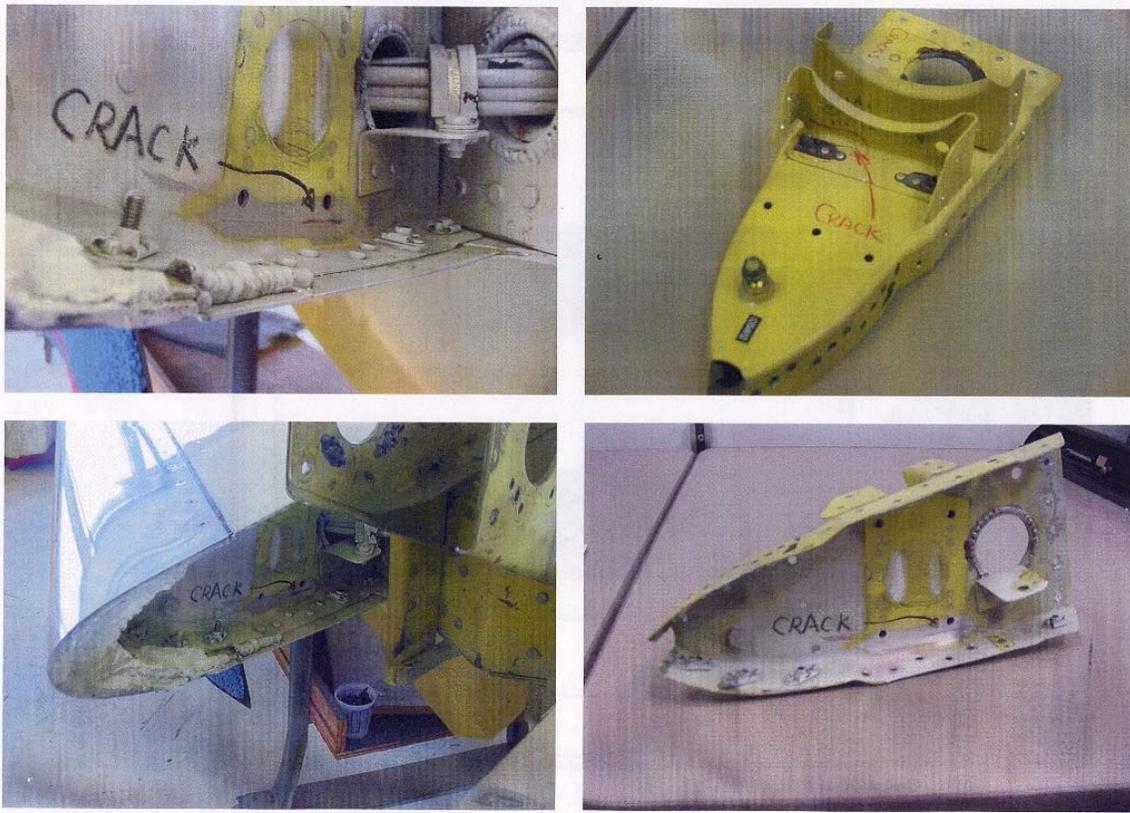
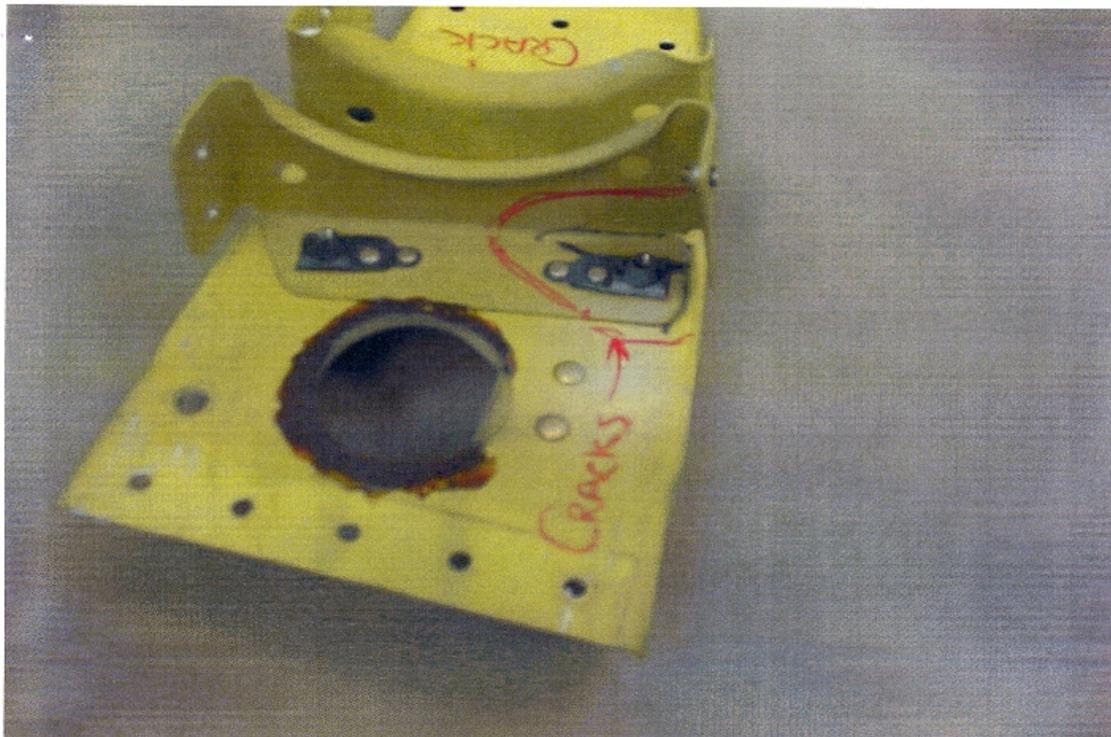
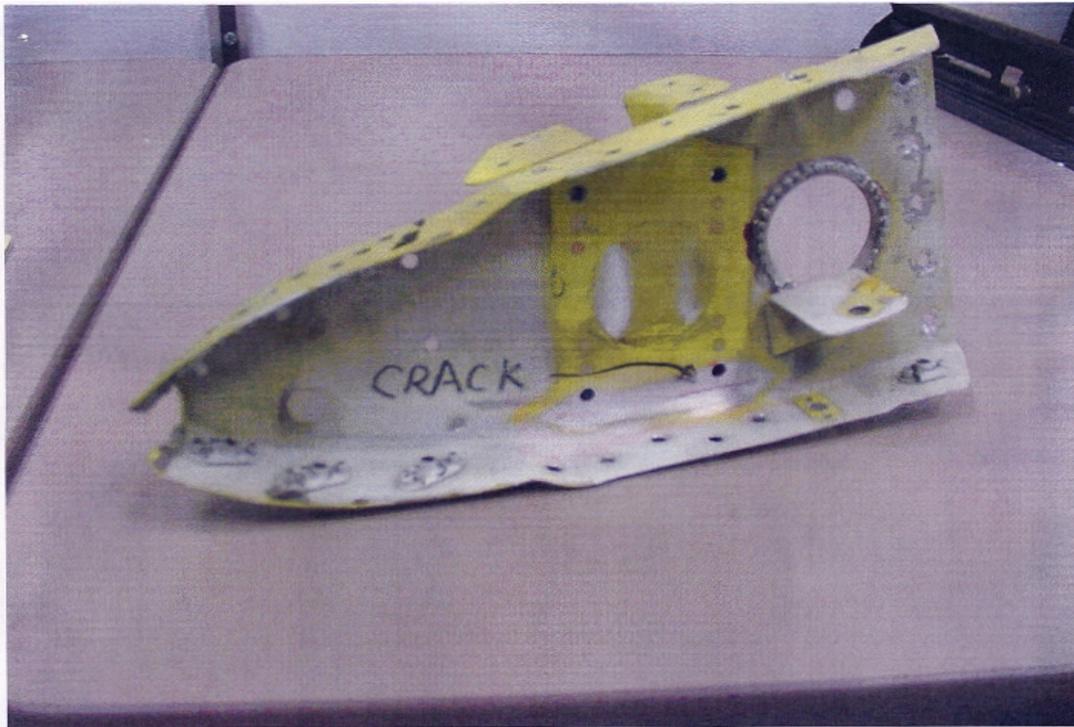
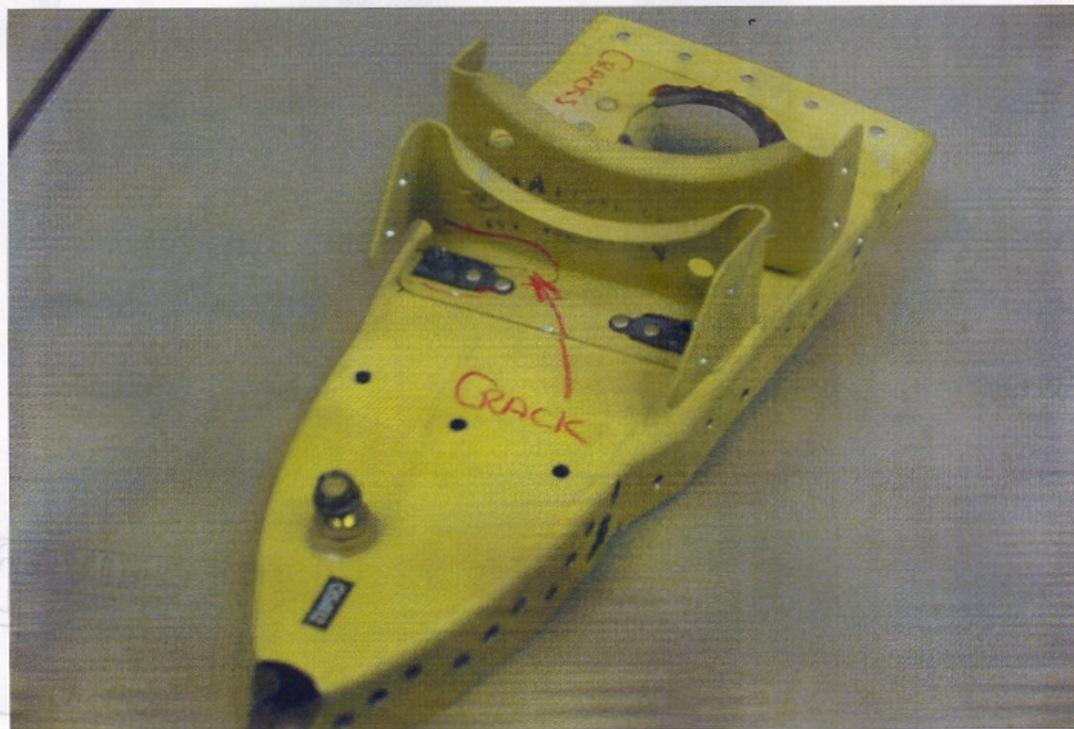
Beechjet: 400A; Cracked Horizontal Stabilizer Ribs; ATA 5511

A submitter from a repair station writes, “The horizontal stabilizer leading edge inboard ribs are cracked at the roller bracket attachment points. *(I have included applicable pages of the...)* Raytheon Safety Communiqué and photographs *(of our aircraft’s cracked parts.)* Safety Communiqué number 70 is the only published criteria concerning this problem.”

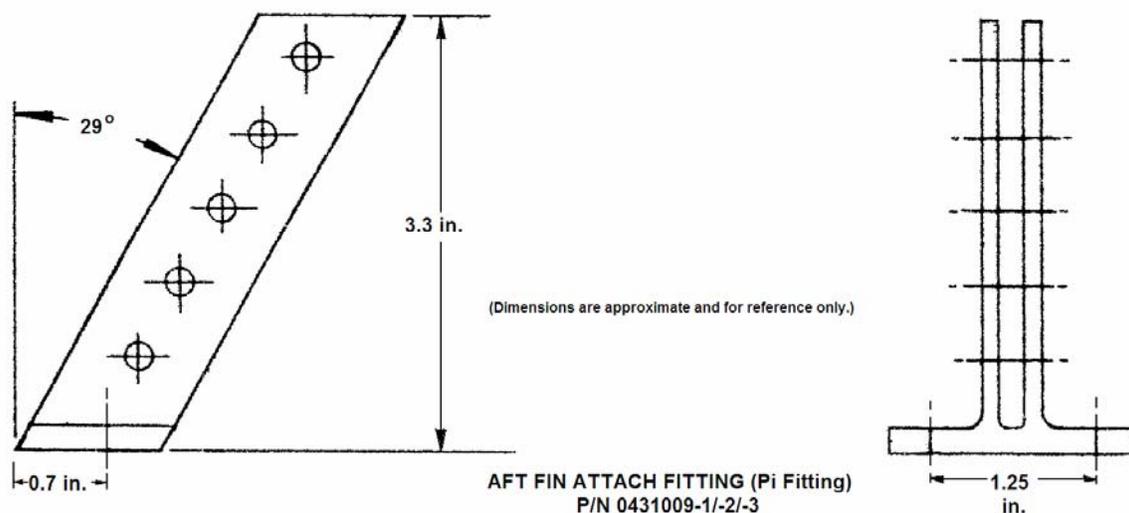
Cessna: 150/152; Cracked Aft Fin Attach Fittings; ATA 5530

“The FAA has received reports of cracks on the two vertical tail attach fittings on Cessna 150/152 airplanes. The aft fin attach fitting is part number (p/n) 0431009. There are three dash numbers: -1, -2, and -3. Most of the 41 reports found in the FAA Service Difficulty Report (SDR) database have been the -3 part. The SDR’s are for cracked, broken or corroded attach fittings. A statistical analysis of the SDR data indicates that the problem was getting worse from 1976 through 1991. Since 1992, these analyses indicate improvement, with SDR’s reported less frequently, due to the awareness of maintenance technicians to this problem. However, the FAA wants to keep the technicians, owners and operators aware of this problem because of the way these airplanes are used. That is, the Cessna 150/152 airplanes are used for training, aerobatics and spins. These uses put additional air loads on the vertical tail surface. So, a failure of this attach fitting could be catastrophic. Past failures have occurred in the transition from the vertical straps to the lower plate portion of the fitting. Cracks tend to form in the outboard portion of the fitting, with the outboard strap failing before the inboard strap.”

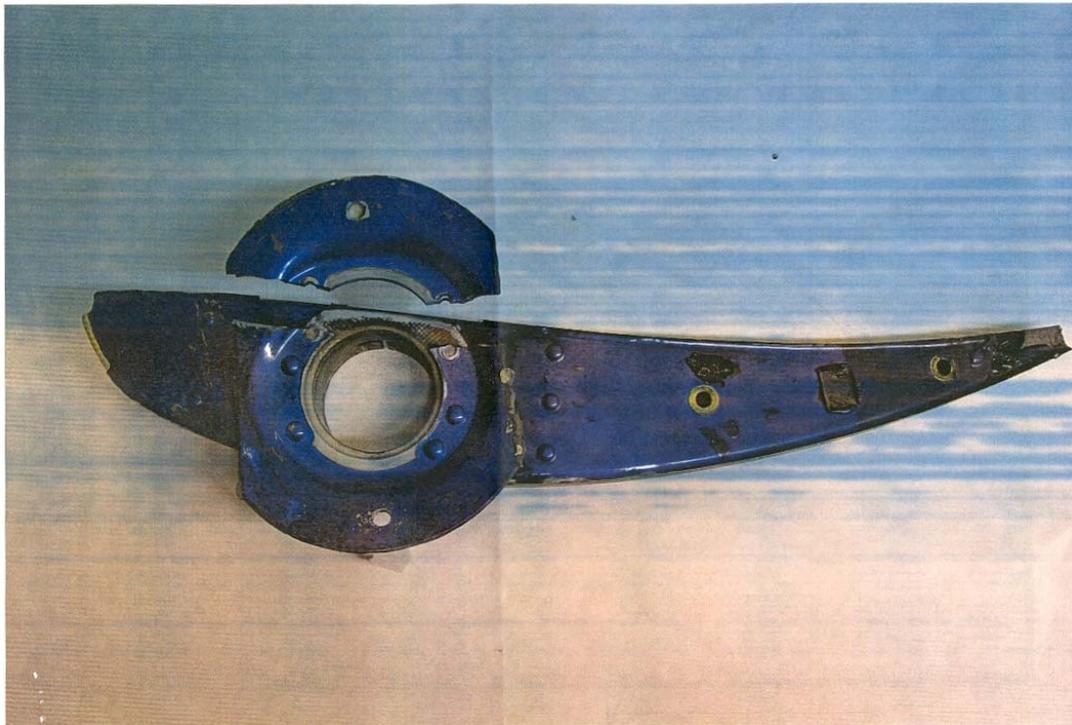
Bell: 206B; Cracked Horizontal Stabilizer Rib; ATA 5511

“During the course of a scheduled inspection,” writes a mechanic, “the R/H horizontal stabilizer was removed to troubleshoot a problem with an auxiliary strobe light that is attached to the stabilizer. During removal, the flange on the inboard rib that attaches the stabilizer to the tail boom was found cracked and separated into two pieces. Due to the location of the crack (*this defect*) was not visible with the stabilizer installed.” (*Rib and fitting assembly P/N 206-020-123-048*)

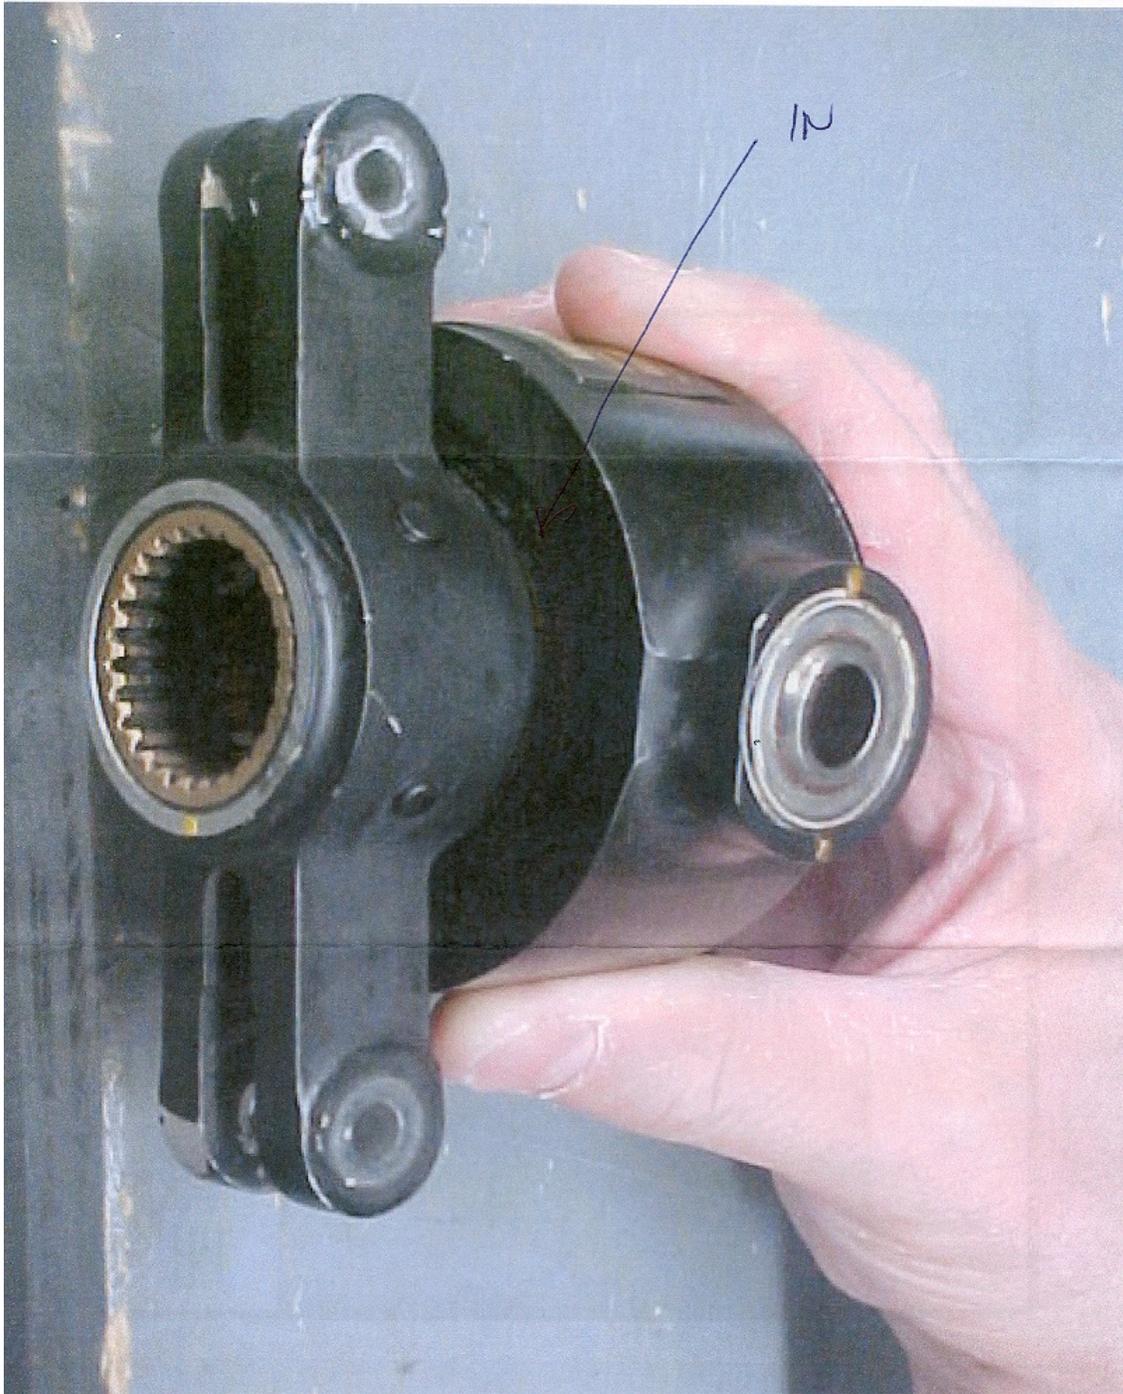
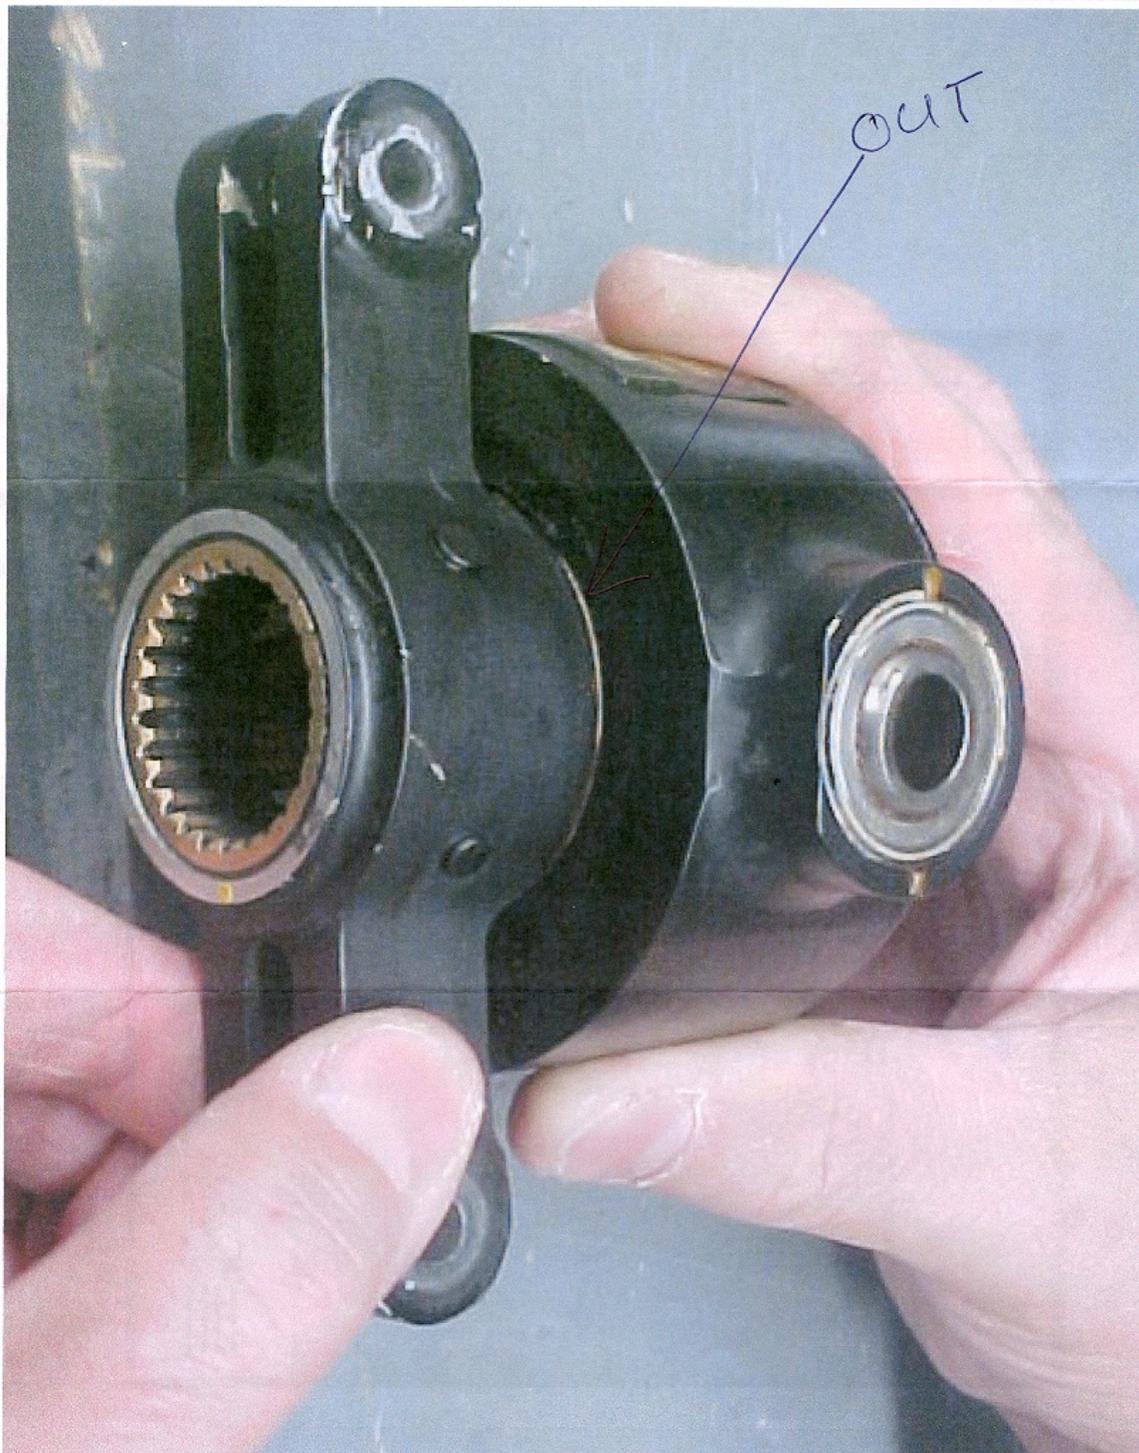
A repair station technician states, “During a 100 hour inspection, ‘play’ was noticed between the rotating and non-rotating swash-plates of the tail rotor pitch control (P/N 369D21800-501). After removal it was noted the bearing was dry and rough—records indicate *(this unit was lubricated)* in December of 2006.

(Wow! Very careful pictures. I almost missed it—even with the big arrows. Thanks—Ed.)

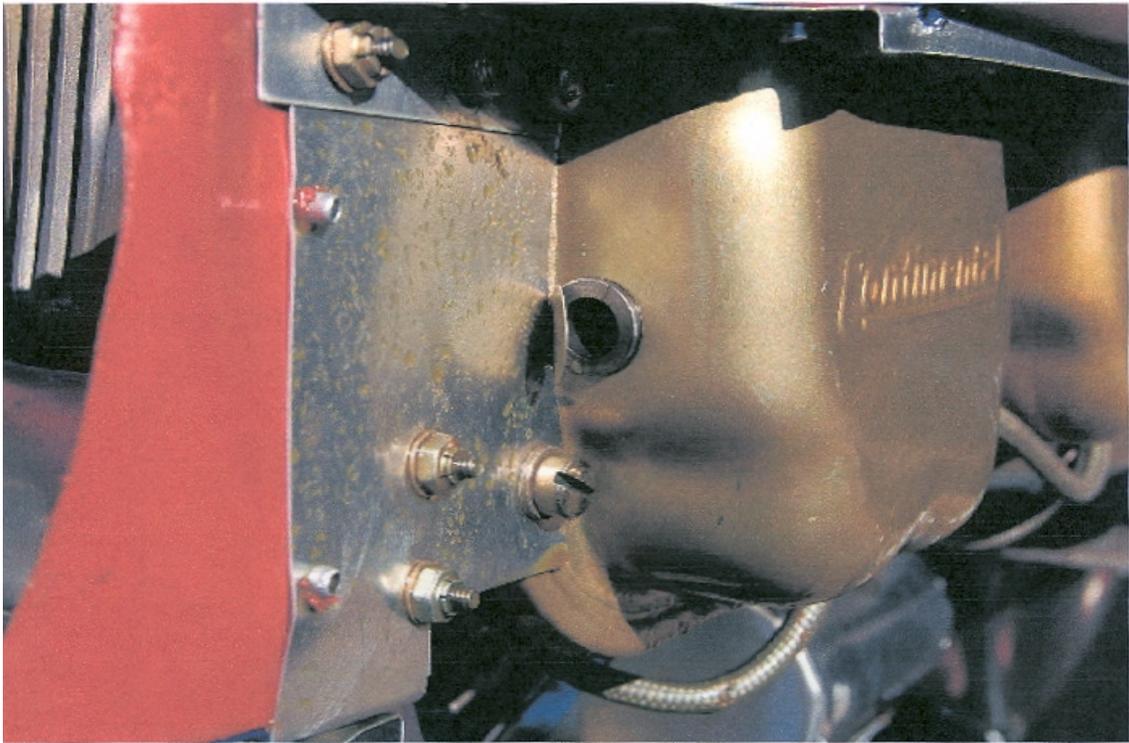
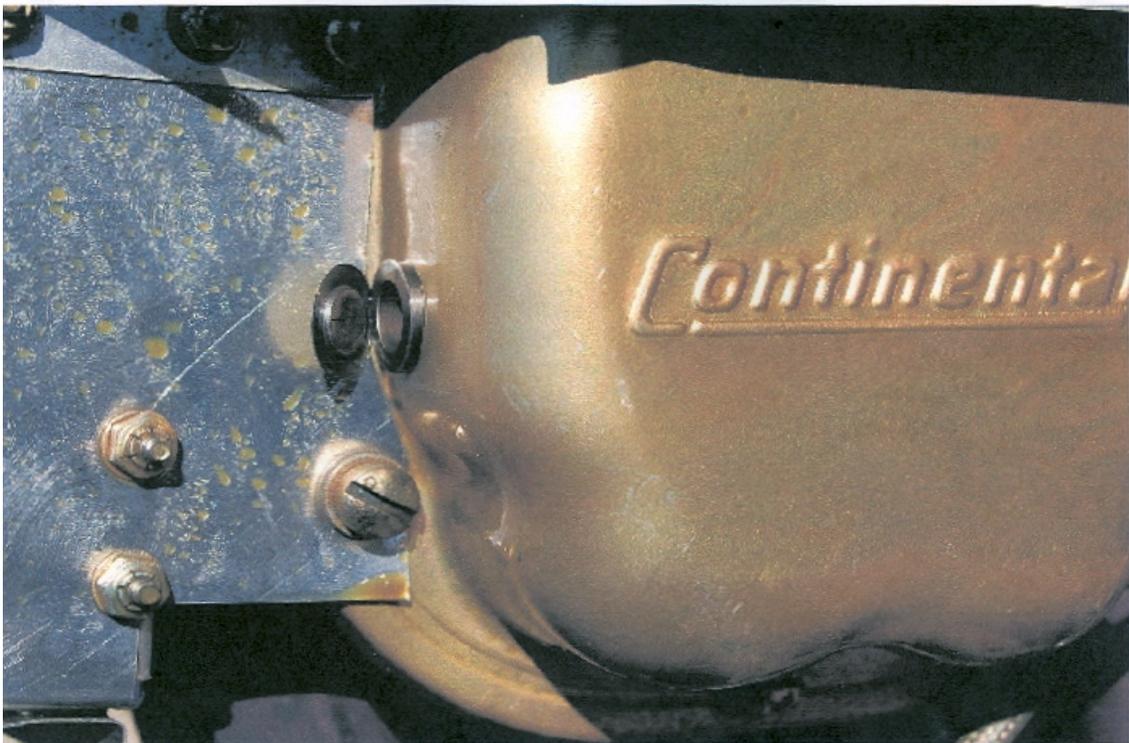
A mechanic/operator of *Smokey Mountain Aviation* writes in this first of two reports, “An owner found oil dripping from the cowl of the aircraft. On inspection (*I found*) the rocker shaft on cylinder number four had cut a hole through the rocker cover. (Note: the new O-200A engines have a ‘flat’ cut into the rocker shaft and a set screw in the center boss to retain the shaft. This shaft is sharp on its ends (unlike the old style) and has a cut mark across the end of the shaft—used in aligning the ‘flat’ for the set screw. This engine was removed and sent to TCM for warranty repair. It was then reinstalled on the aircraft. TCM told the owner they are working on a revised cylinder due to this problem. At some later date TCM will send us four new modified cylinders to install on this engine.

“Problem: the set screw is (P/N) MS51963-64: it uses no ‘Loctite’ or mechanical type lock. (*Additionally,*) the flat in the rocker shaft is not deep enough to provide adequate locking.” (*An attached letter from this submitter provides additional descriptions. He continues here, in part:*) “As you can see in the pictures provided with this report, the rocker shaft on cylinder number four has a hole cut in the rocker cover. TCM told us not to open the covers as they wanted to be able to see exactly the problem (*and its cause*). After working on the (*other aircraft...see next*) there is no doubt the Allen screws backed out, allowing the shaft to float free. The sharp edge of the shaft cut through the cover.”

“Recommendation: The shaft should have the flat cut deeper, and the boss should have a small pilot hole drilled into it to accept a mechanical lock tab with a bolt installed (instead of the set screw). (*Another proposed solution would be...*) to remove the (*new style*) shaft (P/N 654375) and set screw (P/N MS51963-64) and discard (*both*). Install the old style shaft (P/N 21153) that has worked with no problems for sixty years.” (*Part time on this particular engine: 66.2 hours.*)

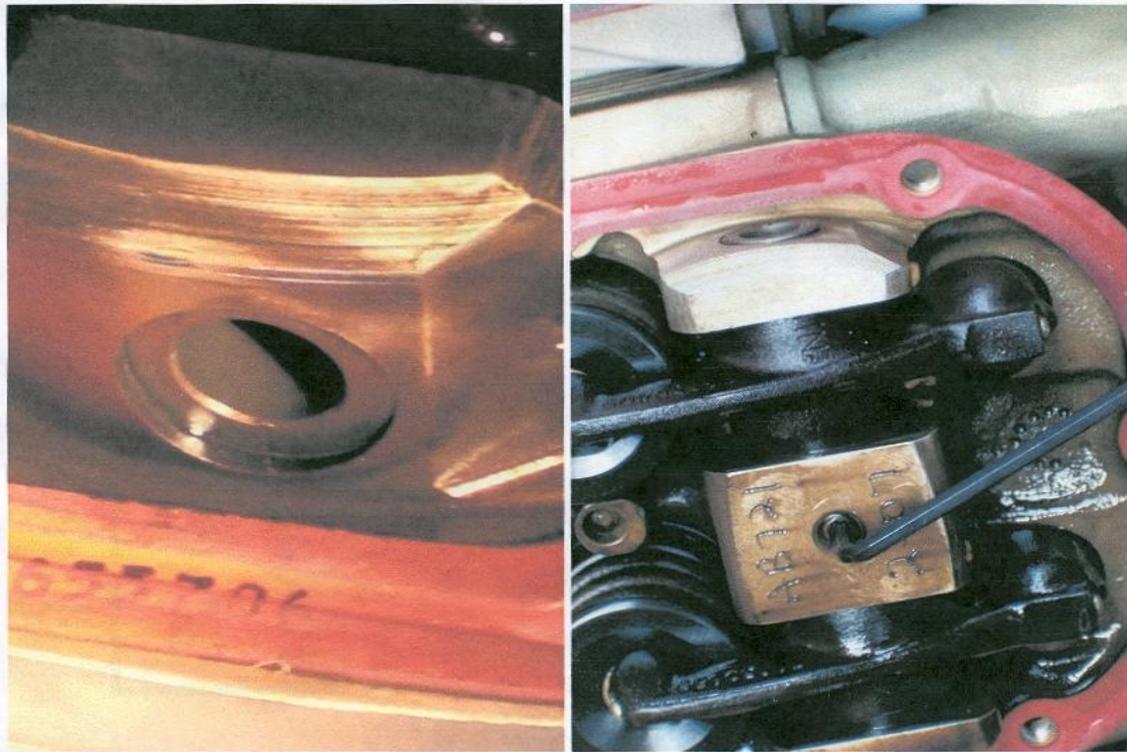
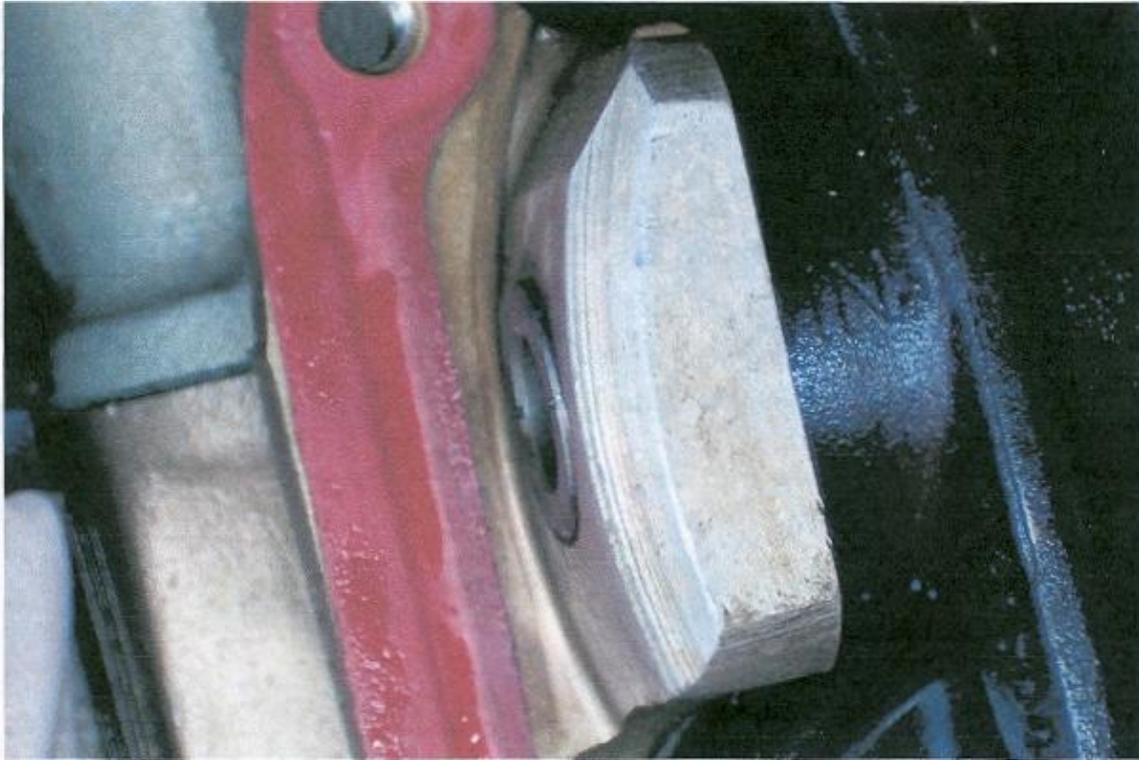
“As per the owner’s request I removed all four rocker covers to inspect the rocker shaft and set screws. I found all four set screws loose, and all four shafts moved towards the intake side of the bosses. None have cut the rocker covers yet *(but I estimate this would have happened with another 20 hours of operation.)*”

“As you can see in the pictures provided with this report, the screw shown with the Allen wrench was found loose. This allowed the shaft to move towards the intake side of the cylinder. You can see clearly...the shaft is not centered in the bosses.” *(Part total time on this second engine: 38.08 hours.)*

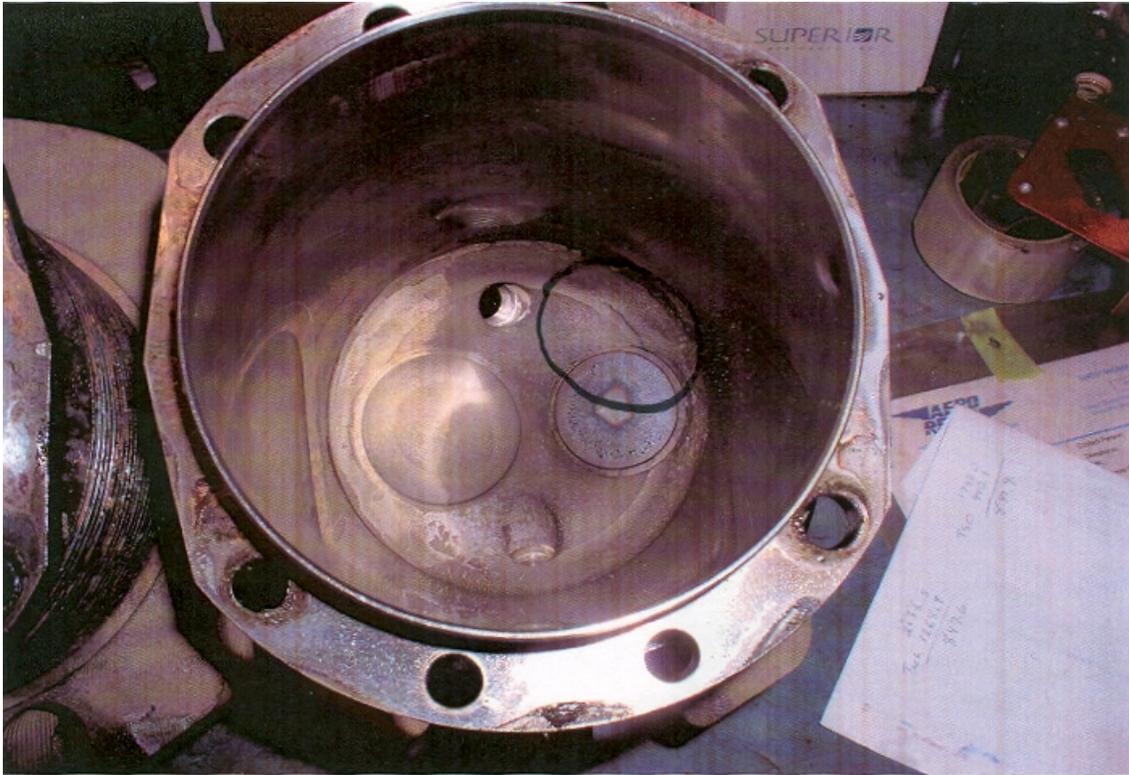
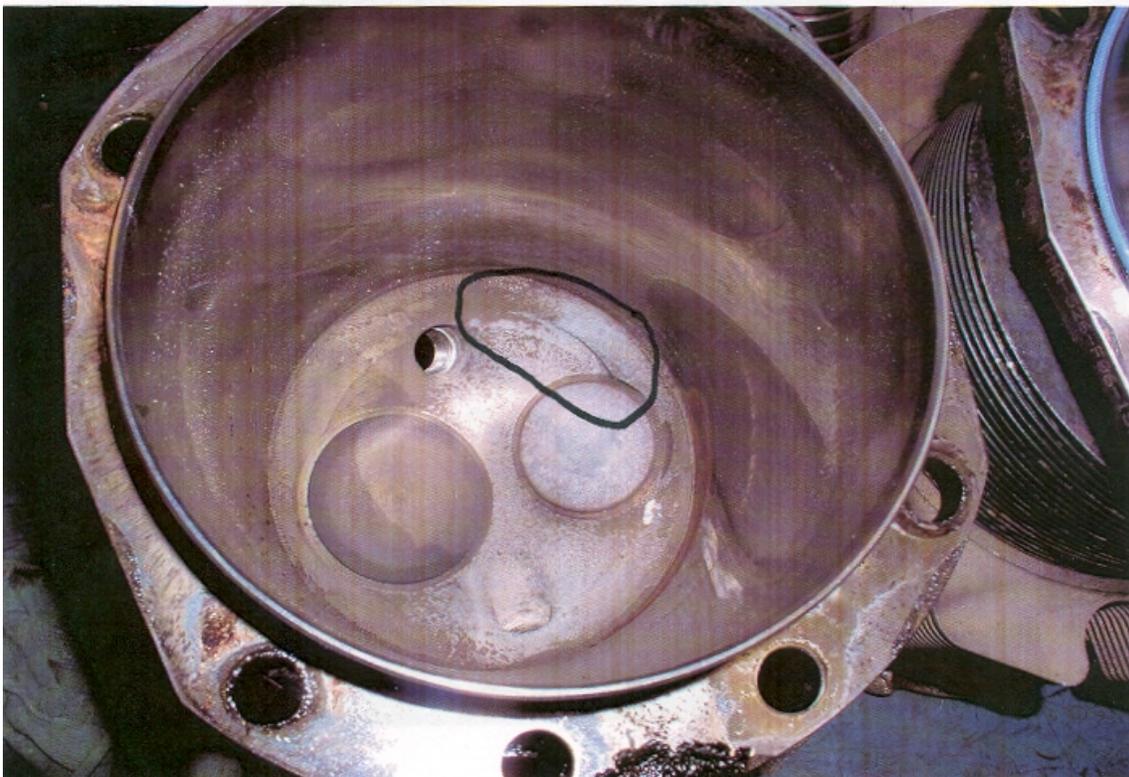
Superior: P/N SA52006-A20P; Cracked Cylinder; ATA 8530

An unidentified submitter writes, "Both cylinders (*numbers 3 and 4*) have visible cracks originating at the exhaust valve seat." (*The engine is listed as a Continental IO-520-F hanging on a Cessna U206F.*)

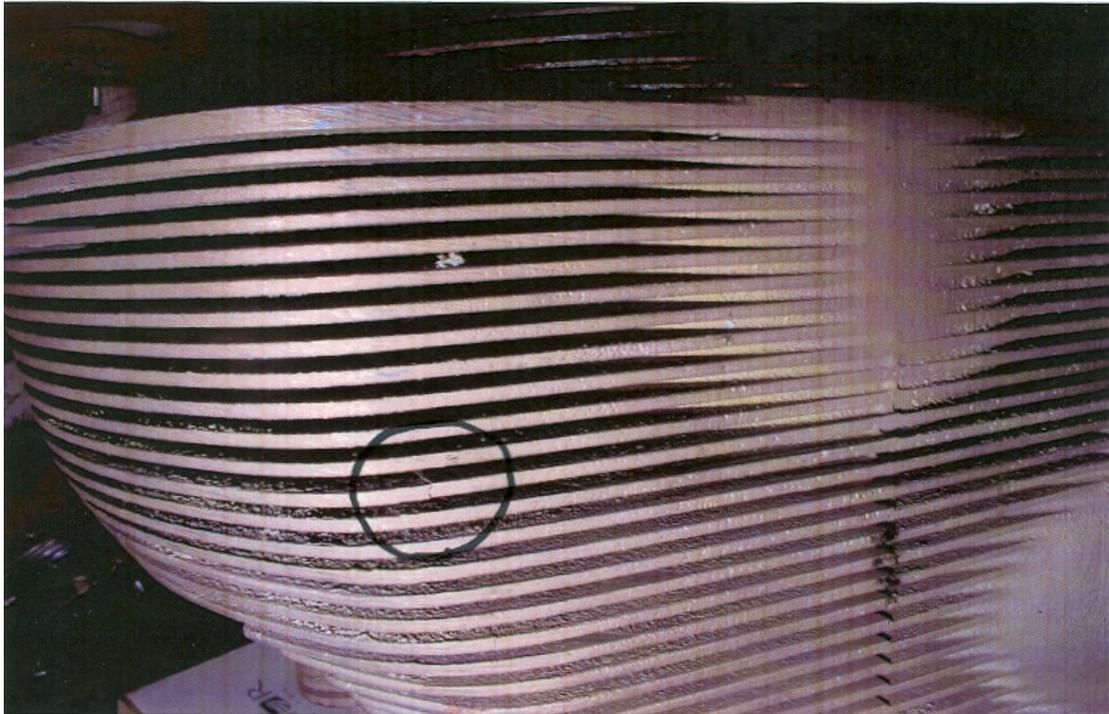
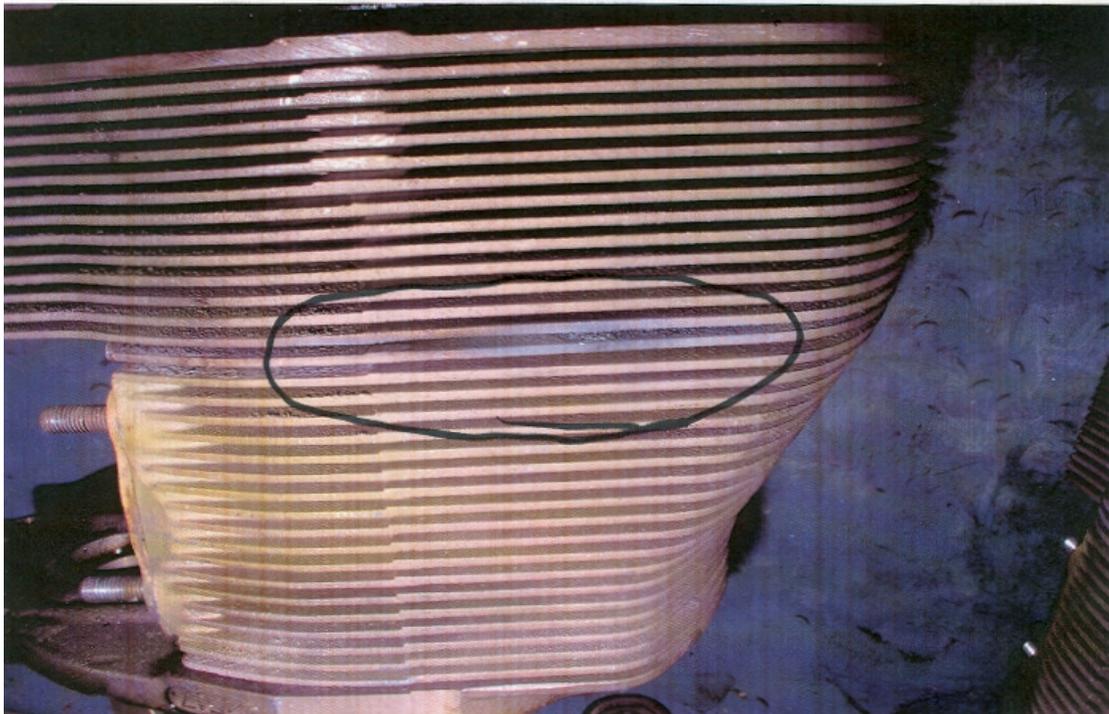
(Note the tell-tales on the outside of the cylinder: next picture.)
