ADVISORY CIRCULAR

43-16A

AVIATION MAINTENANCE ALERTS

**ALERT
NUMBER
360**

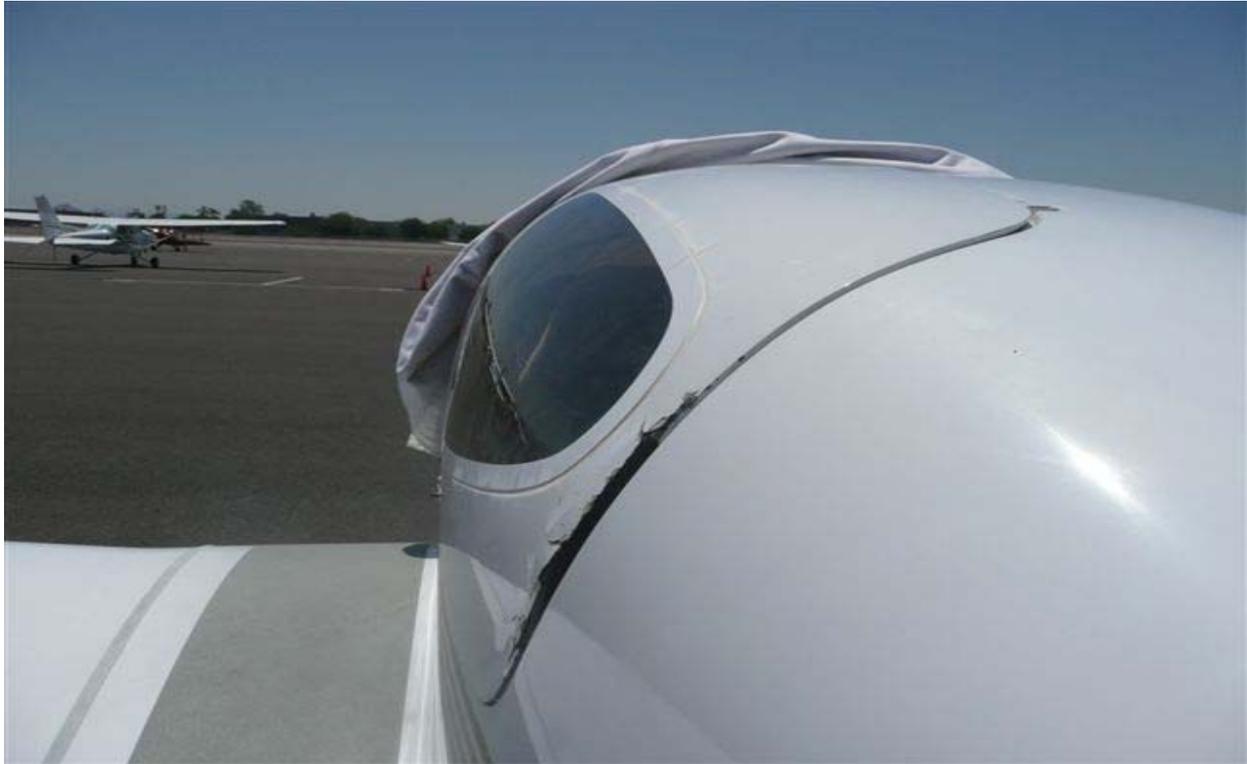
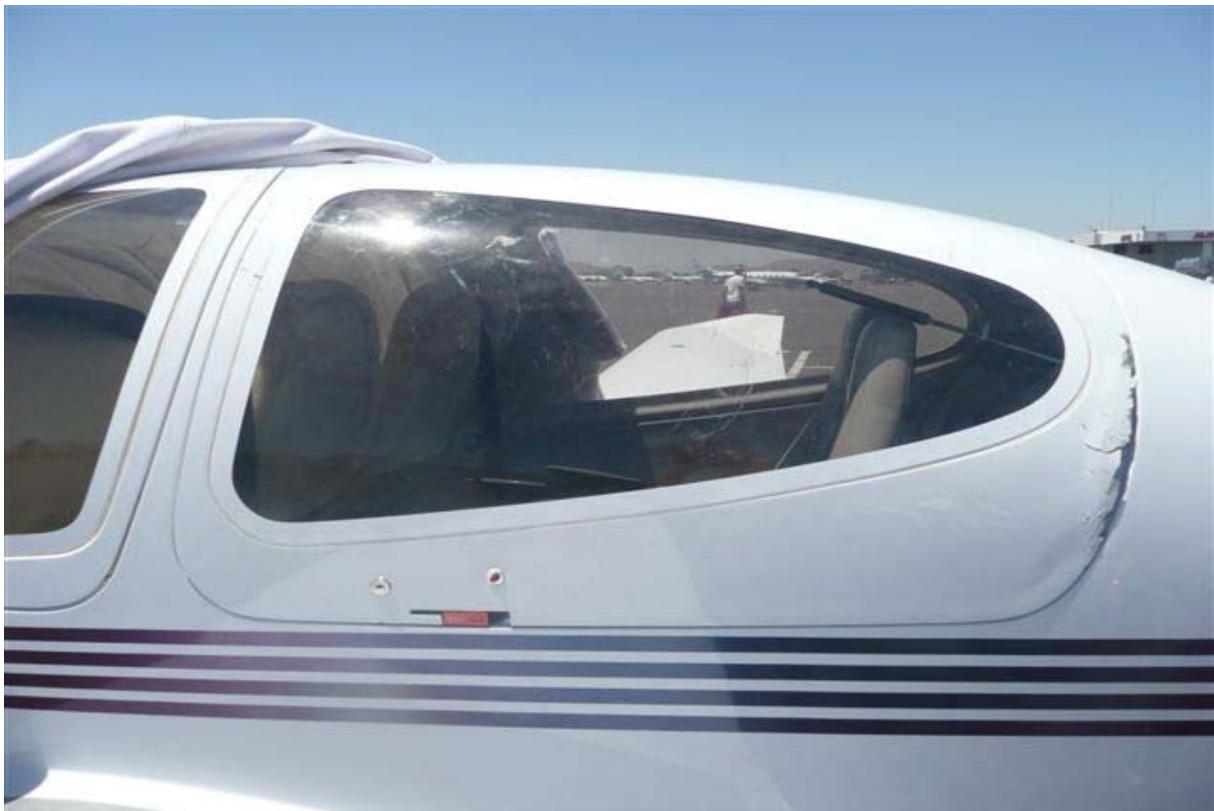
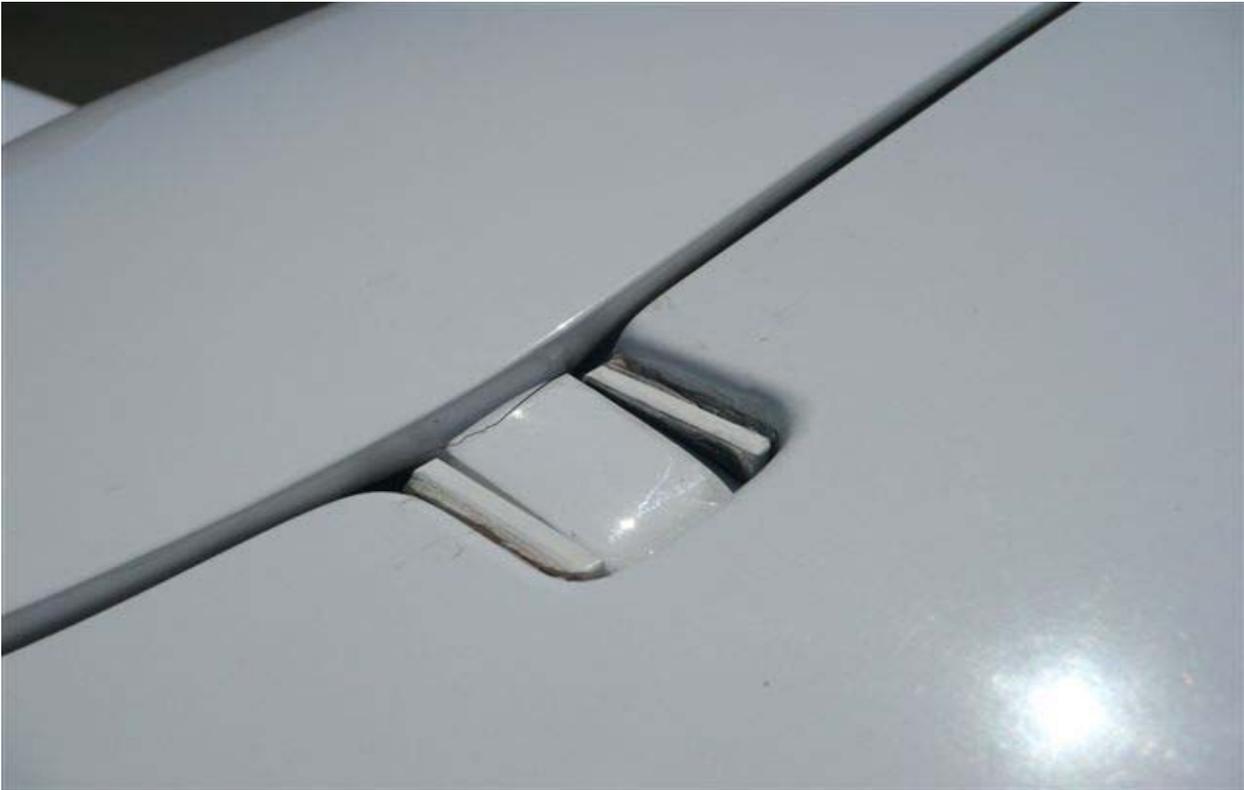
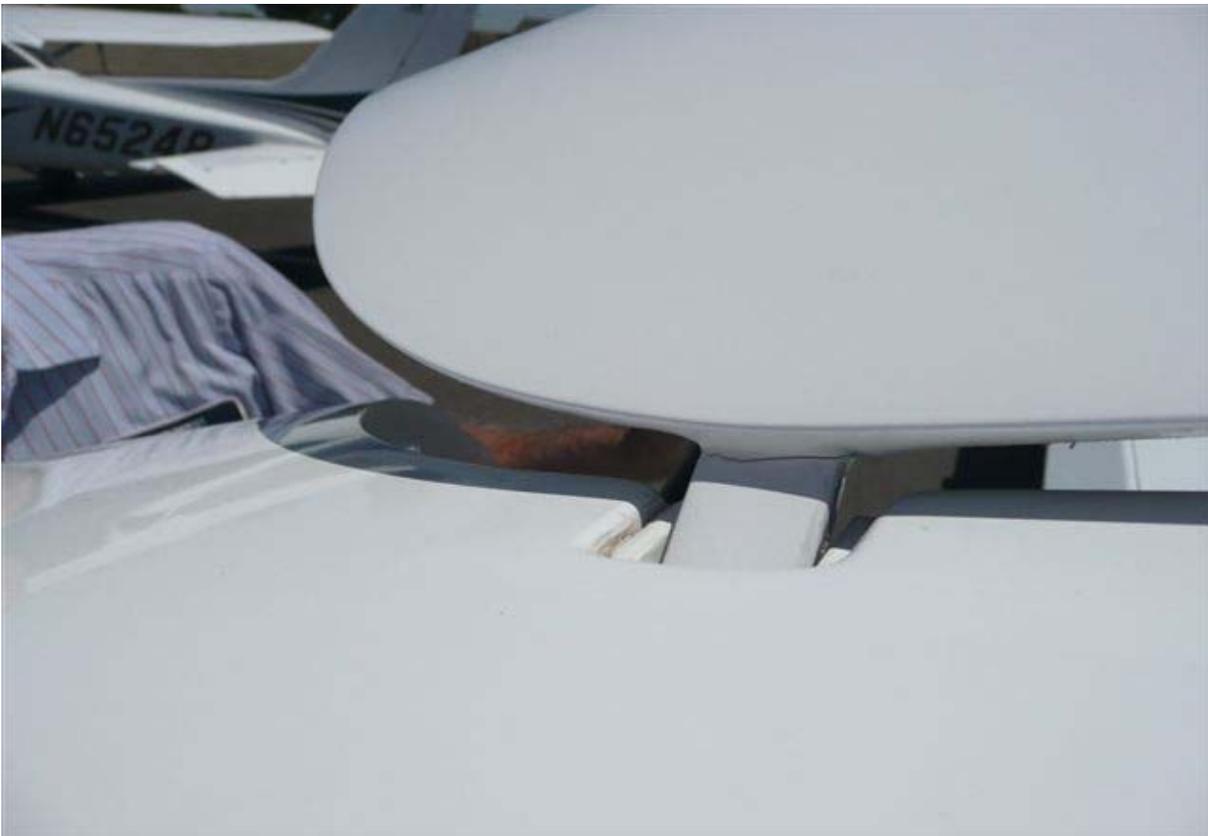
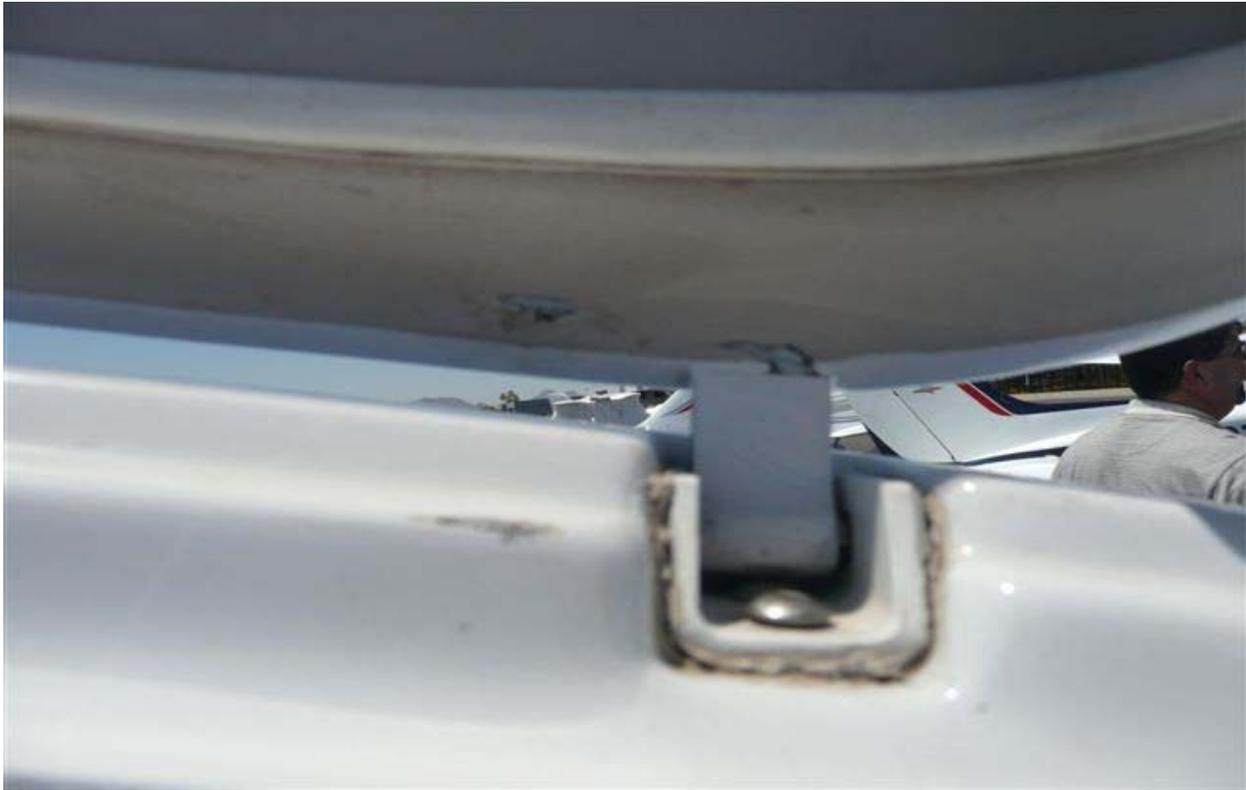
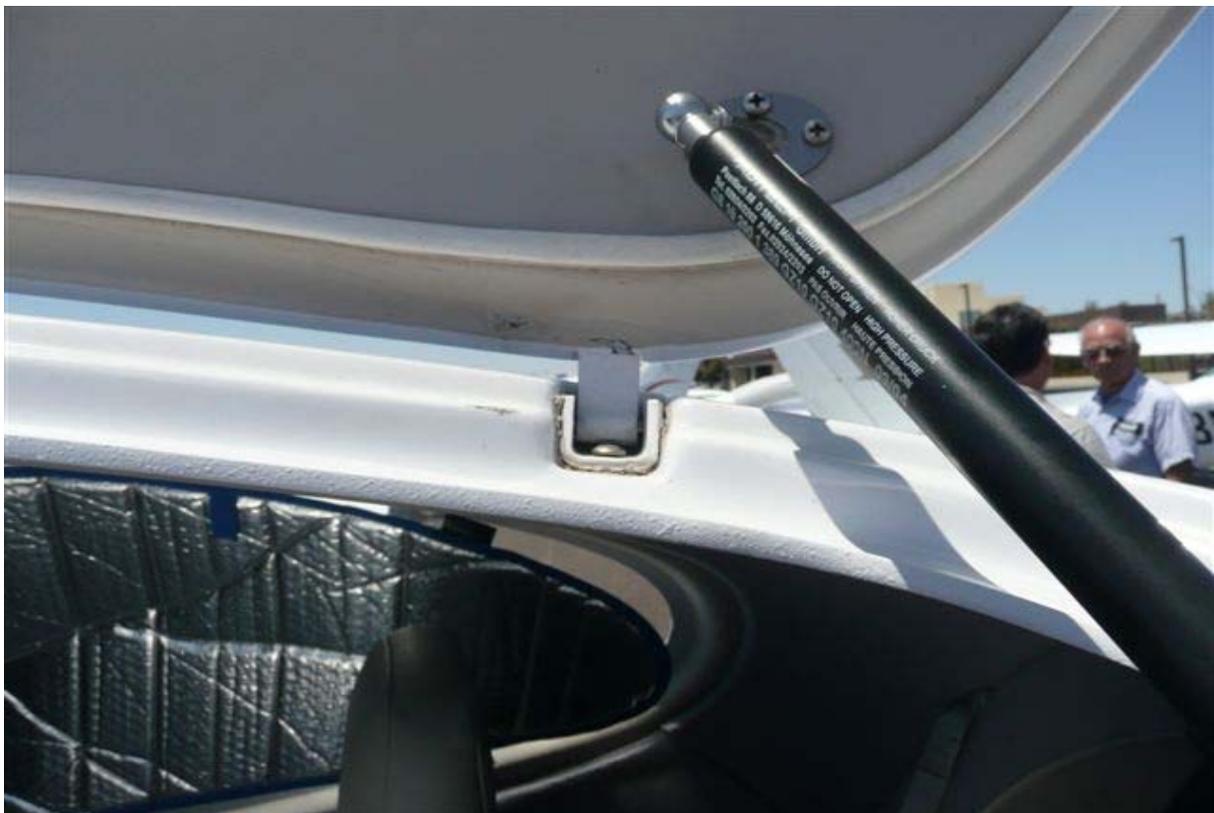
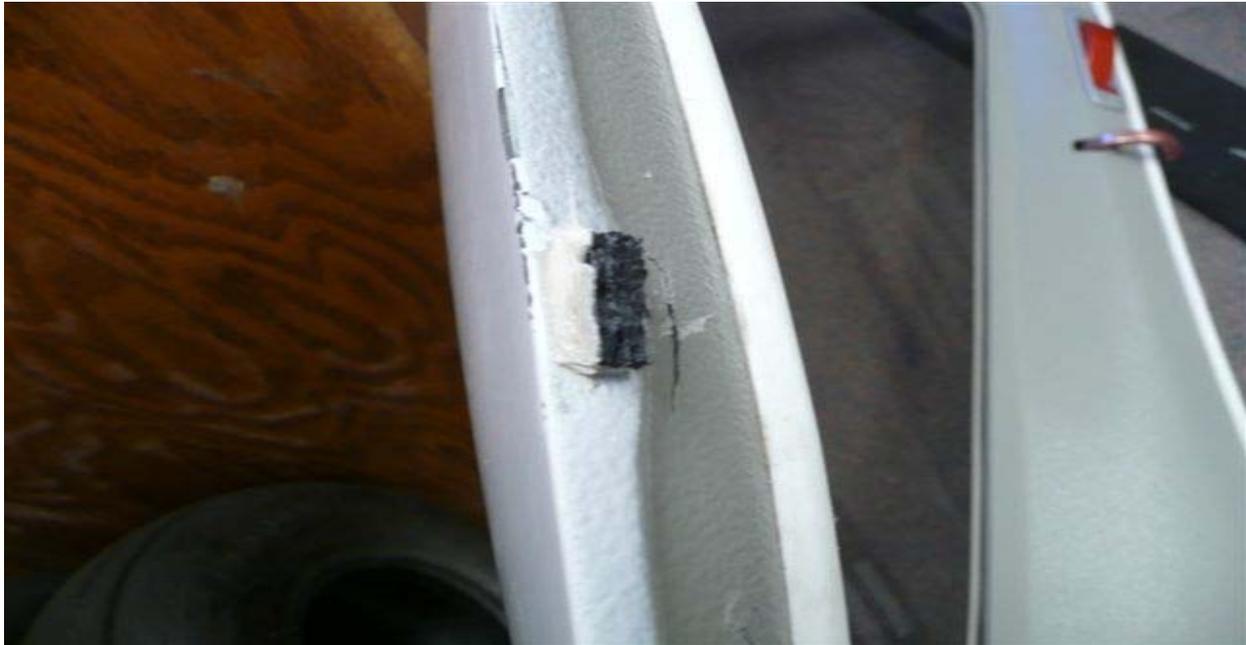
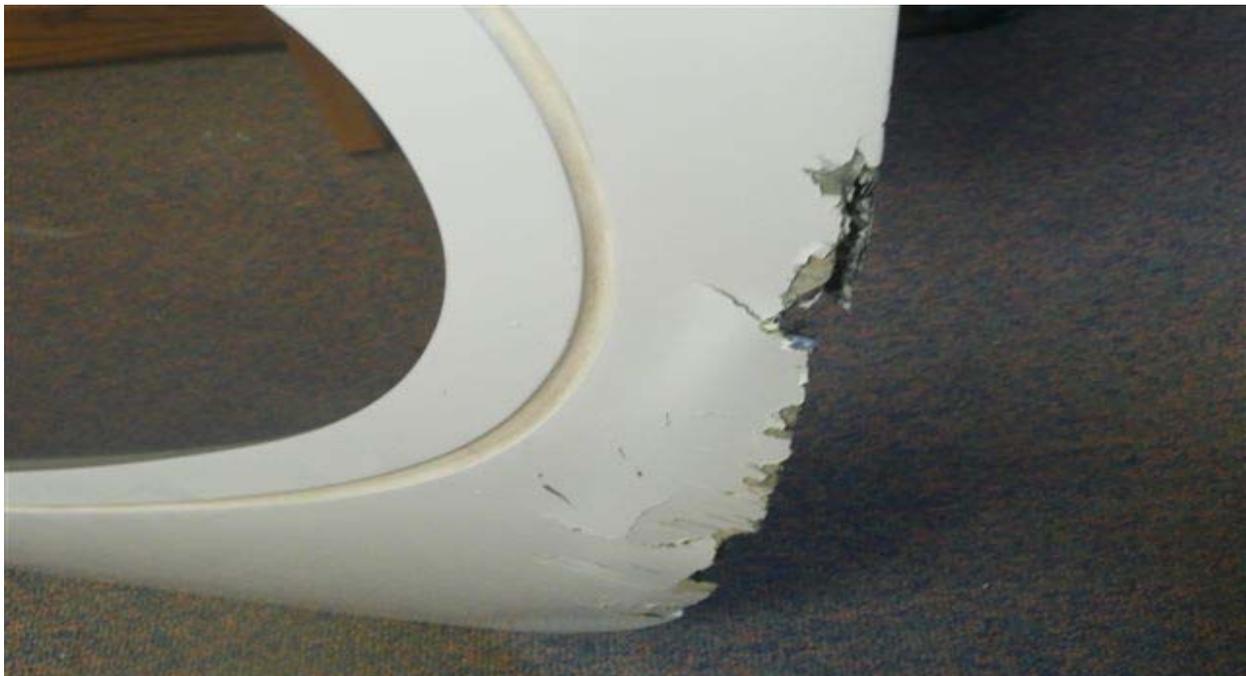
A mechanic writes the same description for two different reports. "The rear hinge (*can be seen*) developing cracks in the (*laminate*) fibers under normal operating conditions. A probable cause: the rear hold-open cylinder is causing stress on the hinge point." (*Rear door P/N: D41-5221-00-00. Scary pictures can be found further down—keep reading.*)

The first incident report states, “On take-off roll (*at rotation speed*), the aft passenger door departed the airframe.” (*Door P/N: DA4-5221-00-00-2; part total time: 615.0 hours.*) The second report says, “Cracks were found in the aft door hinge.” (*P/N: DA4-5221-00-00-2; part total time: 628.0 hours.*)

Inspector Steffes expands the two discrepancies in supplemental correspondence stating, “In June of 2008 a Diamond DA40 aircraft operated by a flight school had the rear passenger door depart the aircraft, narrowly missing the tail plane and rudder. The door was later recovered. The aft hinge was broken off and the forward hinge damaged. Investigation revealed the hinge had cracked (then broke), due in part to the materials used in part fabrication and the high pressure placed upon it by the door opening strut (gas spring: Diamond P/N DA4-9052-00-11; vendor P/N G8-19-200-1-389-GZ10-400N). The door and hinge are one assembly made of a composite type material. The hinge is approximately $\frac{3}{4}$ inch wide. The strut is attached near the rear hinge. It exerts approximately 90 pounds of force near the hinge attach point. Even though the door employs a safety latch handle, when the aft hinge fails the door flexes enough to slide past the stop.

“An inspection of another aircraft in this (*operator’s*) fleet found it too had recently had doors separate in flight under similar circumstances. This same aircraft showed signs of cracking at the rear hinge on the replacement door. This (*door separation defect*) is the third such occurrence this operator has experienced.”

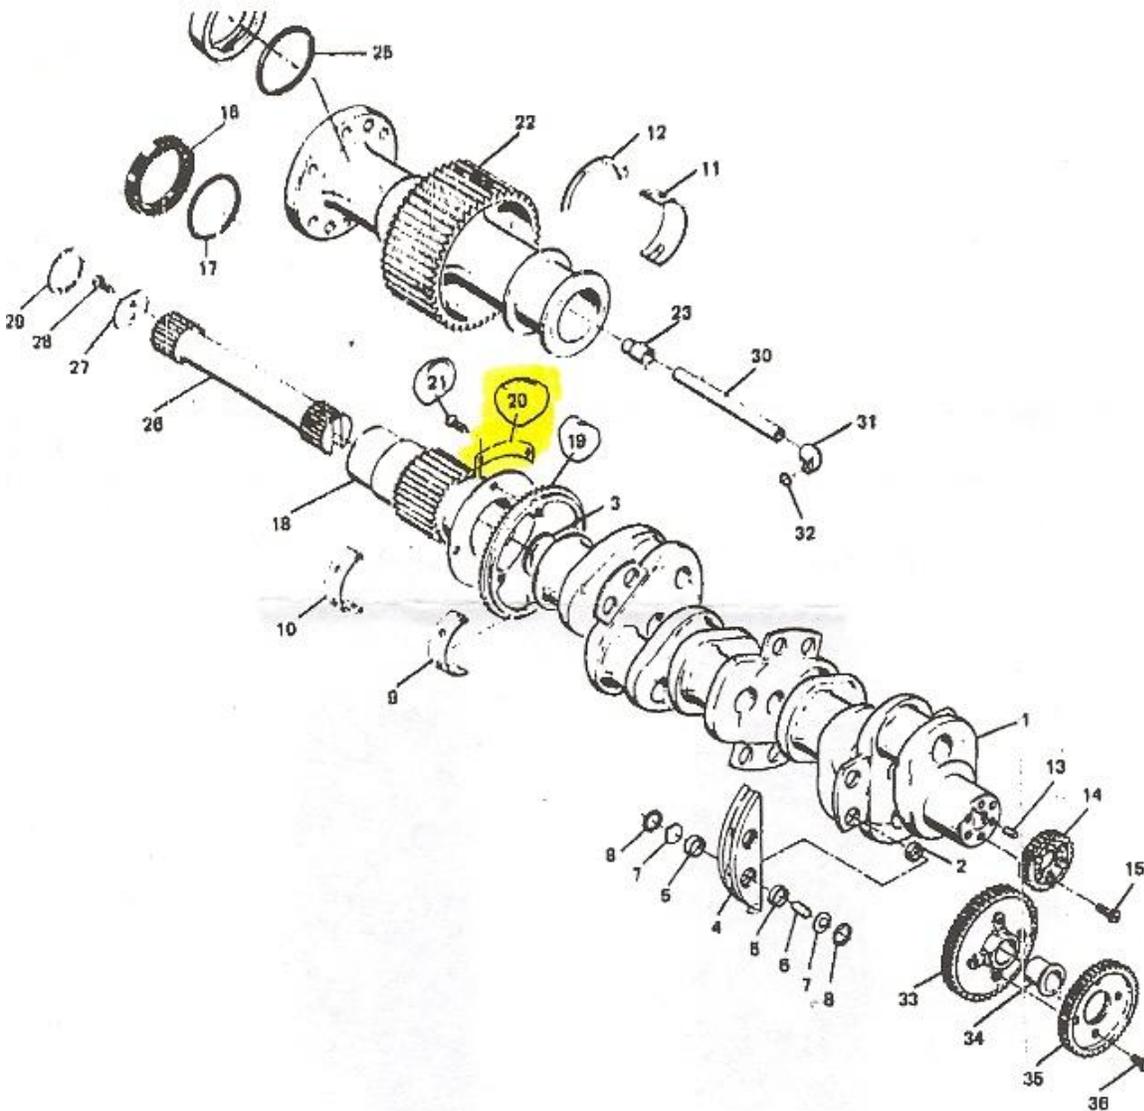
FIGURE 4. CRANKSHAFT GROUP

An unidentified repair station submitter states, “This *(Cessna 421B)* engine was removed in August due to a cracked engine case. It was sent to Ram Aircraft for repair. The engine was returned in September and reinstalled back on the aircraft. During a November night flight the pilot experienced an alternator failure *(which)* he reported the next day. Upon inspection of the alternator it was found in pieces, with the mount housing still attached to the engine. The inside of the alternator installation hole was inspected, revealing the attach bolts on the alternator face gear had no tab lock plates installed *(P/N 641909; item number 20)*. *(Conclusion:)* the attach bolts came loose and damaged the engine and alternator. Ram Aircraft was notified of the problem. It is *(my)* recommendation to inspect for missing parts in the alternator attach hole before engine installation. This engine had 65.6 hours since the previous installation.”
