ADVISORY CIRCULAR

43-16A

AVIATION MAINTENANCE ALERTS

**ALERT
NUMBER
363**

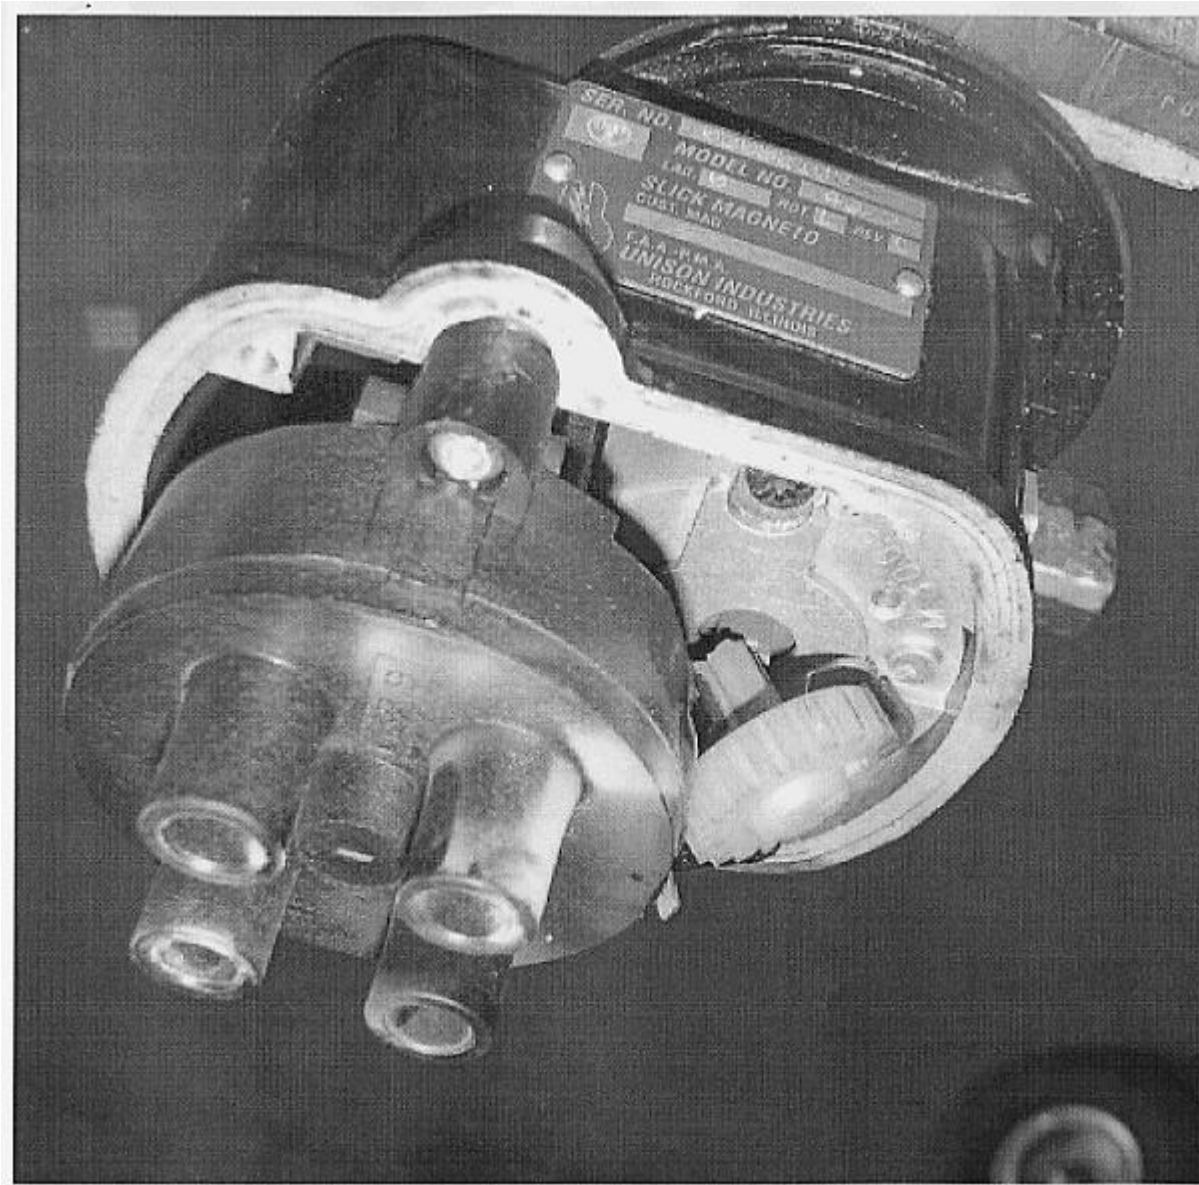
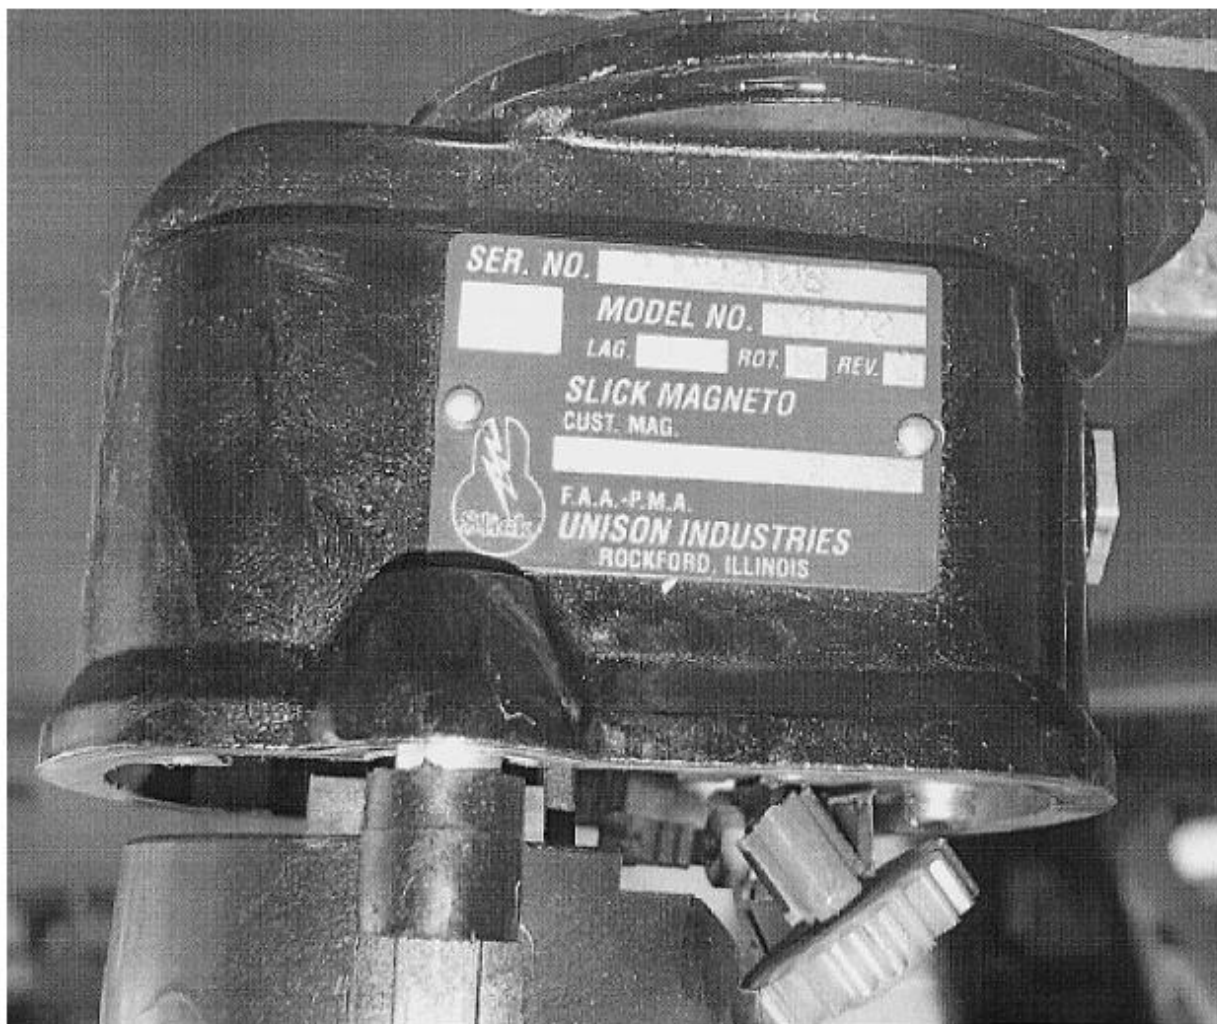
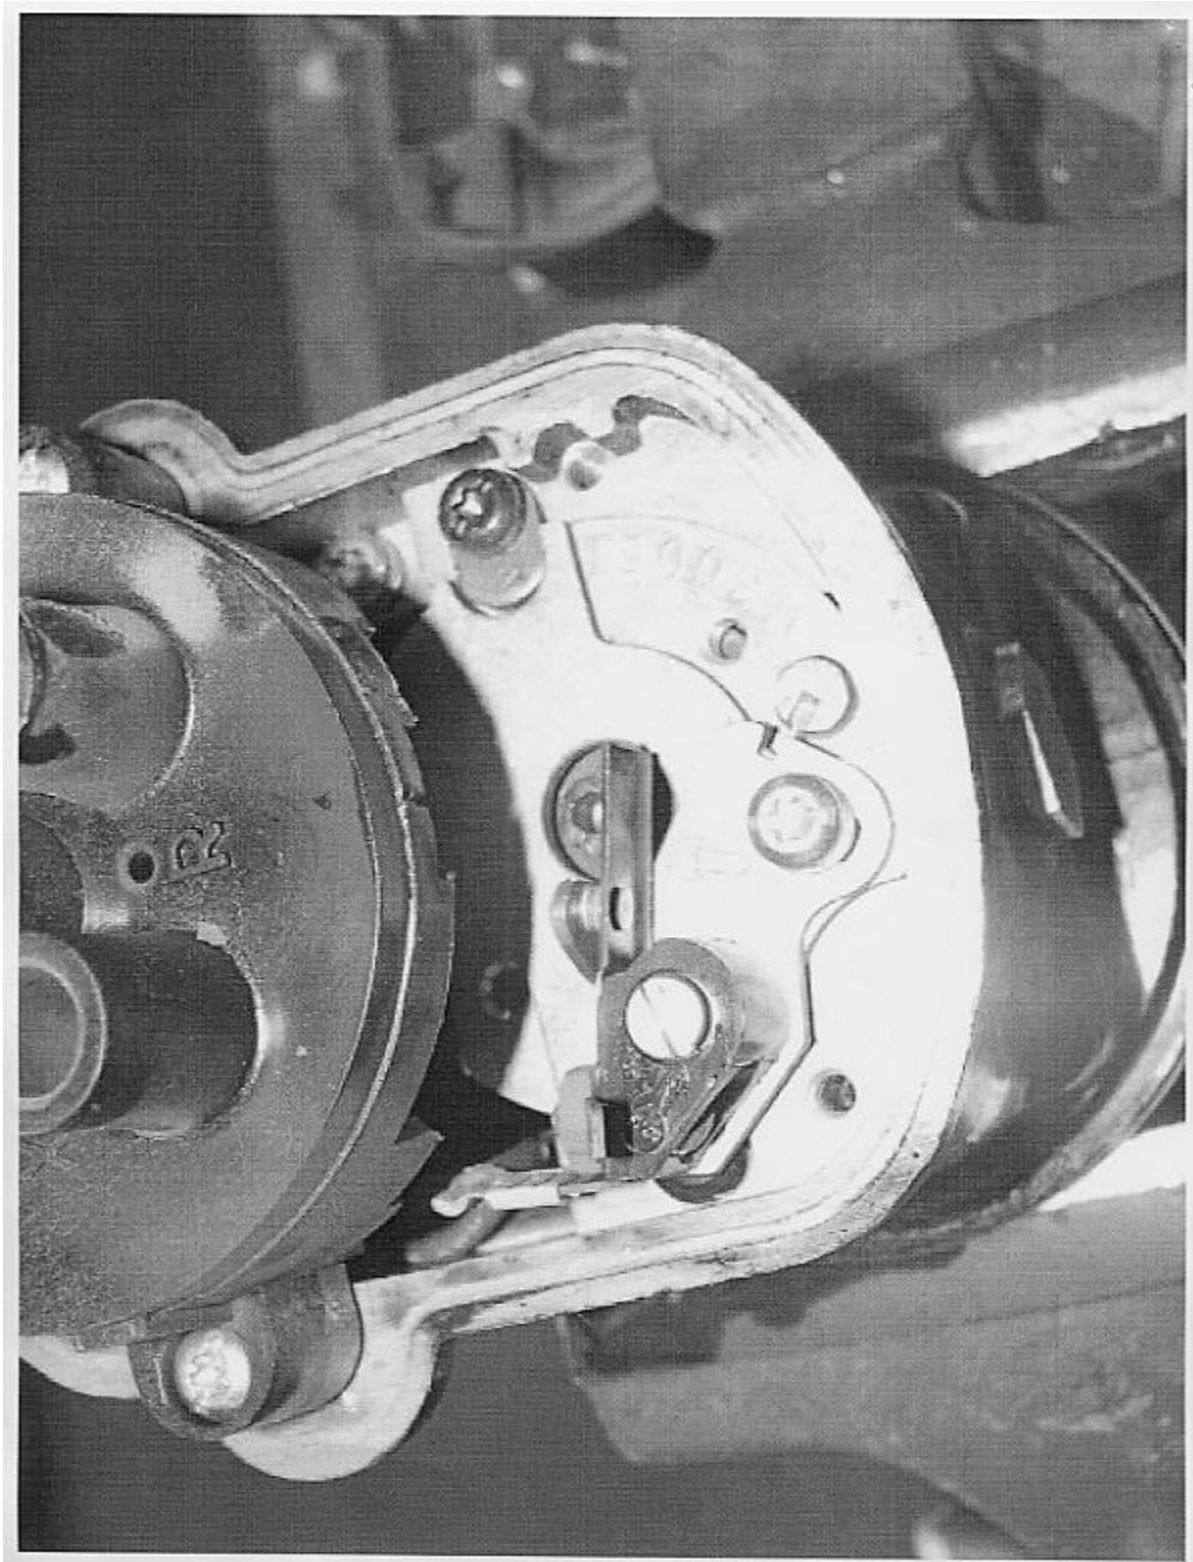
SLICK**Slick Magneto: 4370; Broken Point-Cam Shaft; ATA 7414**

The submitter says, “*(This engine’s magneto)* distributor/point cam shaft broke flush with the upper magneto gear inner race, causing total magneto failure. *The part was returned to the owner.*” *A search of the FAA Service Difficulty Reporting System data base includes 11 additional reports for the 4370 magneto.)*
