ADVISORY CIRCULAR

43-16A

AVIATION MAINTENANCE ALERTS

**ALERT
NUMBER
364**

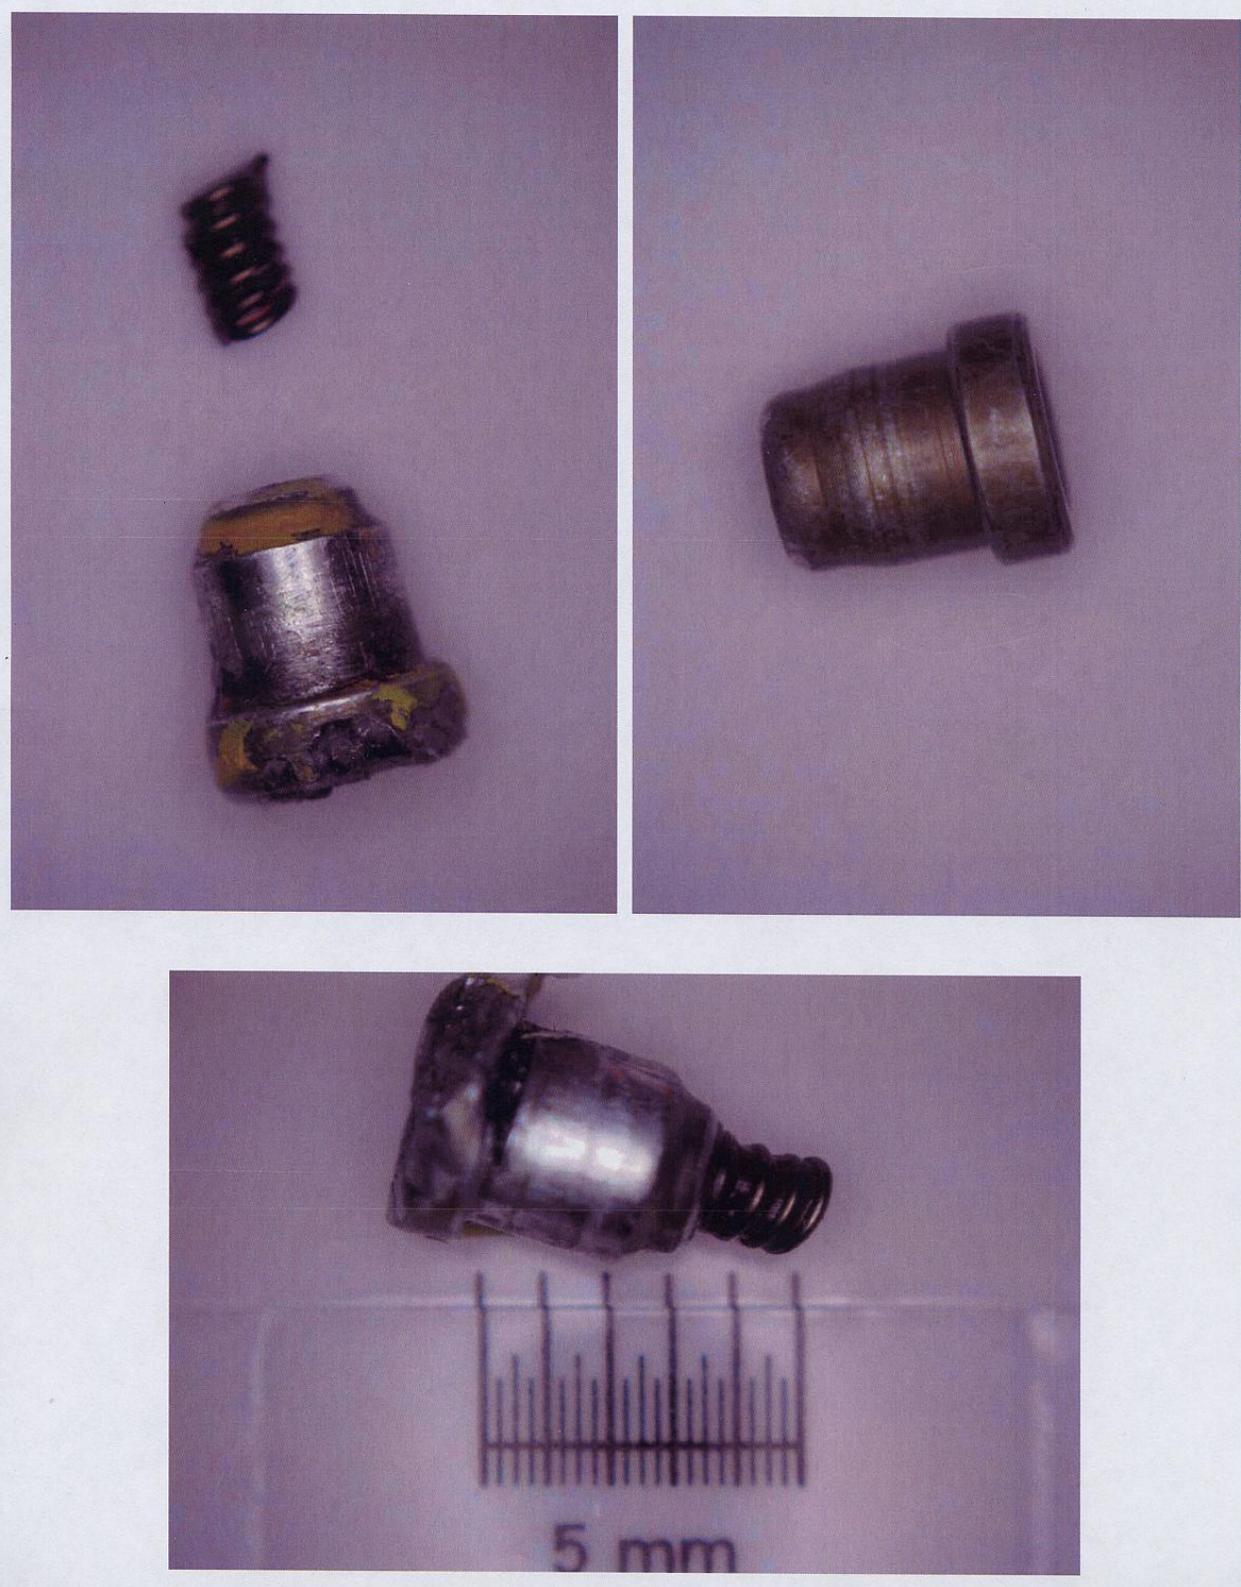
A defect report submitted from Sweden states, "During lubrication of a Main Rotor Hub we discovered the spring in the grease fitting (P/N NAS516-1A) was pressed out from the fitting, blocking the grease passage. This happened three times *(during this lubrication procedure)*. We found the springs after every attempt. This *(defect)* could, for example, result in a loose spring in a rotating bearing, such as the swash plate."

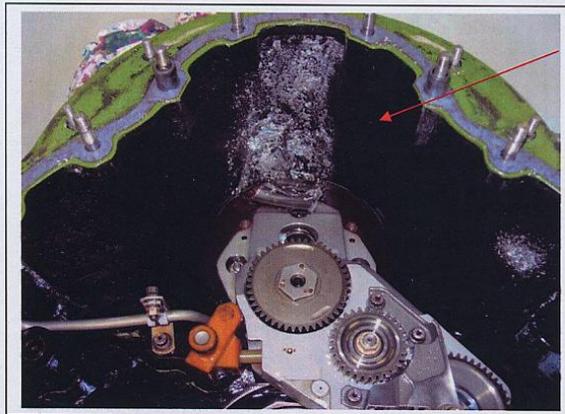
Gear Box Cavity

Metal particles and chunks of metal

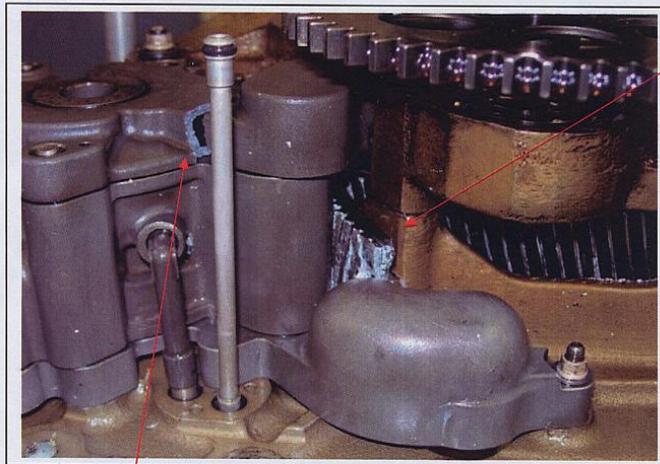
Scavenge Pump

Missing bull gear piece trapped between housing and scavenge pump

Scavenge pump housing broken

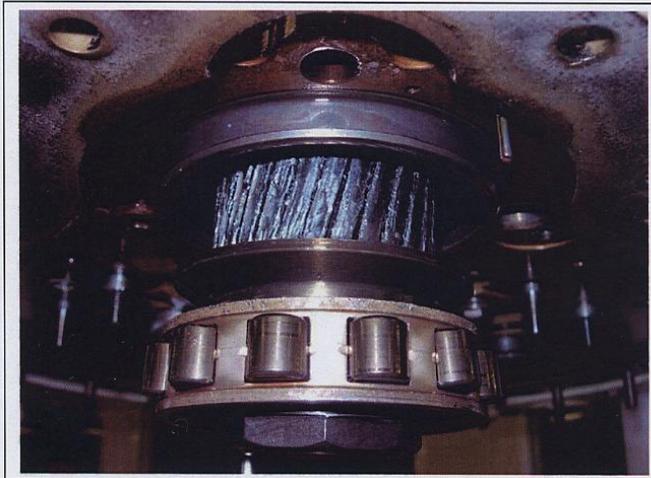
High Speed Pinion Gear

HSP gear helical gear damage

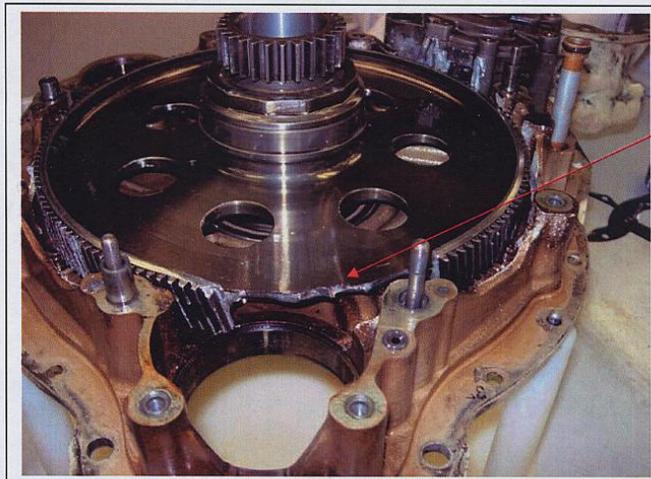
Bull Gear

Rim separation

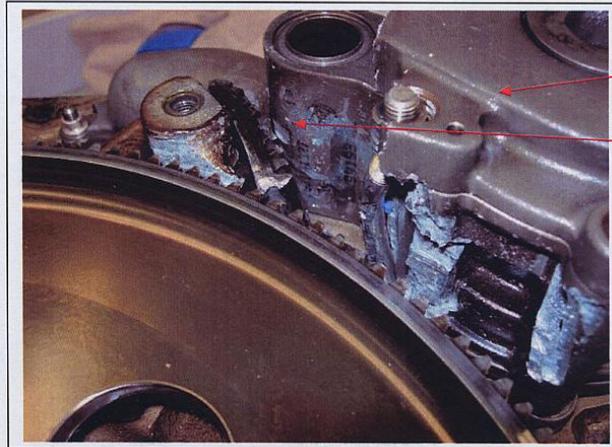
Trapped Bull Gear Piece

Scavenge Pump

Bull gear rim piece

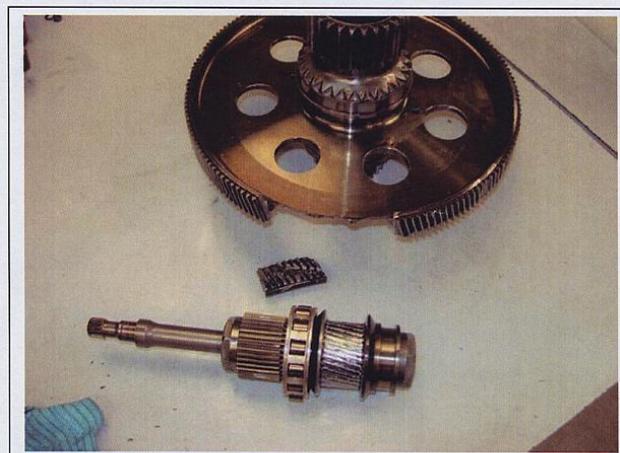
Bull & HSP Gear

Damaged bull gear
& HSP assembly

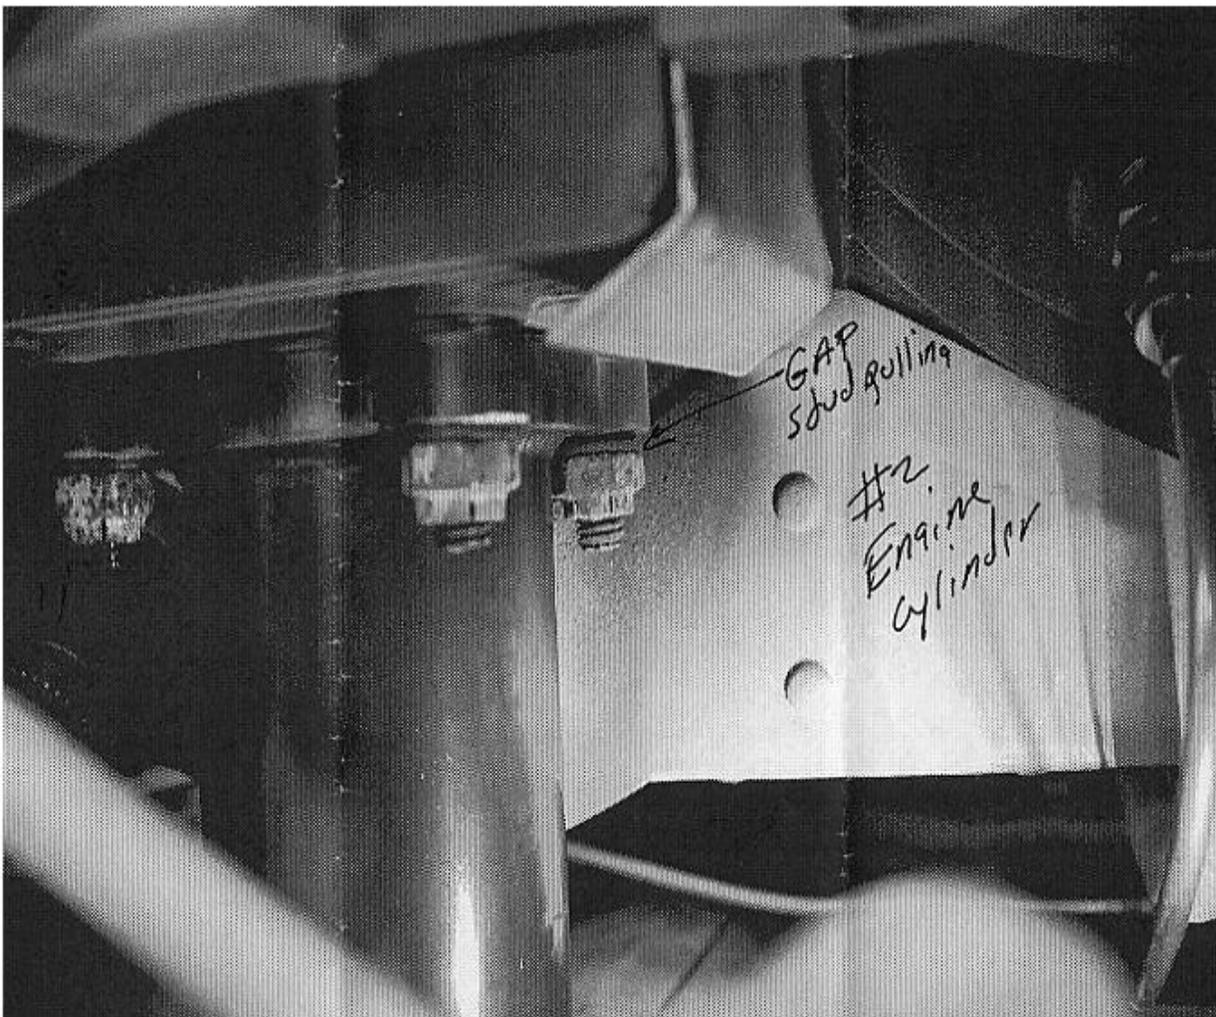
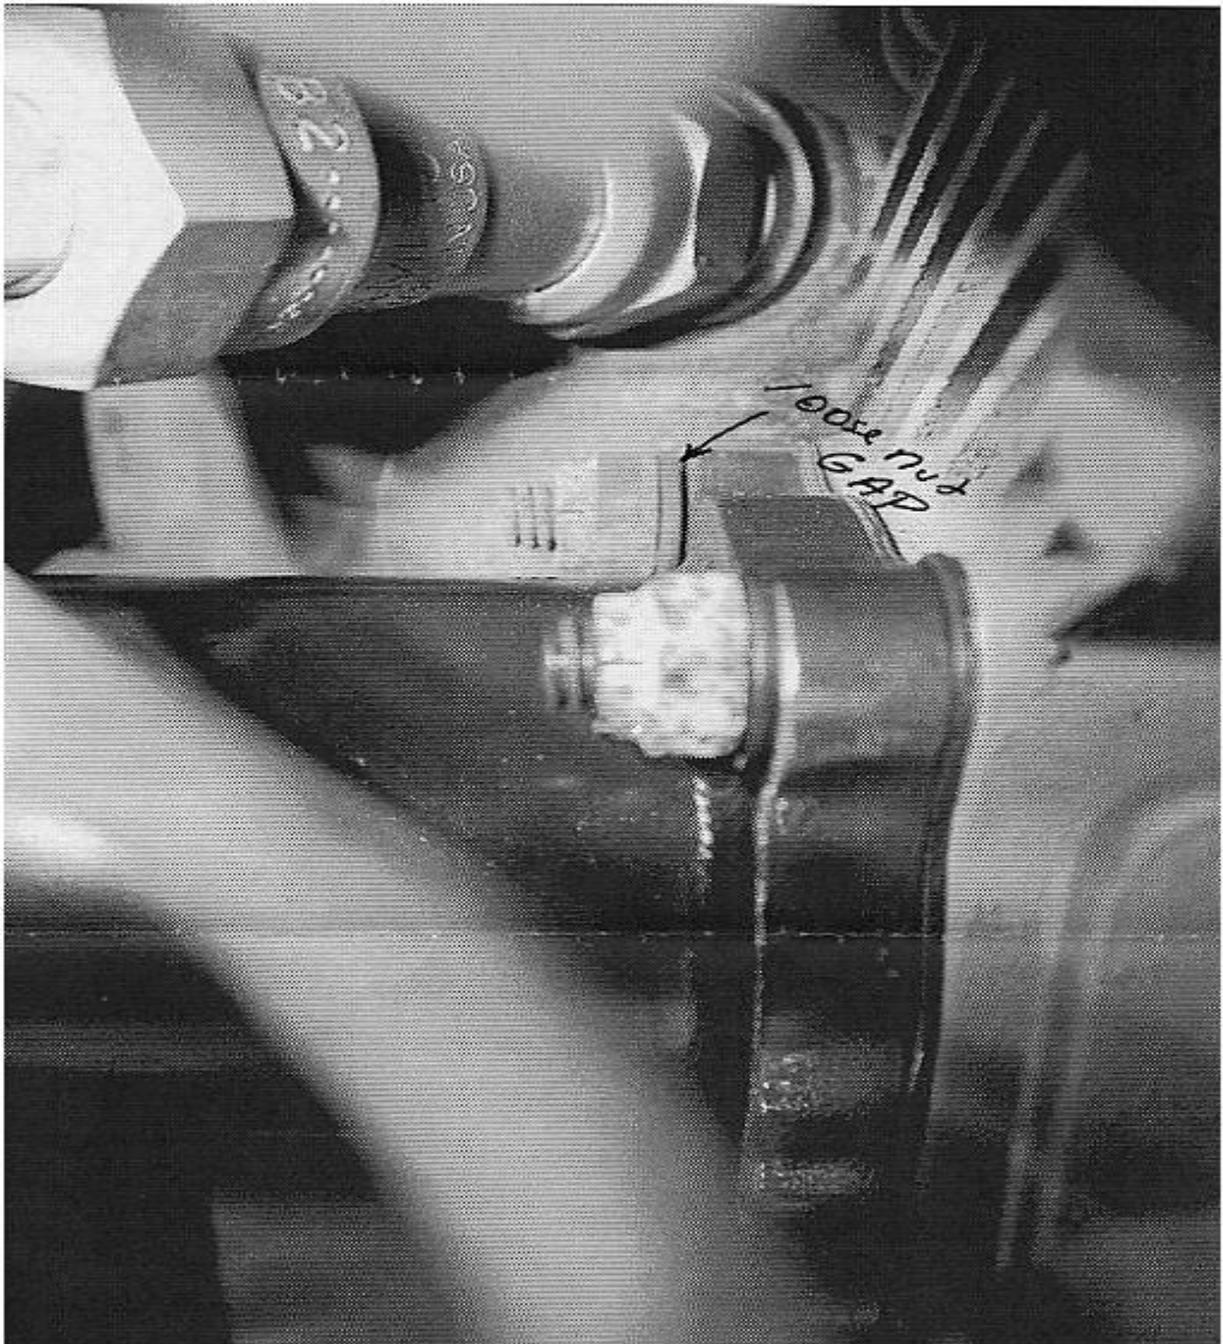
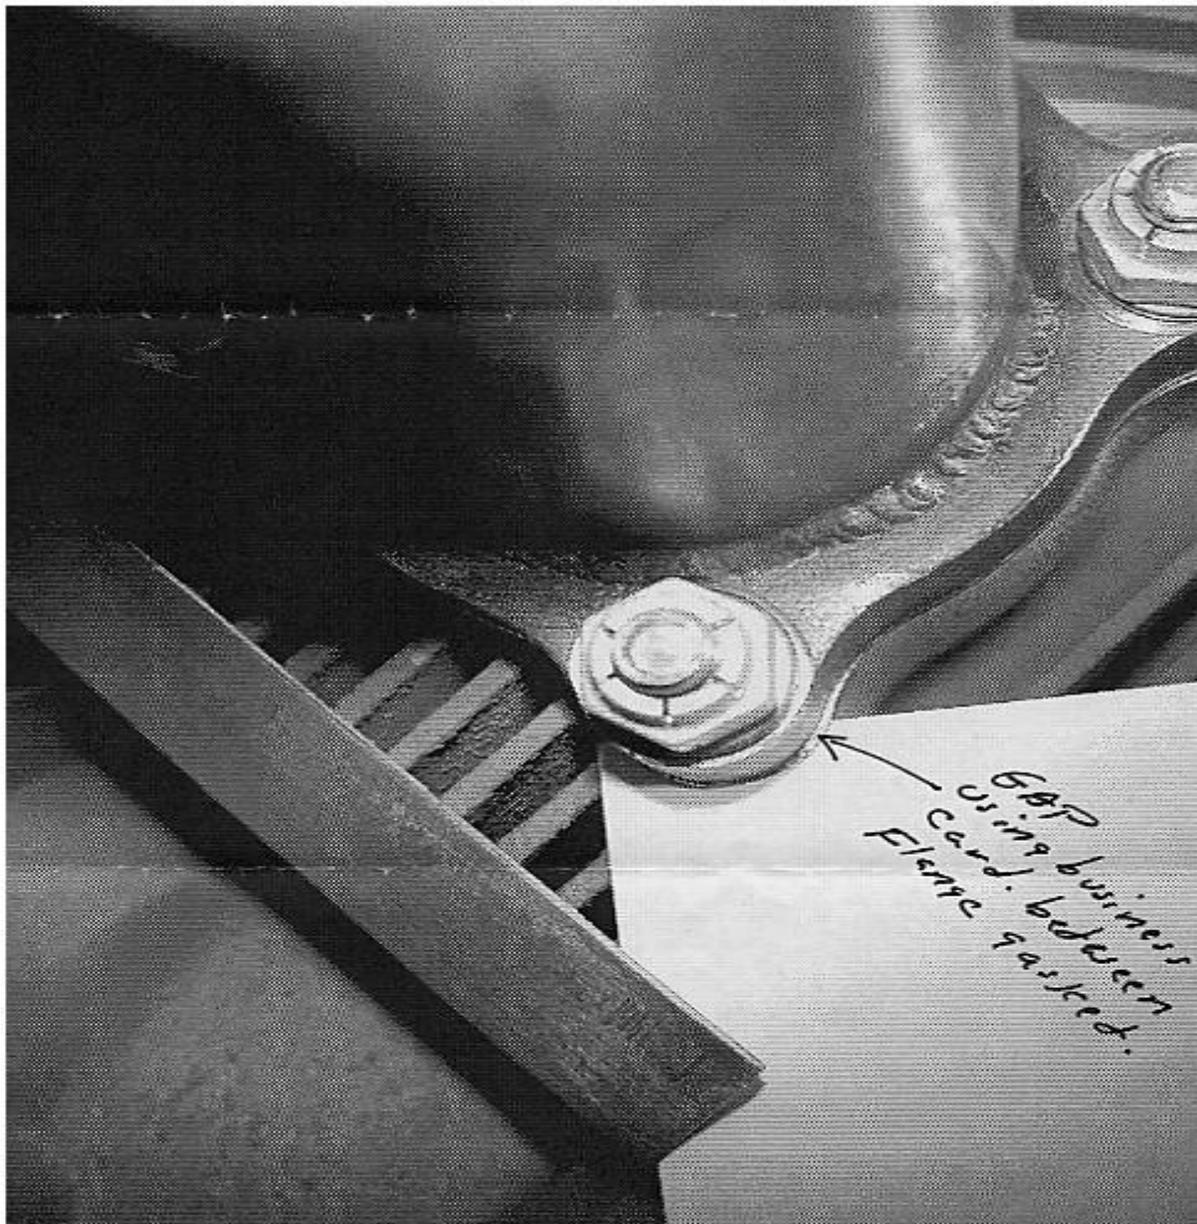
A repair station technician states, "During a Cessna 100 hour inspection, we found the exhaust stack at the number 2 cylinder pulled down approximately 1/16 inch. Further investigation found the number 1, 3, 5 and 6 engine cylinder exhaust stacks also pulled down, but not as much." "During the engine cylinder removal process we found the lower forward, 3/4 inch stud nut under torqued. Further investigation revealed the forward 2 studs (*each*) below Lycoming's recommended driving torque for cylinder hold-down studs in the case. We installed new, oversized studs (0.003") as per the engine manufacturer's recommendations. We installed the new, number 2 engine cylinder and new exhaust crossover pipe as required (see pictures). Note: tightening the exhaust flange nuts does not stop the leak on all of the studs; on some of the studs the nut bottoms out on the threads. After tightening, the previously effected exhaust flange areas have come loose again after 50 hours time in service." (*Exhaust assembly P/N: 40B222318.*)
