ADVISORY CIRCULAR

43-16A

AVIATION MAINTENANCE ALERTS

**ALERT
NUMBER
373**

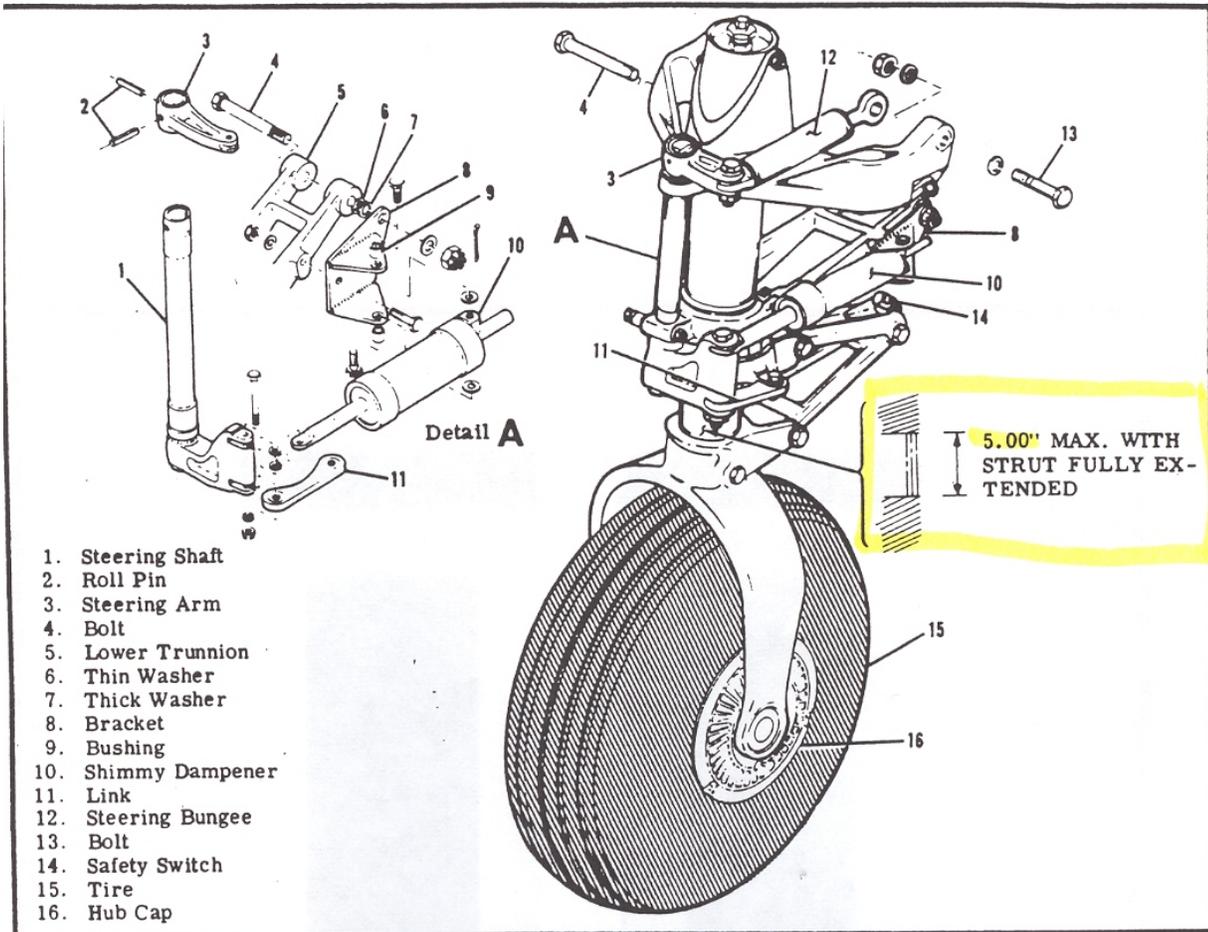
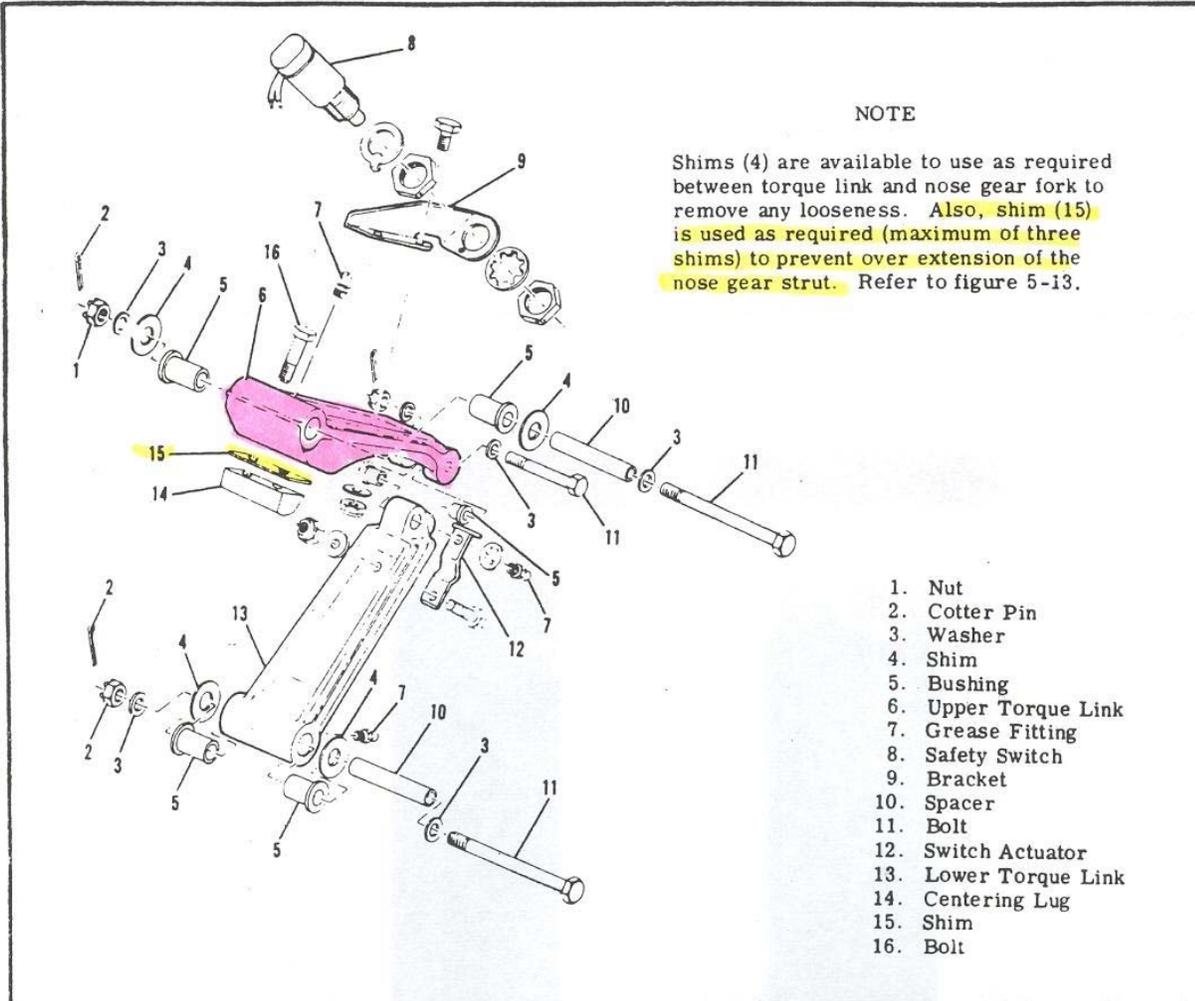
Figure 5-18. Nose Gear Torque Links

An aircraft technician states, "Our repair station has replaced several of these same upper torque links due to finding them bent at inspection (approximately five *have been found*). This is the first one found cracked.

"I believe the probable cause is landing impact with more than the recommended strut extension (5.00 inches max.), according to Cessna Service Manual, figure 5-15. (*This strut extension...*) is adjustable by adding shims (item 15; three maximum) in accordance with the note on figure 5-18." (*The shim P/N is 1243618-2.*)

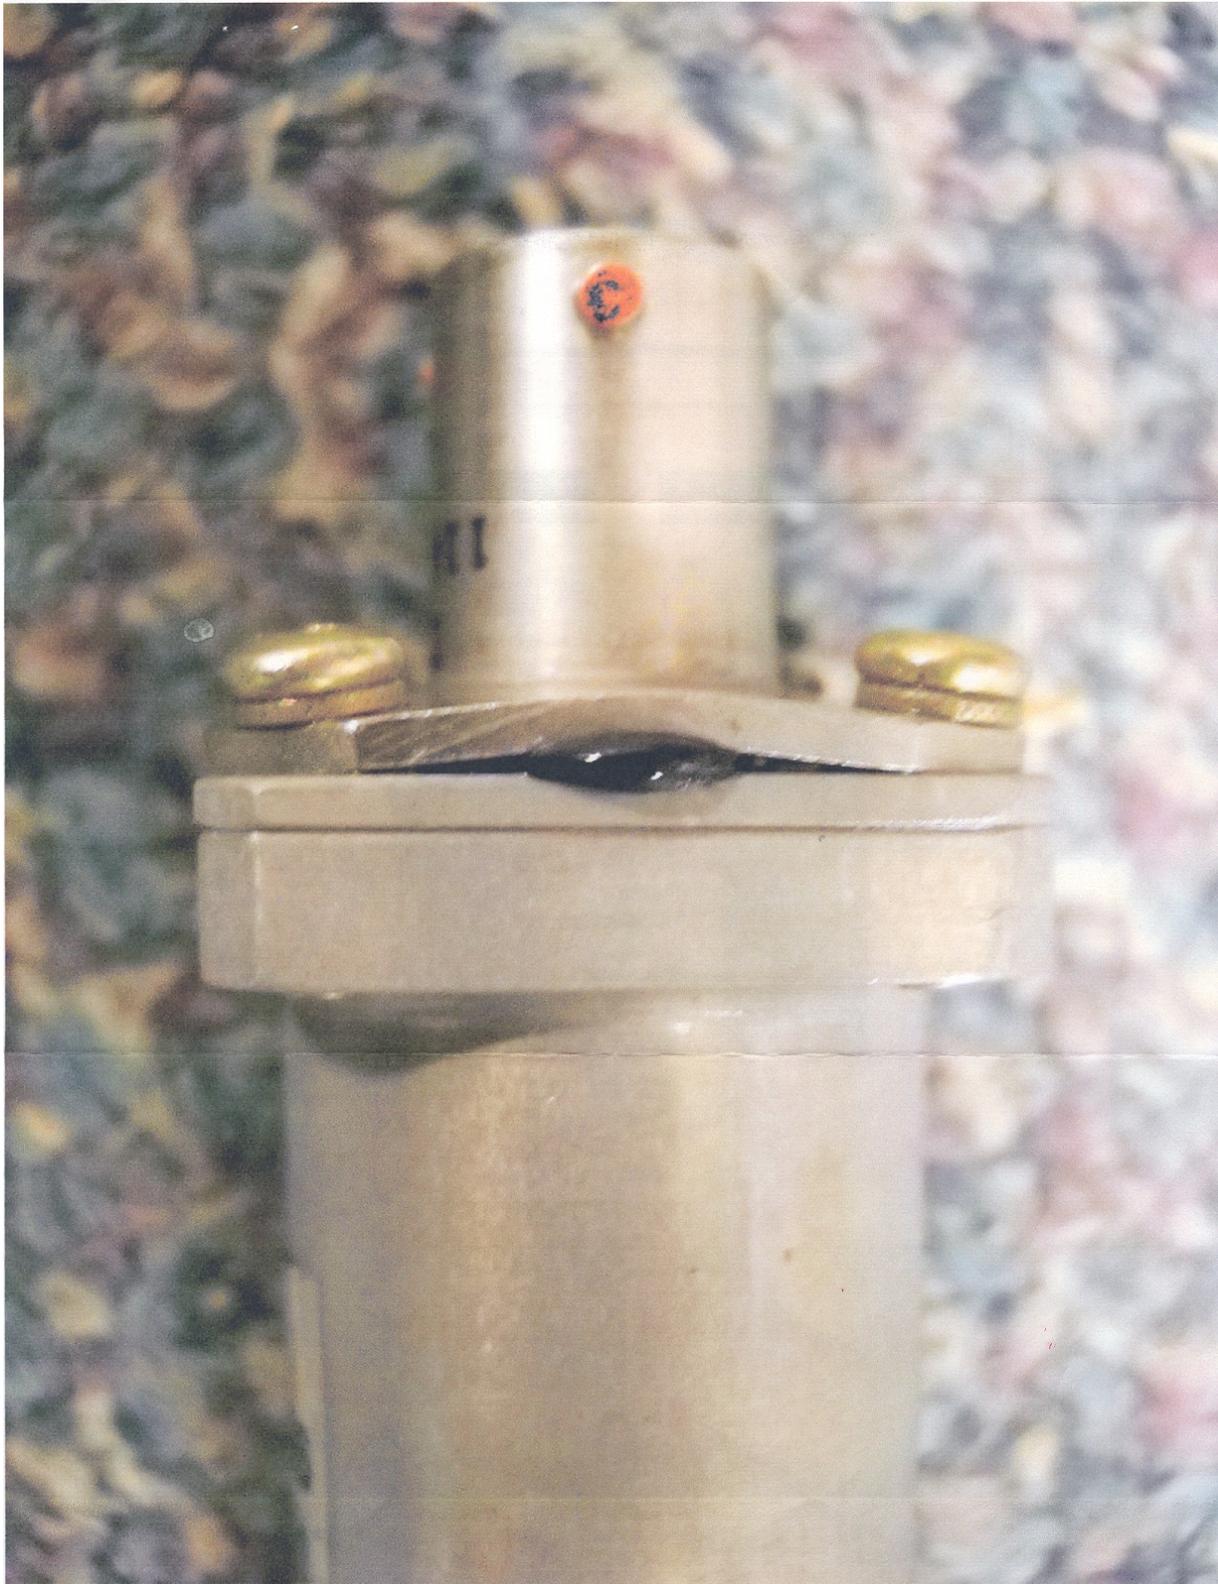
An inspector for a repair station writes, "The Cannon plug adapter on the back of the switch deforms under pressure; the o-ring displaces and hydraulic fluid leaks *(past)*. Loss of hydraulic fluid led to complete hydraulic failure. *(The pilots allowed the landing gear to free-fall to the down position.)* Learjet is working to replace this and four similar switches in the aircraft. *(I)* recommend replacing this switch *(P/N 7629001004-001)* with a stronger unit."

(The submitter includes the manufacturer's P/N: 51158, and locates this pressure switch below the hydraulic reservoir. Okay—the background is a bit difficult...but the subject is spot-on, tells the story, and removes any doubts. Thank-you for the photo effort—Ed.)

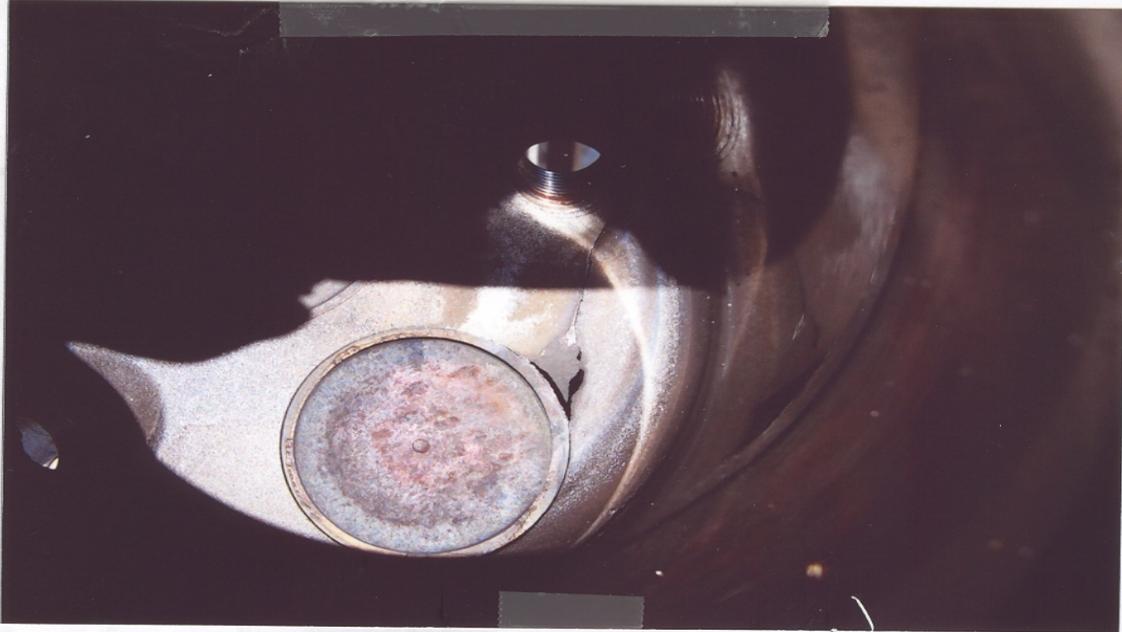
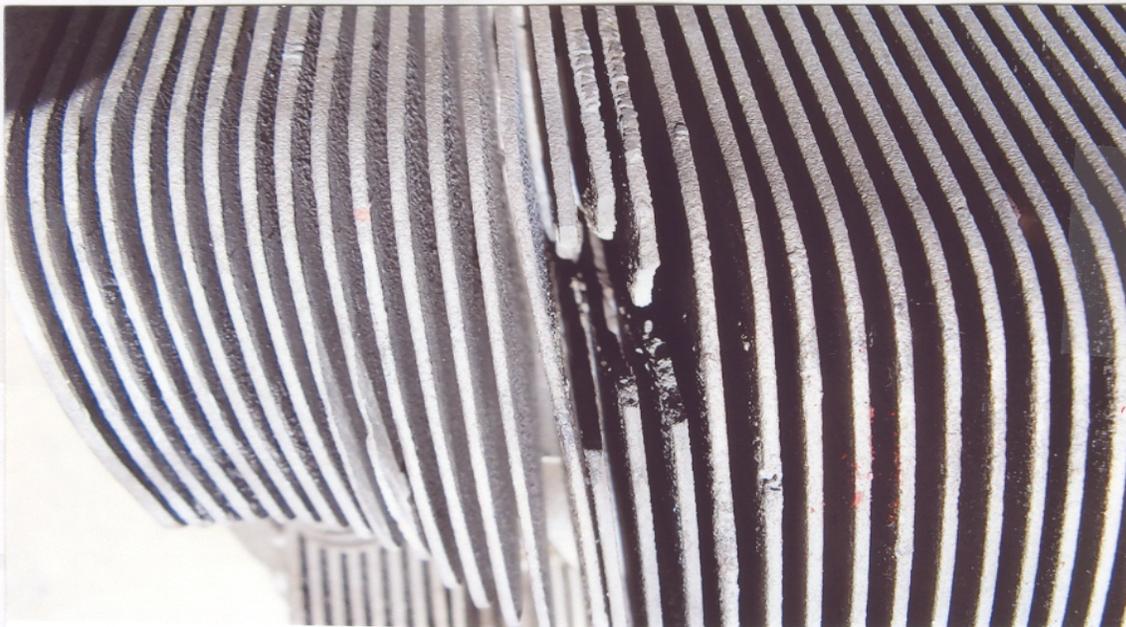
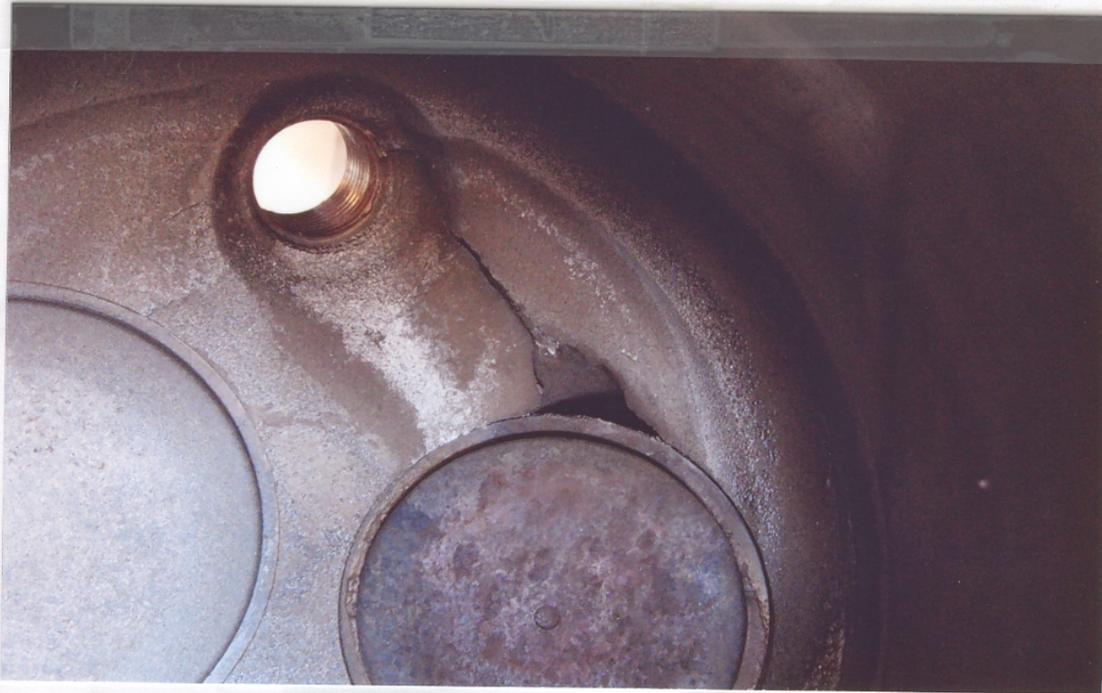
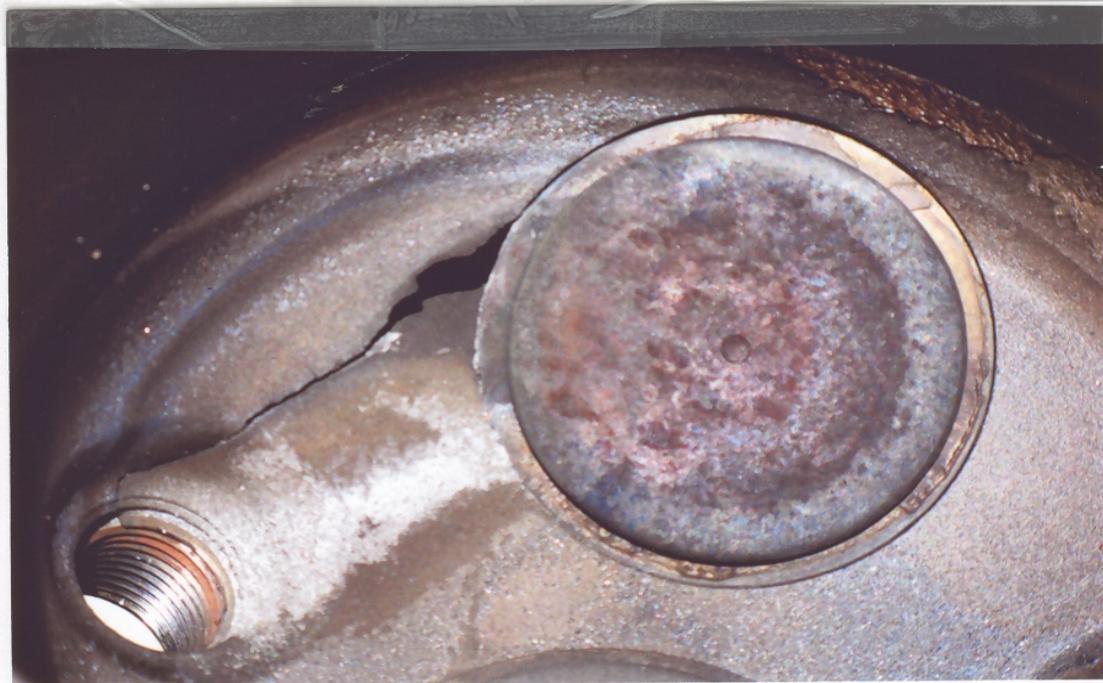
AEC631397 SN.71.2
S/N 25526.22

A mechanic for a Cessna 414A describes the following engine defects. "The ECI Titan cylinder head failed in flight and blew out a section of the head and fins. Investigation revealed a 0.50 inch hole had developed from a crack that progressed from the exhaust valve seat to the upper spark plug hole. An additional crack was found on this (*particular*) cylinder, (*moving*) from the upper spark plug hole to the injector boss. After inspection of all cylinders on both engines, five other of the original cylinders installed at overhaul were found cracked. All cracks were either from the injector boss to the upper plug hole or from the exhaust valve to the upper plug hole. Both engines were overhauled at the same time—the cylinders all had the same amount of (*operational*) time.

"No metallurgical analysis was performed and no cause could be determined (*for these defects*). All cylinders were sent back to the manufacturer."

(All six reports include the additional cylinder marks: SN71.2 REV P. These are great pictures—slightly stretched by this editor to fit the page. Note the previous entry for additional information.)

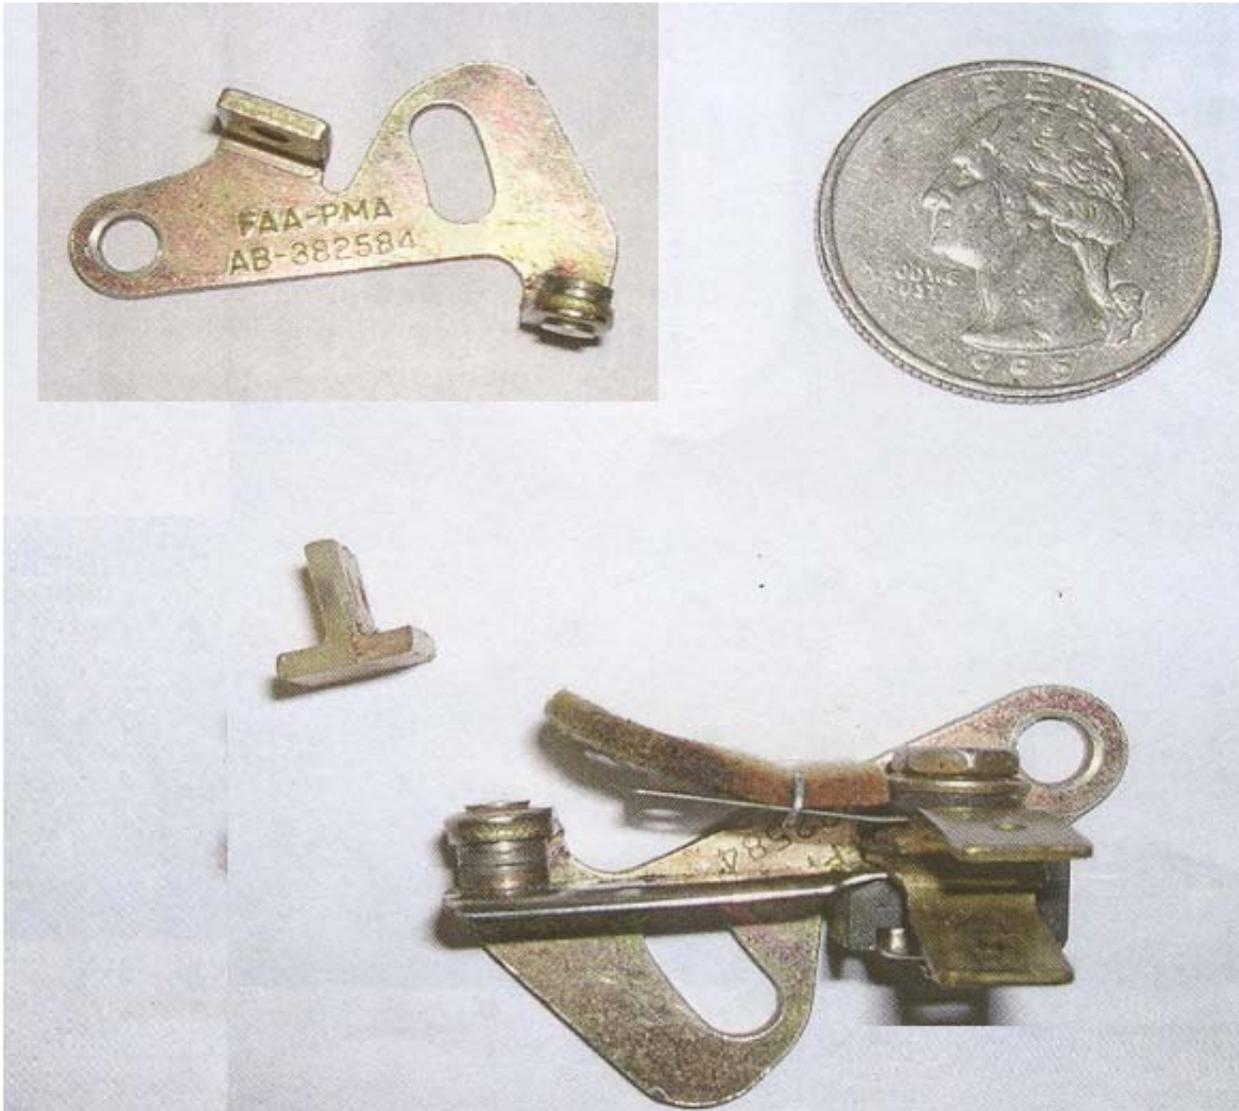
An FAA inspector states, "A broken contact breaker was found during troubleshooting of an ignition problem on a Bellanca 17-31ATC. The contactor rivet was broken in this Bendix Magneto. This rivet may be insufficient (*referencing size/strength*) to properly hold the contactor in place."

(The above photo combines two of the three submitted pictures. Contact P/N: AB-382584.)

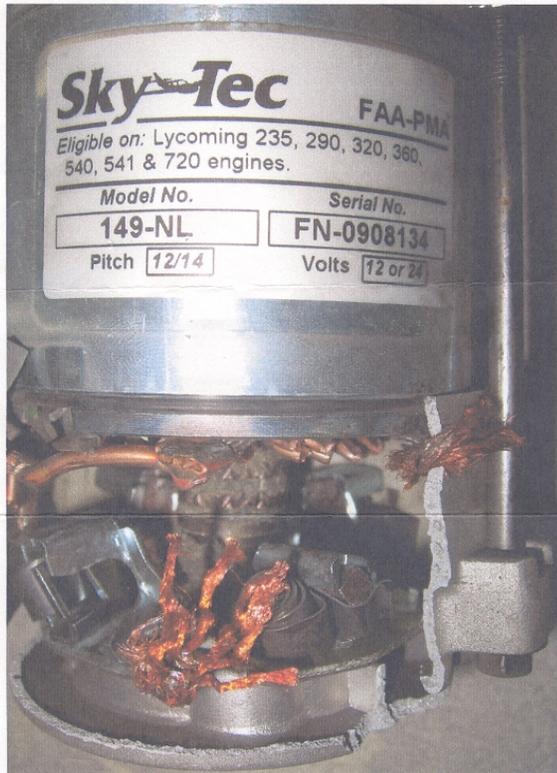
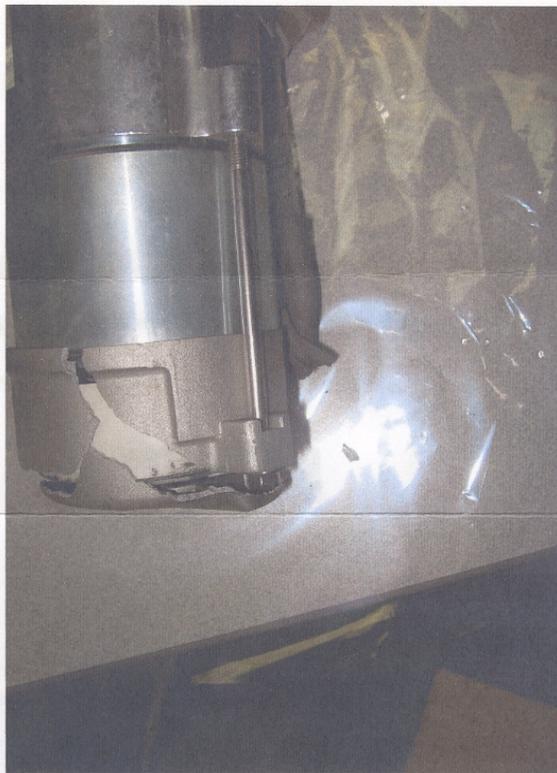
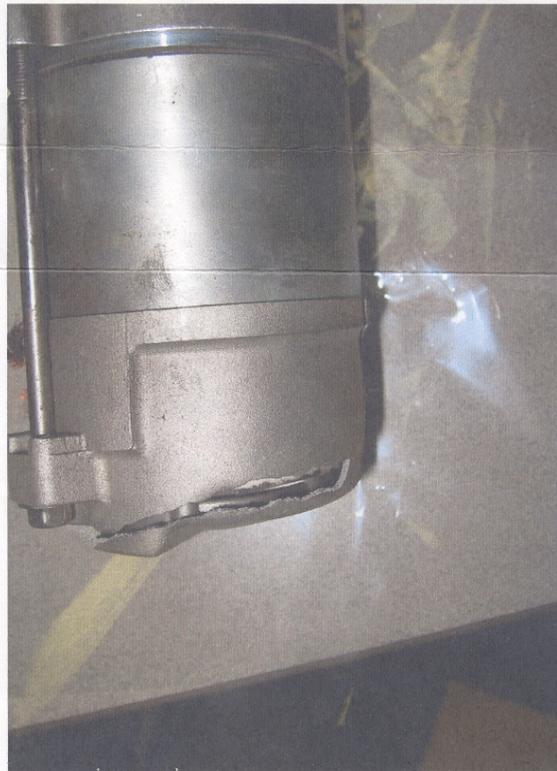
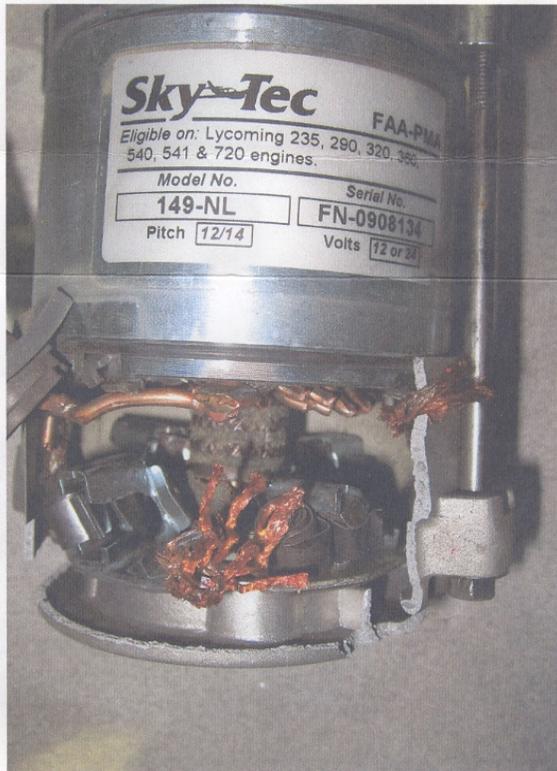
A repair station technician says, "The starter end cap shattered. This is the third occurrence that we have seen on the Cessna 172S aircraft."

(This picture evokes a flinch and cringe! It is dramatic. It does make a statement, and your reporting will make a difference. There are 12 of these listed in the SDRS database now—keep filing those reports!)
