ADVISORY CIRCULAR

43-16A

AVIATION MAINTENANCE ALERTS

**ALERT
NUMBER
375**

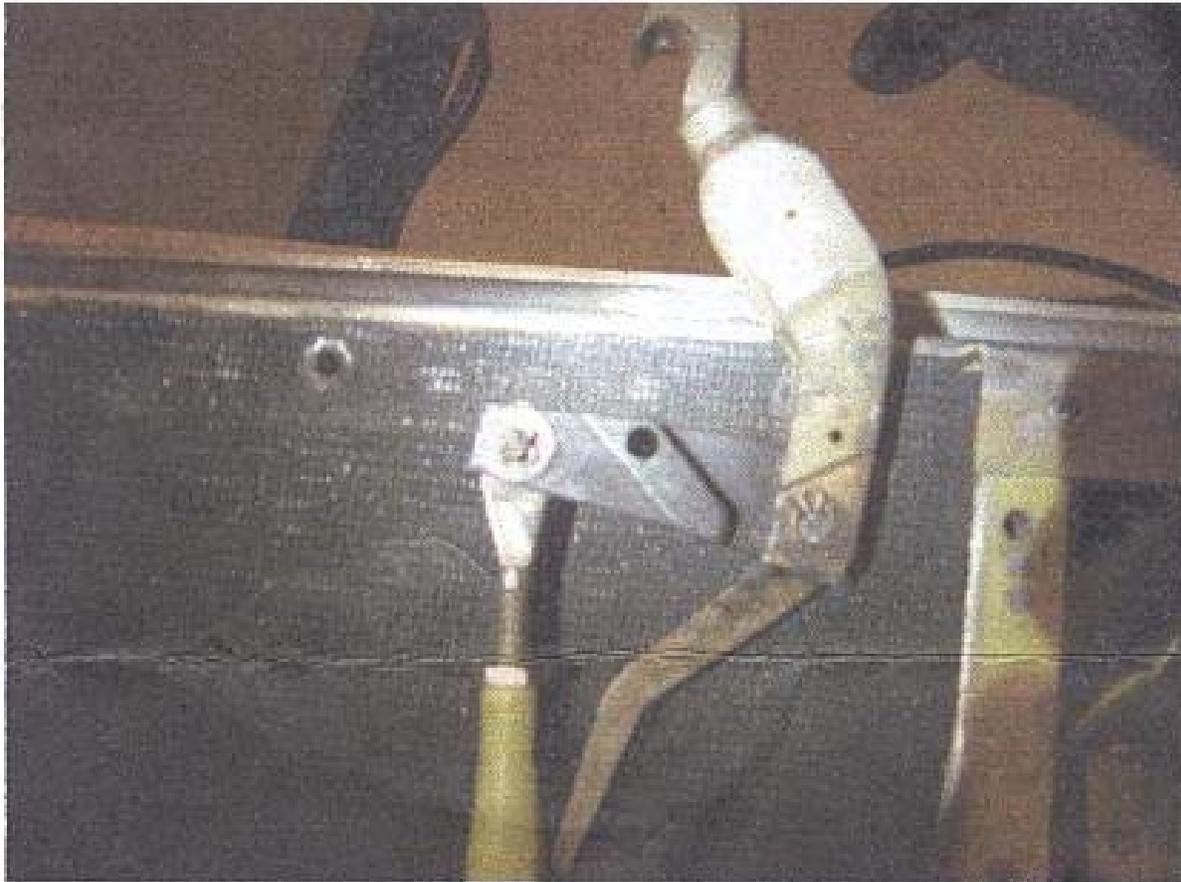
"1) Upper Forward Latch Hook (Missing) Rig Holes: The upper forward latch hook bracket (P/N 50-430062-21) was not drilled for proper rigging. The bracket was replaced 661 hours prior to this incident (figure 1). Proper rigging of the latch mechanism could not be accomplished in accordance with the maintenance manual without

the rig pin holes installed. This bracket is suppose to have a rig pin hole drilled in it from the factory. When rigging the upper latch hooks per the maintenance manual, this hole is used to insure the upper hook assembly has latched in an over-center position. If the hooks are not in an over-center position, they will tend to pull the main cabin door latch toward an open position (reference Beech manual 52-10-00-201).

FIG 1: Undrilled hook assy removed from door

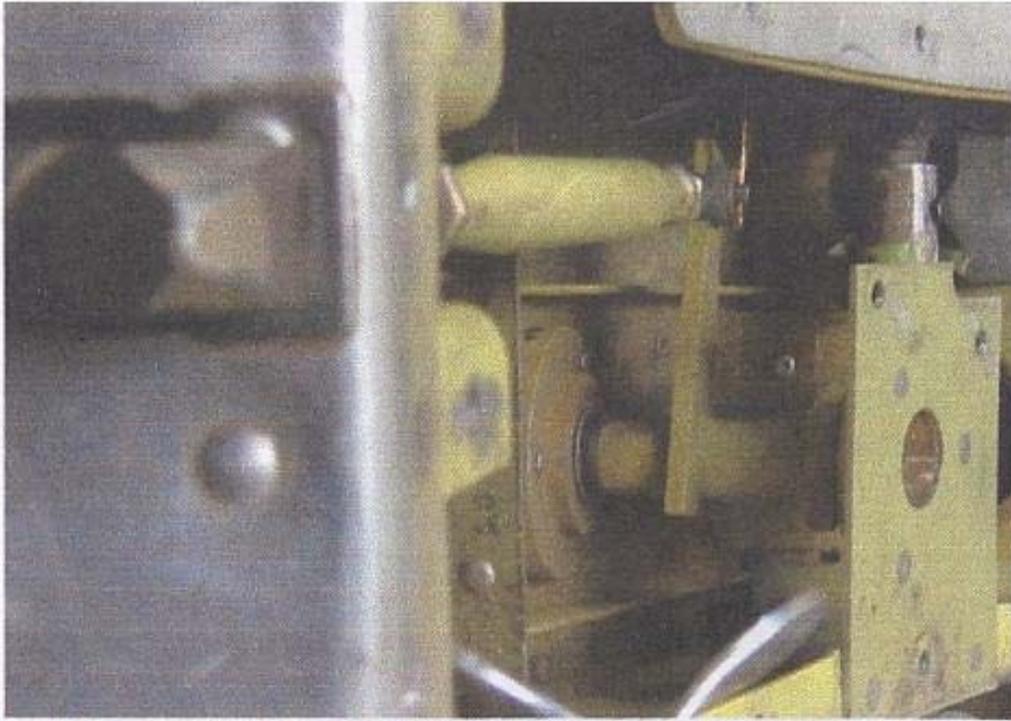
"2) Bell Crank (P/N 50-430031-29) Bent and Twisted: The bell crank is the actuation transition point from the handle to the Upper Hook assembly. It is suspected that this bell crank failed (*because*) of the upper hook not being rigged properly due to the lack of rig pin holes. This area of the door is not accessible for inspection unless upholstery panels and latch cover panels are removed. When inspecting this bell crank, the transition attach points from the handle linkage to the upper hook linkage should be at 90 degrees (reference figures 3 and 4). The improper installation of the bracket assembly (P/N 50-430062-21) led to the twisting of the bell crank assembly (P/N 50-430031-29; figure 2).

Fig 2: This view shows the Bellcrank assy P/N 50-430031-29. Notice twist of shaft.

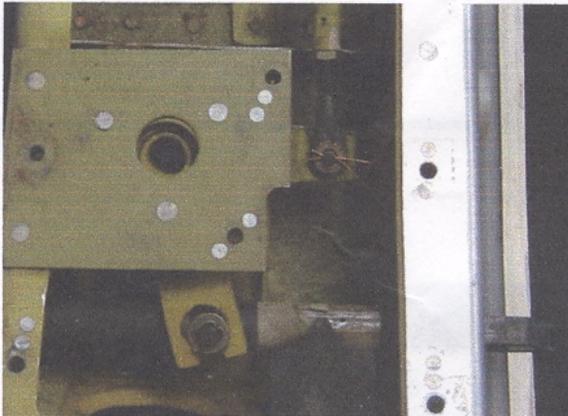
Fig 3: Forward: DAMAGED BELLCRANK
Top view of bellcrank notice less than 90 degree's between actuating rod and clevis for Hook Assy.

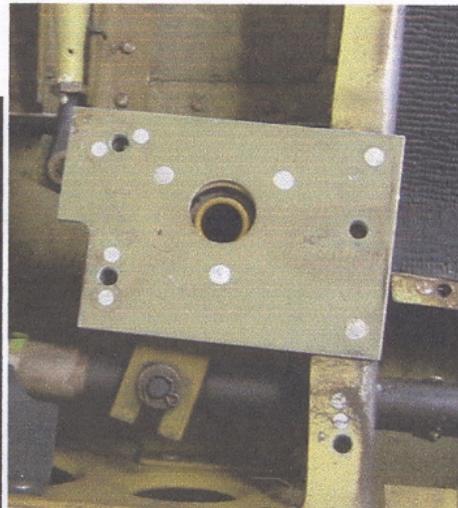
Fig 4: AFT: GOOD BELLCRANK
Main cabin door bellcrank 50-430031-29. Notice 90 degree's between actuating rod and upper hook rod clevis.

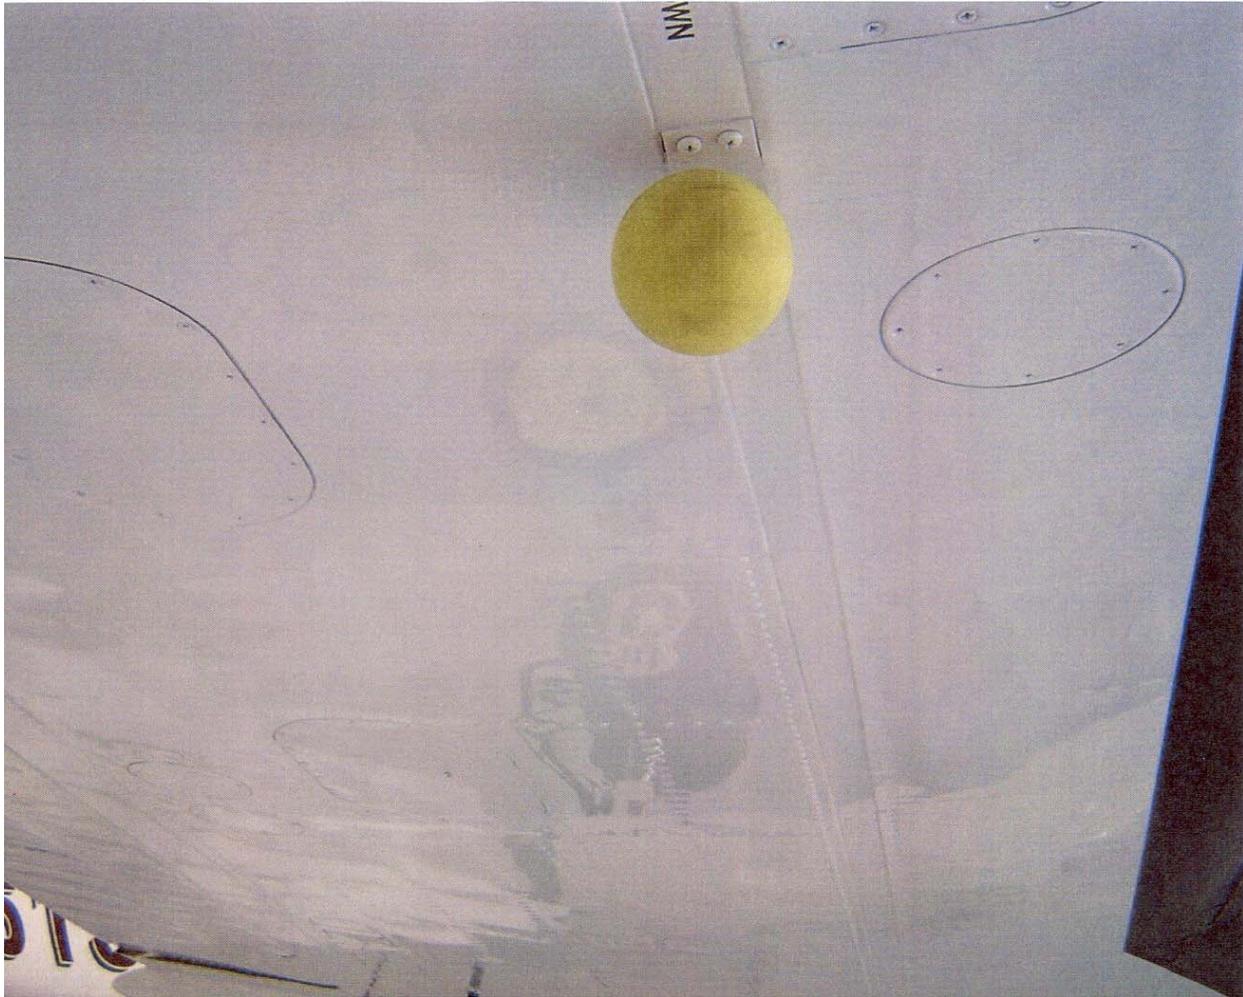
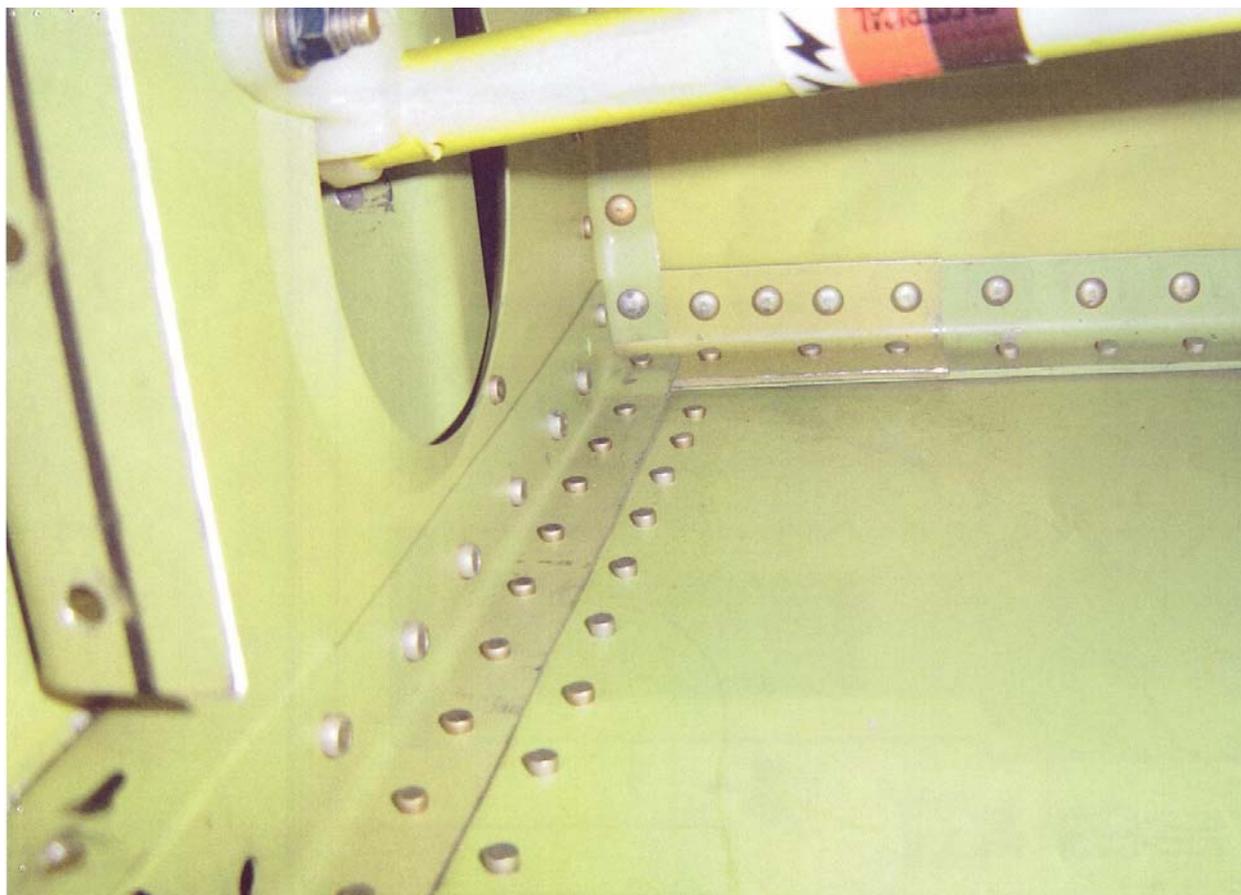
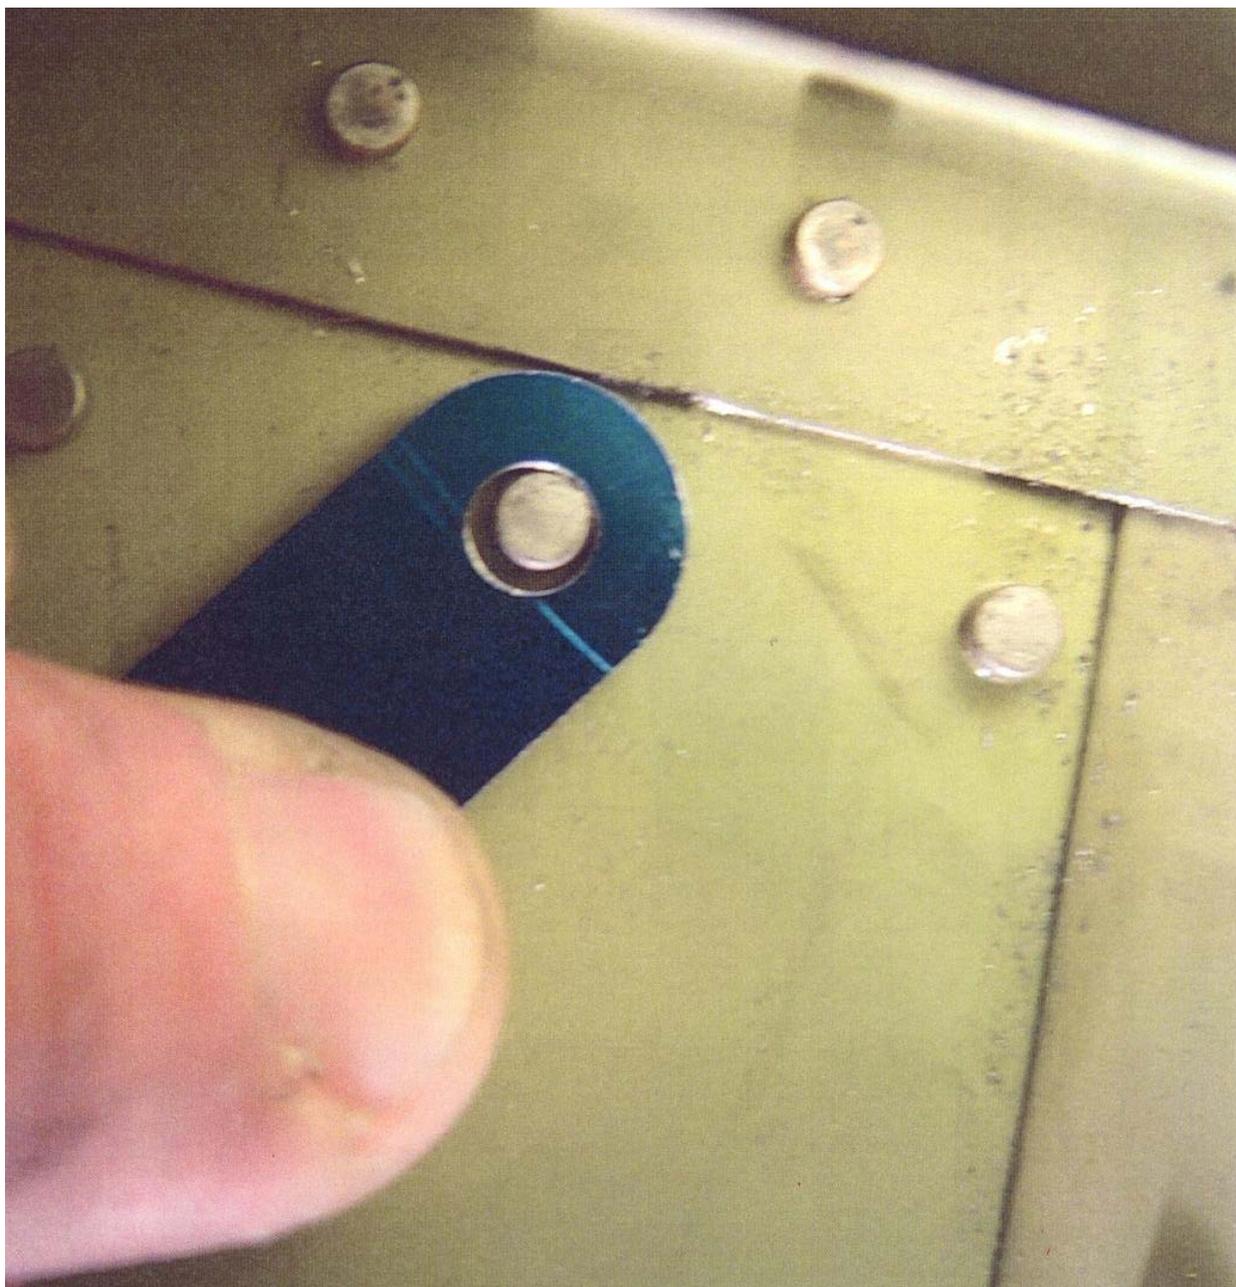
Beechcraft: B300; Loose Wing Skin Rivets; ATA 5730

"The aircraft was brought in for inspection of a double row of rivets at wing station 209.016. Rivets were found smoking, and paint was popped on the rivet heads. A borescope was used to inspect the rivet buck tails (*shop heads*). All of the rivets in the double row of the skin lap at WS 209.016 were under-driven. These rivets were installed new at the factory. The aircraft has a total time of 1,659.1 hours (*201.8 hours for the second report*). (*I*) recommend inspecting these rivets for popped paint and smoking condition (*loose rivet indicators, like streaming grease marks*) and installing new rivets per AC 43.13-1B."

(Left wing and right wing P/N's: 101-110072-27 and -28. Nice photography! Also, neat trick for head protection in the first picture—Ed.)

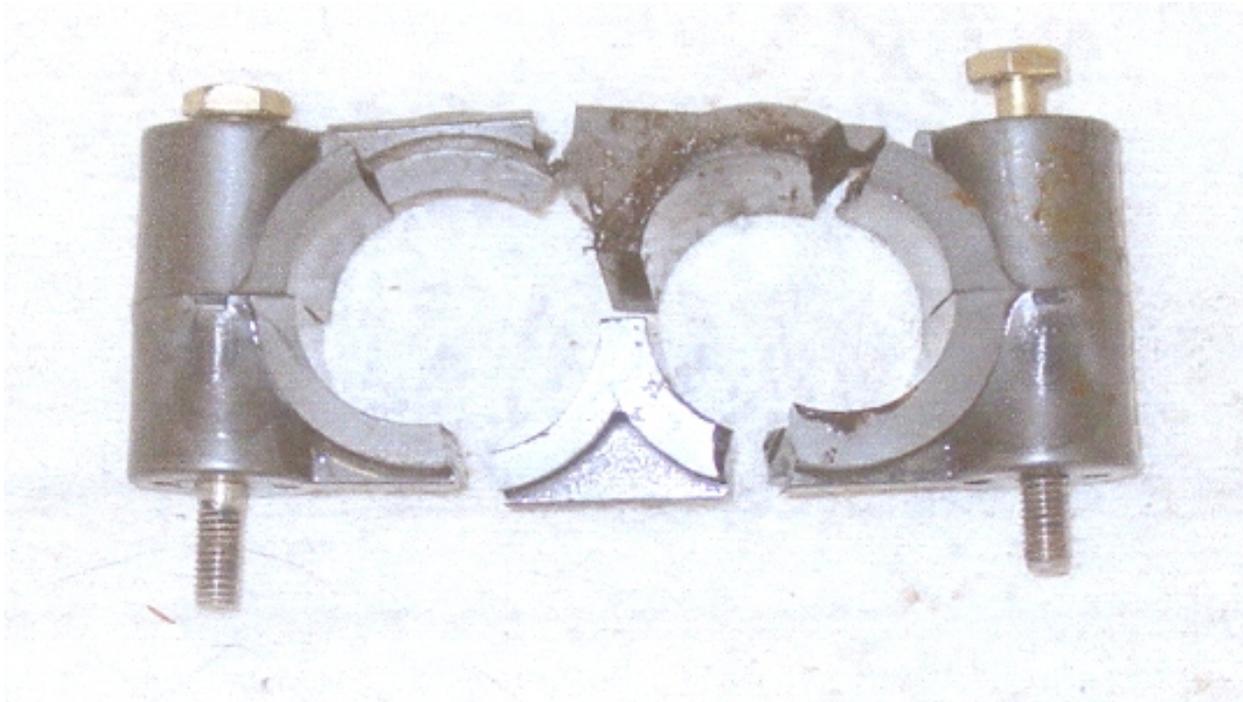
Cessna: T210M; Broken Rudder Pedal Bearings; ATA 2720

"While performing a run-up of the aircraft during an annual inspection, it was noticed that the pilot's right rudder pedal had an unusual feel while braking," states the submitter. "During the inspection of the rudder pedals it was found that each of the pilot's side, inboard rudder pedal bearing halves (P/N S1675-1) had broken into several parts. These bearing halves are constructed of plastic, and the likely reason for breaking would be due to the aging and embrittlement of the plastic. I would recommend these bearings be constructed of a material other than plastic, or have a part replacement interval before breakage occurs."

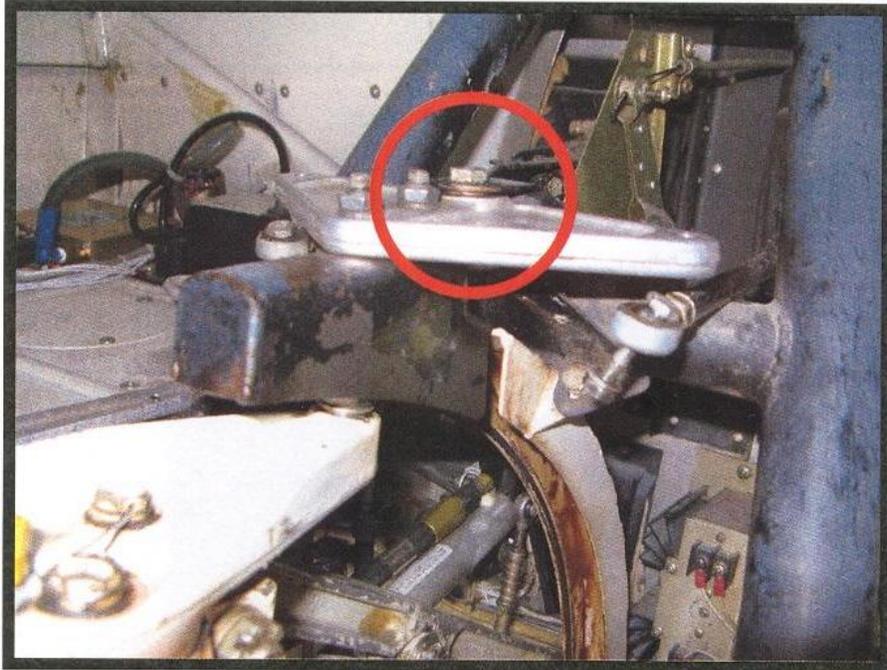
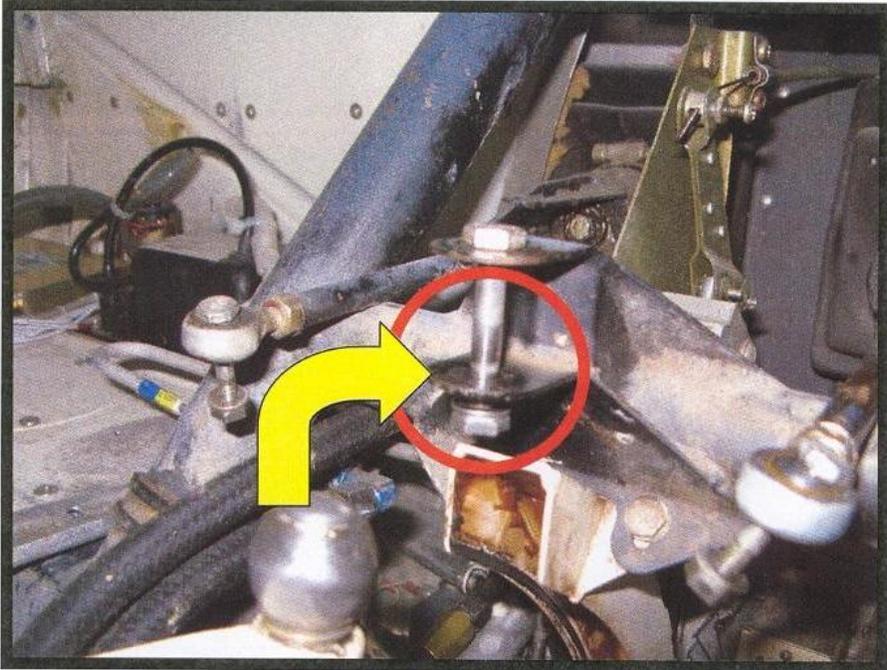
An inspector for a repair station provides the following discrepancy. "The nose landing gear mount assembly (P/N 95551-23) attachment point for the steering arm assembly (P/N 95395-00) has excessive wear at the lower mount hole. The Piper service manual does not specify a fix or allowable limits for this (*nose landing gear mount assembly, P/N 95551-23*). This discrepancy was found during an inspection in accordance with Piper Service Bulletin 1123A & B—and an annual inspection in accordance with the service manual inspection guide. Service Bulletin 1123B gives the service limits to the steering arm's center pivot bushings and center pivot sleeve. However, the more critical component—the nose gear mount assembly—is not addressed for the service limit of the steering arm mounting tabs (see attached photos). Piper should incorporate service limit data that covers the nose gear mount assembly and (*its*) repair data."

**NOSE LANDING GEAR MOUNT ASSEMBLY
LOWER MOUNT HOLE ELONGATED AT
STEERING ARM ASSY**

**LOWER MOUNTING FLANGE HOLE ELONGATED
AND AN4-14A BOLT HAS EXCESSIVE PLAY**

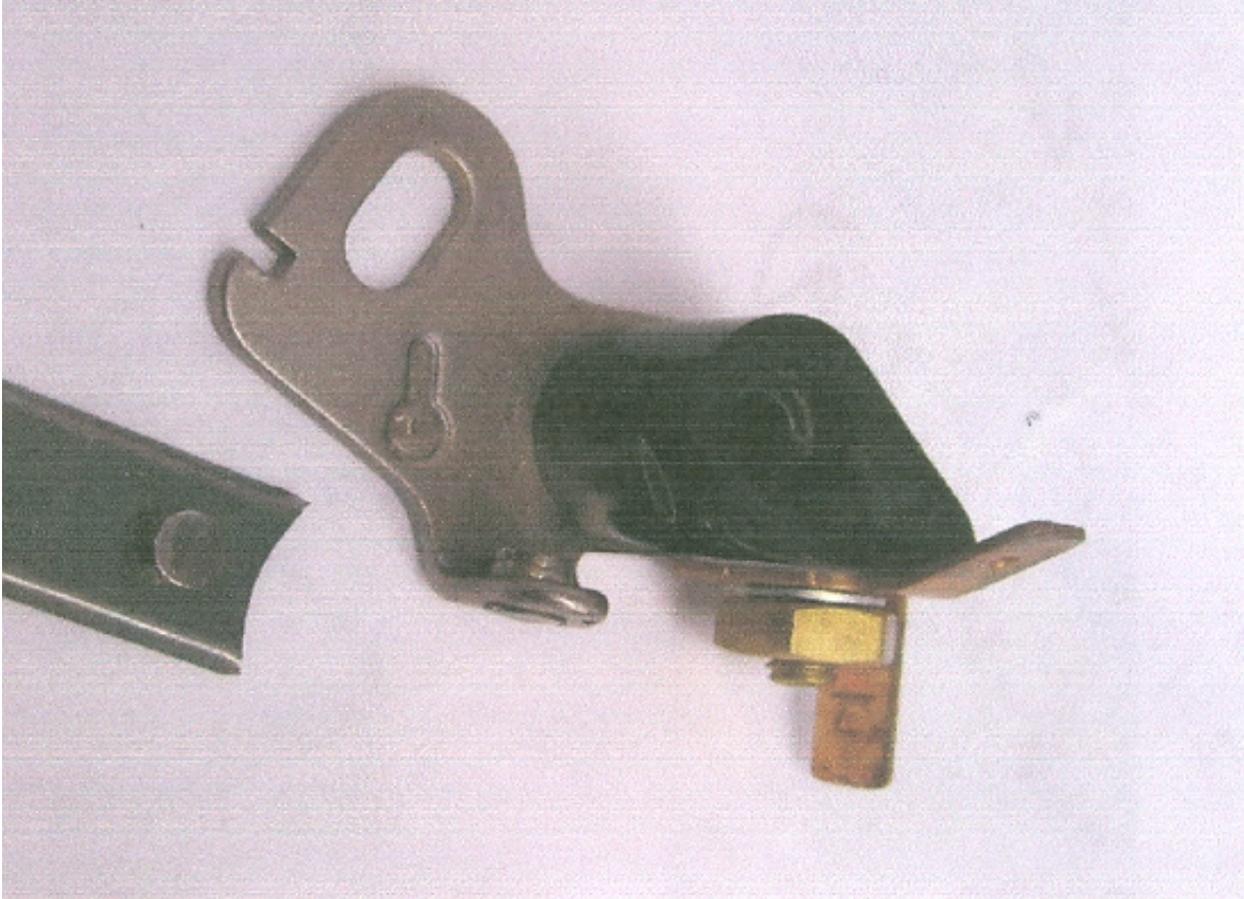
Slick Magneto: 4370; Broken Point Contact Arm; ATA 7414

An aviation mechanic states, "The arm for this magneto's contact points broke inboard of the points after only 133.1 hours time since installation."

(The parent magneto was installed on a Lycoming O-320E2D leading a Cessna 172M around the sky. Point set P/N: M3081. The SDRS database stores 14 reports for this item.)
