**Federal Aviation
Administration**

ADVISORY CIRCULAR

AVIATION MAINTENANCE ALERTS

**ALERT
NUMBER
376**

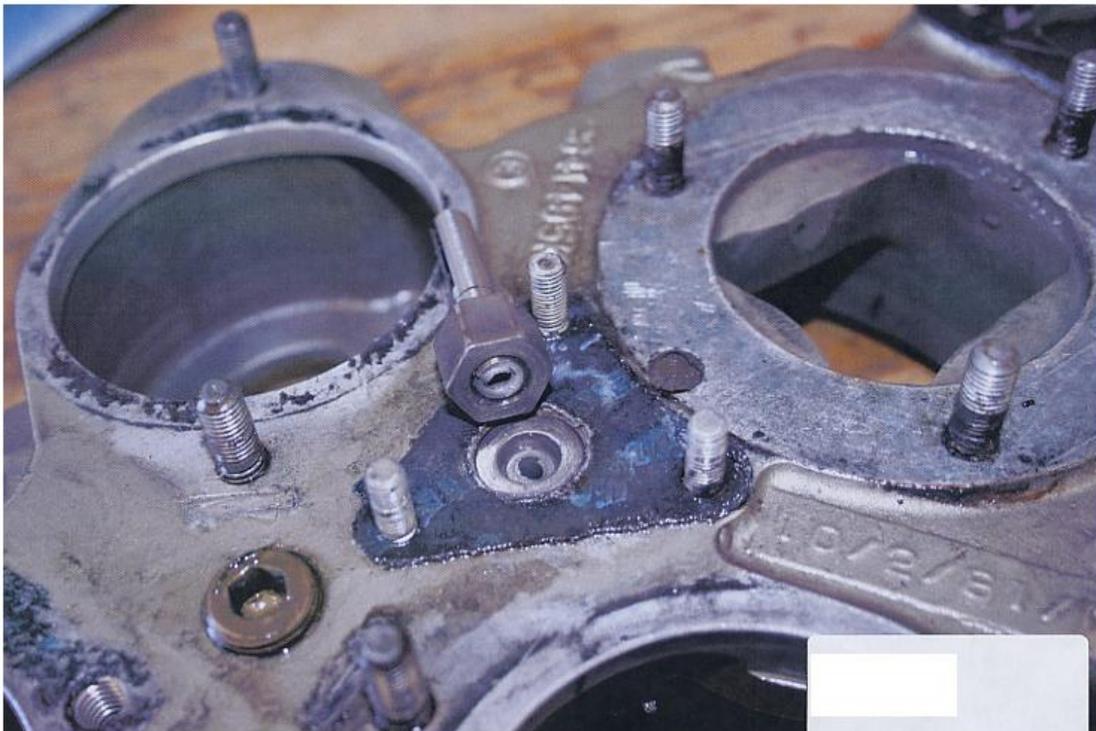
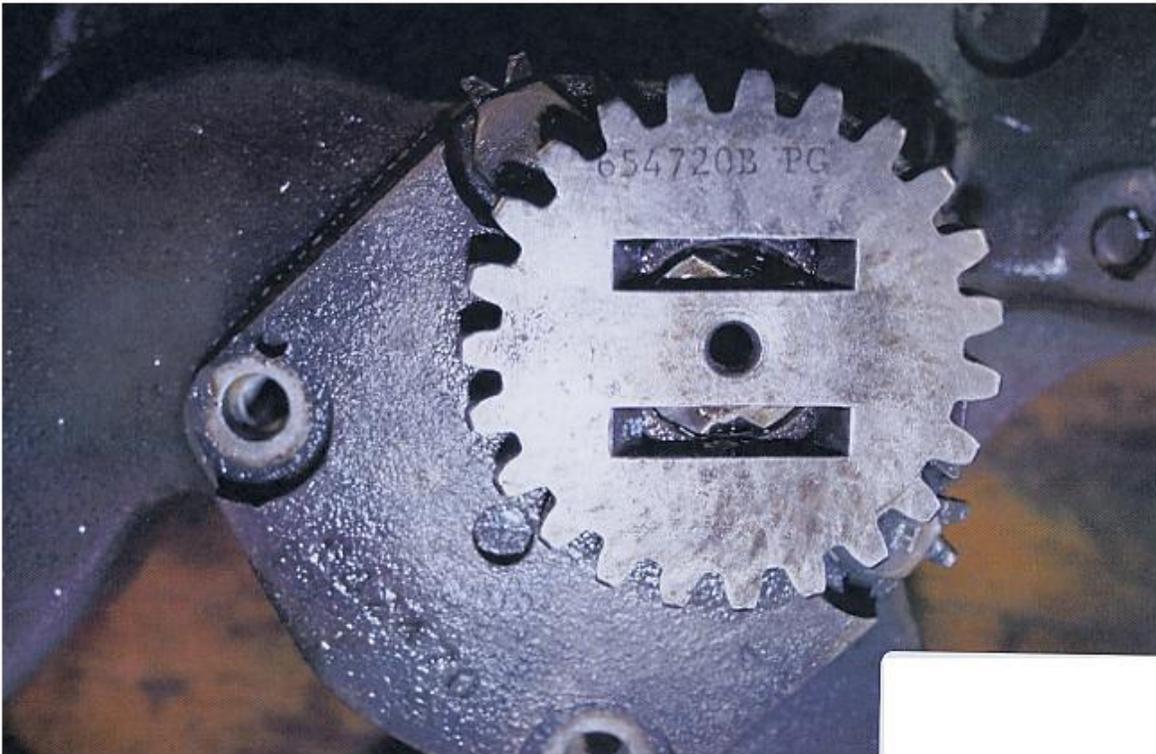
Continental: TSIO360; Failed Oil Pump Drive Shaft; ATA 8550

An unknown submitter writes, "(*There was...*) an in-flight failure of this engine due to a shaft shearing on the oil pump drive gear (*gear component P/N: 654720BPC*). (*This occurred*) while the pilot was at cruise altitude of approximately 4,000 feet MSL. He made an unscheduled landing at an airport."

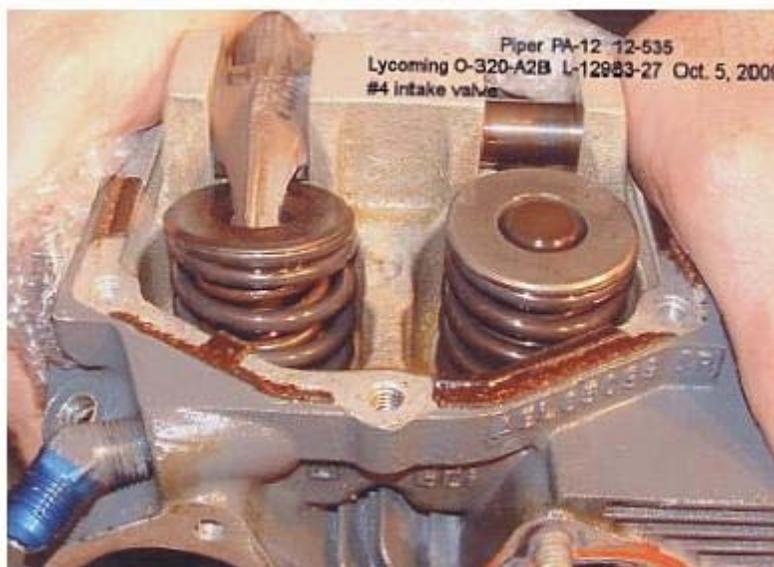
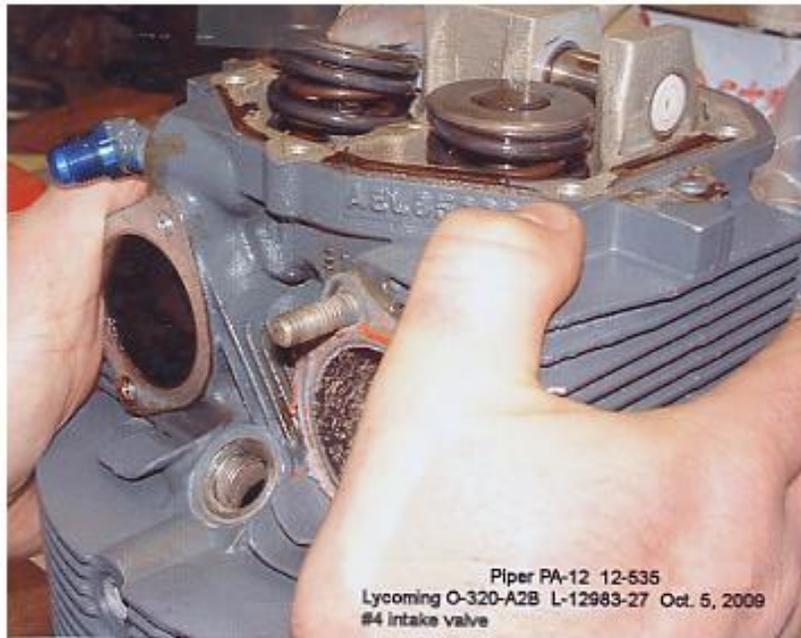
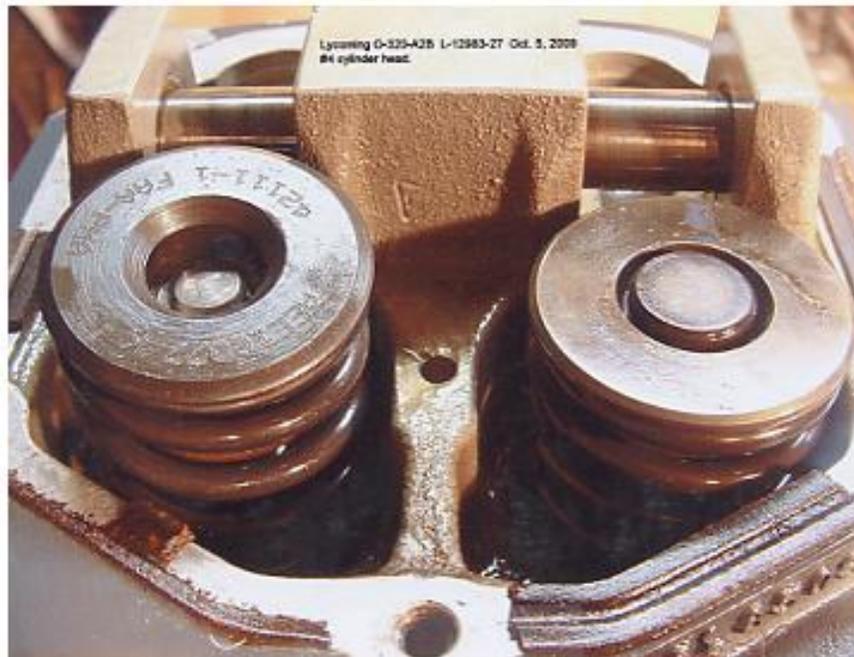
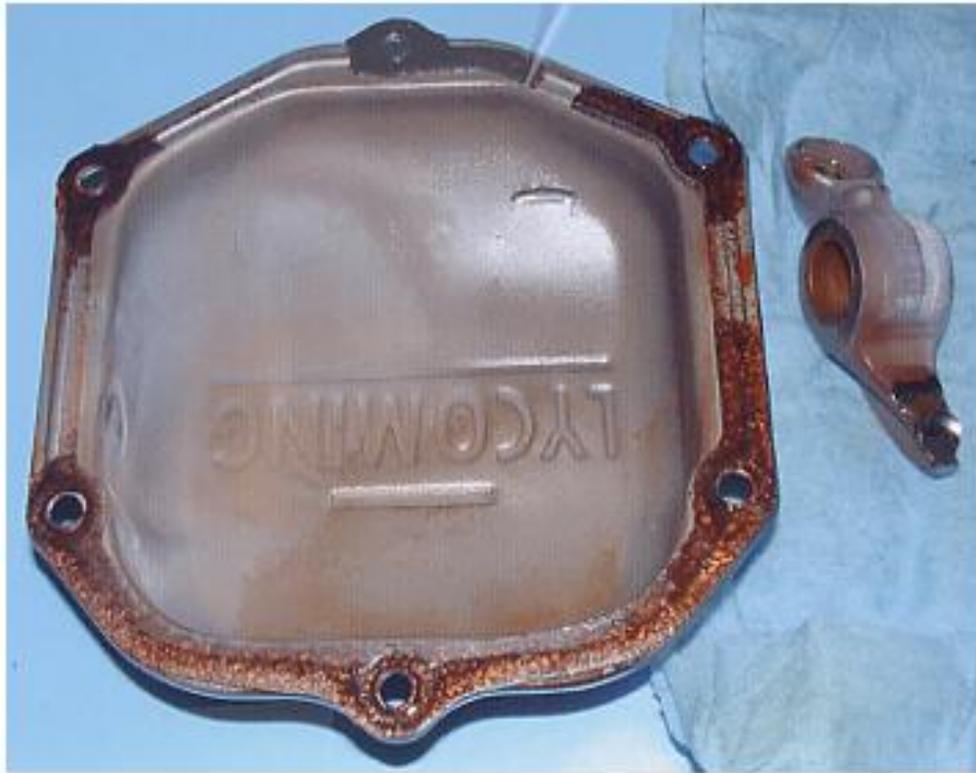
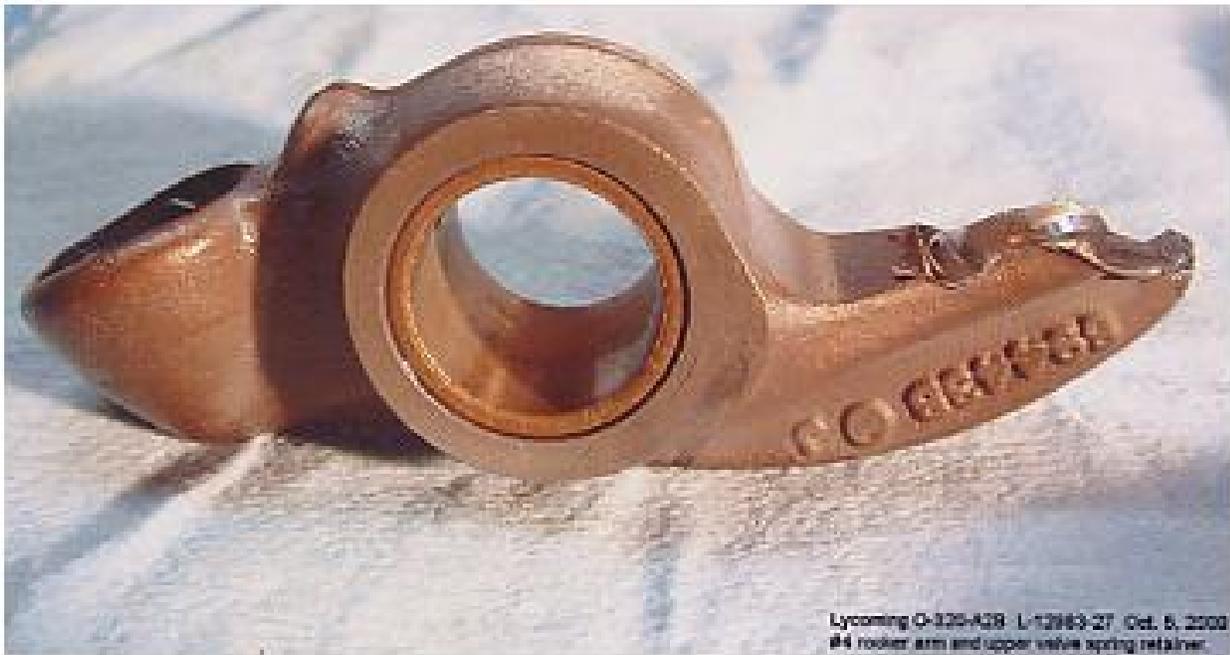
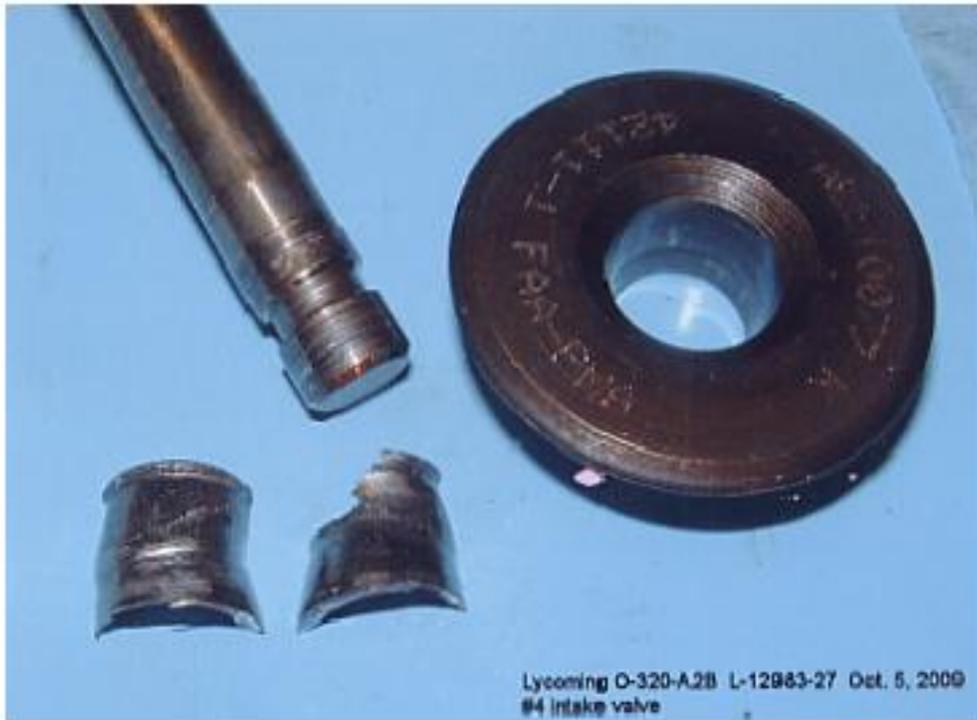
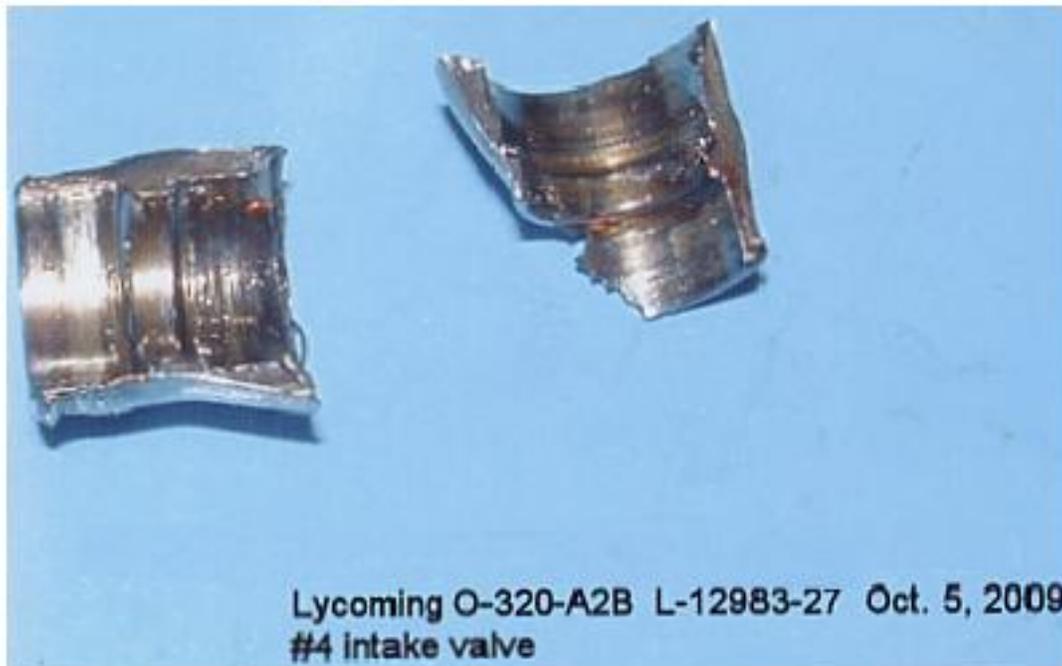
ECI Cylinder: TIST06.0CA; Failed Intake Valve Keys; ATA 8530

A mechanic holding an IA (*inspection authorization*) states, "This engine was overhauled in March of 2007 and currently has 237.3 hours since overhaul. The material at the lower end of the intake valve keys wore away, allowing the upper valve spring seat to move too high on the valve stem. This caused the rocker arm tip to wear abnormally, resulting in most of the rocker arm tip wearing away or breaking off. The upper valve spring seat continued moving up the valve stem until it began to make contact with the neck of the rocker arm. This caused the spring seat to tilt at an angle, eventually tilting enough to make contact with the rocker cover, wearing a ½ inch cut through the cover. The pilot did not notice any roughness in the engine's operation. He said that it felt like the engine might have been a little underpowered and not reaching full RPM at takeoff. The engine normally doesn't make full takeoff RPM on the first flight of the day if it has not had enough time to warm up and the oil is still cool." "*(The pilot)* assumed this was the case and continued with the takeoff. The engine ran smoothly throughout the flight. Upon landing, he noticed an oil streak running along the side of the aircraft. After opening the cowling, he found the cut that the upper valve spring seat had worn through the rocker cover. Because the aircraft was not at location where tools and supplies were available, we decided to replace the entire cylinder assembly. The cylinder was returned to ECI for warranty consideration."
