ADVISORY CIRCULAR

43-16A

AVIATION MAINTENANCE ALERTS

**ALERT
NUMBER
380**

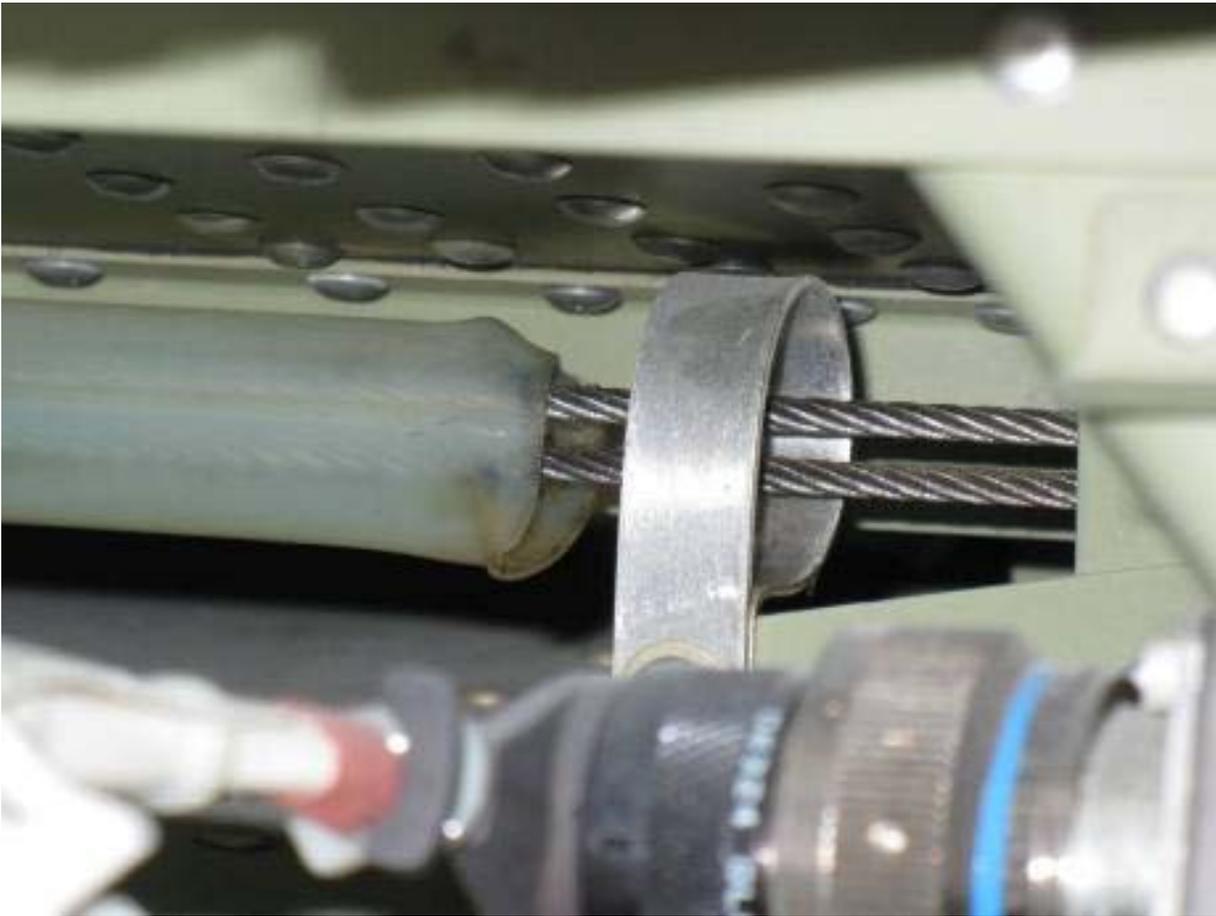
Cessna: 560XL; Rudder Cable Guide Tube—Too Short: ATA 5320

A general aviation submitter writes, "The rudder control cables pass through a plastic guide tube between the wing and fuselage. This guide tube is not supported at *(the)* aft end. It is too short to pass through the supplied support clamp. Service Bulletin (SB) 560XL-27-20 addresses this condition, but *(it)* is not applicable to this serial number aircraft—*(as)* the intent of the service bulletin was incorporated during production. Replacement of the guide tube with a longer tube would correct the problem, but due to access difficulty, replacement is not really feasible. The manufacturer supplied drawings to correct the situation on this aircraft." *(No part number accompanied this report, but a great photo makes up the difference--Ed.)*

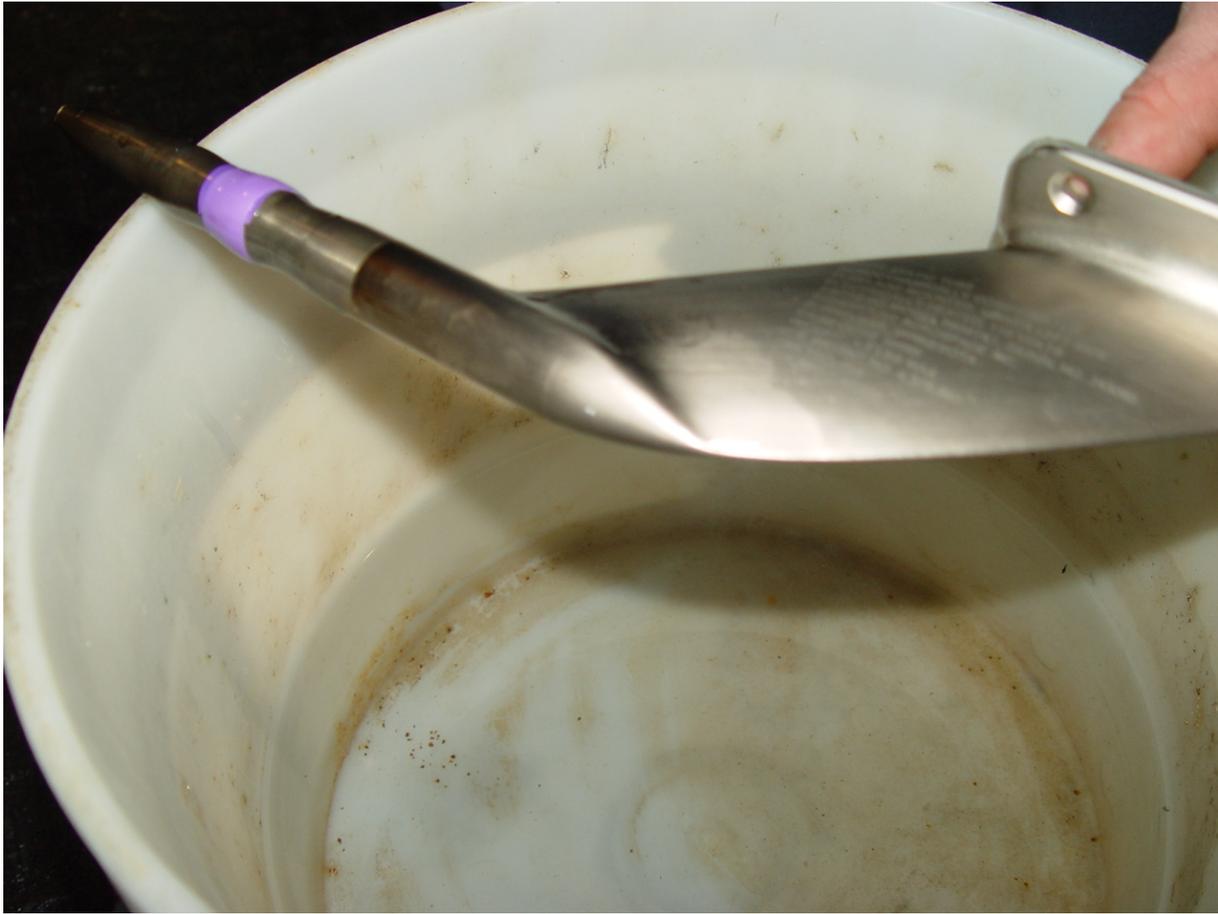
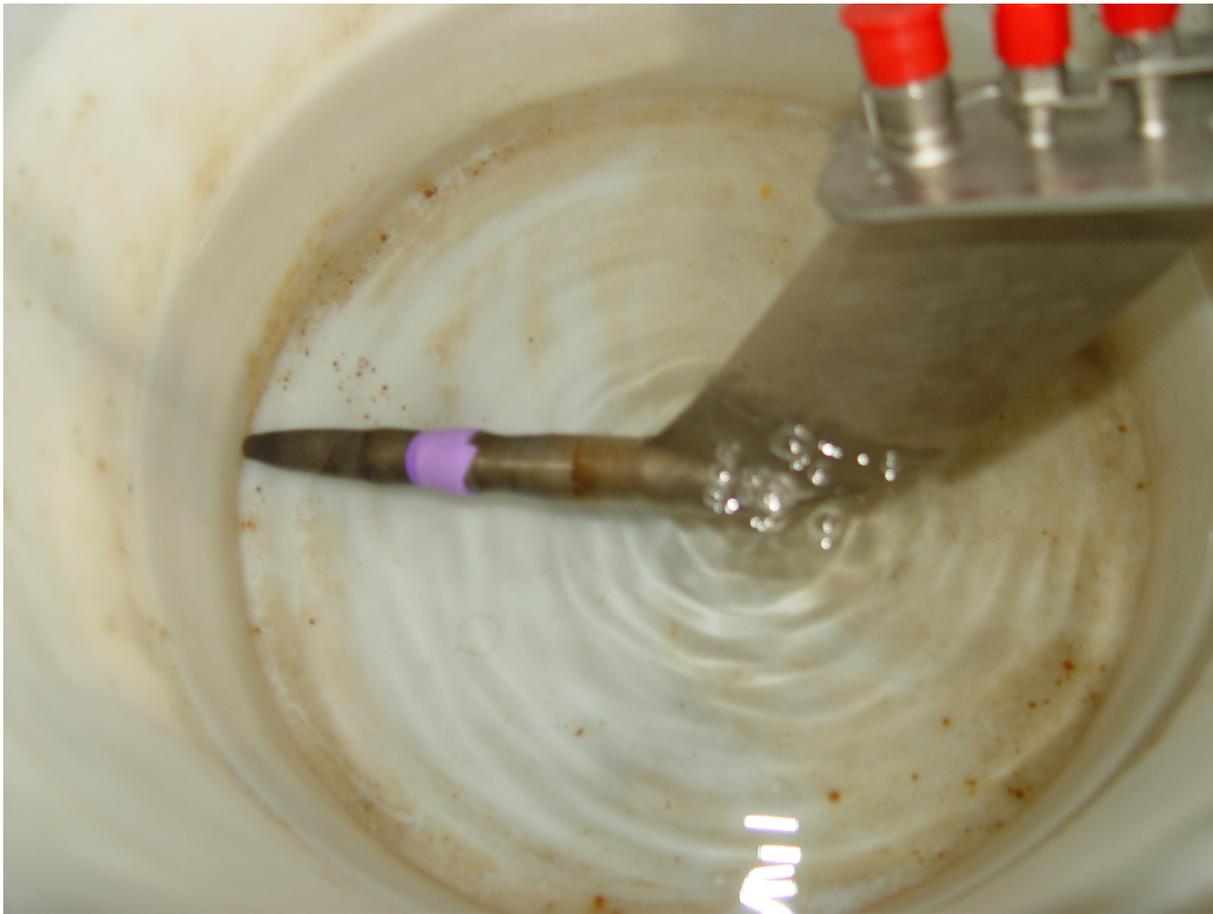
Gulfstream: GV; Leaking Pitot Probe; ATA 3411

The Chief Inspector for this corporate aircraft states, "The pilot wrote up an altimeter split, with MADC (*Micro Air Data Computer*) number two showing 240 feet difference from MADC numbers one and three. Maintenance performed a pitot/static leak check which (*indicated*) a static leak beyond limits for MADC number two. (*We*) troubleshot the system and found the lower left pitot/static probe to be leaking. Upon examination of the probe, tooling marks were found from the manufacturer at the aft part of the tube—resulting in small holes and (*allowing*) static air pressure to leak out." (*Pitot probe P/N: 0856TK1.*)

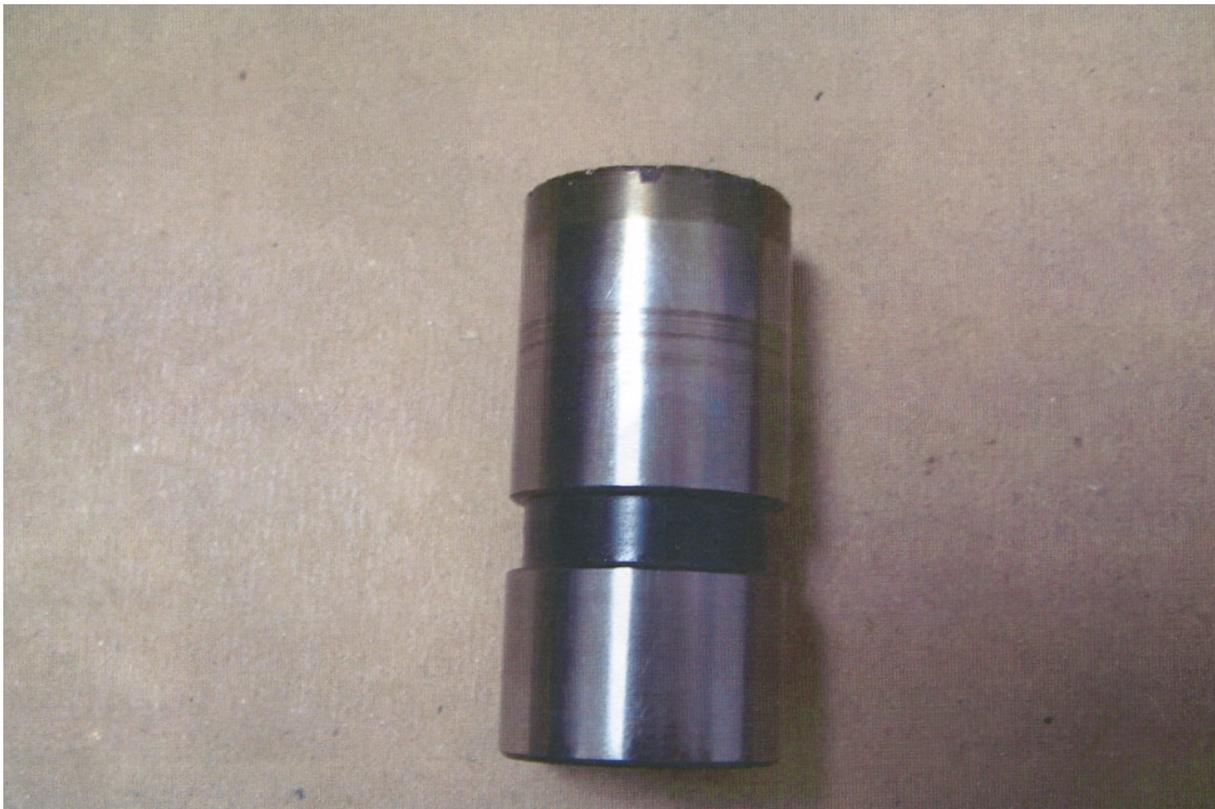
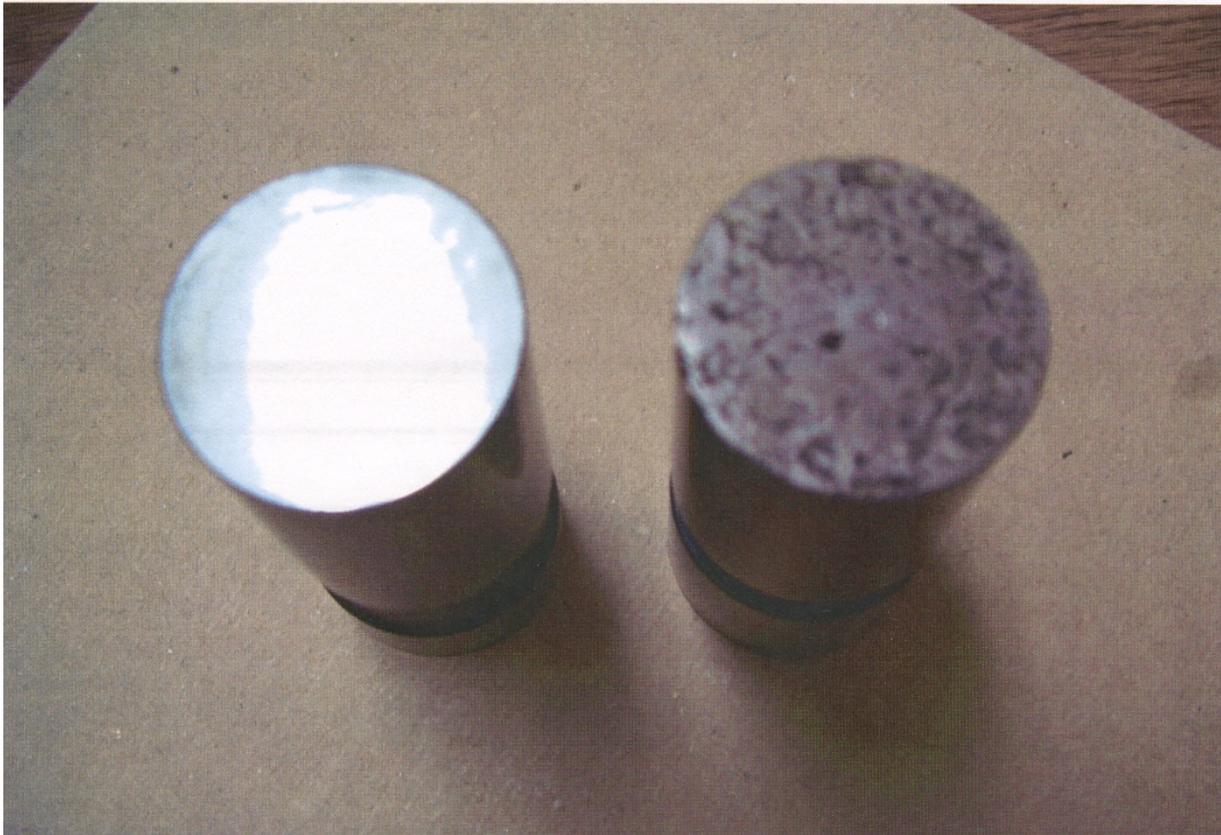
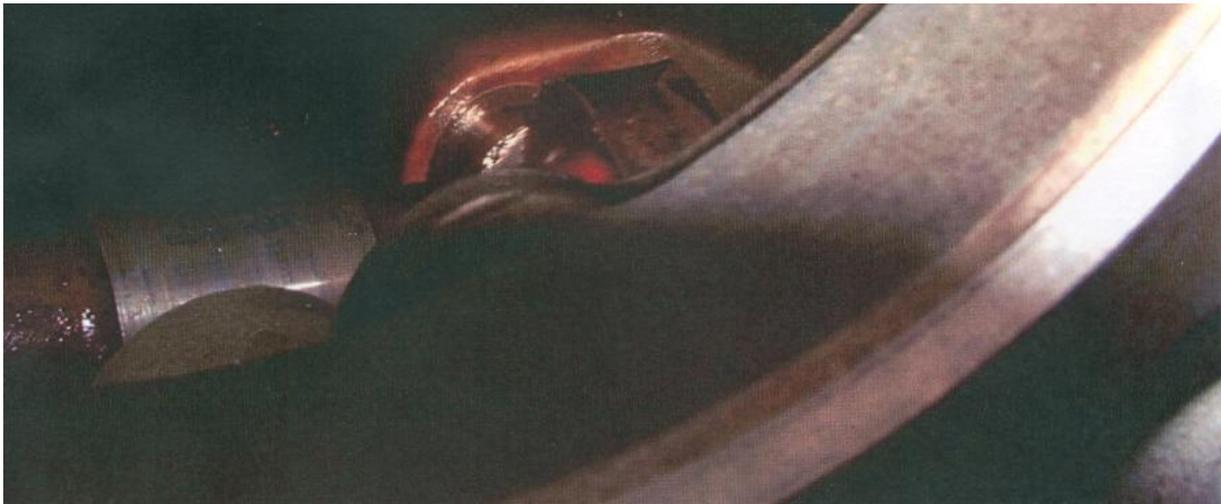
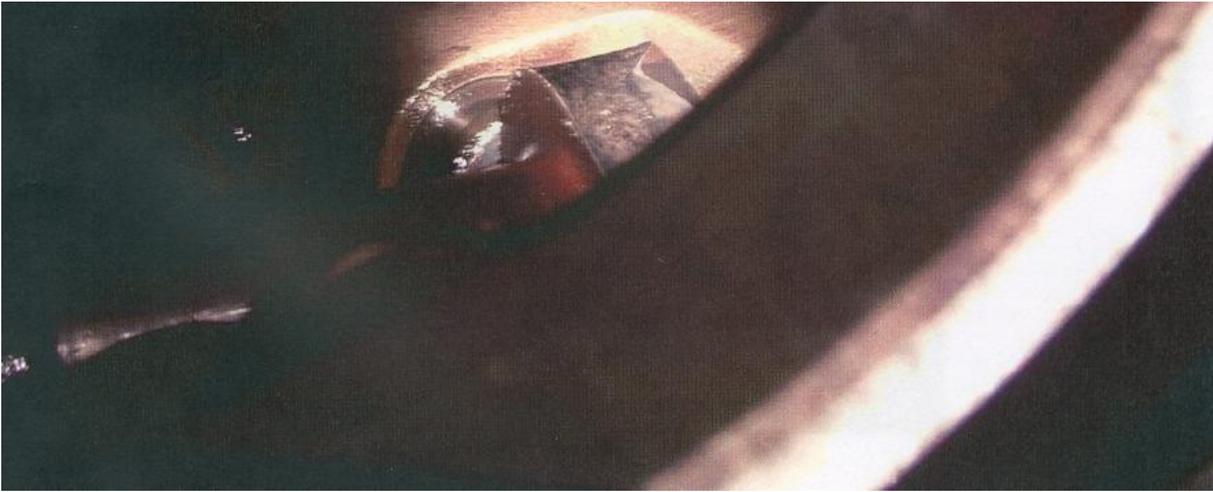
Continental: IO-550C; Lifter Spalling, ATA 8530

An A&P repair station mechanic says, "(I) removed the number six cylinder for repair...." (*Not provided is the discrepancy for initiating this cylinder removal.*) "While inspecting the associated components I found spalling on the face of the number five exhaust lifter (P/N 653888)—and on the numbers five and six intake lifters, causing damage to the camshaft lobes."

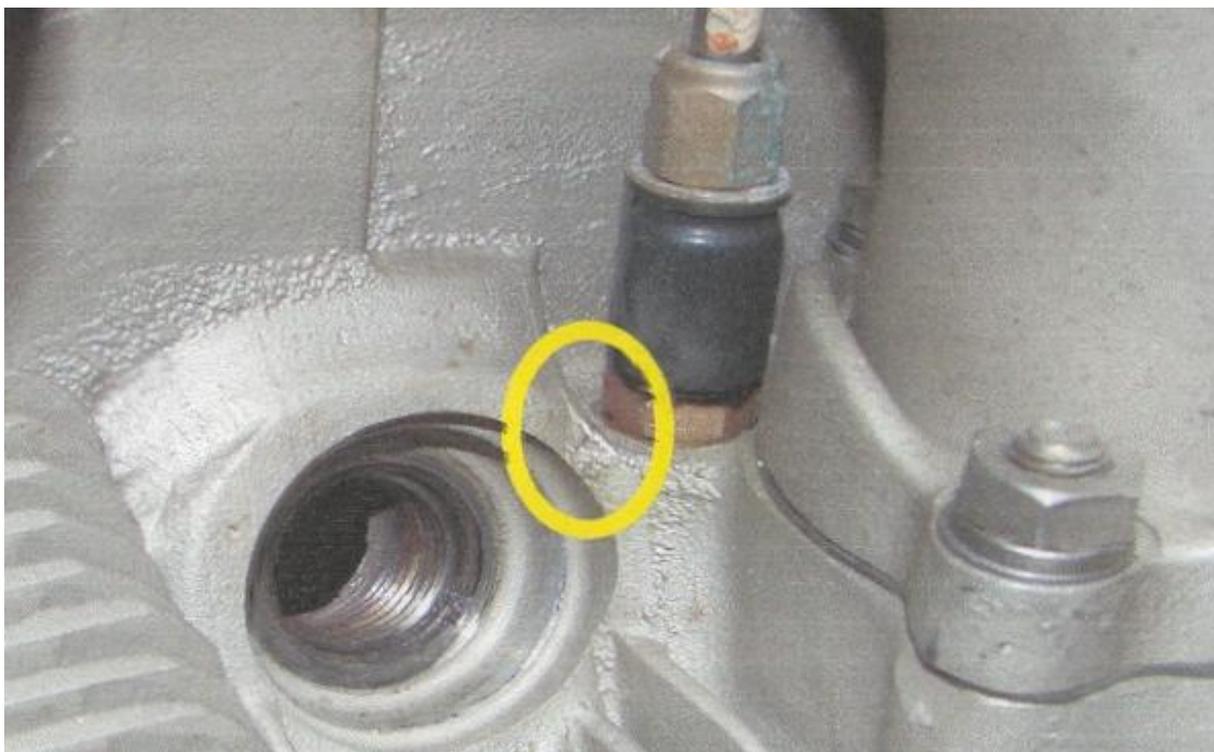
Continental: IO550-N37B; Cracked Cylinder, ATA 8530

The chief inspector for a repair states, "During an Annual Inspection (I) found a crack (*running*) from the fuel injection nozzle port toward the spark plug port on the number five cylinder (P/N 655932). It has 368.9 hours since new. The engine was manufactured in October of 2006 and installed in the aircraft in November...."

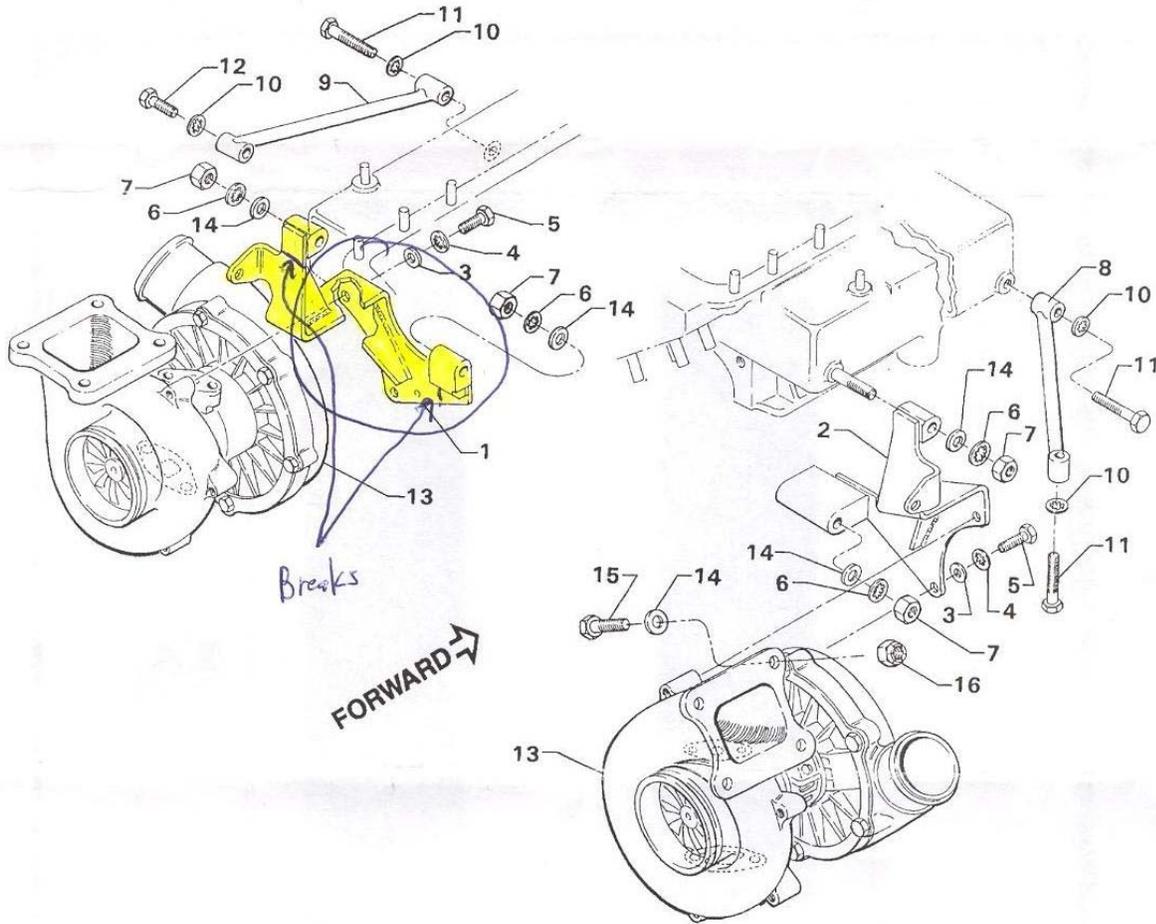
Figure 28. TURBOCHARGERS, SUPPORTS AND ATTACHING PARTS

"During an Annual inspection," says a repair station technician, "the left turbocharger mounting bracket (P/N 07A19870) was found broken in 2 places. The cause was probably a combination of heat and vibration."

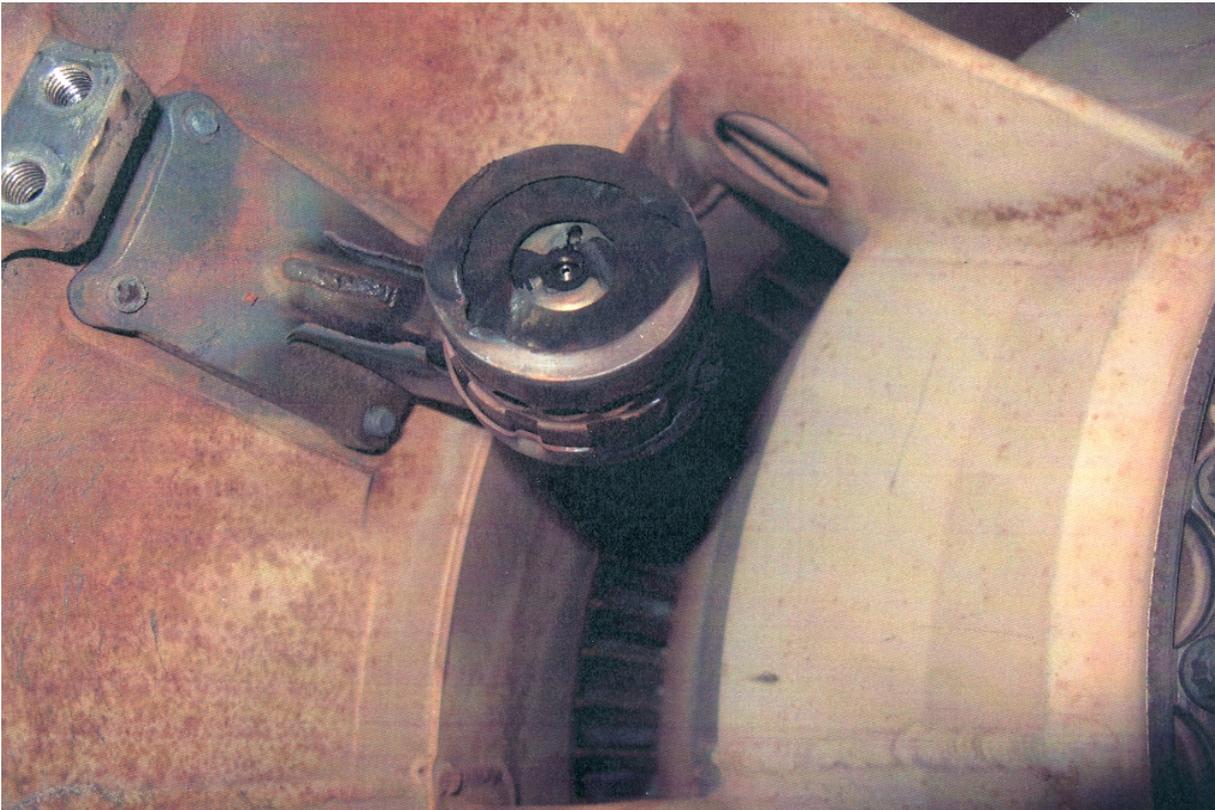
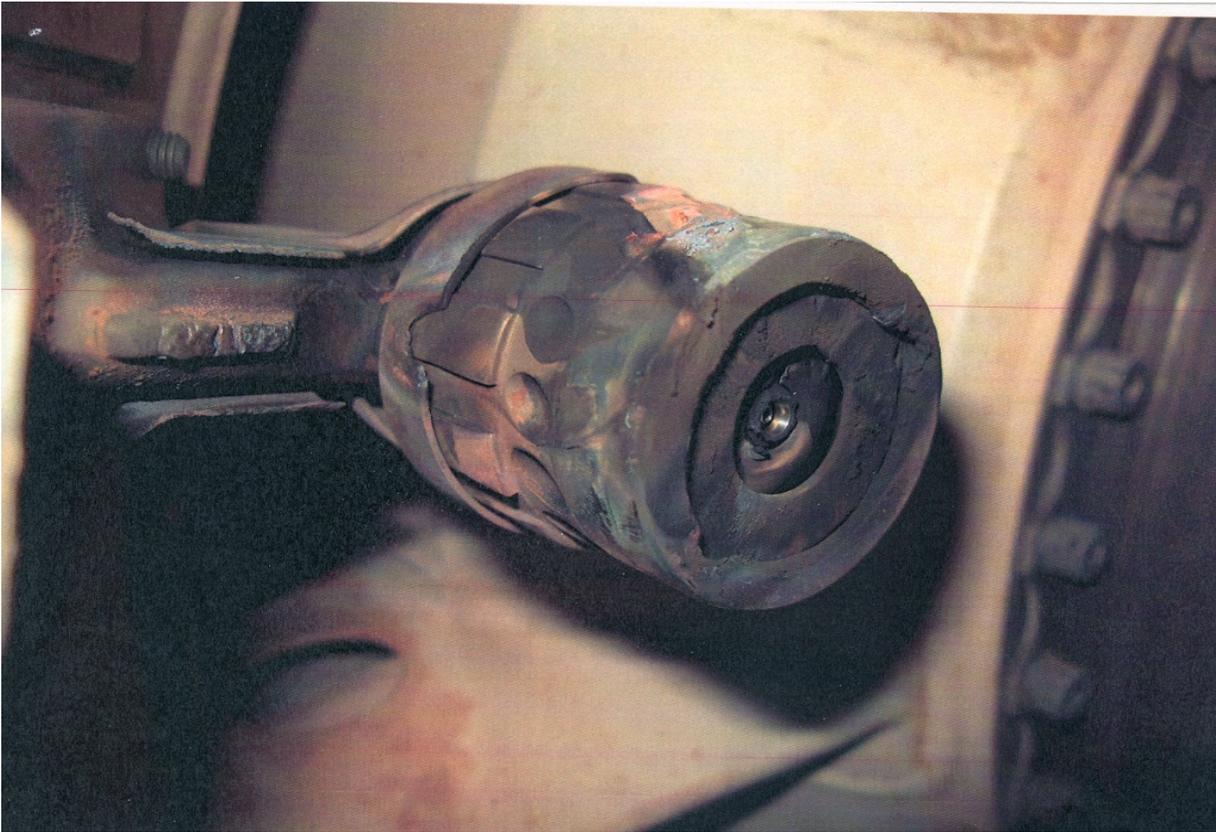
Pratt & Whitney: JT8D-15A; Burned Fuel Nozzle; ATA 7313

A technician for a New Zealand repair station writes, "As a result of burned T2 (*turbine*) vanes the combustion module was disassembled. The number eight fuel nozzle retaining nut was found loose—with its lock tab intact. Several areas of the fuel nozzle body, combustion can swirl vanes, internal louvers and the number one liner were burned away. The diffuser case buckled from heat around the number eight fuel nozzle mount pad, and heat soak was evident on both the primary and secondary fuel manifolds. Breakout of T2 vane (*material*) due to heat has resulted in extensive FOD to the LPT (*low pressure turbine*) module and the trailing edge of T1 vanes.

"The number eight fuel nozzle (*P/N 809884-001*) was removed from service and forwarded to the overhaul vendor for disassembly and a detailed findings report. Other unserviceable parts will be repaired/replaced as required."

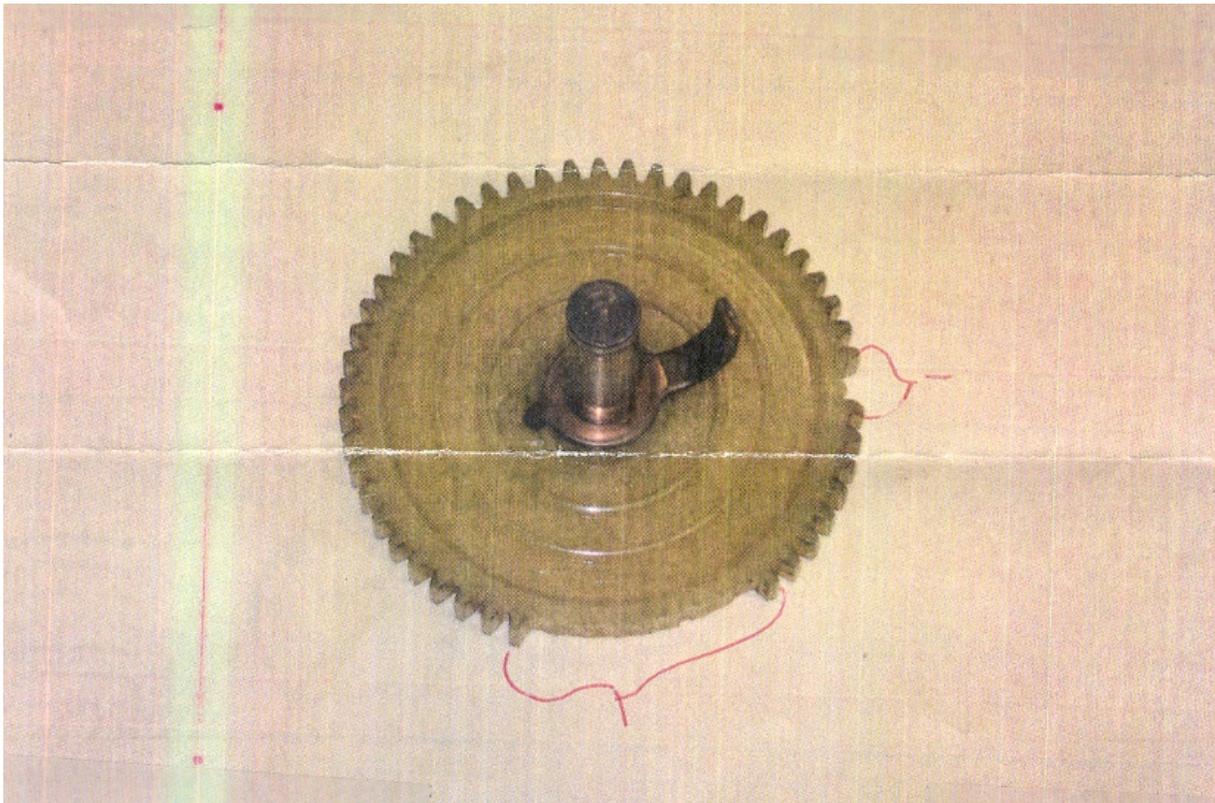
Report 1: "During pre-takeoff engine run-up, it was noted there was some engine roughness. The magneto check indicated the L/H magneto was not firing properly (the engine was quitting). The magneto was removed and opened for inspection. (*Subsequently,*) the distributor gear was found to be missing approximately ten teeth in succession and another (*tooth*) missing about an inch away. This caused the magneto to become untimed to itself—and not fire properly. The logbook inspection revealed the 500-hour magneto inspections had been complied with at the correct intervals. There is no indication what caused the teeth to fail." (*Distributor gear P/N: 10-357586.*)

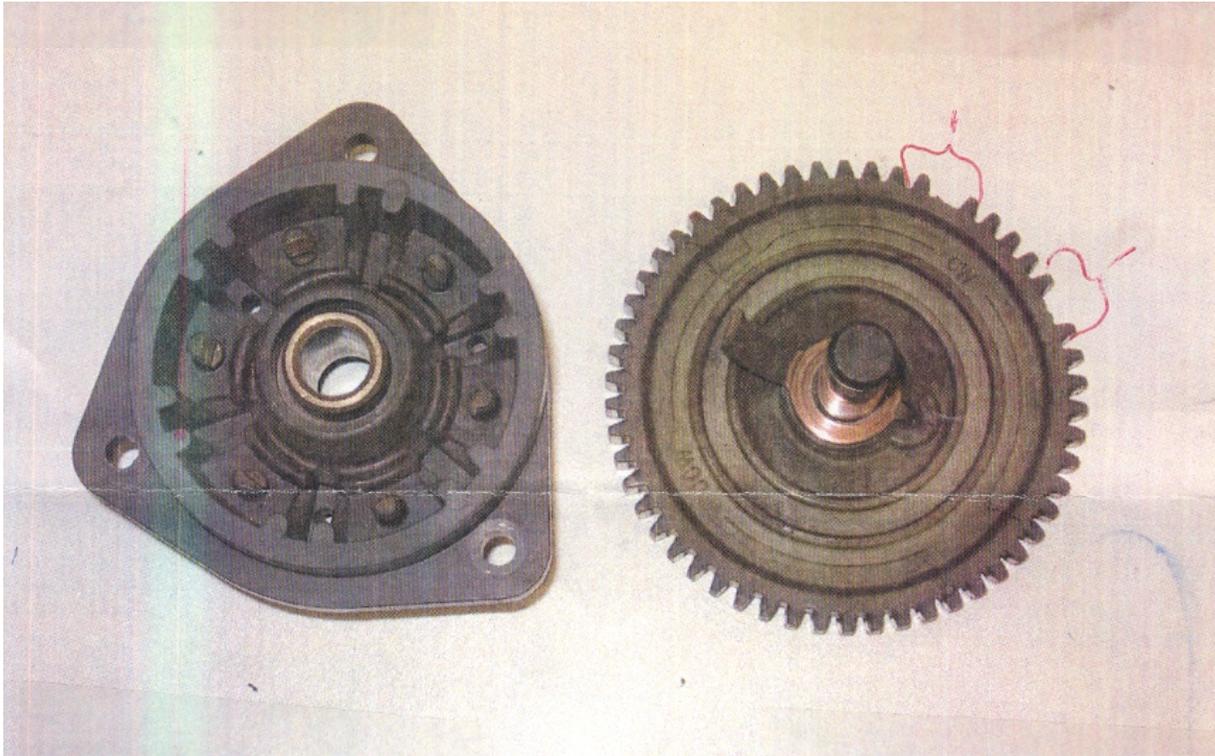
Report 2: "The magneto was removed from the aircraft for routine, 500-hour magneto inspection. During this inspection, the distributor gear was found to be missing a few teeth. The electrode was loose in the distributor gear and had worn the distributor block electrode posts. Both parts were replaced. There is no indication of what caused the teeth to be broken off or the electrode to become loose—(*neither*) was there an indication during pre-inspection run-up that there was a problem with the magneto internal components."
