U.S. Department
of Transportation

**Federal Aviation
Administration**

ADVISORY CIRCULAR

AVIATION MAINTENANCE ALERTS

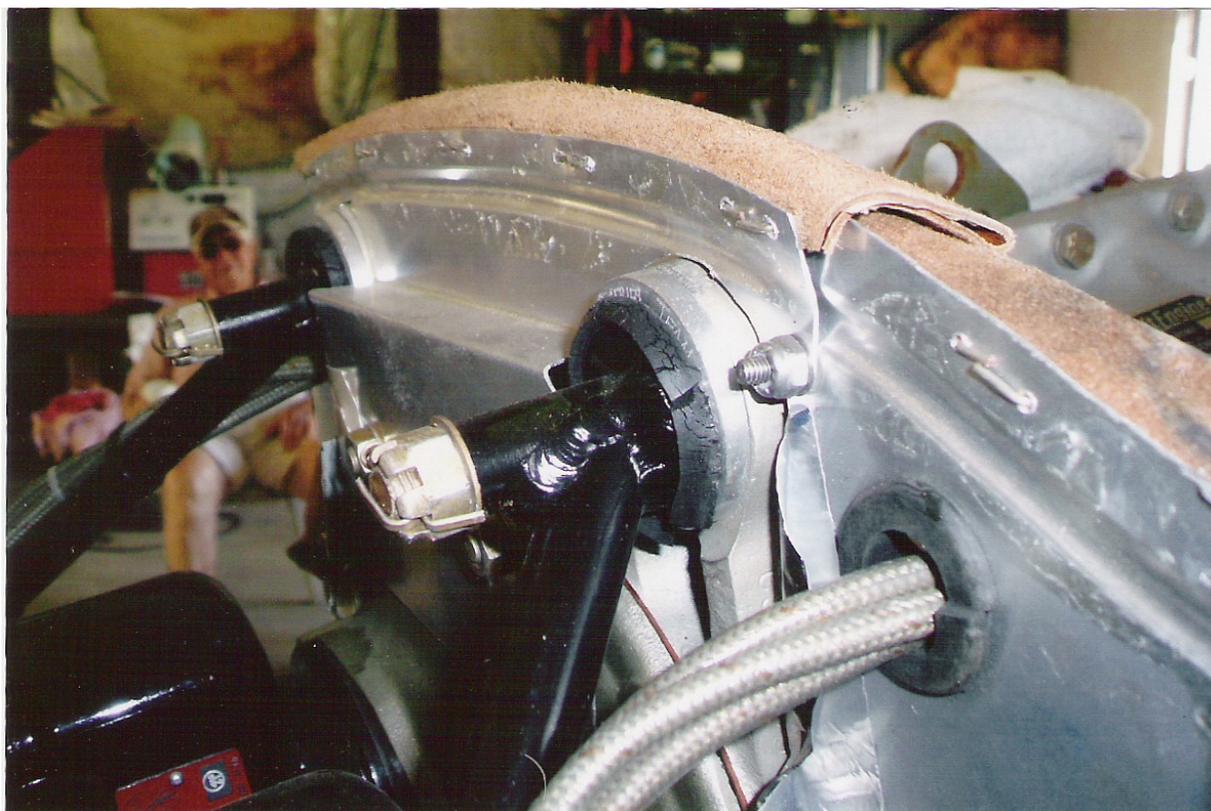
Airtractor: AT301; Cracked Isolator Mounts; ATA 7120

An unidentified submitter writes, "The engine isolator mounts (P/N 22387) were replaced when the aircraft was restored. At the first Annual Inspection (with approximately 60 hours total time) these mounts showed excessive cracking and deterioration—requiring replacement. The lower mounts showed the most amount of wear, with the area around the metal engine mount cracked two-thirds way around, *(and there were)* pieces missing. *(I)* was told by the aircraft owner that he had heard the *(rubber)* mount composition had recently been changed. I have no recommendations at this time, other than to closely monitor *(these mounts)*."

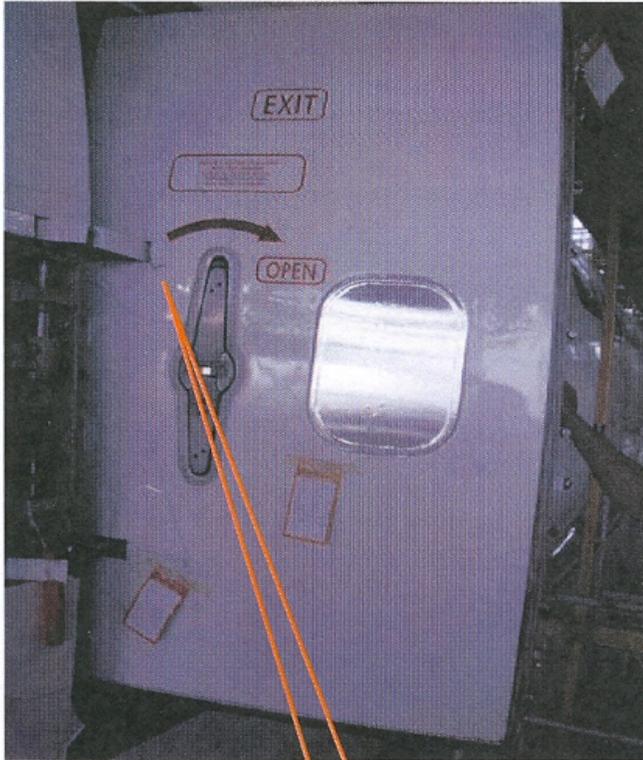
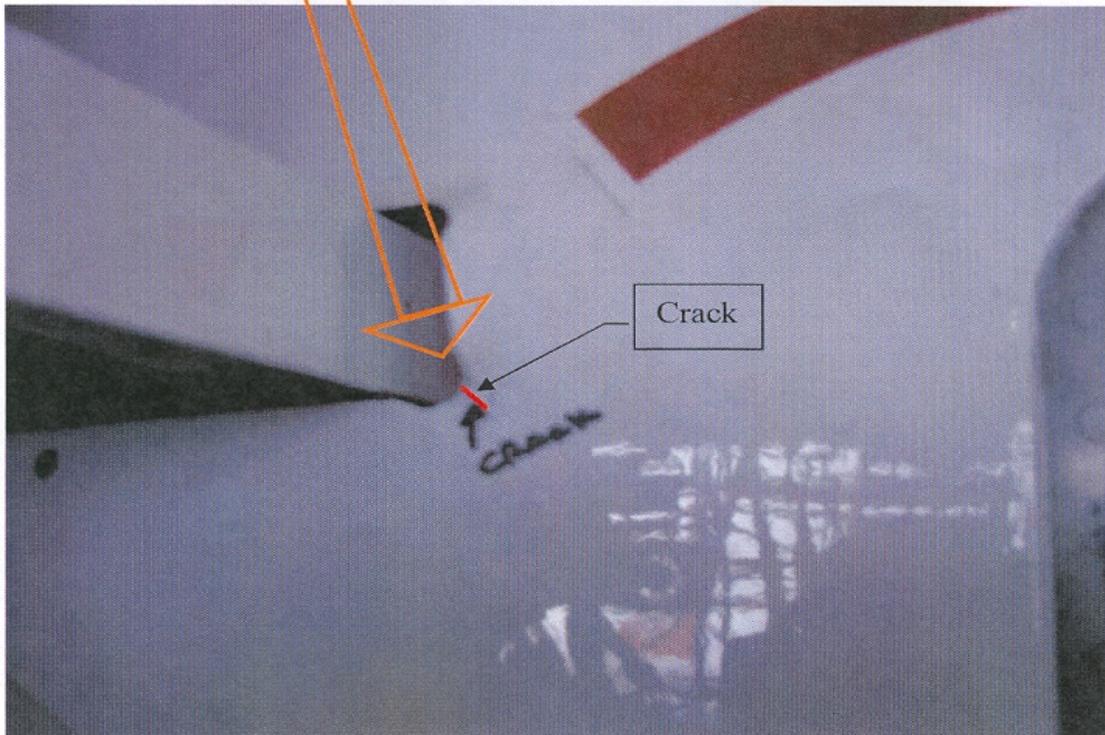
RR551 MED No 1LH – Hinge Cut Out Doubler Crack

A very short submission from an unknown source writes, "The main entry door's number one upper outer skin doubler (*has a*) crack 0.35 inches at the upper hinge door (*mount*)."

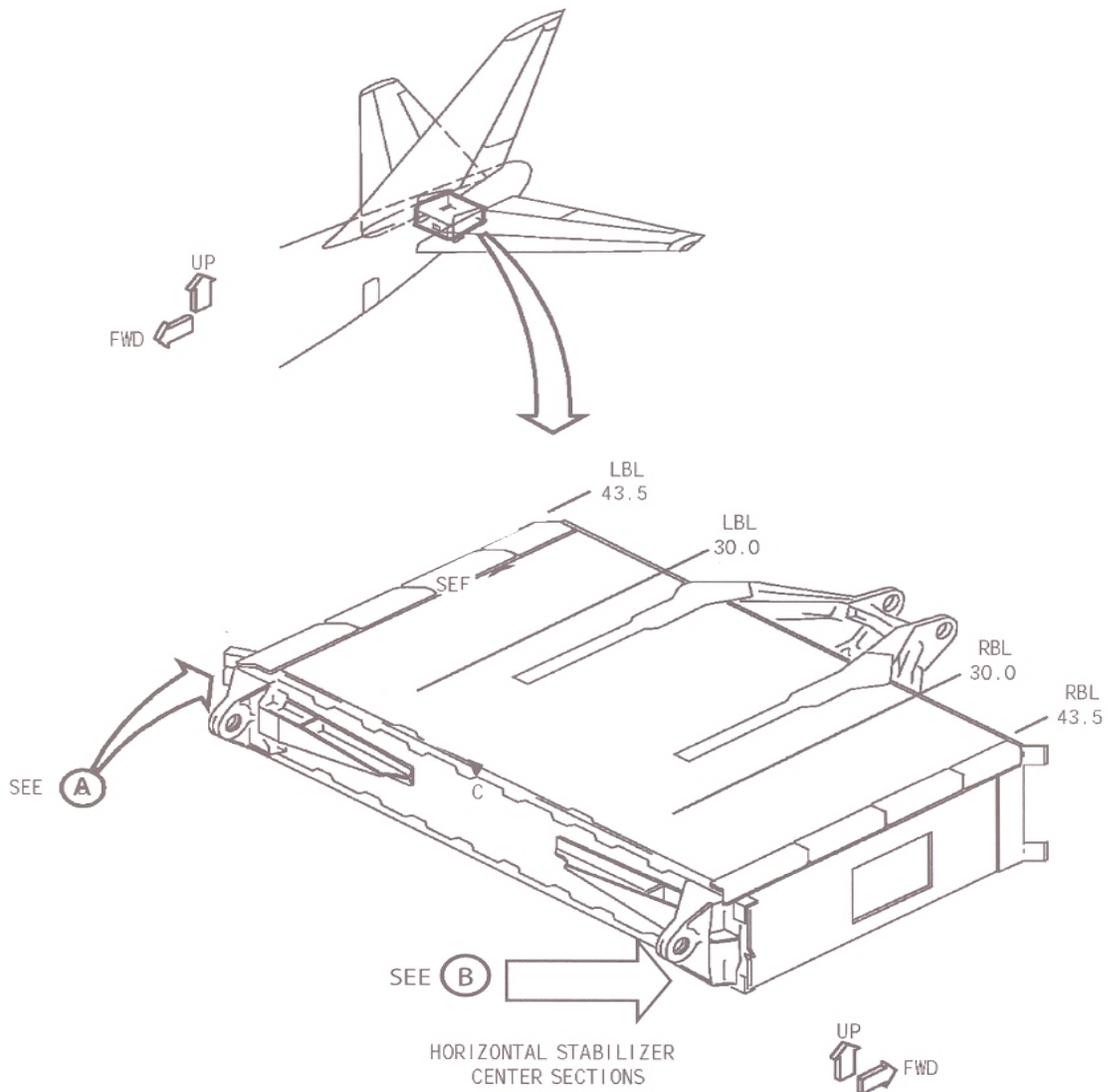
RR551 - RH & LH Horizontal Stabilizers Hinge Fittings Crack

The previous submitter provides another discrepancy report stating, "The L/H and R/H horizontal stabilizer hinge fitting had two cracks each: 0.8 and 0.9inches, and 0.85 and 1.1 inches, (*respectively*)."

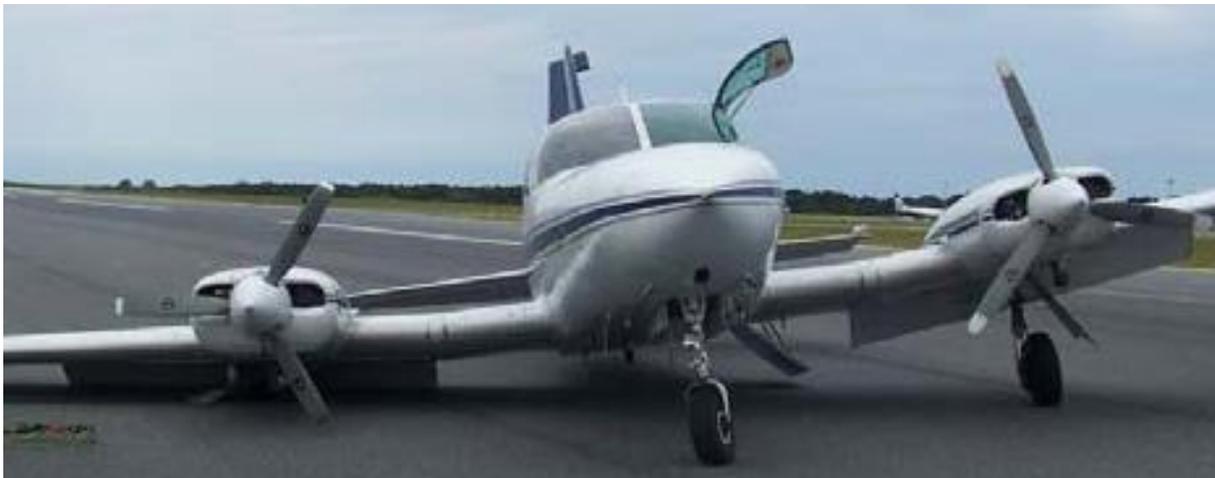
The gear failure depicted below occurred on an airplane estimated to have 30,000 landing cycles during 12,000 hours of flight time. Search of the FAA's *Service Difficulty Reporting System* (SDRS) database generated 28 failed gear reports (for these models) in a production fleet of 2,290 airplanes. Model 402C alone produced 21 of these reports—681 of these aircraft were built between 1979 and 1985.

Photo 1: Cessna 402C with a collapsed main landing gear.

Cessna is working to develop Supplemental Inspection Documents (SID; number 32-10-05) for these specific aircraft. They have developed a *surface eddy current* process to inspect for cracks on the main gear (upper barrel), targeting both the actuator and upper torque link attachment fittings (photo 3). The crack initiating this failure can just be seen in the last picture—an internal view of the gear cylinder where this kind of defect may first be detected. The Cessna inspection requirement is expected to be available by August, 2011. It is scheduled to be accomplished at 5,000 landings, and thereafter at each 2,000 landings.

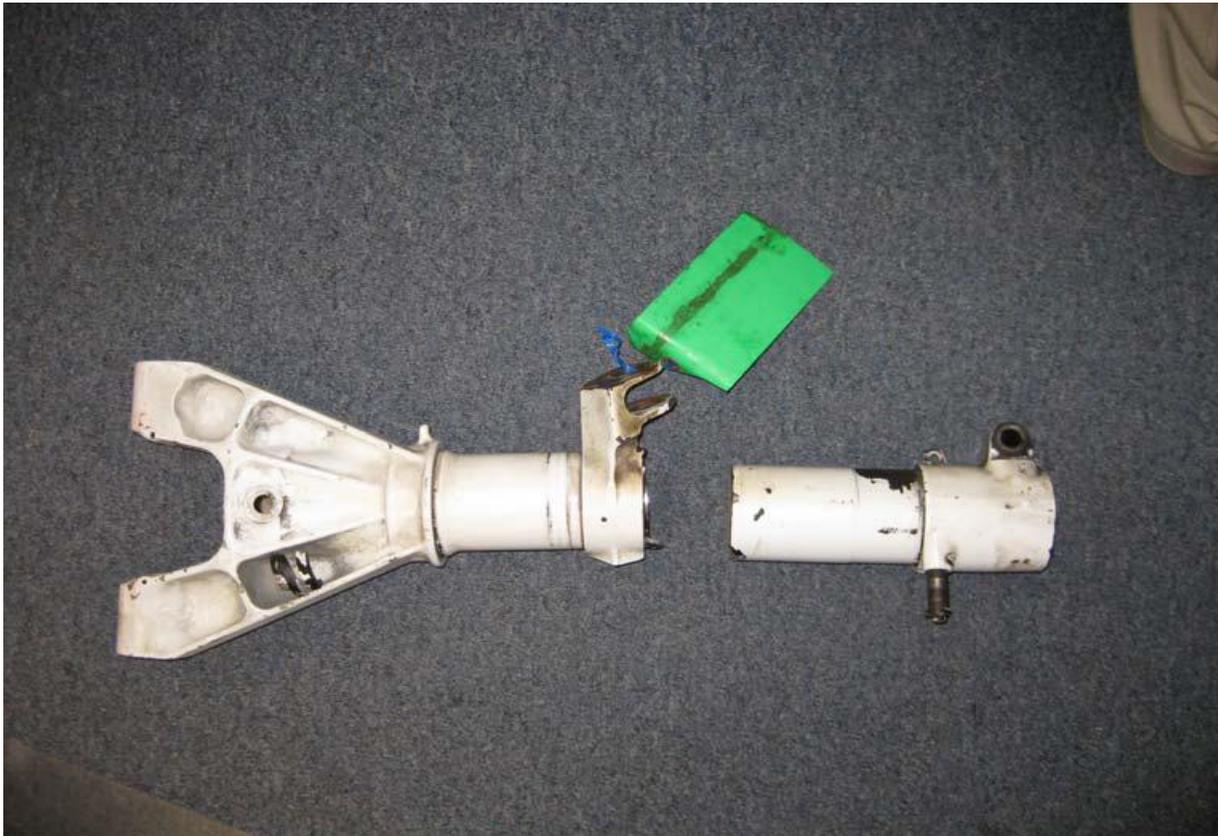
Photo 2: Gear strut removed from airplane (P/N 51401103).

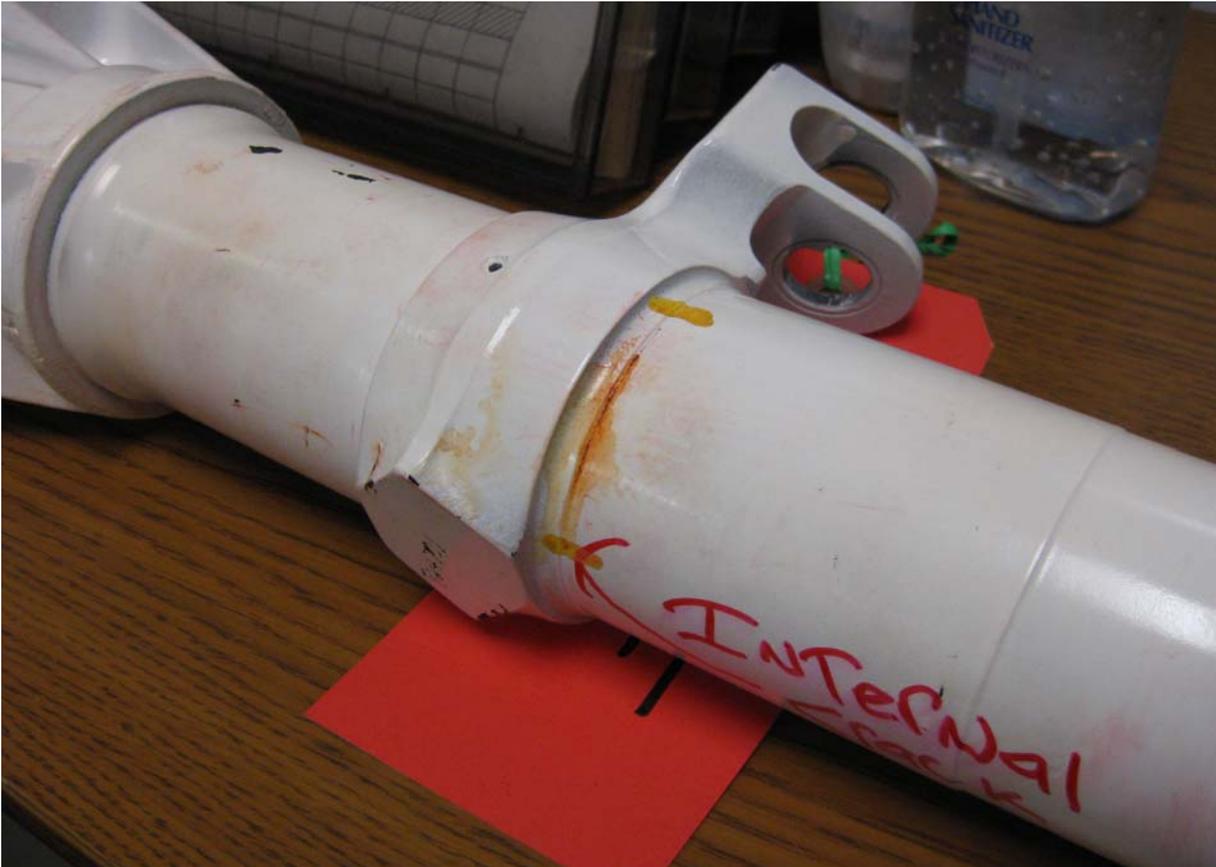
Photo 3: The same part removed from another airplane, illustrating a crack that may be found during an inspection.

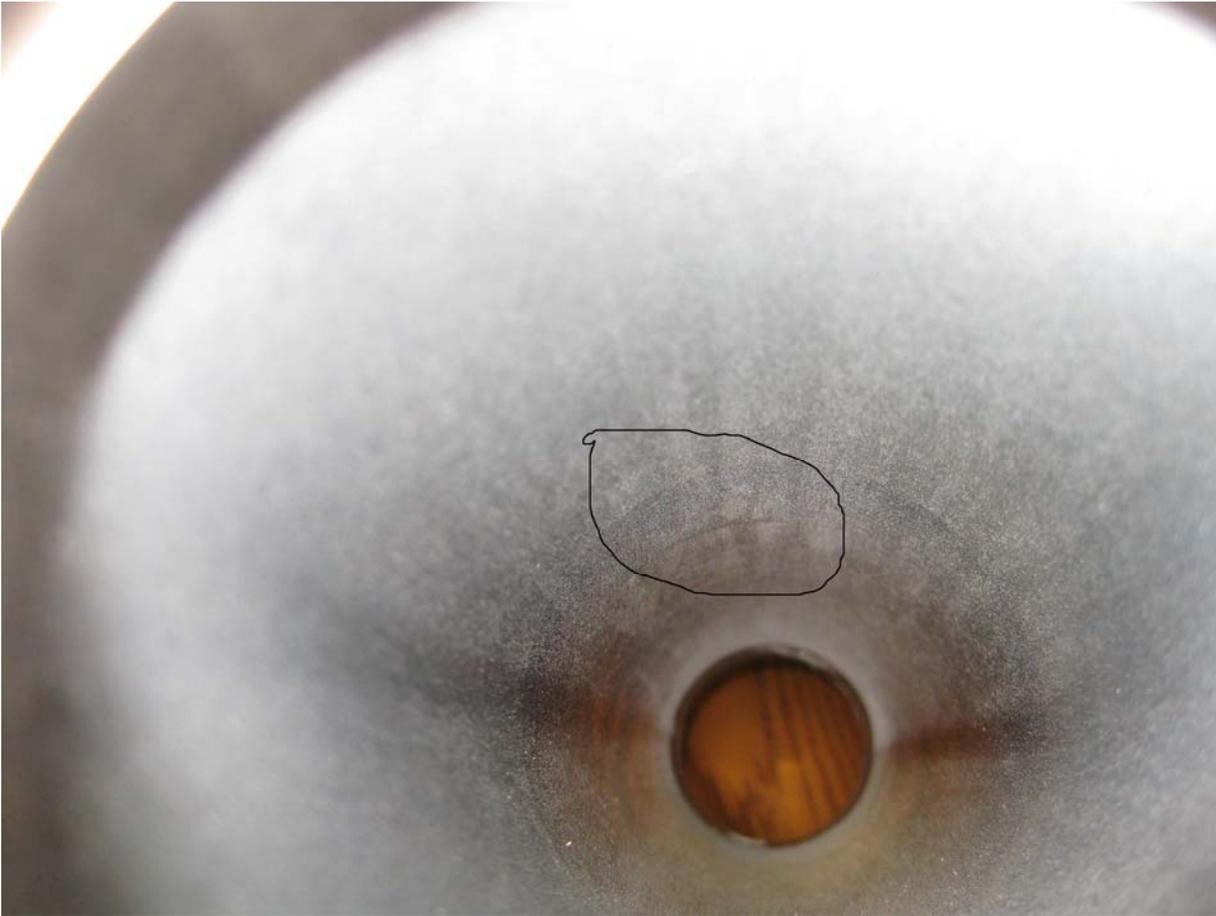
Photo 4: An internal view of the above part showing initial crack development.

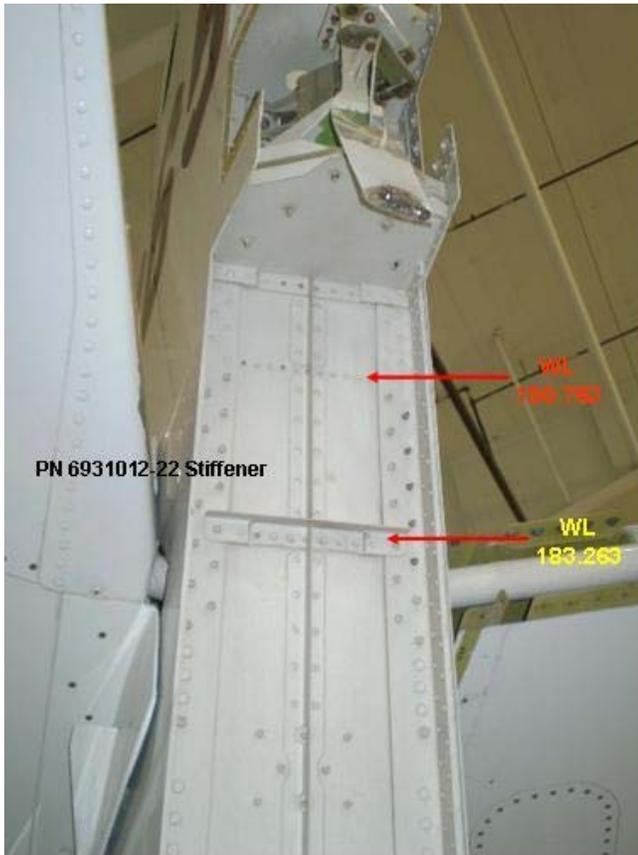
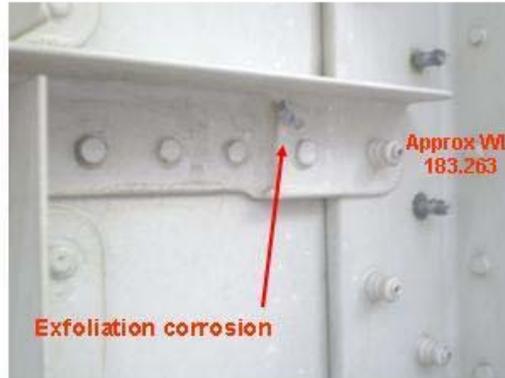
Ref IPC 55-30-00 item 166 Spar Assy:

An unidentified general aviation technician states, "During replacement of the rudder hinge brackets on the vertical stabilizer's rear spar (P/N 693101222), exfoliation corrosion was found on the 1) lower bracket (P/N 6931050-10) of the upper rudder hinge point; and 2) on the lower bracket (P/N 693105012) and upper bracket (P/N 6931050-11) of the middle rudder hinge point. Exfoliation corrosion was also noted on the vertical stabilizer aft spar stiffener (P/N 65931012-22) at approximate water line WL 190.763. (This stiffener) required replacement."

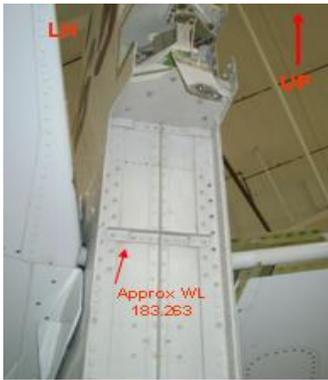
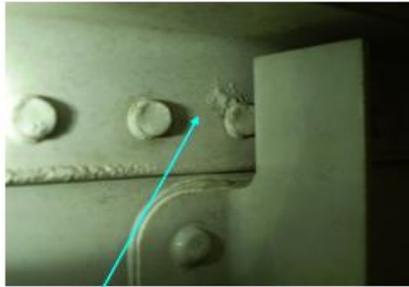
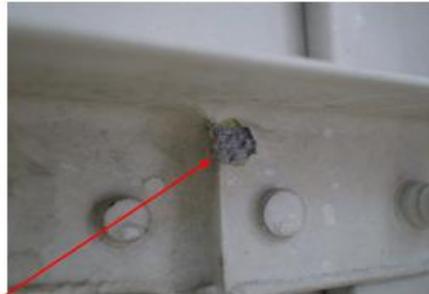
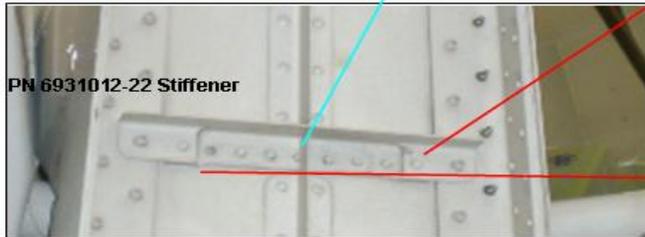
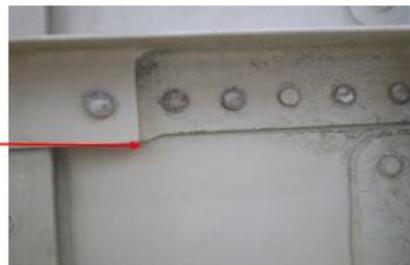
Ref IPC 55-30-00 item 166 Spar Assy:
Additional Corrosion to Stiffener and rivet heads.

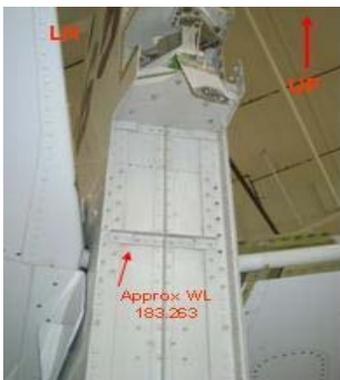
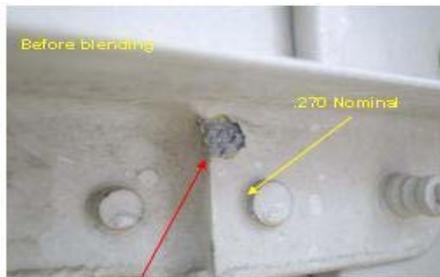
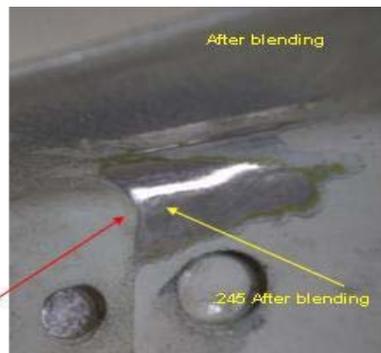
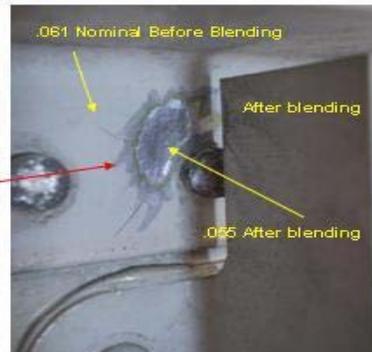
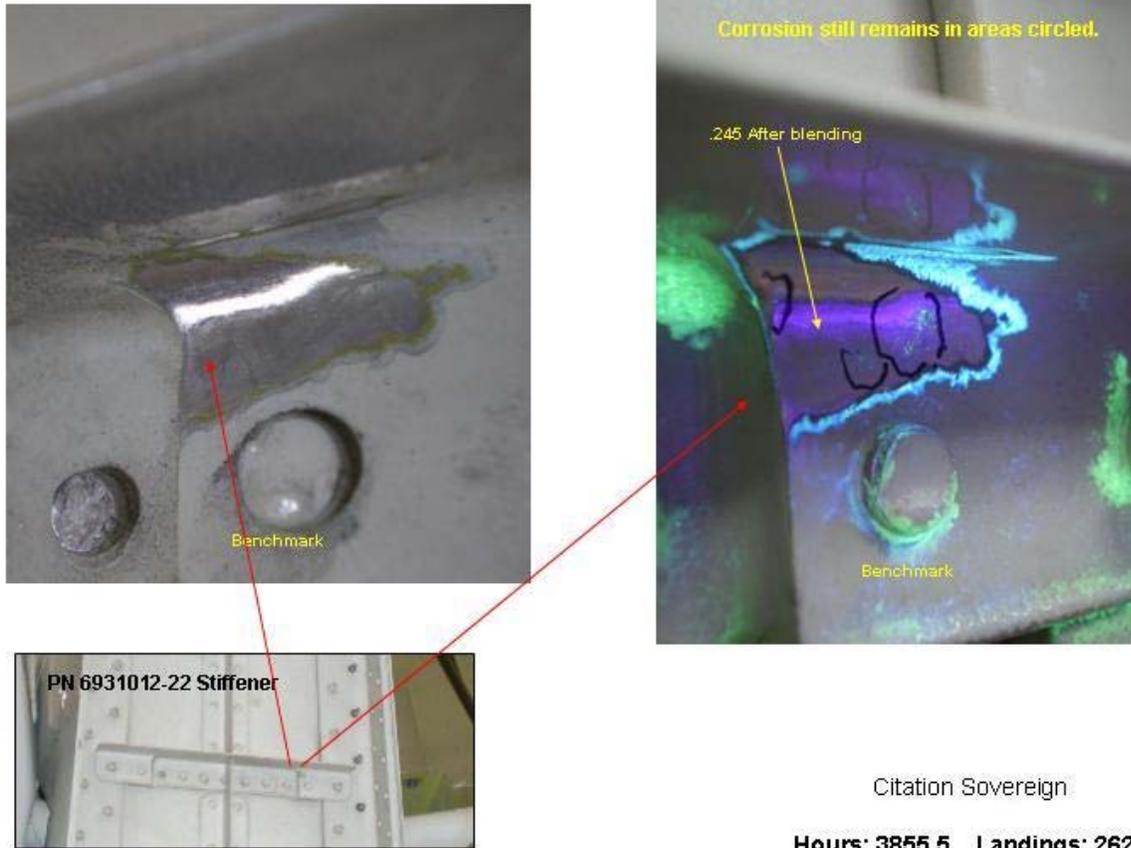
Ref IPC 55-30-00 item 166 Spar Assy:
Additional Corrosion to Stiffener and rivet heads.

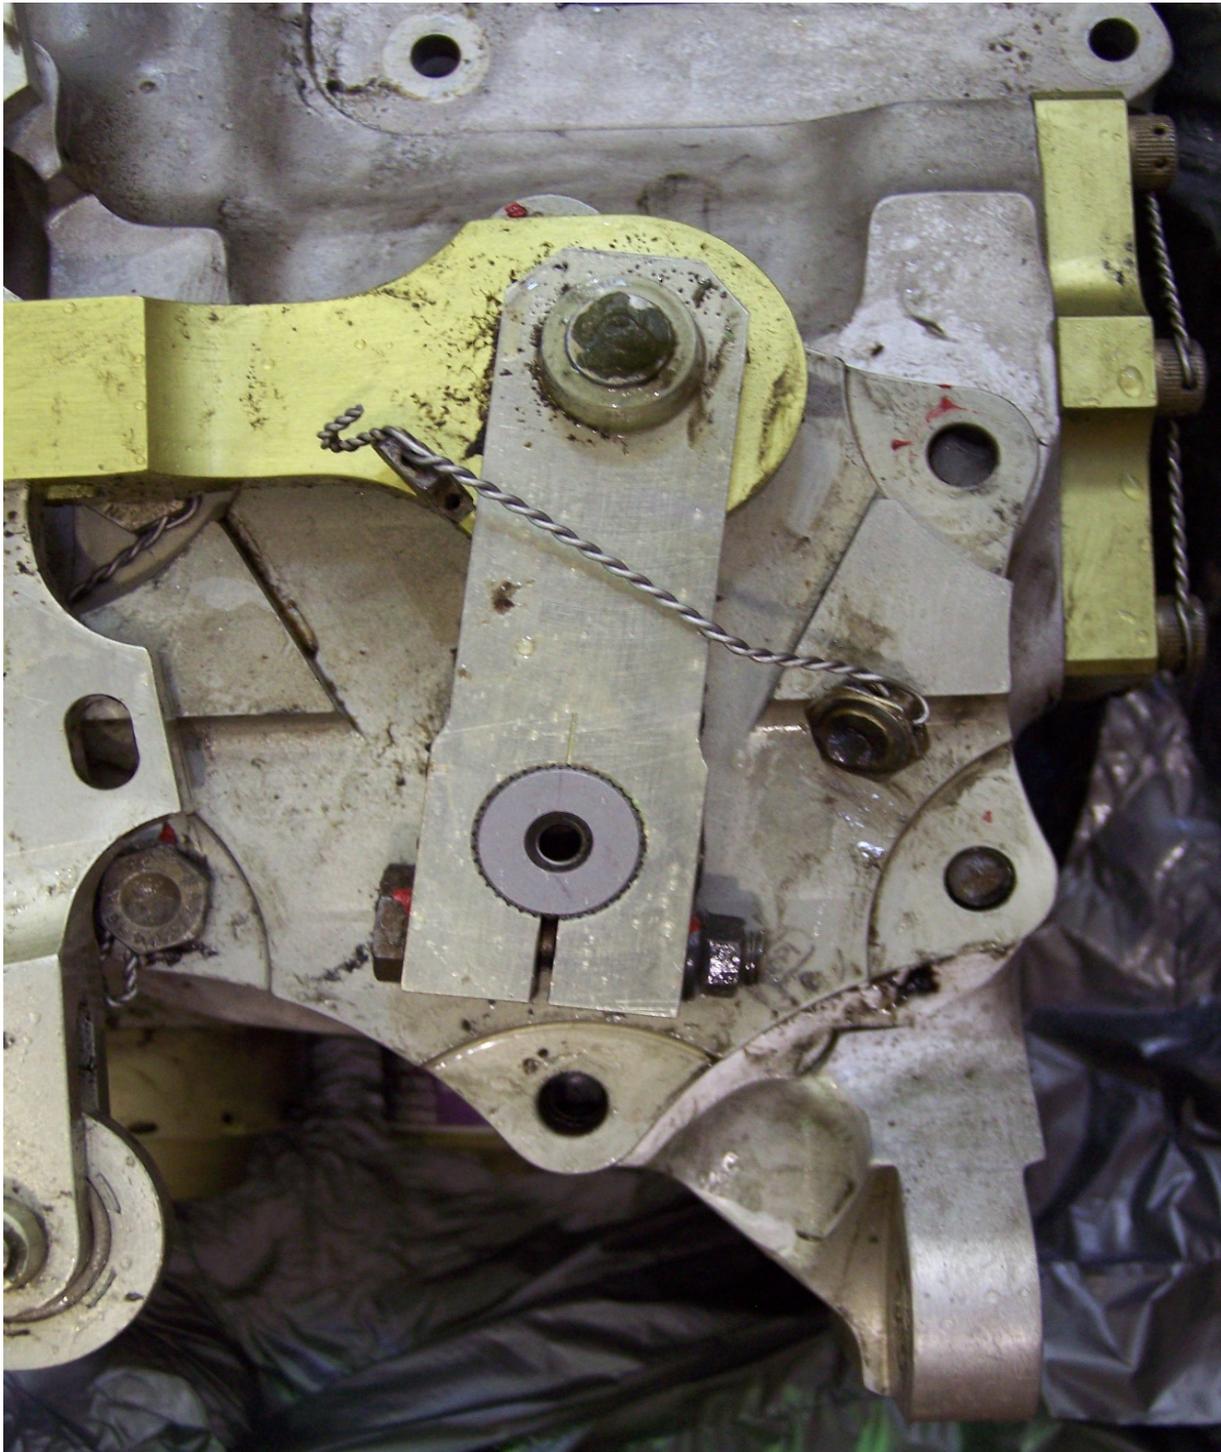
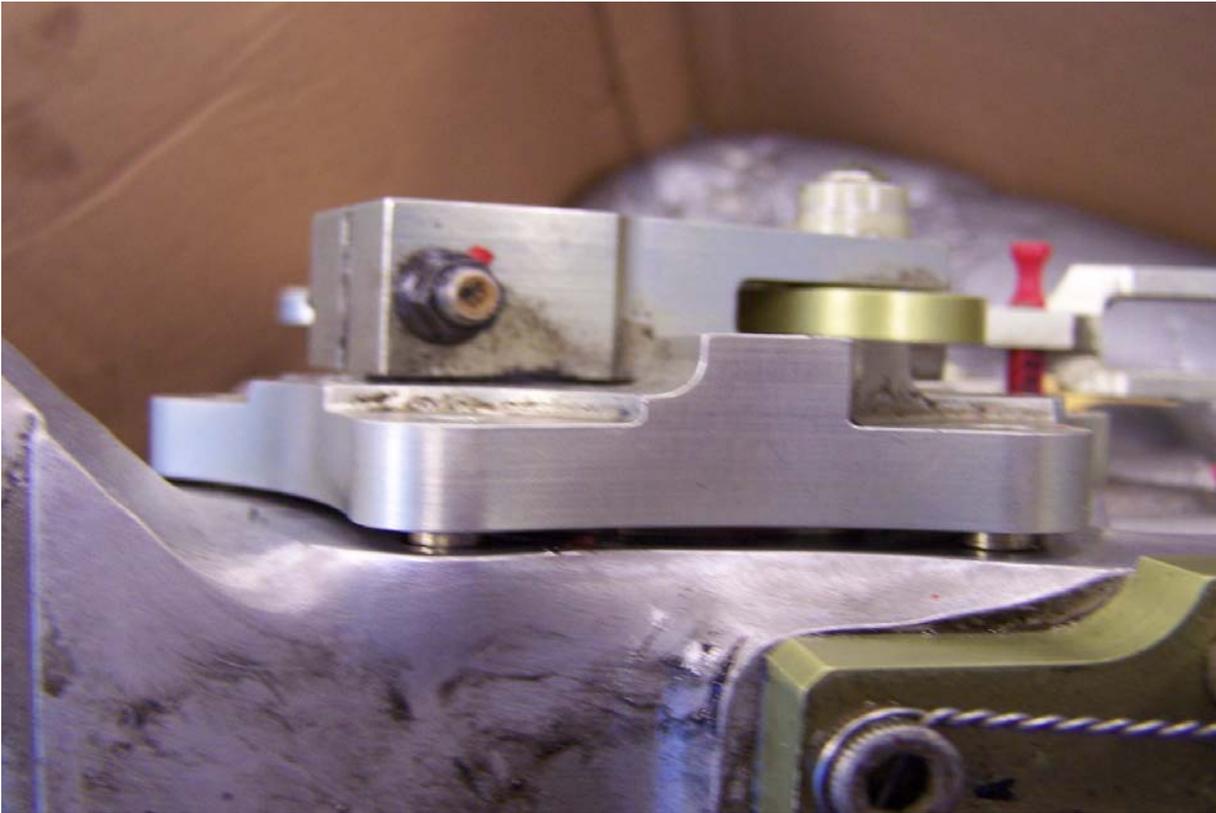
Another unidentified submitter says, "The pilot reported a number two Low Quantity on the EICAS (*engine indicating crew alert system*) while on the ground. Maintenance inspected and found the rudder power control unit (*PCU*) to be leaking. (*This unit*) was removed and replaced in accordance with EMB 145 Maintenance Manual 27-22-03. It operationally and leak checked good. (*We*) serviced the number two hydraulic system IAW EMB 145 AMM 12-13-01. The aircraft was returned to service. The (*defective*) rudder PCU was missing (*several*) bolt (*heads*)—causing the leakage." (*The SDRS database includes ten of these PC units, none but this one having a reported bolt problem!*)

(The PCU is from Parker-Hannifin. Great photos; but very scary scenario! I wish you would have speculated as to why this might have occurred. For example: if those steel bolts thread into an aluminum casting, we could probably rule out over-torque as an issue--right? Or, are there nut plates on the other side? Might the bolts, then, be defective? Have you seen this before? Would 24,000 hours indicate an extreme bolt life for this application? Have the bolts and/or the PCU been flagged for any kind of failure analysis? Please keep me informed of any similar PCU events via e-mail on the Alerts address page. Thank-you—Ed.)

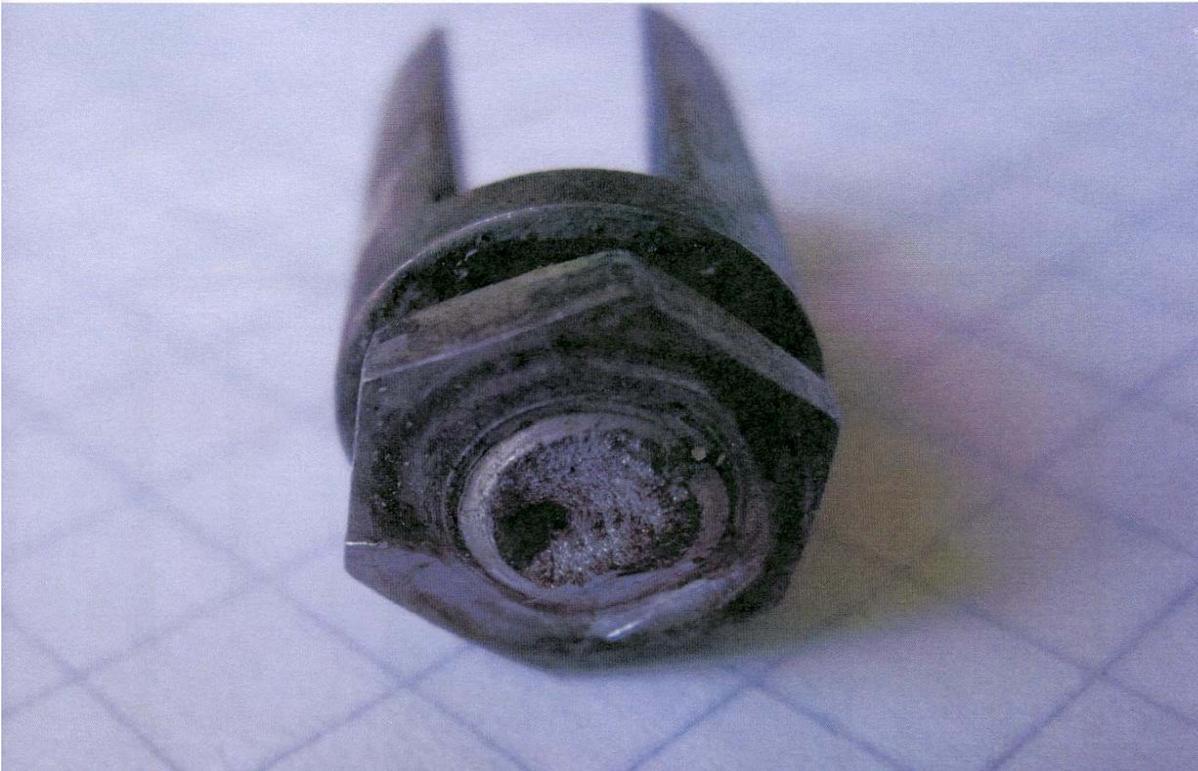
"On landing," says this general aviation technician, "*(this aircraft)* lost braking action. An investigation found the brake piston clevis rod—between the brake pedal arm and the master cylinder—had sheared below the lock nut." (*Piston clevis rod P/N: 4008. Component name and P/N: Brake Arm; 41533458. See photo below.*)

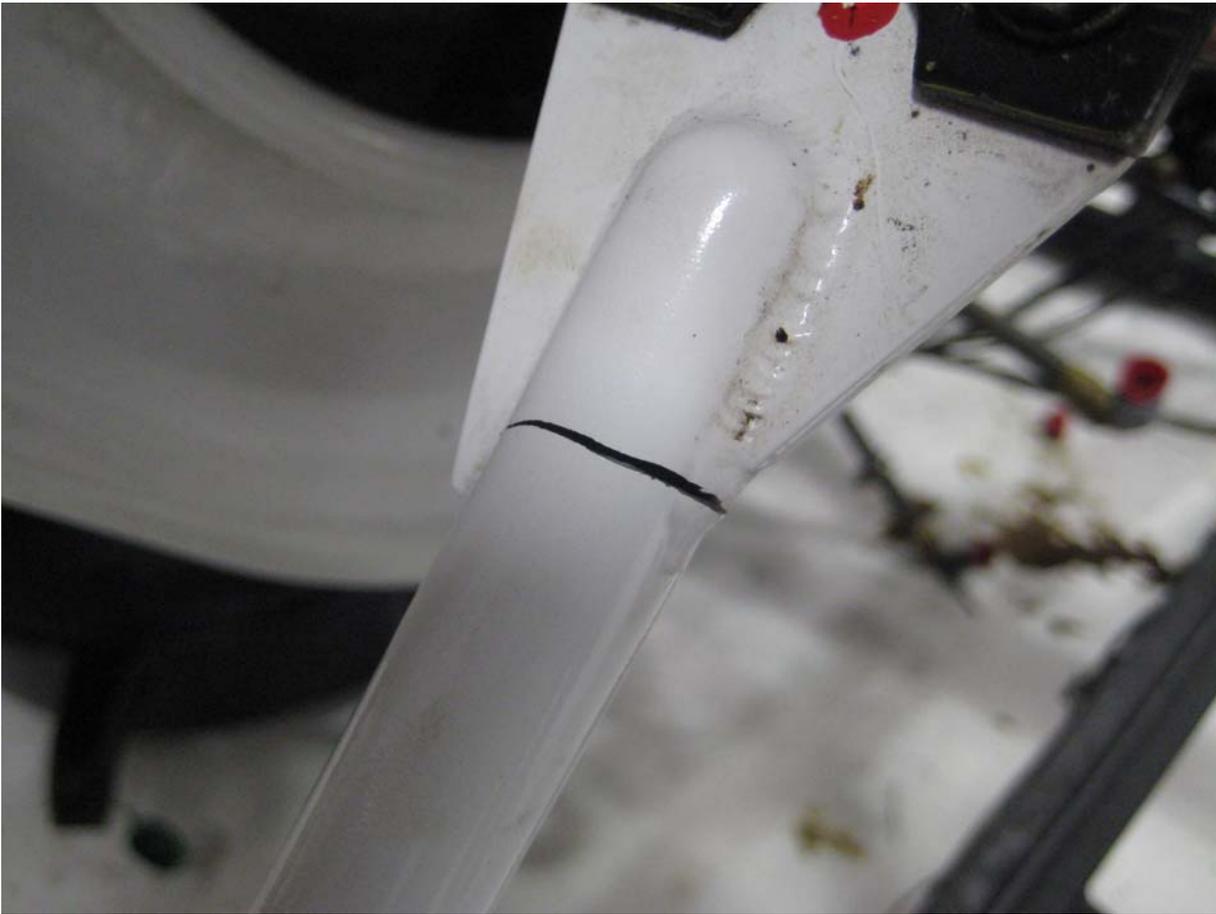
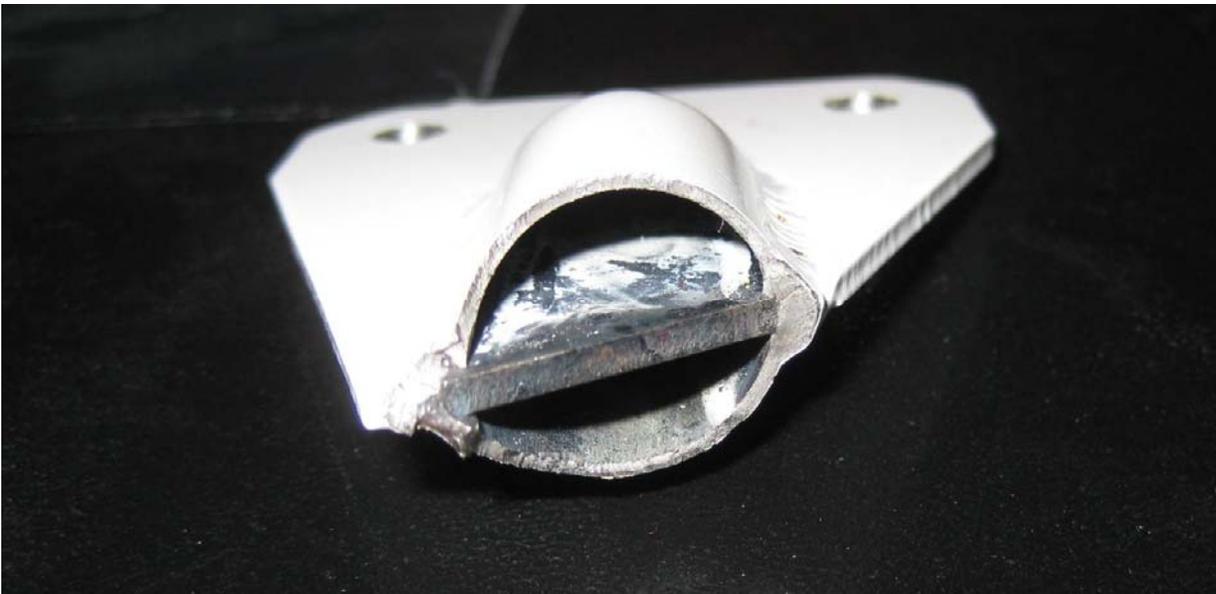
"During unscheduled maintenance," states an unidentified general aviation technician, "the lower drive support strut (*P/N 269A5423009*) was found to be cracked 90 per cent through the tube—where the upper attach lug is welded. Upon removal, the lug completely separated from the tube. If this tube had separated during flight, loss of main rotor torque would have occurred."

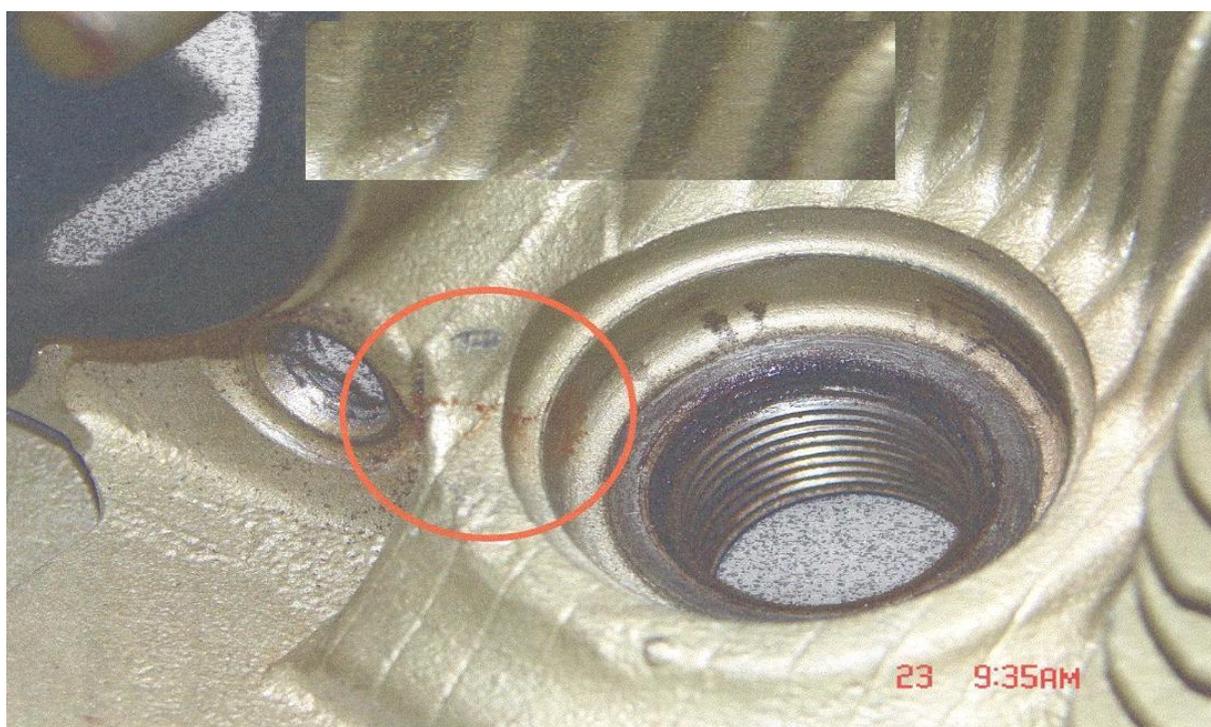
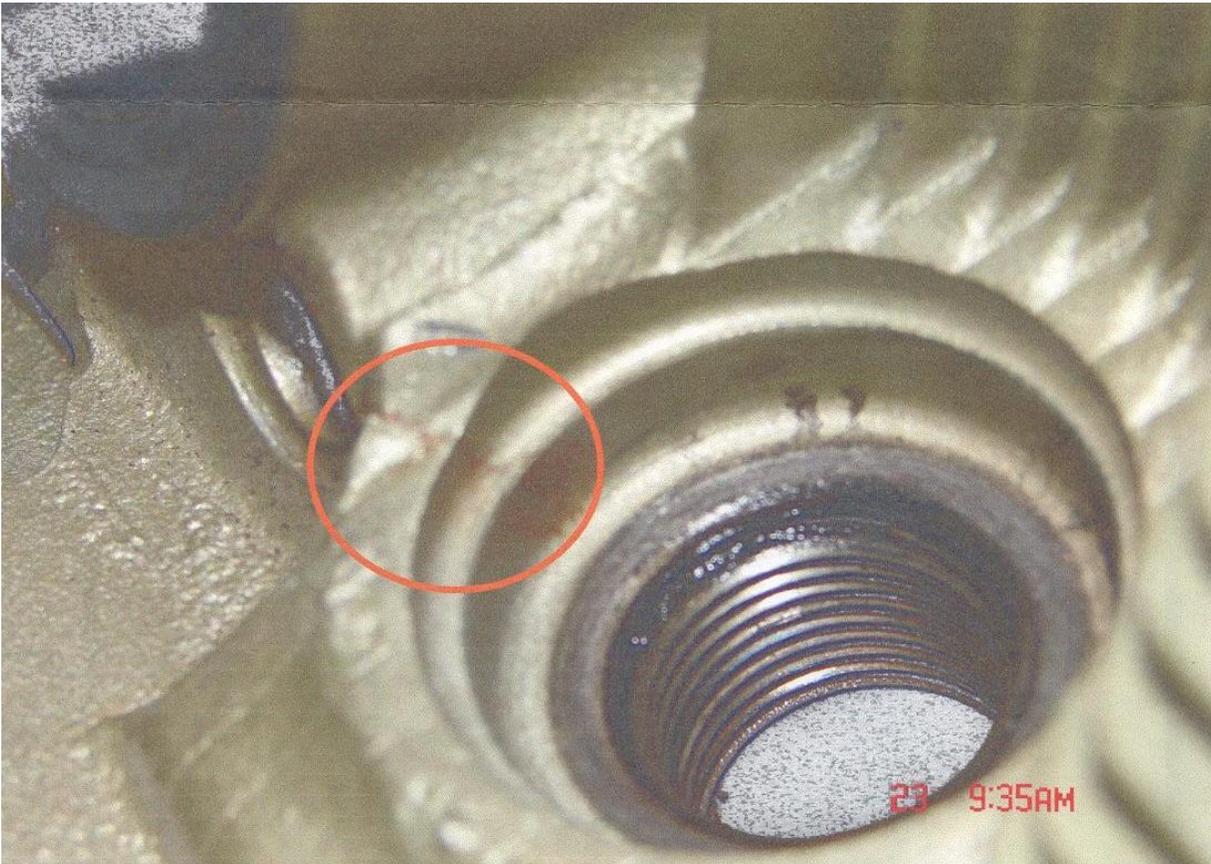
A Chief Inspector for a repair station says, "During an Annual Inspection, (*we*) found a fuel stain trailing from the fuel injector nozzle port toward the spark plug hole on number three cylinder (*P/N 655465*). This cylinder has 980.9 hours since new. The engine was manufactured in July of 2003. It was installed in this Lancair 550FG in August 2003 by the Lancair company."
