**Federal Aviation
Administration**

ADVISORY CIRCULAR

AVIATION MAINTENANCE ALERTS

**ALERT
NUMBER
390**

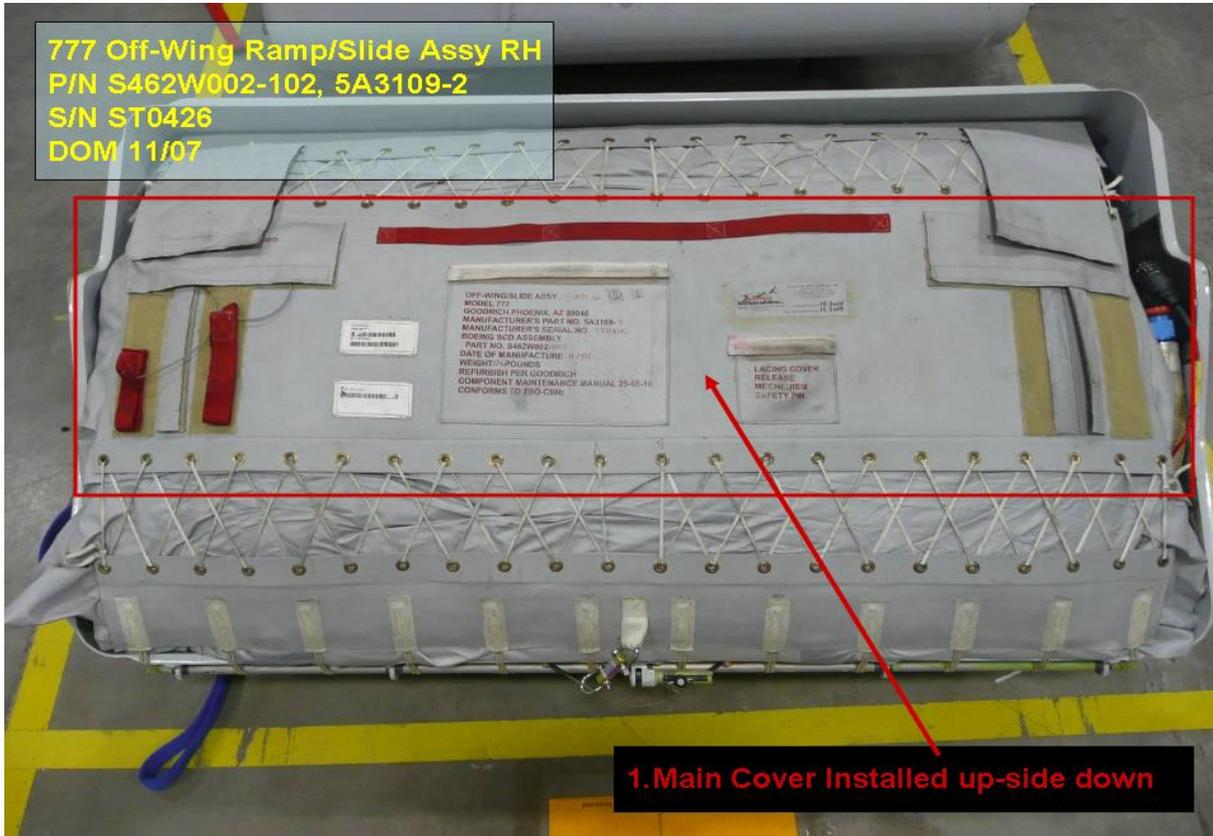
- 1) The main pack cover was installed backwards.
- 2) The proper pack contour (dimensions) were not achieved.
- 3) The slide pack release cables were incorrectly routed.
- 4) Roughly 80 % of the corrosion resistant coatings were missing from the aluminum Release Rod Assembly.
- 5) A length of round black cord was discovered wrapped around the inflatable inside the slide pack. This black cord was drawn tight around the inflatable folds and securely tied off. It is believed the black cord was used as a folding aid during slide packing.

"With these conditions present, it is not likely this Evacuation Ramp/Slide would have been able to function as designed in the event of an emergency." (*Goodrich Component P/N: 5A31092.*)

1. Main Cover Installed up-side down

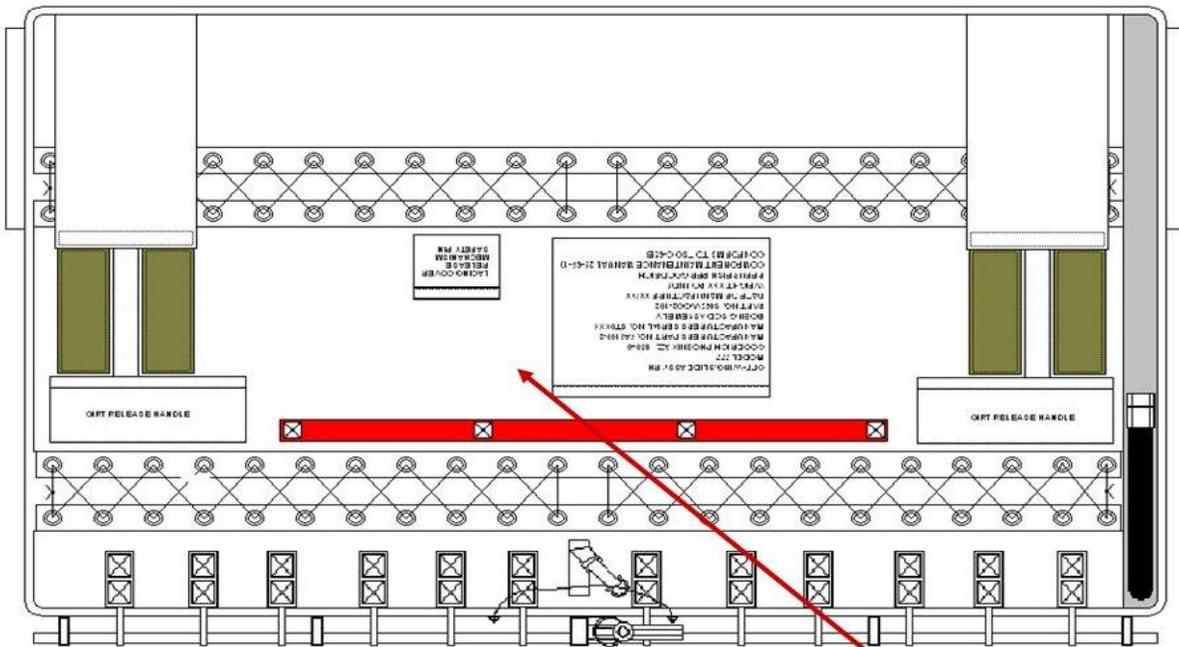
1. Main Cover shown installed correctly

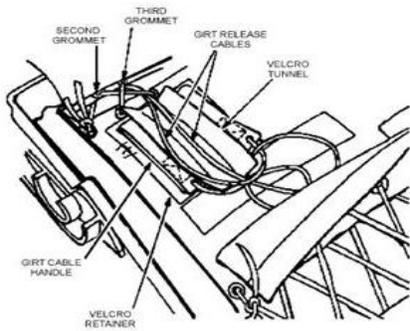
Figure 93

- H. Secure the manual girth release cables according with the following.
- (1) Route manual girth release cables between second and third grommets. (See Figure 93).
 - (2) Attach girth cable handles to velcro retainers, and lay cables along velcro tunnel. (See Figure 93).

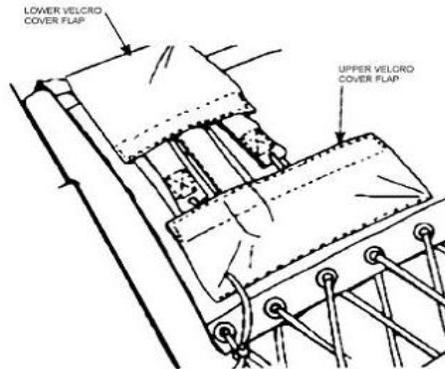
Figure 94

- (3) Secure upper velcro cover flap, and close velcro tunnel. Coil excess cables and secure them beneath lower velcro cover flap.

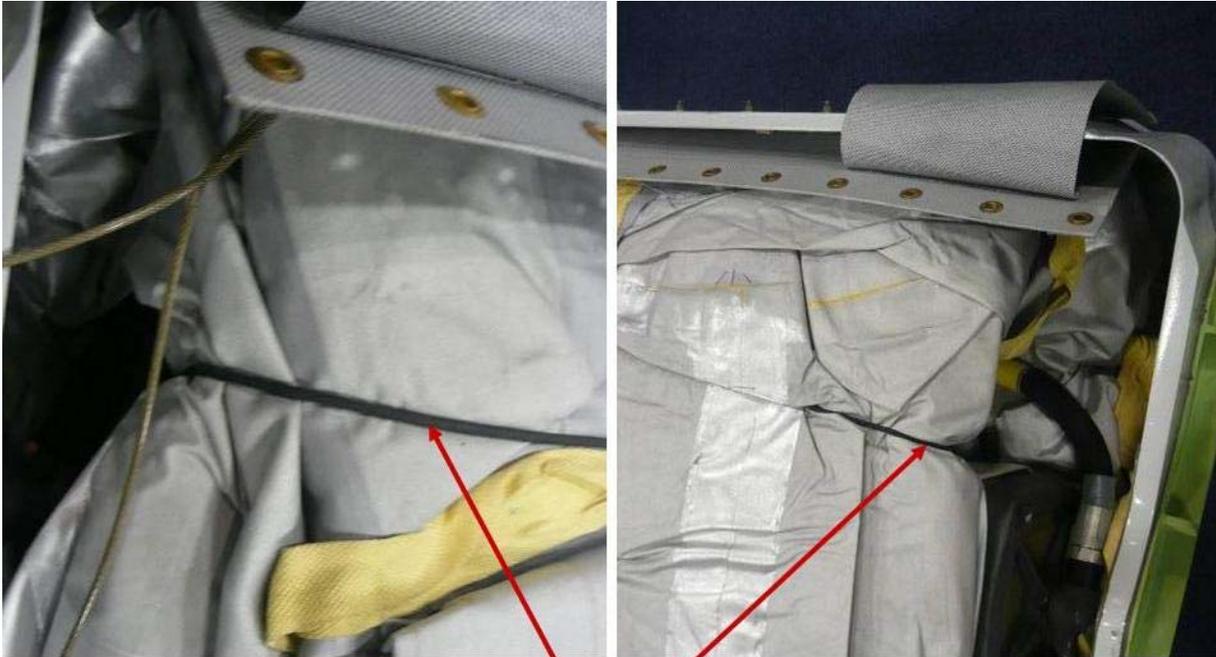
5. Black Nylon cord

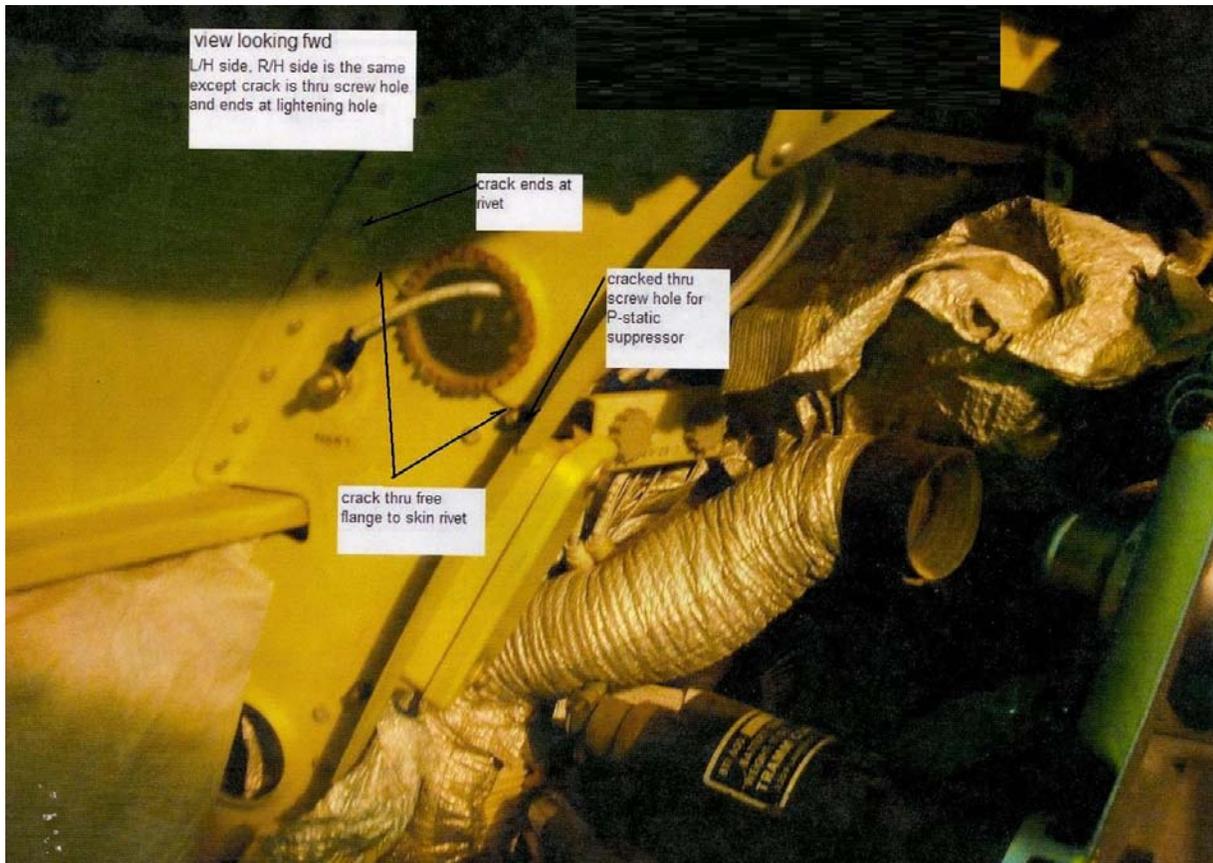
A repair station submitter says, "The forward fuselage frame at station 235 above the pilot's and copilot's floor was found cracked during a 240-month inspection. Refer to the attached picture."

(Structural frame P/N's: 600-34014-102 and -107. The photo's obvious black rectangle is the artful contribution by this editor to remove identification data.)

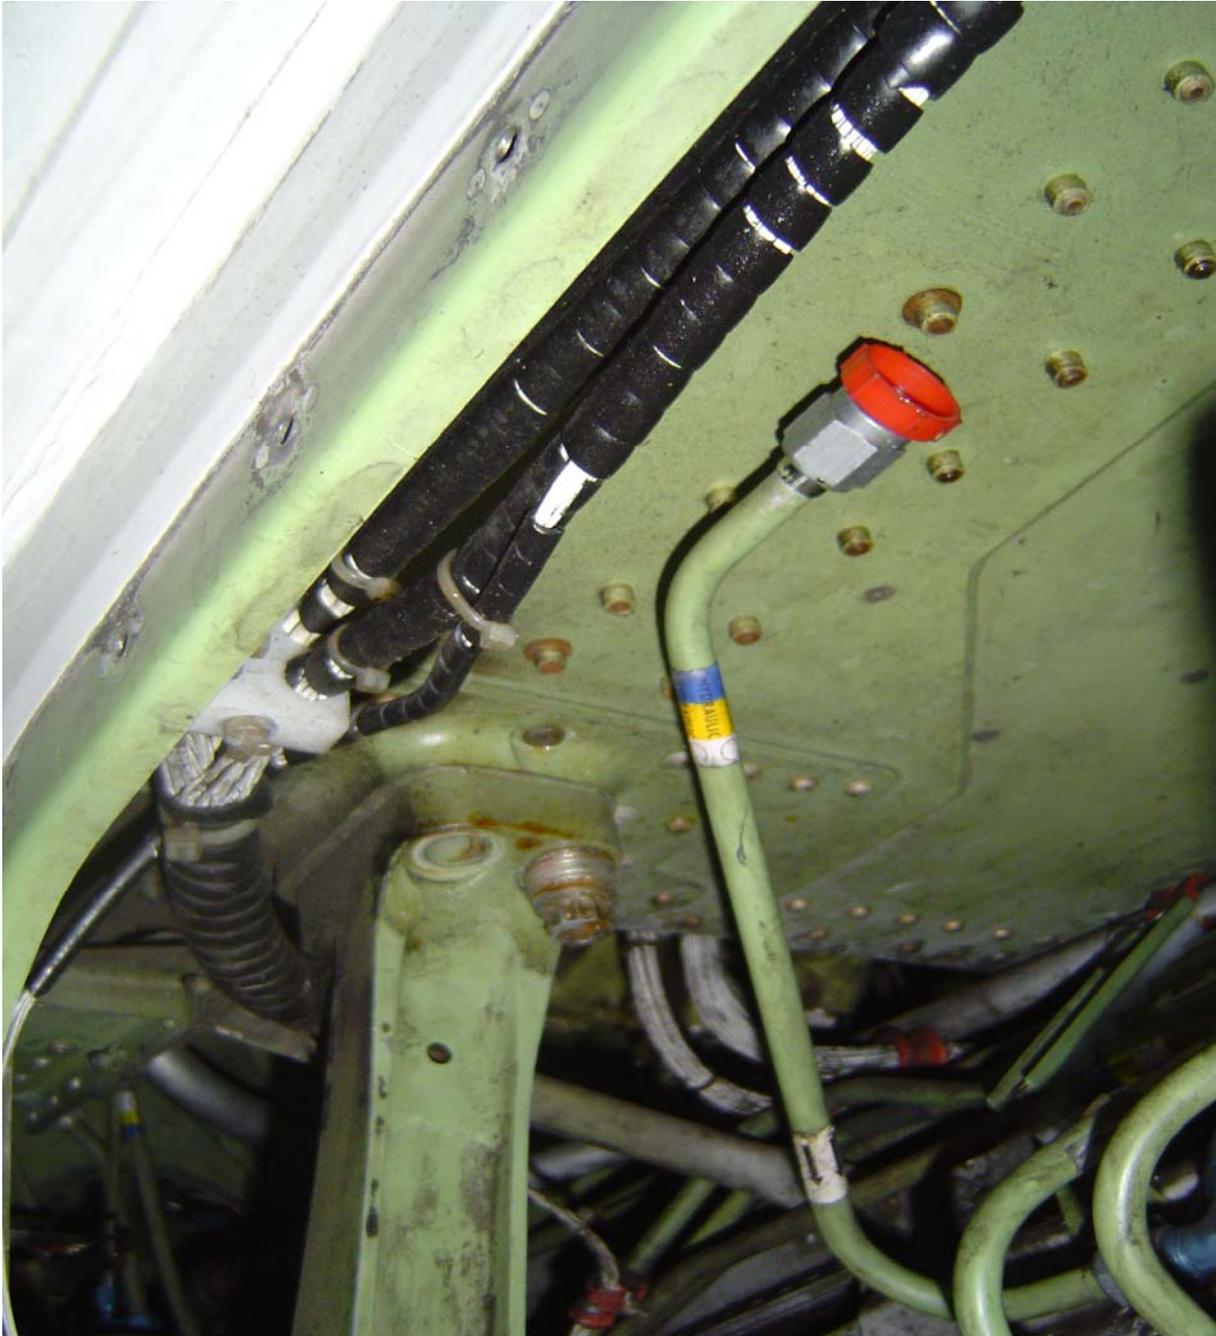
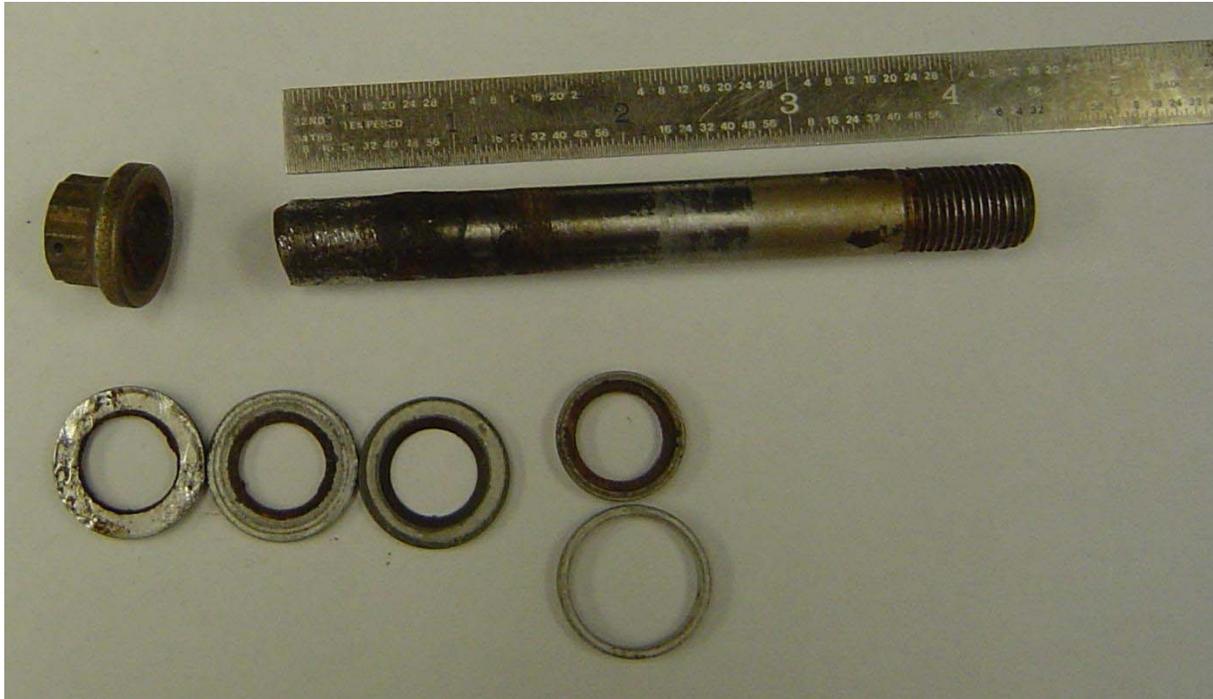
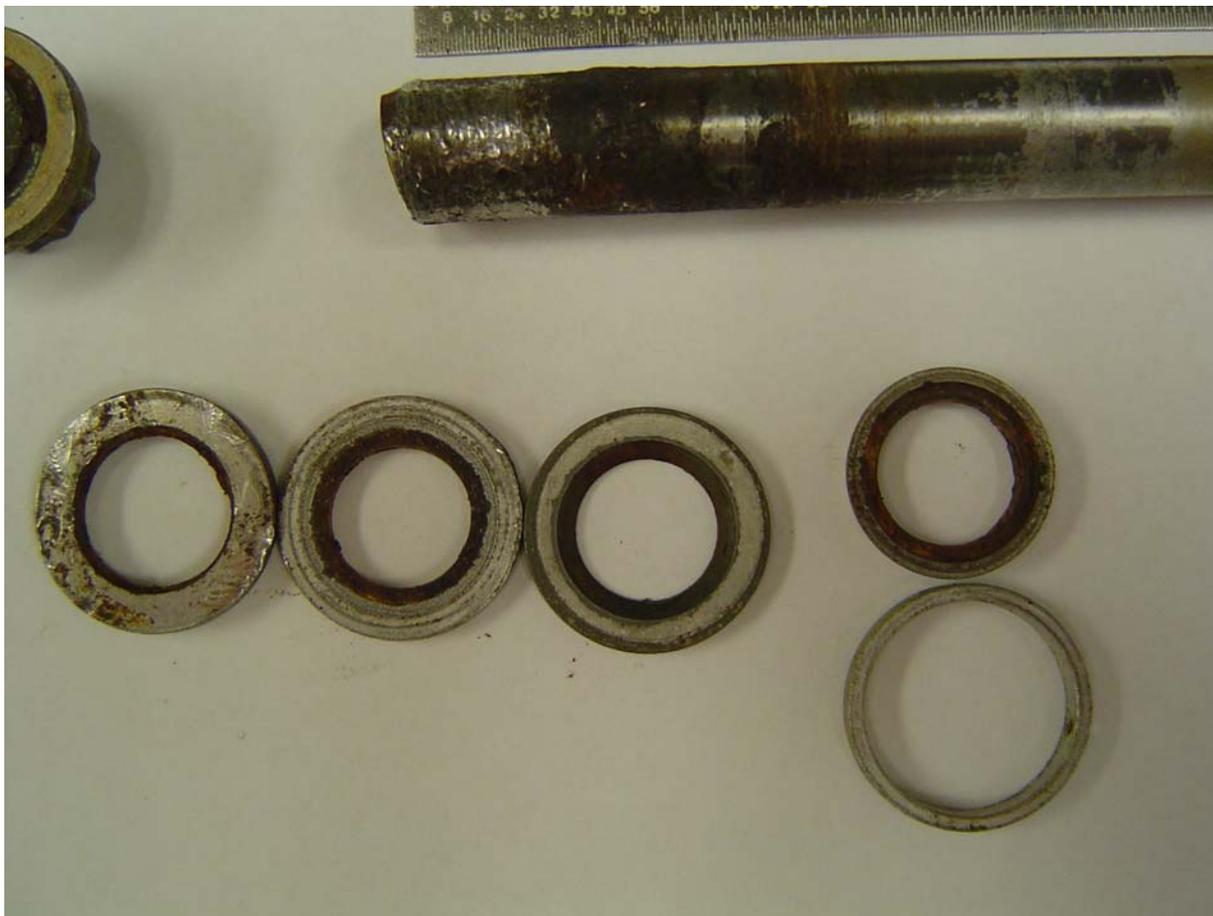
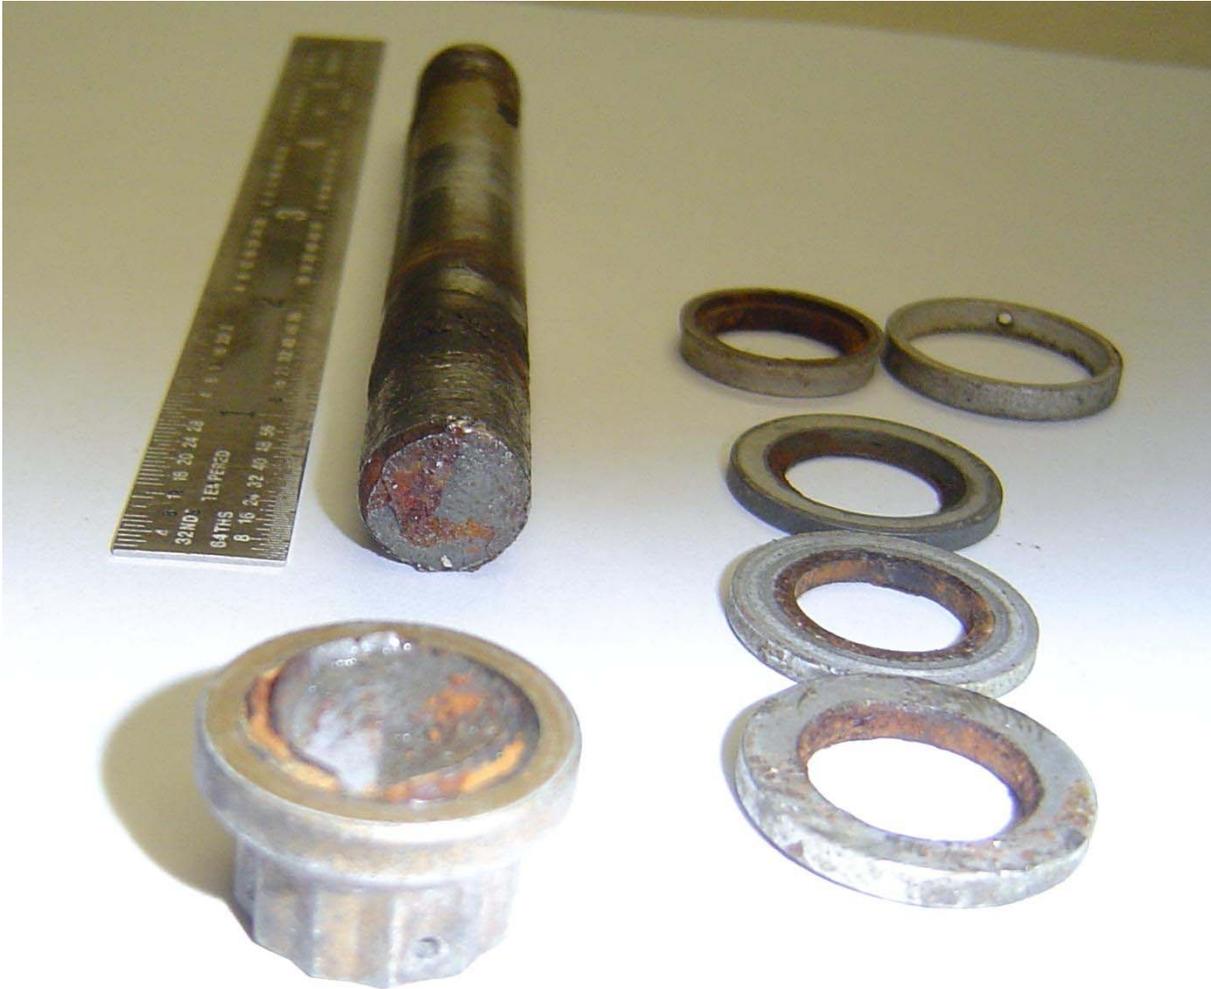
"While inspecting for a possible hydraulic leak at the R/H wing root, " says this Hawaiian submitter, "maintenance discovered one of the wing bolts for the rear spar steel support struts had failed. The bolt head had separated from the shank of the bolt and was dangling from the safety wire. Upon removal, it appears that corrosion may have been a factor in the failure. The incident has been reported to the manufacturer, and the effected parts are in quarantine waiting disposition. The location (*of this bolt*) is at station X424.12; Z174.54 on the R/H side of the aircraft. It is the forward, outboard bolt of the rear spar support strut (hockey stick)."

(Bolt P/N: MS2125H08056. What a scary bolt! Thanks for sharing this...nightmare? Also, look twice at this total time.)

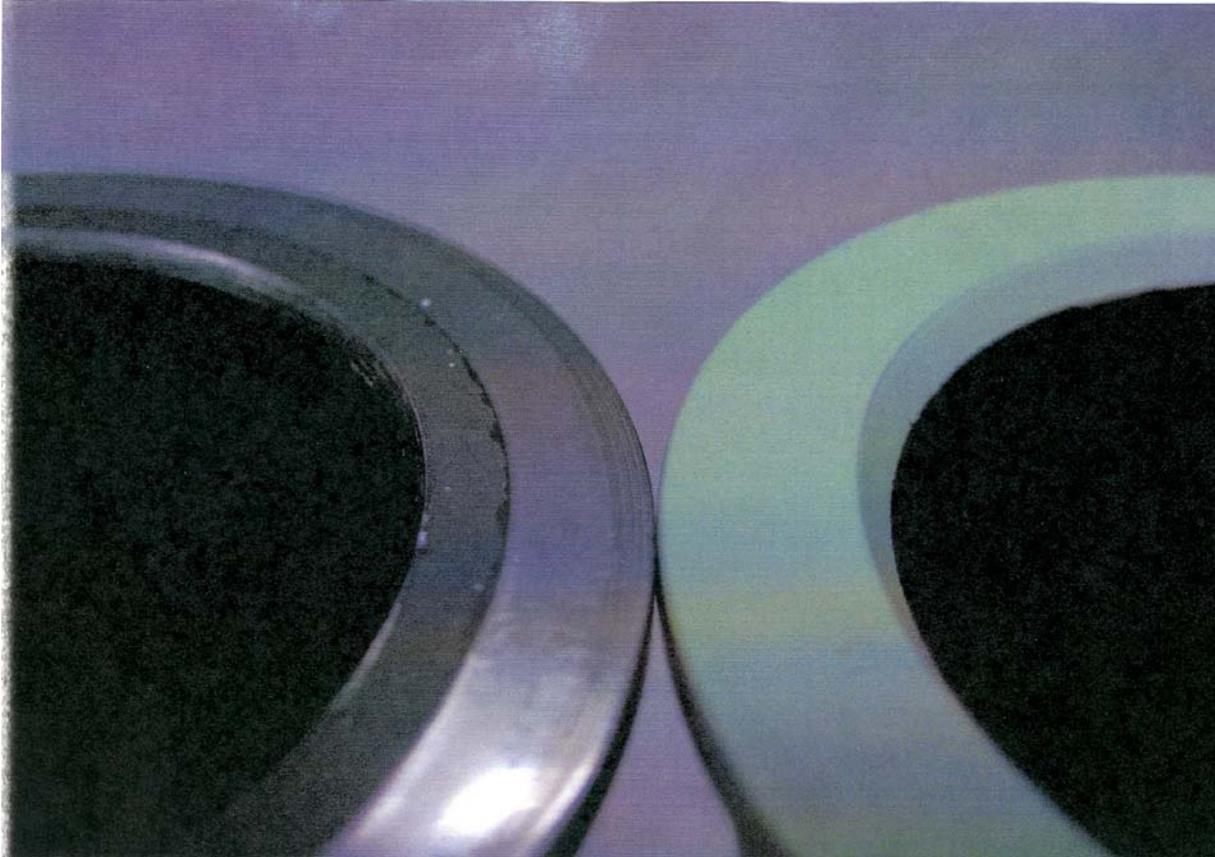
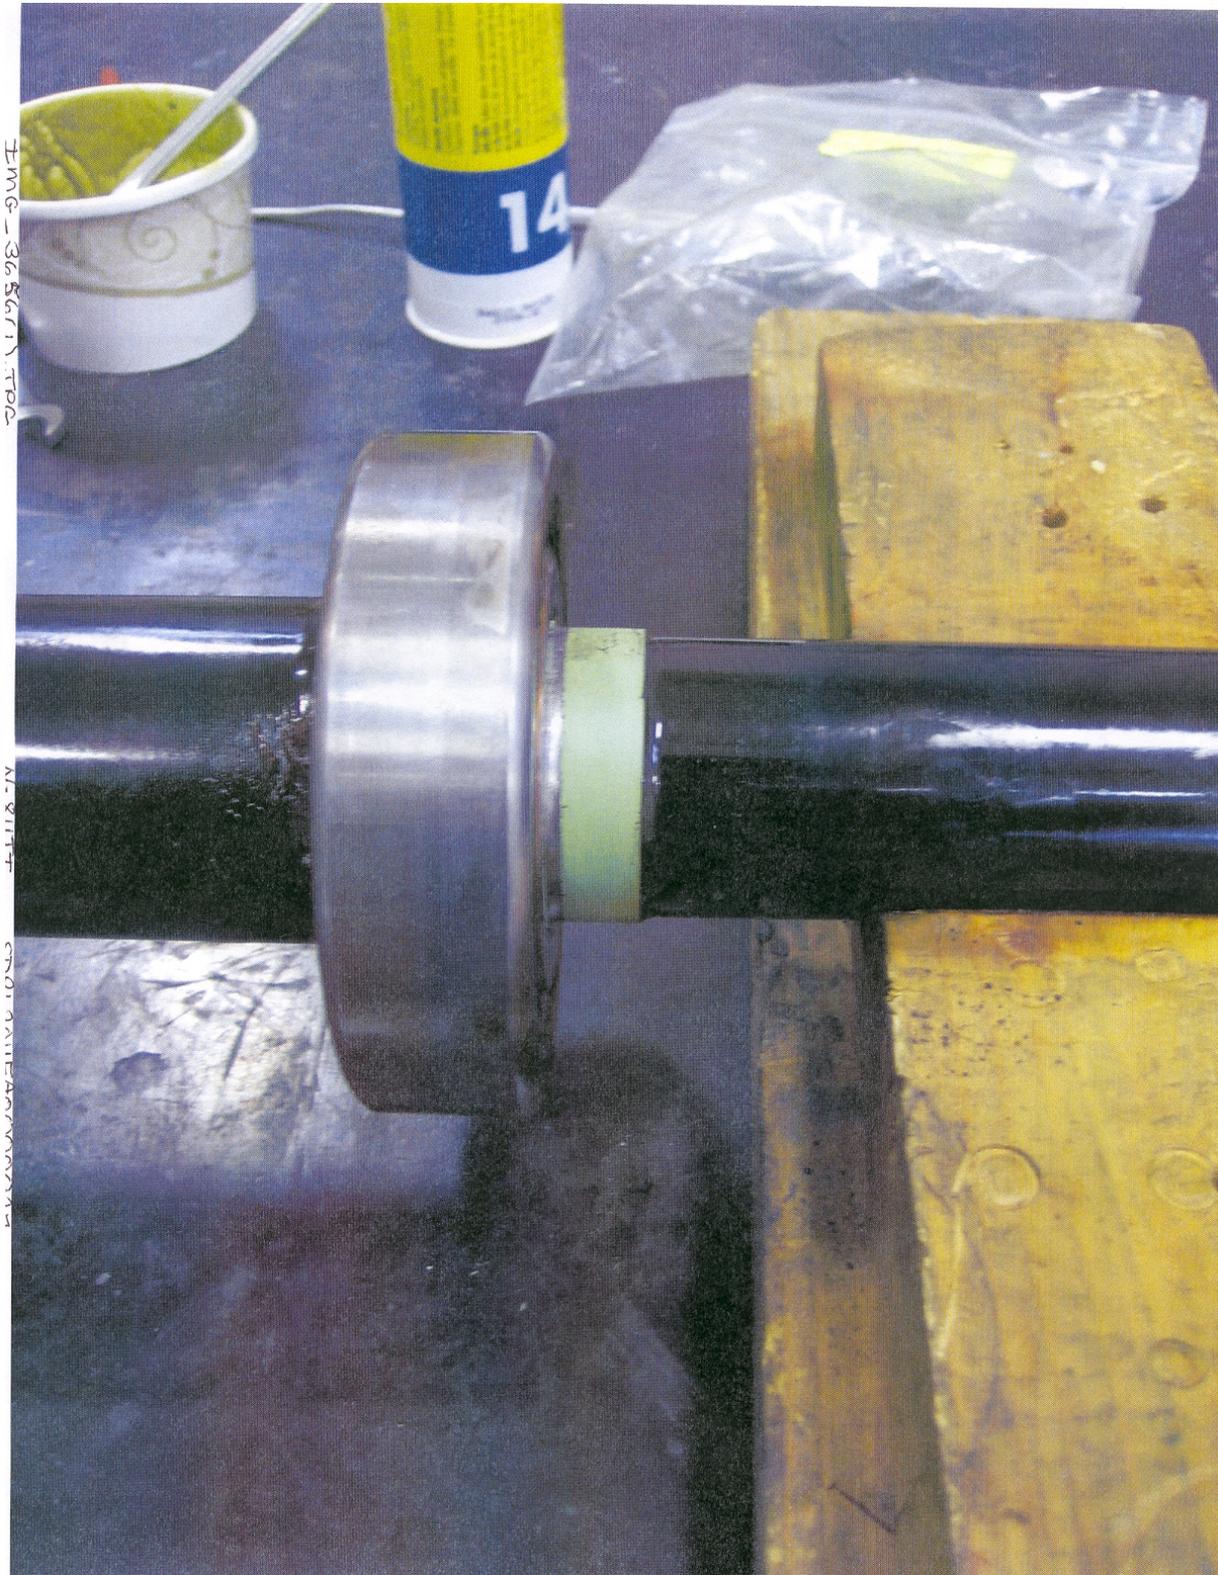
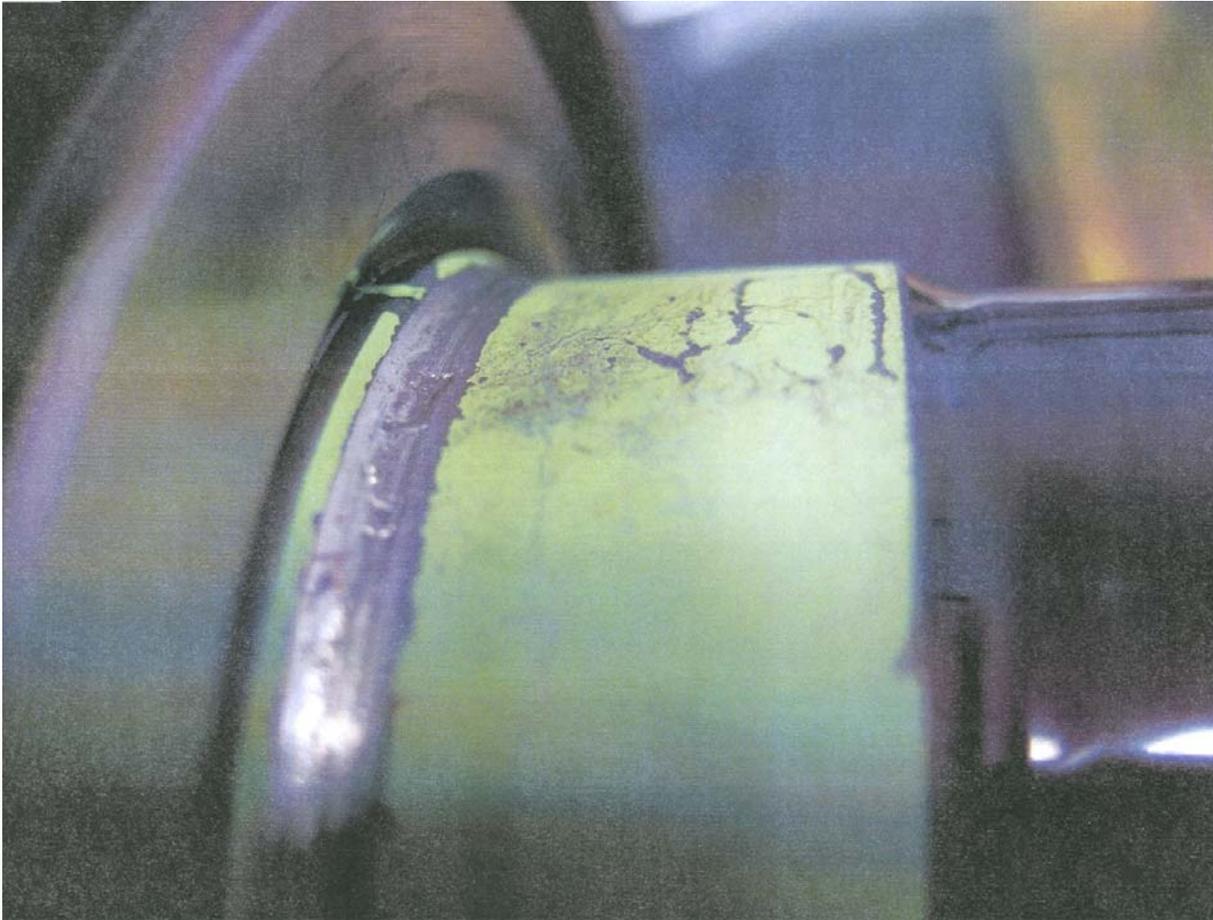
"During (*an inspection*) the main rotor drive shaft was found to be worn just above the main rotor thrust bearing," says this technician. "Upon further inspection the wear was determined to be caused by the main rotor thrust bearing tube not being chamfered in the contact area. This was confirmed by comparison with a new thrust bearing tube. The manufacturer has been contacted and the main rotor drive shaft sent for their evaluation." (*Thrust bearing P/N: 269A18135. Inspection intervals included 800-hour inspections, 12- and 24- month inspections.*)

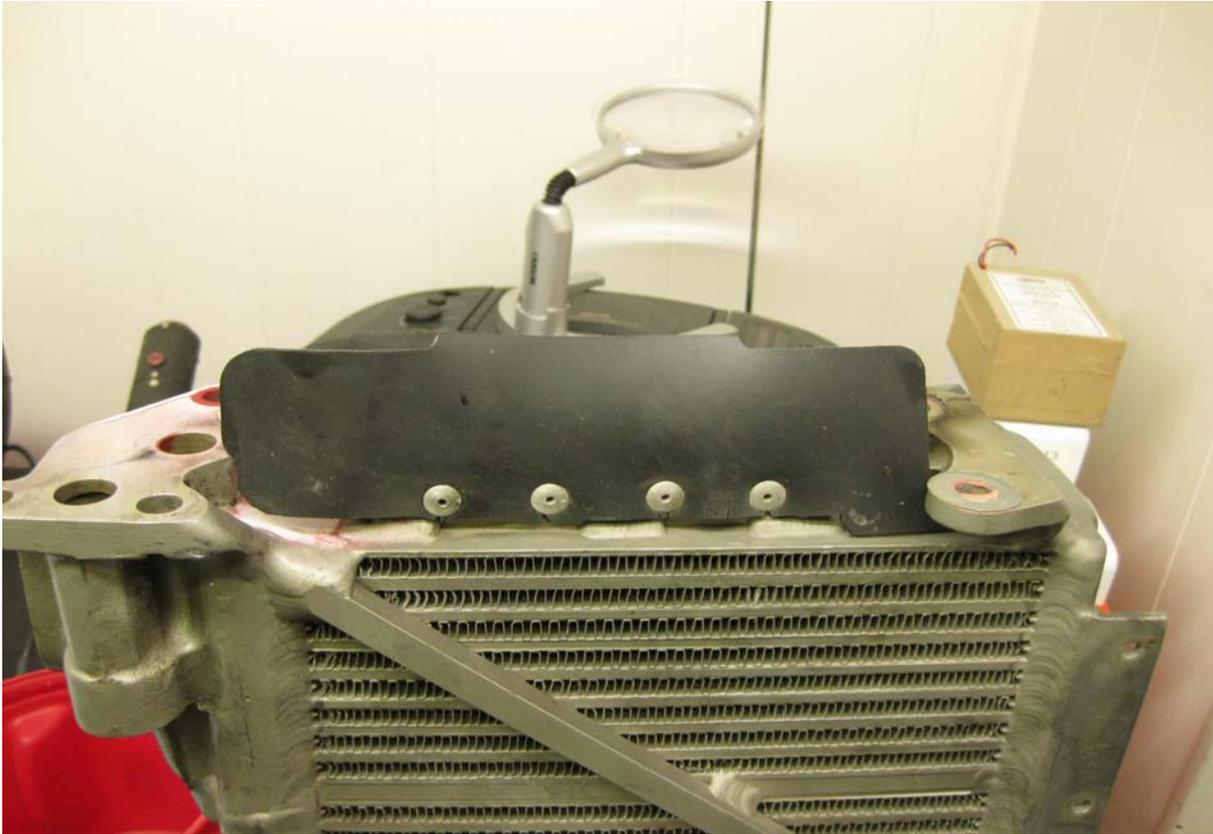
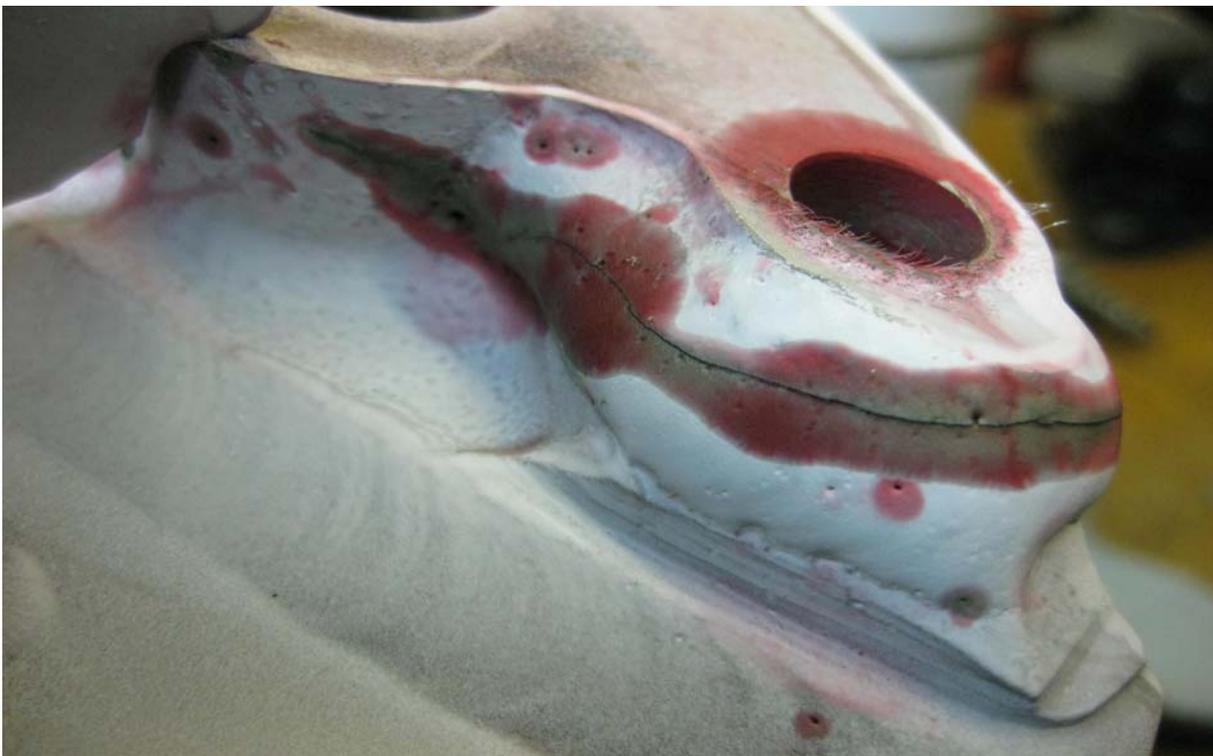
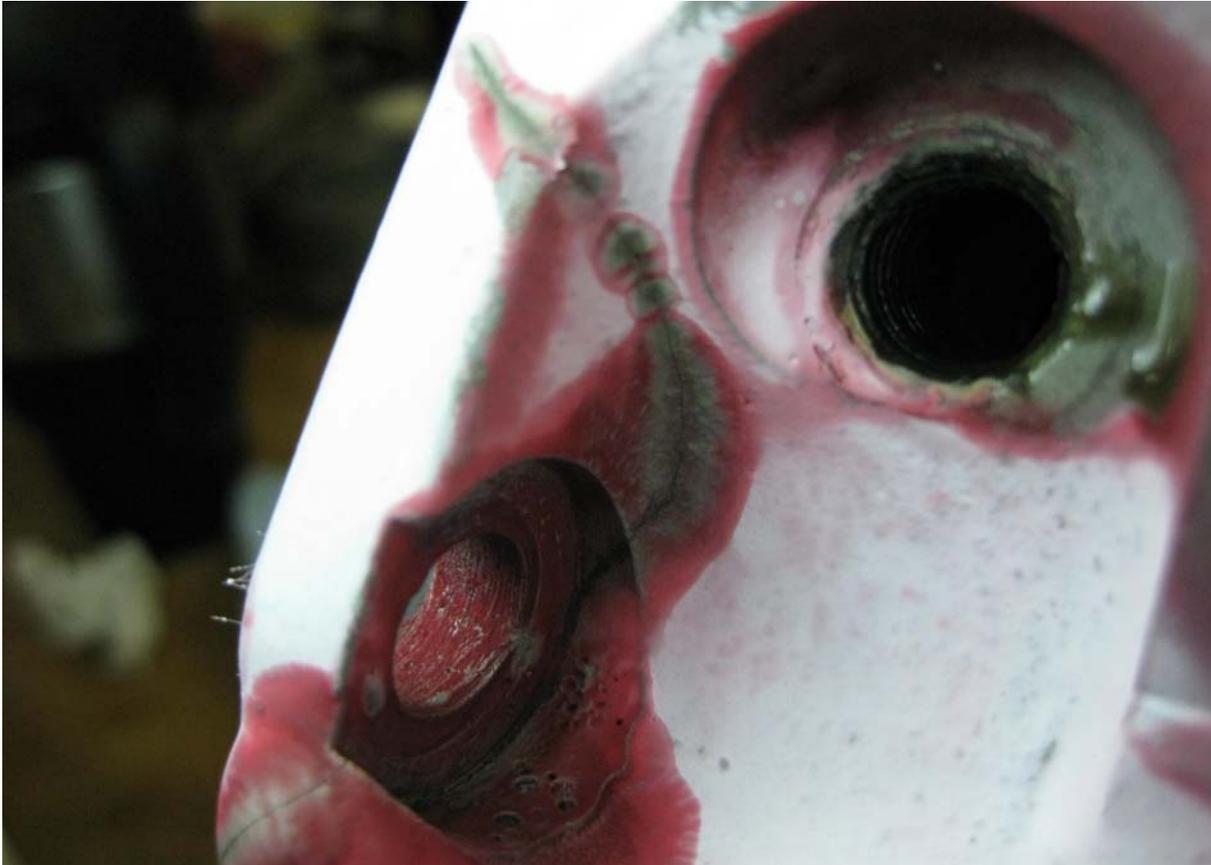
An unidentified repair station mechanic writes, "After an oil change with a new customer, (*the same*) customer complained of oil on top of the nose gear well area behind and below the engine. The engine compartment was cleaned of oil, ground run, and the engine compartment was inspected for leaks. None were noted. The customer contacted this shop the following week after flying over the weekend with the same complaint. The engine compartment was cleaned again and the pilot instructed to fly the plane just around the pattern and return to the shop. A few drops of fresh oil were noted. An oil hose was removed to inspect the oil cooler where it is bolted to the engine core. There appeared to be a small crack in this area around the aft lower mounting bolt hole. The cooler was removed and a much larger crack was discovered that could not be seen as mounted to the engine. This part and most labor was covered under a warranty program provided by the over-hauler, a well known and respected (*business*). It appears to this inspecting mechanic the oil cooler could have developed the crack in one of two ways. There could have been a casting flaw in the metal at the time of manufacturer or overhaul. This mechanic also discovered a way to create stress in this area at the time of installation. If the bottom three mounting nuts are tightened on the studs before the top two are fully seated, the top nuts will bottom out on the mounting flange and create a bending motion at the bottom of the cooler in the area of the discovered crack. Care should be taken during installation to turn the top nuts all the way down before the bottom ones. Pictures have been included with this report."

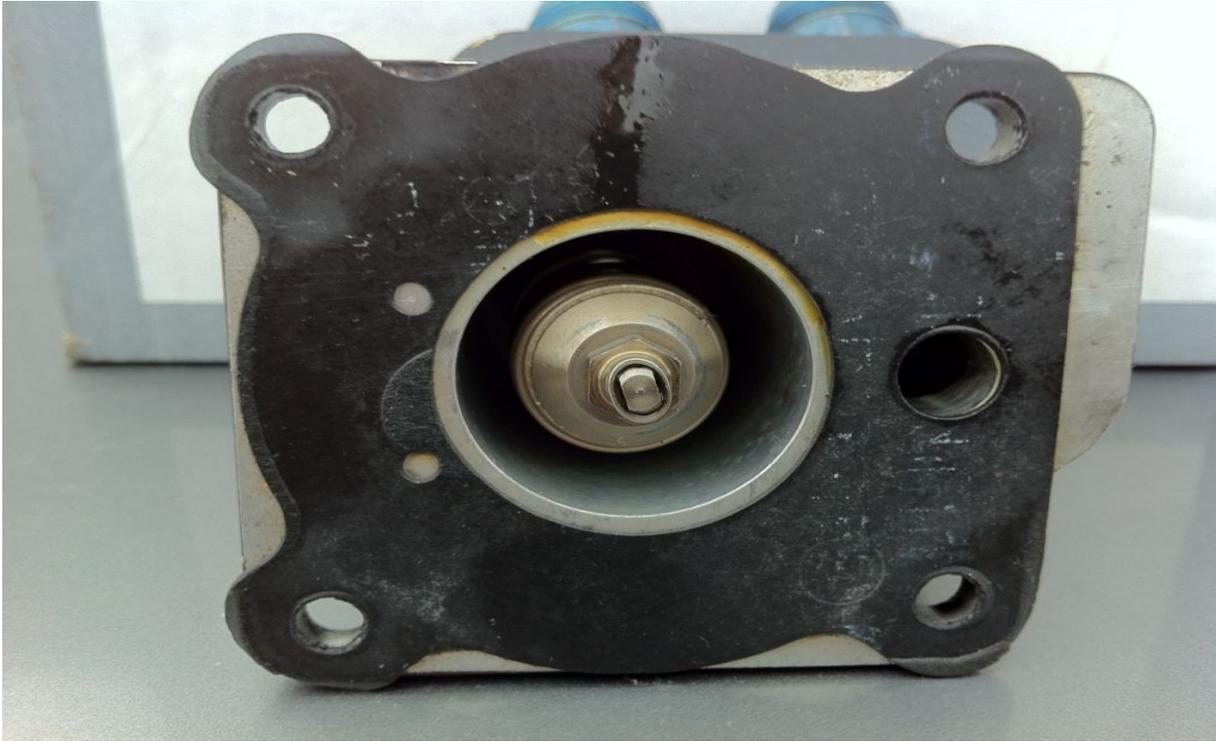
This general aviation submission says, "(I) removed the Vernatherm housing (P/N 700117) which was installed IAW ADC's STC SA4172NM (dated 04/01/1993) as (an) adapter for (an) external oil filter. (During the airplane's...) Annual Inspection I discovered two problems related to the original ADC Vernatherm housing (P/N 700117). 1) Wear marks on the seat of the valve indicated the Vernatherm was not centered over the port in the accessory case (preventing the Vernatherm from fully closing). It appeared to be striking the seat about 0.065 inches off center. 2) The port for oil returning from the oil cooler was about 60% occluded by the base of the Vernatherm." "(I had to buy a new housing from ADC...) which is the same part number, but it has been redesigned with a recess machined in the housing to allow less restriction over the port which returns the oil from the oil cooler. The new housing was installed and the seating of the Vernatherm confirmed with the use of Prussian blue dye on the seat of the valve. A test flight (was performed)."

(Original housing)

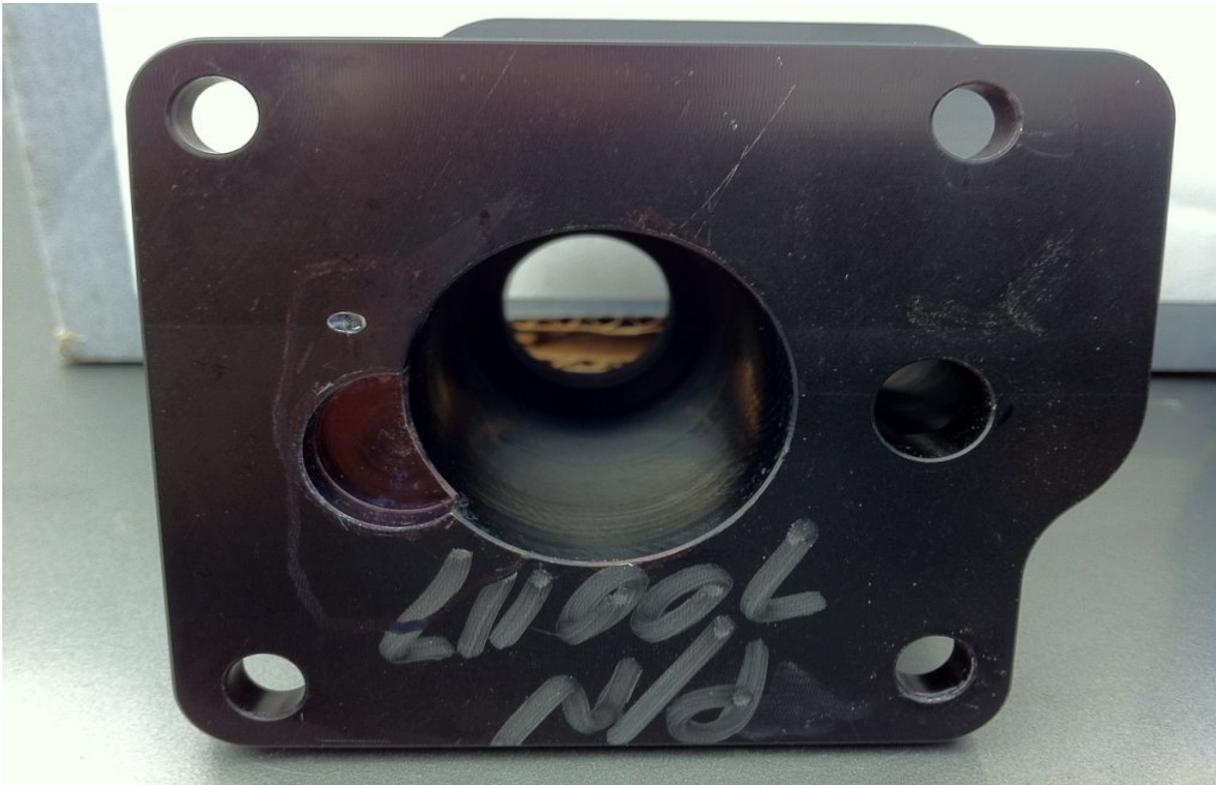
(Replacement housing)
