ADVISORY CIRCULAR

43-16A

AVIATION MAINTENANCE ALERTS

**ALERT
NUMBER
391**

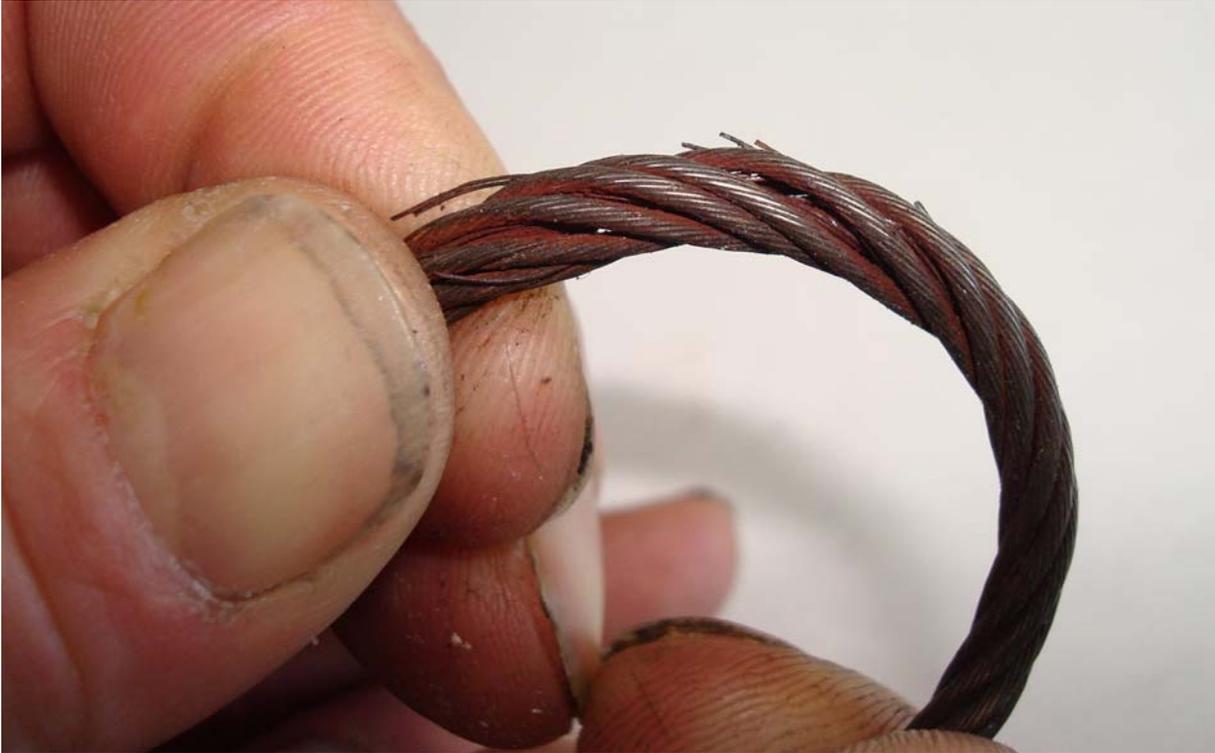
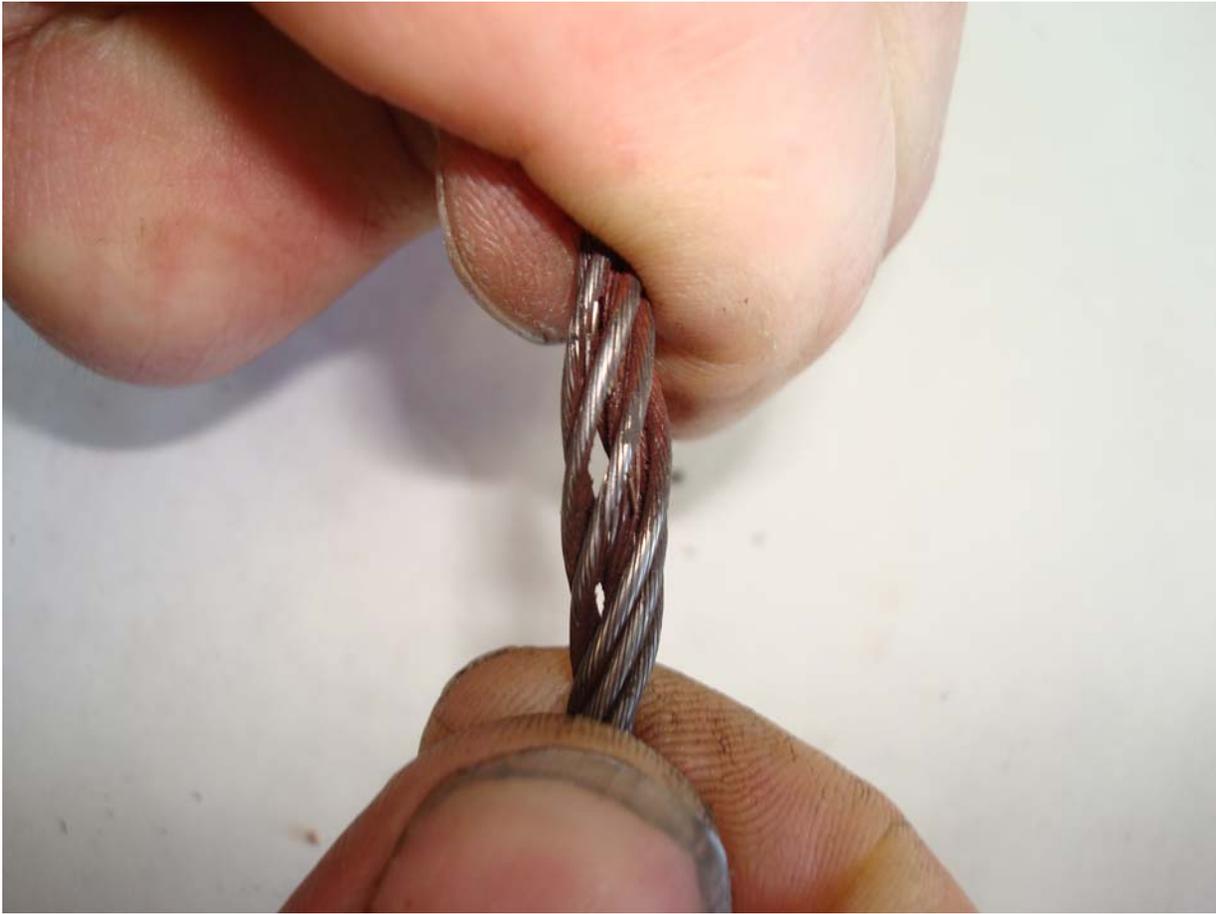
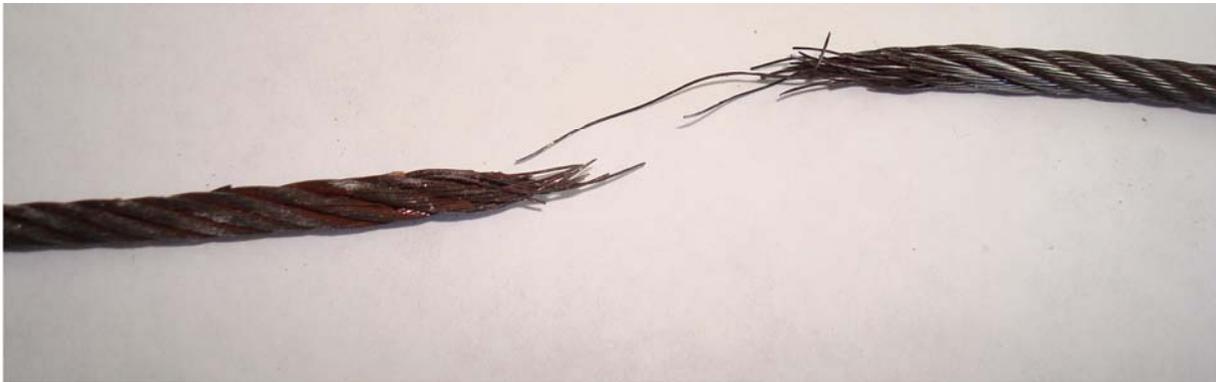
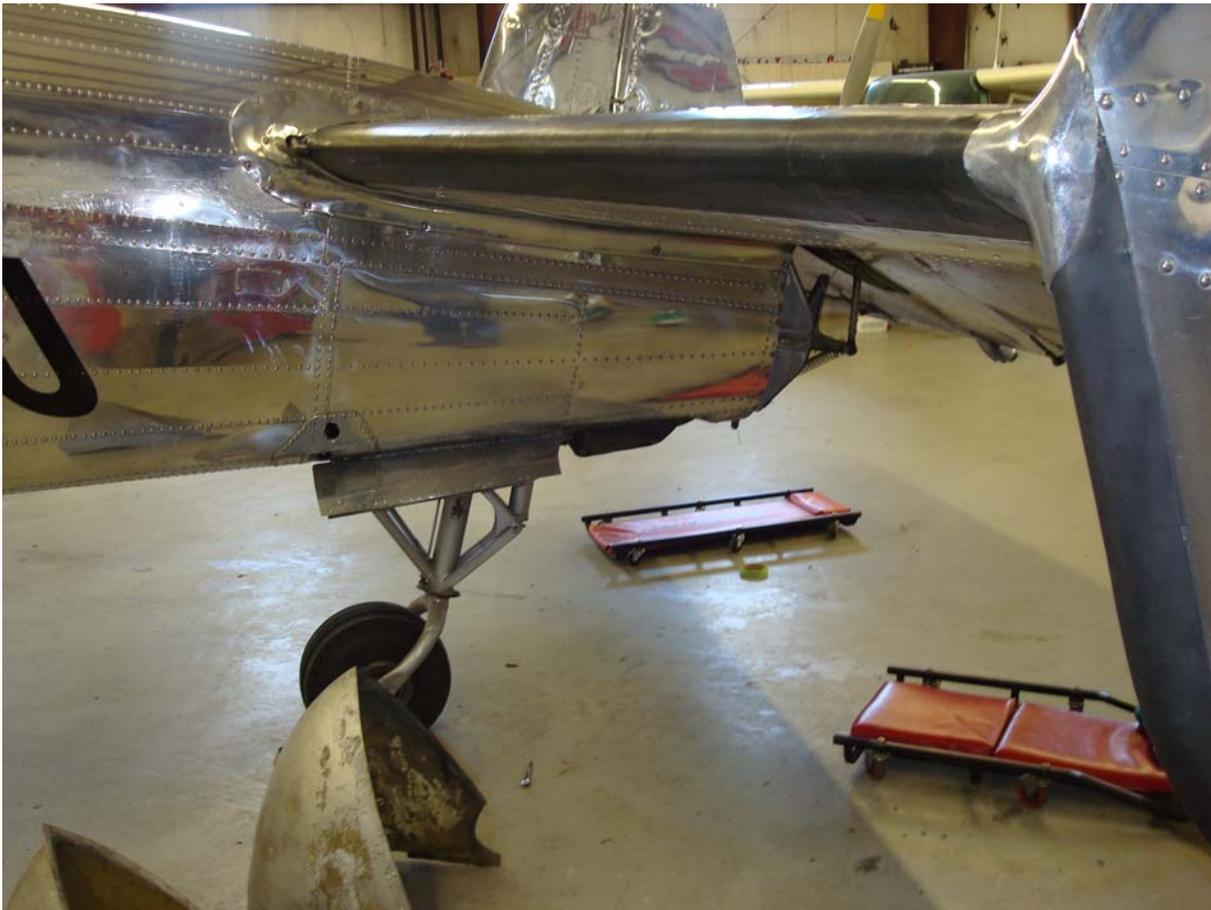
Inspector Anderson states, "This report concerns an operational check flight after an Annual inspection. After takeoff, the pilot heard a "snap" and the aircraft pitched up. The pilot realized he had lost down elevator. Control of the aircraft was regained by the use of power reduction, help from the passenger in the right hand seat, and elevator trim. The aircraft returned for a successful high speed wheel landing.

"The cable appears to be galvanized steel and was completely covered with Paralketone. The break was at the pulley above the tail wheel, at bulkhead number 14. The pulley was free to rotate, however, it did show signs of wear—possibly from over tensioning of the cable. After removal of the cable from the aircraft, further inspection revealed broken strands in the area of its attachment to the elevator control *bull wheel* (reference the attached figure). Note the total time on the elevator cable (P/N 414-187097-1) is unknown."

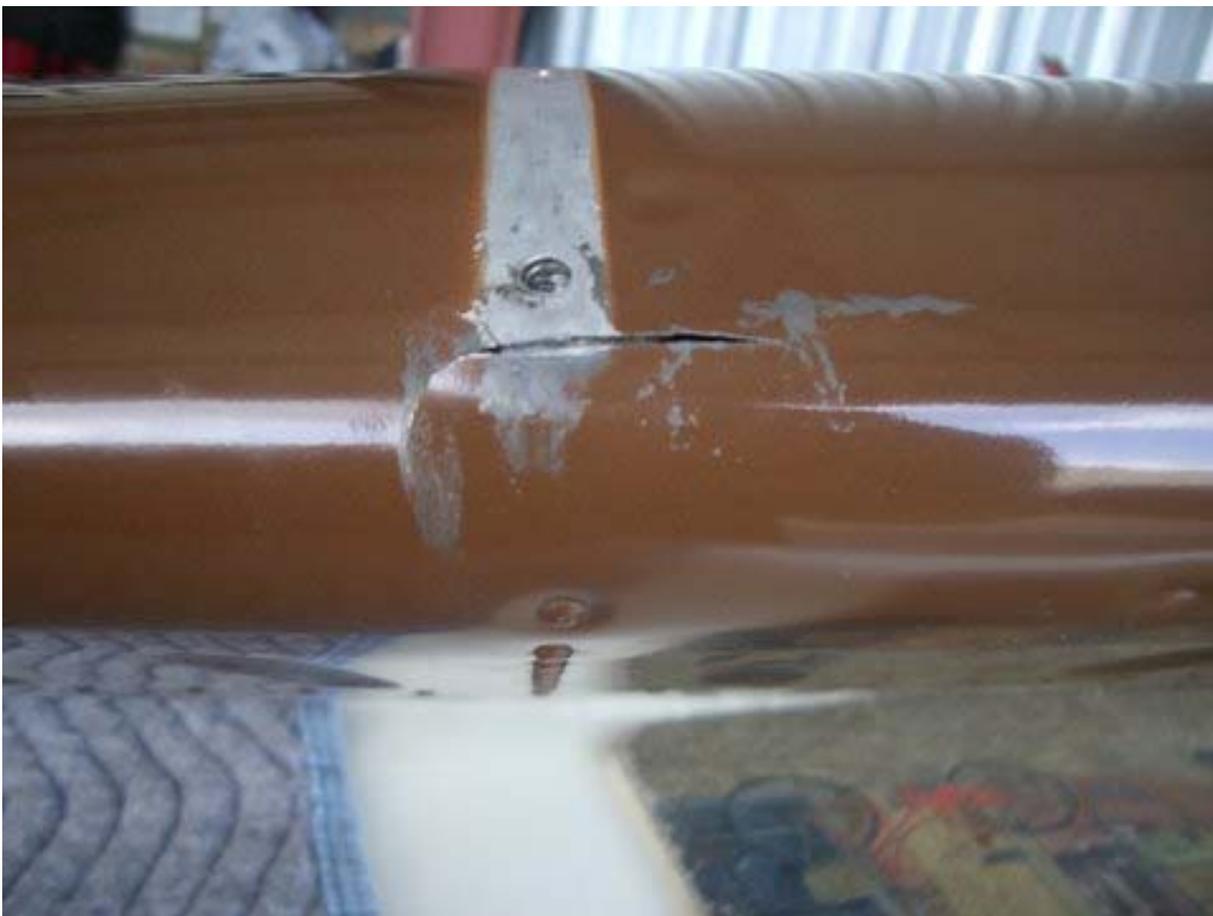
"(I) performed an inspection," says this repair station submitter, "according to Hawker Beechcraft Safety Communiqué number 313/FAA SAIB CE-11-21. The R/H flap leading edge was found cracked (approx. 1.50 inches) in the vicinity of the 'flap actuator bracket'. The nose rib was also cracked. This flap (P/N: 35165050606) was removed for repairs."

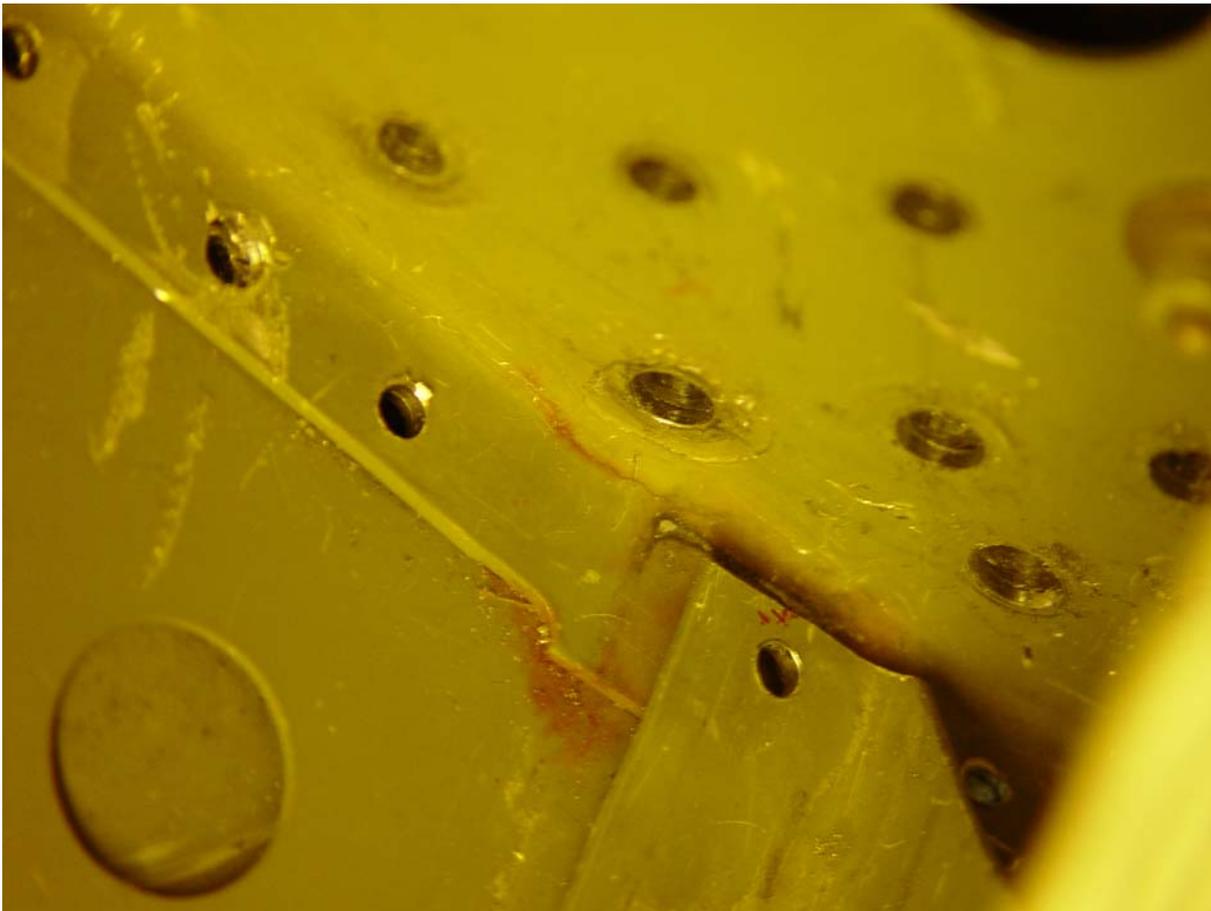
"A Beechcraft Barron 58...was in for a routine maintenance inspection at the operator's home facility," says this technician. "During the Annual Inspection a crack in the right forward spar web bend radius (forward side) was noticed during a visual inspection of the area. A dye penetrant inspection was performed and the crack was verified. The inspection was performed following the Hawker Beechcraft Corporation Barron 55 and 58 Maintenance Manual: P/N 55-590000-13G, Rev. G2, dated October 1, 2010; Section 53-00-00, page 202; B(1) 'Wing Forward Spar Carry-through Structure Inspection—Without Repair Kit'. The aircraft was then flown to our facility for verification of the crack and the installation of Hawker Beechcraft Corp. Kit P/N 58-4008-9 (which is applicable to this aircraft serial number TH-1990). It should be noted AD90-08-14 'Wing Spar Structure'—and Beechcraft MSB2269 Rev. 1 'Fuselage: Wing Forward Spar Carry-Through Structure Inspection and/or Reinforcement' are not applicable to this aircraft by serial number. The crack was found in the area referenced in both the AD and MSB, but 'stop' applicability for this aircraft model 58 was at serial number TH-1475. The Hawker Beechcraft Corp. Kit P/N 58-4008-9 was installed on both the right and left forward spar, forward web structure in accordance with Beech Aircraft Corporation Kit Information—Reinforcement Installation Instructions, Drawing number 58-4009 and Kit Information Drawing number 58-4008, Revision C."

(Trick photography! Not only is the crack quite apparent, but the overall photo provides a nice example of an inside/outside optical illusion—Ed.)

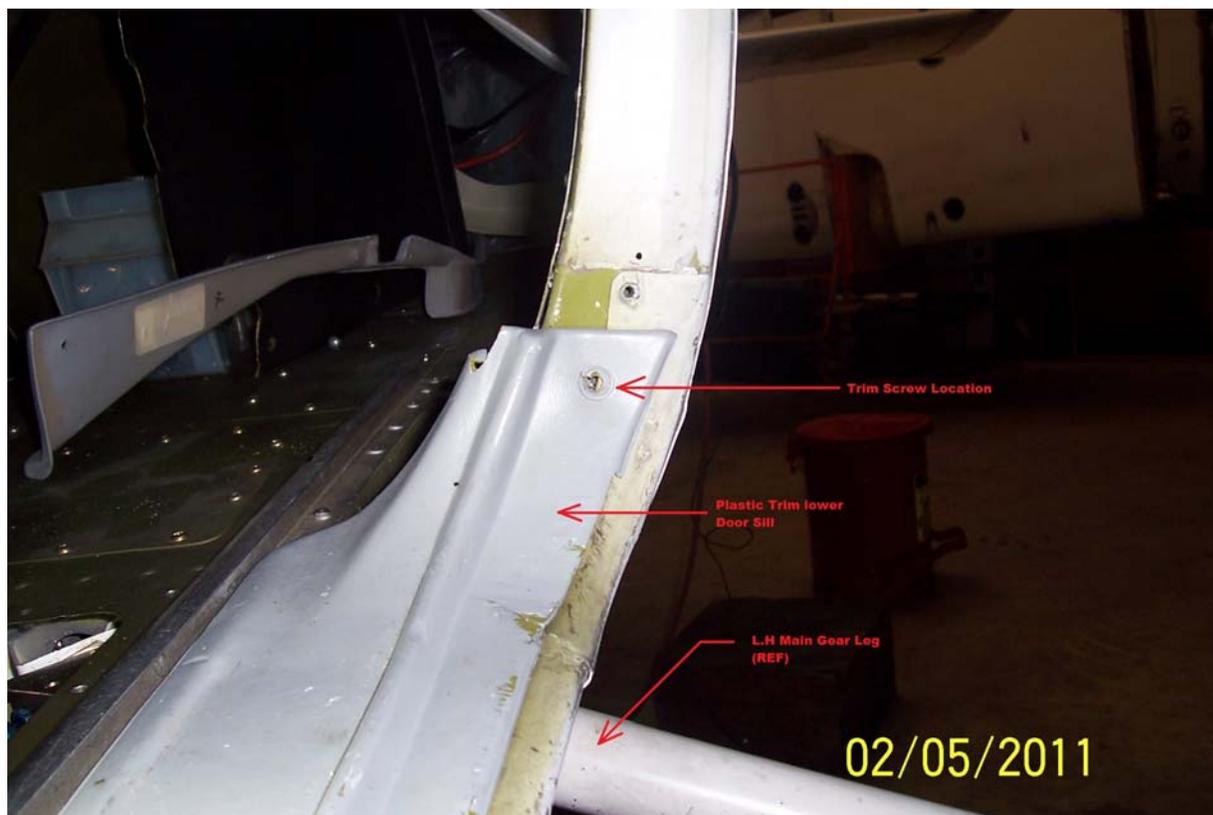
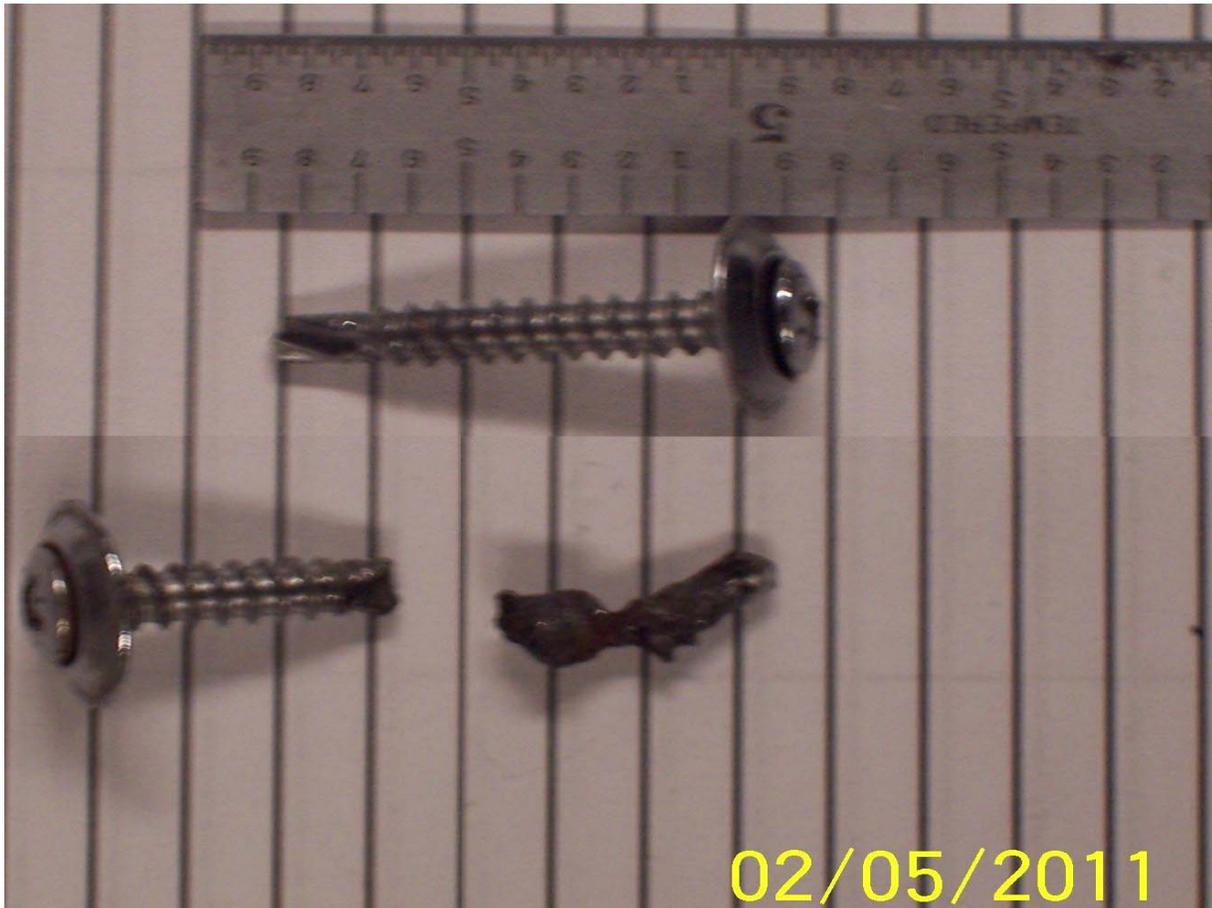
A technician writes, "(I) found an improperly sized (too long) interior trim replacement screw installed in the pilot side lower door sill opening, shorting into the Main Power Cable (P/N W-PA4). The pilot (*had*) complained of intermittent panel lighting/flickering, and recent regulator replacement (twice) and alternator/charging issues."

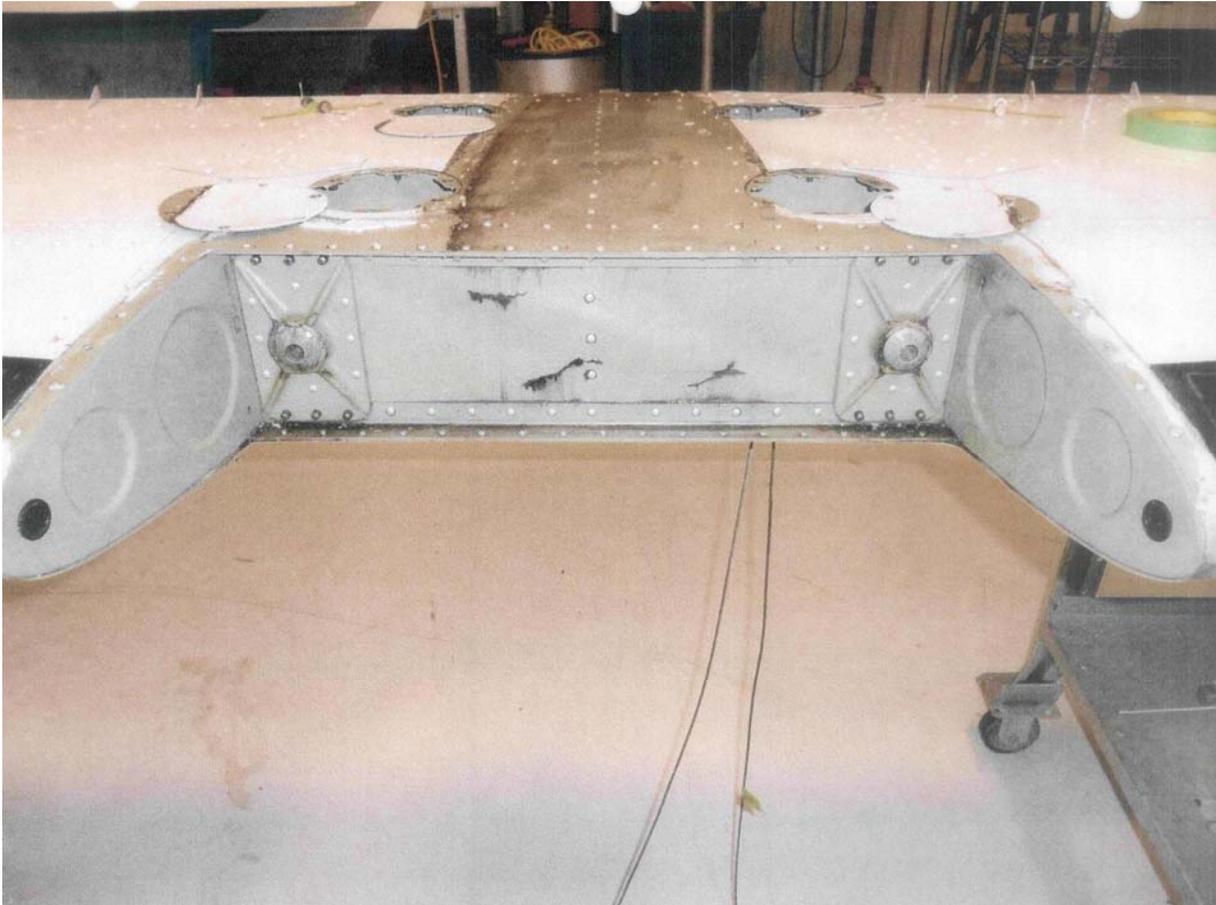
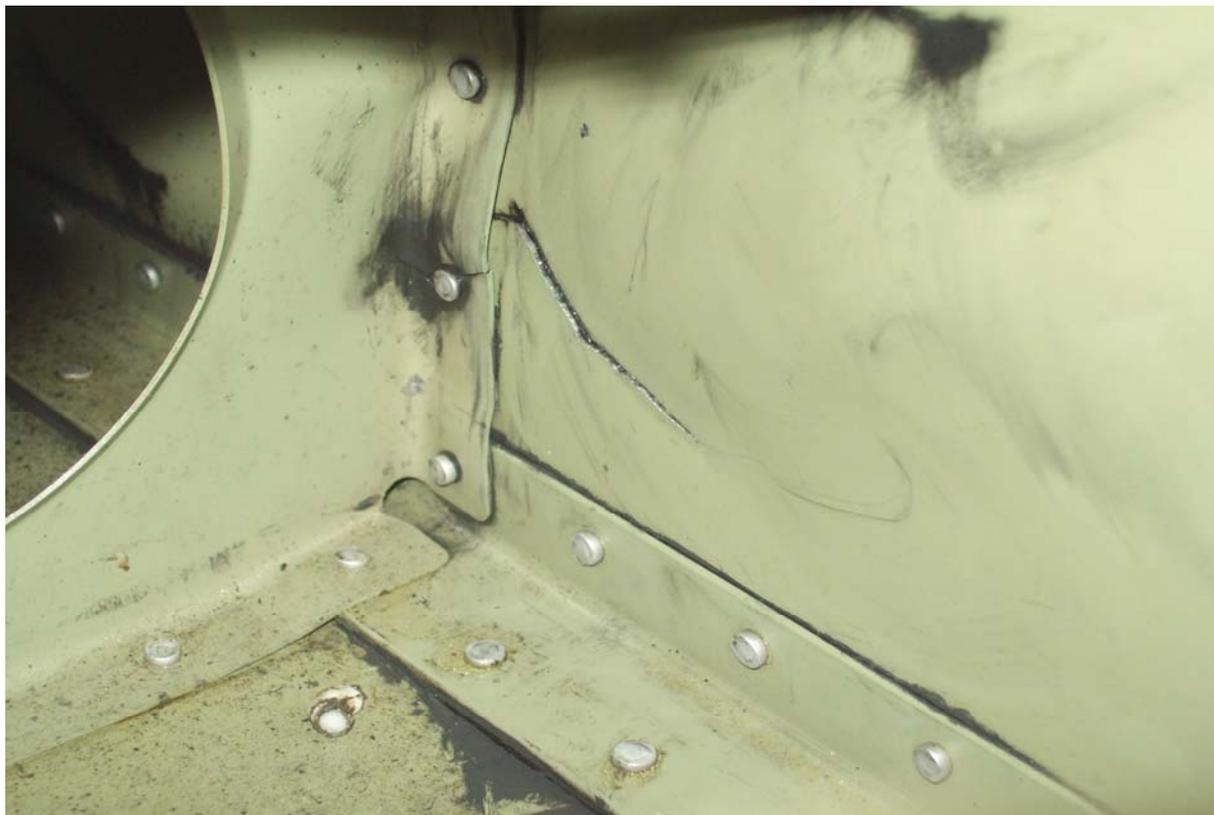
"During a phase 10 inspection of a Cessna 208 (on floats), maintenance personnel discovered multiple cracks in the center section spar of the horizontal stabilizer (P/N 26300038). Several ribs were also found wrinkled and distorted, and a straight-edge confirmed deformation of the stabilizer's top surface.

Removal of this stabilizer revealed extensive damage to the center spar web, rendering it unairworthy. Subsequent investigation determined the damage was caused by cleaning personnel using this critical flight surface as a work platform during cleaning of the tail area.

Inspection of this operator's remaining fleet of aircraft found no other problems. The stabilizer was repaired and reinstalled. *No Step* placards were fixed on all subject aircraft in the effected areas. The total cost of this repair exceeded \$17,000.00—not including down-time of the aircraft.

Operators should be vigilant for those ground operations that can cause aircraft damage—cleaning activity is but one example. Proper training and adequate support equipment (proper stands) are critical elements for elimination of this kind of safety hazard and economic waste."

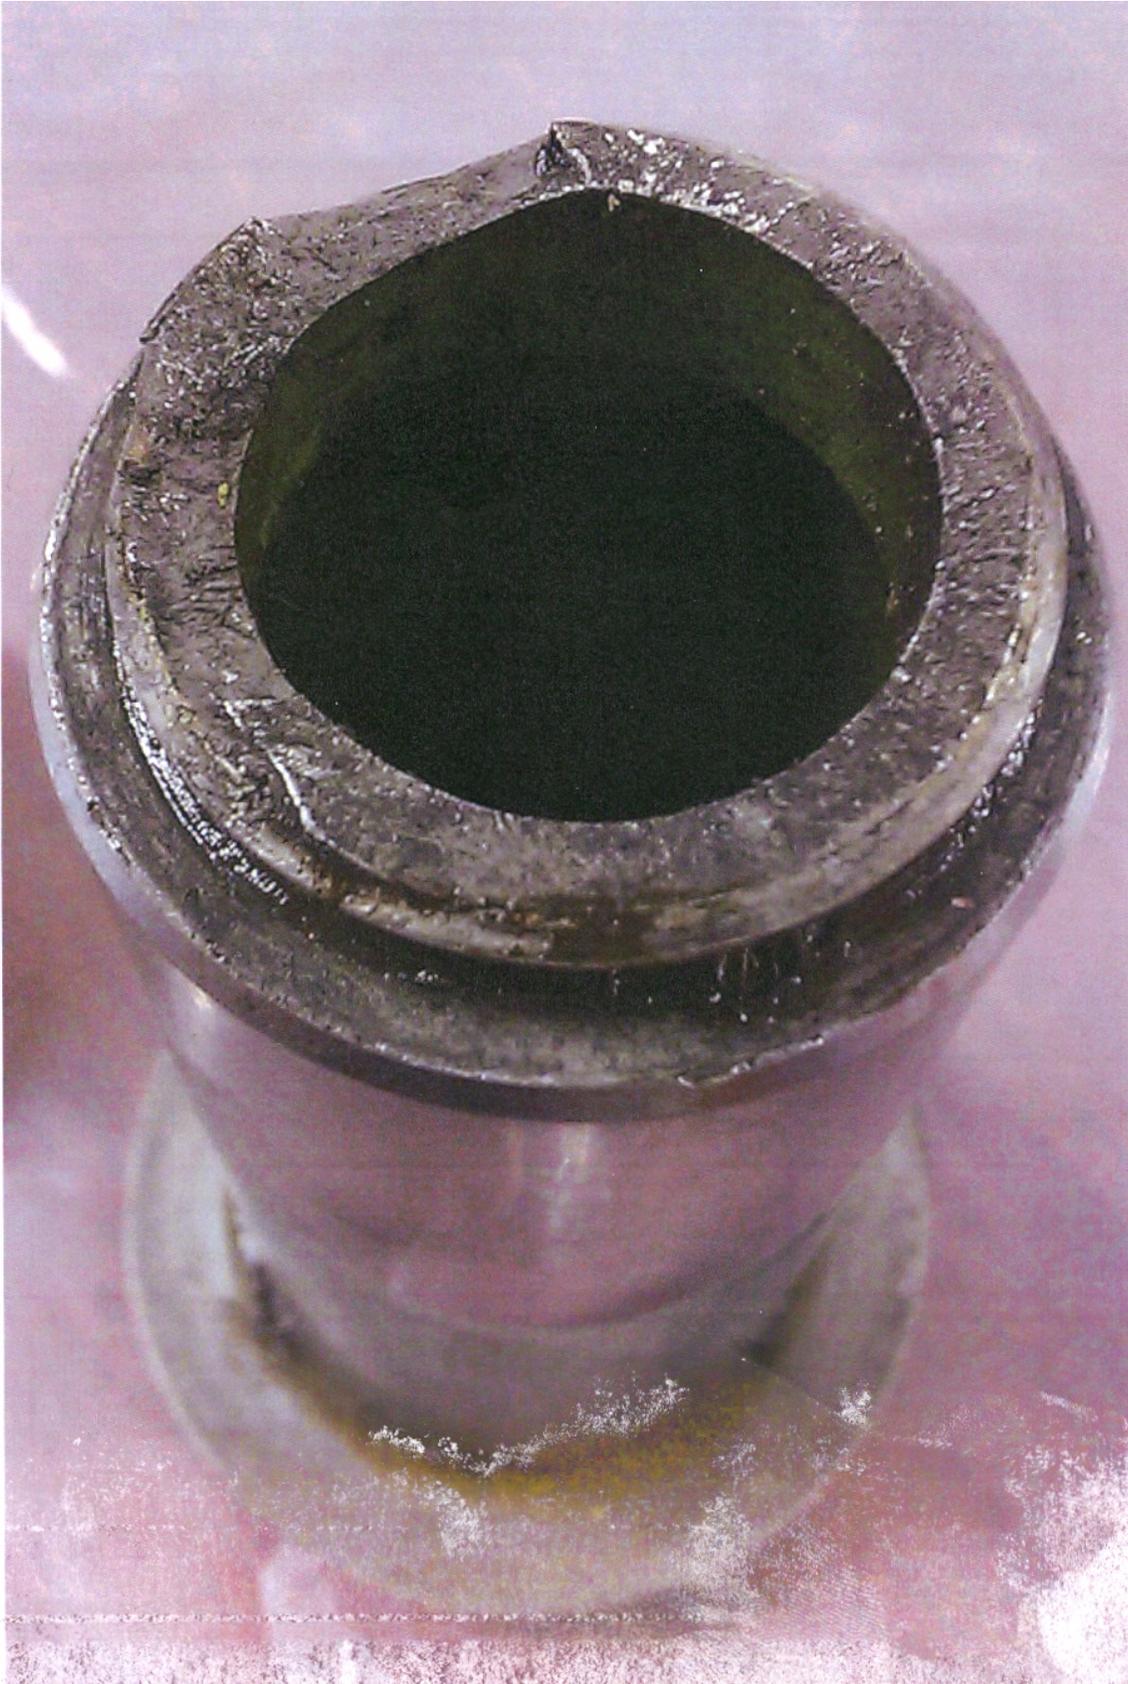
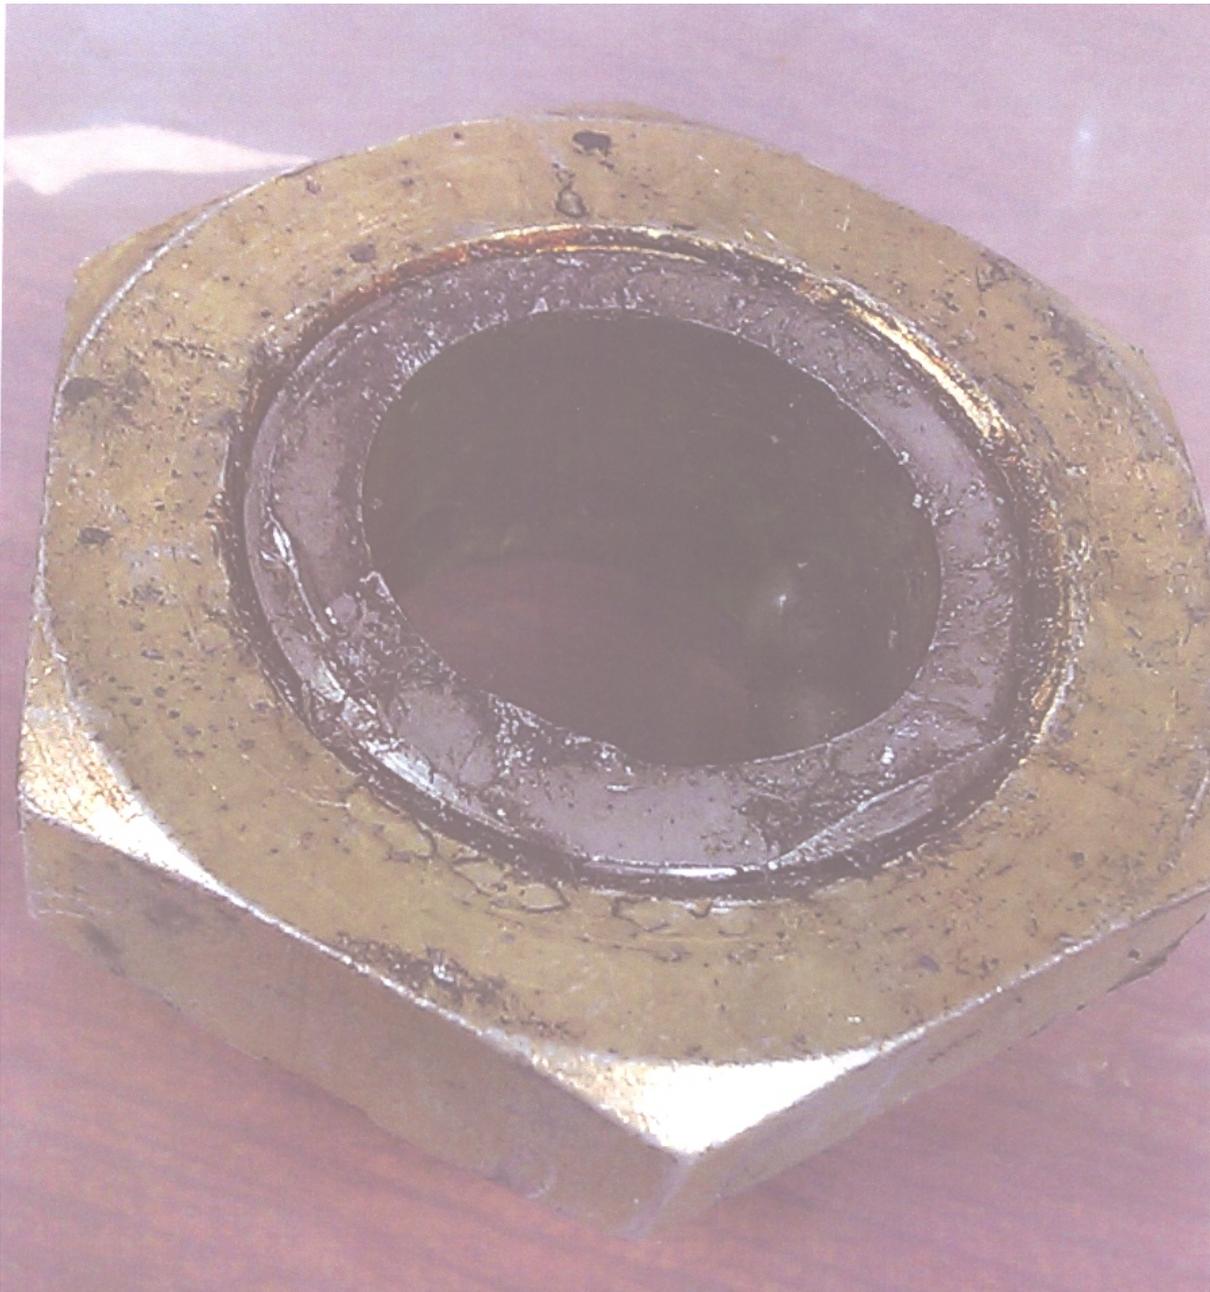
"This event occurred late in the evening," says a quality manager, "during disassembly of the landing gear at overhaul. While accomplishing the un-torque check IAW SP145-32-0097, the nut fell off the subject axle as torque was applied to the upper attach axle (P/N 23092029001). The axle had sheared at the point where the threads entered the nut. The operator was informed of the defect by phone and e-mail, (and provided this defective) axle."

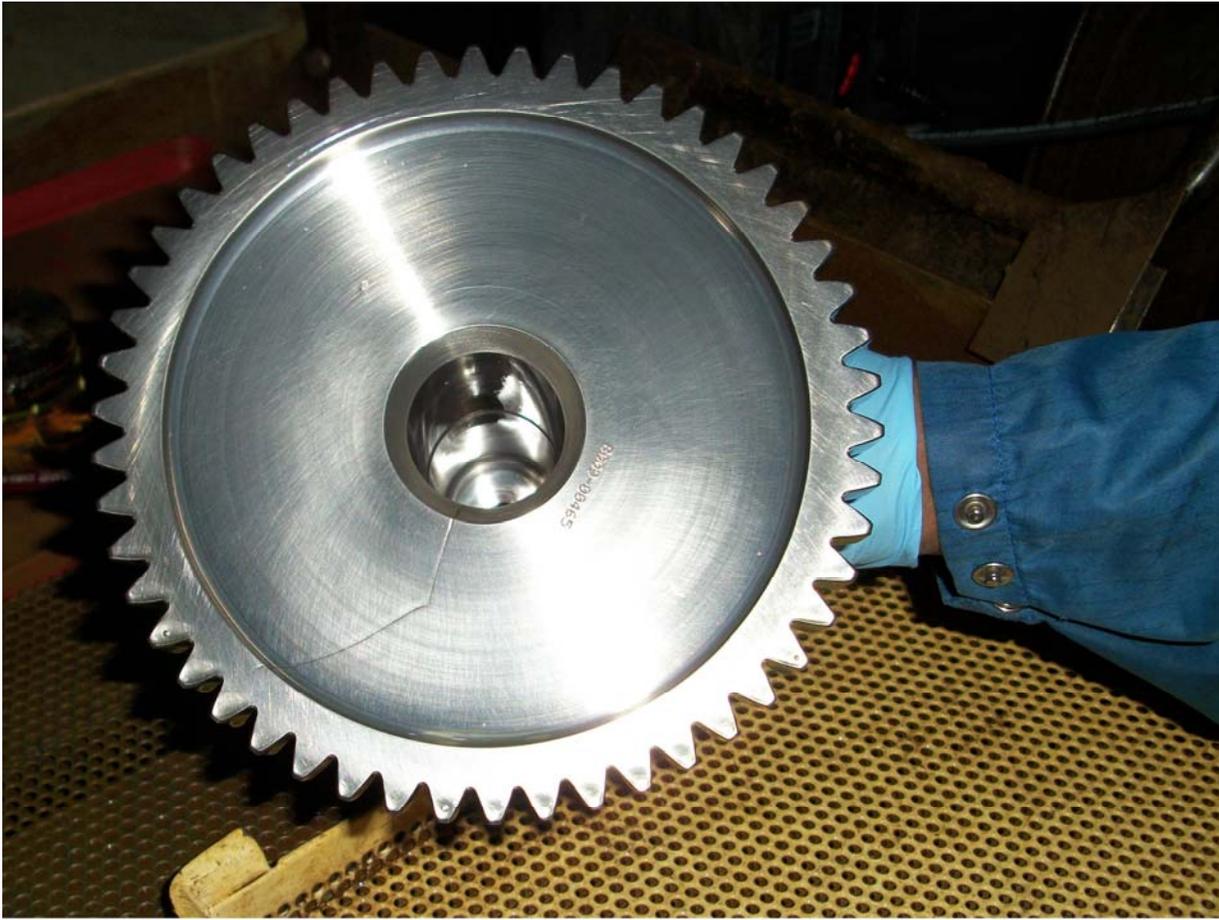
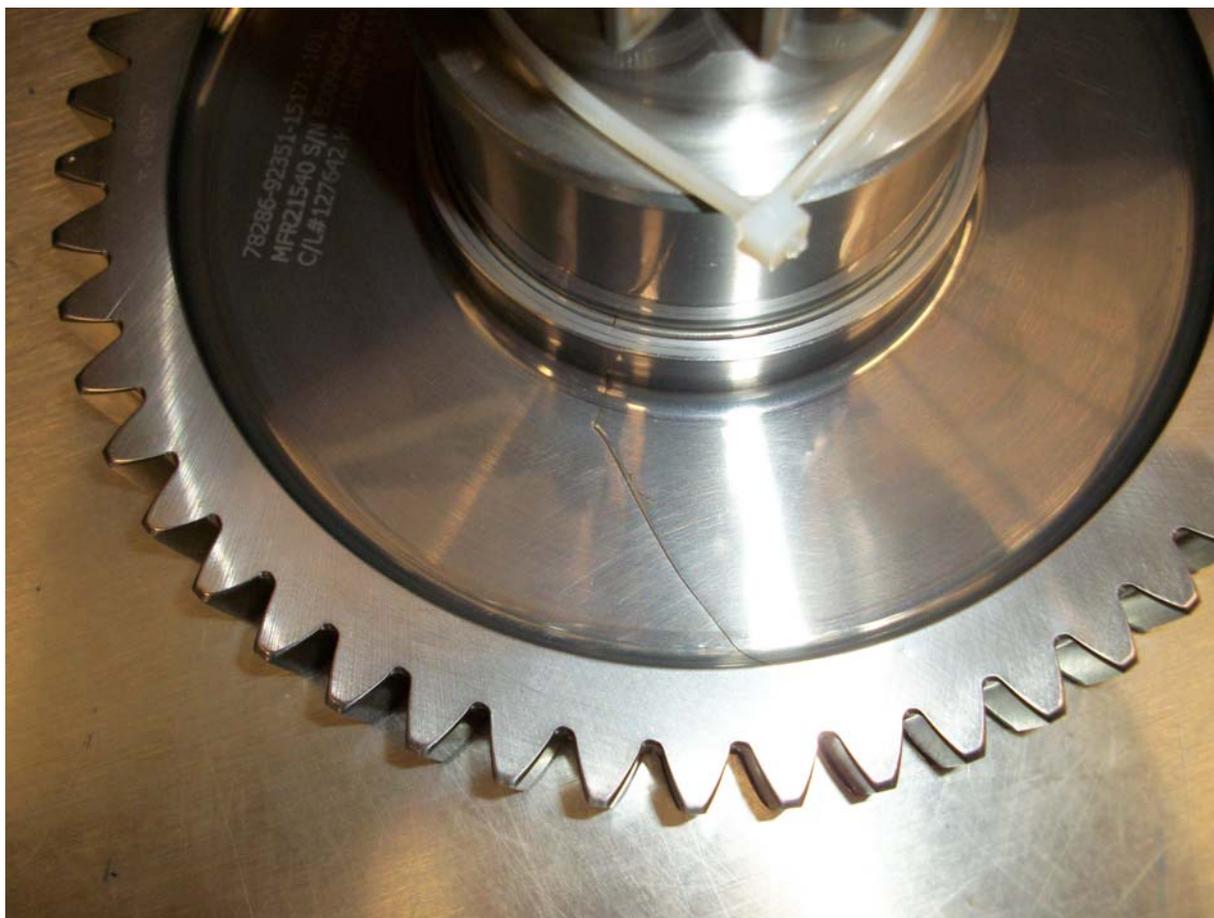
"A large crack was discovered (*propagating*) through the web section of this planetary gear," says a chief inspector. "(*It was found...*) while conducting an MPI (*magnetic particle inspection*) as a normal part of the repair process. Sikorsky and HSI have been notified; they will be conducting a full metallurgical investigation." (*Gear P/N: 9235115171101.*)

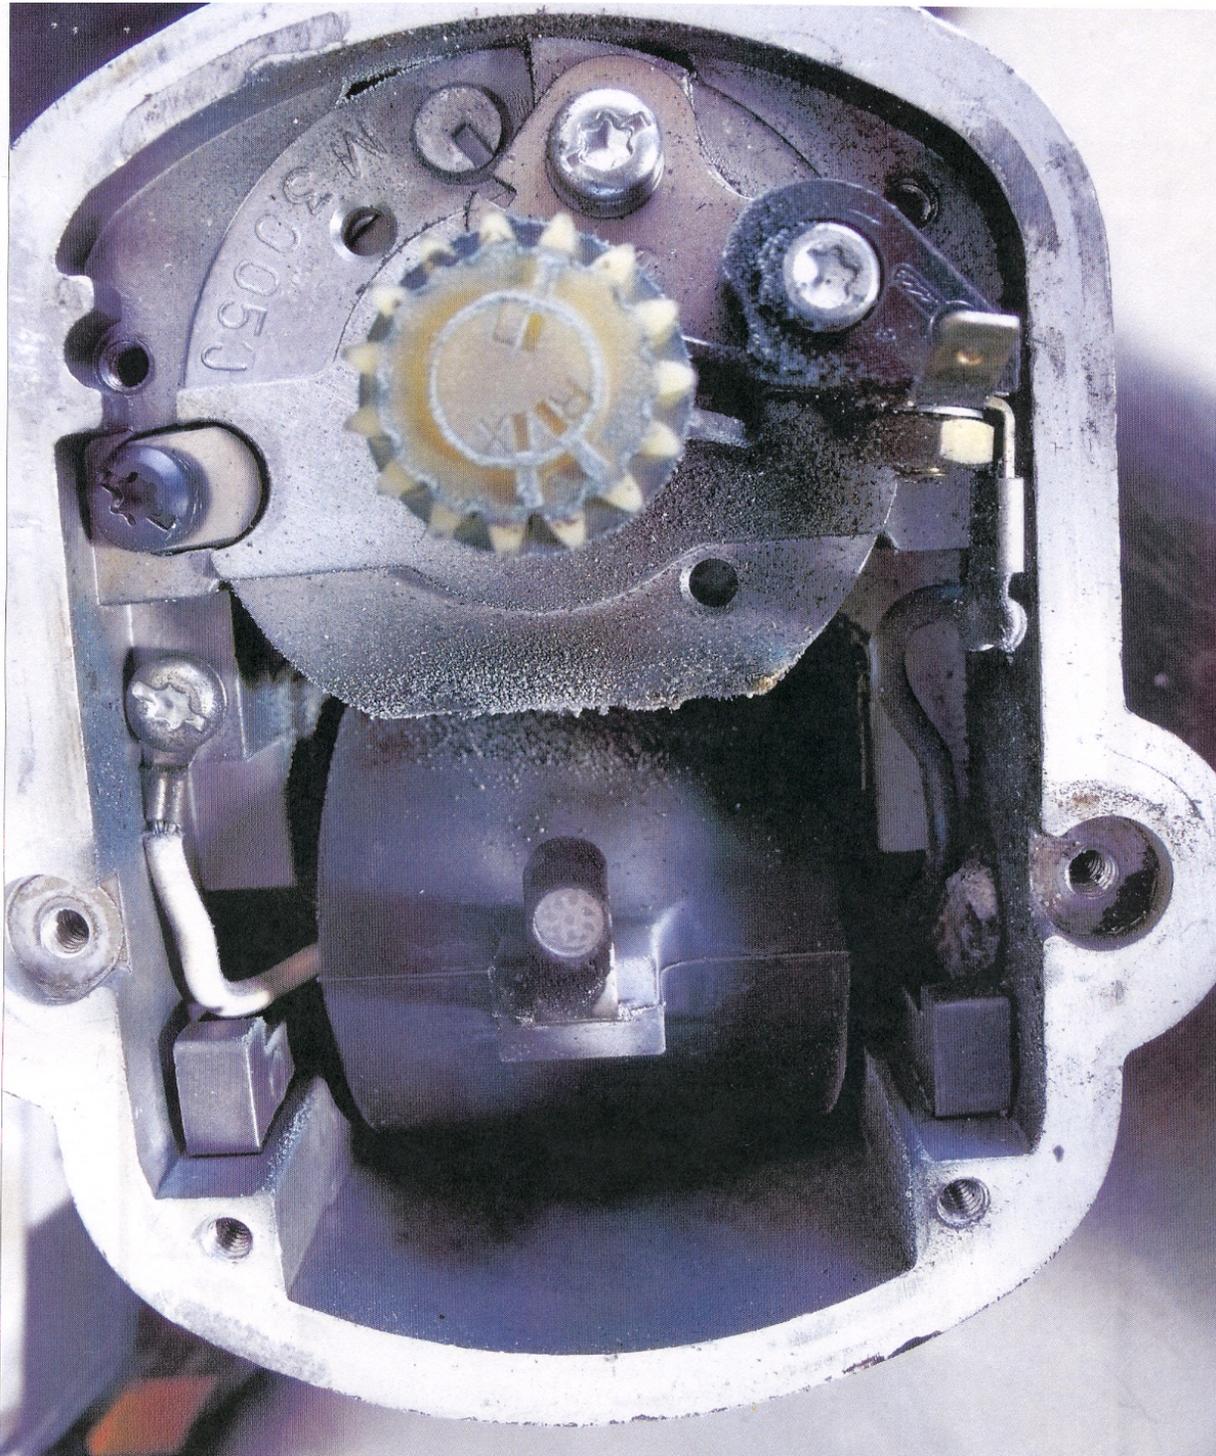
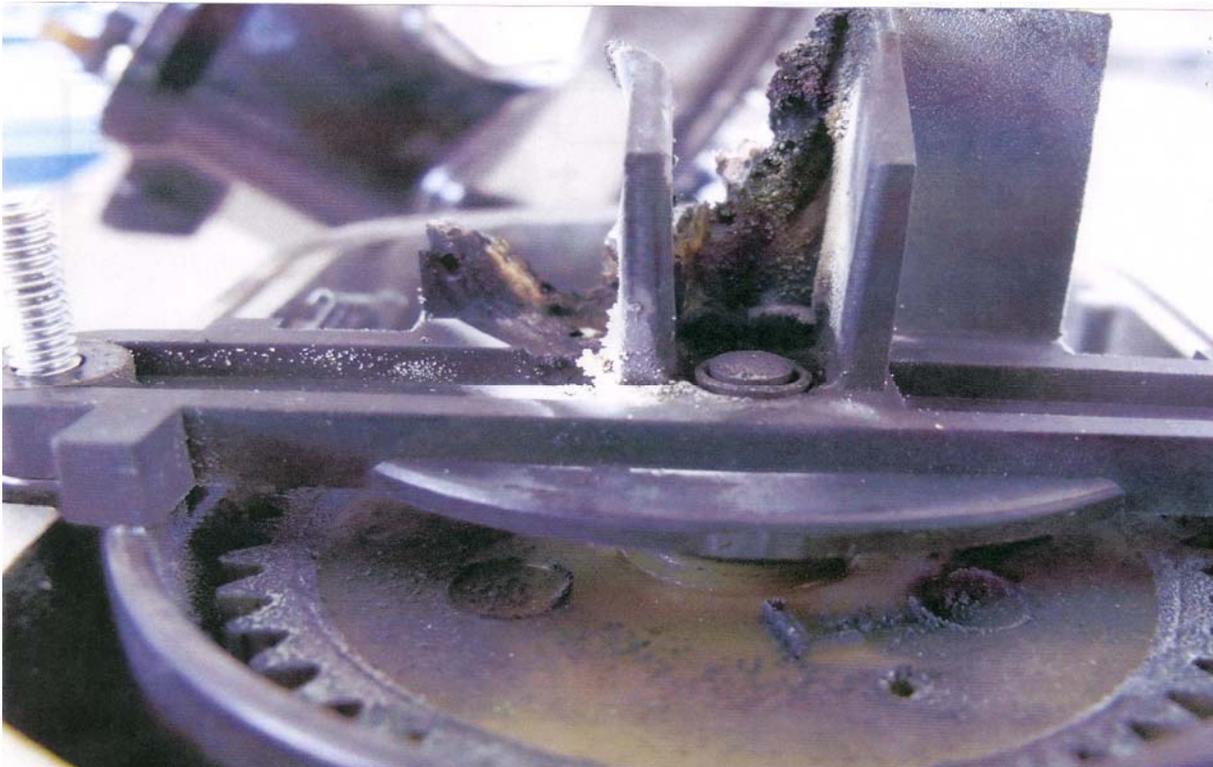
A general aviation submitter states, "(I) removed the left magneto (*from a Cessna 182T*) for a 500-hour inspection and found the distributor block assembly burned through—pieces were floating around inside the (*unit*). A large amount of dust coated the surfaces, and burning was evident on the coil and rotor housing. The carbon brush and cam were extremely worn. During pre-inspection run-up the magneto drop was no more than 75-80 RPM at 1800 RPM—mixture full rich.

"According to the engine log the magnetos were removed and replaced at tachometer time of 1,007.7 hours for a 500 hour inspection." (*The SDRS database reflects at least ten of these particular magnetos.*)
