## ADVISORY CIRCULAR

43-16A

# AVIATION MAINTENANCE ALERTS

**ALERT  
NUMBER  
392**

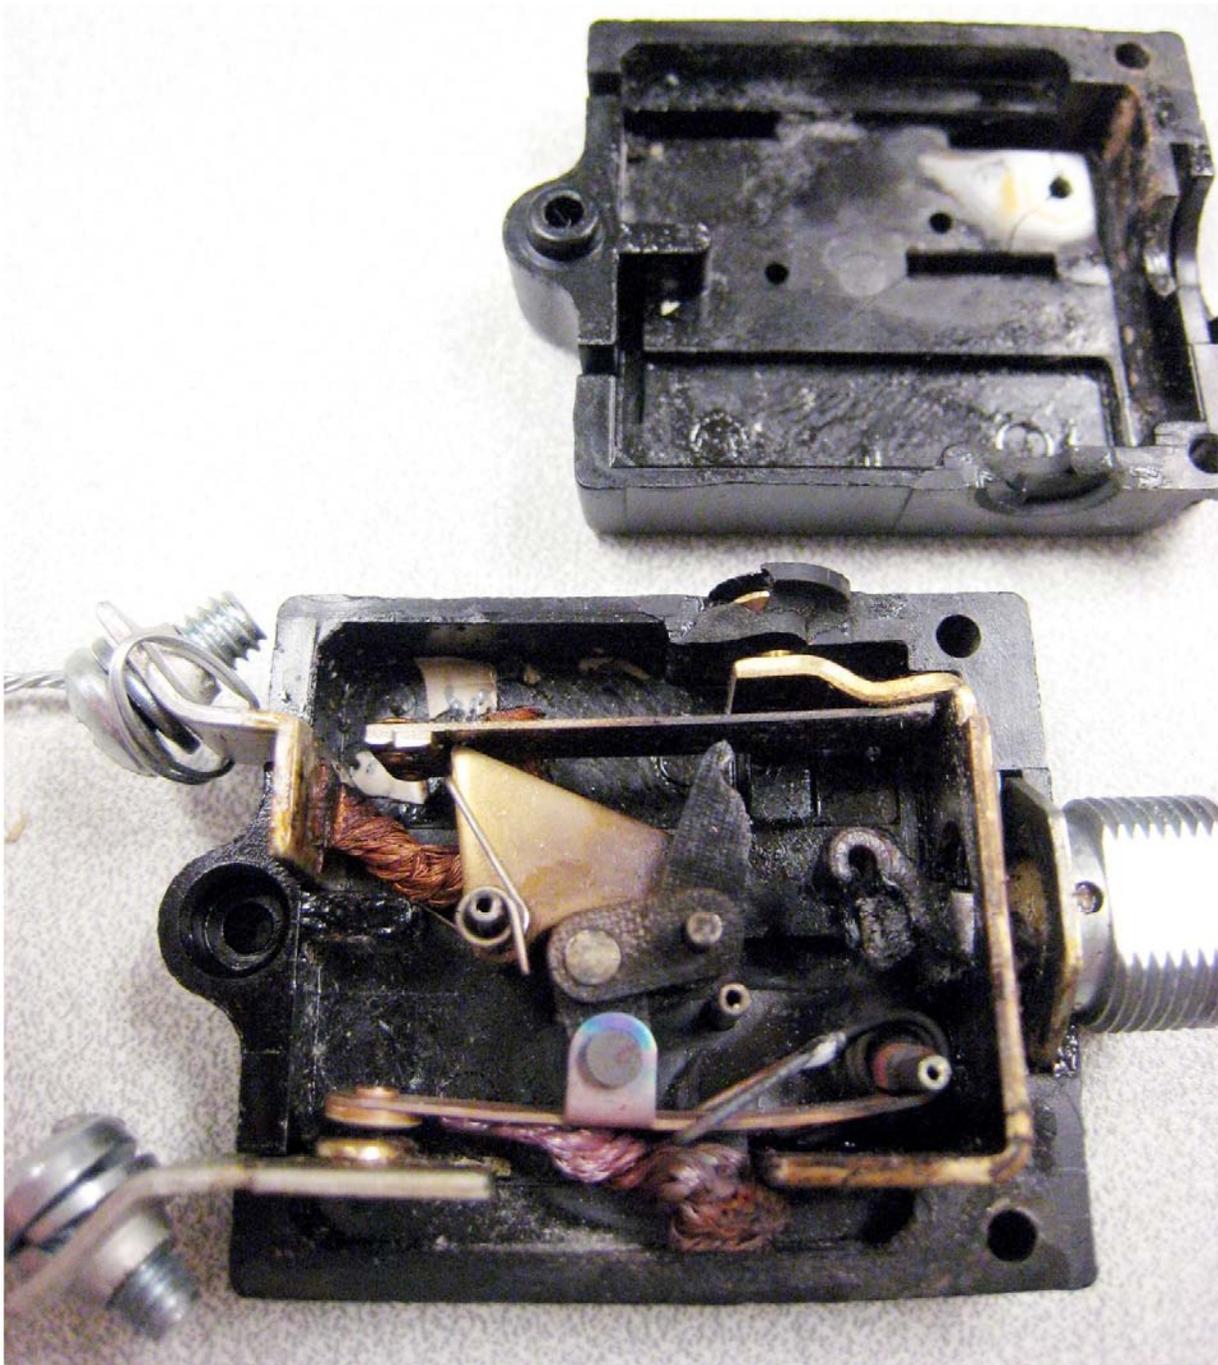
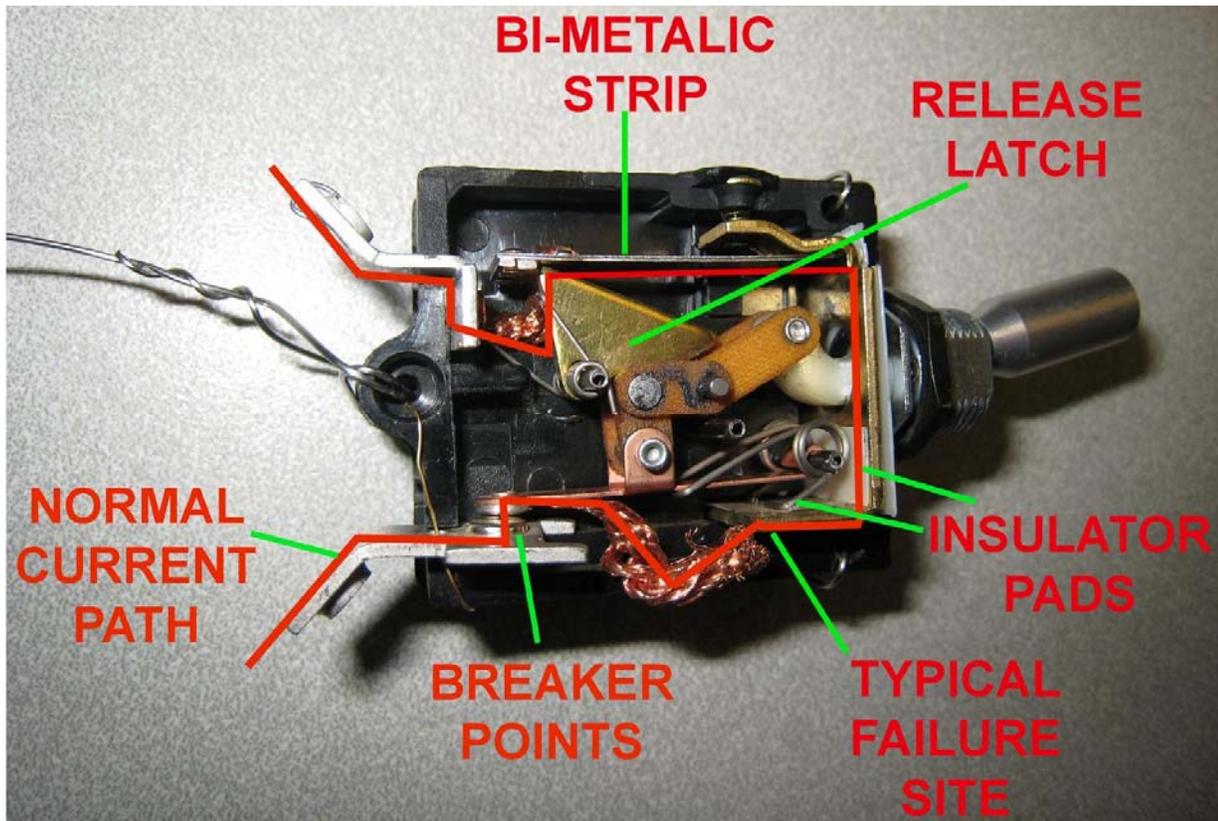
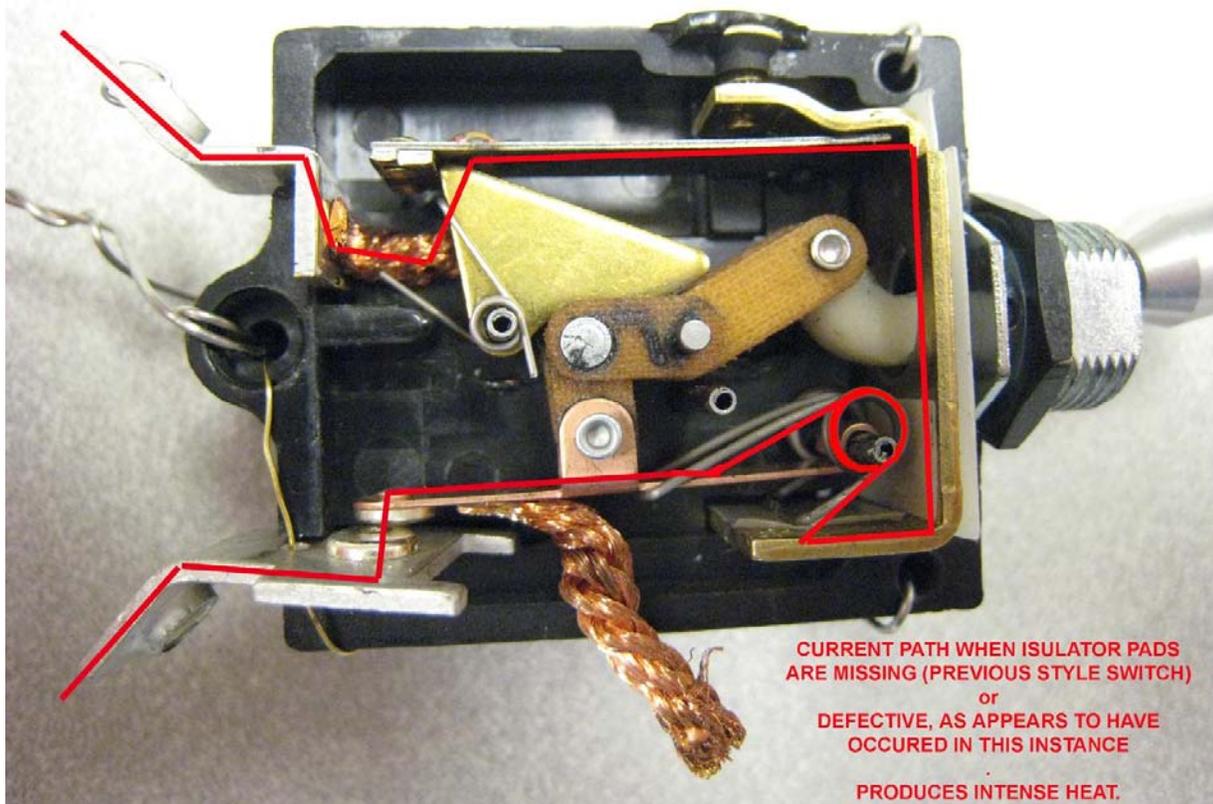
**Beech: 58; Burned Landing Light Circuit Breaker Switch; ATA 3340**

"The pilot reported a burning smell in the cabin," says this submitter. "An inspection revealed the taxi light circuit breaker switch to have an unusual feel. Following replacement of the switch, the failed switch was disassembled and found to have burned internal components. This switch (P/N 35-380132-105) is the improved model that was required by AD2008-13-07 which was modified to prevent the burning situation in the failure mode. This was accomplished by installing two insulator pads at the actuator spring to prevent current from flowing through the spring when the wire braid fails. Unfortunately, when these switches overheat, it is difficult to impossible to determine if the insulators had been installed improperly, or installed at all. This is the second post AD switch in our fleet that has failed and overheated." *(Switch manufacturer's name: Tyco. Aircraft total time: 8,059 hours.)*

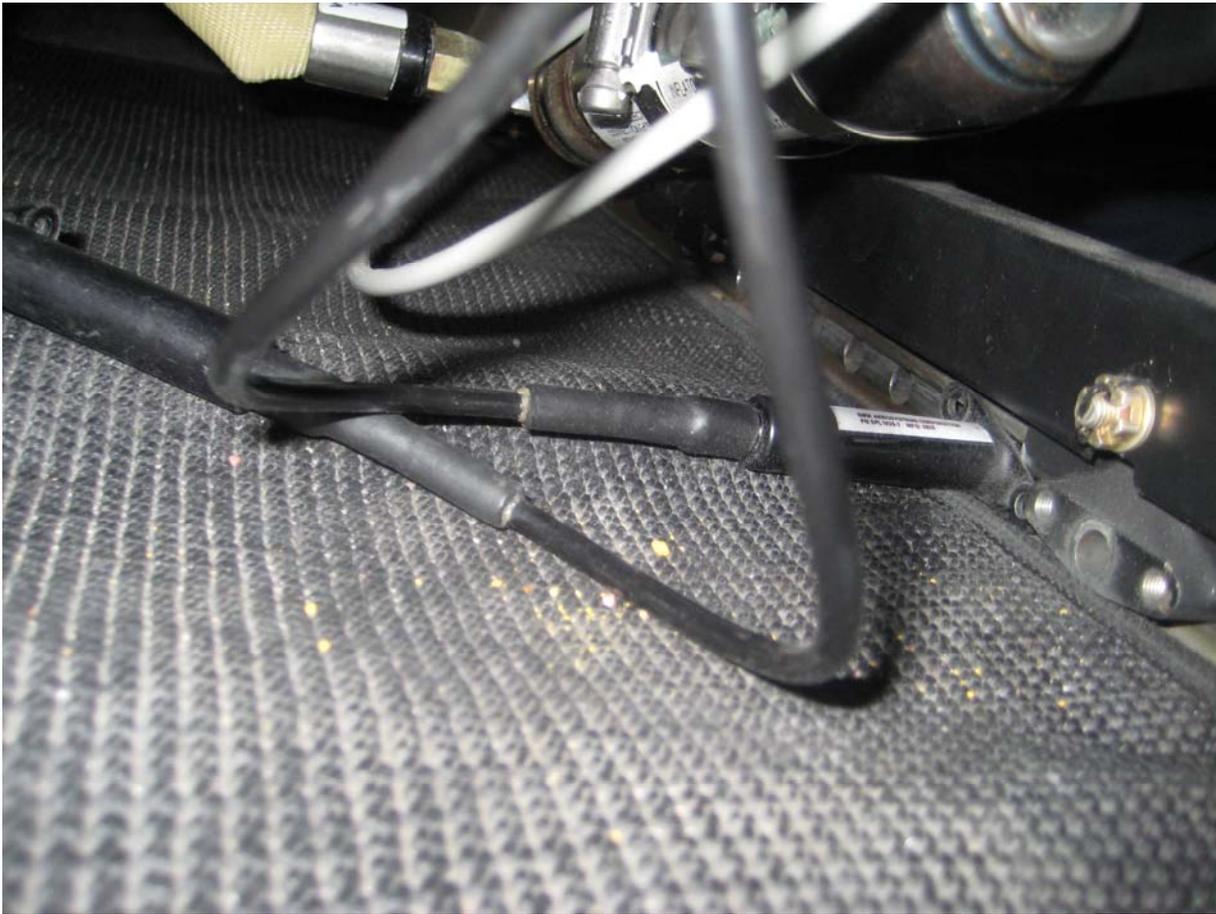
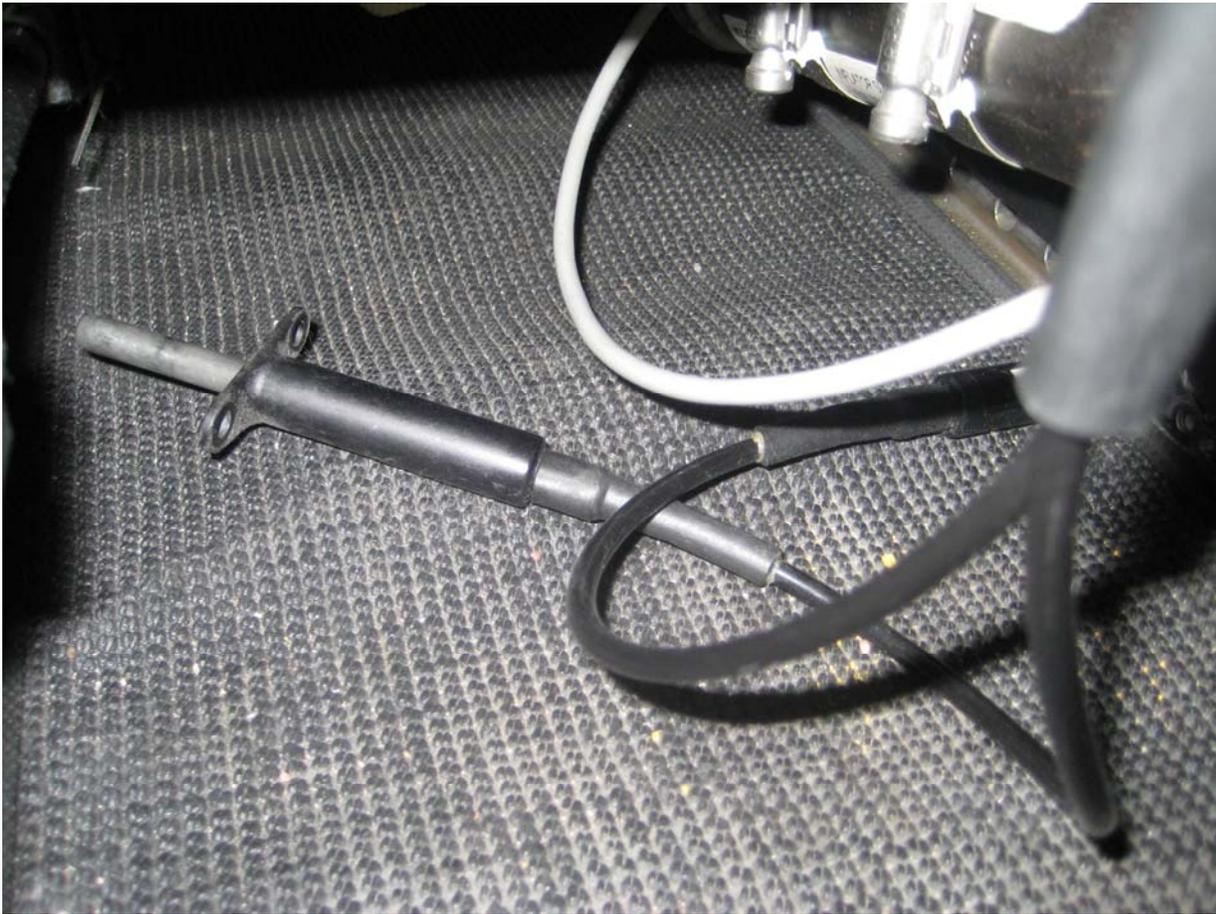
#### **Cessna: 172S; Loosened Seat Lock Attach Screws; ATA 2510**

A writer says, "During a training flight the student pilot reported his seat would not lock into position. The aircraft returned to base without incident. Upon troubleshooting the problem a maintenance technician found the attachment screws of the left and right seat stop pins had backed out, allowing them to be detached and ineffective. A check of the other aircraft in the fleet found six (*additional*) aircraft (*having*) loose attachment screws (*P/N MS35207256*). All loose screws were removed, inspected, and reinstalled with Loctite 242 as per the manufacturer's suggestion." (*Component name, P/N, and manufacturer: Seat Latch Assembly; SPL19251; Birk Aerosystem.*)

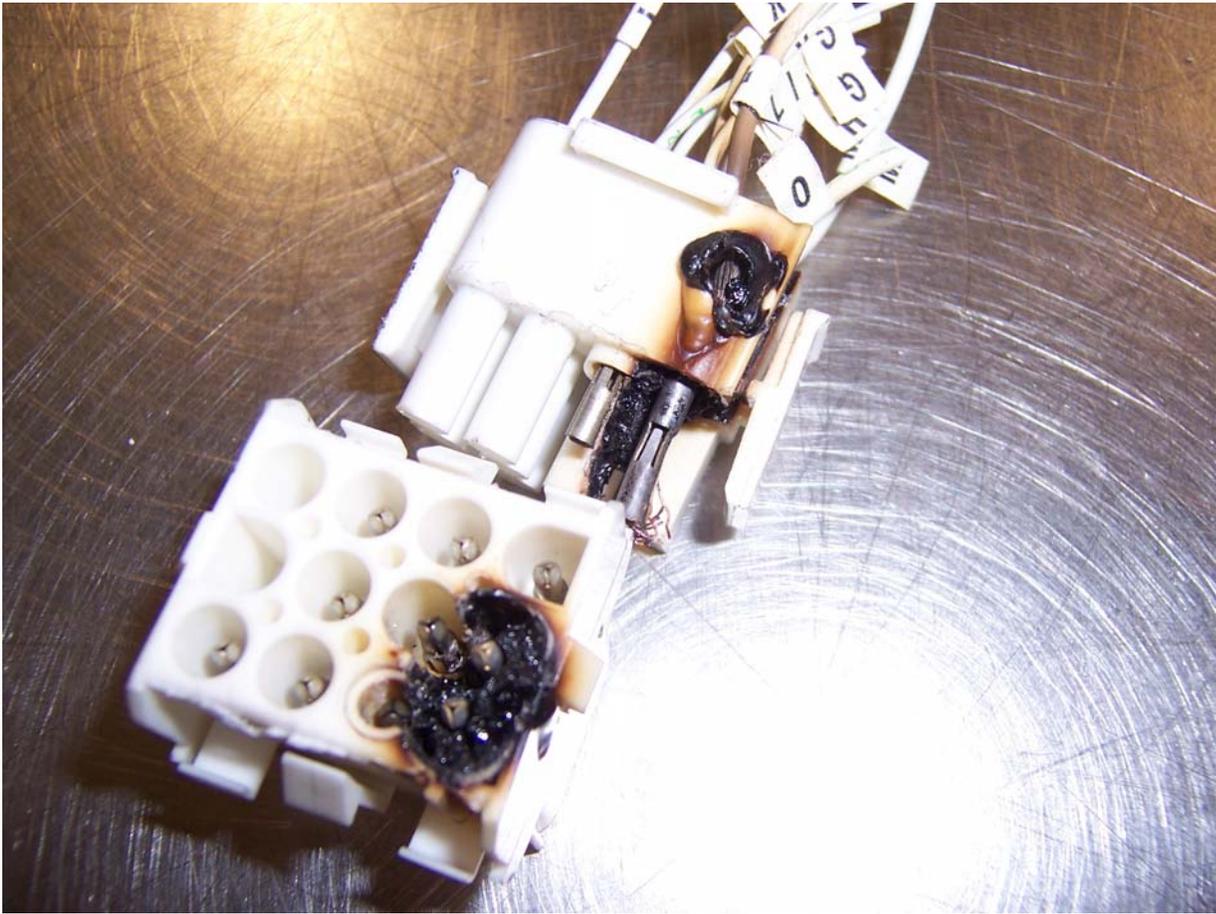
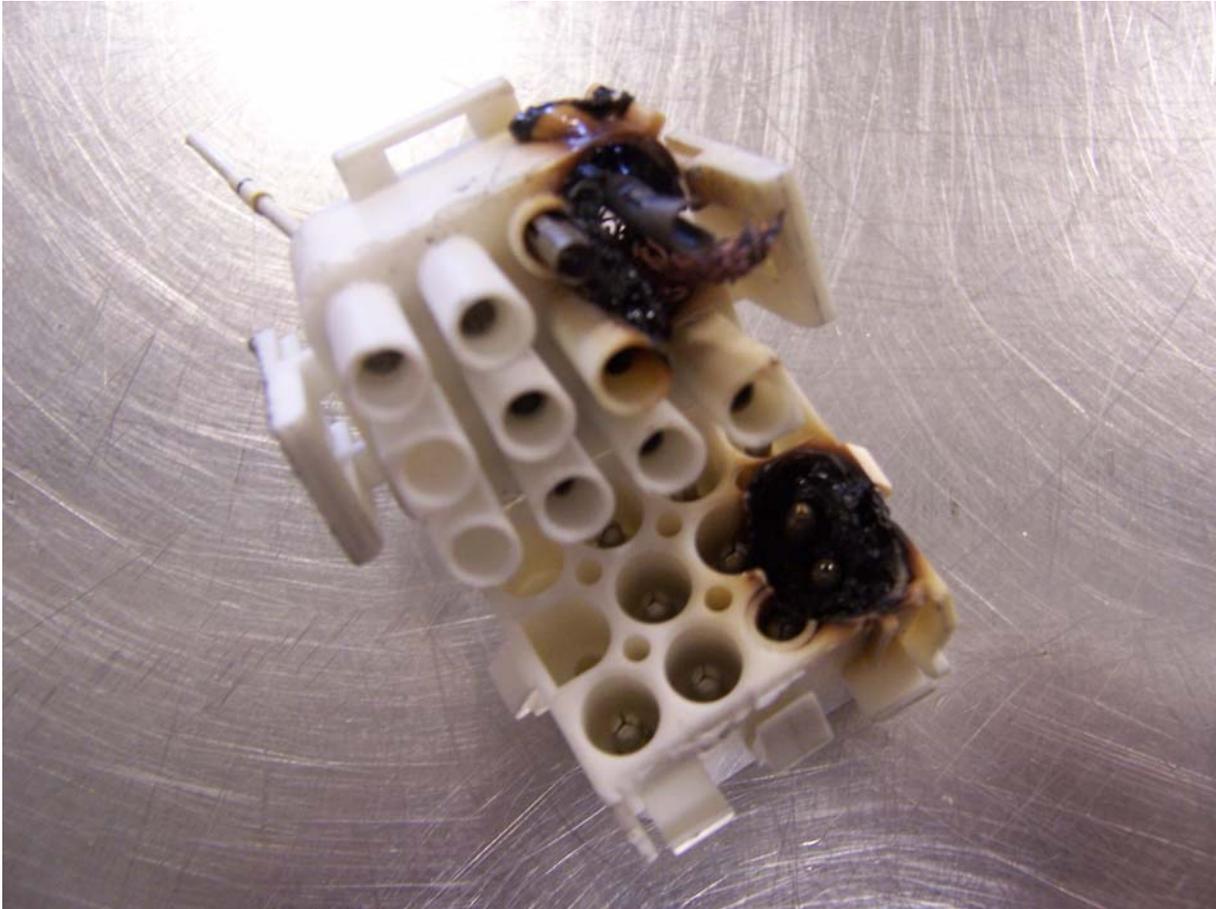
**Gulfstream: G200; Burned Lavatory Electrical Connector; ATA 3897**

An electrical technician states, "While troubleshooting the flight phone (*I*) found the lavatory plug (*number*) 548 P2 showing signs of discoloration and overheat. I capped and stowed the wires for plug 548 P2 IAW WDM 20-00-00. I collared (*blocked*) the circuit breakers for the lavatory water heater, the ribbon heater, the water system control, and the toilet—and verified no power at plugs 548 P2 and J2."

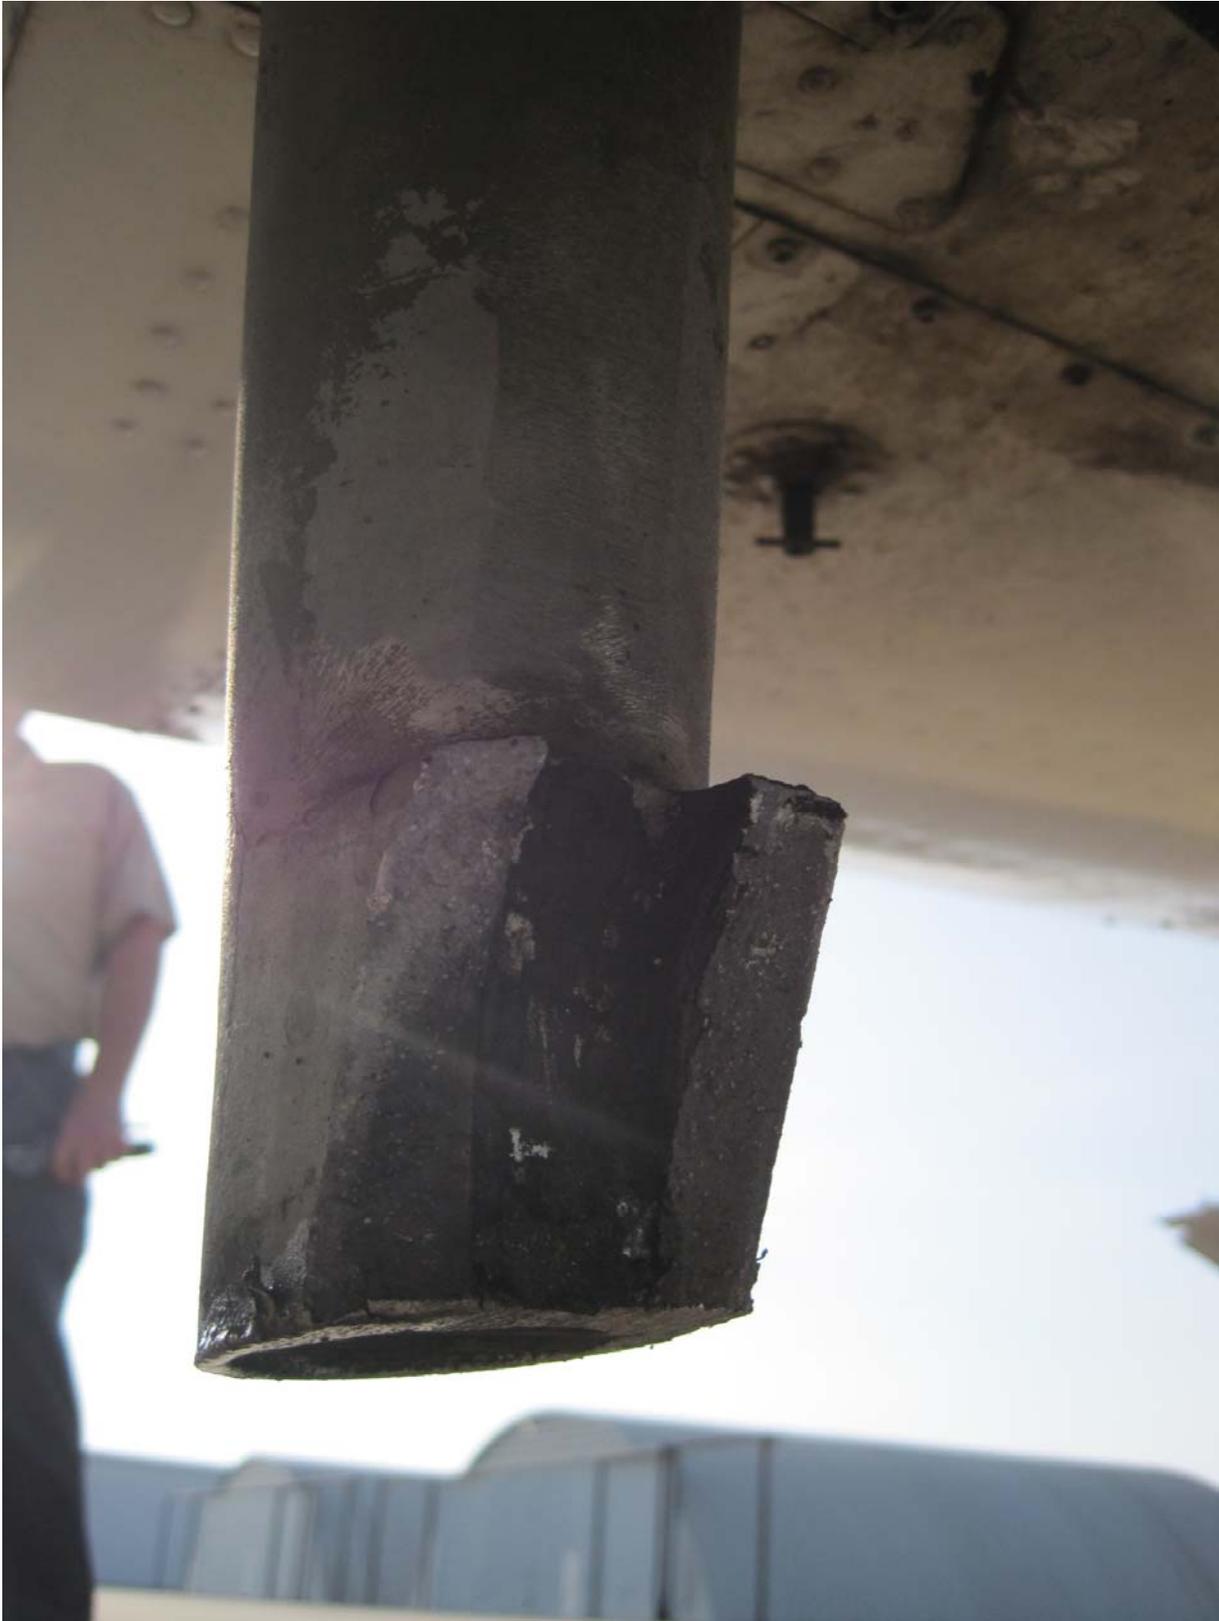
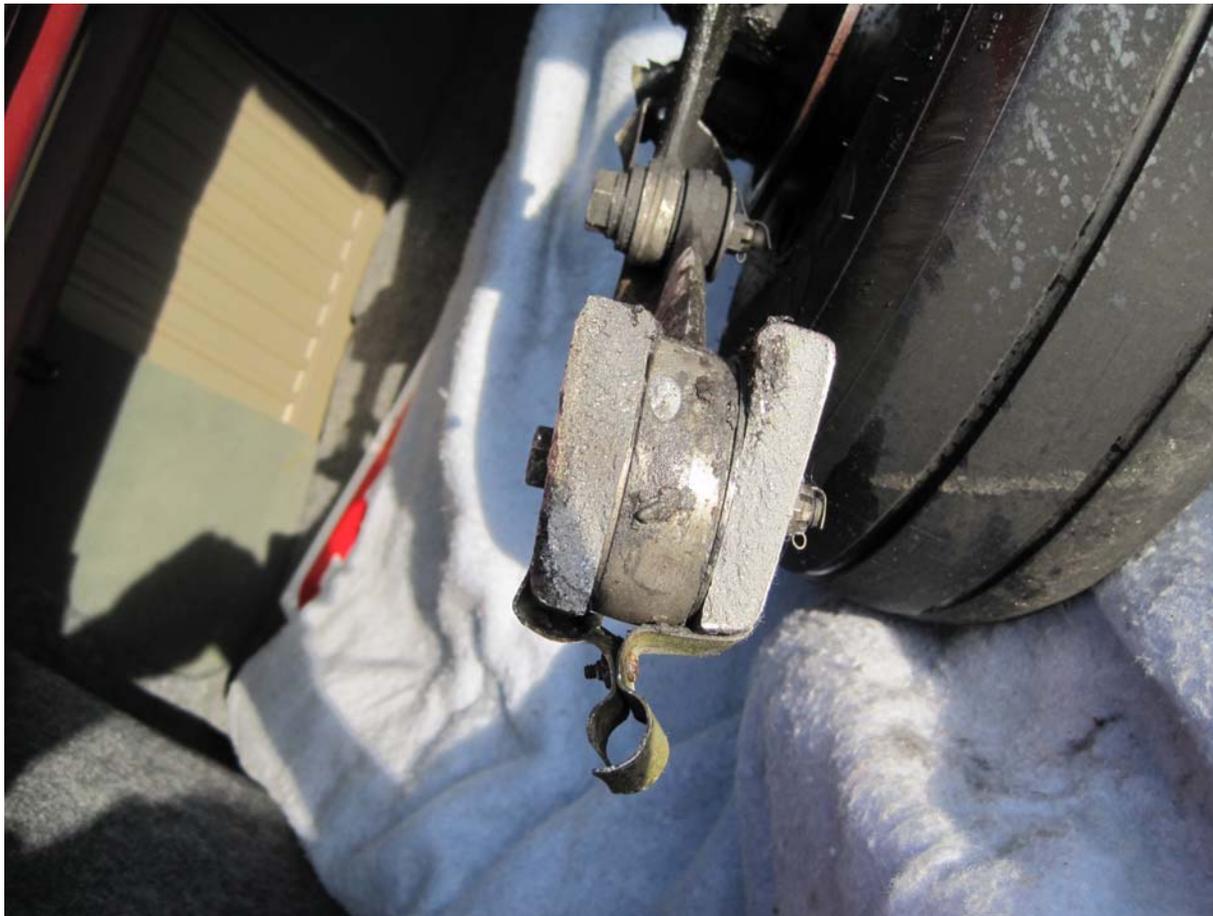
### **Piper: PA28-180; Failed Landing Gear Strut; 3213**

A general aviation report states, "The right main landing gear lower strut fell off when the aircraft lifted off the runway at *(the airport)*. The student pilot flew to *(his destination)* and landed, resulting in damage to the upper landing gear strut (*P/N: 6531904*). When the lower strut departed *(from the)* upper housing, it struck and damaged the flap skin.

"The right main landing gear upper torque link mounting ears broke off the cylinder, allowing the lower gear leg to fall out of the upper cylinder and depart the aircraft. This cast aluminum cylinder is original since 1972. The inboard ear appears to have been partially broken for some time. Once it broke all the way, the outboard ear could not support the twisting forces applied during normal turns, taxi, and torque during takeoff. I feel this led to the outboard ear breaking off, and on takeoff, the gear left the aircraft. This upper torque link attach point is covered with a fairing, preventing the pilot from seeing any defects during preflight." *(The SDRS database reflects this part number 22 times.)*

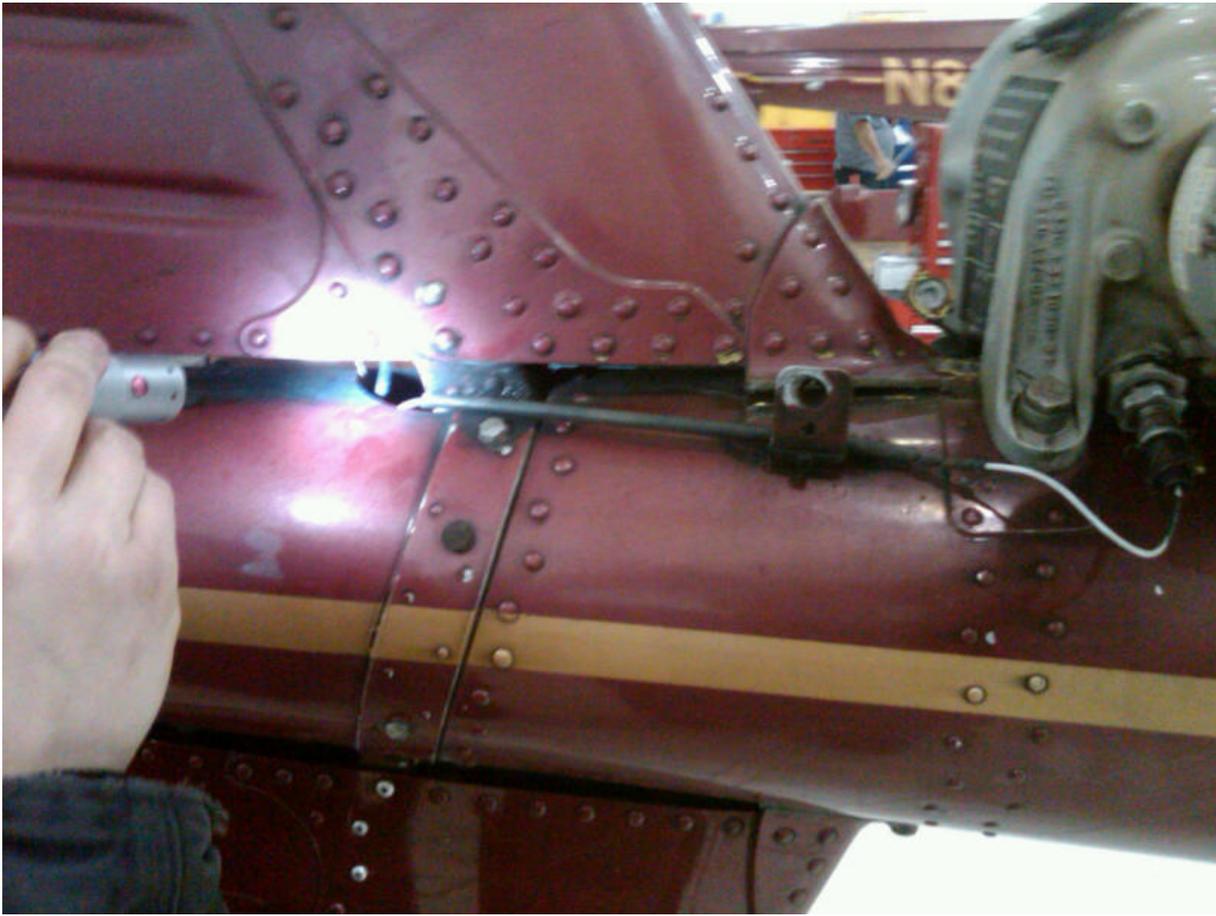
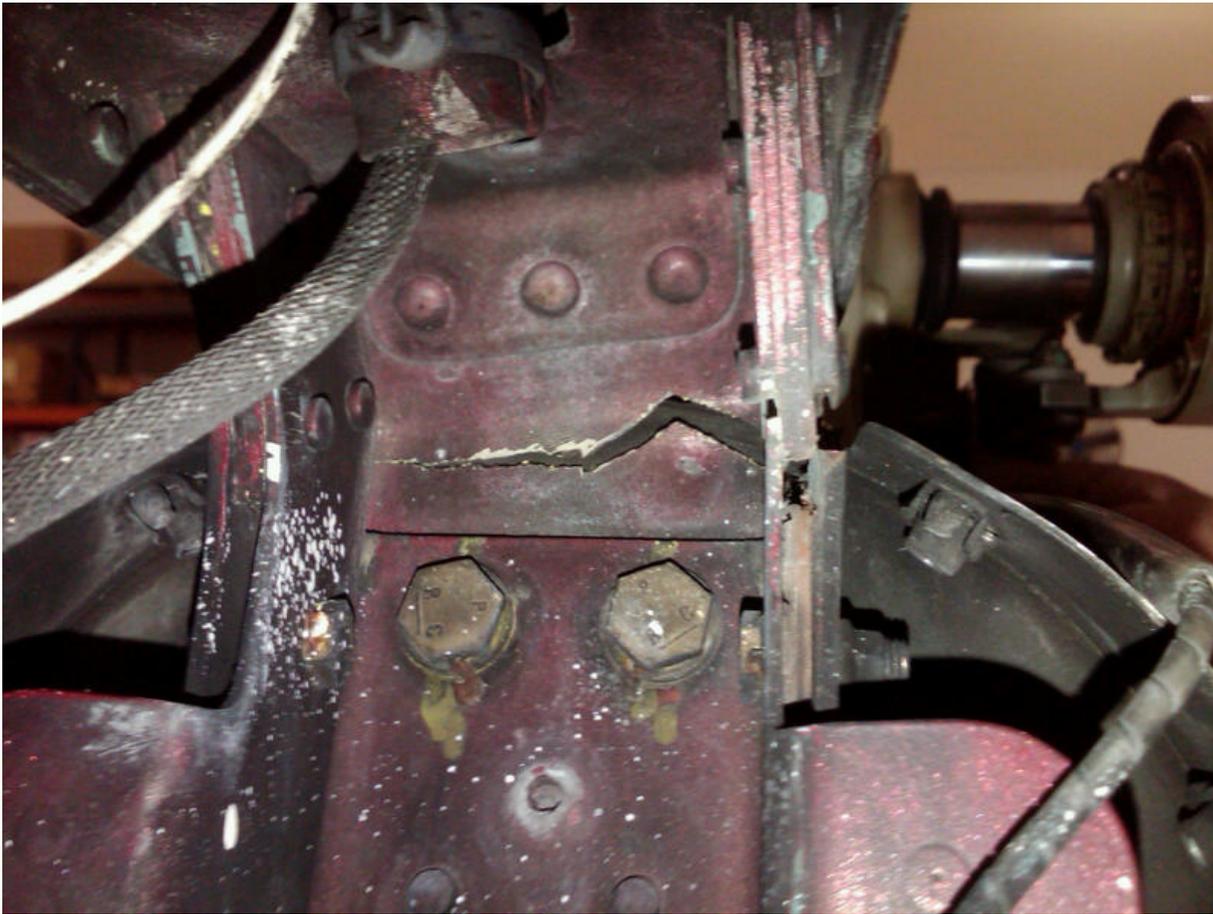
**Eurocopter: AS350B2; Cracked Vertical Fin Mount; ATA 5330**

"A crack (*was found*) in the vertical fin mount," says an unidentified technician. (*Vertical fin P/N: 350A1100201101*).

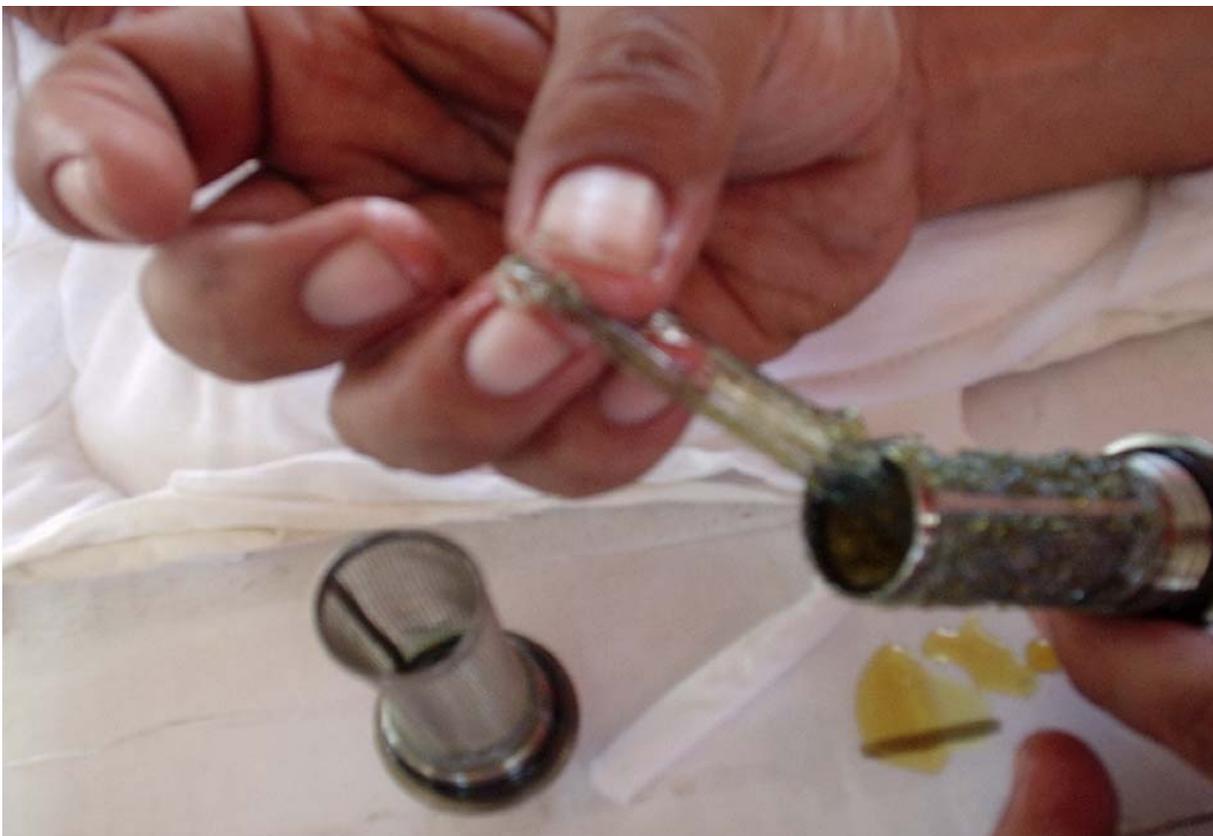
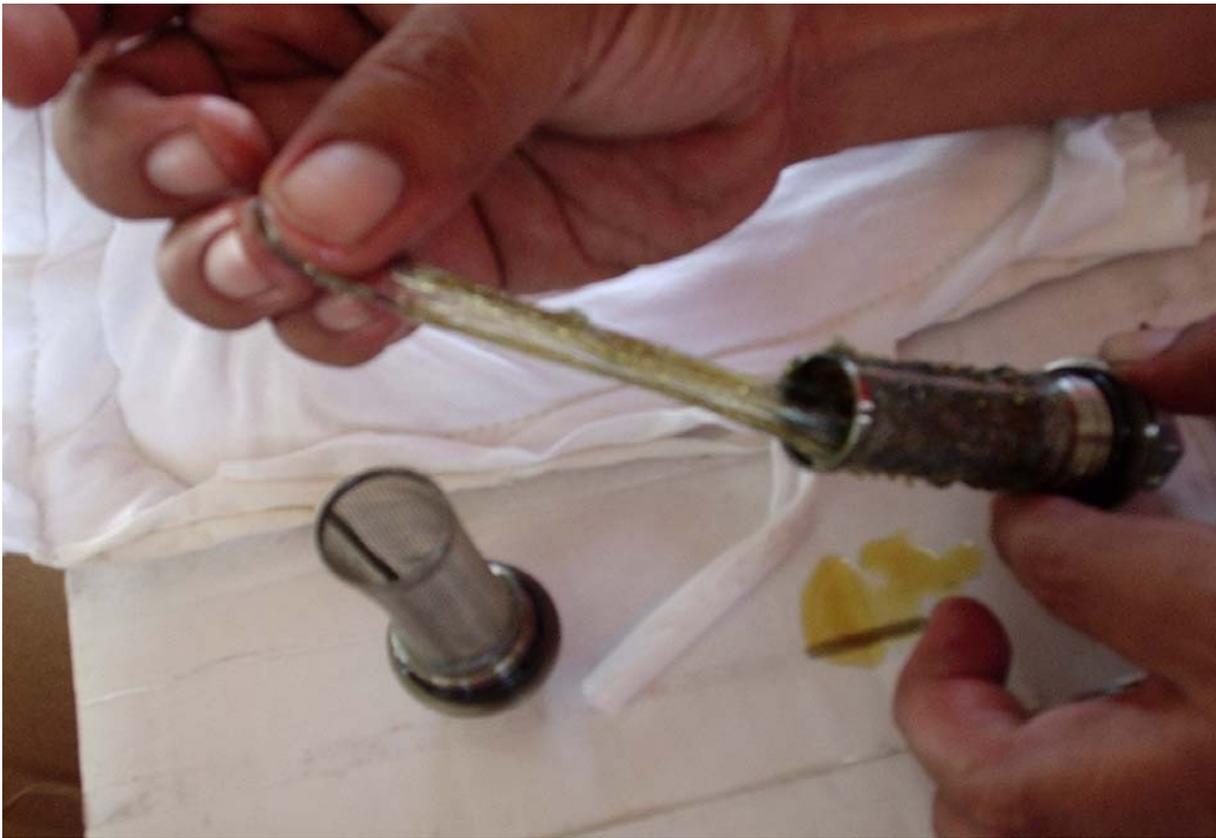
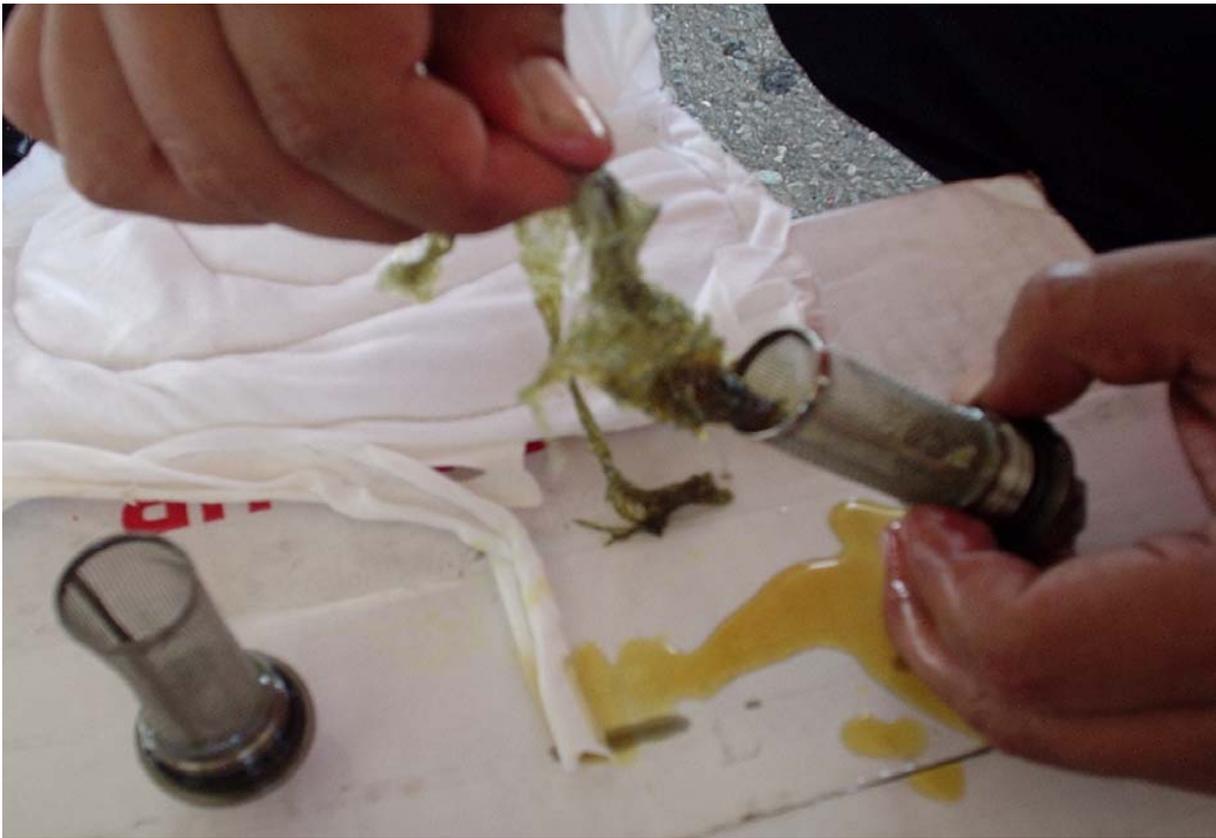
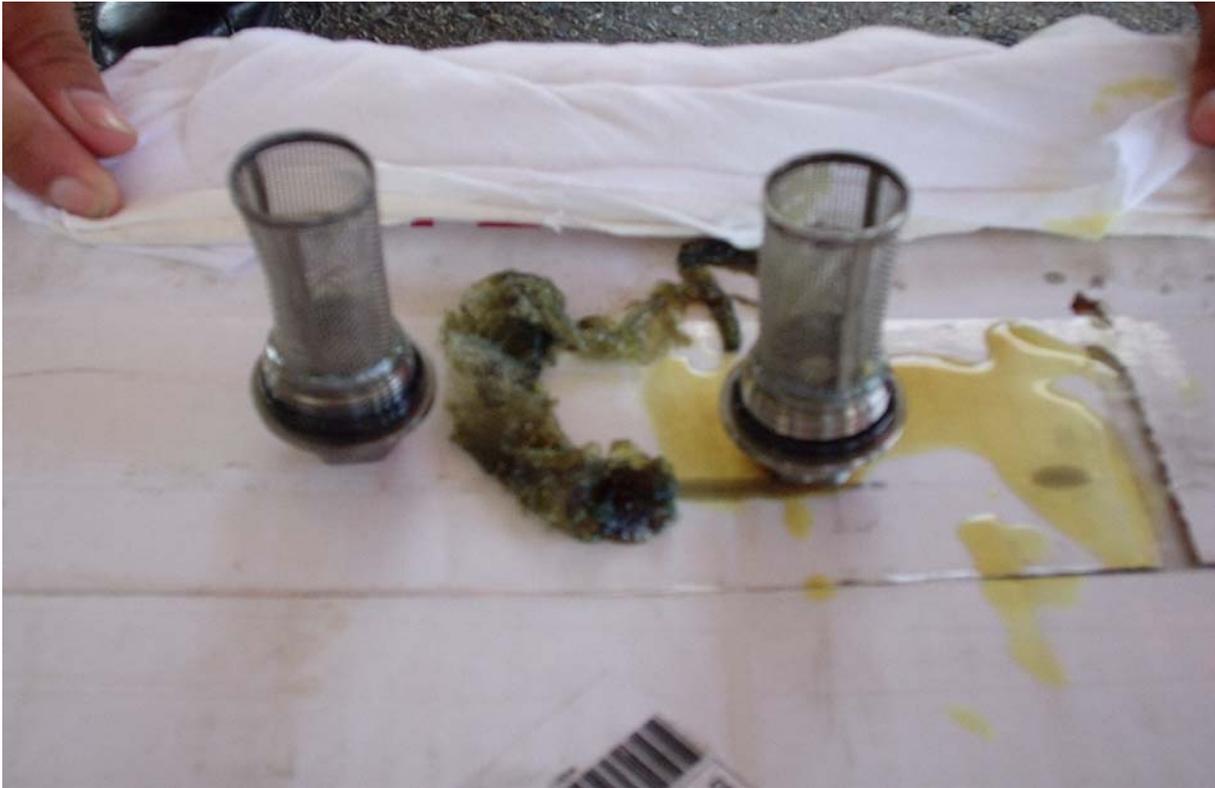
A Chief Quality Control inspector from our southern neighbor Columbia writes, "*The aircraft pilot report read...*" The right engine oil quantity *(indicated)* zero and the engine oil pressure was low. *(An)* engine shutdown was directed by checklist *(and subsequently performed in flight)*.. The oil pressure was always above 10 PSI. *(This)* flight diverted to another *(airfield)*.'

"Corrective action: *(We)* performed B767 FIM *(fault isolation manual)* 71-05-00, figure 119, block 1-6 and 25. We found the transfer gearbox (TGB) *(oil scavenge)* screen blocked by *(unknown)* material.... The screen contamination was removed and an Oil System Contamination Inspection accomplished." *(The maintenance action concludes with a satisfactory engine run-up with all operational parameters normal. A separate attached note indicates the debris in the following photos as "foreign plastic material.")*

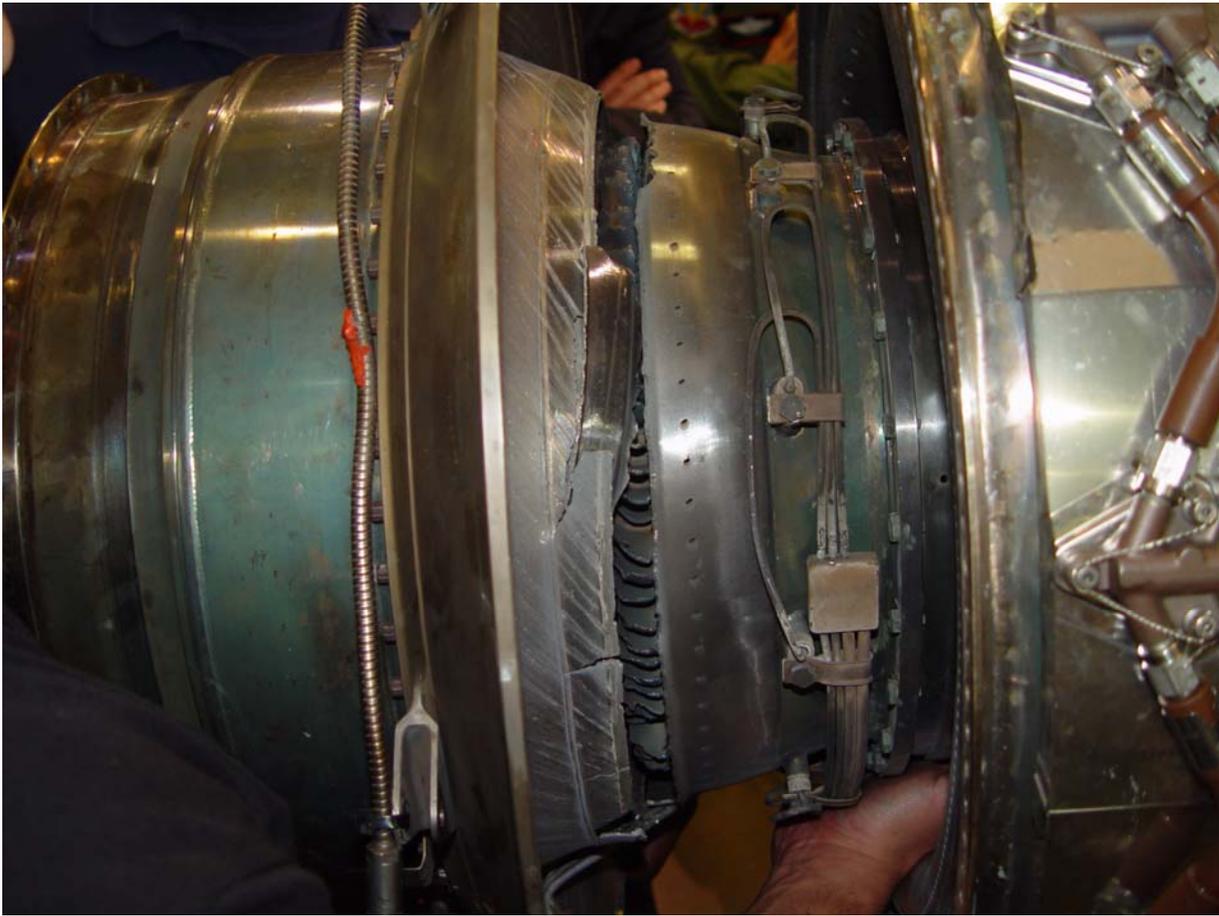
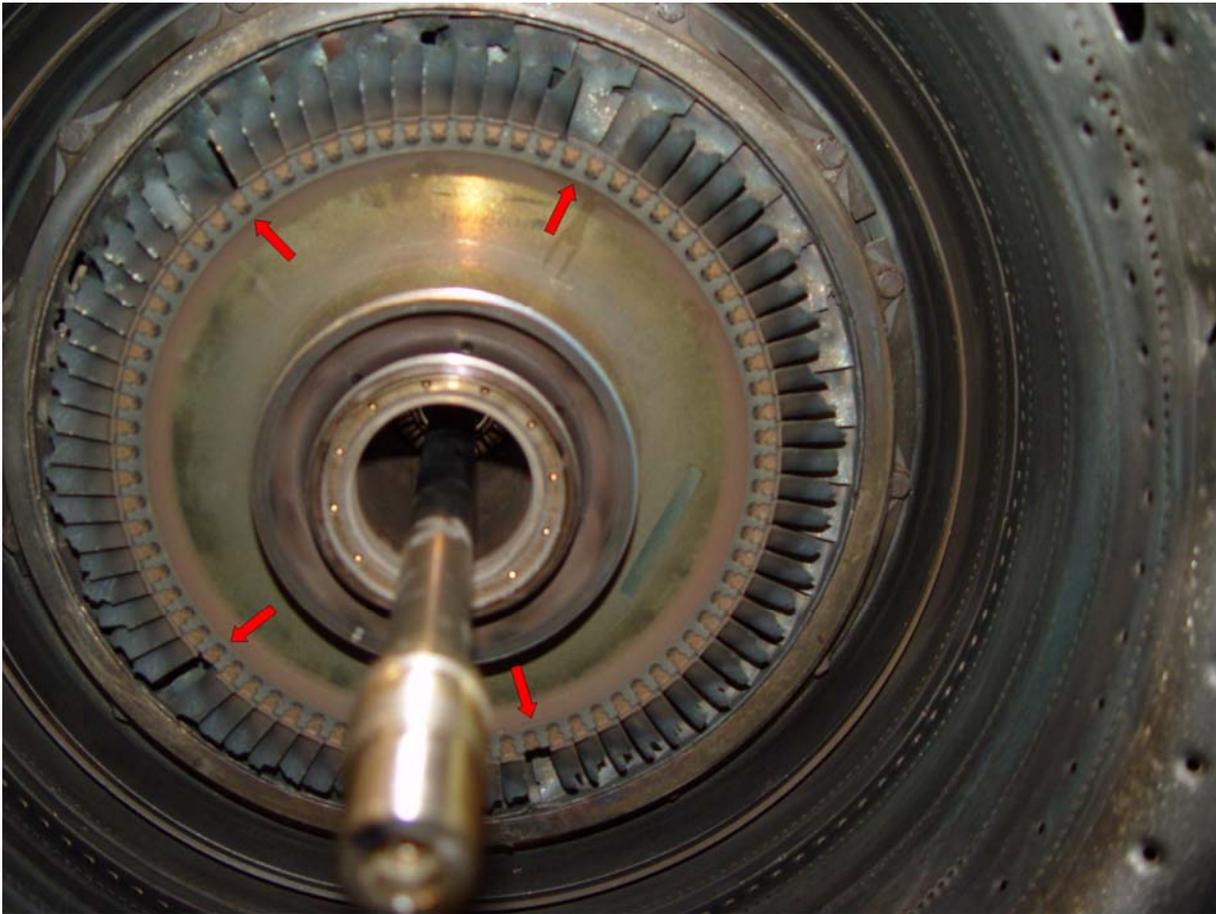
"At 400 feet (AGL) after takeoff," says this submitter, "the crew heard a loud bang from the left engine, (*then*) the engine RPM went to zero. The crew circled (*the aircraft*) and made a safe landing. The engine was removed and sent to (*a repair*) facility. During engine teardown, five high pressure turbine rotor blades were found broken (*directly*) under the blade platform and separated from the disk. The outer engine cases were not penetrated. The cause of the blade failure is being investigated by the engine manufacturer and the (*repair facility's*) engineering staff." (*Turbine blade P/N: 30727122.*)

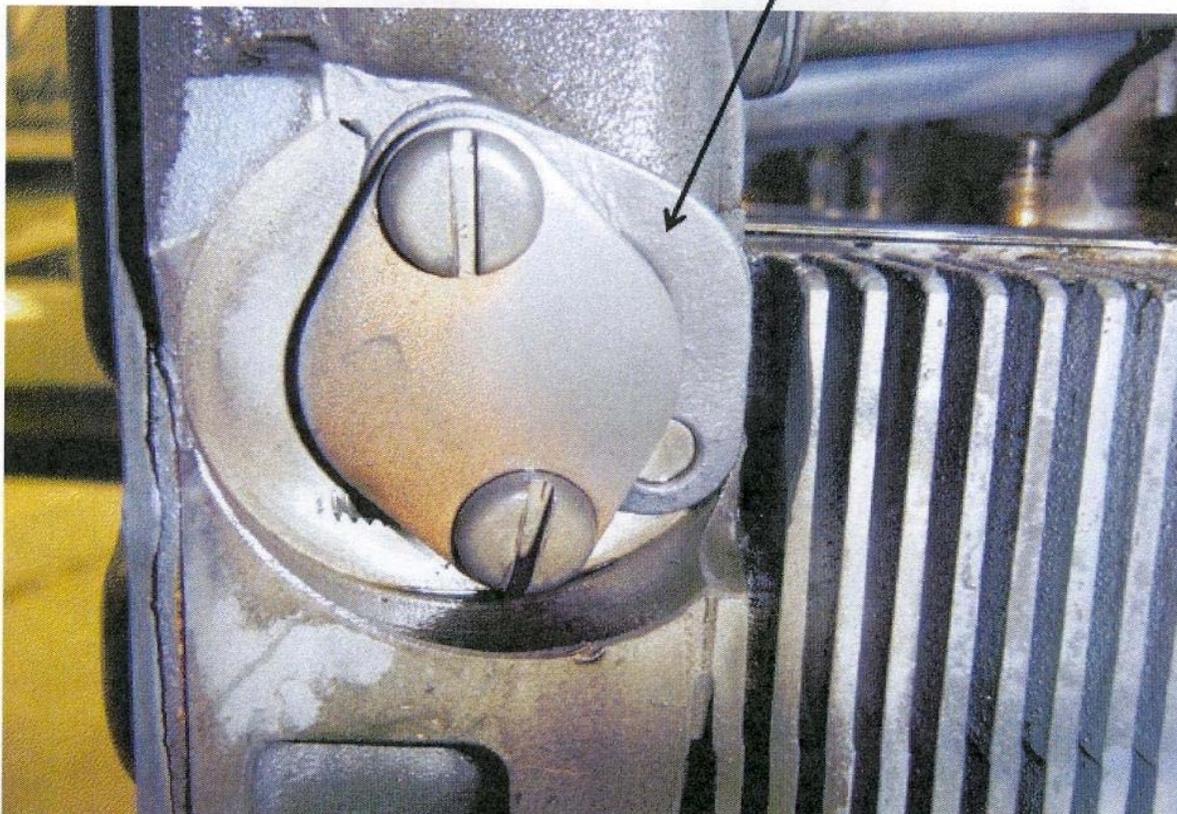
"The aircraft was written up by the PIC (*pilot in command*) for a large oil leak on the number two engine," says this mechanic. "Inspection revealed the number three cylinder (P/N LW-12966) had a gasket (P/N 66732) installed incorrectly under the rocker shaft cover (P/N 72710). The cover is secured with two screws (P/N 72709).

Note Gasket Position – Screw was installed correctly

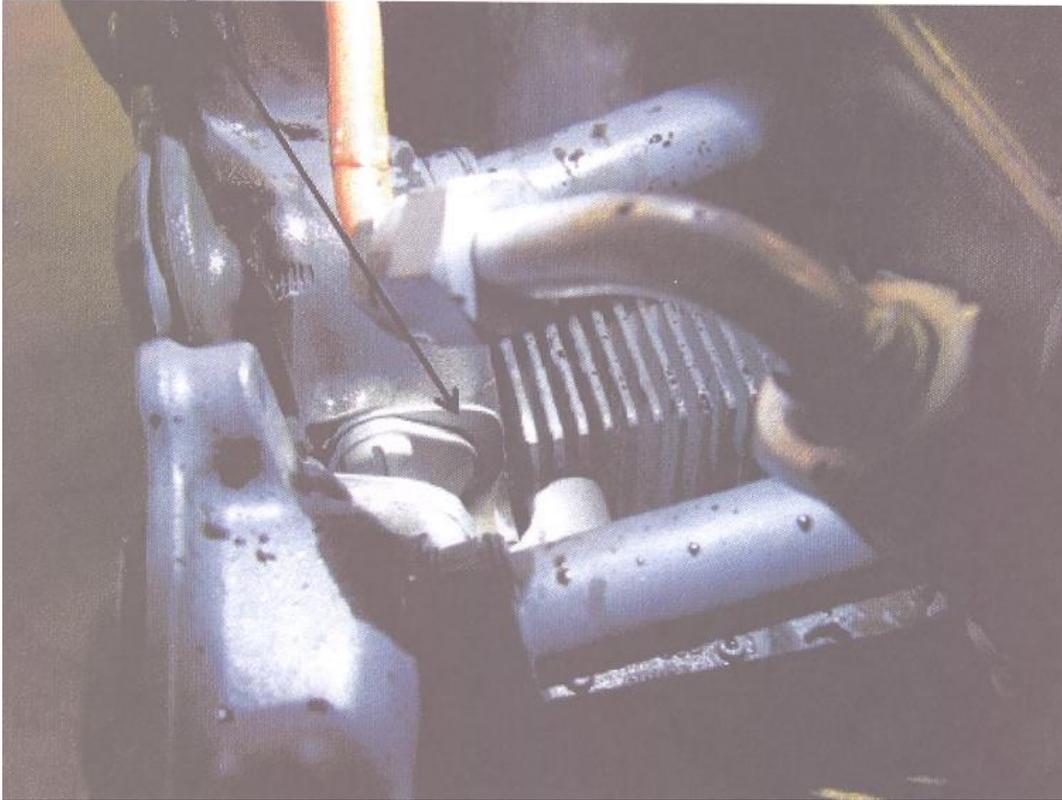
Top View with cylinder installed – Note that the gasket still has the paint on it from the overhaul
