## ADVISORY CIRCULAR

43-16A

# AVIATION MAINTENANCE ALERTS

**ALERT  
NUMBER  
392**

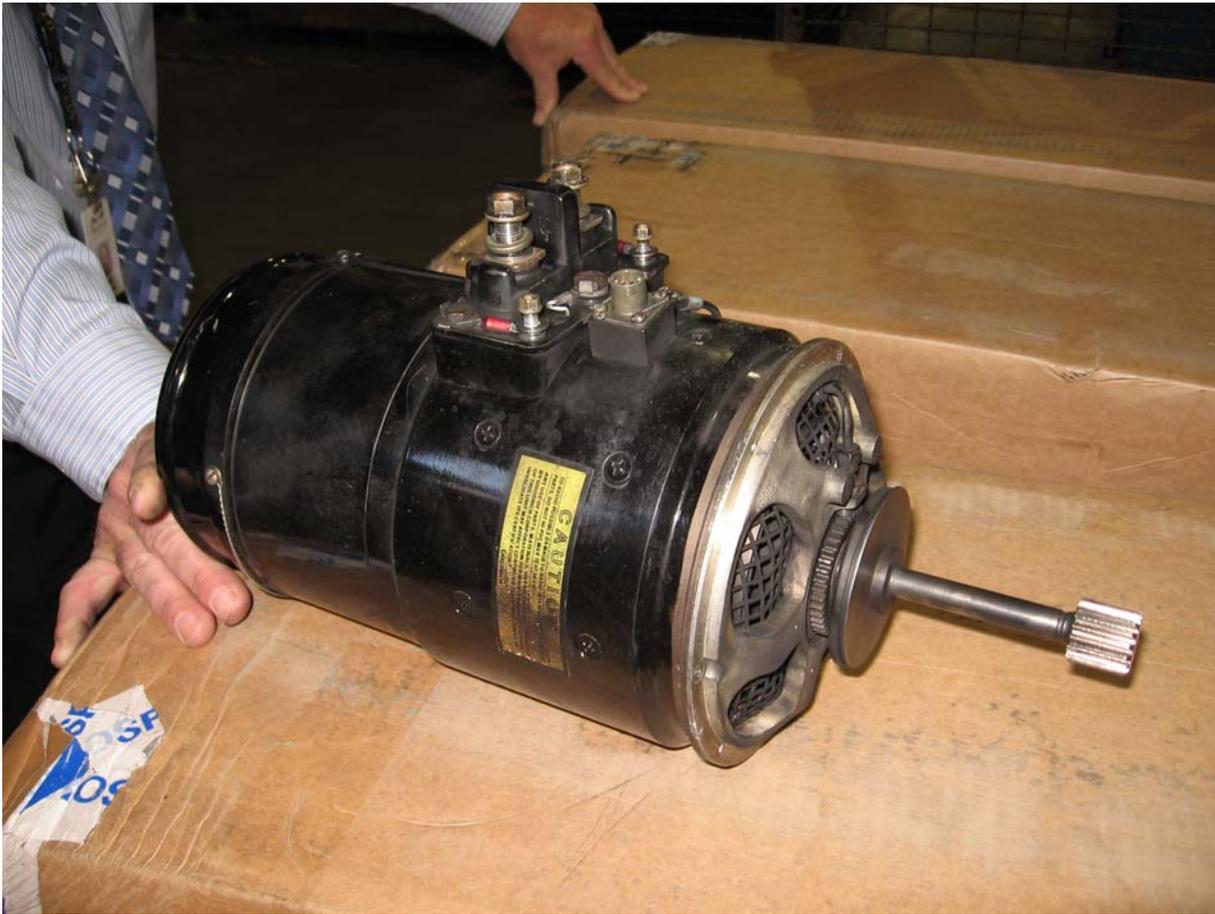
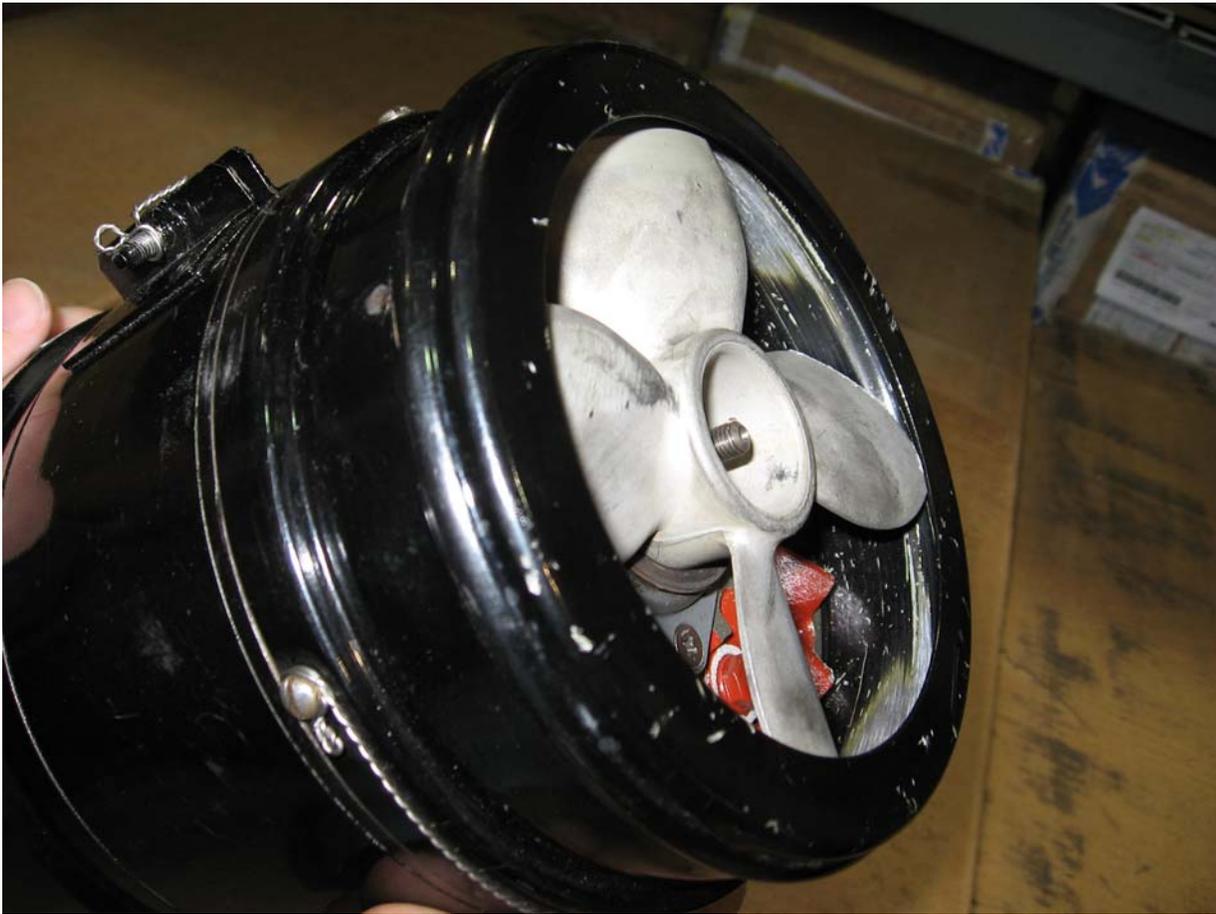
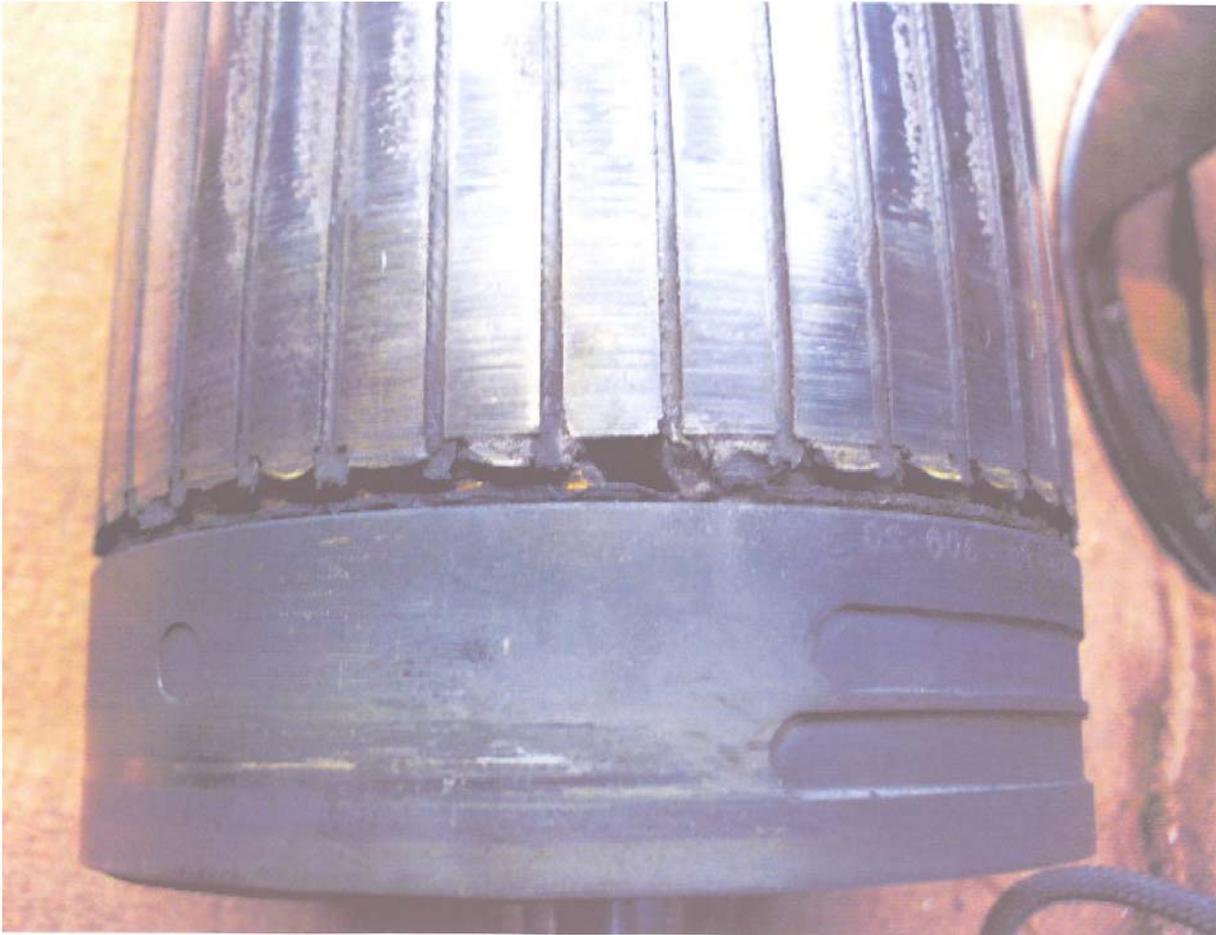
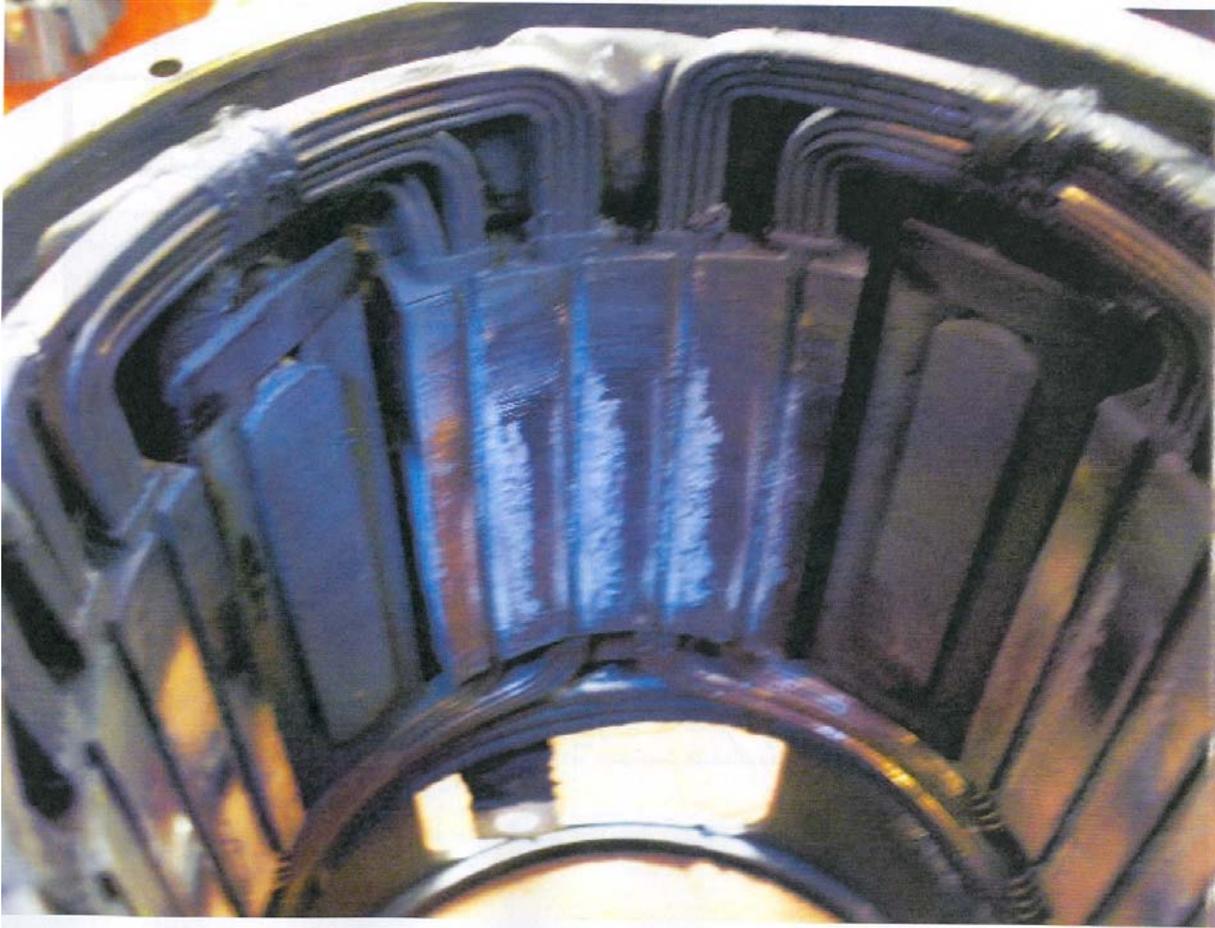
**Pratt & Whitney: PW305B; Failed Starter/Generator; ATA 2435**

"The (*Hawker 1000*) aircraft experienced moderate vibration in cruise (*flight*)," writes this technician. "The flight crew felt the vibration (*originated*) from the number two engine, followed shortly with a Generator number two fail indication. The crew shut down the engine and diverted their flight to an (*alternate*) airport for a non-eventful, single engine landing.

"Maintenance removed the engine starter/generator and found it failed—with the internal cooling fan assembly contacting the generator shroud. This unit had 305.1 hours since overhaul (TBO is 1000 hours)." (*This Starter/generator's manufacturer: BF Goodrich; P/N: 23091002. At least three of these units are described in the SDRS database.*)
