**Federal Aviation  
Administration**

## ADVISORY CIRCULAR

# AVIATION MAINTENANCE ALERTS

**ALERT  
NUMBER  
395**

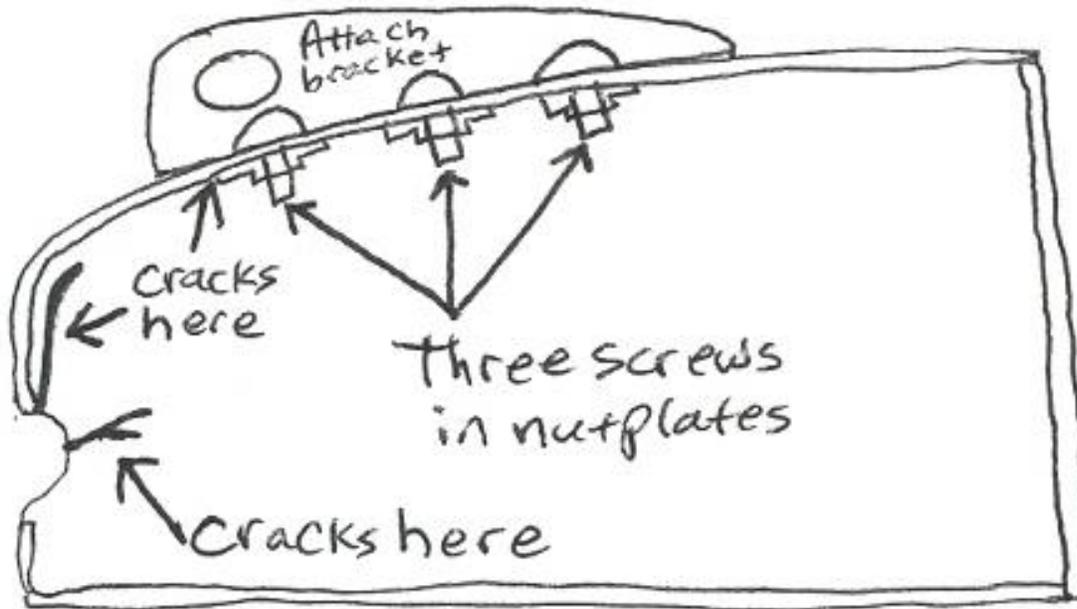
**Beechcraft: A36; Cracked Flap Nose Rib; ATA 5753**

"During an Annual Inspection," says this repair station technician, "one nose rib was found cracked in the right flap. It is the rib located directly beneath the attach bracket mounted on the skin." (*R/H flap P/N: 35-165050-79; nose rib P/N: 35-165050-84. The SDRS database reflects 17 of these ribs.*)

*(One could not ask for a better road map! See the next entry for a similar report. Thanks for the artwork—far better than I can produce—Ed.)*

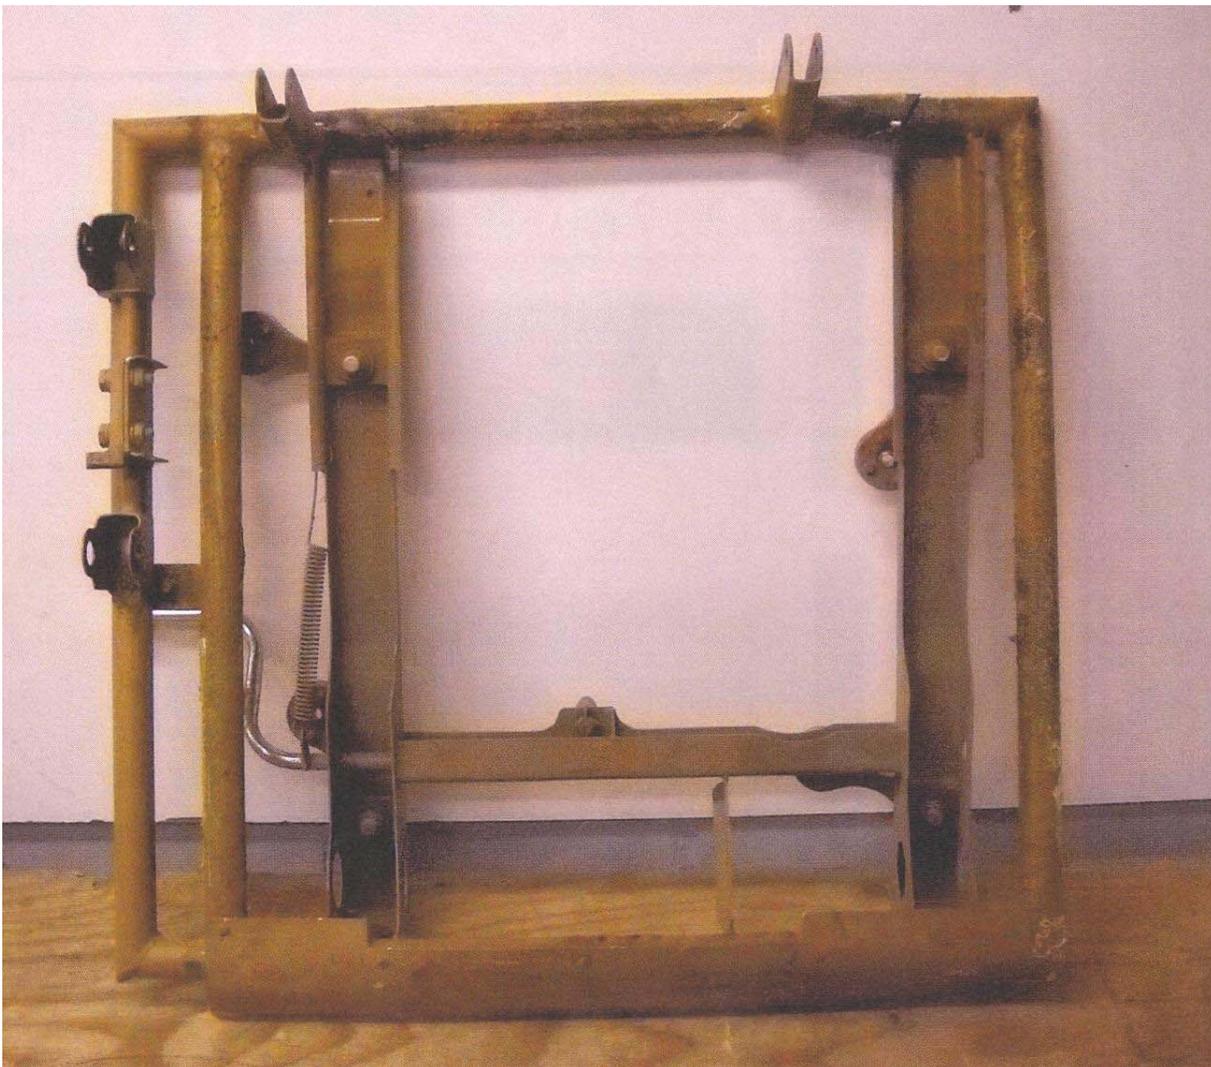
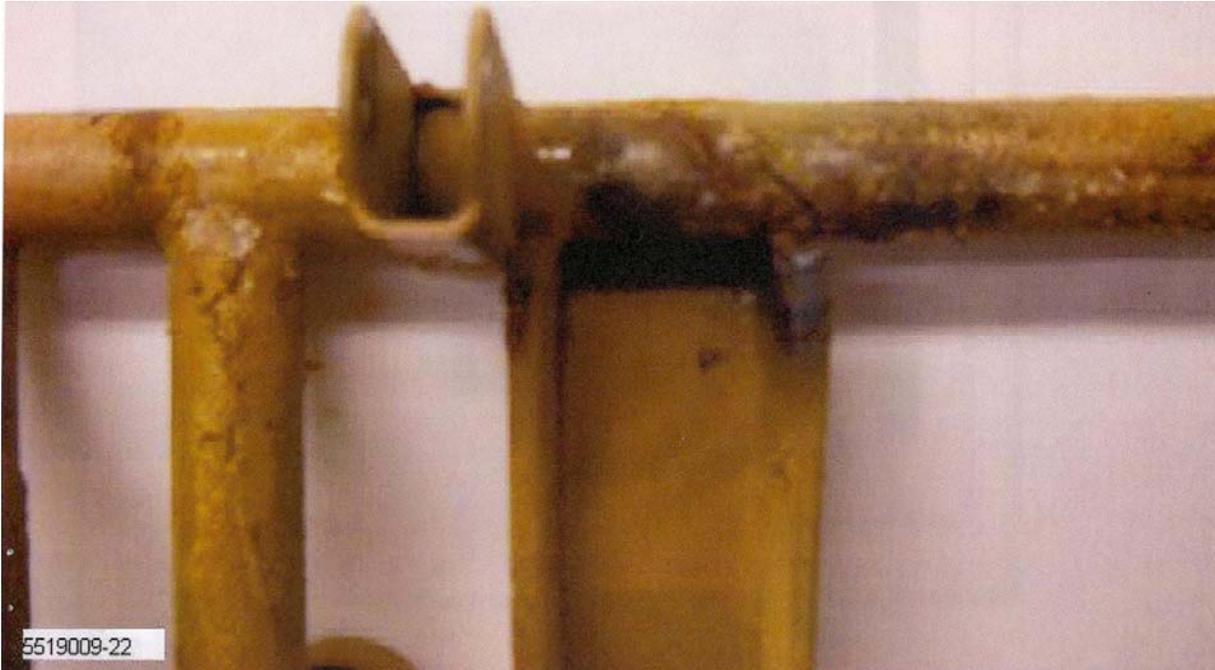
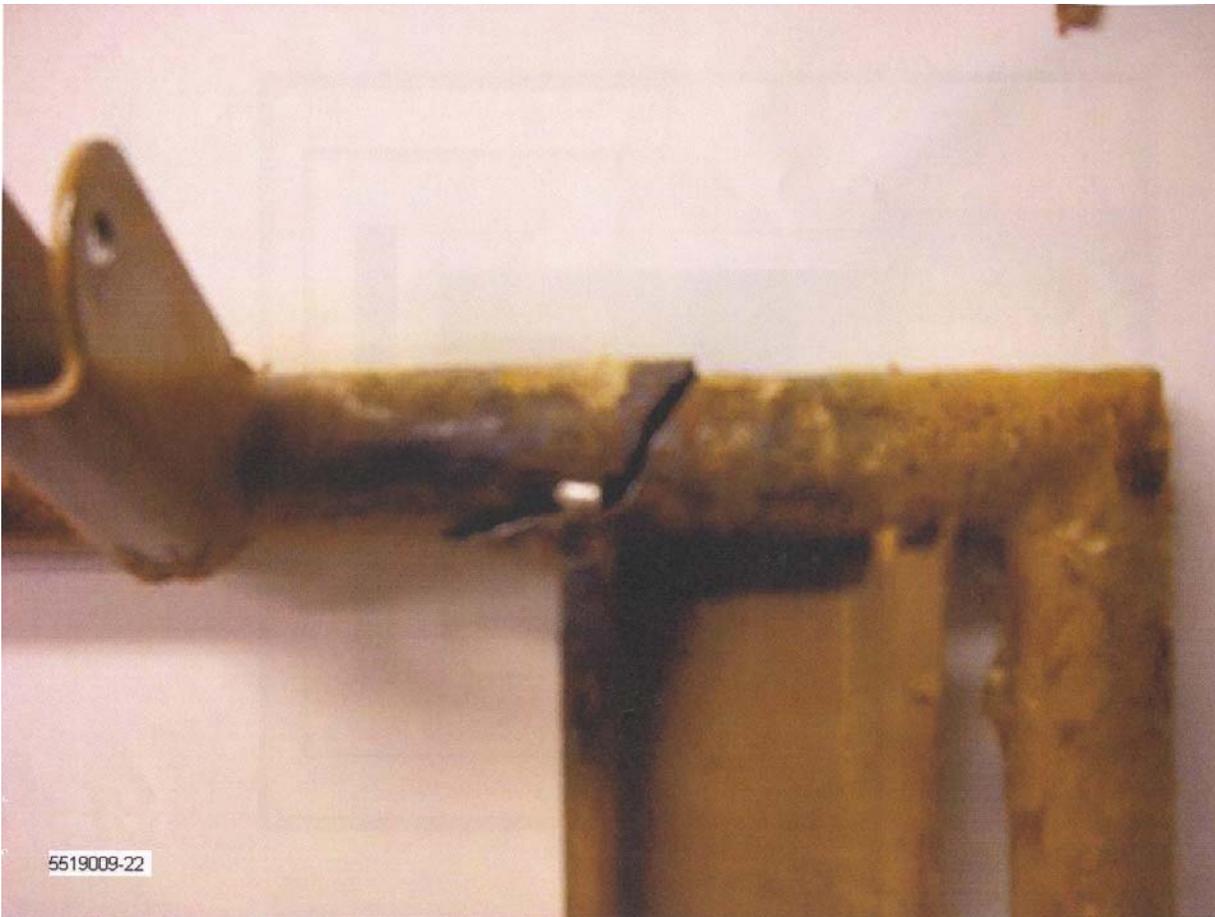
**Cessna: 551: Cracked Seat Base Assembly; ATA 2510**

A repair station provides this brief defect report concerning a seat frame. "The upper seat base assembly is cracked at the chair back attach points. (*I speculate*) stress on the chair back and metal fatigue as the probable cause. A previous, inappropriate repair (*has been observed on this frame*). This chair was repaired in accordance with AvFab STC STO1043WI, P/N 42-0312K, and drawing D-10394, Revision 'A.'" (*Seat assembly P/N: 5519015-16; Seat base P/N: 5519009-22. The Alerts profiled these seats four separate times in 2005: reference July, September, November, and December—all with attached photos. The SDRS database reflects eleven of the -22 part numbers.*)

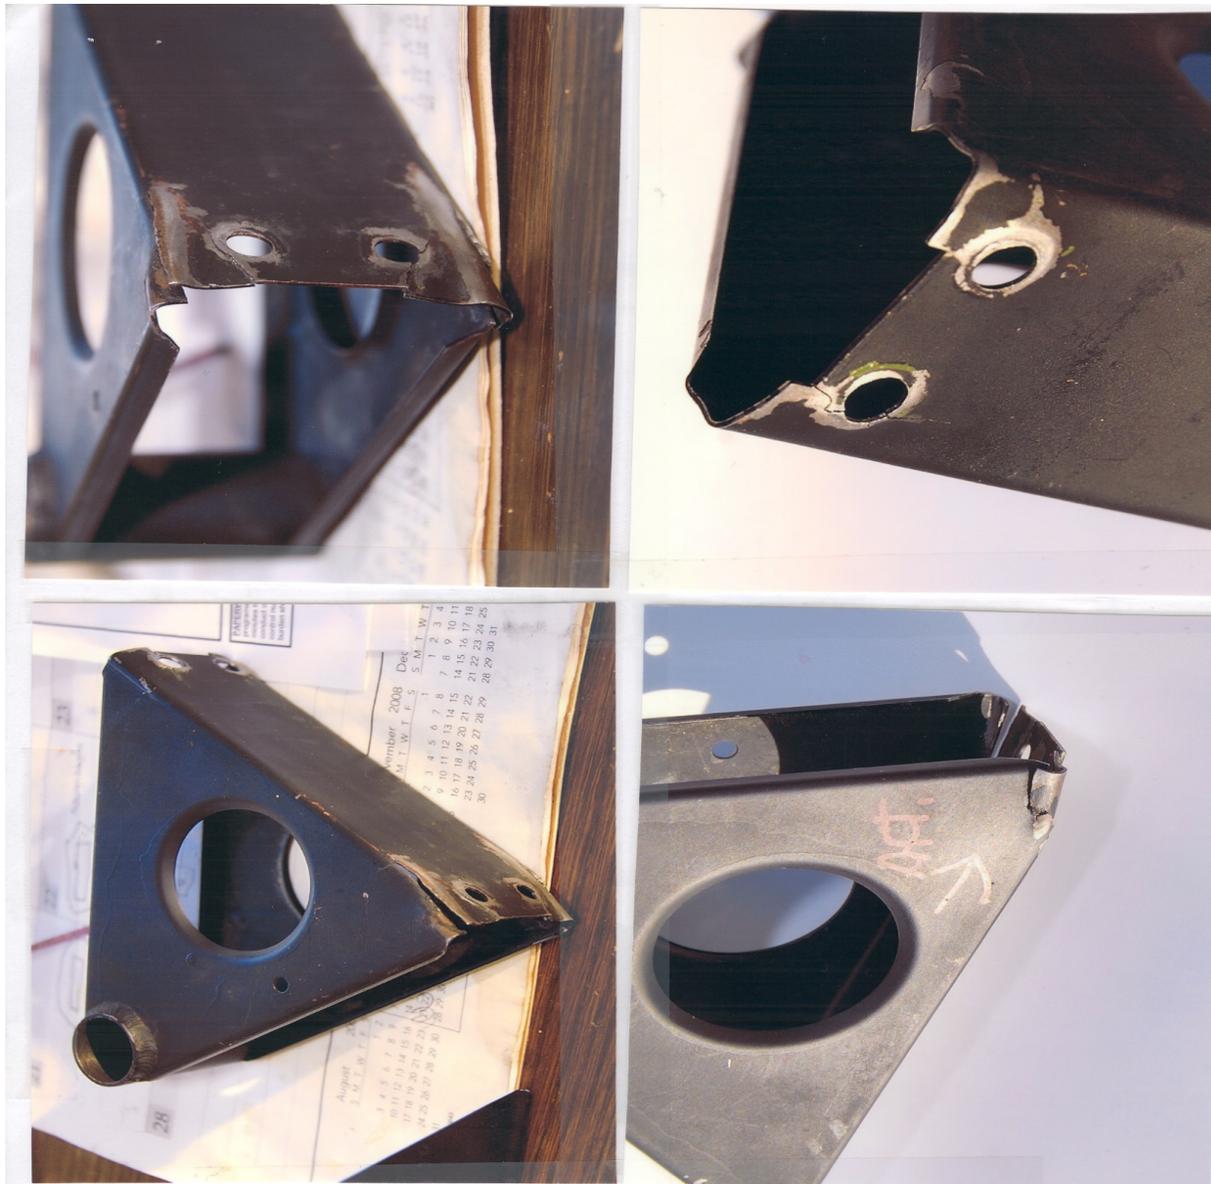
**Piper: PA28-235; Cracked Rudder Bar Support; ATA 2720**

An Aviation Inspector says, "(This support assembly...) should have AN960 washers under the four AN3-4L bolts to spread the load on the (support) assembly (P/N 63451-00). There are no washers shown in the parts list."

(Reference February Alerts 2009 for a similar report. SDRS has six entries.)

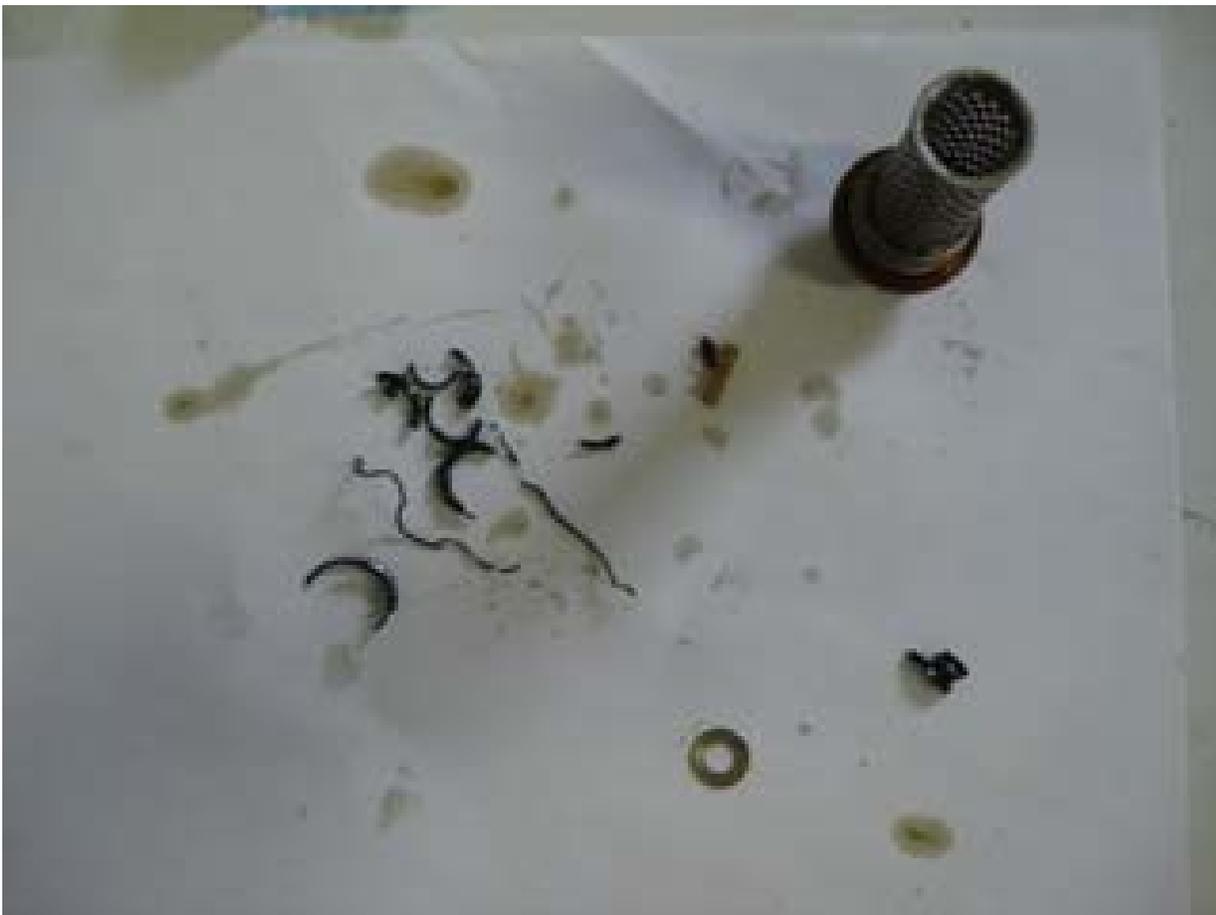
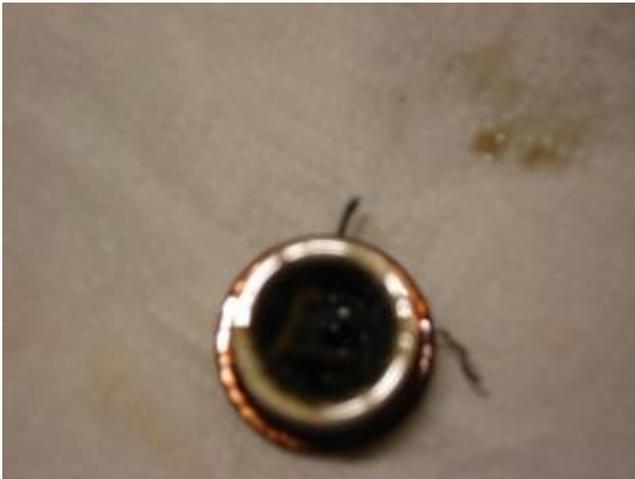
### Continental: IO360KB; Contaminated Oil Pump; ATA 8550

"(I) removed the engine oil pump suction screen as part of a 100 hour inspection," states this technician. "I found the old style suction screen with FOD: (*this debris includes*) a ¼ inch AN flat washer; two springs, such as those used in Garlock seals (these had partially penetrated the suction screen about ¾ inch); small pieces of plastic grommet, as used where the dipstick meets baffling; and approximately ½ teaspoon of silicone globules. I cut (*open*) and inspected the oil filter—no debris was found. (*Next*) the oil pan and accessory case were removed to gain access to the oil pump. I found scoring in the oil pump housing consistent with FOD being run through the pump. The oil pump drive gear marked with P/N 634010A and impeller P/N 633602B were found installed with Woodruff key in the slot. These parts were subject to AD 81-13-10R1—I was unable to verify compliance with this AD. The overhaul facility specifically stated in their log book endorsement they had complied with TCM Service Bulletin 97-6 which required replacement of the oil pump gears with new style parts (IAW SB 96-4) and replacement of the suction screen with an improved design. This was not done, as old style parts were found in the engine. I removed the engine and sent it to (*an overhaul facility*) for a complete teardown inspection and repair. It is likely had SB 97-6 been complied with at overhaul, the new style screen would have prevented the damage to the oil pump."

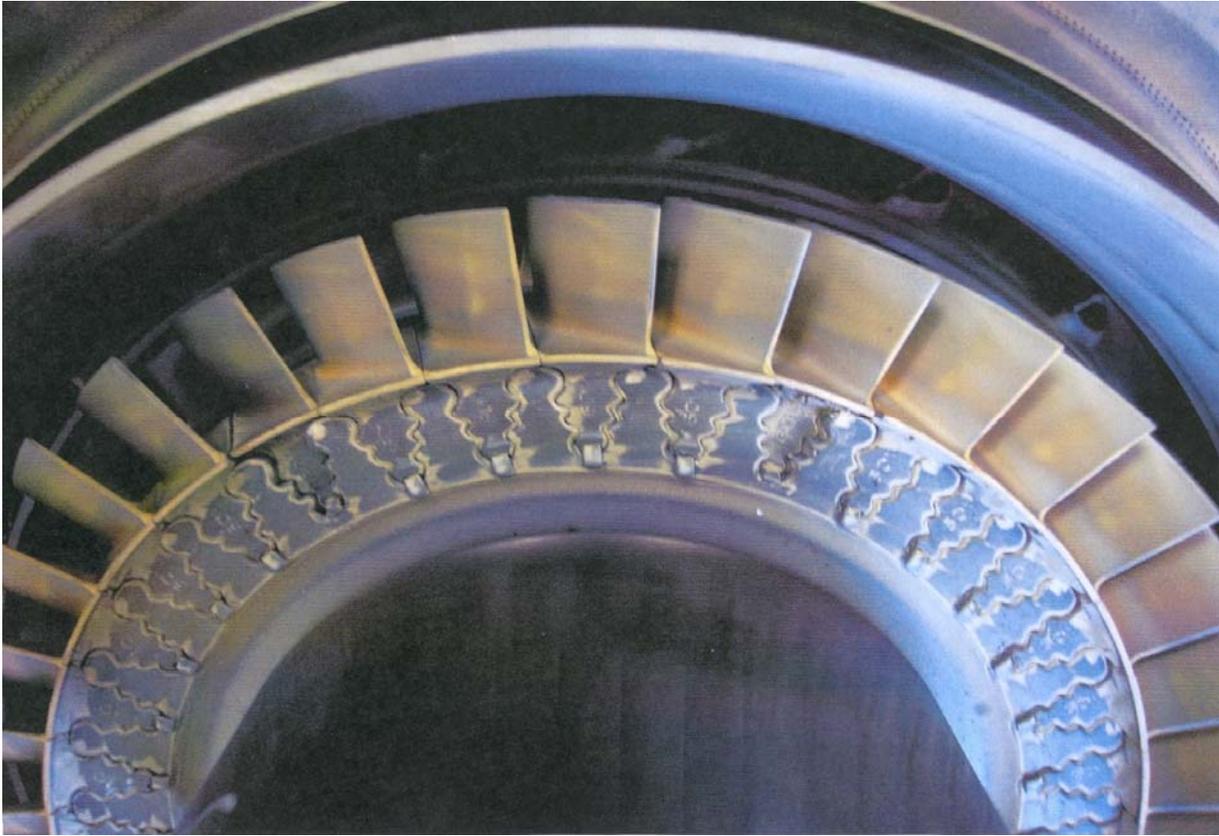
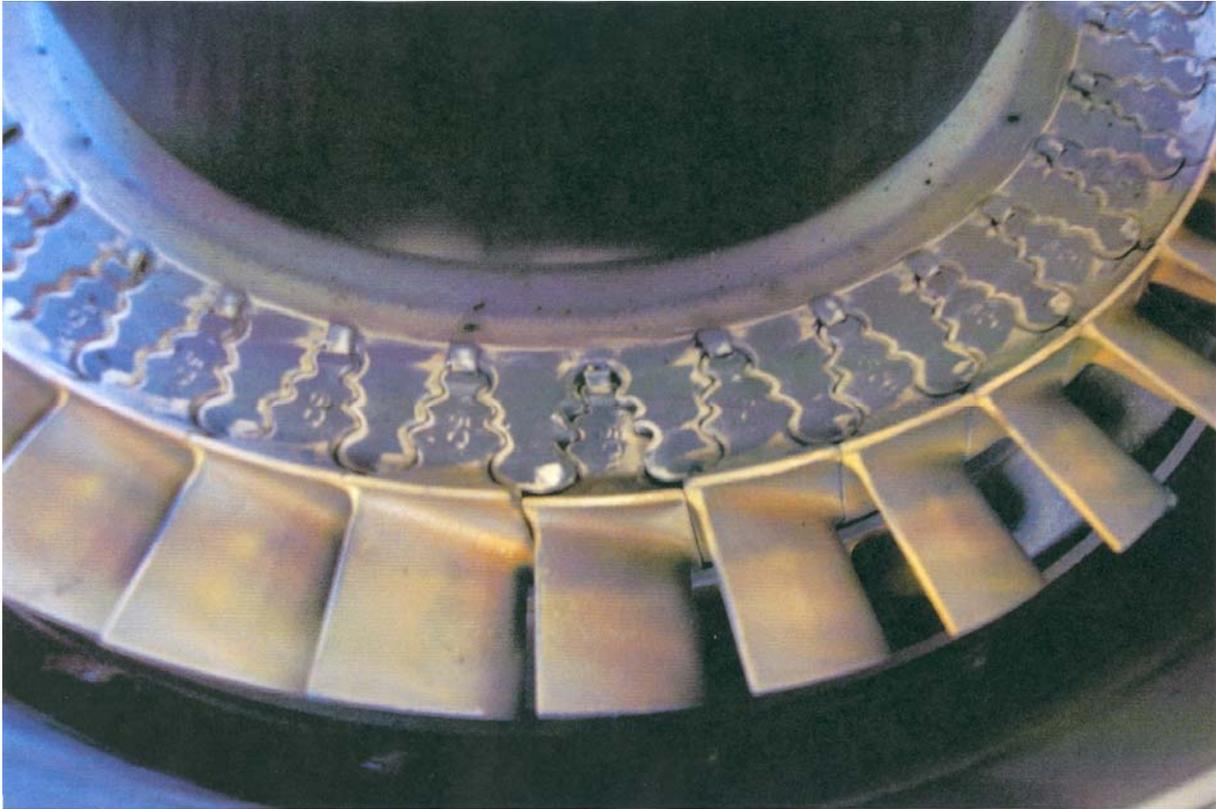
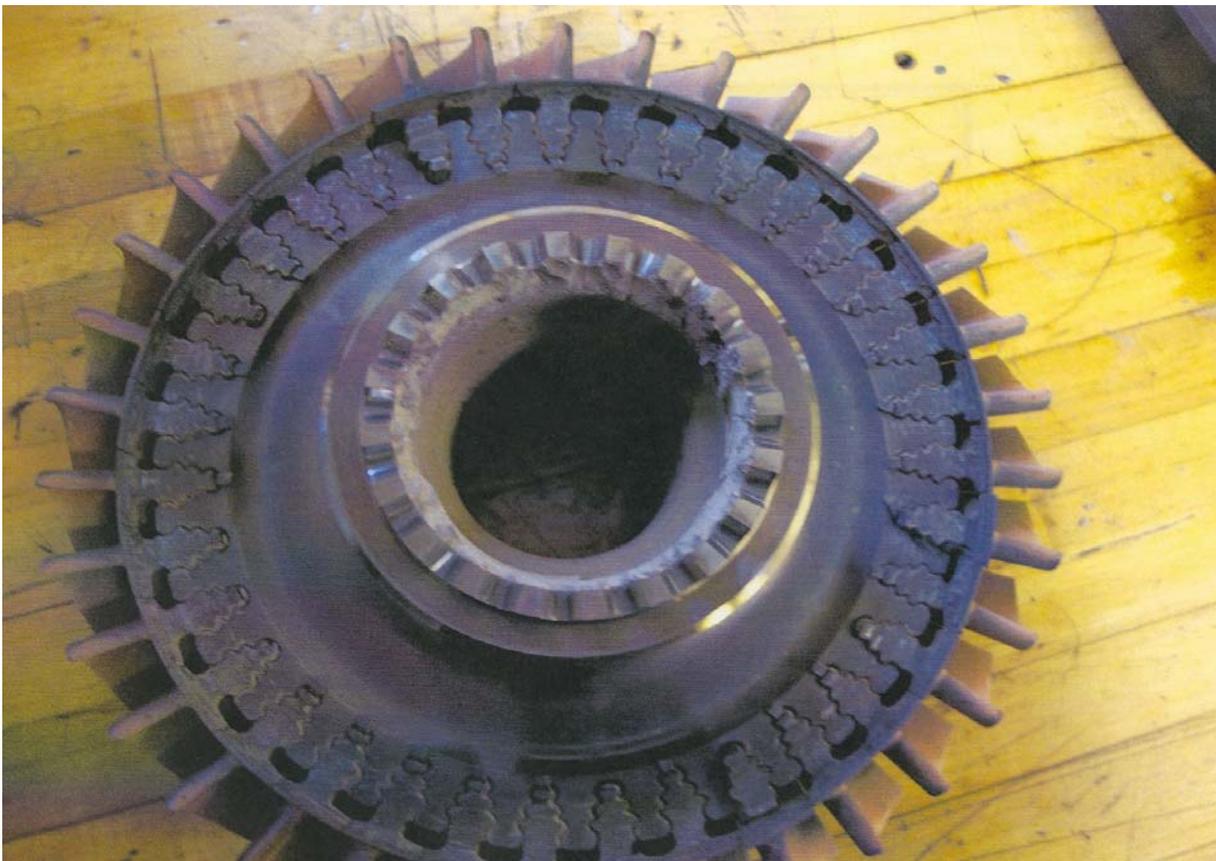
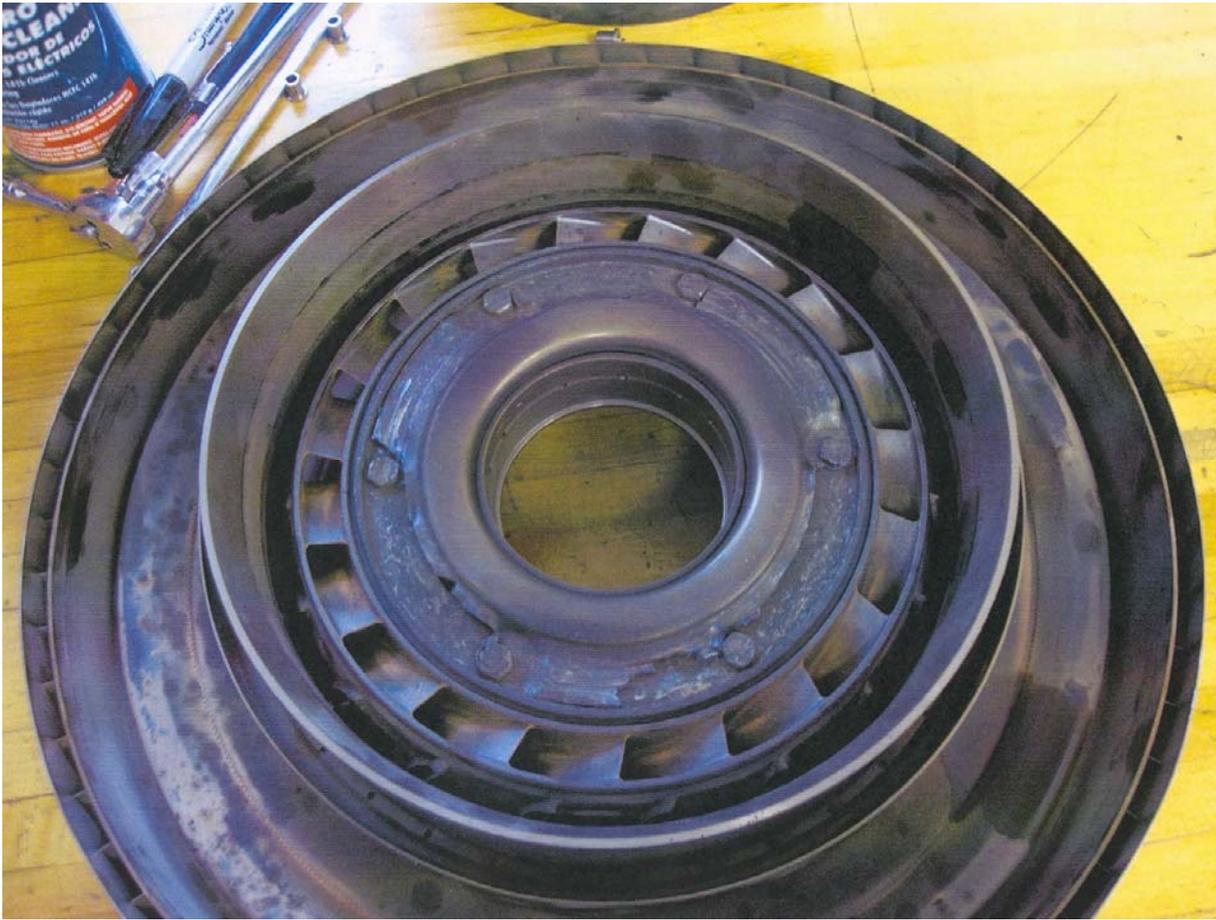
**Turbomeca: Arrius 2B2; Failed Turbine Disk; ATA 7250**

A technician from a corporate operator describes the difficulty with this EC135T2 helicopter engine. "While performing a borescope inspection (and rotating the engine) a noise was heard, and then the N1 section of the engine locked up. (I) removed the engine and disassembled module 1 from module 2, and waited for Turbomeca Support to come and disassemble module 2. Upon disassembly of module 2, (we) found the HP (*high pressure*) turbine disc had three shifted blades—and (*these*) were rubbing into the HP nozzle guide vane. Turbomeca Support is going to replace the HP turbine wheel and nozzle guide vane." (*HP turbine disk P/N: 0319218520.*)

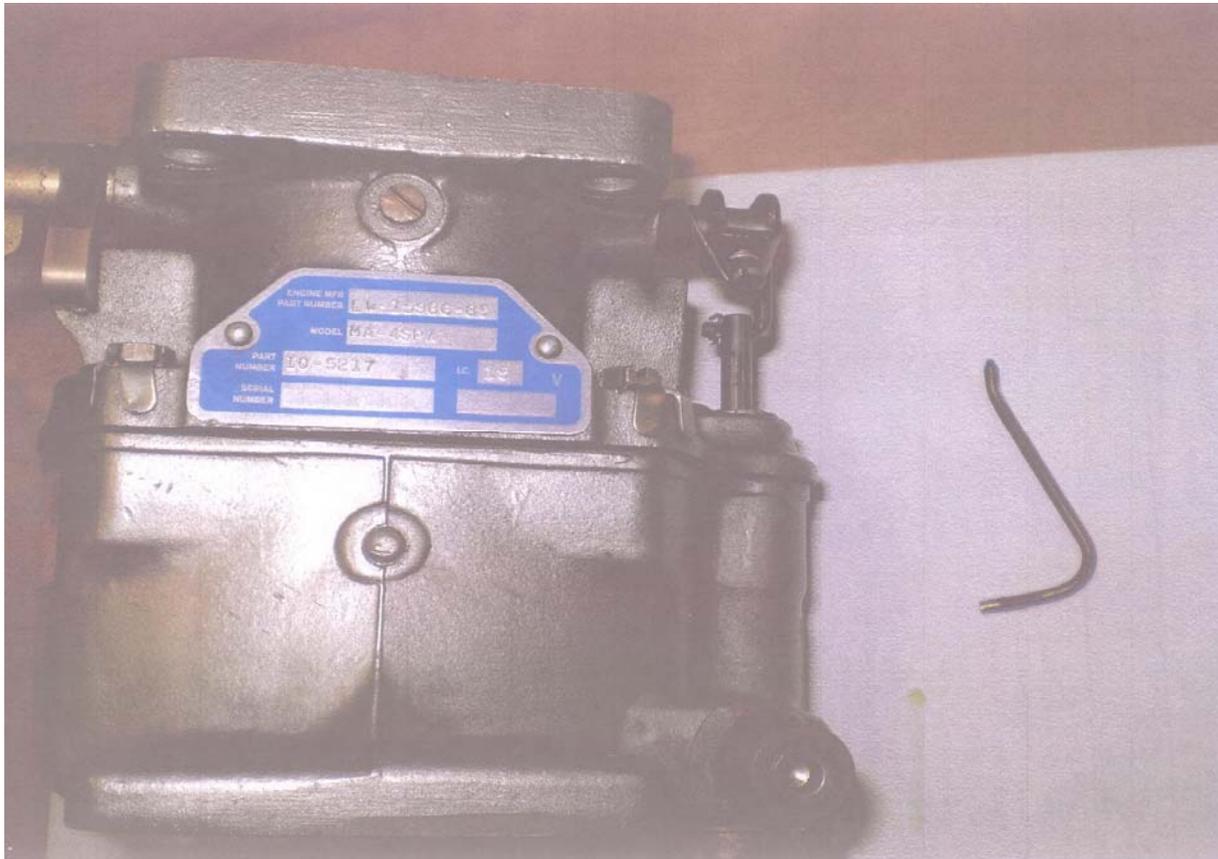
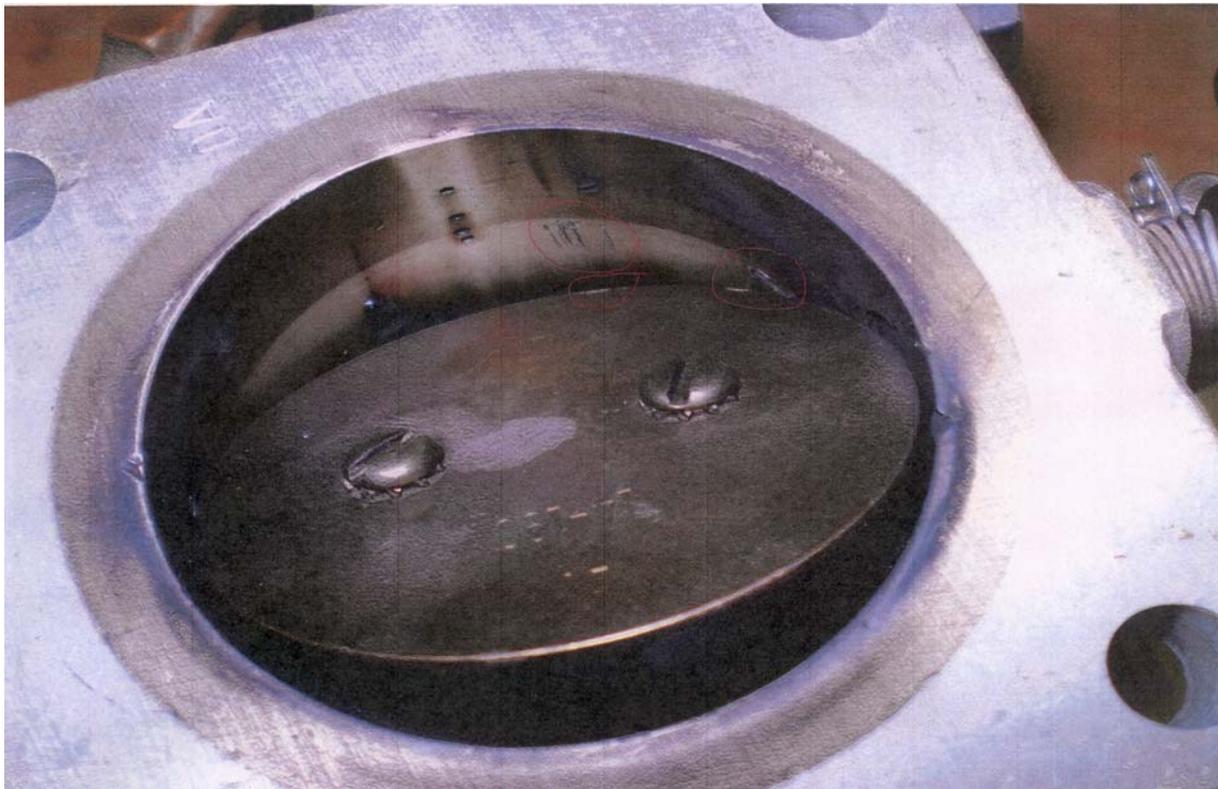
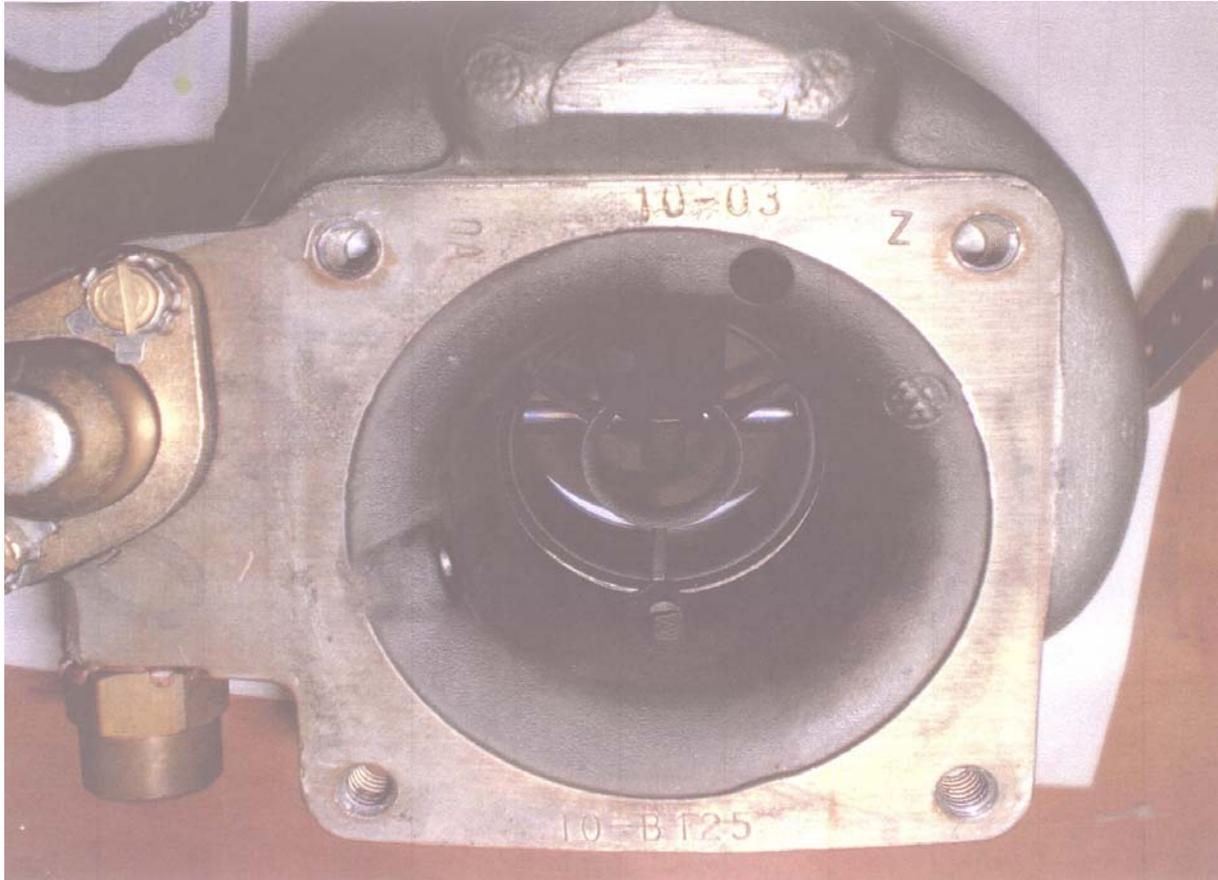
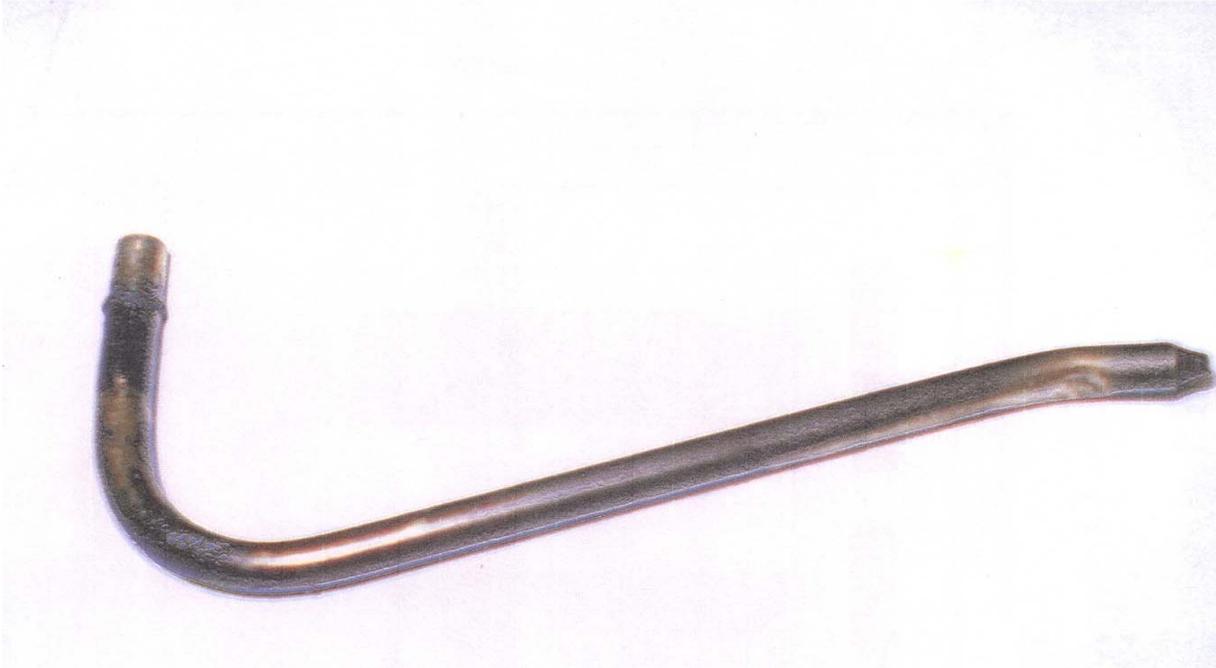
### **Marvel-Schebler: MA-4SPA; Loose Discharge Pump Tube; ATA 7322**

*(This report references a Cessna 172P sporting a Lycoming O-320-D2J.)*

"The pilots made a precautionary landing," says this A&P mechanic, "as they were unable to retard the engine throttle below 2100 RPM. In order to land, the mixture was moved to the idle cut off prior to the landing flare. An off-base airport was selected as a landing site due to the large runway available, and the *(presence)* of ARFF (*Aircraft Rescue and Firefighting*). Off-field maintenance personnel inspected and found the accelerator pump discharge tube had detached from the boss, then lodged between the throttle plate and the carburetor throat—inhibiting throttle movement. The accelerator tube was found bent at the tip, depressions were found in the side of the throttle plate, and scratches were observed in the throat of the carburetor consistent with the discrepancy. (Note: this carburetor was shipped with an overhauled Lycoming Engine directly from Lycoming. The carburetor was supplied to Lycoming Engines from Precision Airmotive.)" (*Carburetor P/N: 10-5217. Time since overhaul: 1,203.7 hours.*)

*(Yes—this carburetor does have a serial number, but in the first photo it fell victim to my art practice, and all four views are skillfully "squashed." Note the SDRS database has 19 reports for this carburetor. Thank-you for the submission effort—Ed.)*
