**Federal Aviation
Administration**

ADVISORY CIRCULAR

AVIATION MAINTENANCE ALERTS

**ALERT
NUMBER
396**

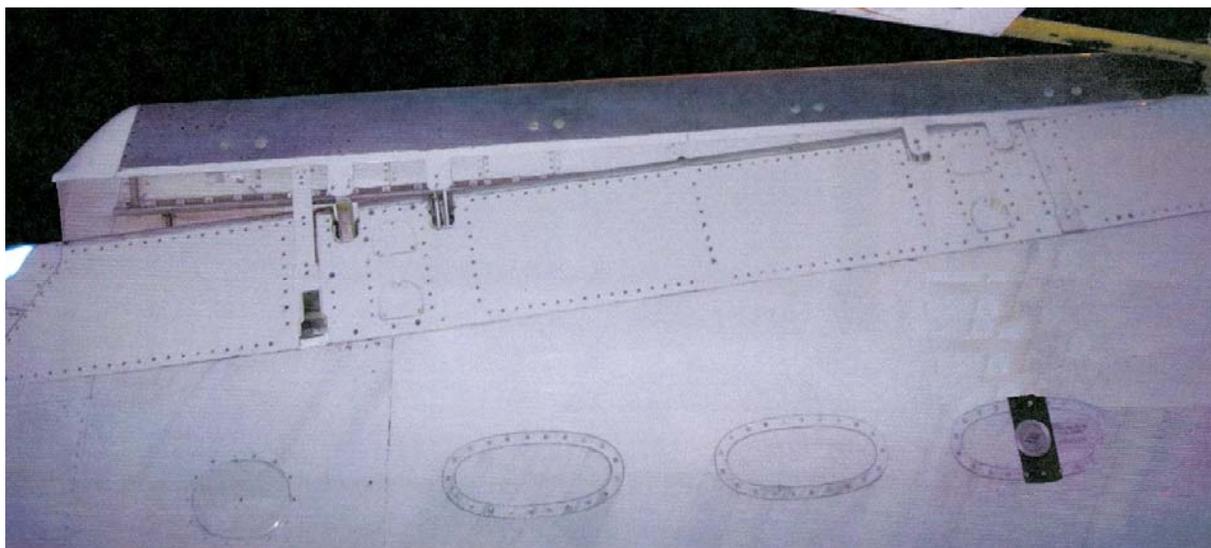
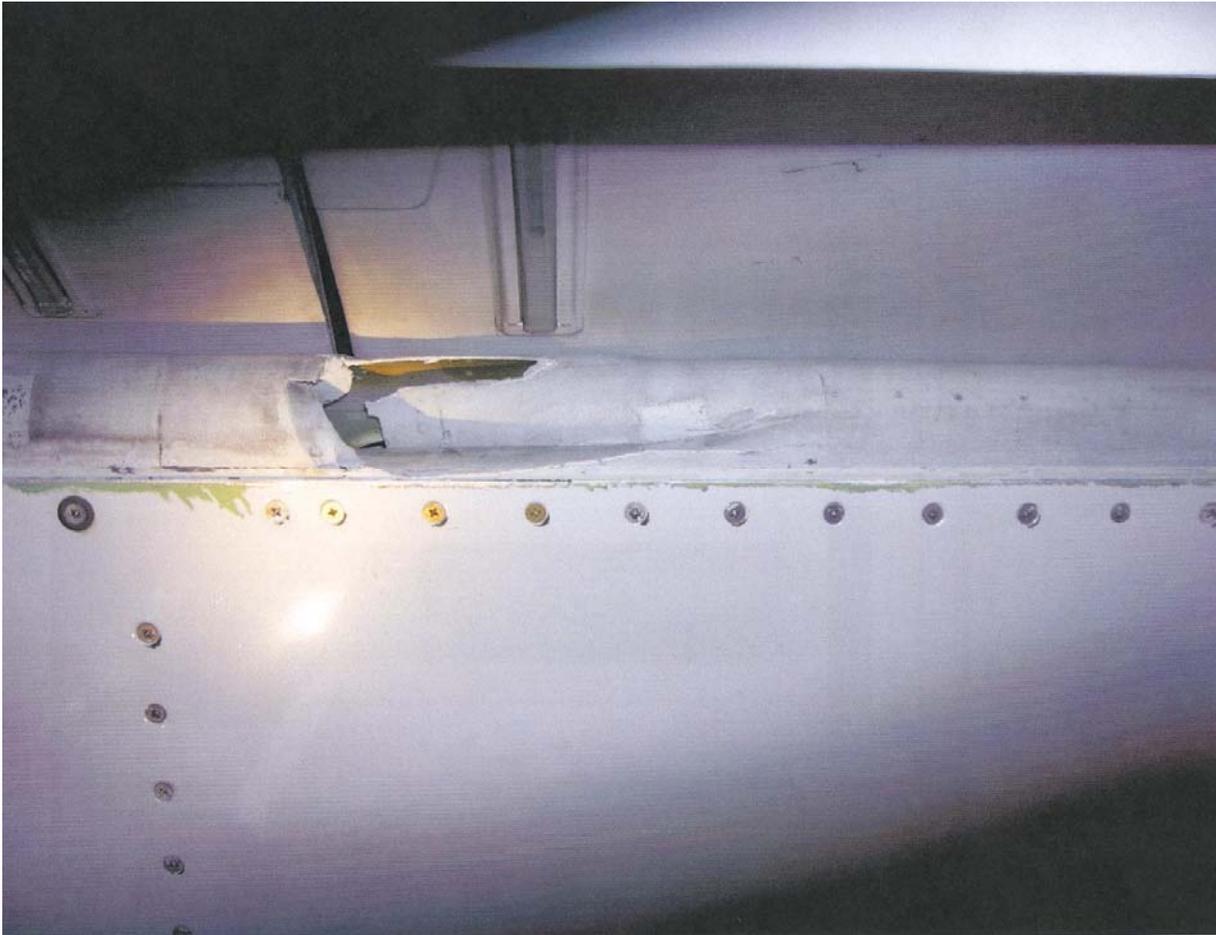
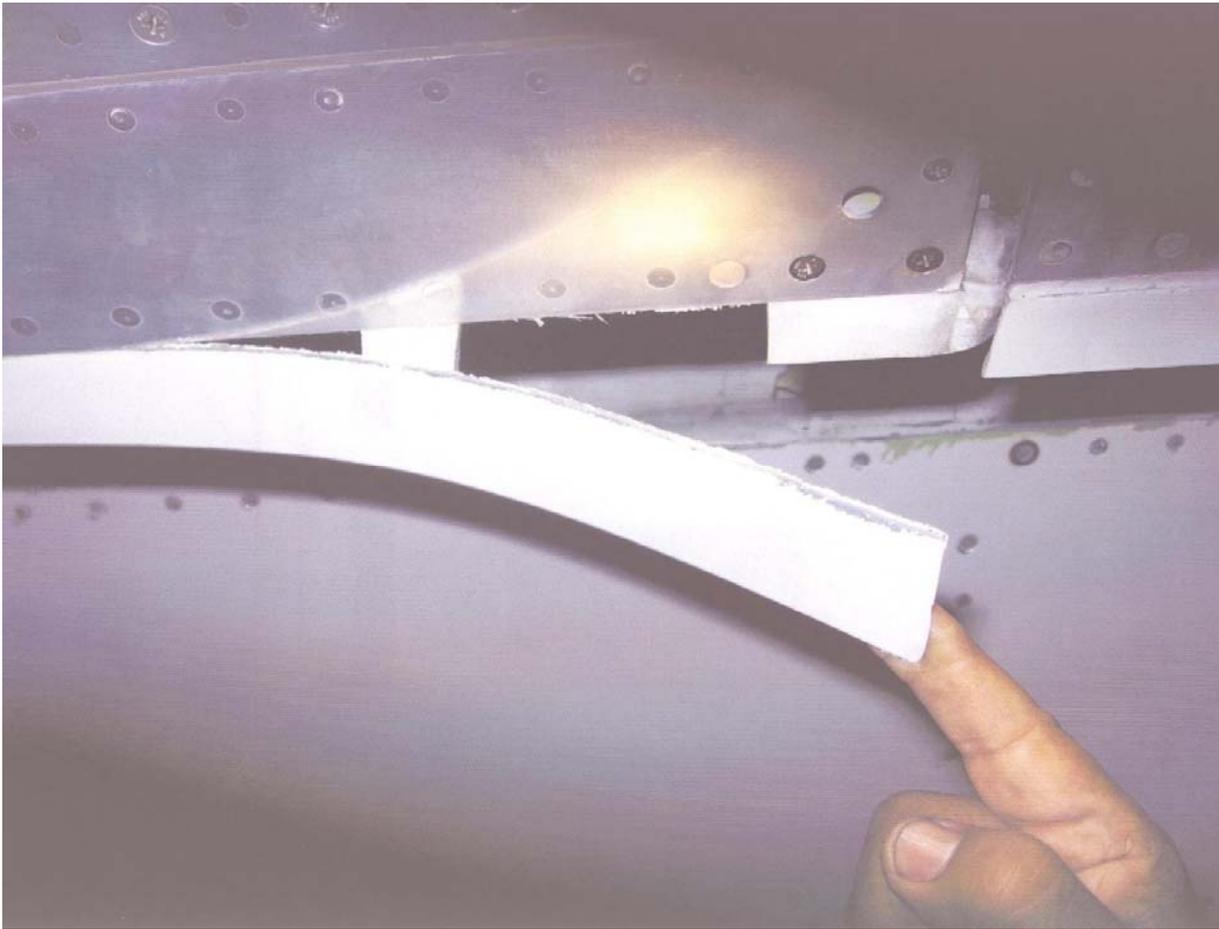
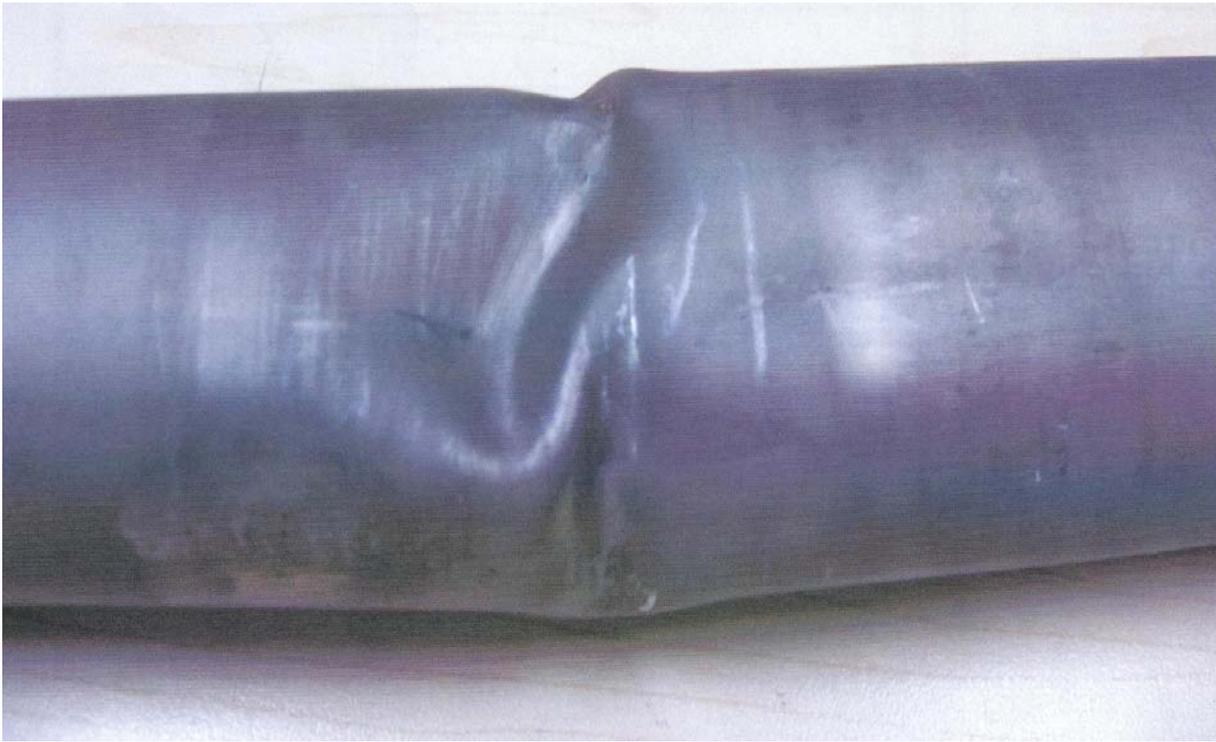
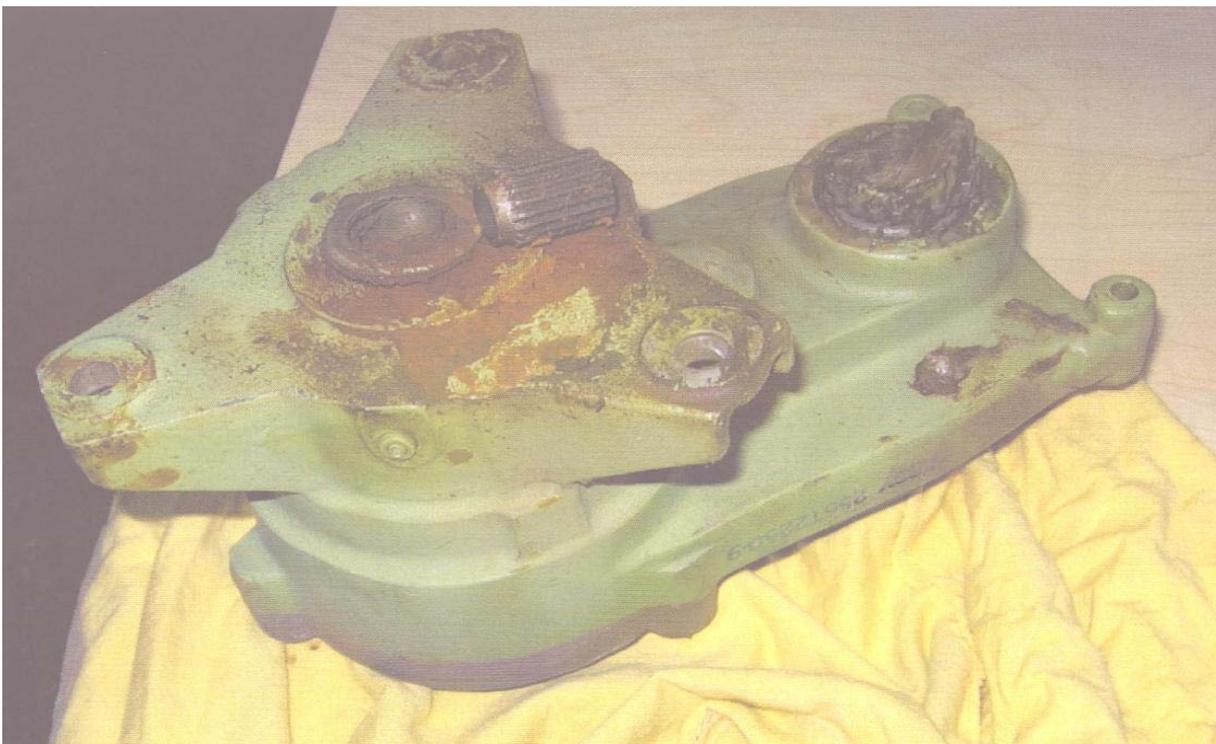
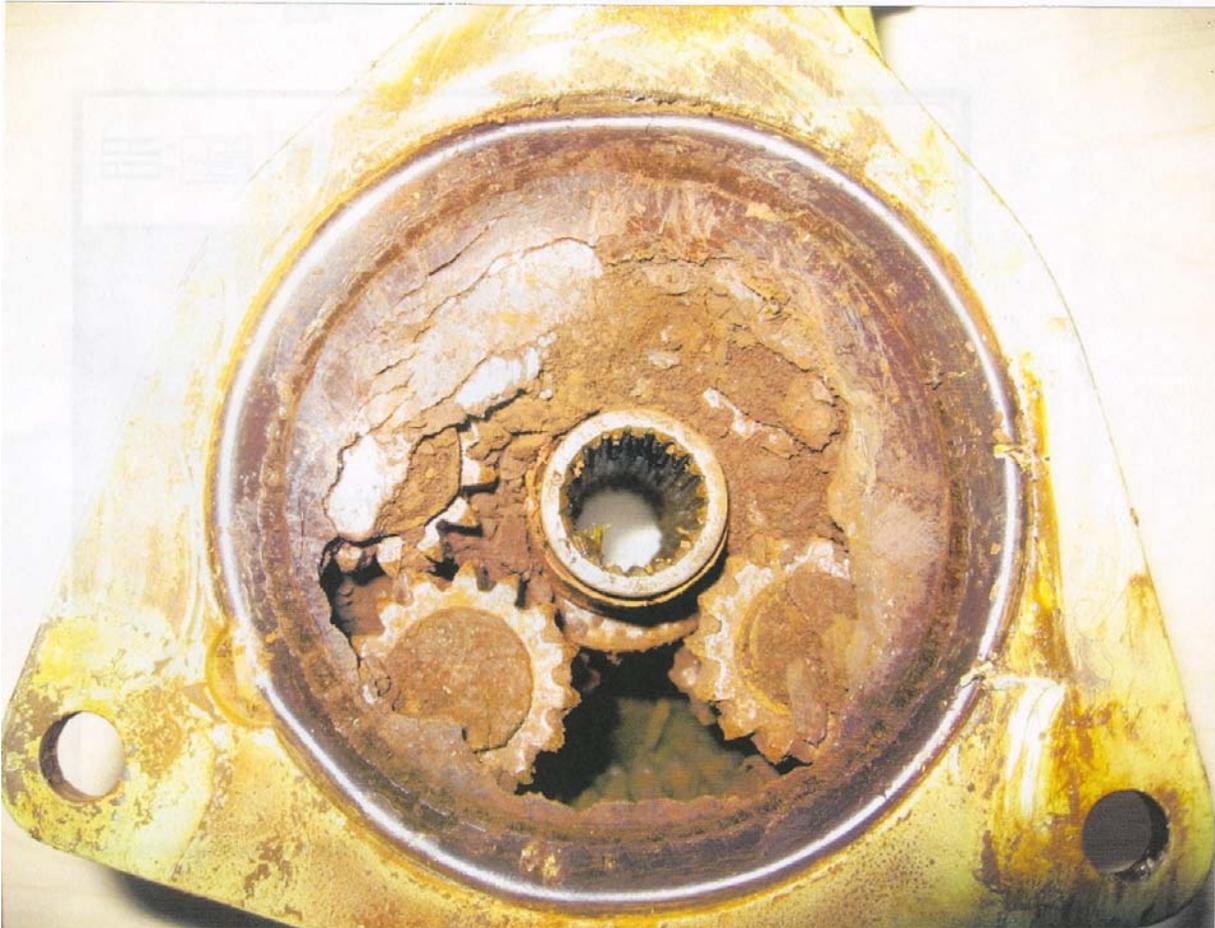
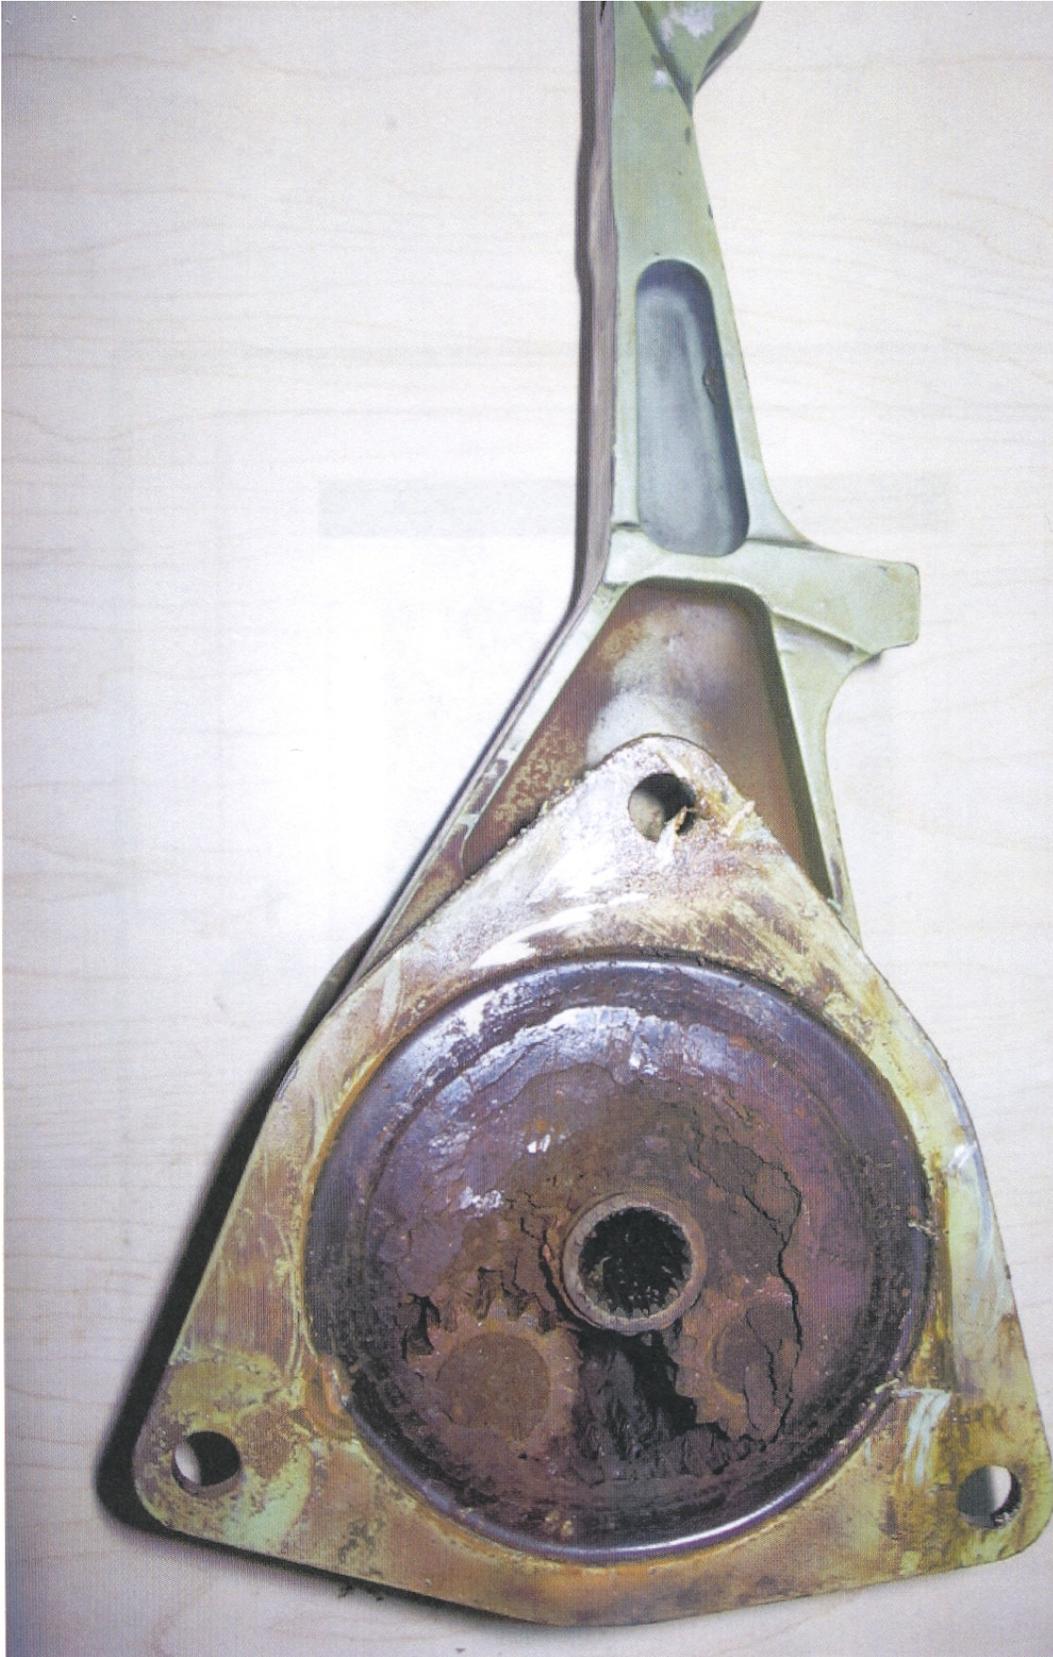
Boeing: 767-200; Sheared Gearbox Shaft (slats); ATA 2782

Referencing a pilot's report an air carrier submission states, " 'During the climbing stage (*of our flight*), a leading edge slat asymmetric (*warning indication*) appeared. The aircraft was turned back to the (*originating airport*).' Ground inspection found slat number 12 hanging down from one side. The slat remained supported from one track, causing holes in some panels of the wing and deflection of the anti-ice tubes. After removal of the slat, the gearbox (P/N 256T2220-12) and rotary actuator (P/N 256T2120-5) were found with signs of heavy internal corrosion. The shaft between these components was completely sheared. The gearbox was disassembled; all gears were found attached one to another by corrosion due to the absence of grease. Other parts (*of the aircraft*) that were found damaged (*include*): R/H leading edge wing with a hole, a bent TAI (*anti-ice*) duct, and a broken trailing edge aerodynamic slat seal." (*Note: one or more of the following photos have been purposefully tampered with by this editor for the cause of identification removal, or "squashing to fit," etc.*)

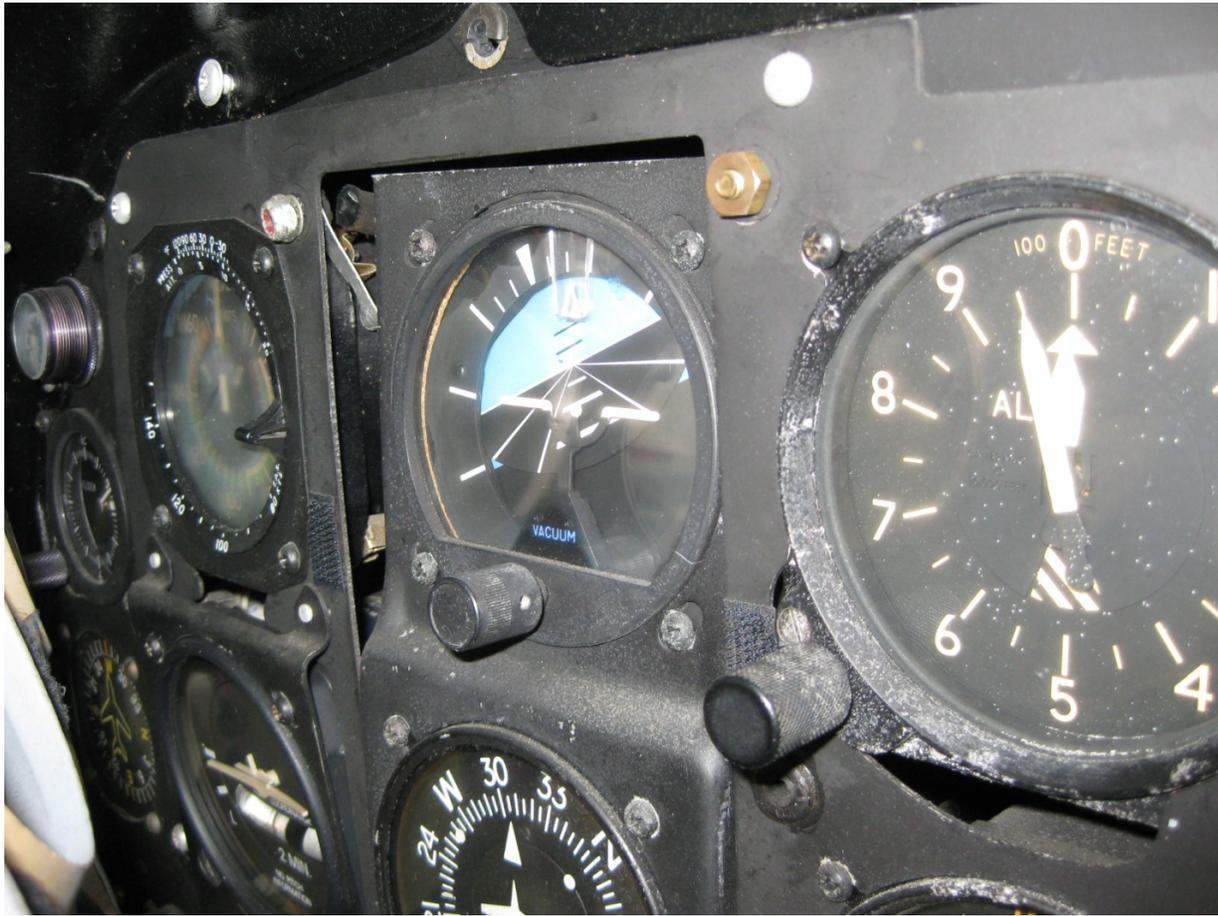
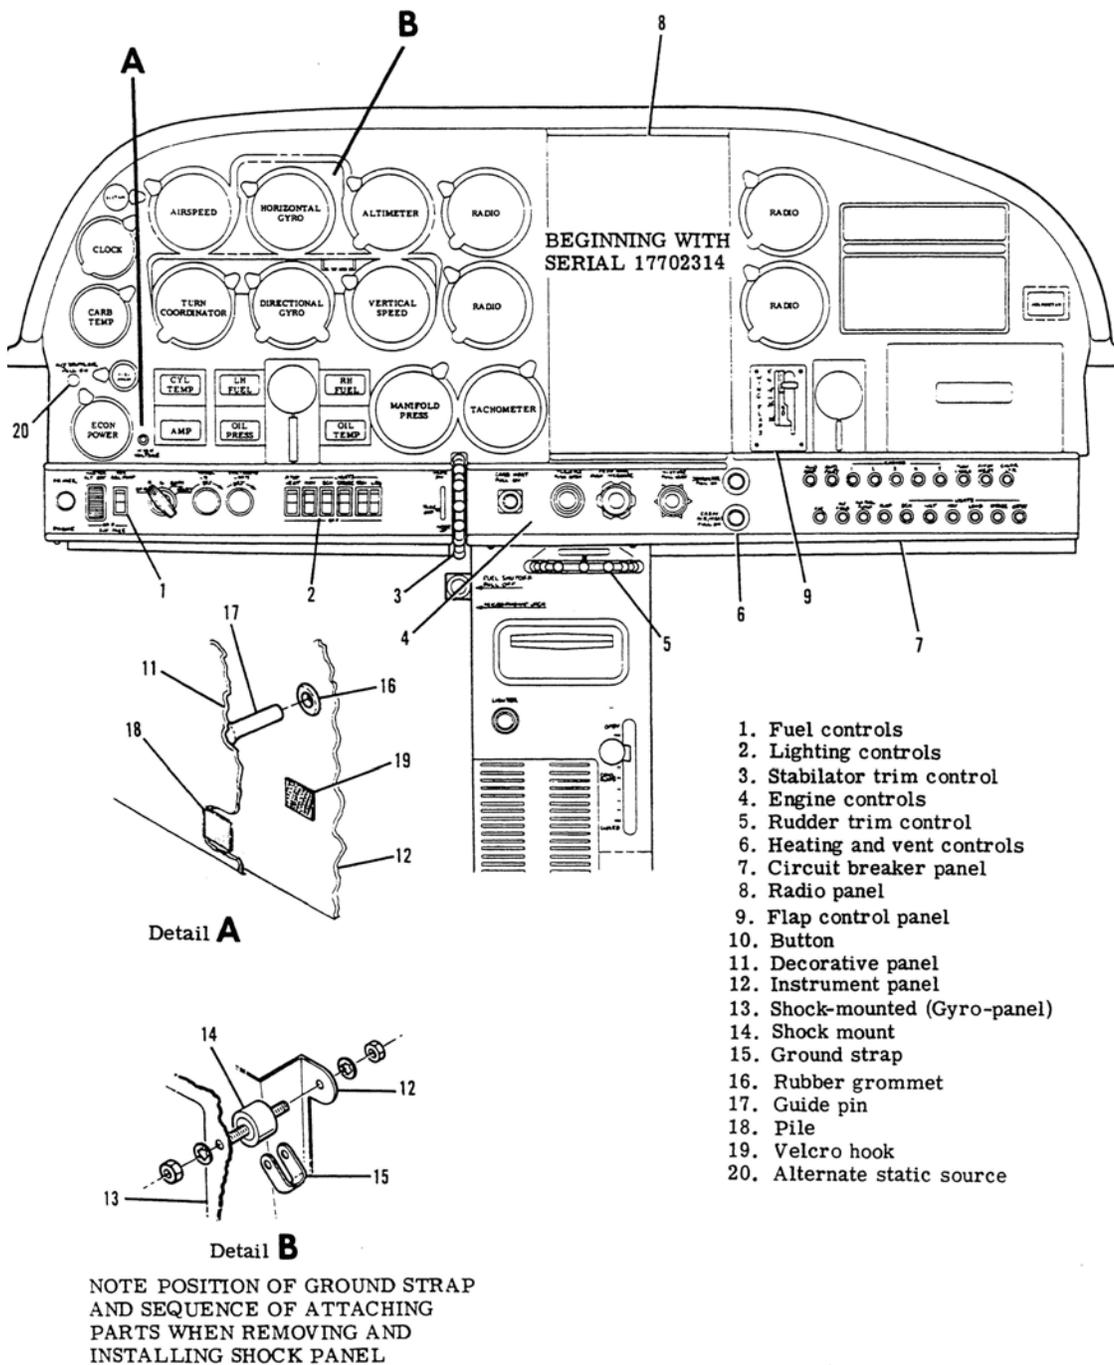
Figure 15-1. Instrument Panel (Typical) (Sheet 2 of 2)

After takeoff, a pilot of a Cessna 177B experienced a jammed elevator control during the initial climb. He immediately (and safely) aborted the takeoff, but the aircraft sustained substantial damage from the emergency maneuver and subsequent hard landing. Examination of the airplane revealed the nut securing the shock-mount to the instrument panel's right side was missing. The left side shock-mount contained improper hardware and was sheared. A portion of the instrument panel had shifted downward, allowing the directional gyro housing to make contact with the yoke control column. This restricted its movement.

The instrument panel assembly consists of shock-mounted and stationary panels. The stationary panel contains fuel and engine instruments not normally sensitive to vibration. The shock-mounted panel contains horizontal and directional gyros—major flight instruments certainly effected by vibration. The stationary panel is secured to engine mount stringers and a forward fuselage bulkhead. The shock-mounted panel is secured to the main stationary panel with rubber shock-mounted assemblies. Service life of the instruments is directly related to adequate shock mounting of the panel. This airplane had been operated approximately 60 hours (or five months) since its last Annual Inspection.

Owners and pilots should ensure instrument panel hardware is inspected for correctness and condition. If removal of the shock-mounted panel is necessary, inspect these shock mounts for deterioration.

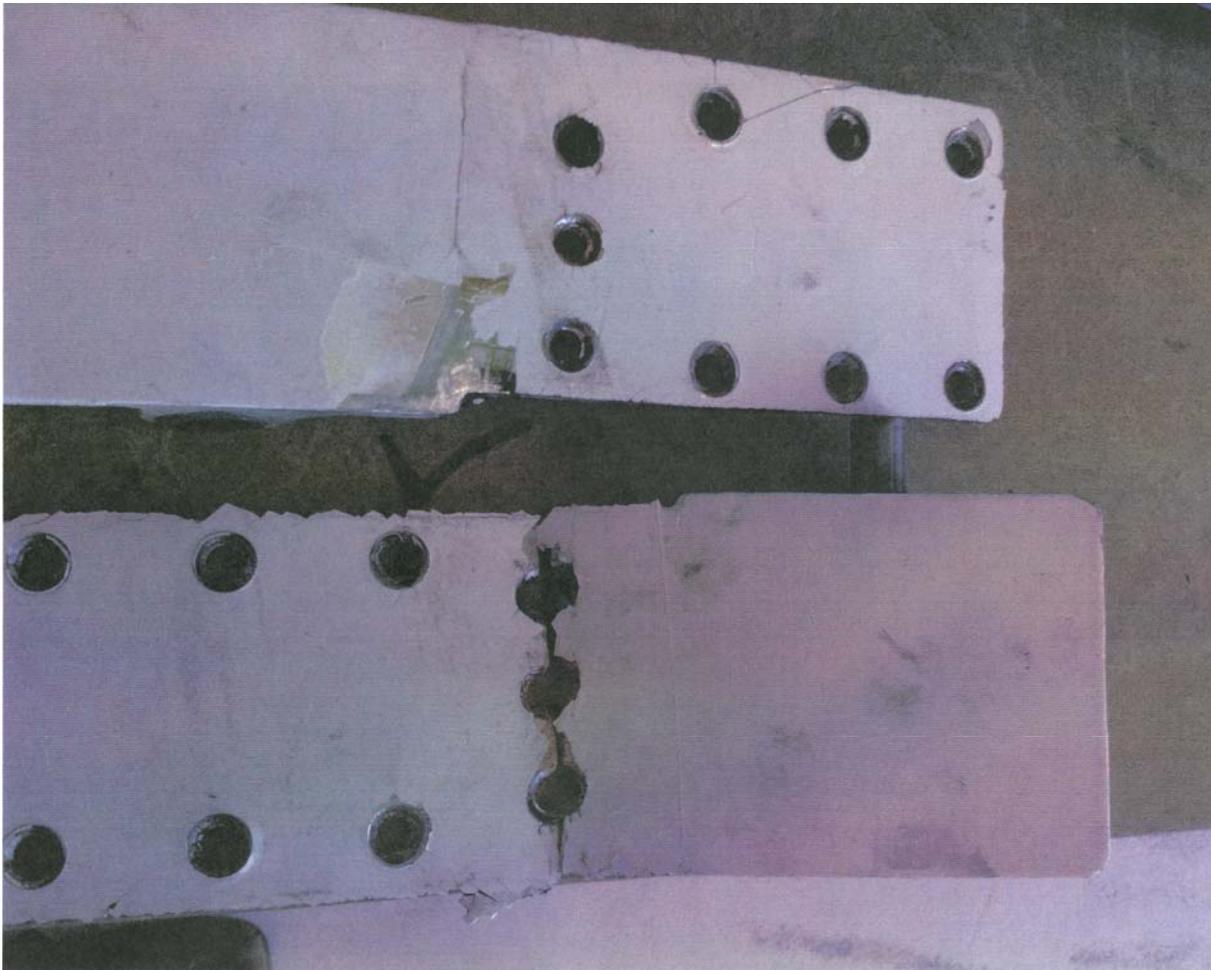
Cessna: 441; Broken Cabin Door Hinge; ATA 5210

A corporate operator's report says, "Exiting the aircraft during post flight, visual inspection found the lower L/H cabin door hinge broken. Further investigation (by eddy current inspection) found (*no cracks*) in the R/H lower door hinge. These particular hinges are required to be replaced per CQB98-09 within 200 hours—or 12 months from December 1998. SID 52-10-02 (Phase 41) was previously accomplished (*on this aircraft*) with 7,903.5 hours. Also incorporated was Service Information Letter PJ81-21." (*Hinge fitting P/N: 5111515204.. Lower door assembly component P/N: 57111652.*)

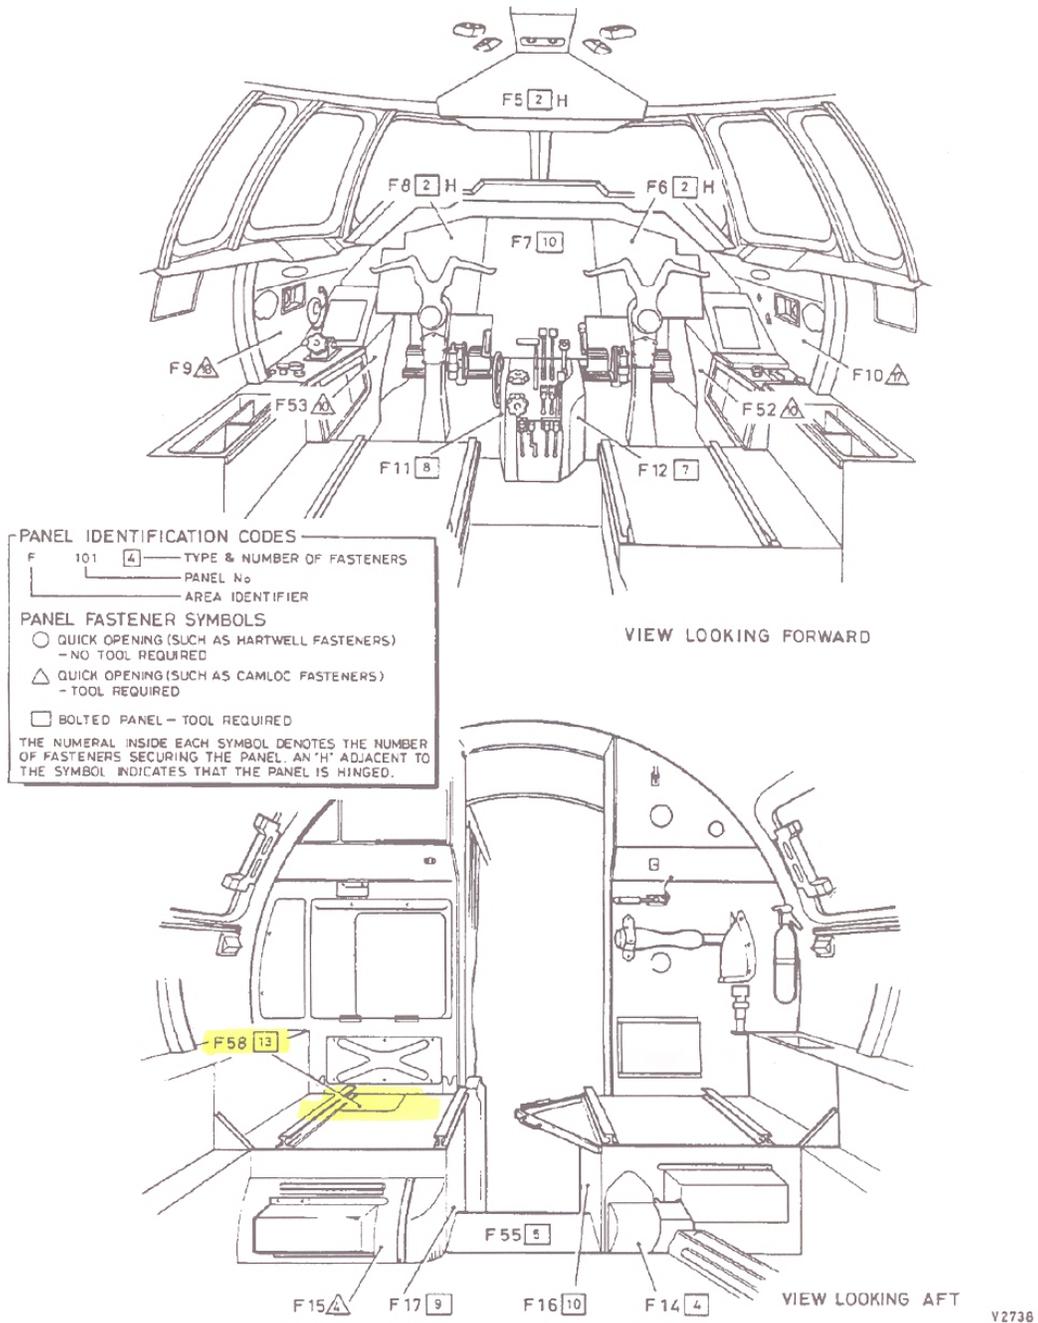
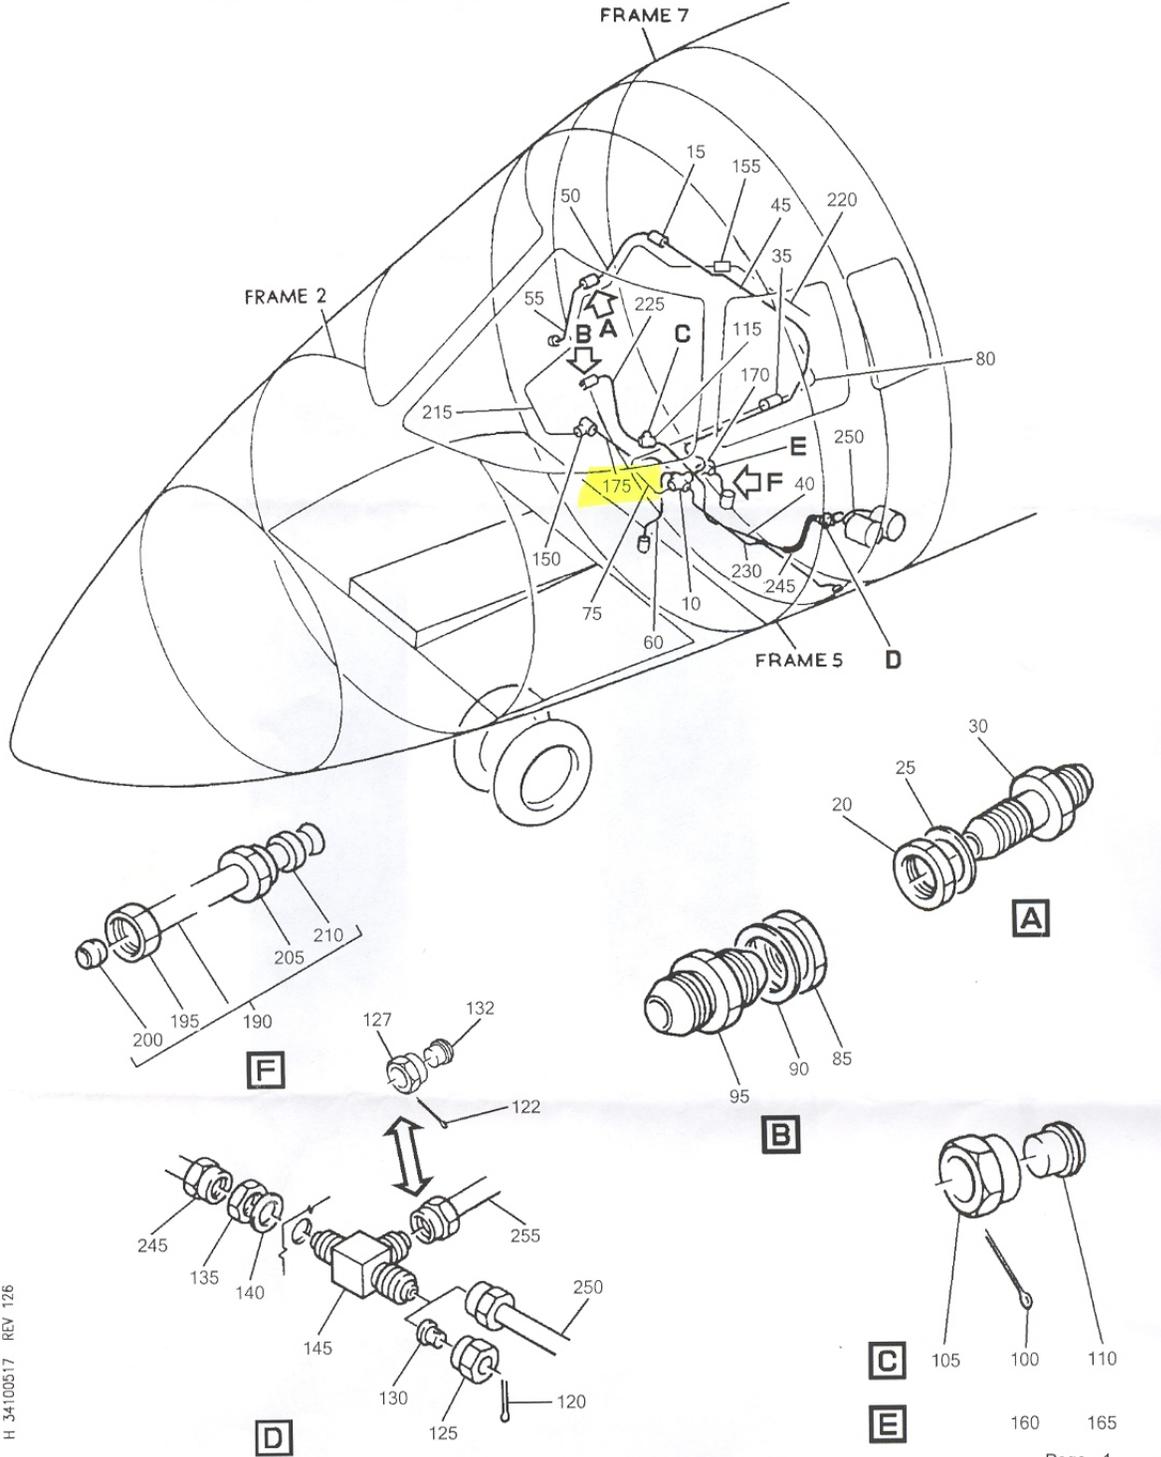
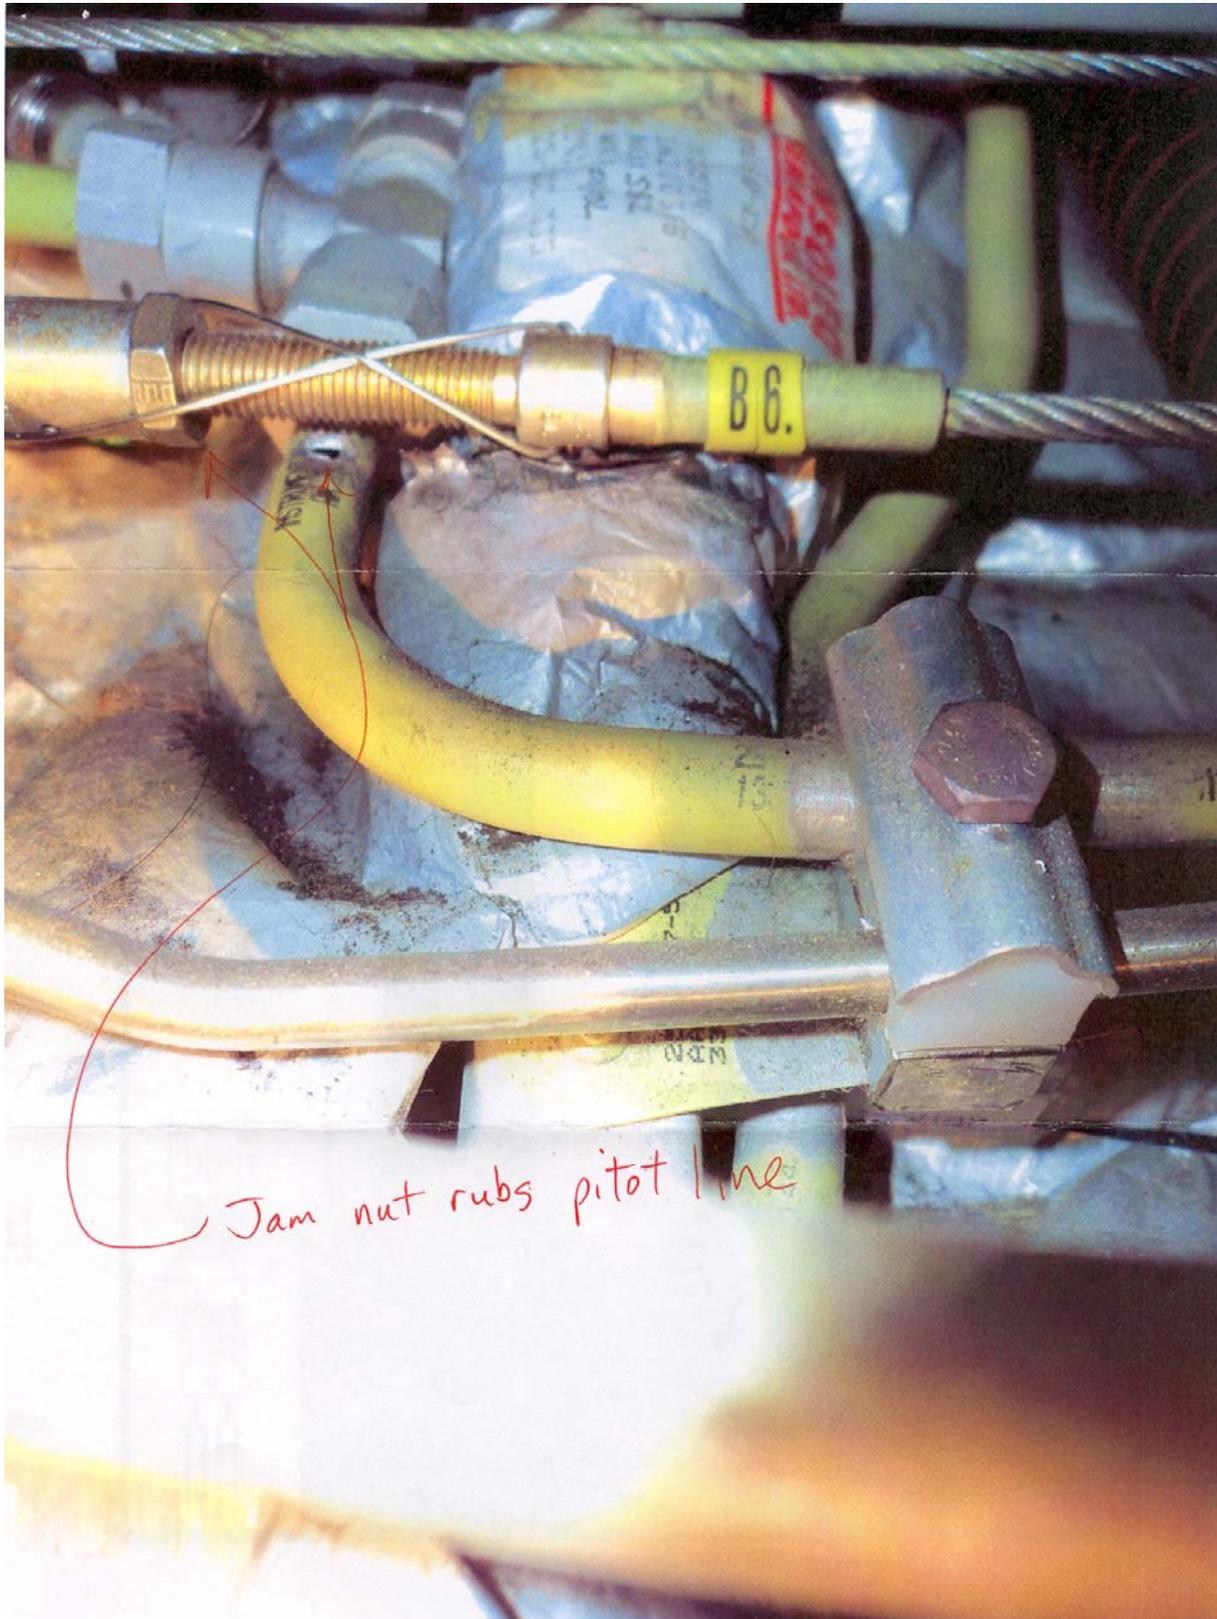
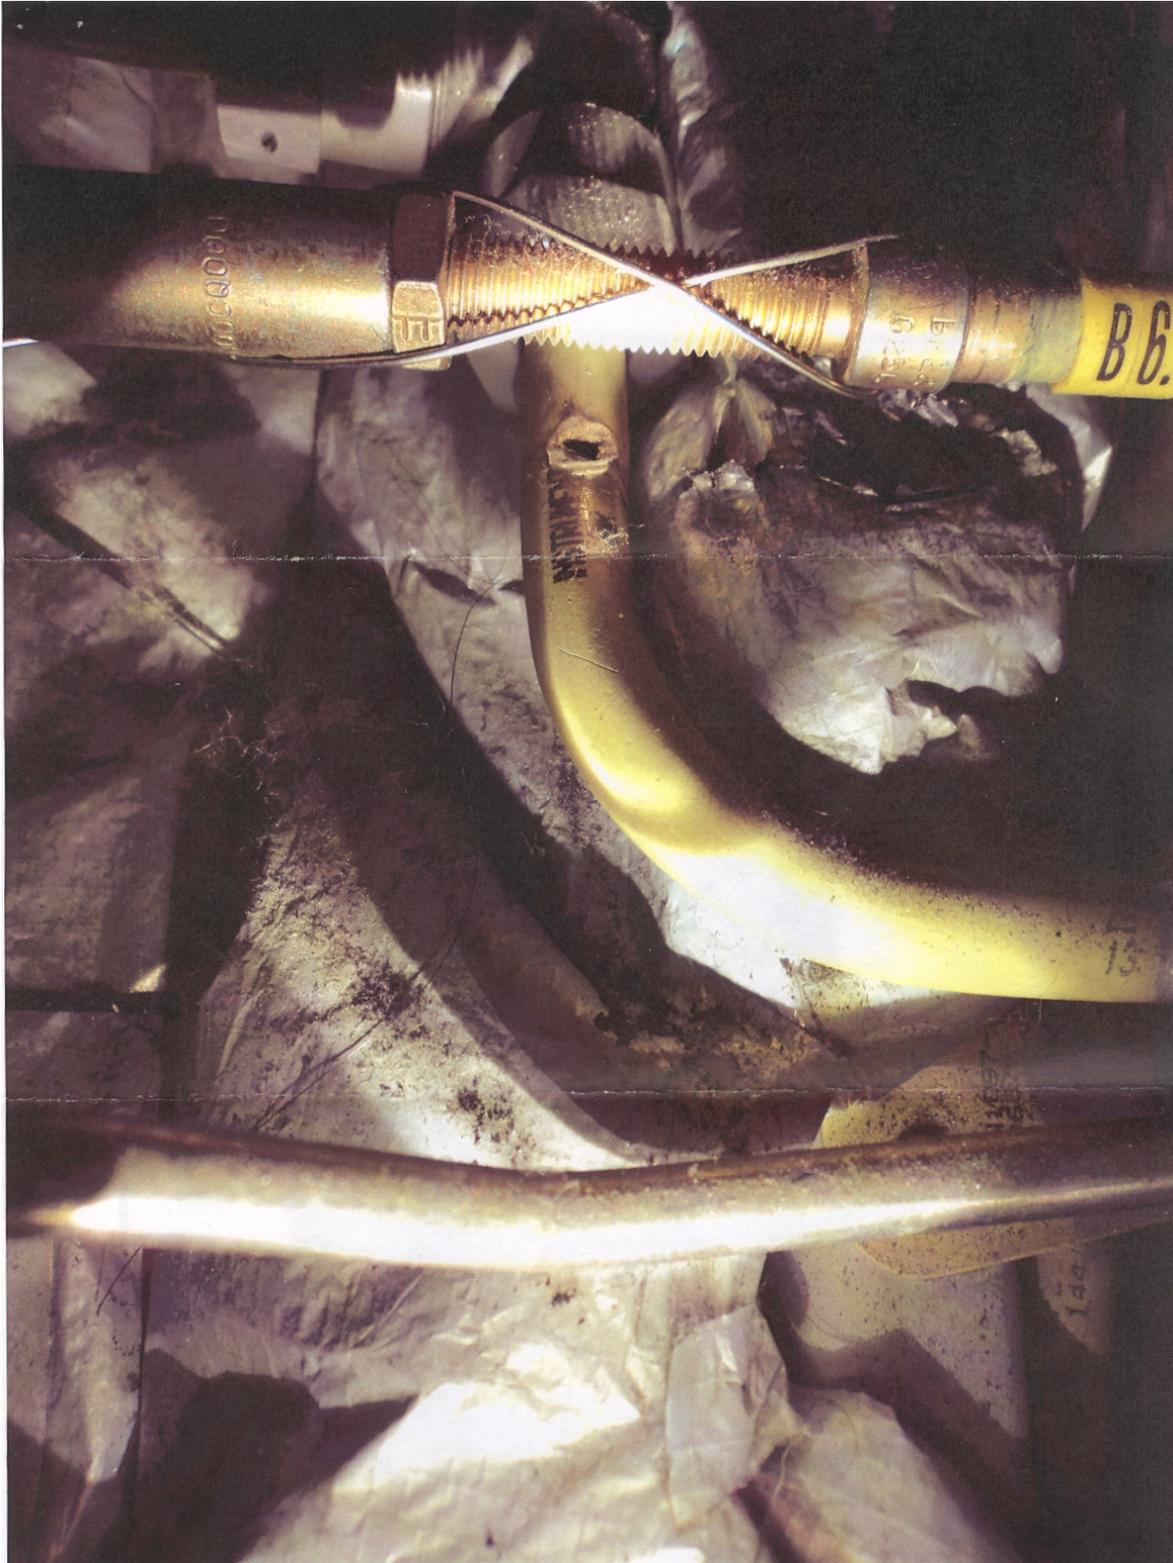
Hawker: 800XP; Chafed Pitot Line; ATA 3411

"This P2 pitot line was chafed through by the outboard loop of the R/H elevator cable," states this repair station technician. "This (*defect*) was not squawked by the crew. It was found by doing a pitot static leak check, which indicated a wide-open leak. This would cause inaccurate airspeed readings. It is only visible after removing panel F58 (under the co-pilot's seat) and the avionics shelf below it. We have found this (*defect*) before with varying degrees of damage. The line can be improperly positioned, causing the chafing. Inspection of this particular area is currently not called out on any inspection, nor is the removal of panel F58 on any inspection. (*I*) recommend adding it to the 'G' inspection (48 months)." (*The attached color photographs should have folks out ripping up floorboards! Pipe assembly P/N 25-7SF207-35A. Thanks for the admonition—Ed.*)

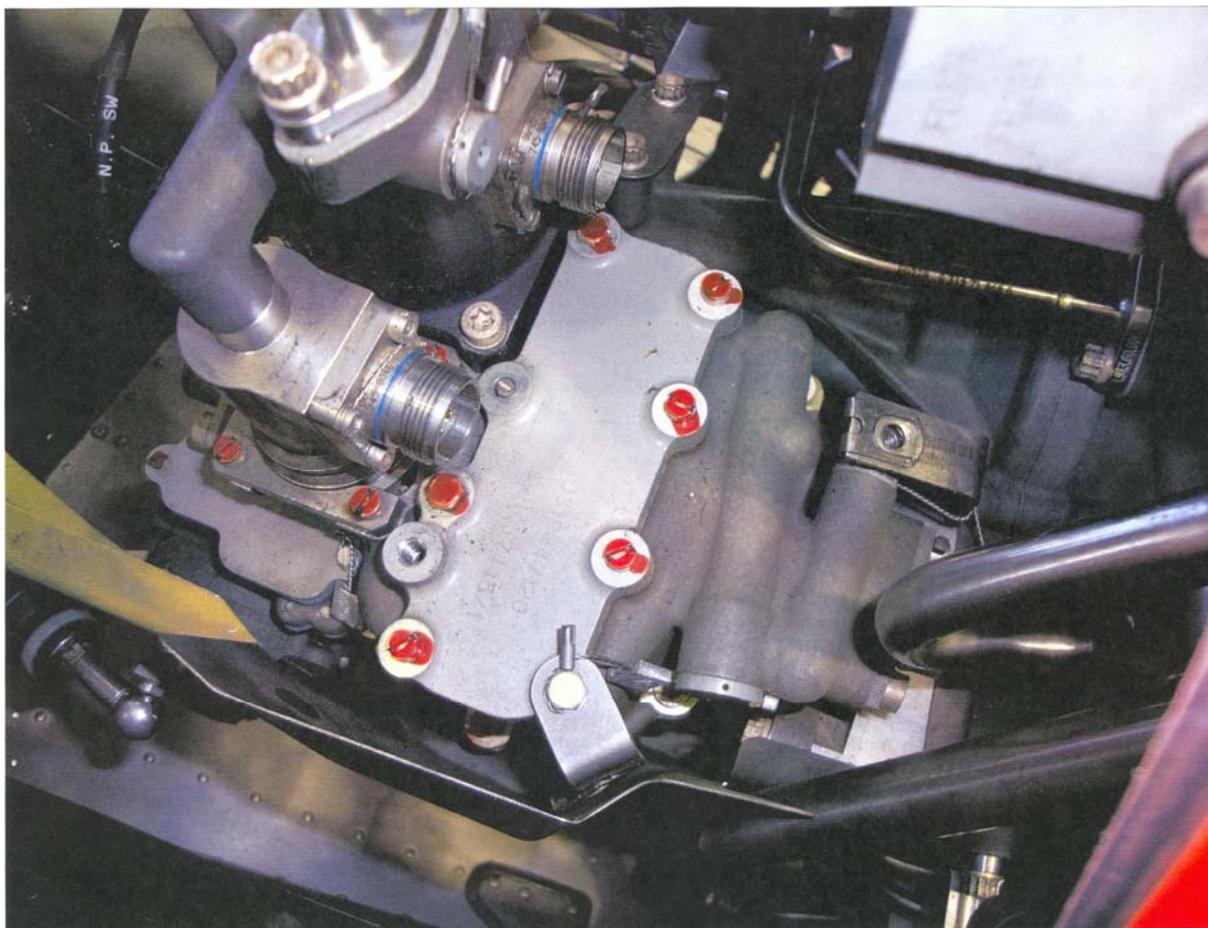
Eurocopter: EC135T2; Broken Screw on Fuel Control; ATA 7321

An unidentified submitter says, "During preliminary inspection of the aircraft for induction into the repair station, (we) found a screw head (lying) on the number two engine deck. Further investigation found the screw head was from a blanking plate on the fuel control unit." (*Engine is an Arrius 2B2.*)
