**Federal Aviation
Administration**

ADVISORY CIRCULAR

AVIATION MAINTENANCE ALERTS

**ALERT
NUMBER
396**

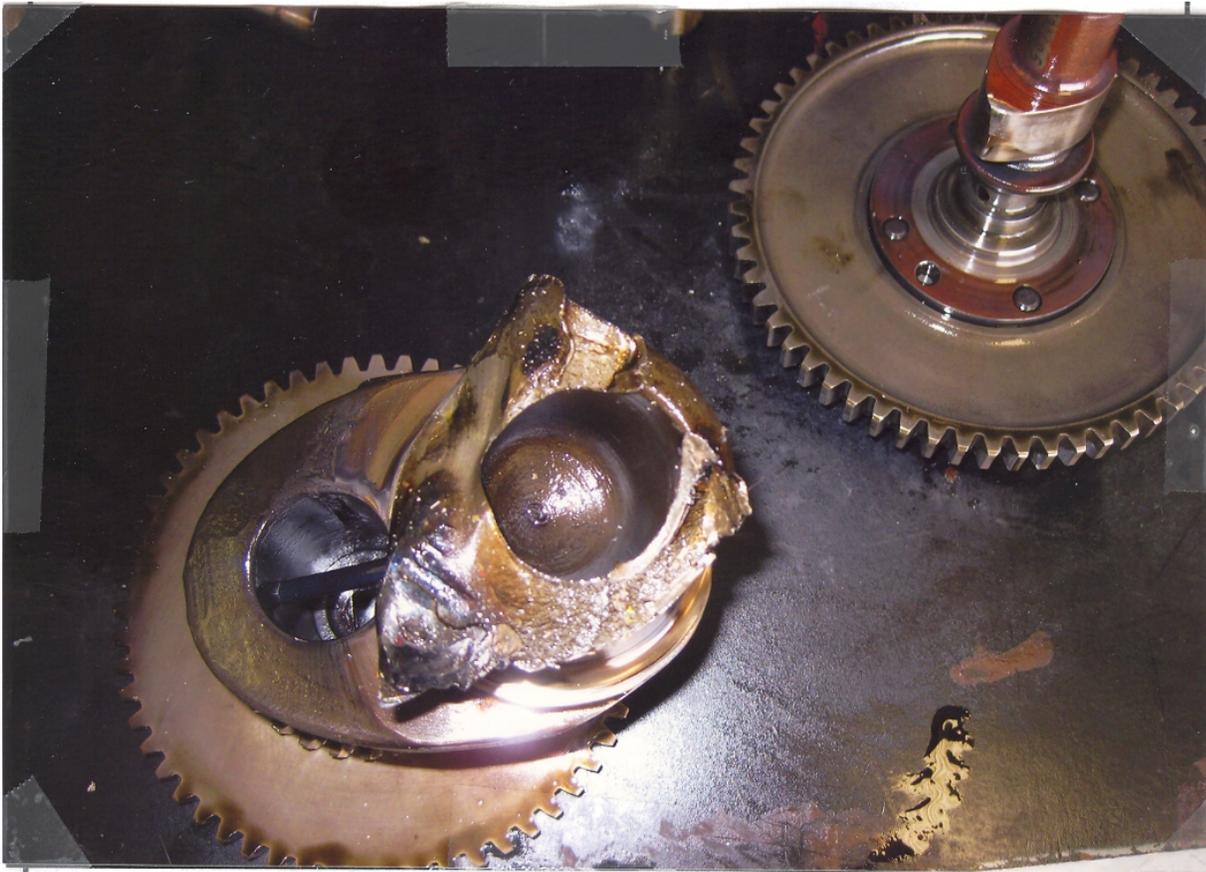
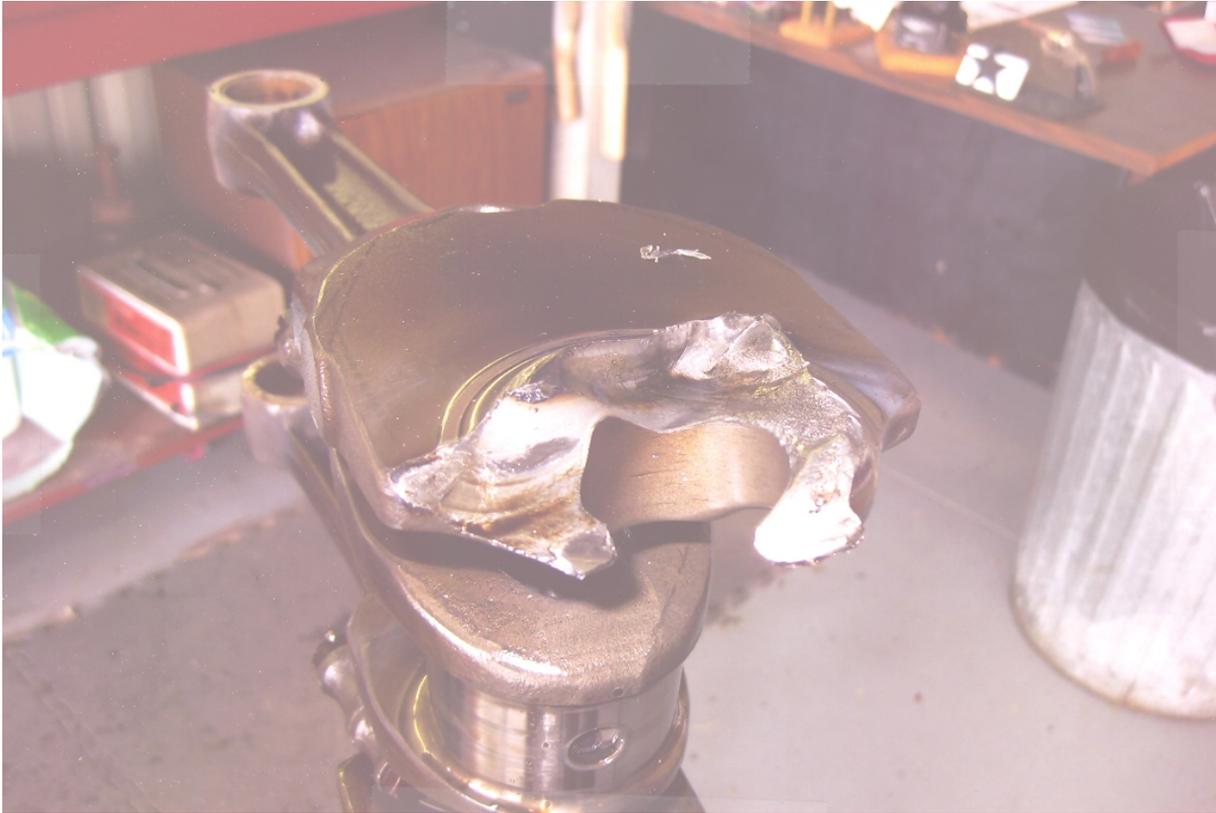
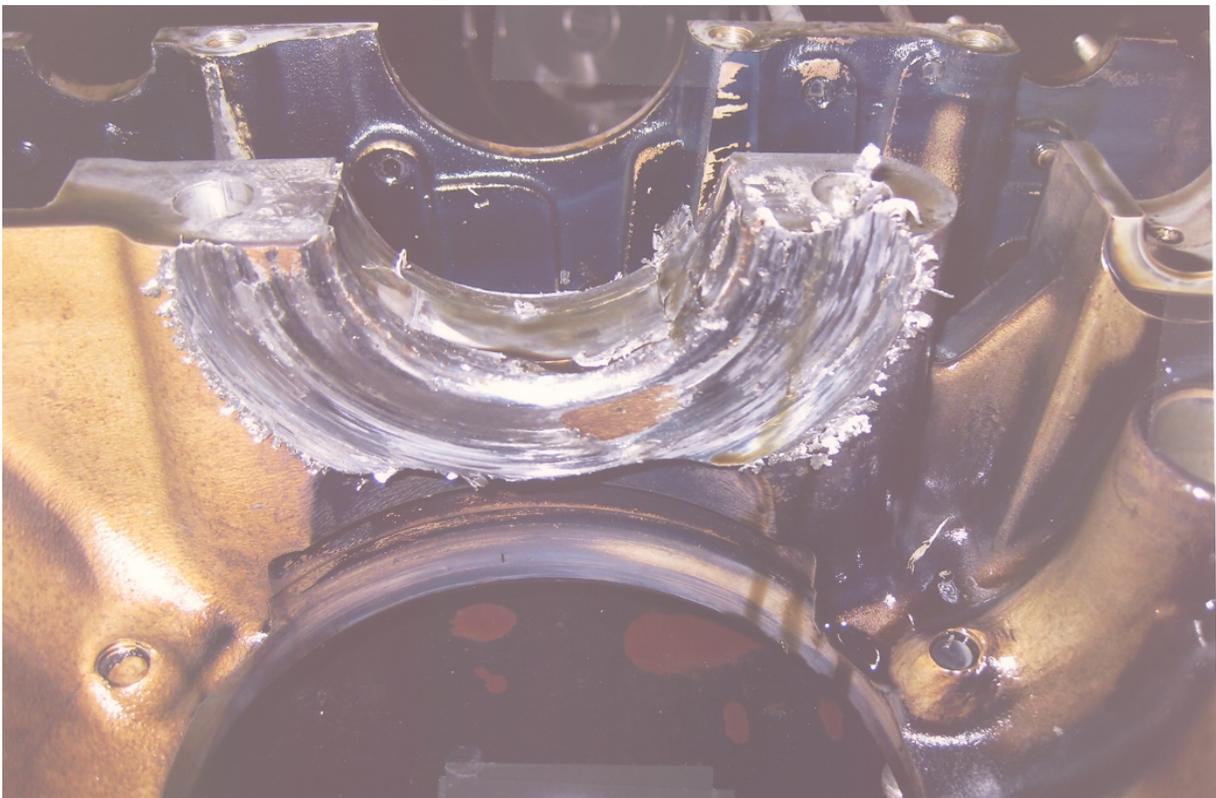
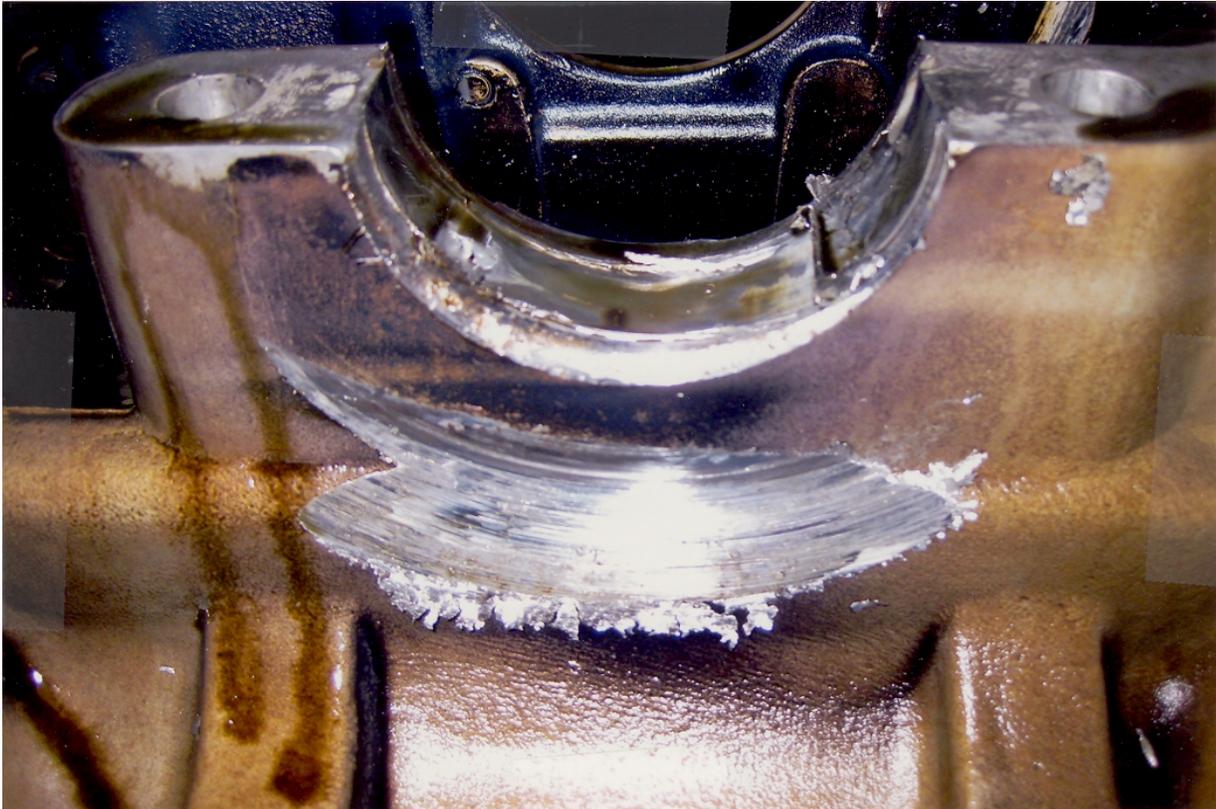
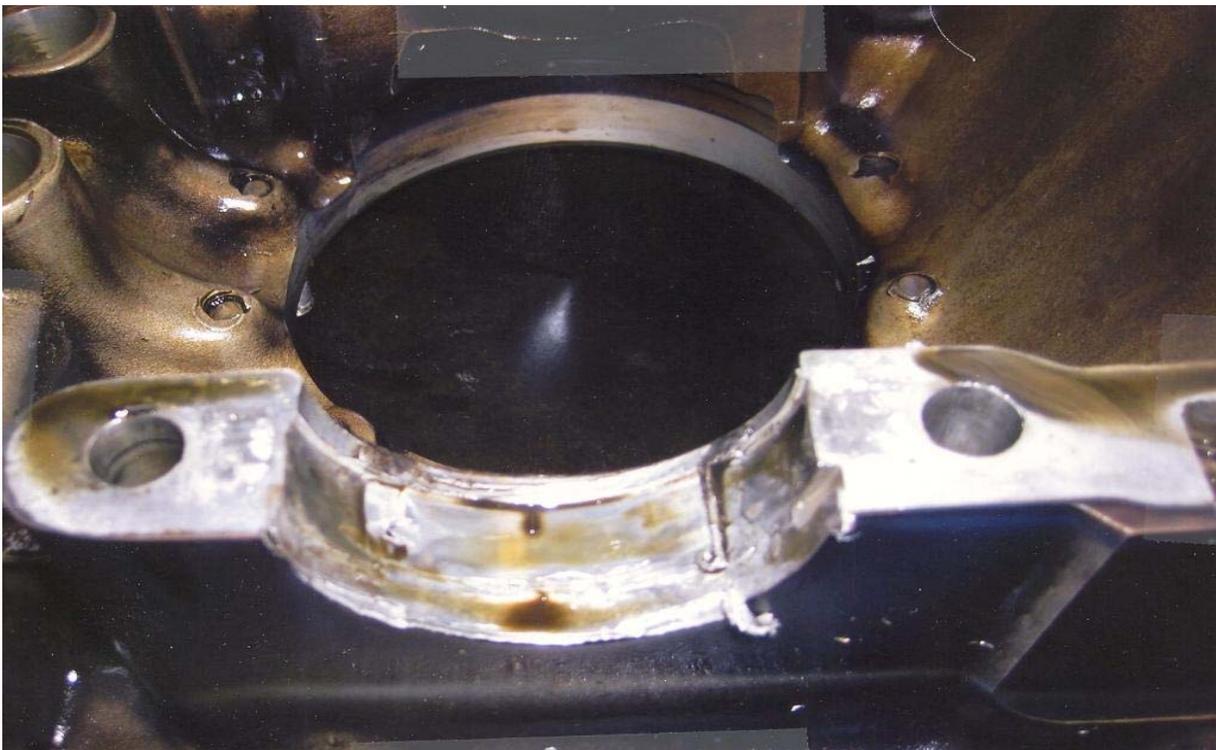
Continental: IO346A; Crankshaft Failure; ATA 8520

"(There was) an in flight catastrophic failure during initial climb," says this mechanic. "The engine ran rough—(then it) quit producing power and stopped. The aircraft landed in a field (without) damage." (*Crankshaft P/N: 630778A1. These are dramatic photos; thanks for sharing—Ed.*)

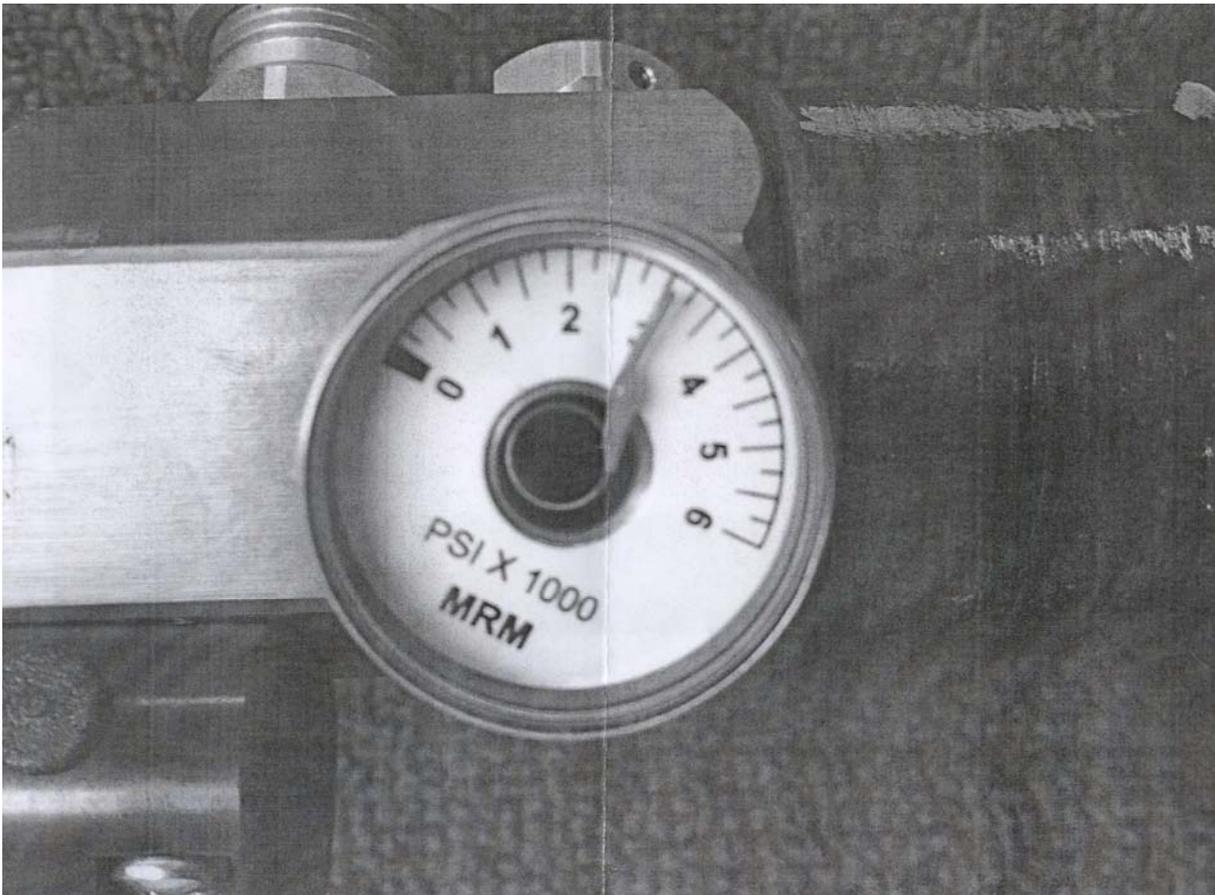
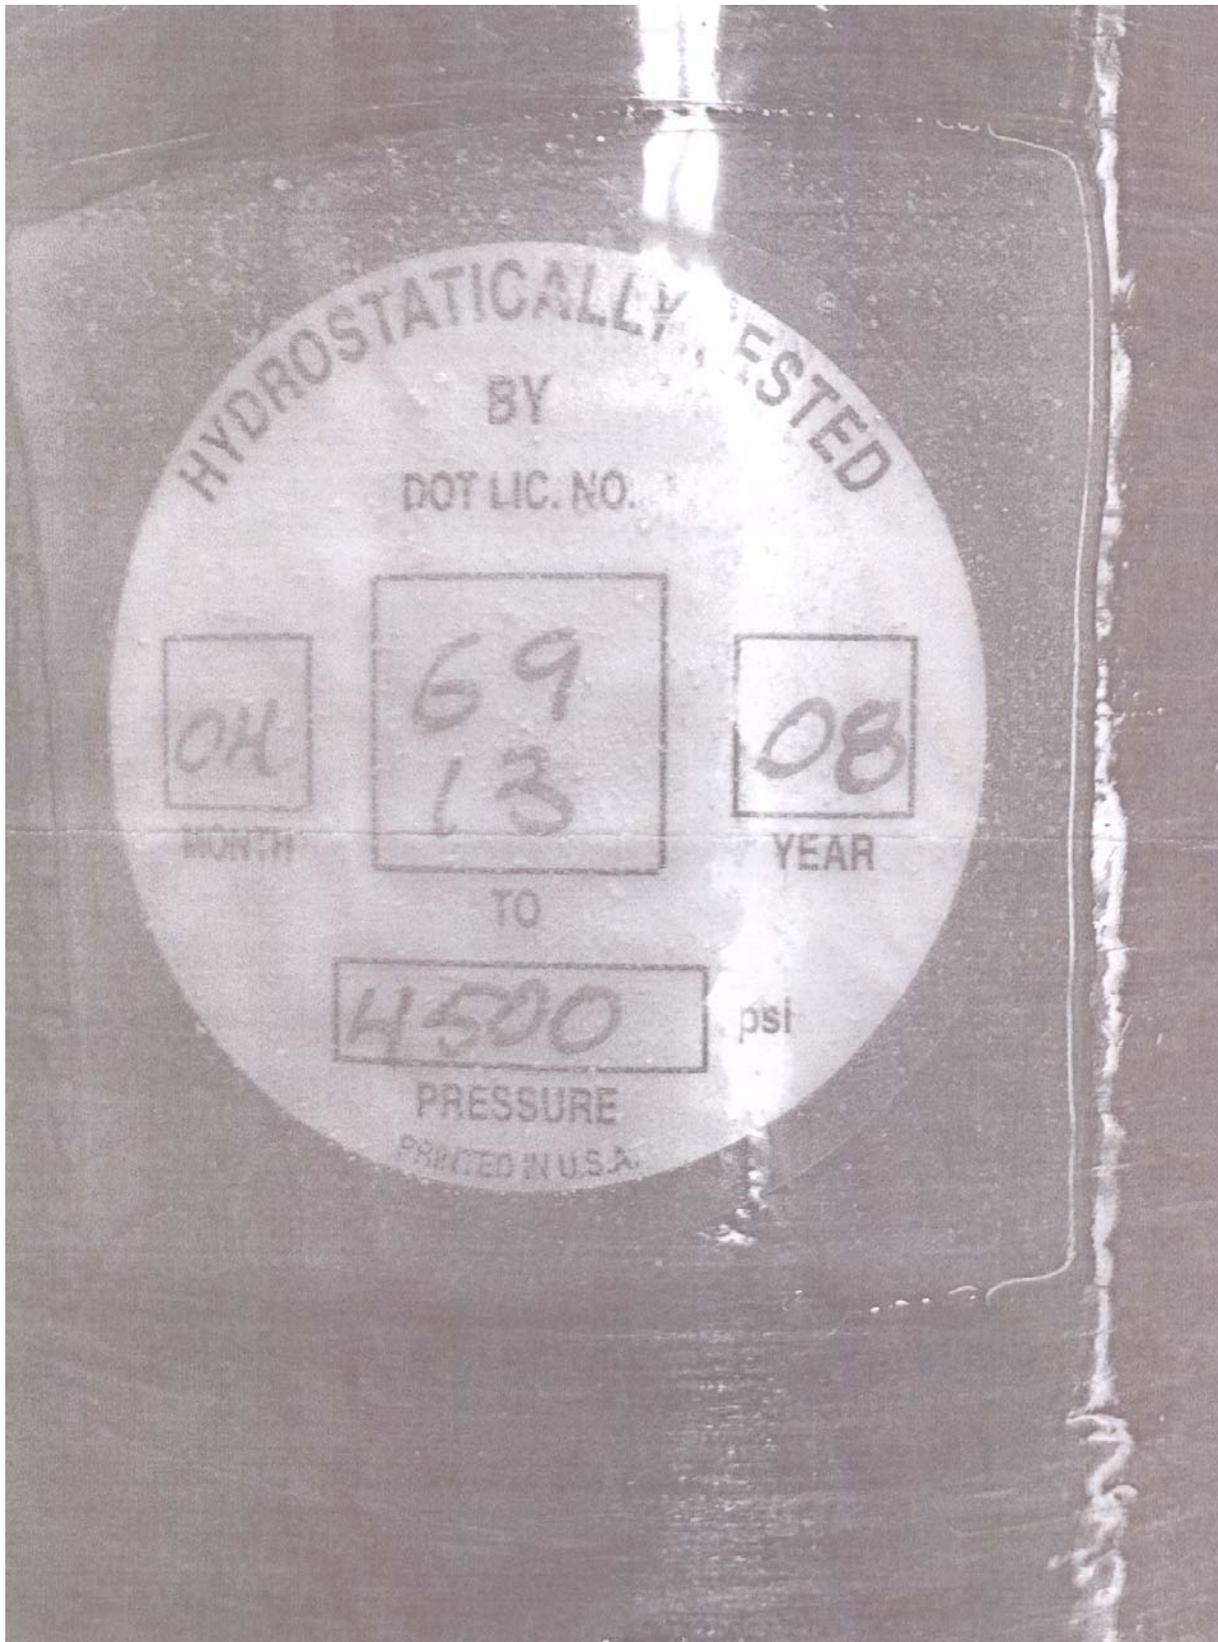
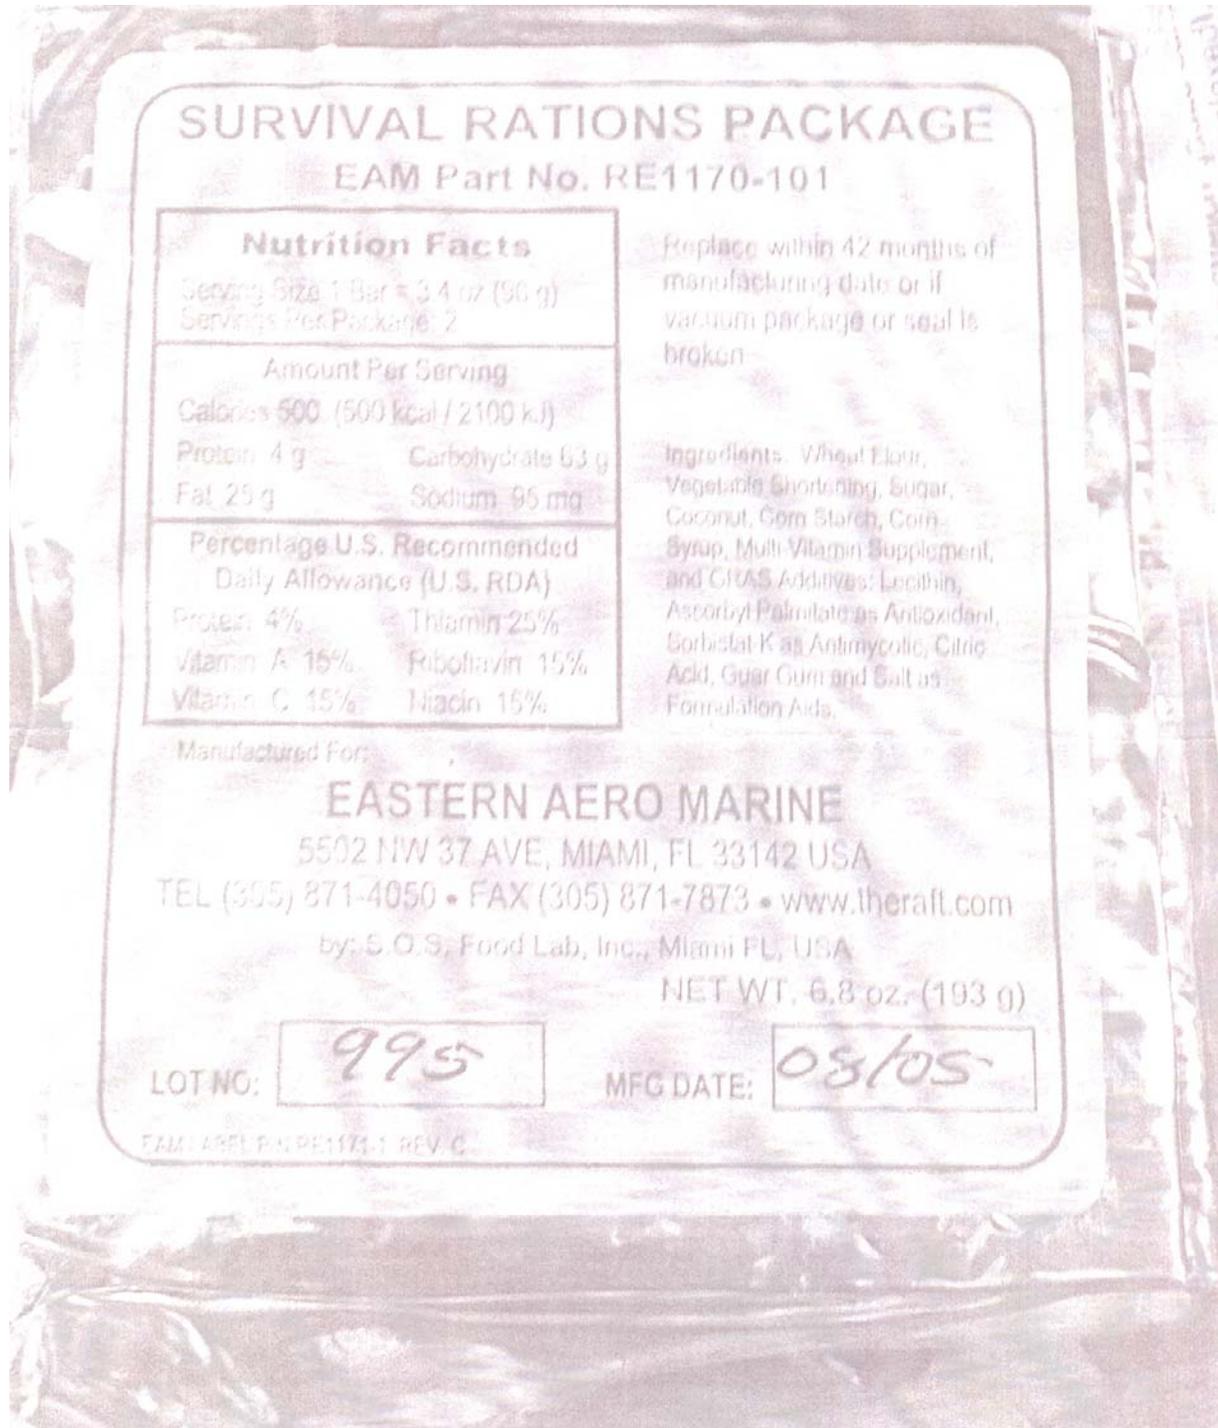
E.A.M. Life Raft: T25; Improper Cylinder Charge; ATA 2564

"1. Two life raft inflation cylinders (P/N R0032-2071) were charged to 3,0000 PSIG. Per OEM (*original equipment manufacturer*) requirements, the charge pressure should be 4,500—4,650 PSIG. This defect would have effected the survival of aircraft occupants in the event the life raft was needed in an emergency. The life raft would not have inflated to its designed requirements.

"2. The hydrostatic test was performed below the required test pressure. As per the hydro test label attached to the inflation cylinders, the test pressure applied was 4,500 PSIG. Per OEM/DOT requirements, 7,500 PSIG test pressure is required. Due to the lower applied test pressure, integrity of the HAZMAT gas filled inflation cylinders was questionable.

"3. Six each RE1170-101 (expired Feb. 2009) survival food rations were found installed in the life raft's survival kit. These rations should have been replaced at the time of inspection in order to avoid having expired items before the next inspection due date. (*This...*) further shows maintenance procedures were not followed (*by the previous repair station*)."

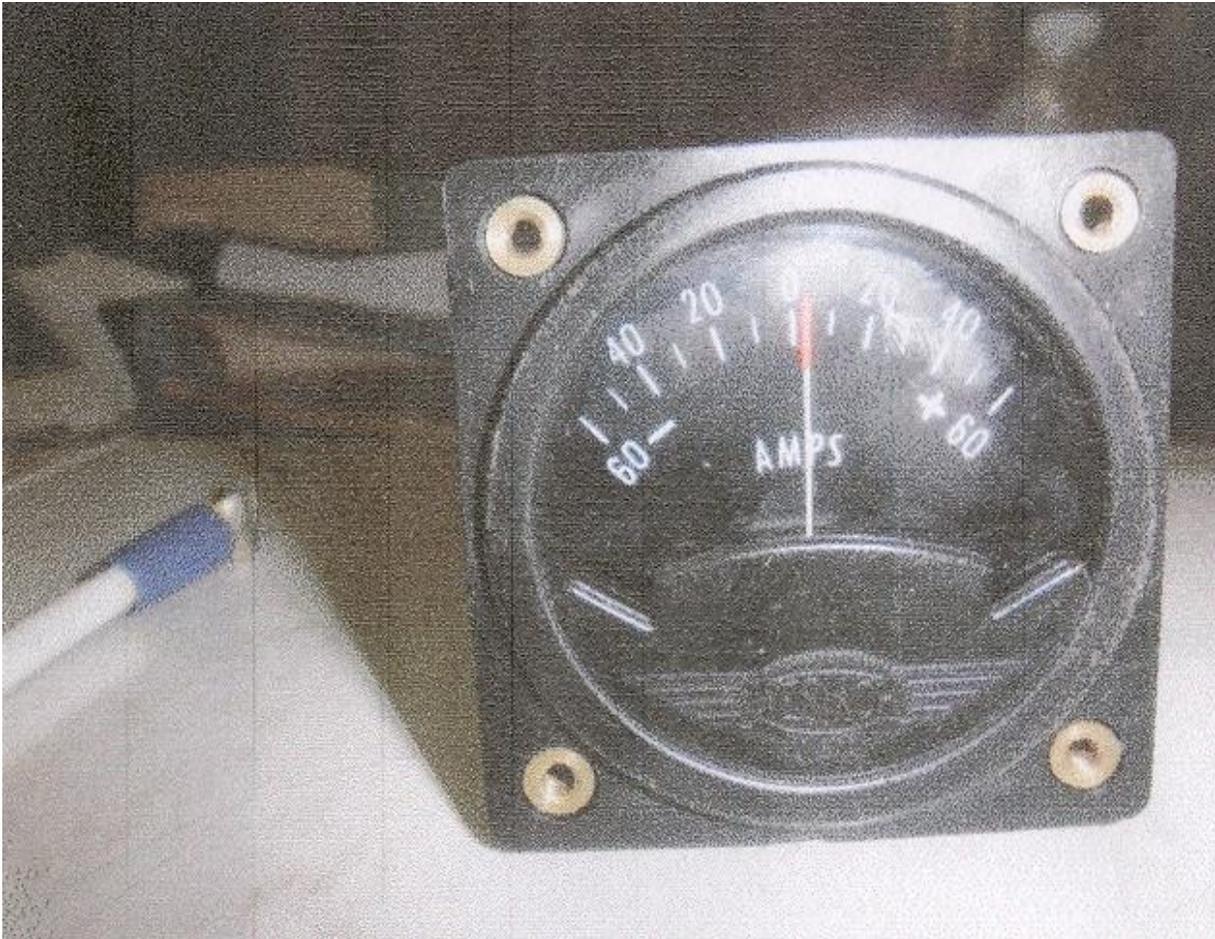
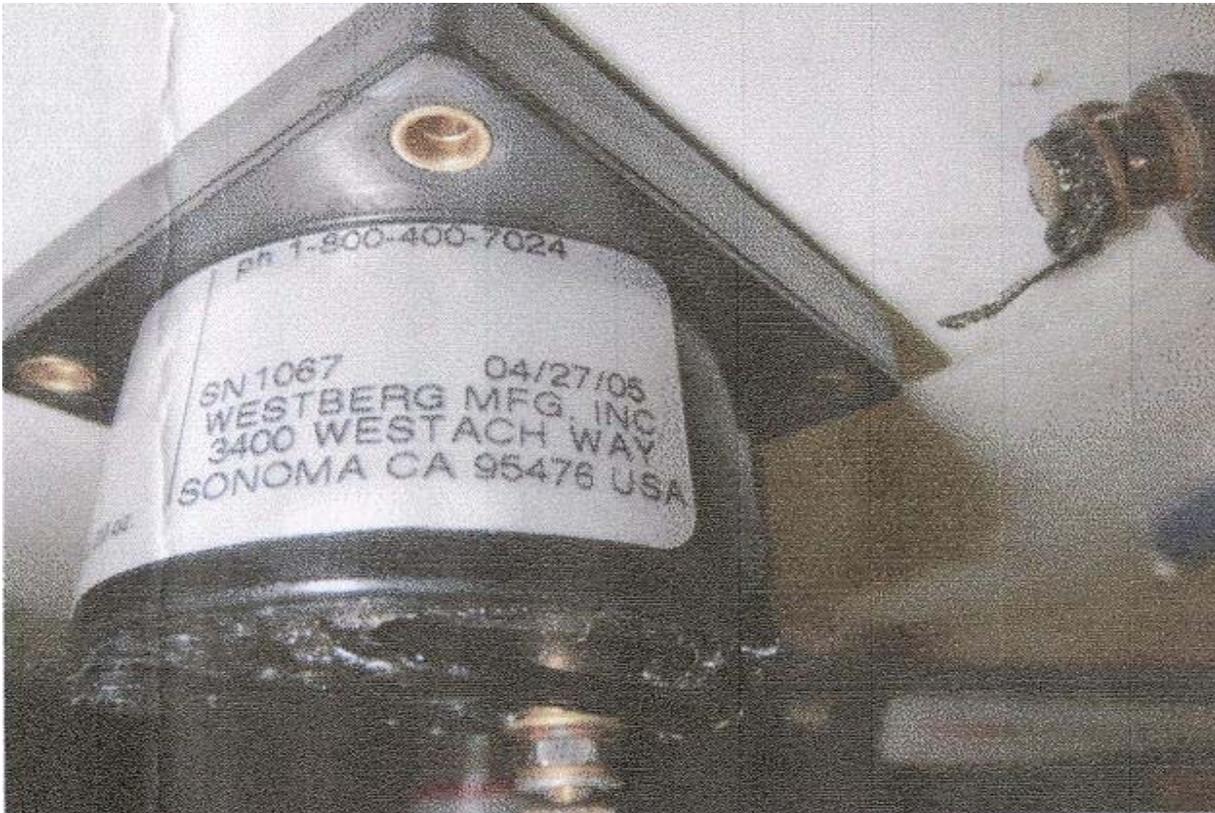
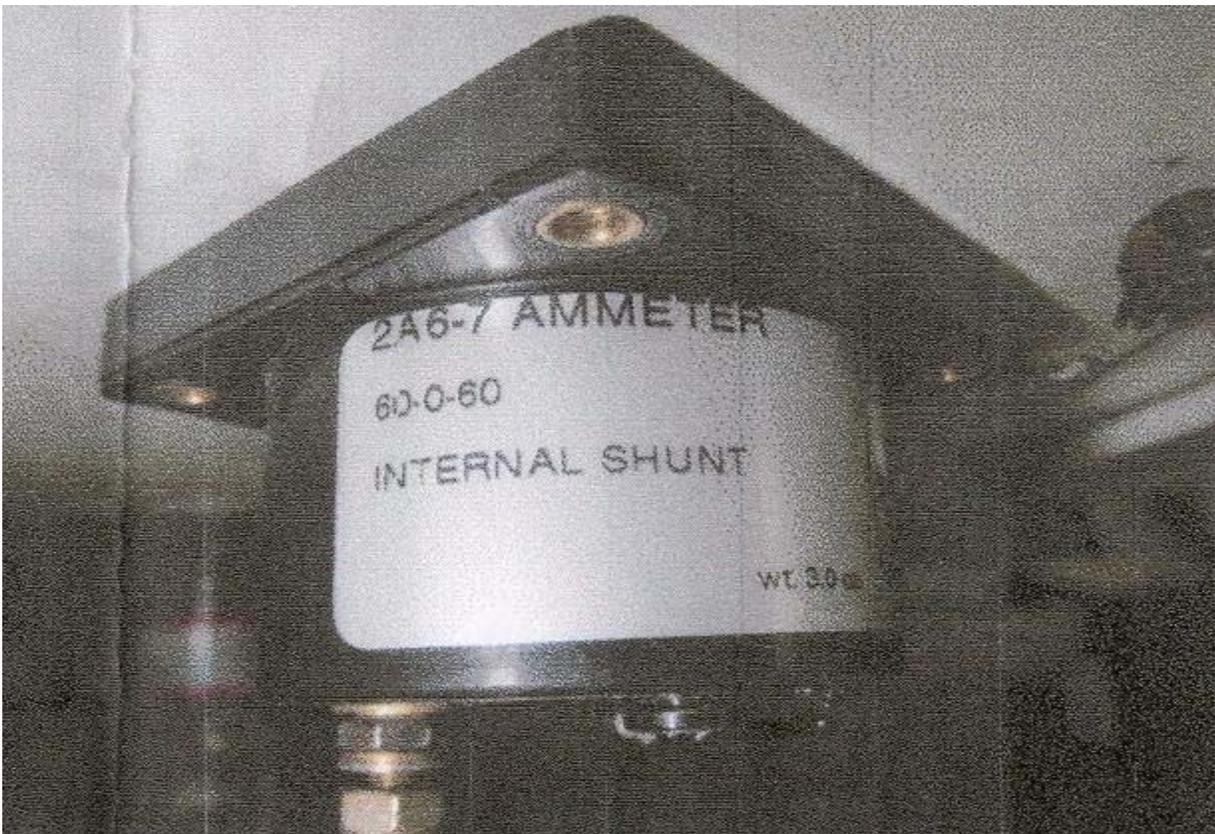
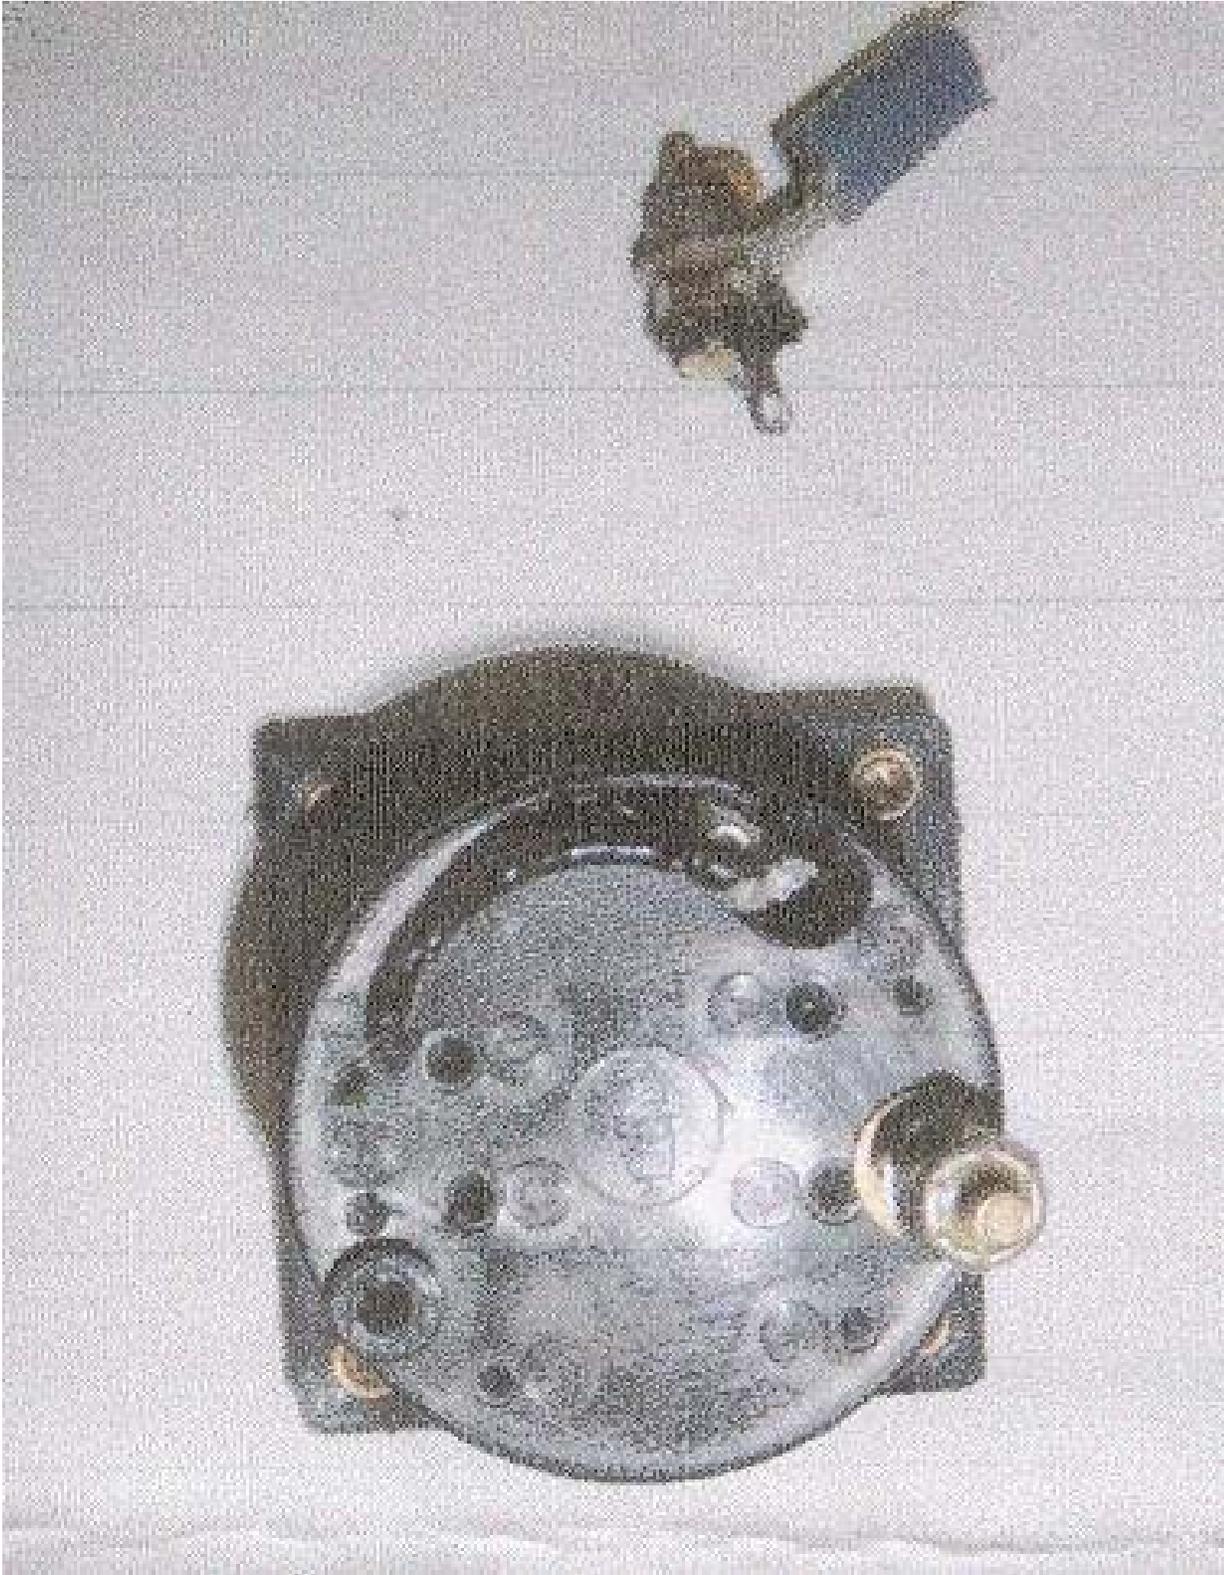
A mechanic states, "The positive stud melted out from the ammeter and the aircraft lost power to the buss bar."
