## ADVISORY CIRCULAR

43-16A

# AVIATION MAINTENANCE ALERTS

**ALERT  
NUMBER  
397**

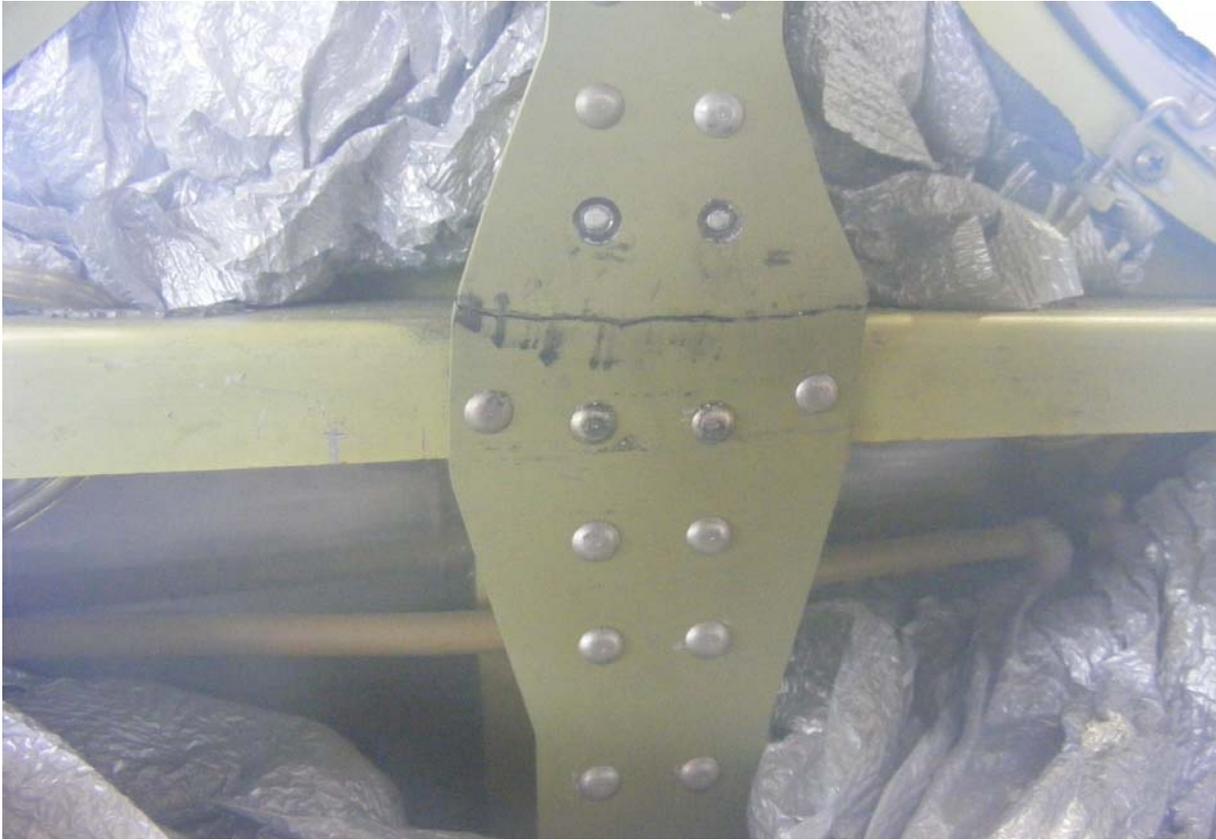
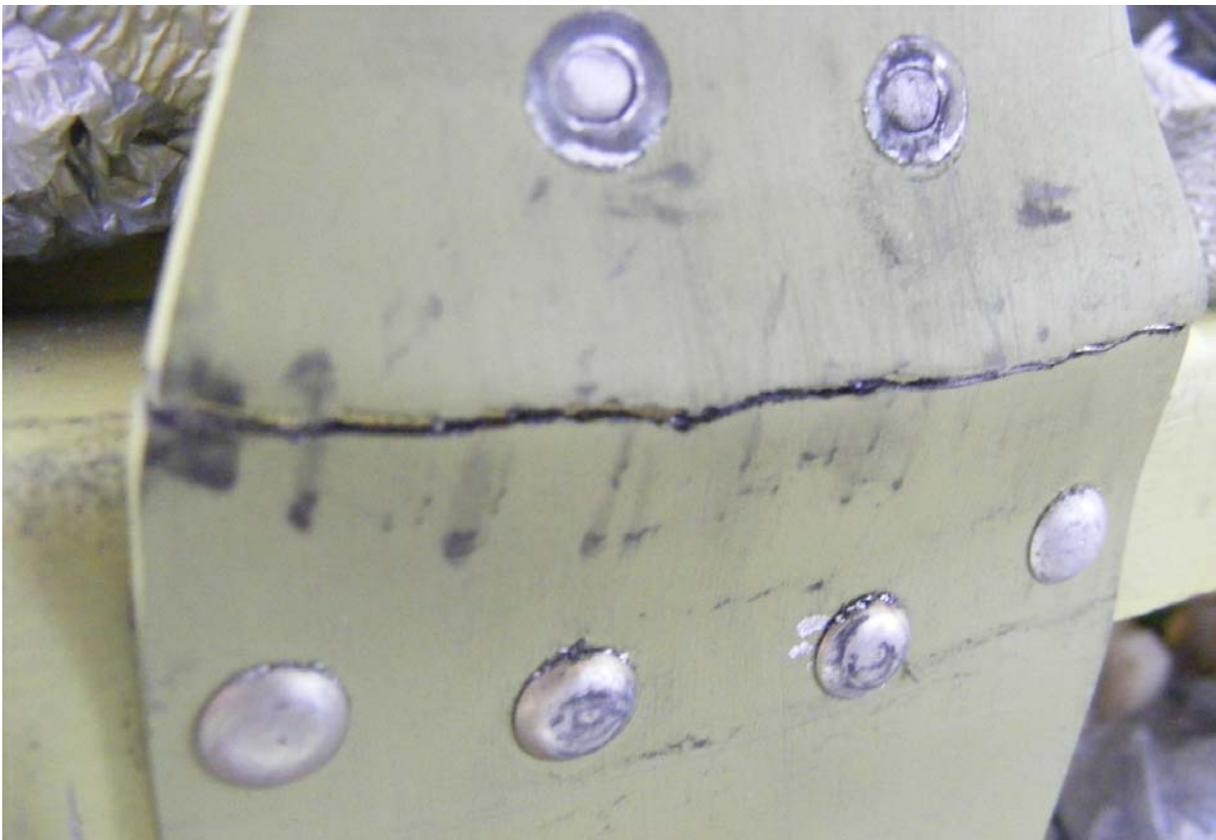
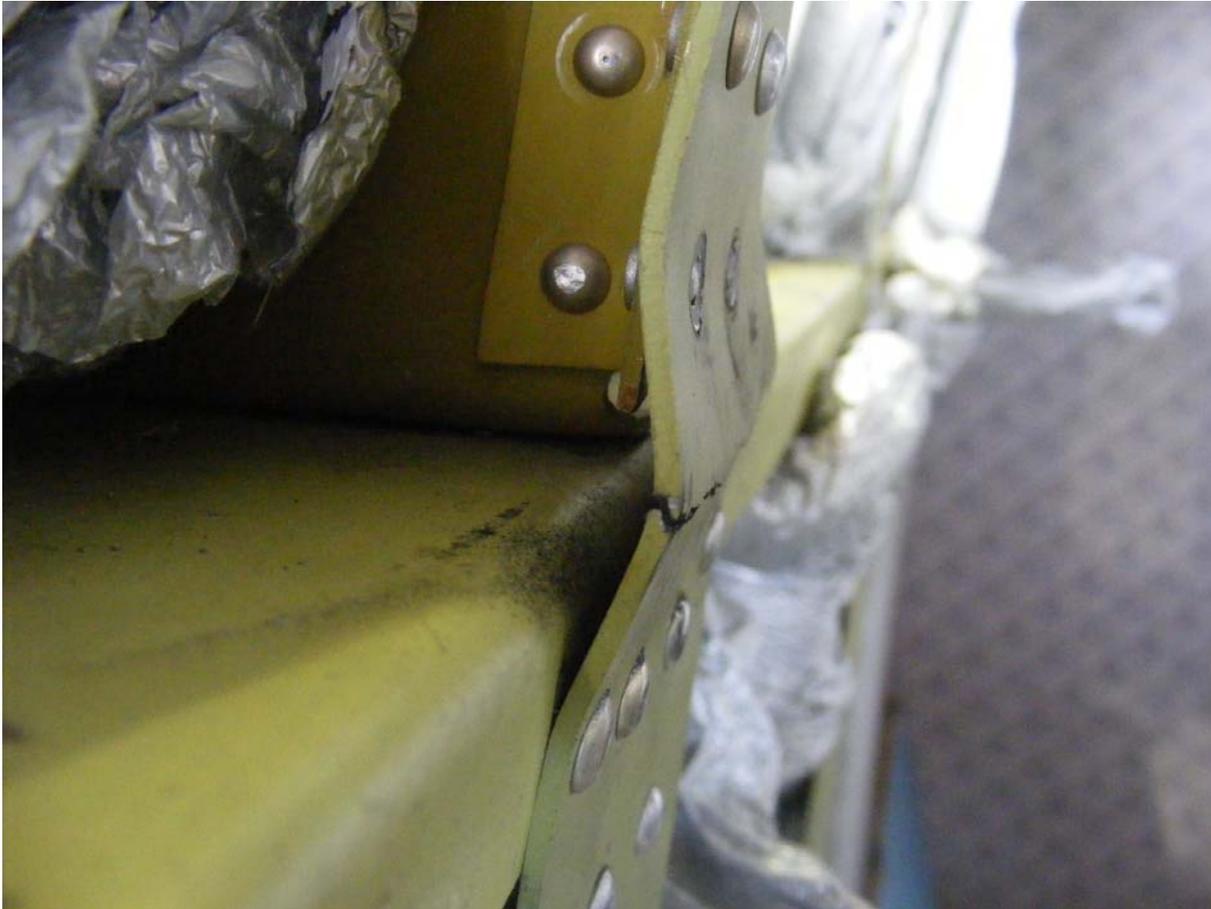
"Inspection of the sidewall structure revealed a failed crosstie at fuselage station 227.125," says this repair station submitter. "This structural tie is situated between the number three and four right cabin windows—vertically *(between)* the lower sidewall to overhead the passenger seat. The part has cracked fully in two *(pieces)*, and it is deformed from its original 'flat' shape—apparently from compression. Two rivets immediately above the break have failed. No other crossties *(P/N: 101-420013-1122)* display any deformation, cracking, or evidence of preload."

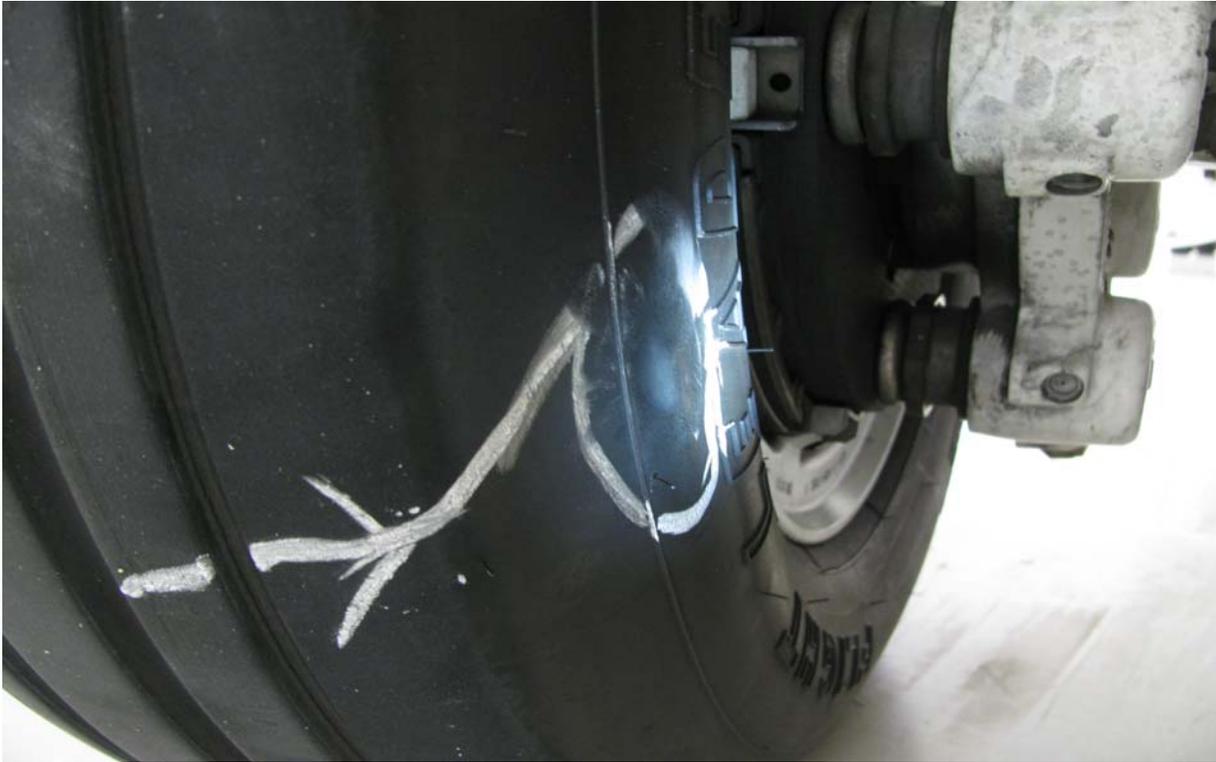
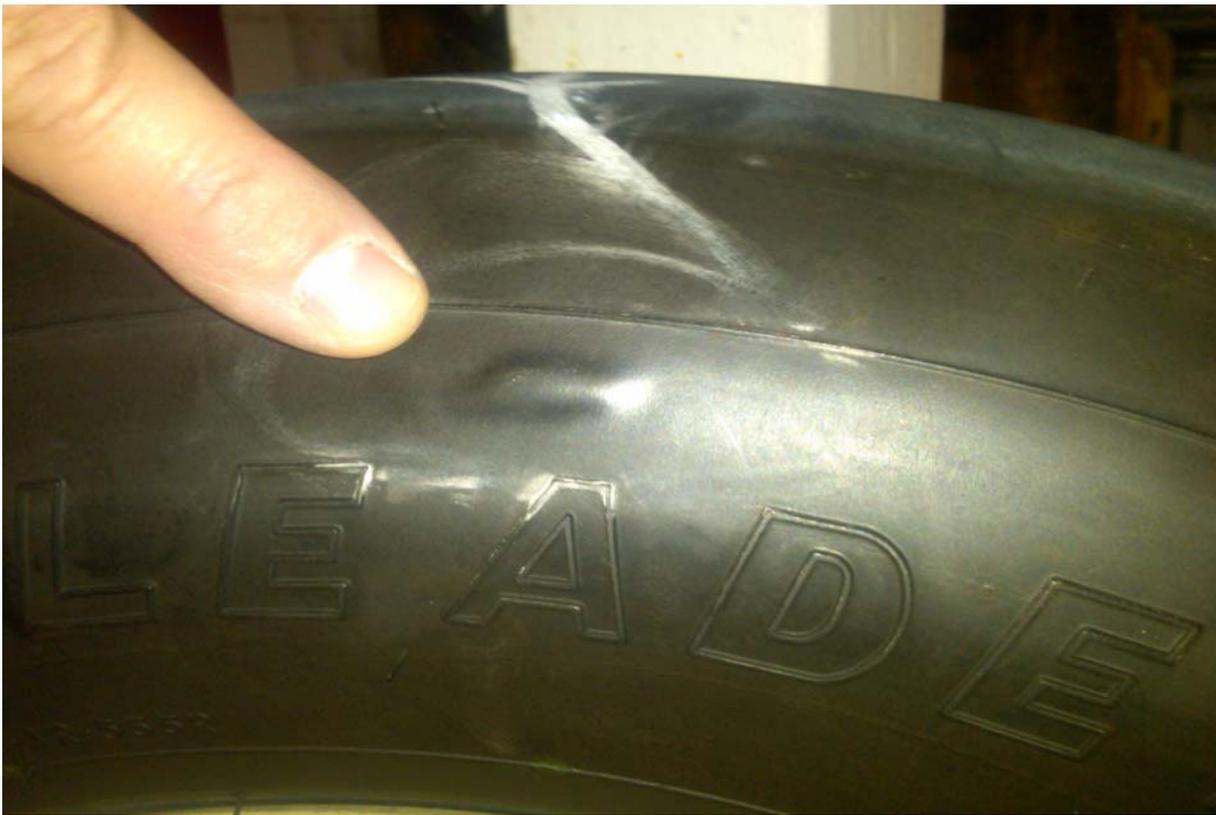
"(I) found a bulge on the sidewall of the number one main landing gear tire," states this mechanic. "The bulge is just below the tire cap and is 0.875 inches long, 0.375 inches wide, and protruded about 0.0625 inches. This *(bulge was found)* on the newer -2 tire for this aircraft—*(this new tire was)* suppose to alleviate bulging as seen on the older -1 tires. I recommend all operators keep a close eye on their tires; this *(particular)* tire *(P/N: 269K432)* only had 56 landings."

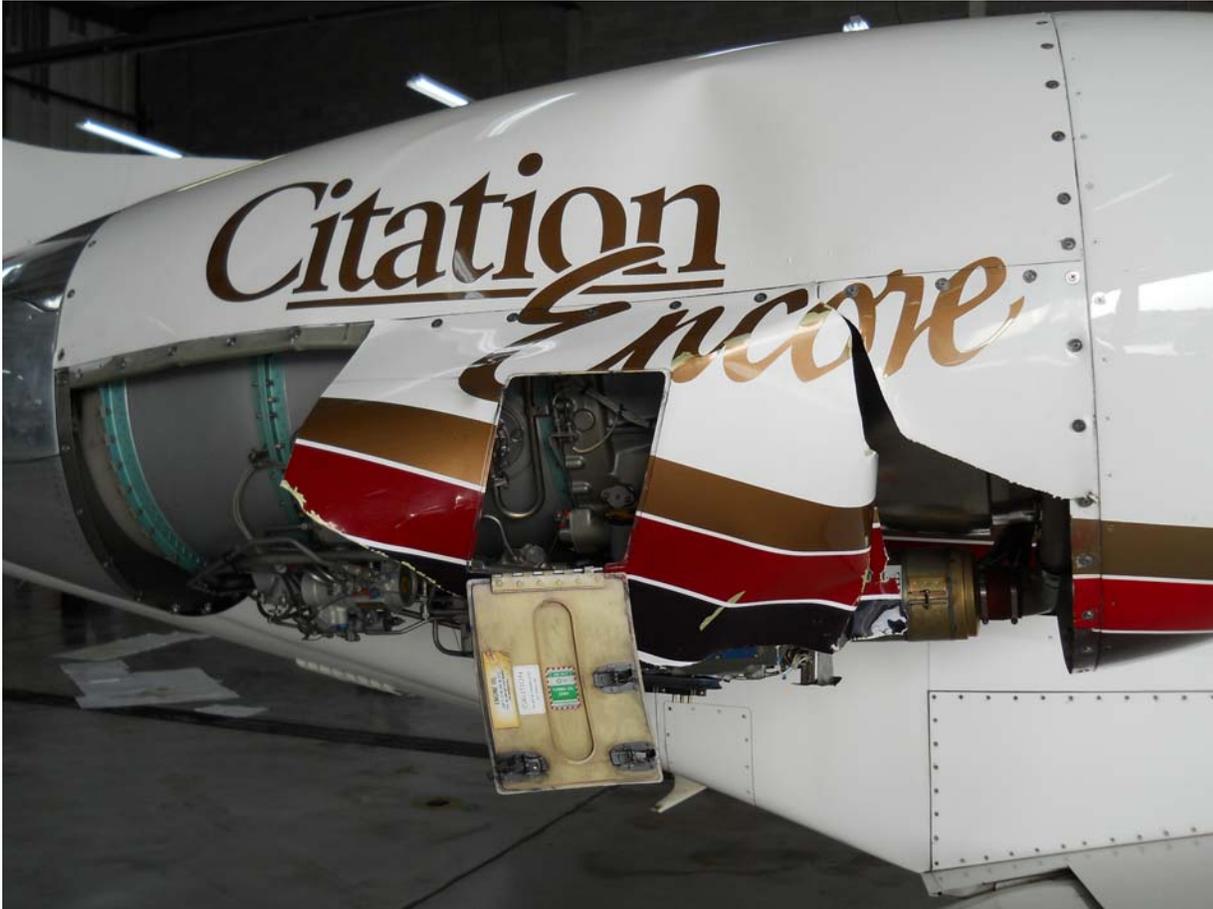
"While in descent (*through*) altitudes 25 to 20 thousand feet," says this submitter, "a faint *bang* was detected and a small jolt was felt throughout the airframe. The flight continued without difficulty to the scheduled destination where landing occurred without incident. Post flight inspection revealed the lower right engine cowling had separated from the aircraft—80 percent of the part was missing. The upper right engine cowling was found bent, but still fully attached. Note: all cowling attach fasteners were found in place—except three lower cowling attach studs located at the inboard trailing edge." (*Engine cowling P/N: 65526508.*)

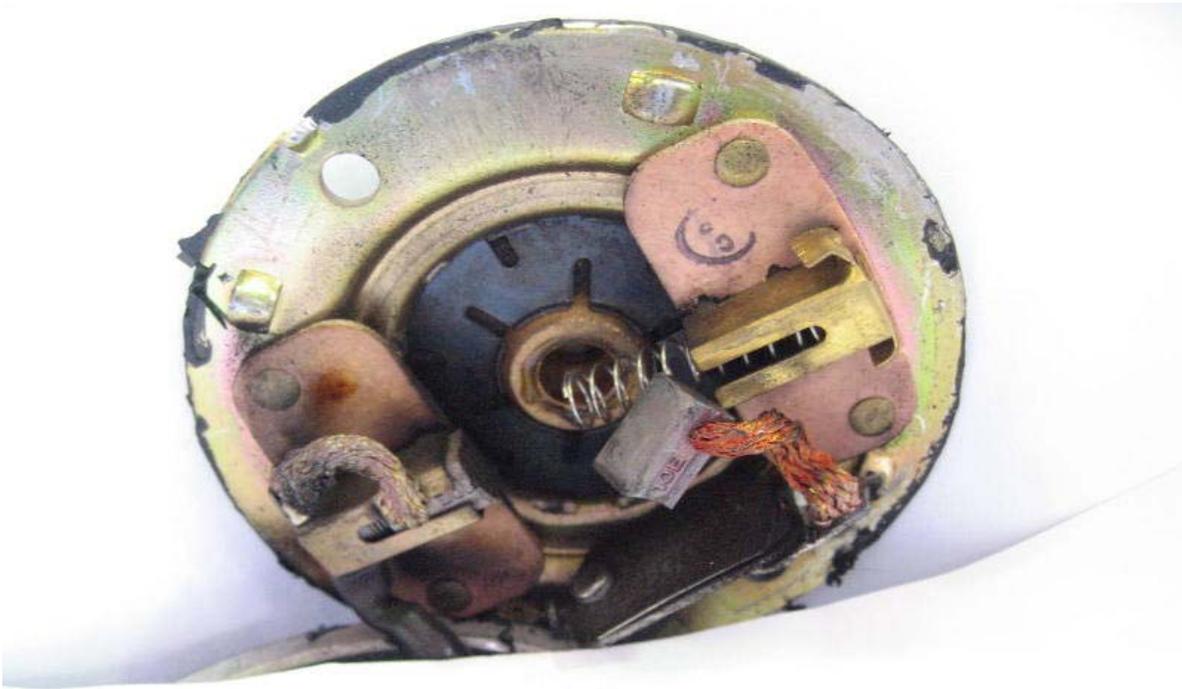
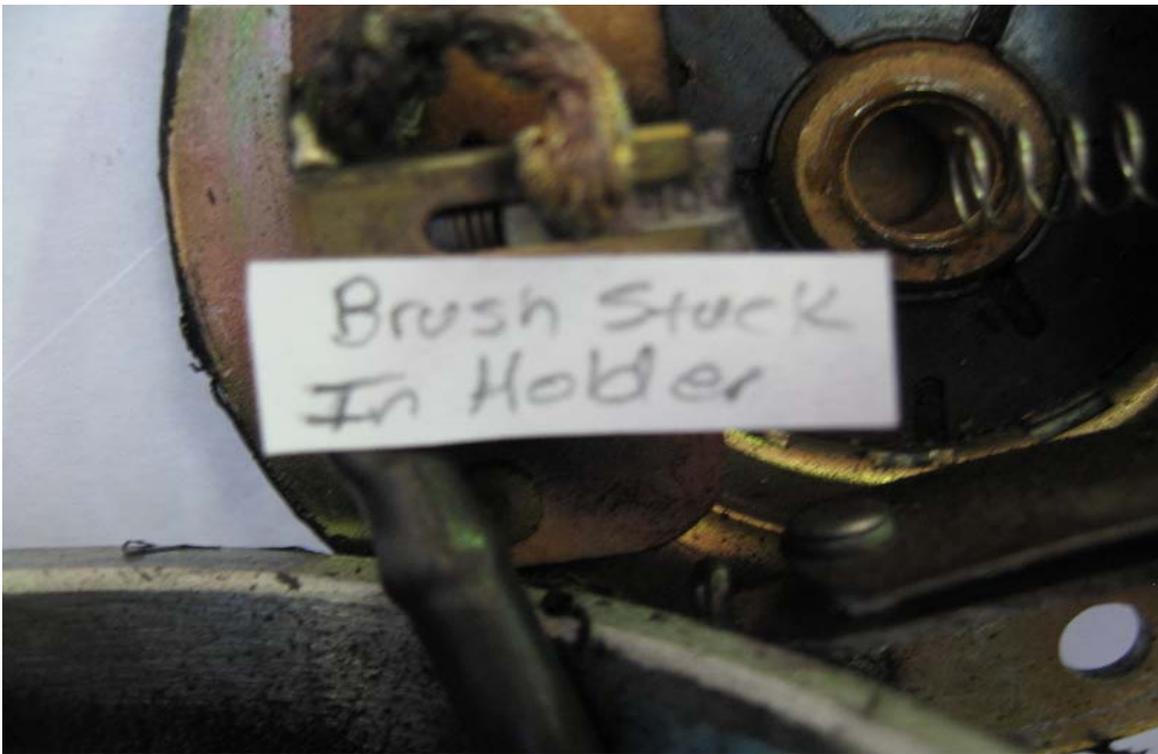
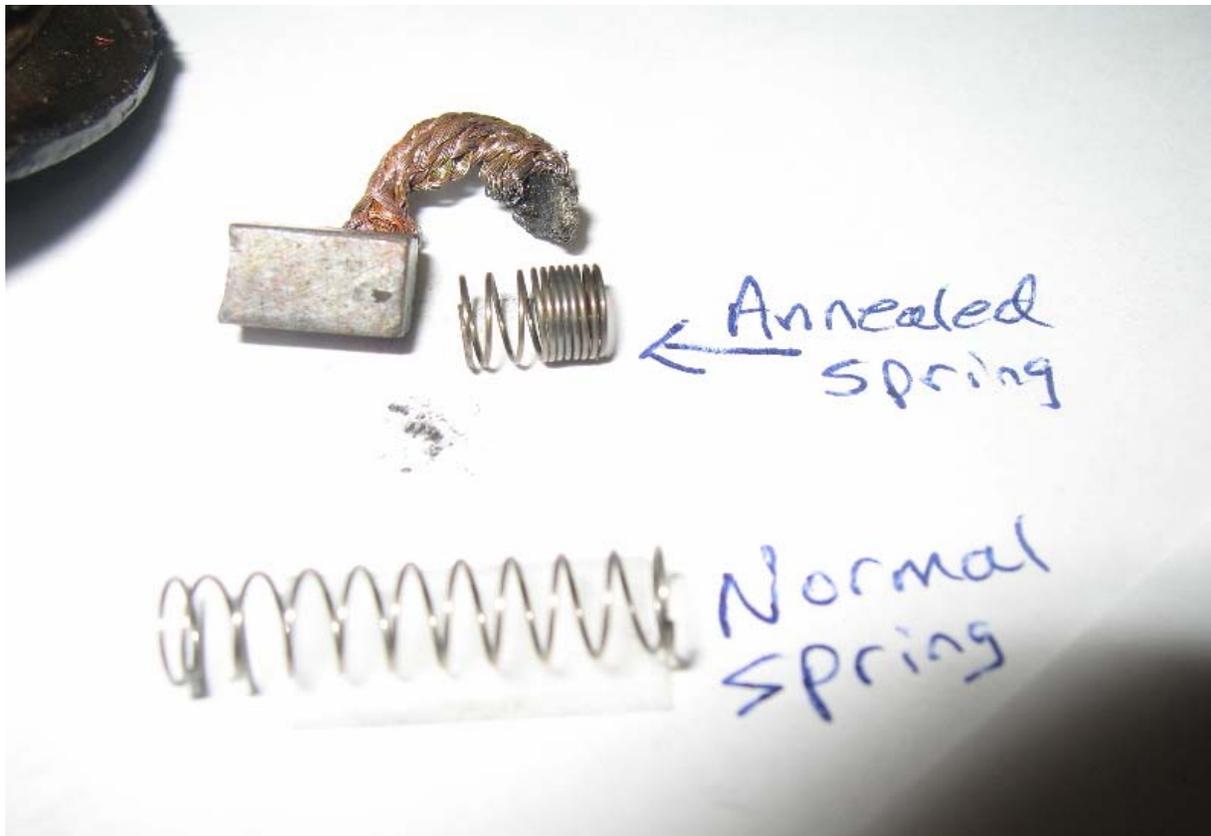
A repair station submitter says, "After (*the pilot's unsuccessful attempt*) to perform emergency main landing gear extension several times, this aircraft made a successful, gear-up landing. The hydraulic (*landing*) gear Power Pack motor (*P/N HYC5005*) failed during initial gear retraction after takeoff. Investigation and troubleshooting determined the cause of the Power Pack failure was due to a fracture of a questionable solder joint that attached one electric motor brush pigtail to the brush holder. The broken solder joint created enough heat from high resistance to discolor the brush holder and anneal the brush spring. This re-heated spring's free length measured 0.330 inches instead of the (*normal*) 0.960 inches. The Power Pack had been overhauled 29 months earlier (or 142.5 hours). Further troubleshooting revealed the static port in the left automatic MLG extension airspeed mast was solidly plugged with a mud (*type*) insect's nest." (*Brush P/N: ESQ12SBRUSHERH22. Power Pack manufacturer: Prestolite; model HYC5005. This motor has 15 entries in the SDRS database.*)

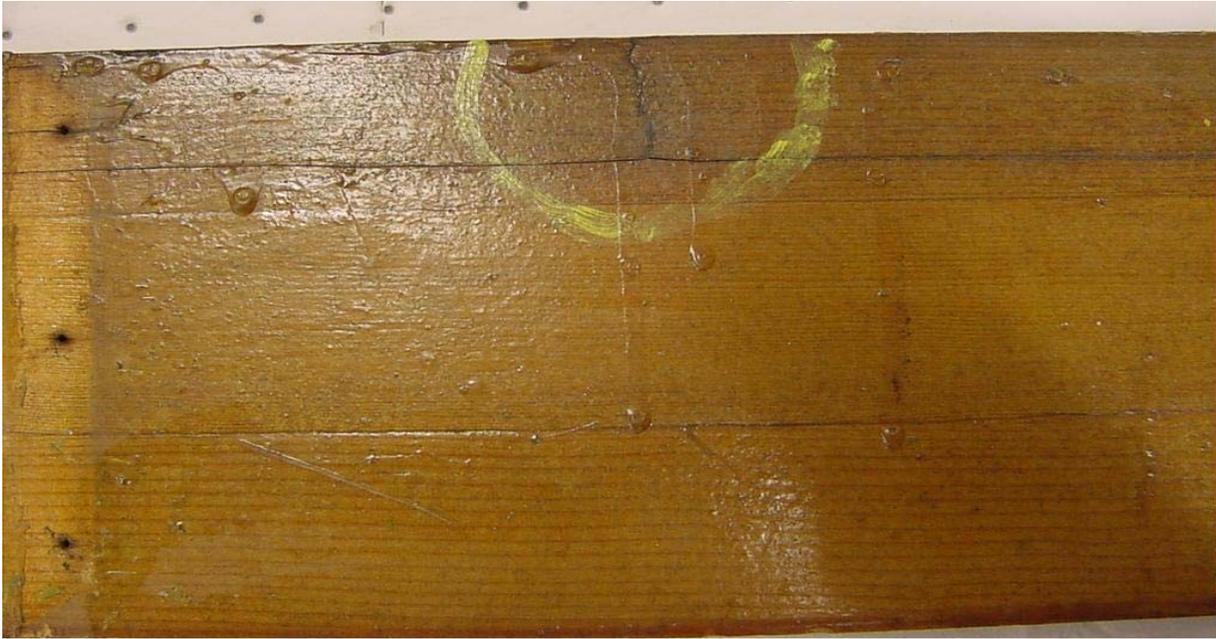
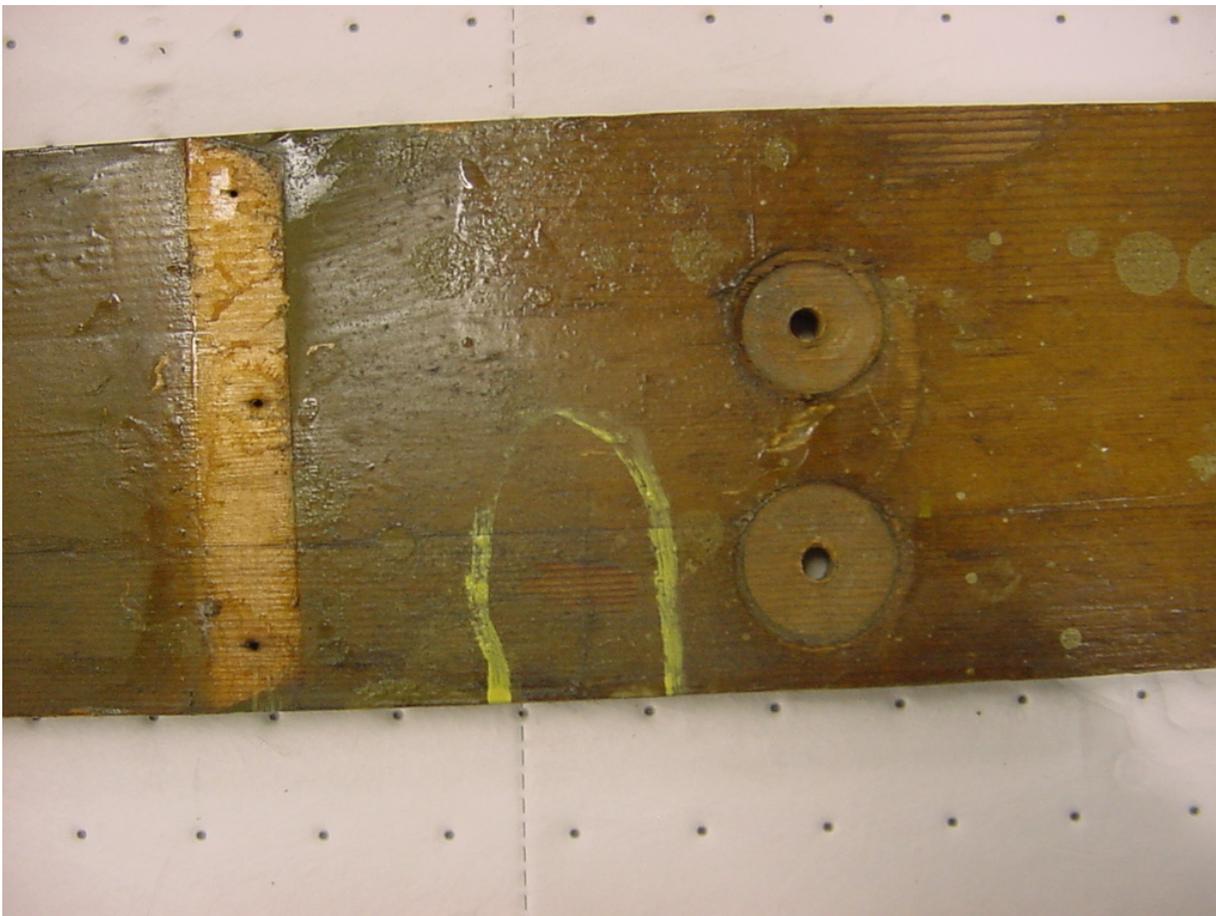
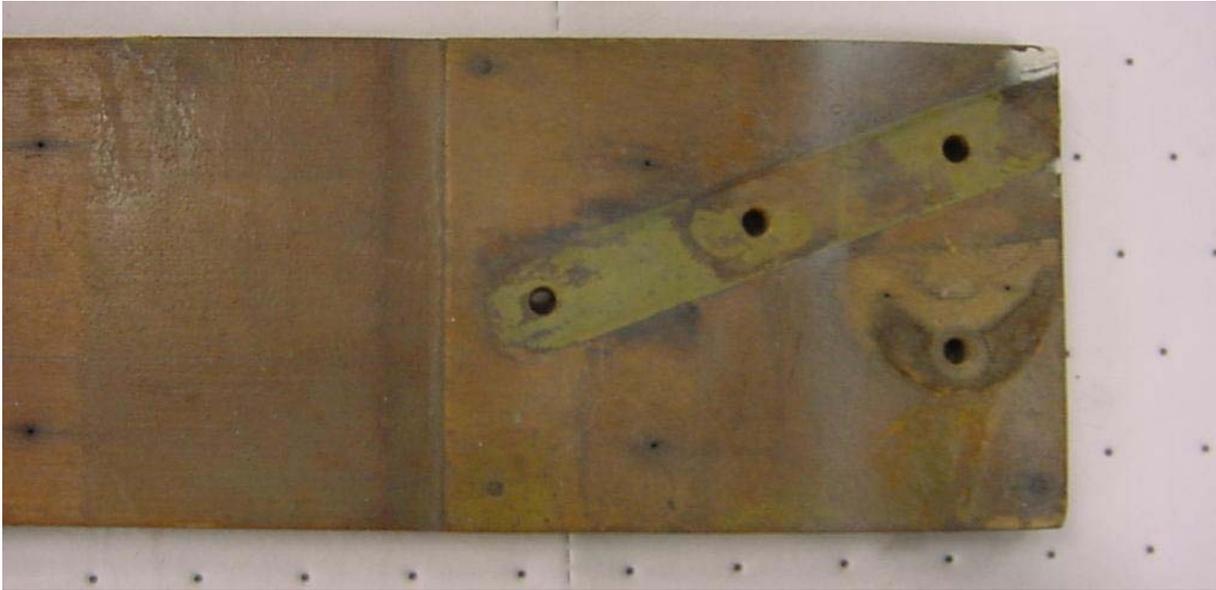
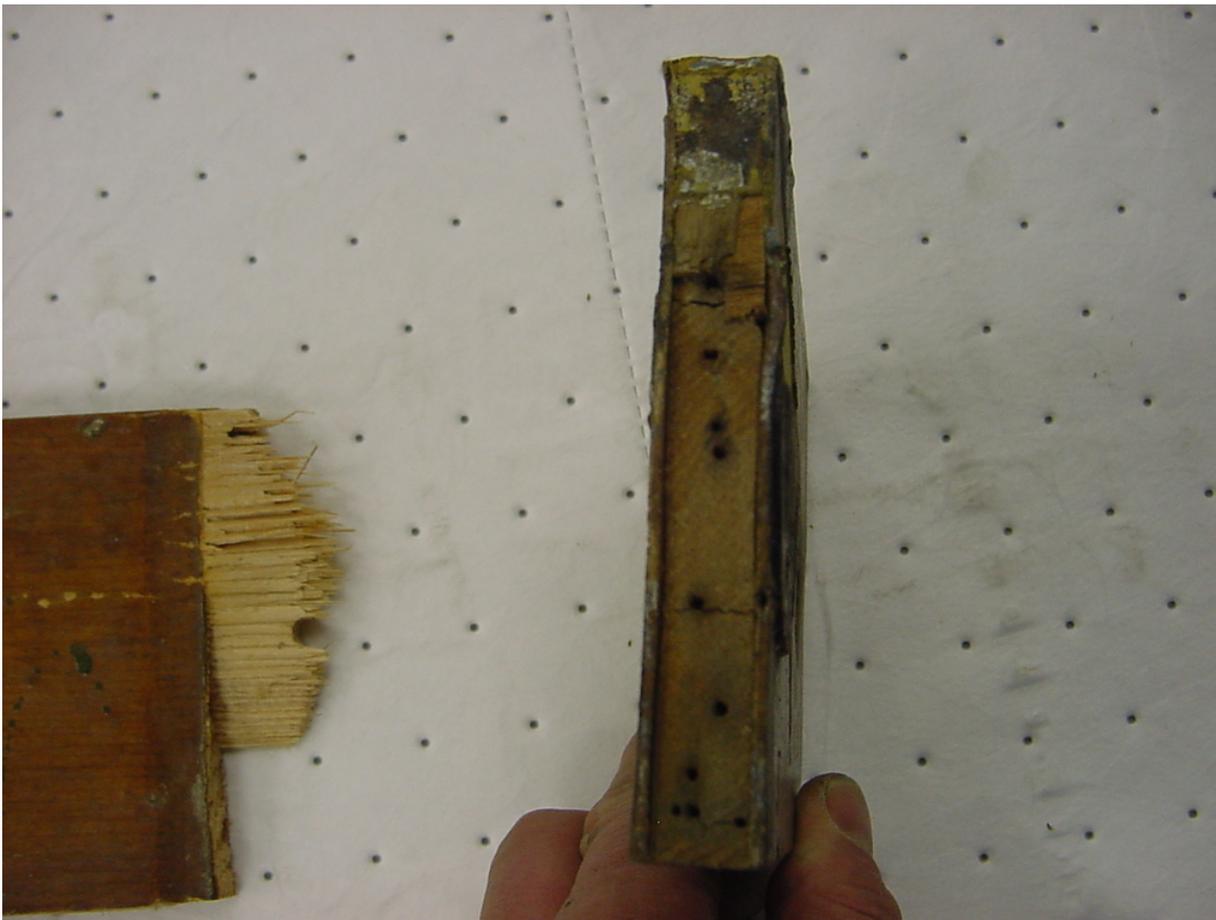
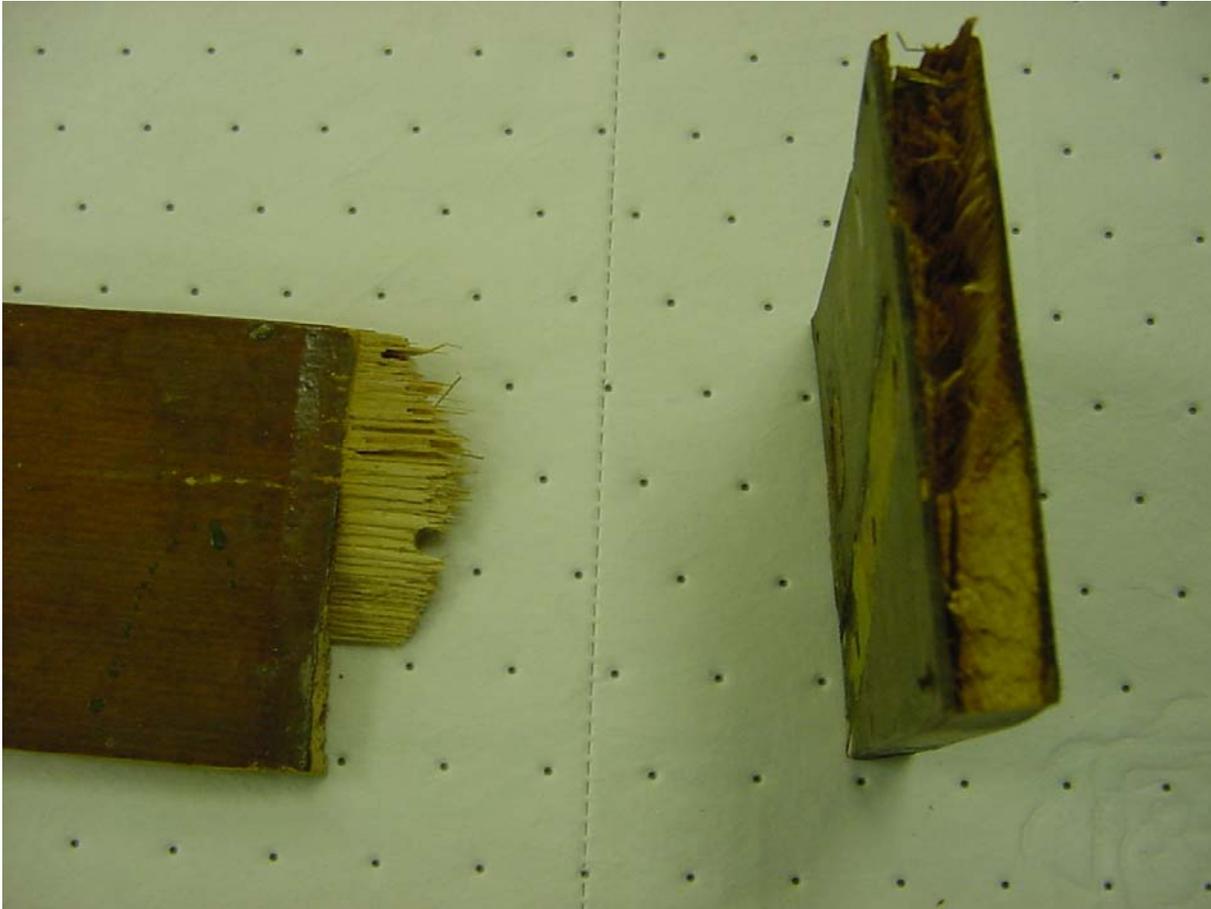
"I am submitting these photos of the rear spars removed from a 1946 Taylorcraft BC12D," says this mechanic. "The photos show several cracks on both spars. One spar was intentionally broken to show the extent of the vertical crack. This aircraft has 185.8 hours since restoration, and 9 years in service. At some point in the history of this aircraft it apparently had been ground looped on both wings before the previous fabric replacement. We have now replaced all four spars due to questionable wood.

"I recommend very extensive visual inspection techniques using high intensity lights and mirrors. Pay particular attention to the upper and lower spar surfaces for vertical cracks—especially near the butt end where the plywood reinforcing plate ends and the spar mill taper begins. If in doubt, remove the fabric cover for better inspections."

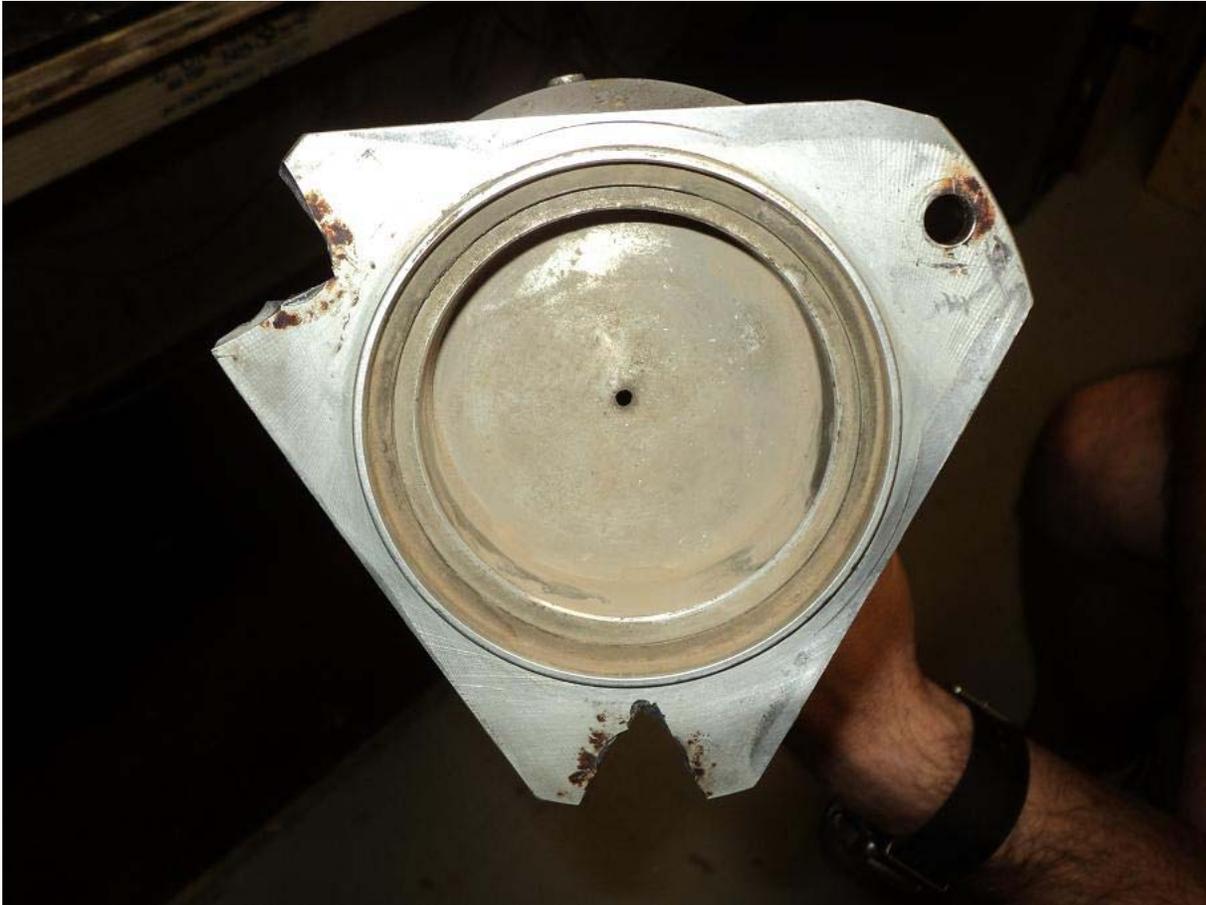
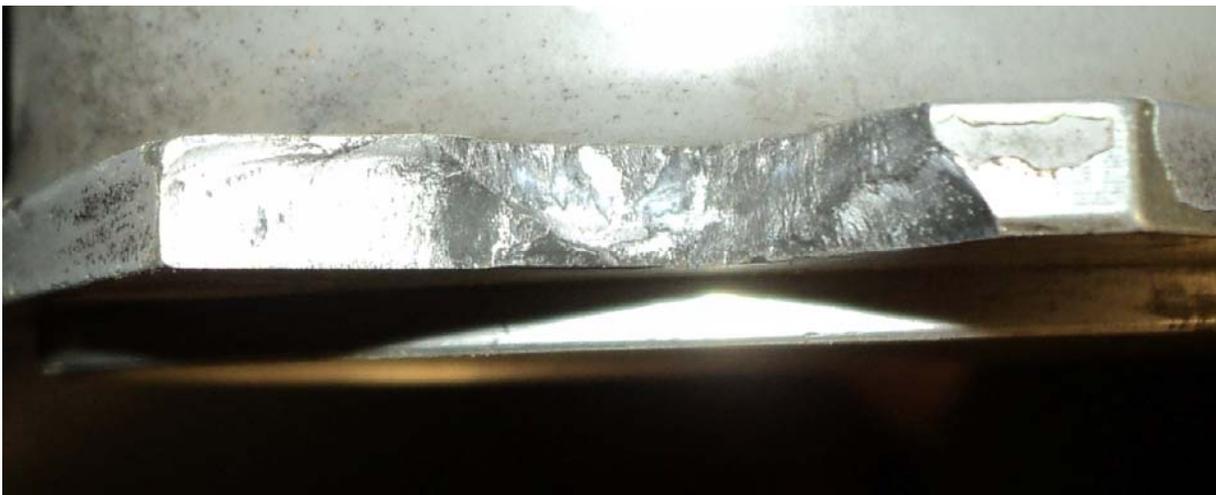
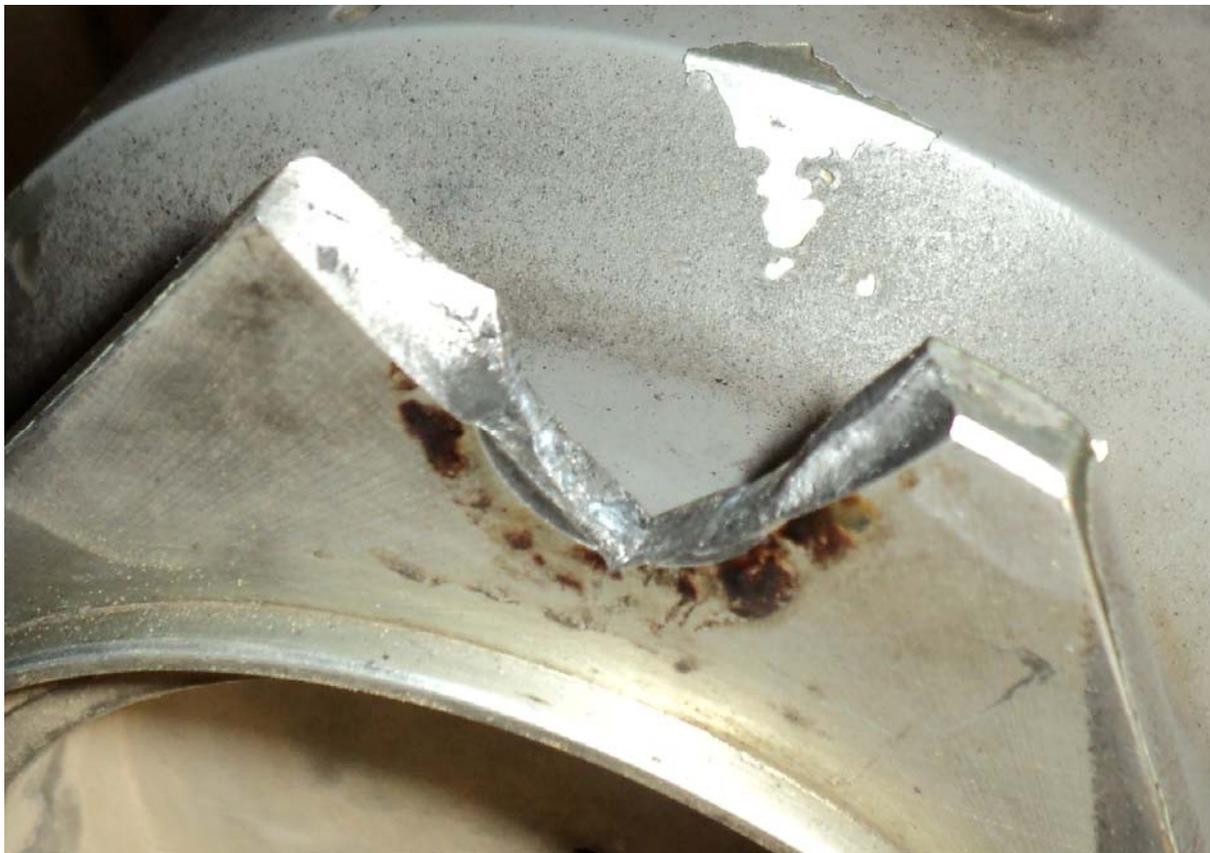
"During a 25 hour check," states a technician, "the number six tail rotor driveshaft mounting flange was discovered cracked on the output side of the IGB (*intermediate gearbox*) coupling. The cracks are (*located*) around the bolt holes. The tail rotor drive shaft is on-condition (*replaced if needed*)." (*Drive shaft P/N: 214040622005. There are nine of these P/N's in the SDRS database.*)

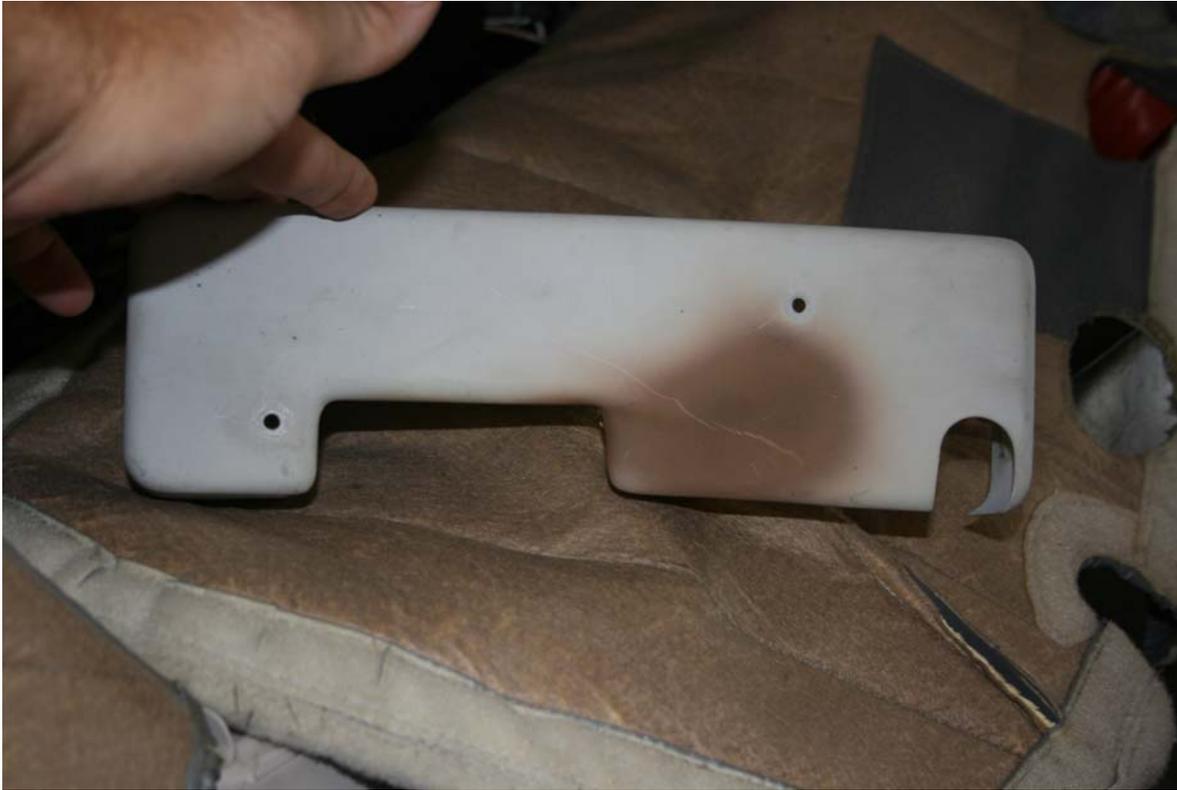
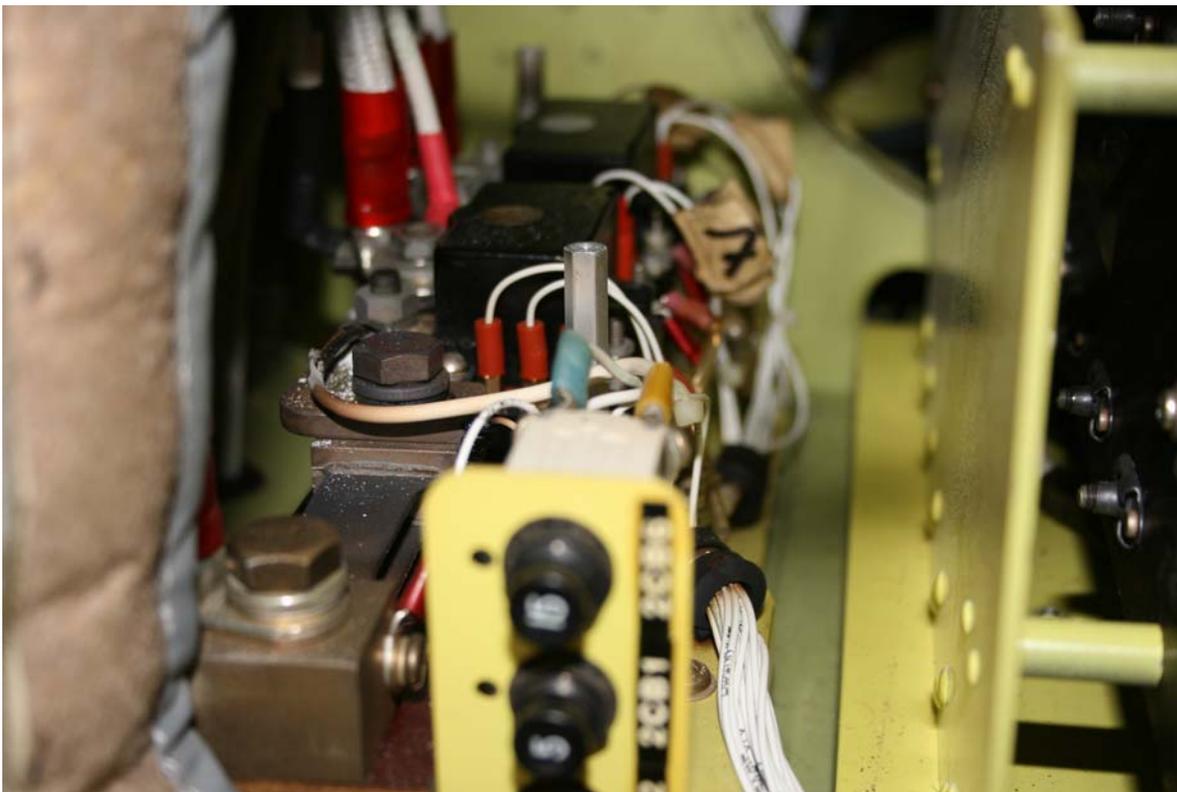
"While enroute, an attempt was made to start the searchlight," states this pilot. "Upon noticing the searchlight did not light off, (I) checked the instruments and found the voltmeter below 25VDC. I attempted to reset the generator with no success. I noticed the ammeter at zero—and then returned to the airport without incident. The next morning an inspection and ground run was performed to troubleshoot the system. We found the generator output at 28VDC, no amperage, and no generator fault Master Caution Light illuminated. These indicators led us to believe the generator relay to be at fault. Access was made to the DC power panel (FS 155). There we noticed discoloration of the power panel cover. Upon removal of this panel we found a wire (P20A12) between the 2K3 generator relay and the 15A circuit breaker (2CB6) 'Generator Field' had melted insulation at the bus bar. And the wire (D10A22) between (its) 5A circuit breaker (2CB2) 'Ammeter' and the 2R1 shunt (we found) to have a melted wire terminal at the shunt. Neither circuit breaker had opened." (Part number for DC Power relay: SM20ACD300A21; manufacturer name: Eaton. There are 31 of these relays listed in the SDRS database.)
