## ADVISORY CIRCULAR

43-16A

# AVIATION MAINTENANCE ALERTS

**ALERT  
NUMBER  
397**

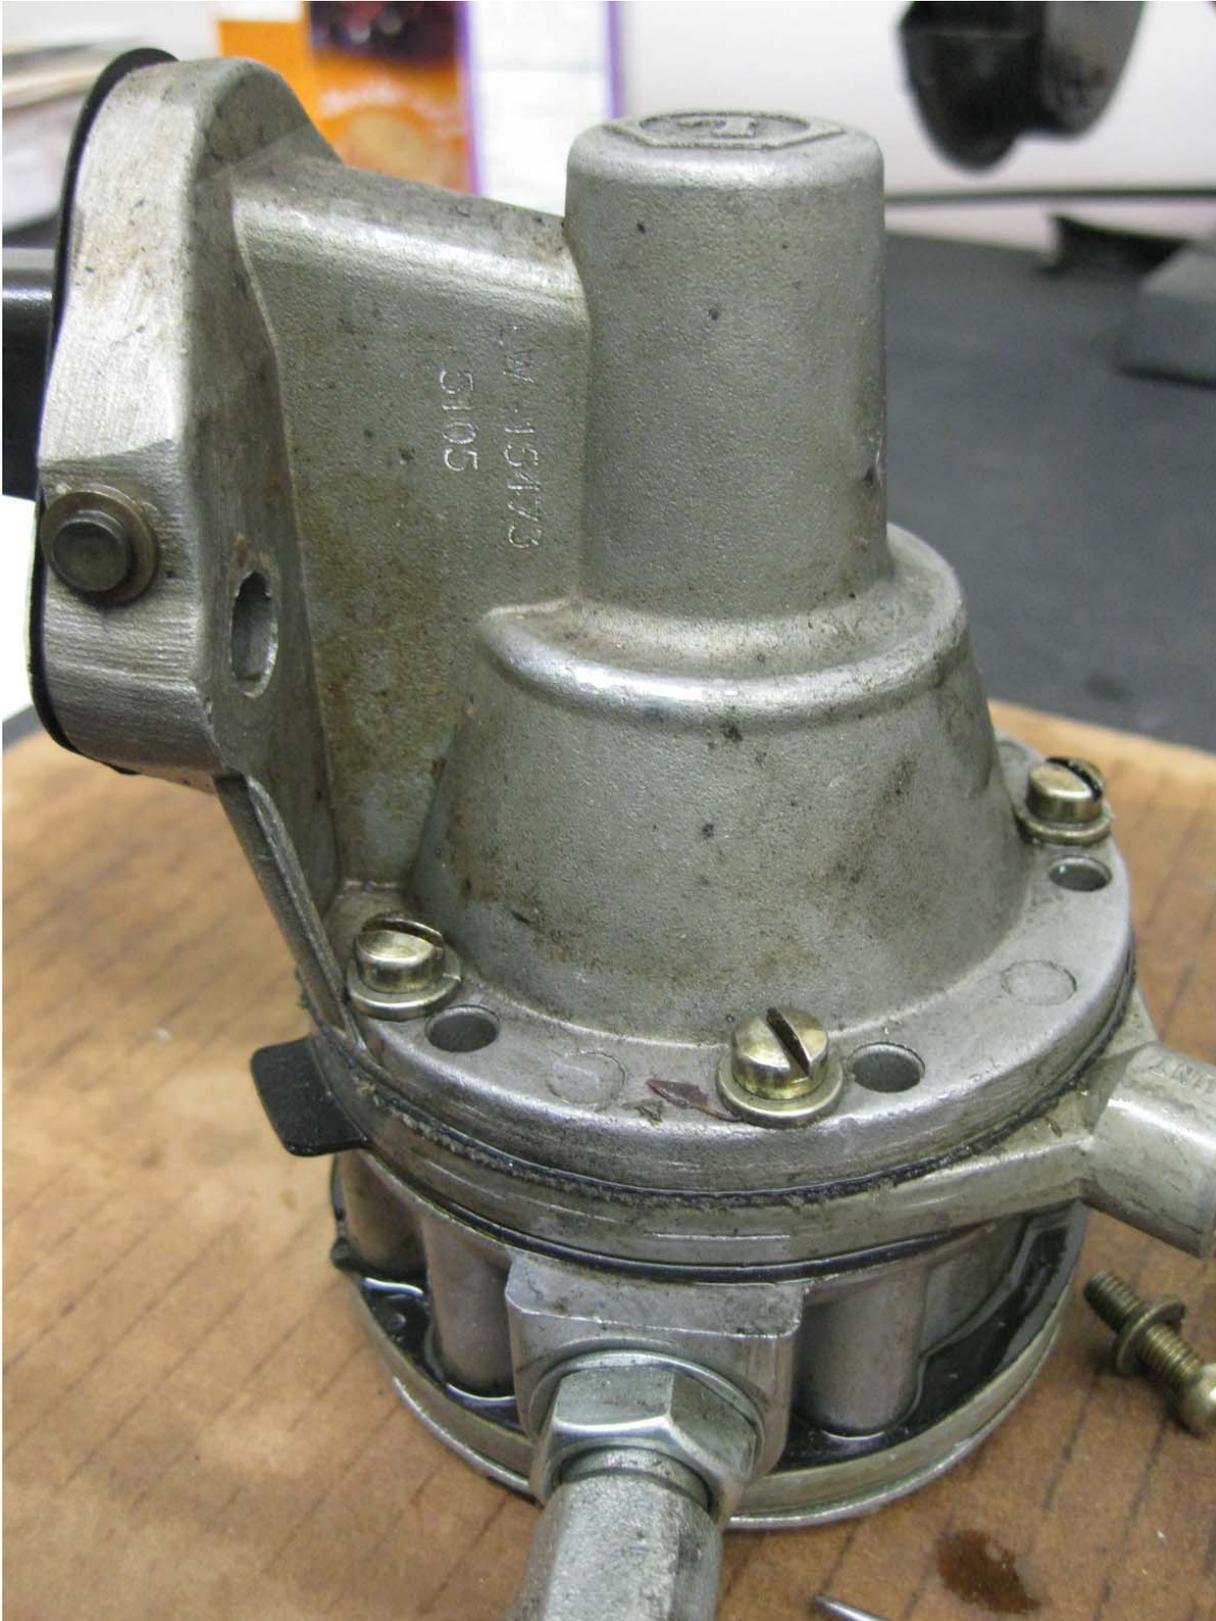
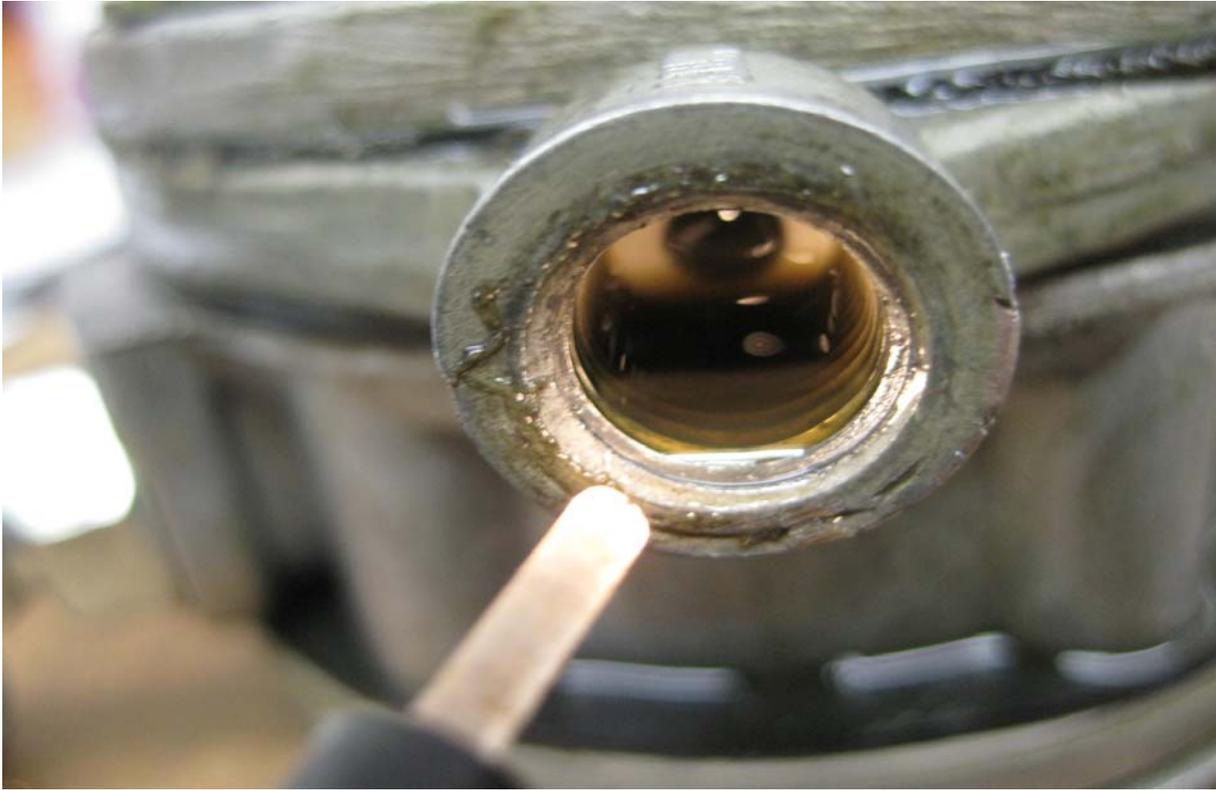
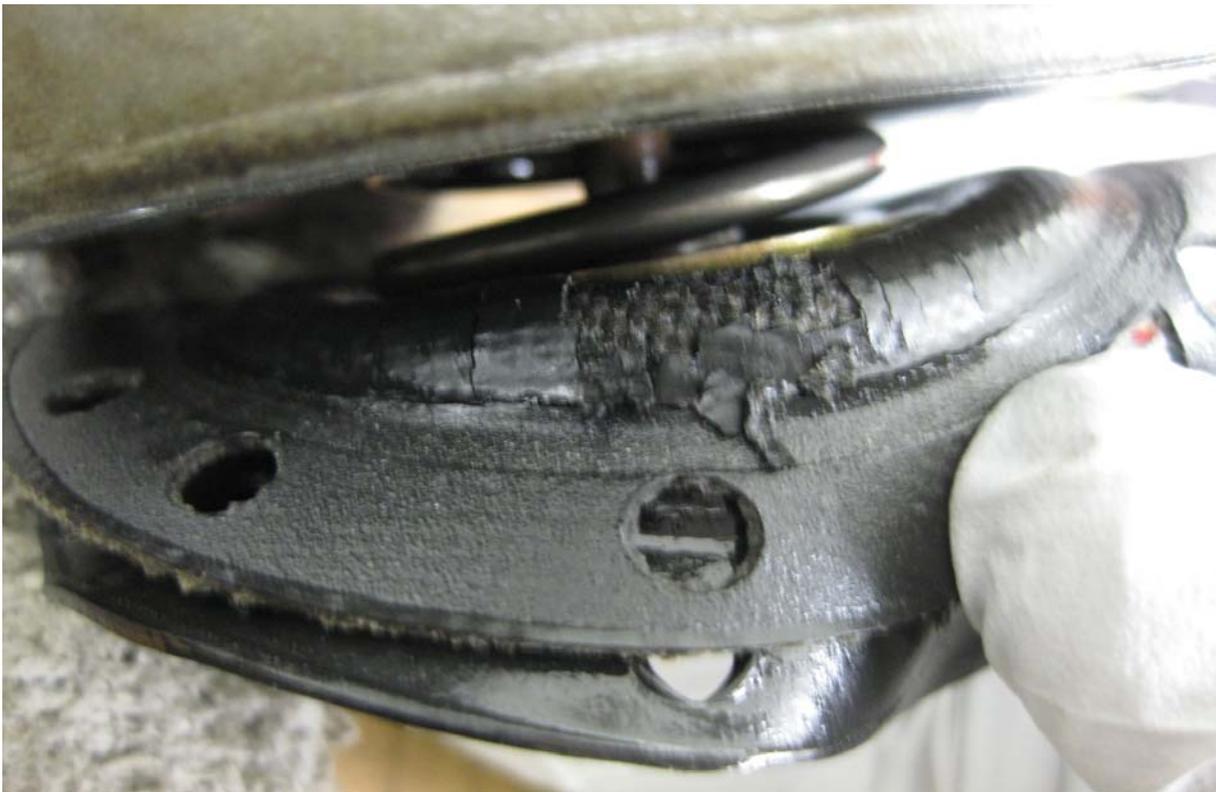
"(We saw) evidence of oil streaming down the belly and to the tail (*of this 172S*)," says this mechanic. "And oil was noted dripping from a drain tube below the firewall. This drain tube connected to an overflow fitting on the engine mounted mechanical fuel pump (*P/N LW15473*). The pump core was disassembled and oil was found leaking through the first of two diaphragms in this dual diaphragm pump. The rubber material covering the base material of the diaphragm was found flaking off. This base material is porous—allowing oil through the first diaphragm and into the ring chamber that allows oil to drain overboard without contamination of the fuel side of the pump. Failure of the second diaphragm would allow fuel injection to become contaminated. In a two month period, we have found two pumps draining oil overboard. A third aircraft was found with oil contamination in the fuel injection system." (*The SDRS database reflects 49 entries for this P/N fuel pump.*)
