**Federal Aviation
Administration**

ADVISORY CIRCULAR

AVIATION MAINTENANCE ALERTS

**ALERT
NUMBER
398**

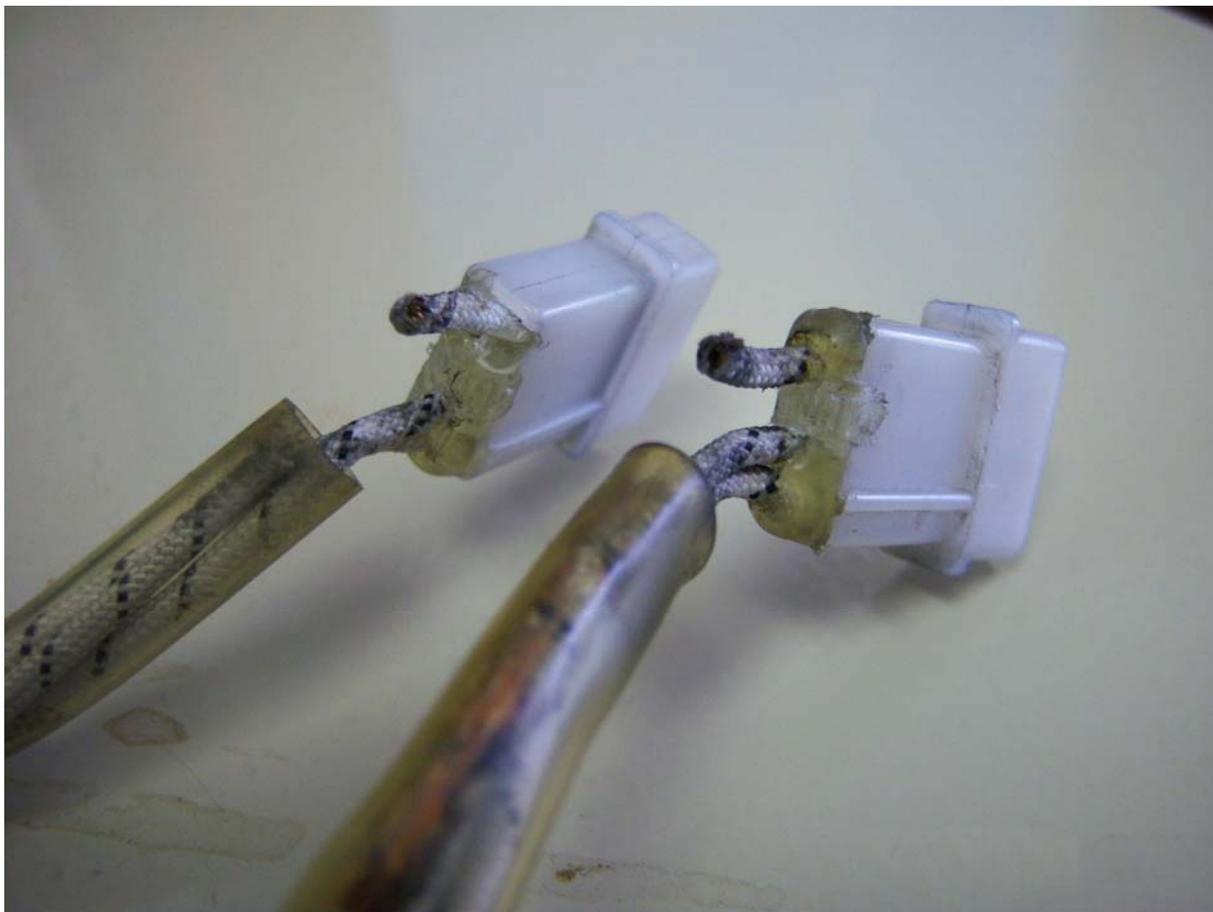
Swearingen: SA227AC; Burned Deice Boot Wires; ATA 6112

"During a routine service check inspection," says a Chief Inspector, "two of the four propeller deice boot leads (P/N SMR23692) were found to have broken and burned ground wires. The ground wires were broken in the exact same place and showed small signs of burned or singed insulation at the point where the wire separates." (*Roto propeller model R321482F8.*)

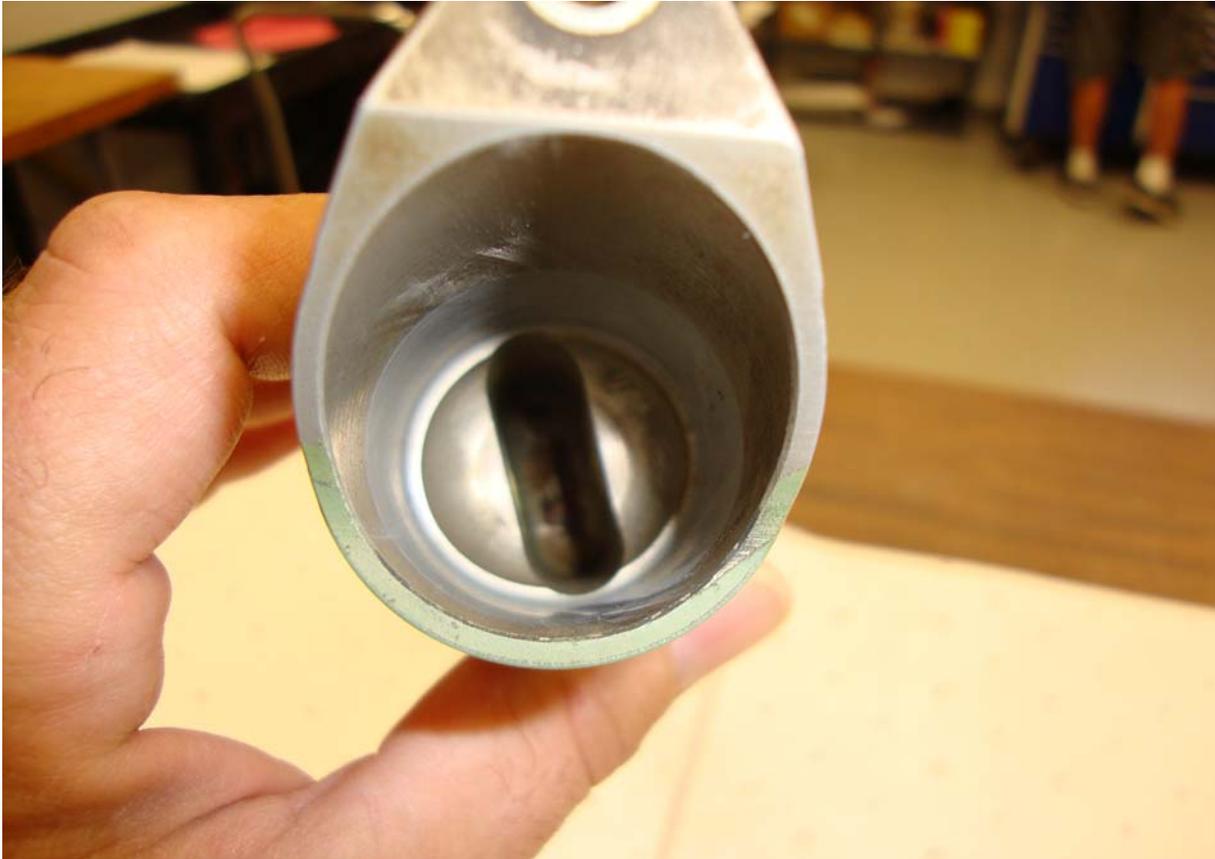
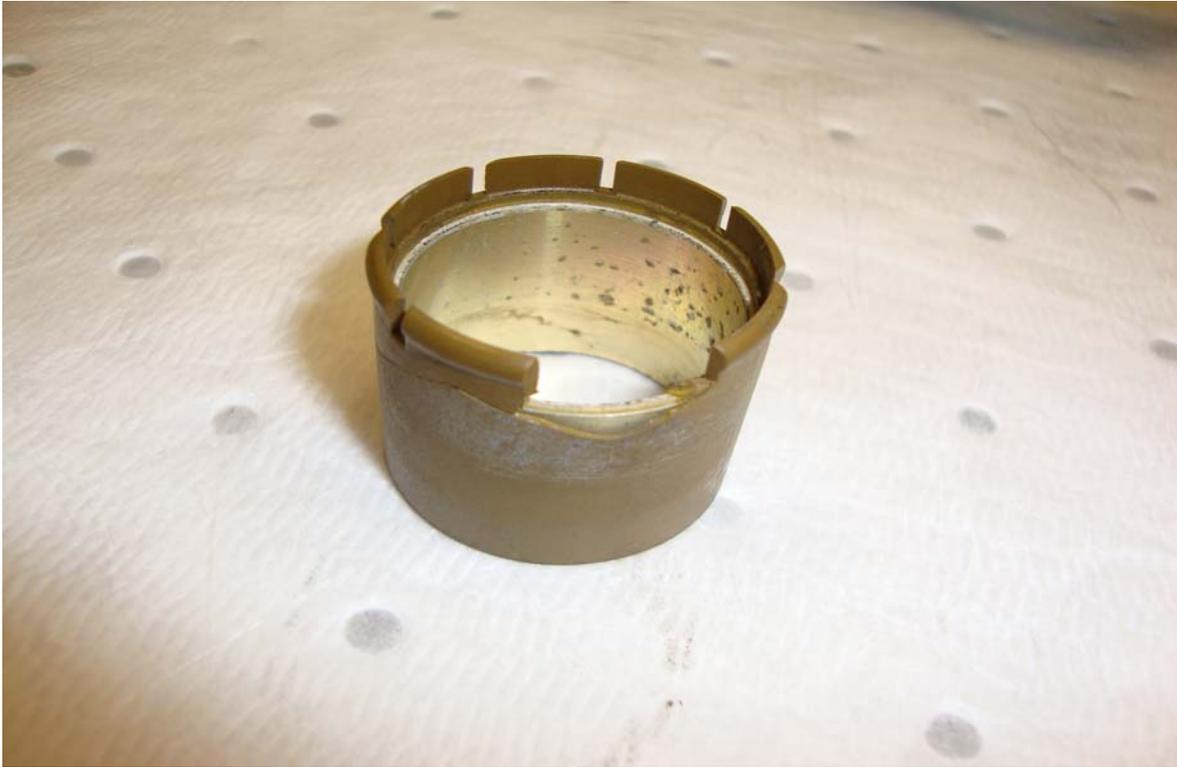
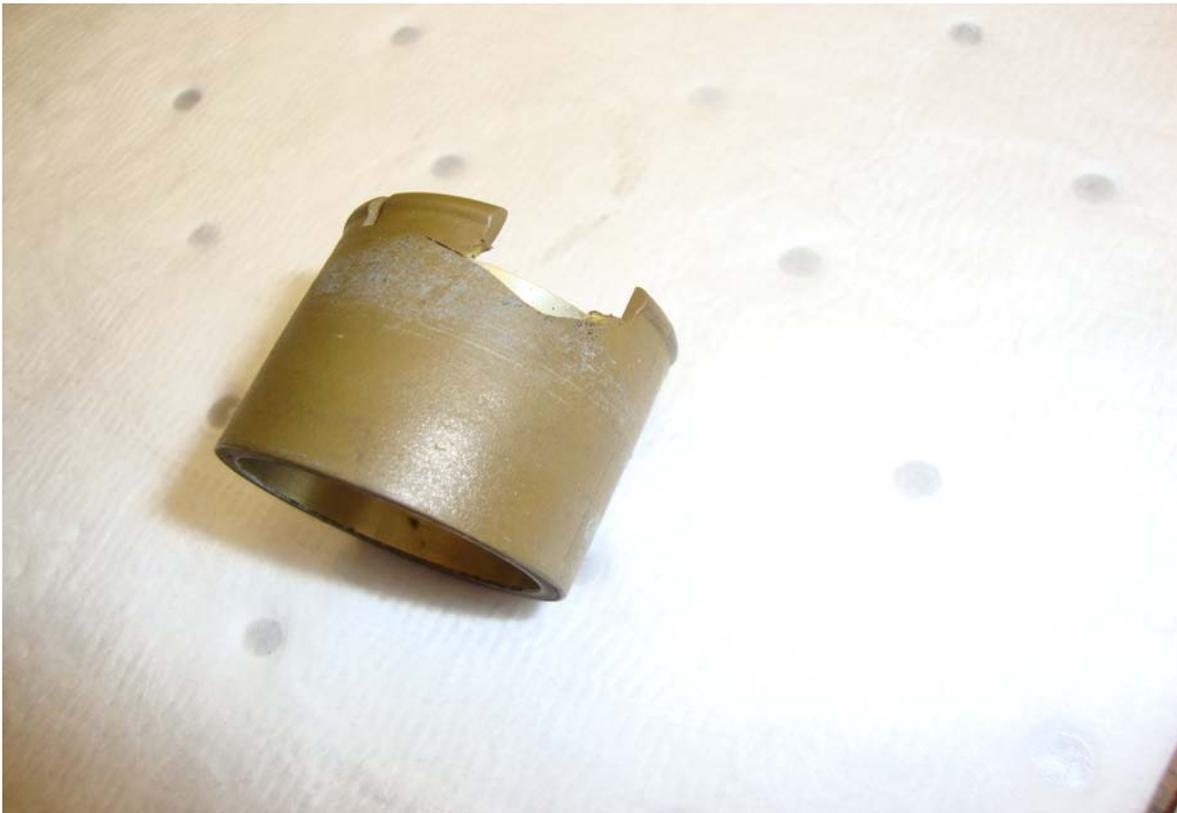
Eurocopter: EC135T1; De-bonded Tail Rotor Blades; ATA 6410

A helicopter technician says, "While performing a 1200 hour/36 month inspection of the tail rotor assembly, (I) found three tail rotor blade (P/N L642A2002101) balance weight pockets de-bonded from the blades. One is cracked and has a piece missing. These three blades were installed together 696.5 hours ago."

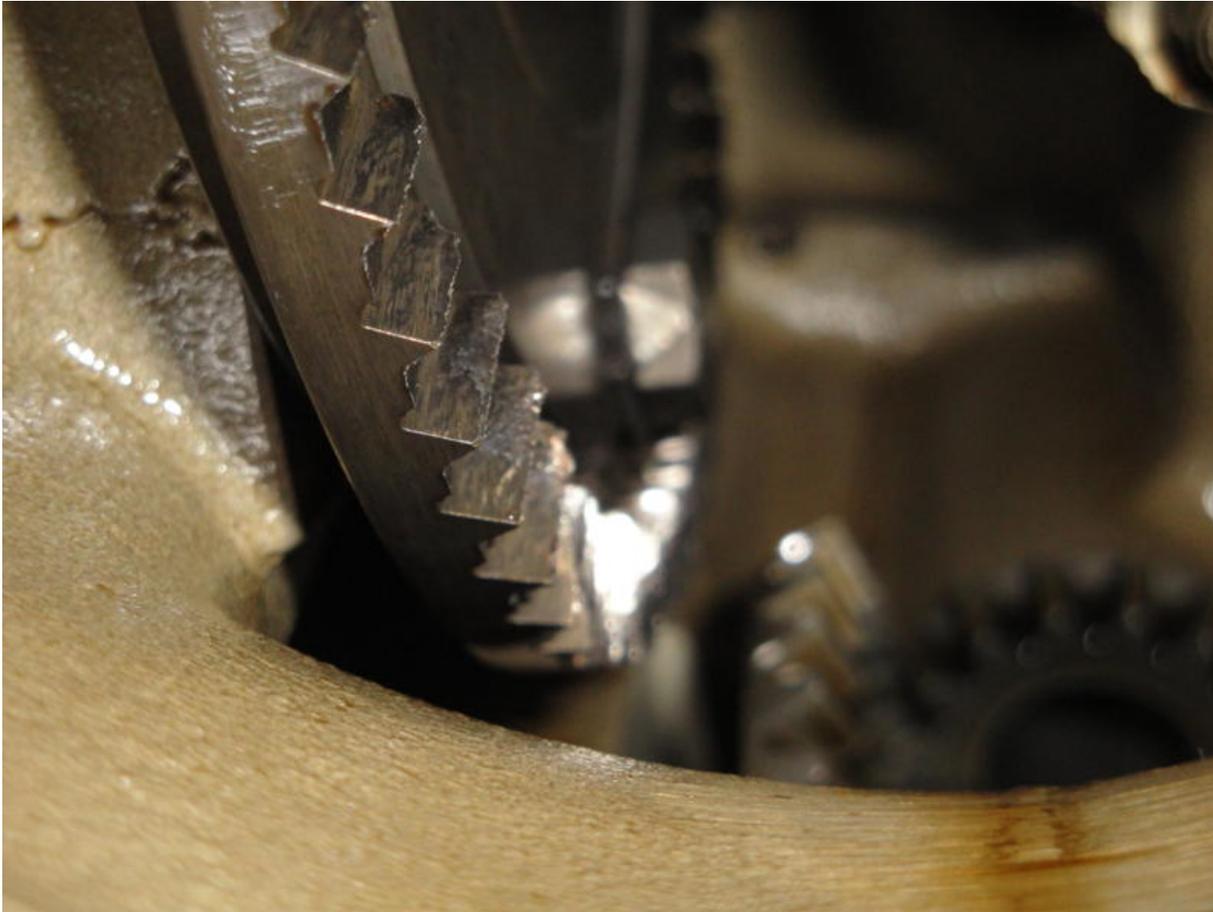
Continental: IO550N; Worn Crankshaft Gear; ATA 8520

"While performing an Annual Inspection of the engine," says this submitter, "*(I)* noticed the alternator housing was loose. I (*also noted*) the 500 hour alternator inspection was due. So, upon removal of the alternator for inspection, I (*observed*) all of the teeth on the crankshaft gear face were either missing or severely worn. There was no indication of alternator failure prior to this discovery. On the incoming engine run-up, oil pressure was (*seen*) to be on the lower side of the green band. However, the magnetic drain plug was covered with filings. Cutting open the oil filter found the paper element was covered in silver—(*but*) with no debris. If there wasn't a 500 hour inspection due on the alternator this problem would not have been found." (*Crankshaft gear P/N: 632018. The SDRS database reflects this part number eight times.*)

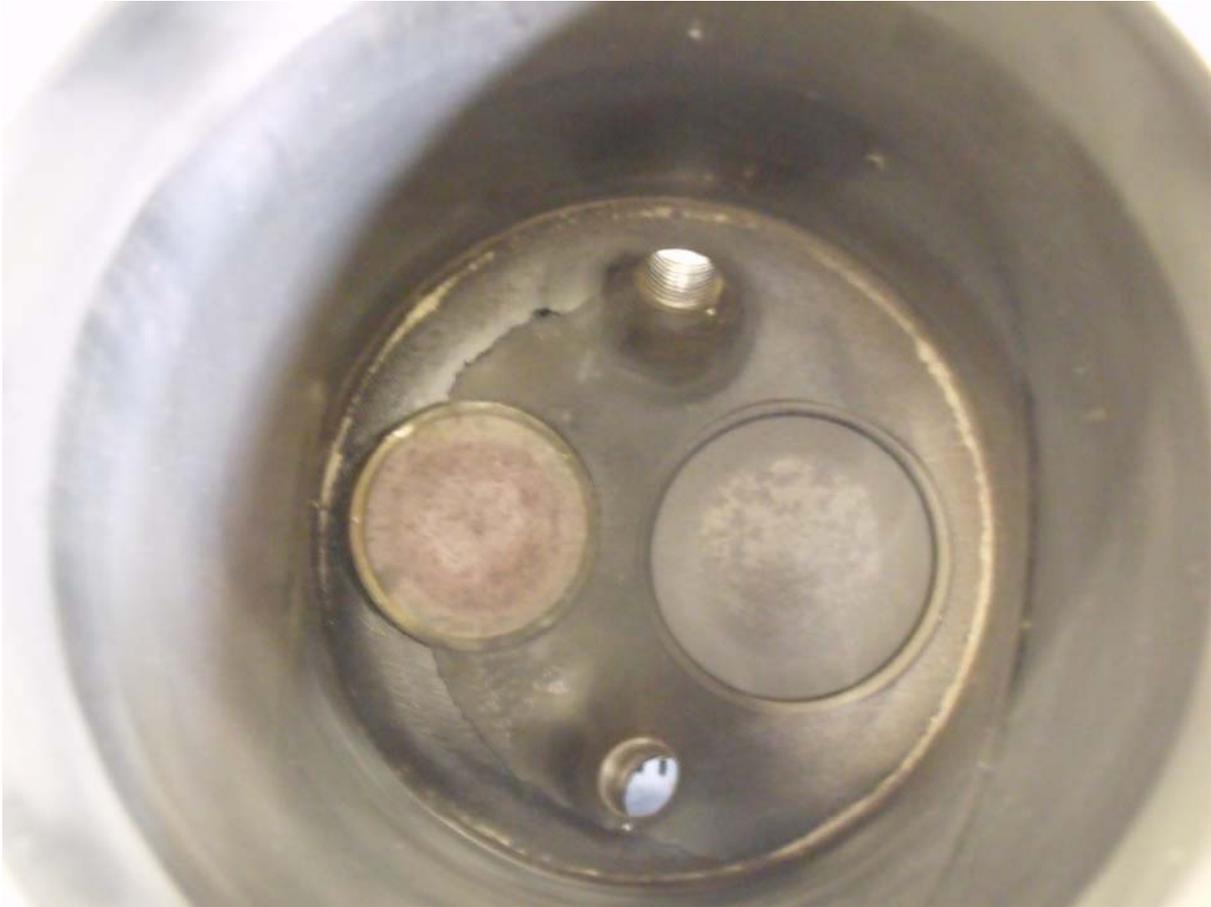
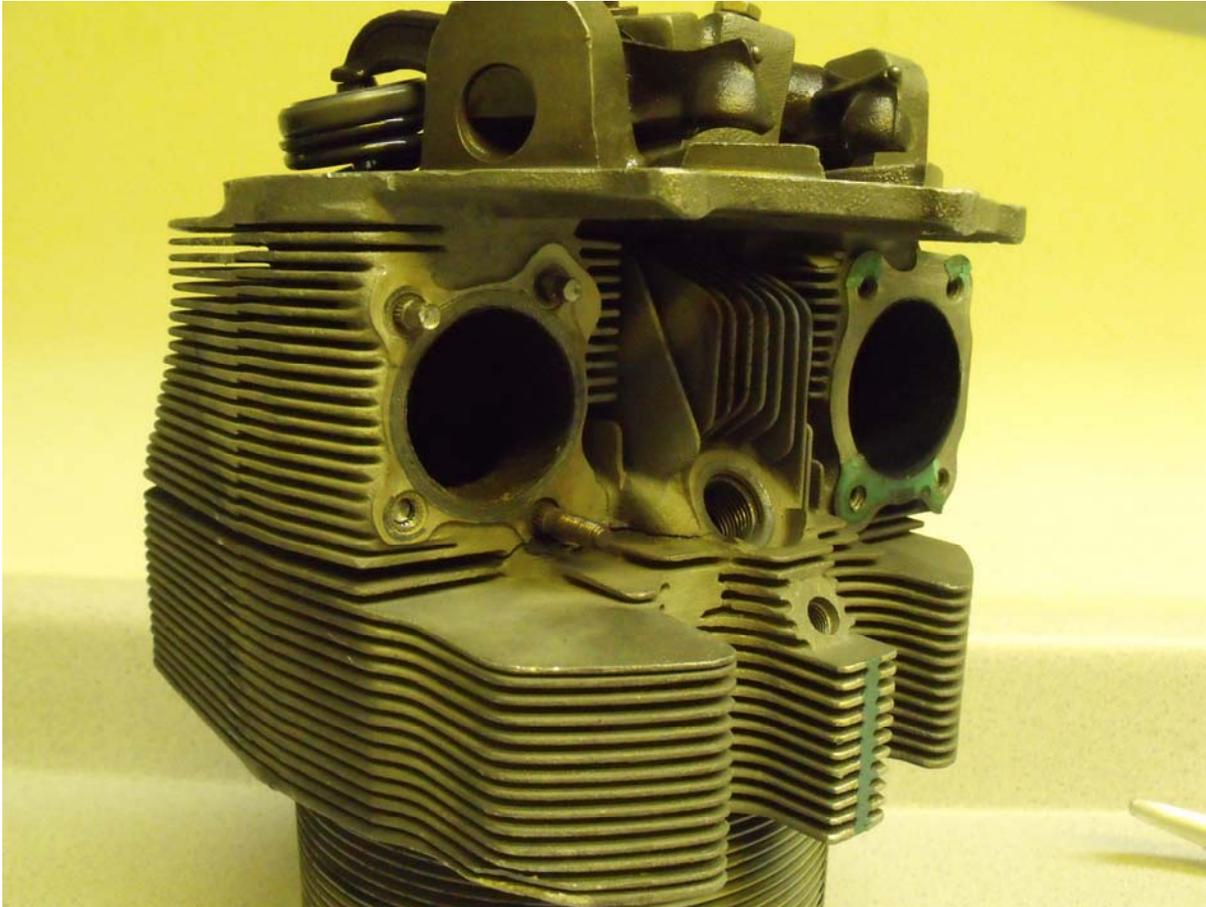
ECI Cylinder: ECC712CN; Cracked Head; ATA 8530

A technician states, "On initial climb-out the pilot noticed a vibration, and elected to return for landing. The number two cylinder was found cracked—from the spark plug past the exhaust valve, *(continuing)* approximately three-fourths *(the distance)* around the cylinder's head. This cylinder (*P/N ECC712CN*) had good compression two months *(ago)*, after being repaired."

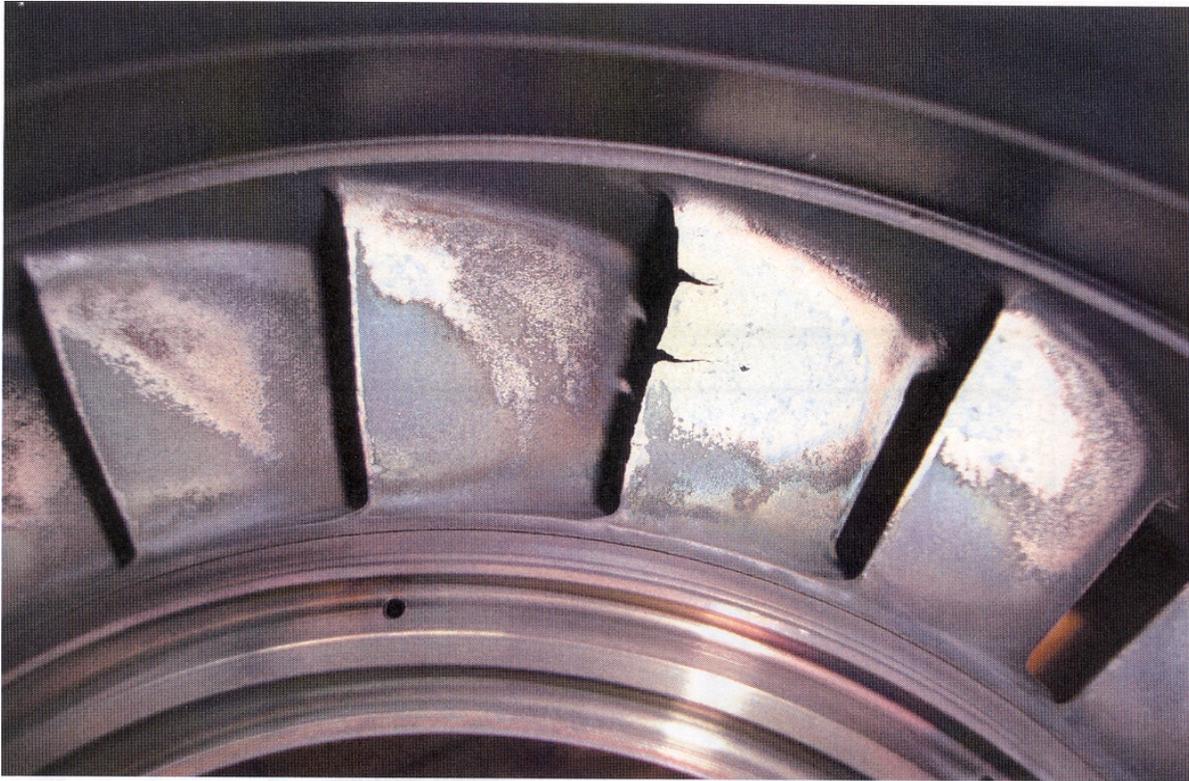
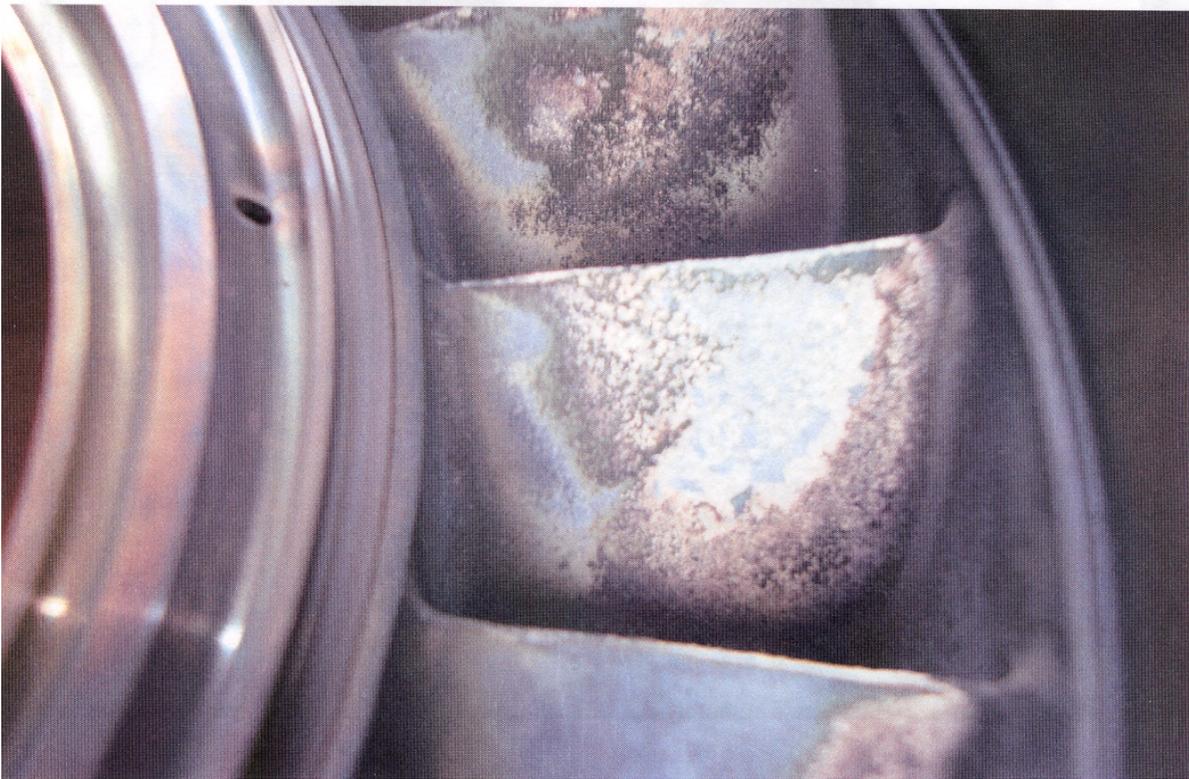
Turbomeca: Arriel 1D1; Cracked Nozzle Guide Vane; ATA 7250

"While performing modification TU347 to module 3," states this engine technician, "we discovered the second stage nozzle guide vane eroded and cracked. We reassembled module 3 and are sending it to a Turbomeca level 4 repair center for repair." (*Nozzle guide vane; P/N 2292401800.*)

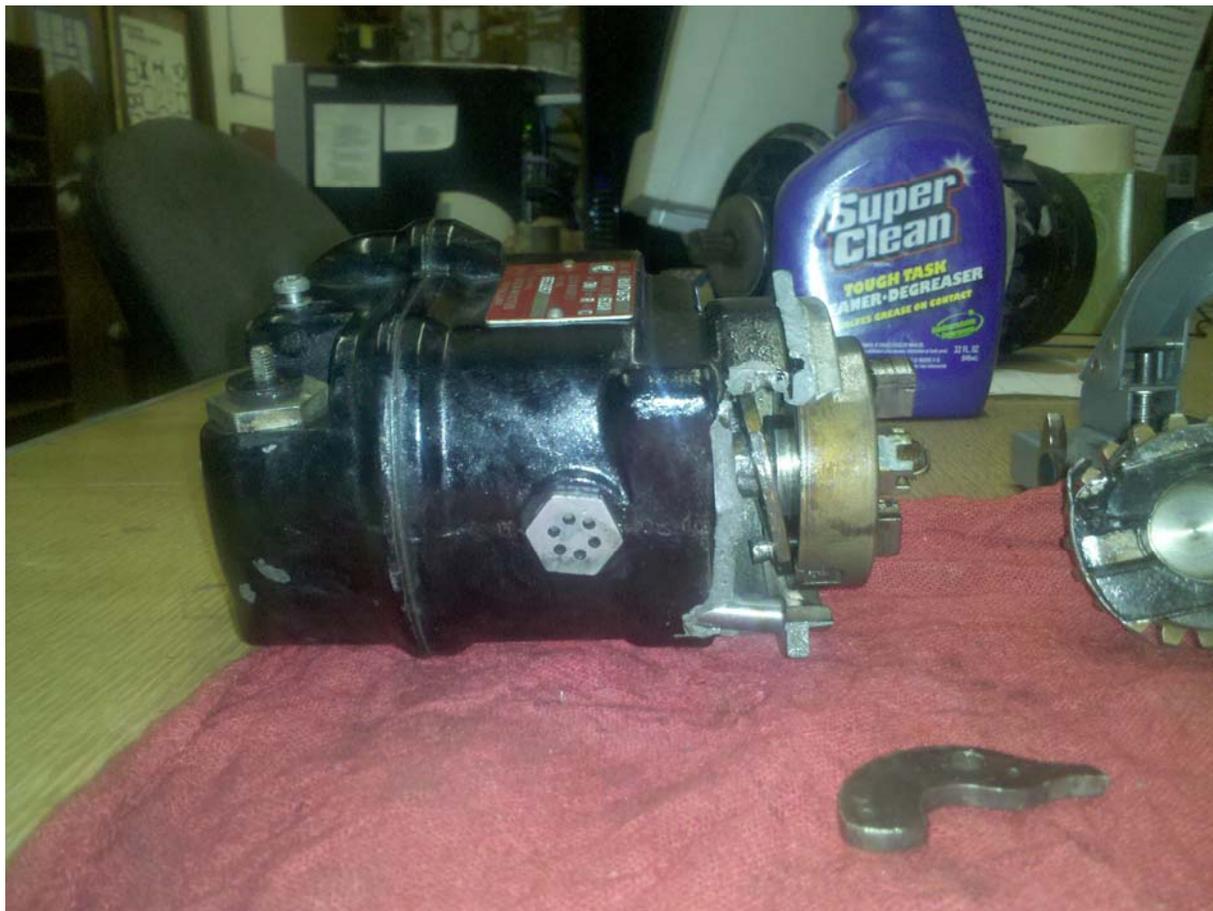
Slick Magneto: 6310; Fractured Housing; ATA 7414

An unidentified submitter says, "The impulse coupling came apart and fractured the magneto housing." *(The impulse coupling P/N: M3050 has 14 entries in the SDRS database. Magneto 6310 has 36 entries.)*
