ADVISORY CIRCULAR

43-16A

AVIATION MAINTENANCE ALERTS

**ALERT
NUMBER
399**

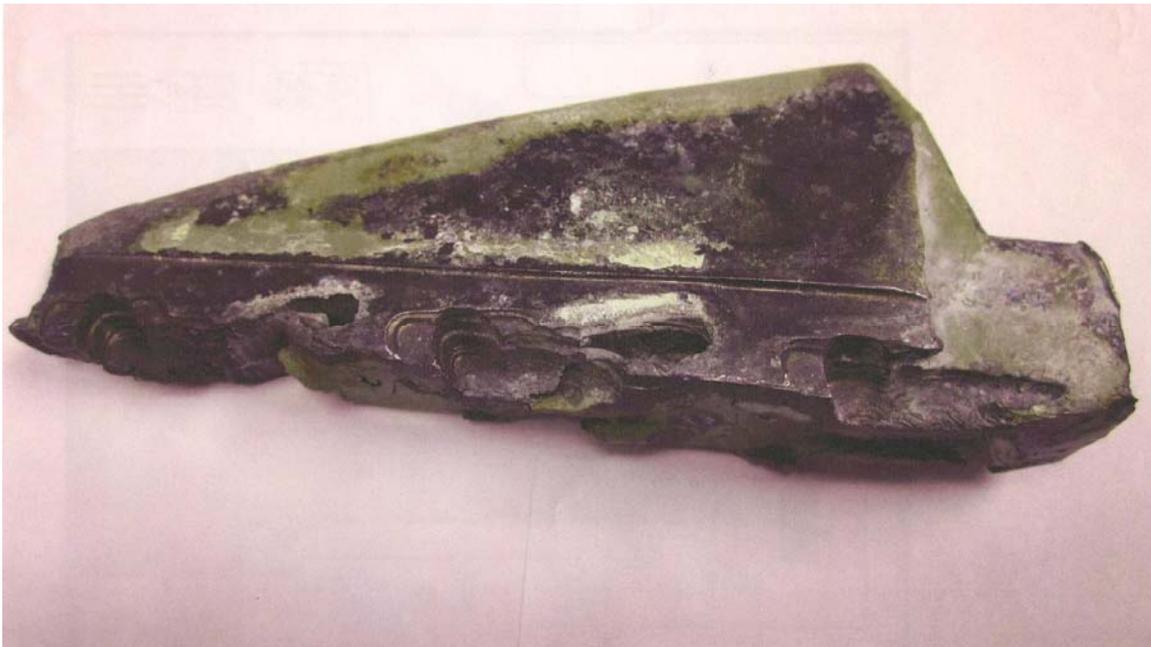
Beechcraft: B58; Broken/loose Elevator Balance Weights; ATA 2730

A repair station mechanic states, "During an Annual Inspection, (I) found the L/H elevator balance weight (P/N 96-610022-7) detached from its mount. The R/H elevator balance weight was found (both) broken and loose on its mount. The detached L/H weight was able to shift position inside the elevator and cause an out of balance condition. This damage appears to be caused by vibration." *(That—and toss in a ton of corrosion, too—Ed.)*

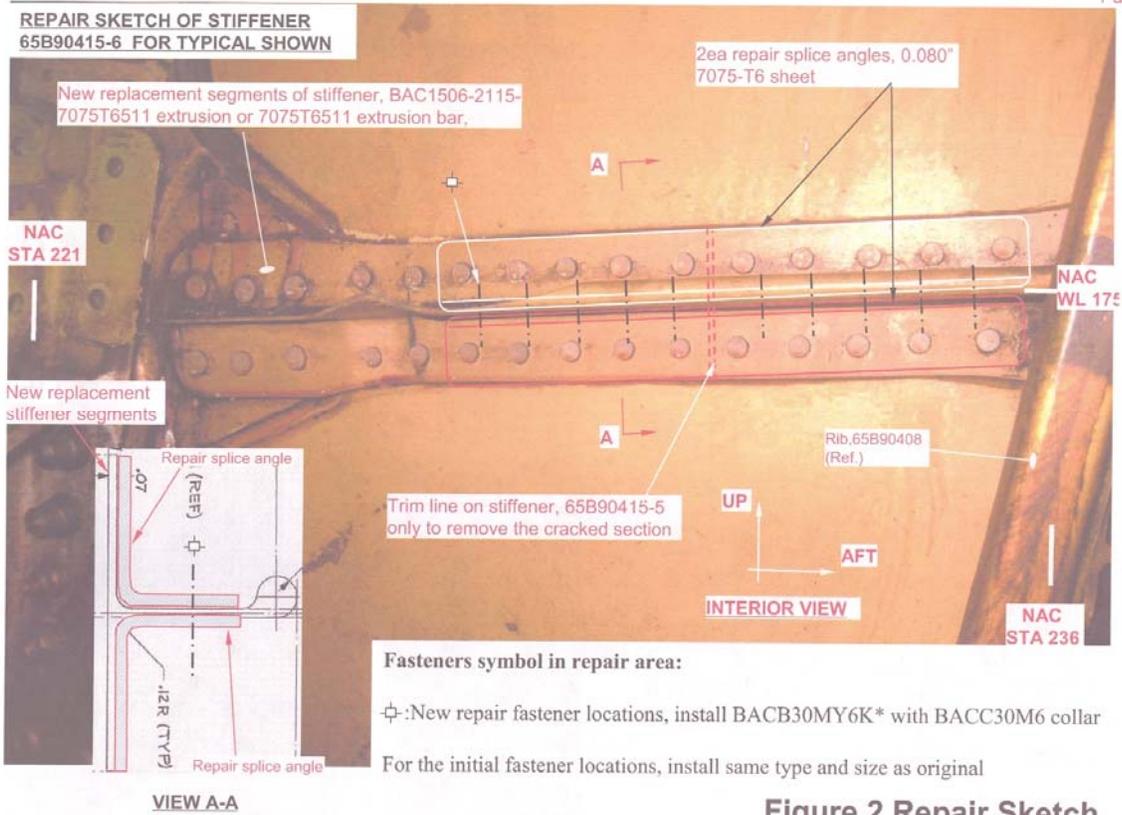
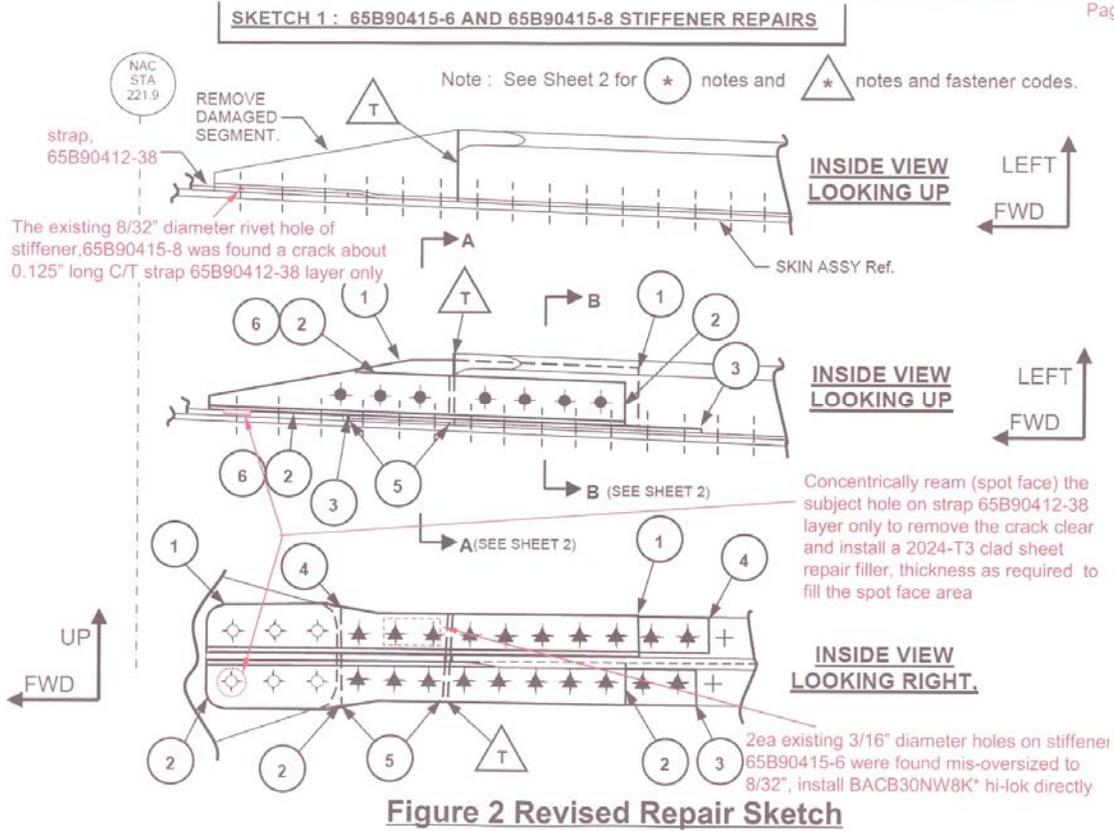
Figure 2 Repair Sketch

Boeing: 747-200F; Cracked Pylon Stiffeners; ATA 5400

A technician from a repair facility in Xiamen, China states, "During inspection, cracks were found on the R/H vertical and horizontal flanges of number two (*engine*) pylon near station 228. Following removal of the damaged stiffener section, the bulkhead strap (P/N 65B90412-38) was found cracked at a stiffener fastener hole. While (*effecting*) the repair, two each existing 2/16 inch diameter rivet holes in the skin common to the new upper repair angle (of stiffener P/N 65B90415-6) were found oversized to 8/32 inches."

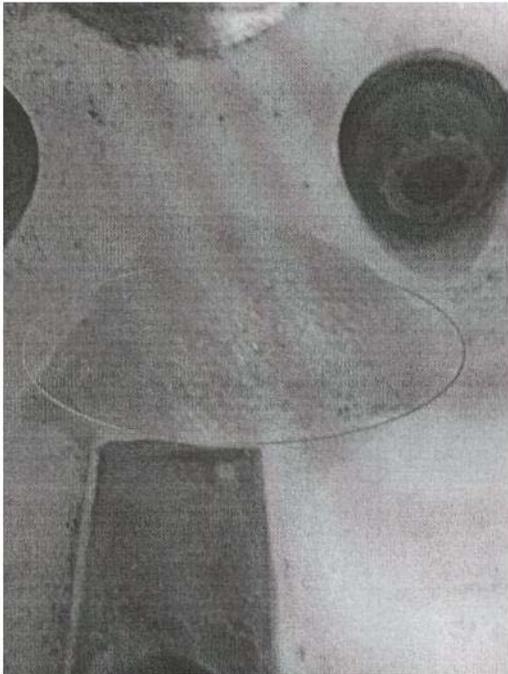
A Director for Quality Control at a repair station states, "This main wheel hub half (P/N AH08901)...was noticed to have air leakage after one day's service. The main wheel assembly (P/N AHA1648) was returned to the (source) location for warranty evaluation. A large crack was visually confirmed in the inboard ring area of the wheel hub half, pictured in figure 1 and 2...."

Figure 1: Soapy Water Liquid Test

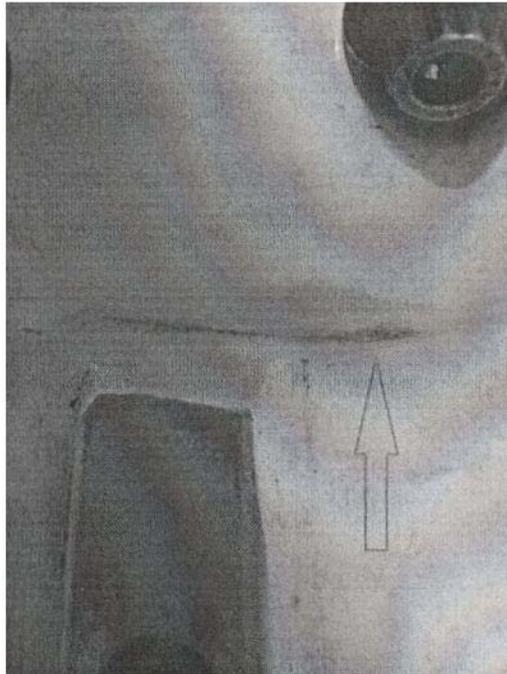
Figure 2: Inboard Ring Area Crack

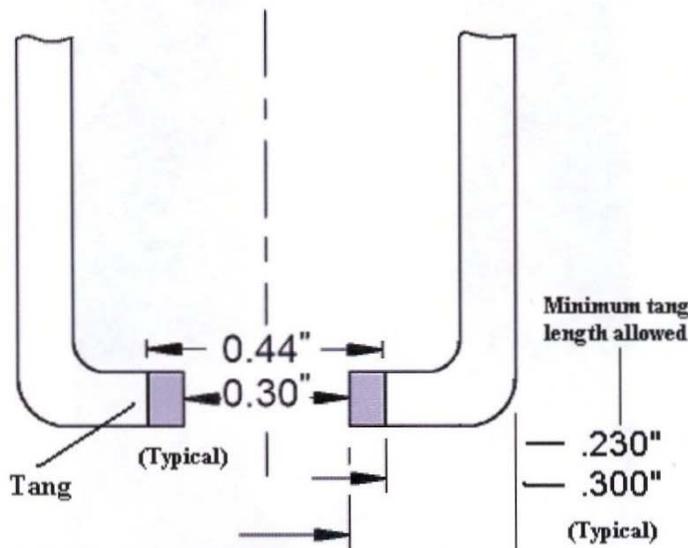
Figure 4. Closeup of seat roller housing and tang gap width

(6) Due to wear or deformation of the tangs, inspect the tang length from the inner edge of the tang to the outer edge (the bend area) of the roller housing (see figure 4).

(i) The minimum measurement allowed for the remaining tang length is 0.230 inches remaining on either of the tangs, from the inner edge of the tang to the outer edge (the bend area) of the roller housing. If the measurement is less than 0.230 inches on either of the tangs, before further flight, replace the roller housing.

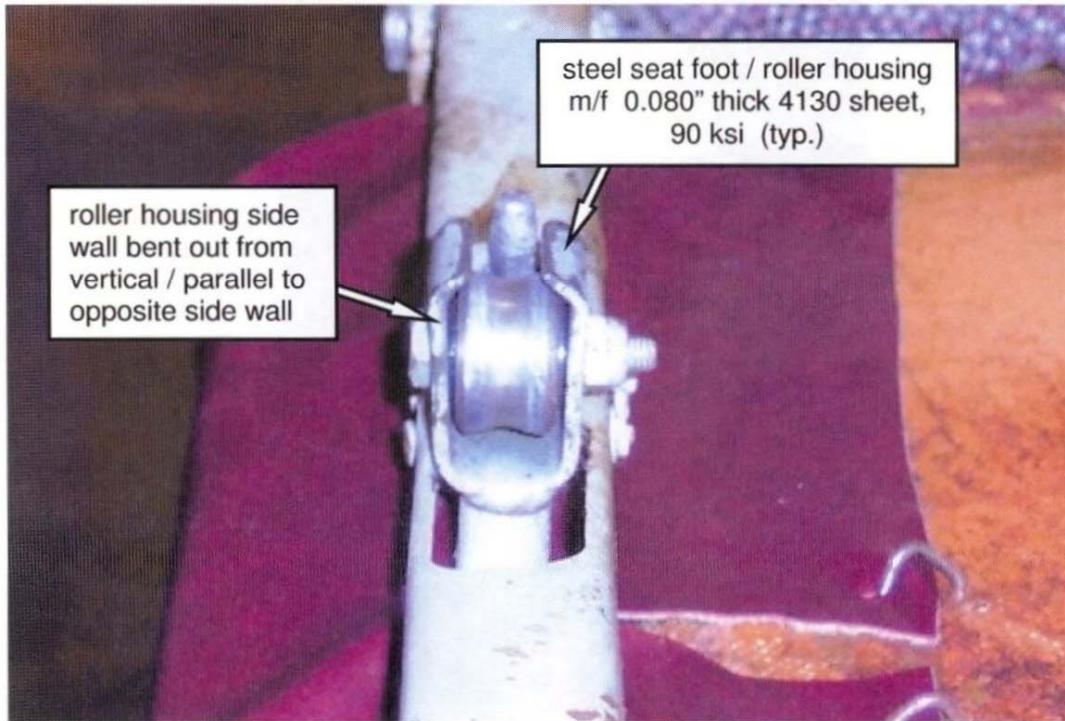
FIGURE 2.0-2 DETAIL OF BENDING / DEFORMATION OF SEAT ROLLER HOUSING SIDE WALL

In the case of seats which use steel roller housings (e.g. as defined by Cessna drawings 0311310 "Roller, Pilot Seat", and 0514016 "Housing Assy – Seat Roller"), the tangs may not meet the dimensional requirements set forth in the AD due to primarily to deformation or bending of the seat feet, rather than being caused by actual wear / loss of material. Ref. Figures 2.0-2 and 2.0-3 for examples of this type of deformation / bending of roller housing geometry.

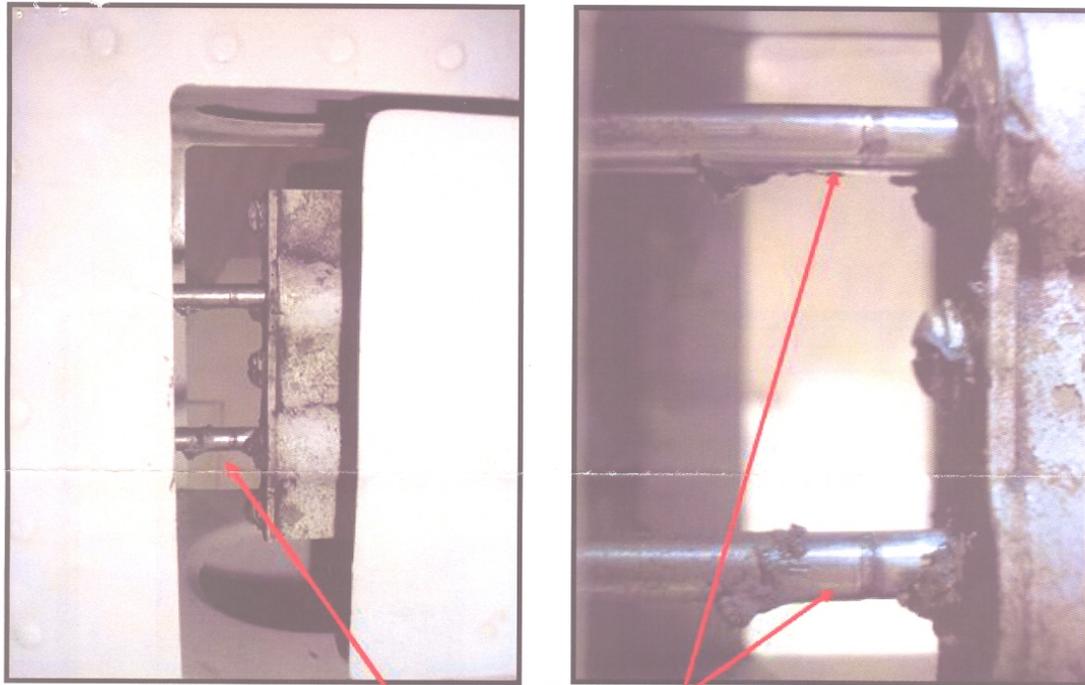
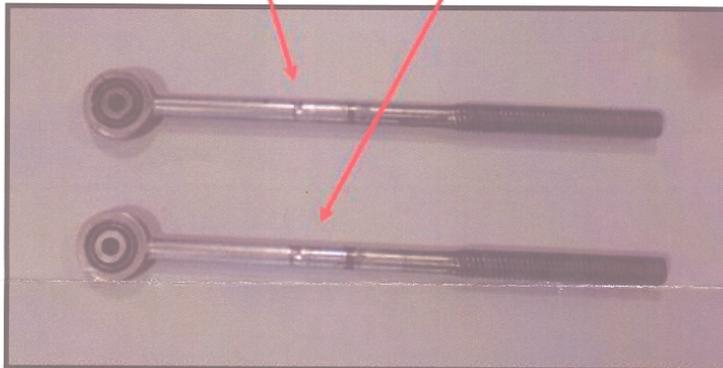
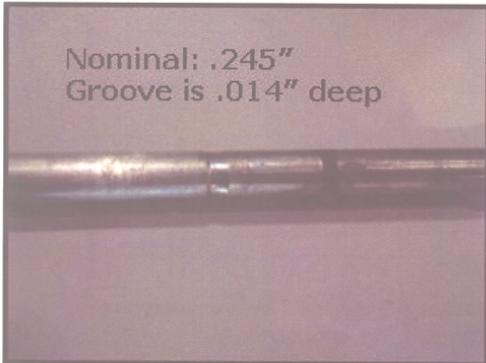
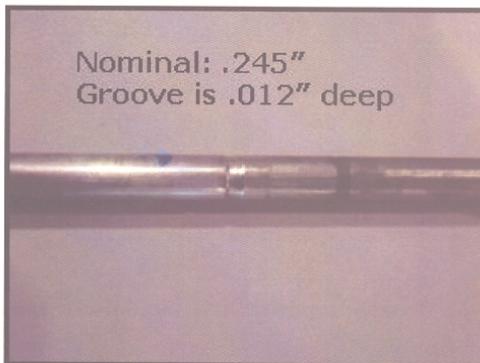
A repair station submitter says, "(I) found grooves worn into the shaft of the two screws (P/N 6660251-52) that enter into the rudder actuator assembly. Probable cause: the aircraft is set for cruise configuration. During flight the tail vibrates, causing grooves to wear into the shaft of the screws at the point where they enter into the actuator."

Note wear rings.

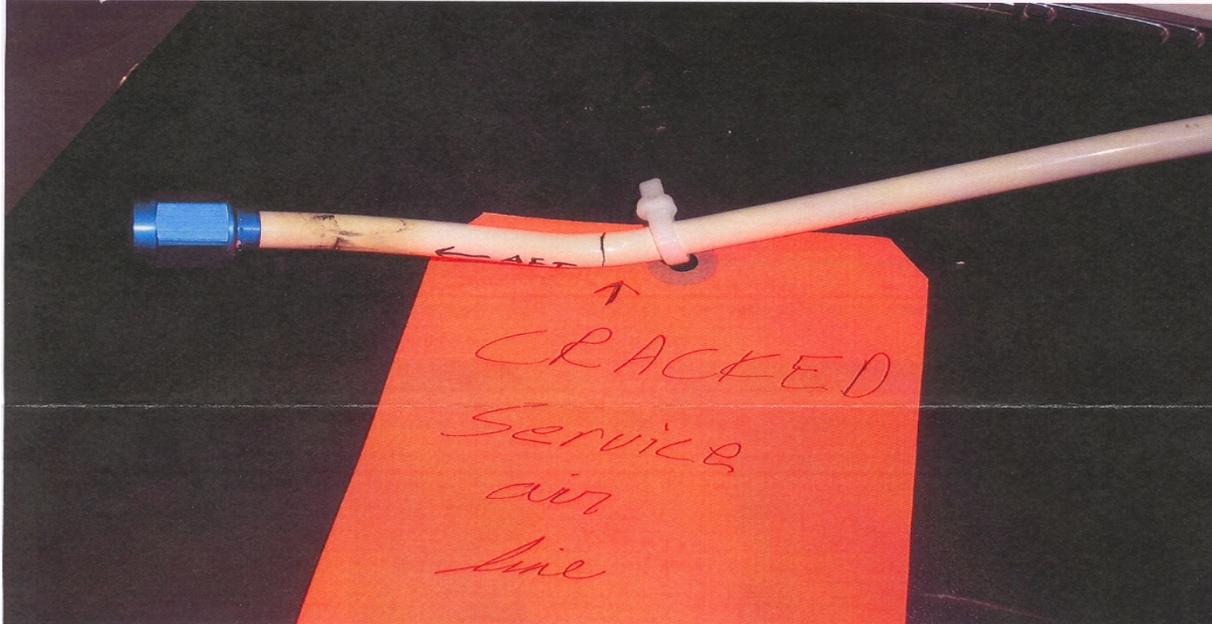
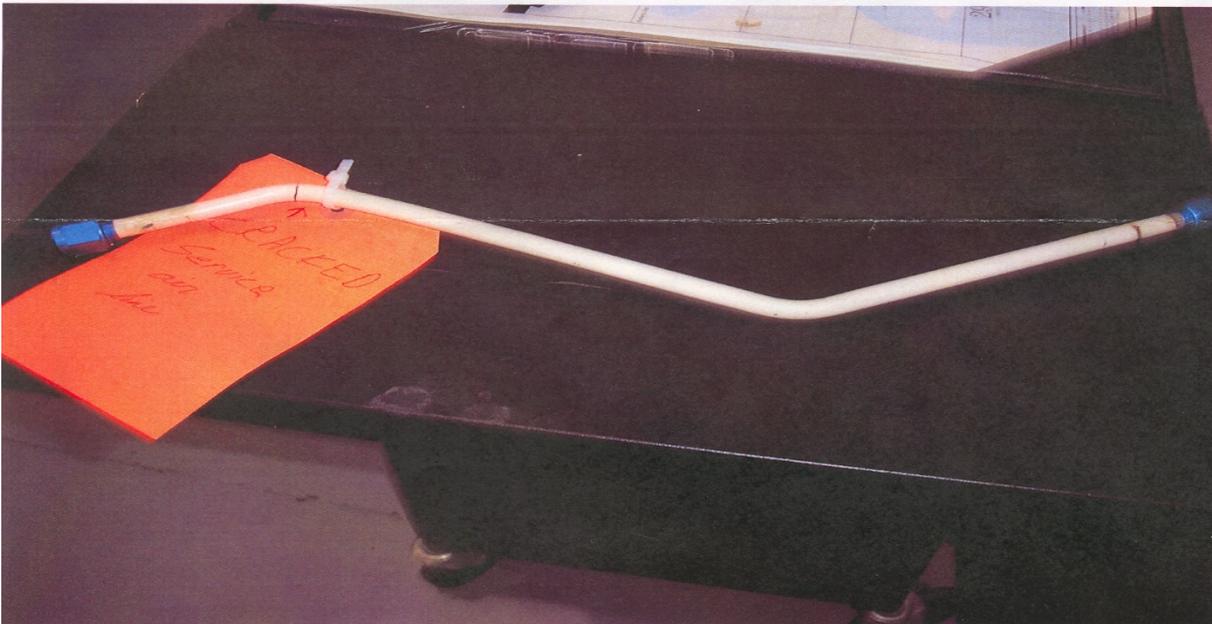
A repair station submitter says, "(I) found the service air tube assembly cracked in the bend radius that leads to the rudder bias actuator in the tail cone." (Tube assembly P/N: 6914040-37.)

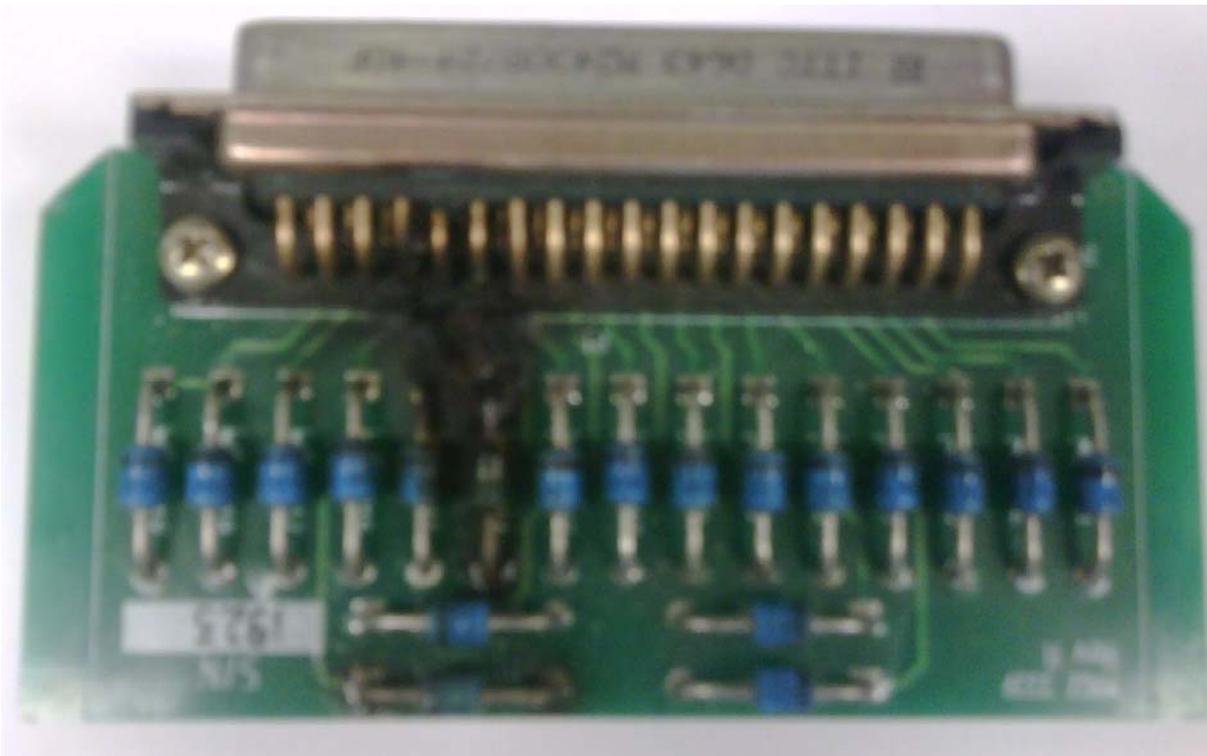
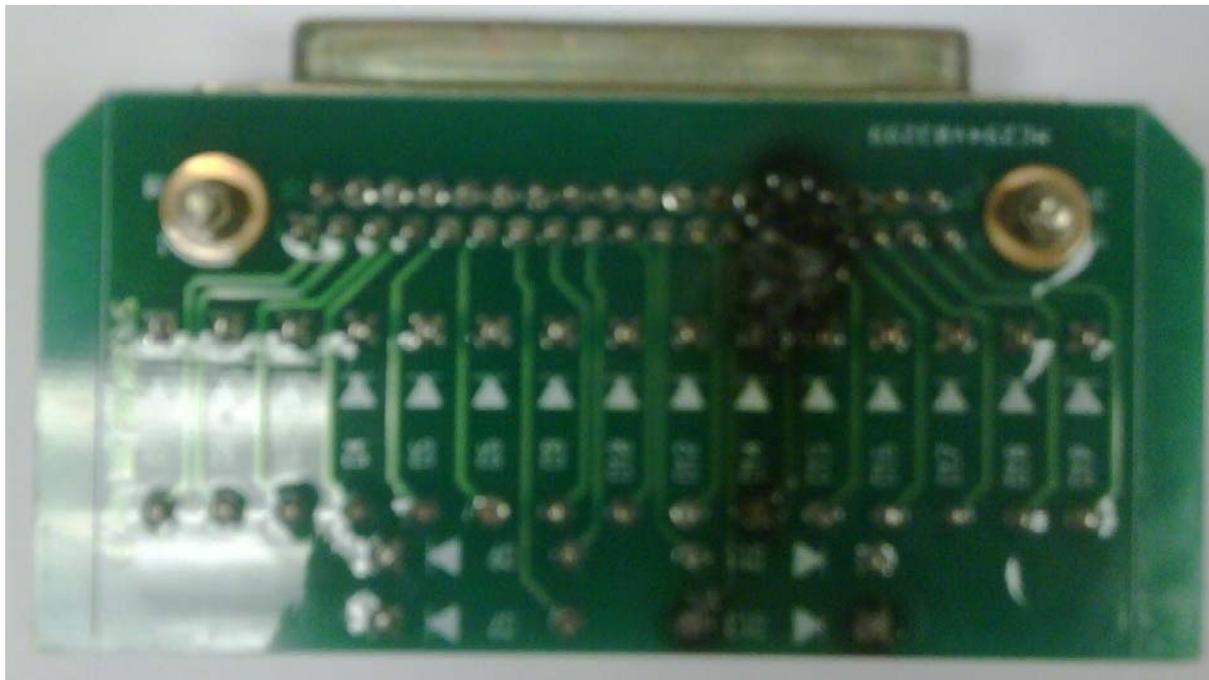
"After takeoff," states an unknown technician/pilot, "(I) noticed a very slight electrical smoke odor. After climbing through 24,000 feet, and the left and right 'Ice Detect Fail' EICAS came on simultaneously (*Engine Indicating & Crew Alert System*). These lights came on for about thirty seconds, then disappeared. Annunciators appeared about thirty seconds later (for a few seconds) around (approximately) 20,000 feet. They remained extinguished for the rest of the flight. No circuit breakers tripped, and everything looked normal on the electrical and secondary EICAS pages.

"After landing, the odor appeared to be coming from wires from the avionics box located behind the pilot's seat—on top of the potable water controls. I found the ice detectors to fail the self-test and the system test. The system would heat normally, but no EICAS indication would (*generate*). We verified the ejector valve heater blankets had not failed by performing resistance checks at relay 350H in the right relay junction box. We investigated this right relay junction box for faults and damaged components. We found the PC diode card 82P to be discolored and displaying burn marks. We removed and replaced card 82P with a new unit. Operational check was good. No further faults were noted." (*Circuit card P/N: SPE3508005001.*)

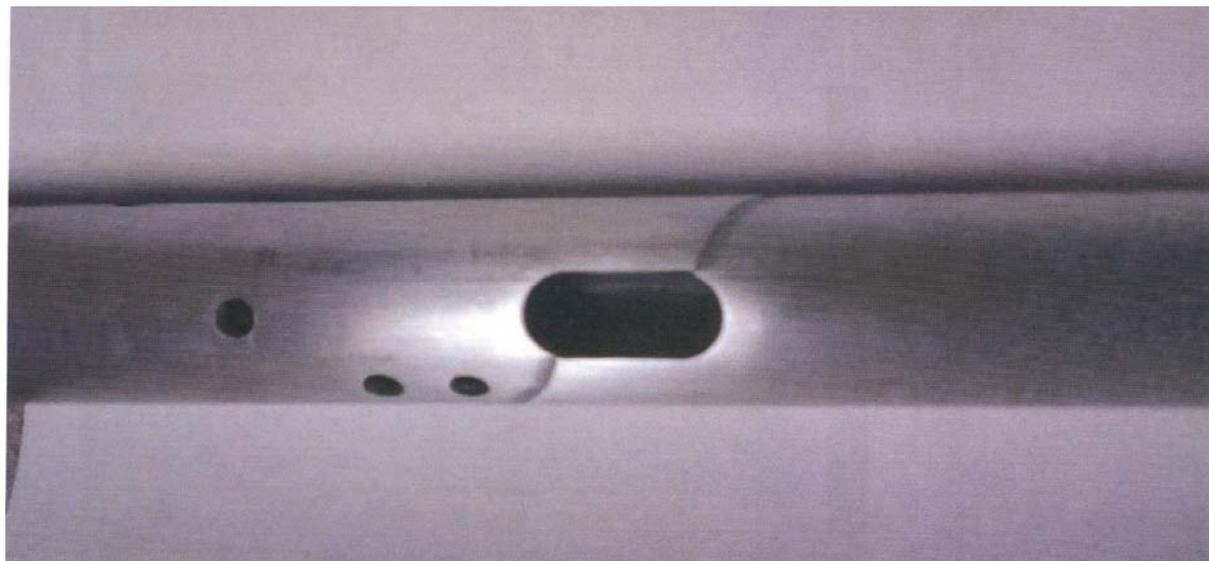
"The co-pilot's seat was removed for recovering," states a submitter. "During the recovering (*process*) it was noticed the seat height adjustment torque tube was cracked (*P/N 2A0590174*). The technicians working on the seat said this was not an uncommon failure."

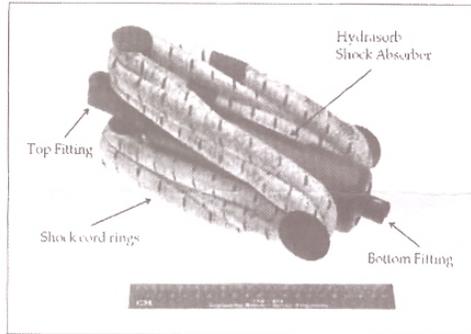
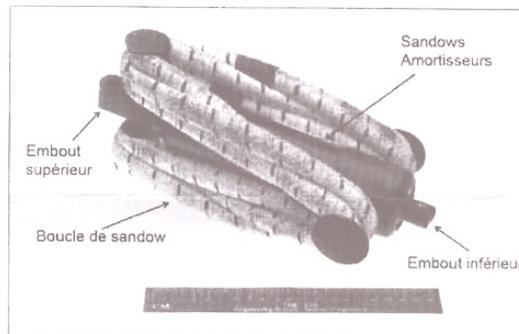
Shock Strut Assembly.

Initial examination determined that the right main landing gear Hydrasorb shock absorber had failed at the bolt hole in the lower fitting, resulting in separation of the upper end of the right main landing gear vee assembly. Subsequent dye penetrant inspection (DPI) determined that the lower fitting on the left Hydrasorb shock absorber was also cracked through the bolt hole. The Hydrasorb shock absorbers, in combination with shock chords, absorb and dissipate landing loads within the shock strut assemblies.

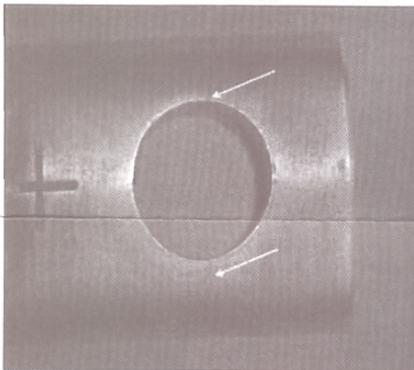
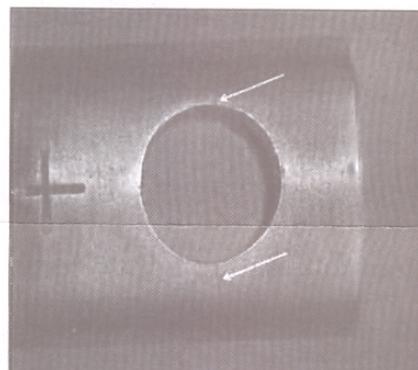
Photo 2. Fatigue crack in end fitting

Both main landing gear shock strut assemblies were submitted to the TSB Laboratory for metallurgical examination. It was determined that the right Hydrasorb shock absorber had failed due to the instantaneous overstress extension of a high-cycle fatigue crack through the bolt hole in the bottom end fitting (see Photo 2).

A similar fatigue crack was found on the bottom end fitting of the left Hydrasorb shock absorber (see Photo 2). In both cases the fatigue cracking had initiated from multiple origins located at the sharp edge of the bolt hole and at residual tool marks on the bolt hole surface which had acted as stress risers. Examination showed that the lack of a chamfer on the bottom end bolt holes and the use of non heat-treated steel were contributory to the fatigue failures of the bottom fittings.

TCCA strongly recommends that all affected owners and operators pay close attention to the main landing gear shock absorber assembly, both during scheduled maintenance activity and during post and pre-flight inspection. To prevent unnecessary damage in the event of a failed Hydrasorb shock assembly, it is recommended to incorporate the Laviasa SB 25-32-04, or at a minimum, incorporate the cable installation as per the Service Bulletin.

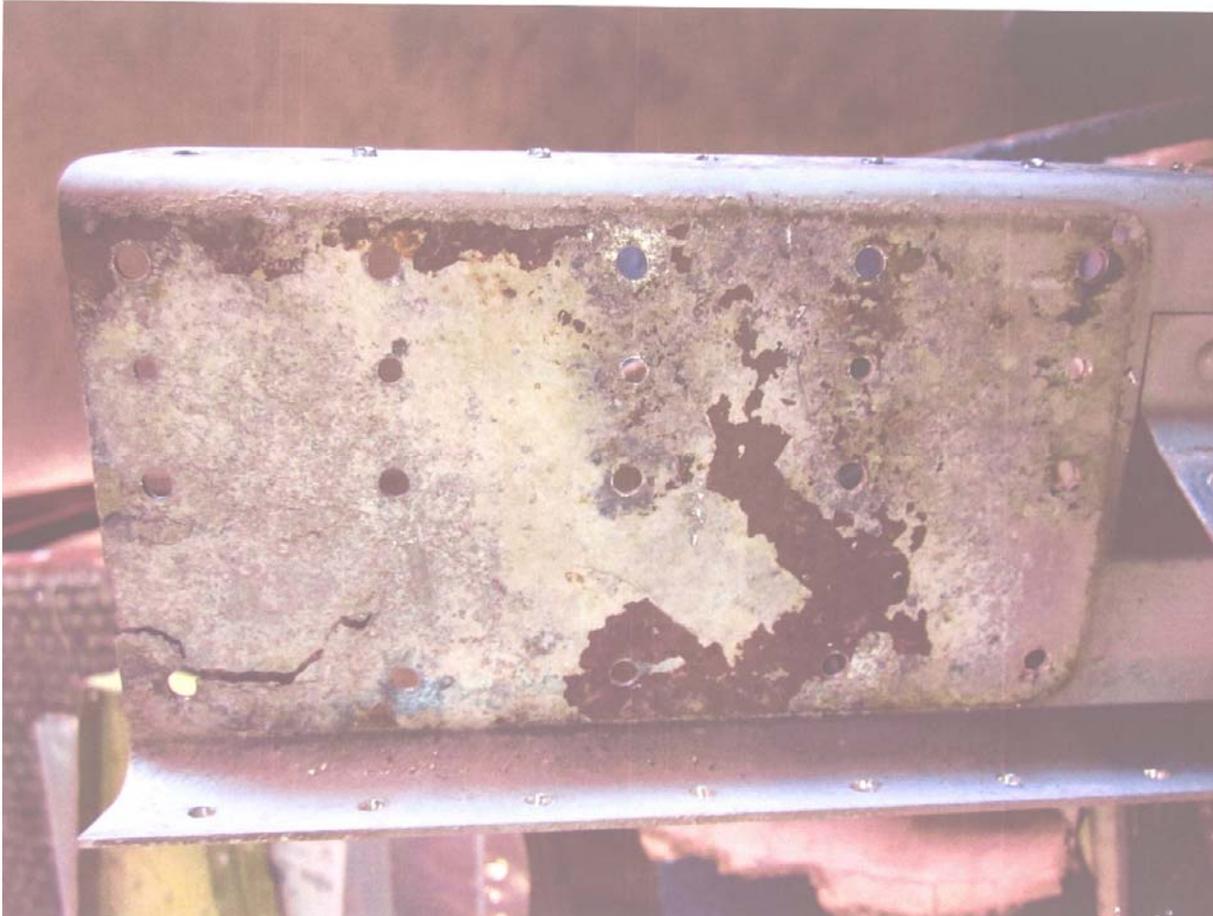
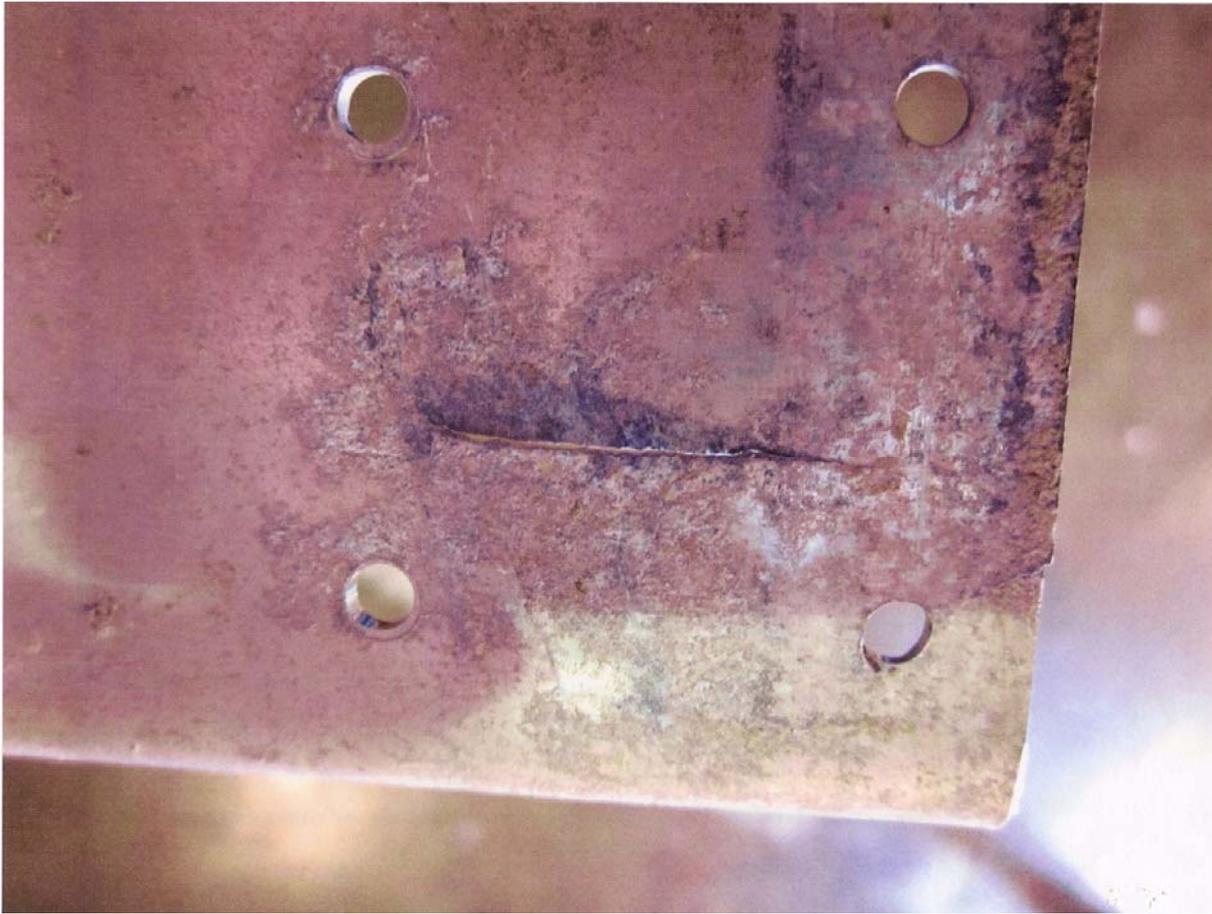
A mechanic writes, "During repair of the L/H wing, the aft spar attach fitting was removed. Severe corrosions was found under the fitting. Possible cause is trapped moisture, lack of a preventing treatment(s), and lack of proper inspection of the area." (*L/H Aft Spar P/N 62054-000. This number is found three times in the SDRS database—and several more times as the trailing zeros are removed in the search.*)
