## ADVISORY CIRCULAR

43-16A

# AVIATION MAINTENANCE ALERTS

**ALERT  
NUMBER  
400**

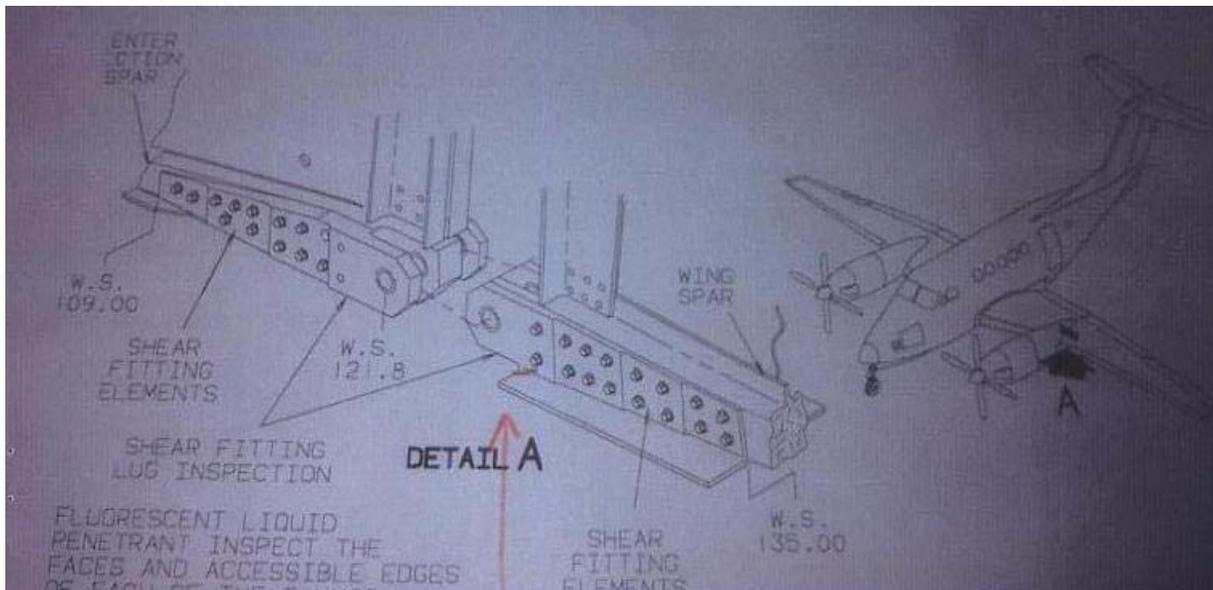
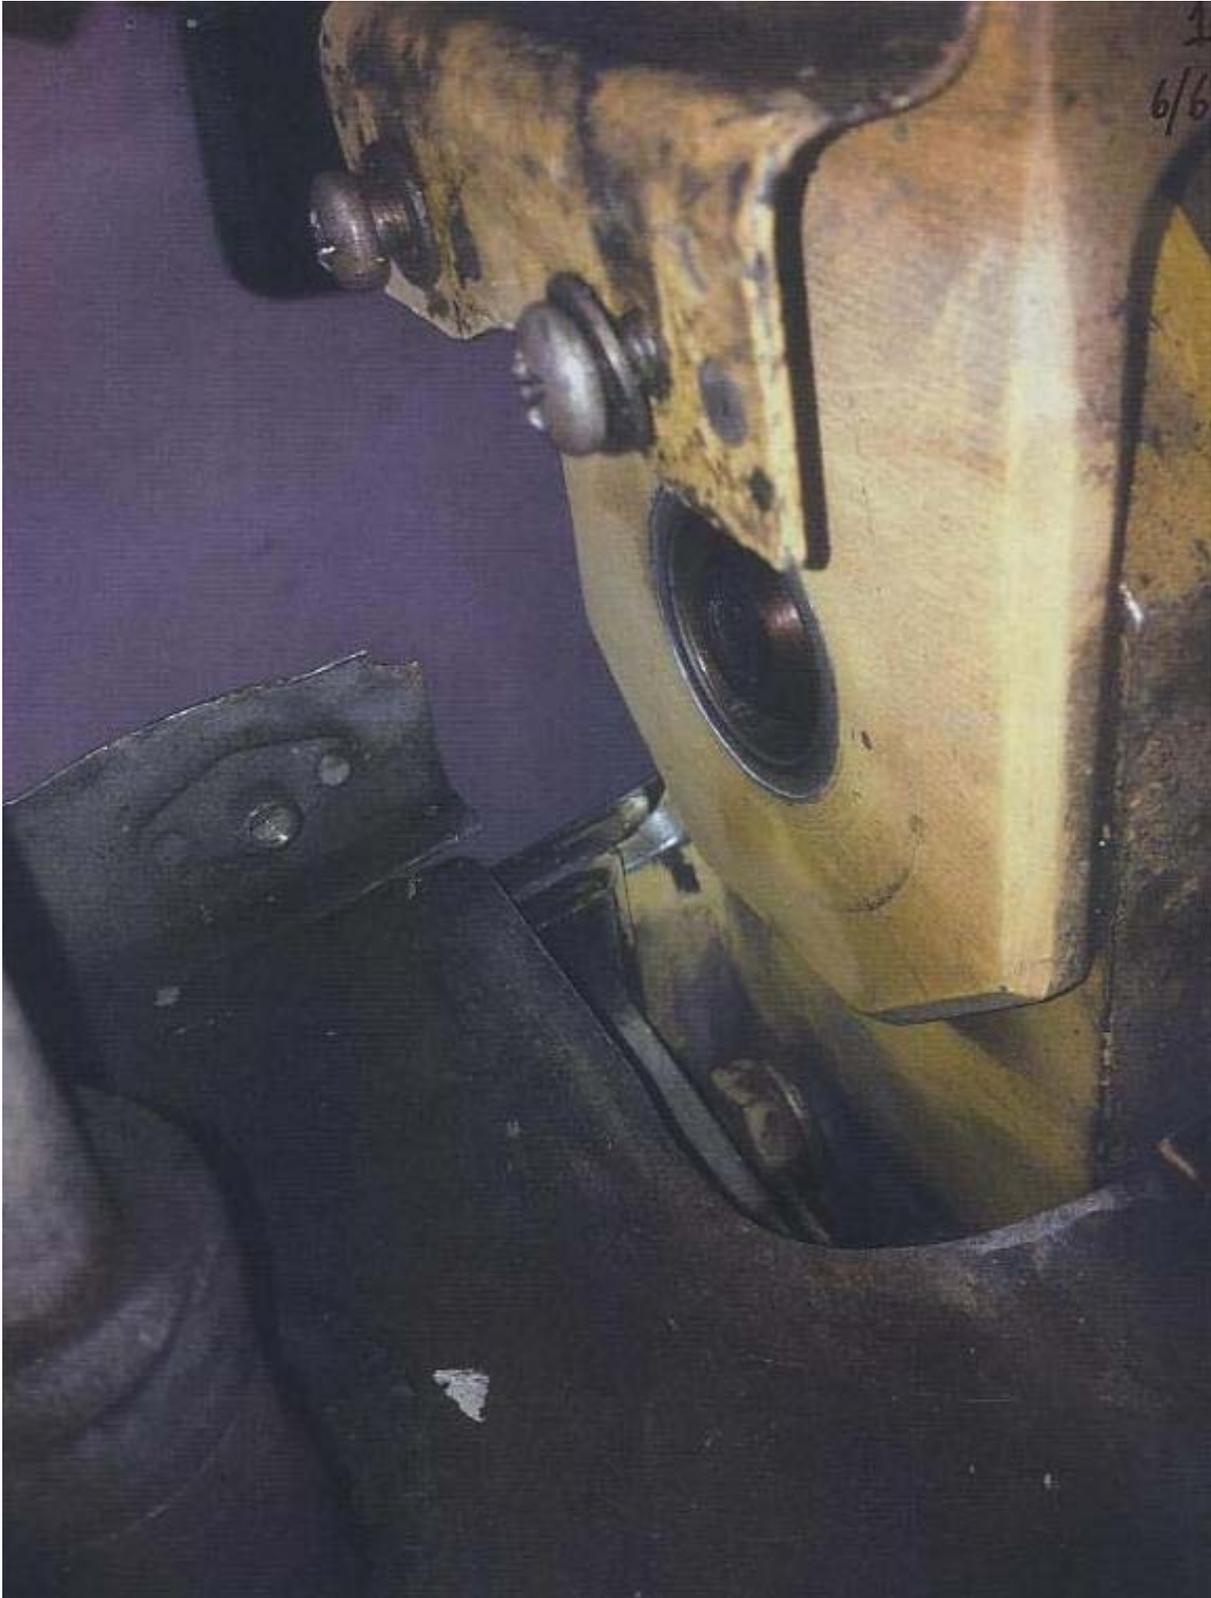
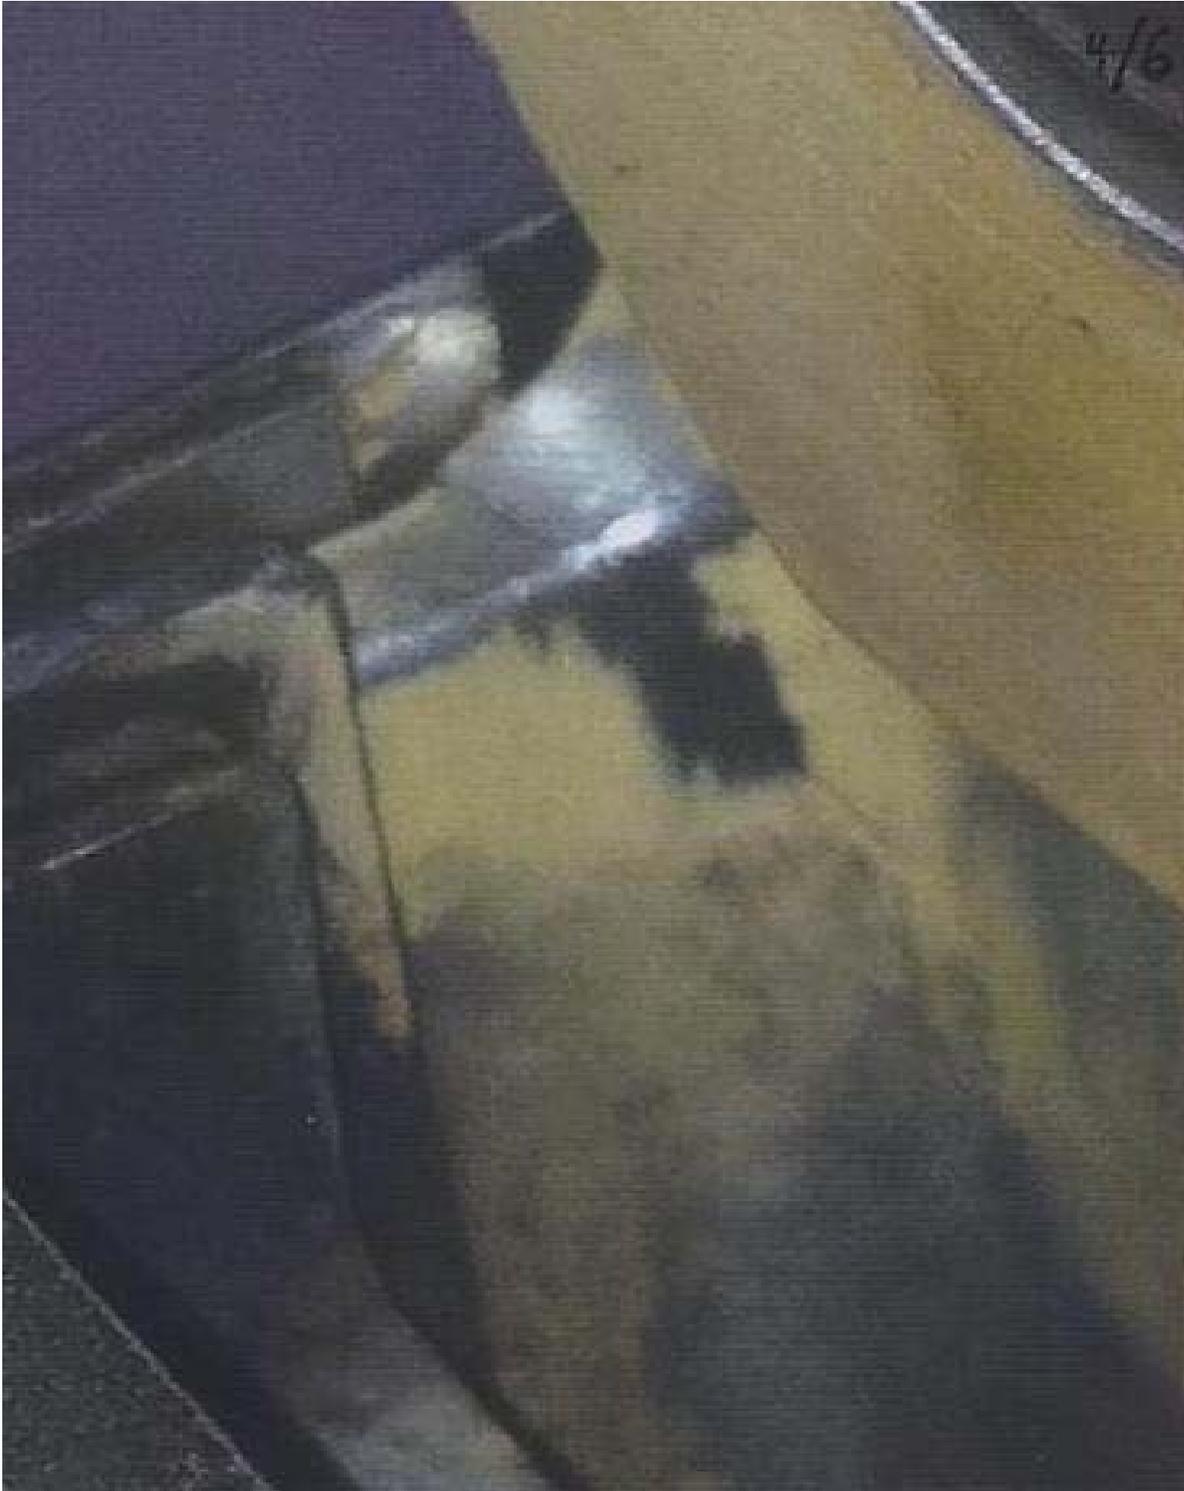
A general aviation submitter states, "While accomplishing a wing bolt inspection, the L/H lower wing spar attach shear fitting was found cracked (P/N 1011100731). This crack is approximately 0.75 inches long—located in the forward flange area."

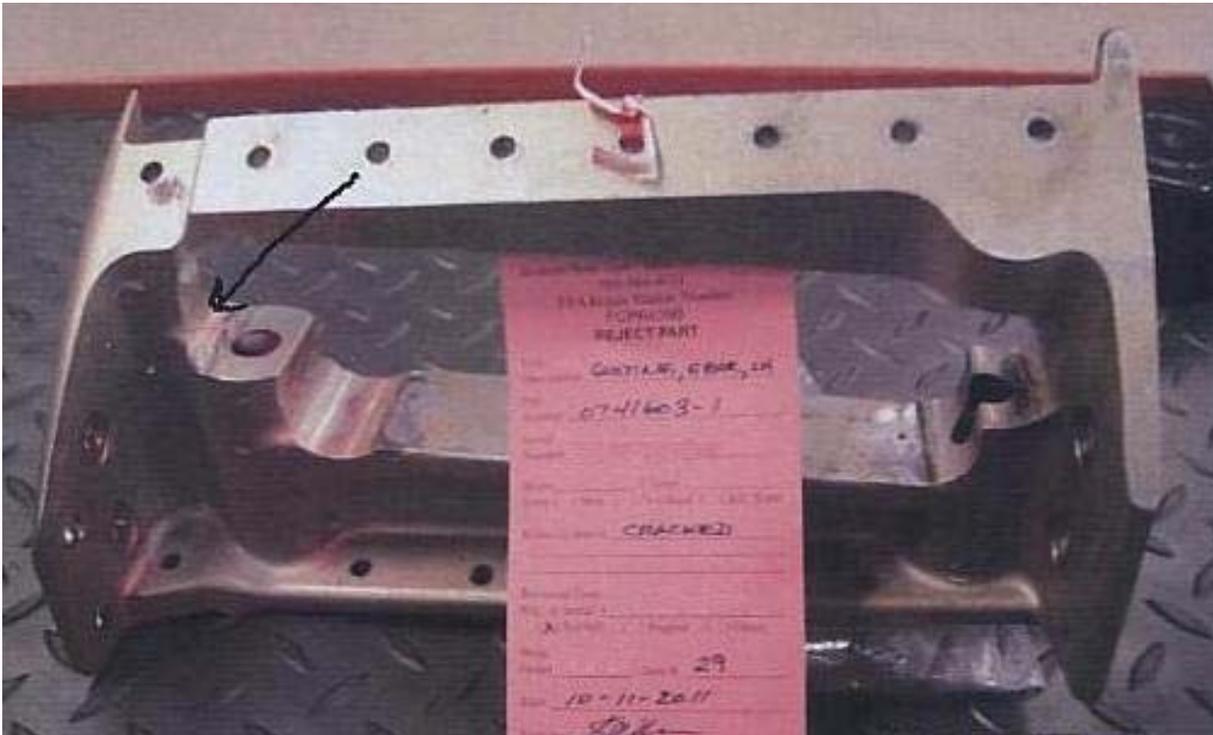
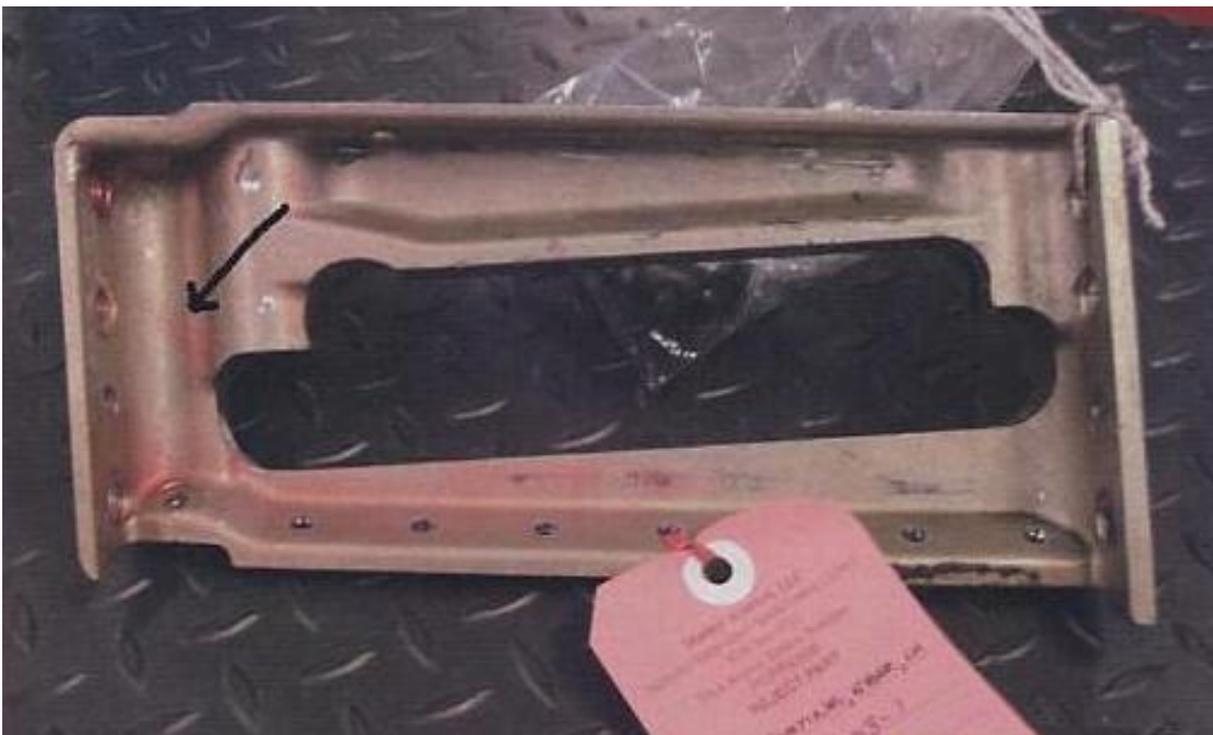
"The (*main landing gear attach*) casting crack was found by visual inspection," says the repair station technician. "The crack is located on the forward end of the support casting, and (*starts*) 0.25 inches from the mount holes on the outboard side (*and extends*) to within 0.25 inches of the mount holes on the inboard side of the casting (*P/N 07416031*)."

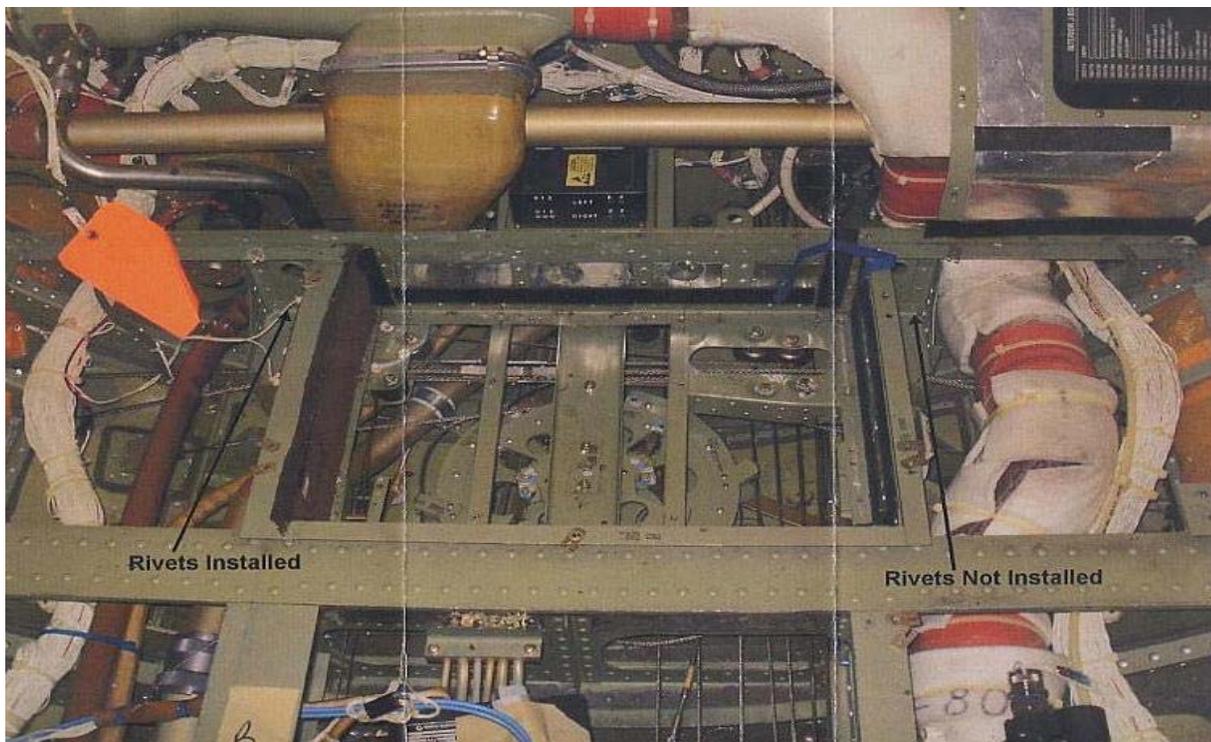
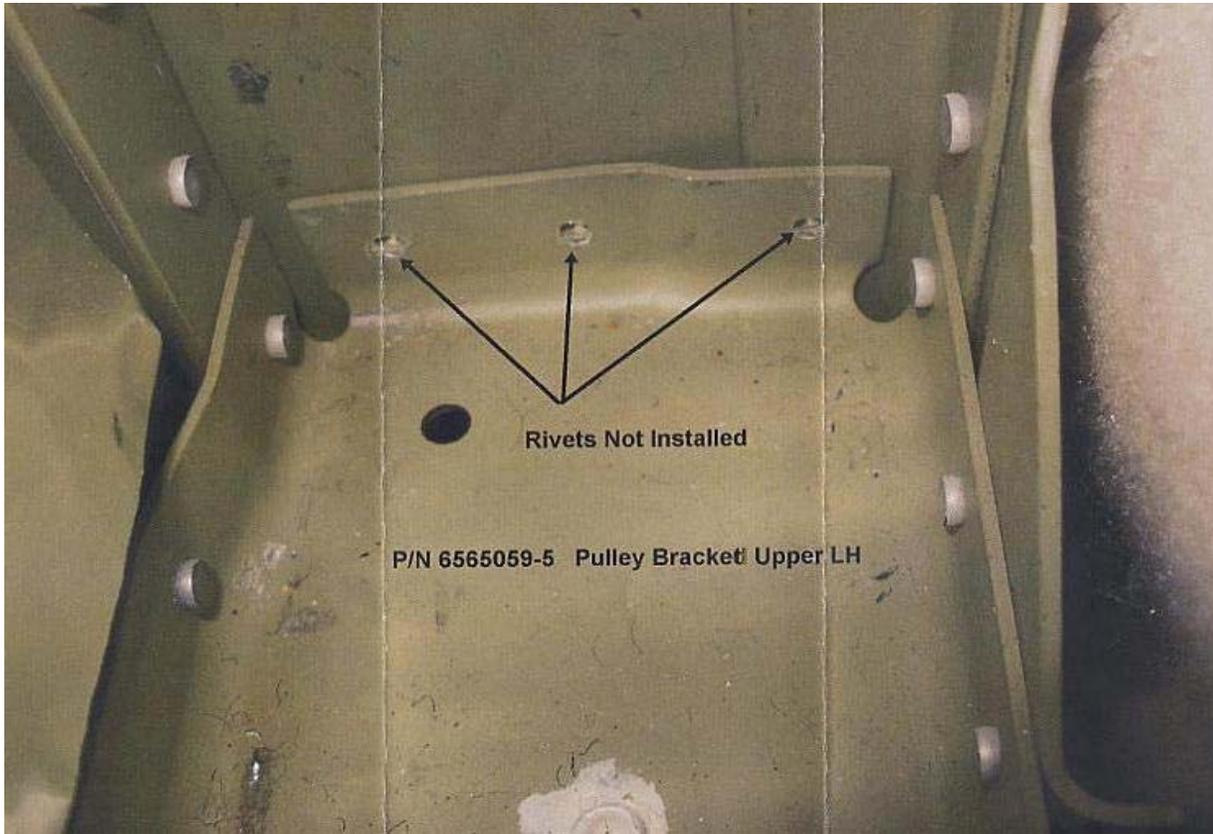
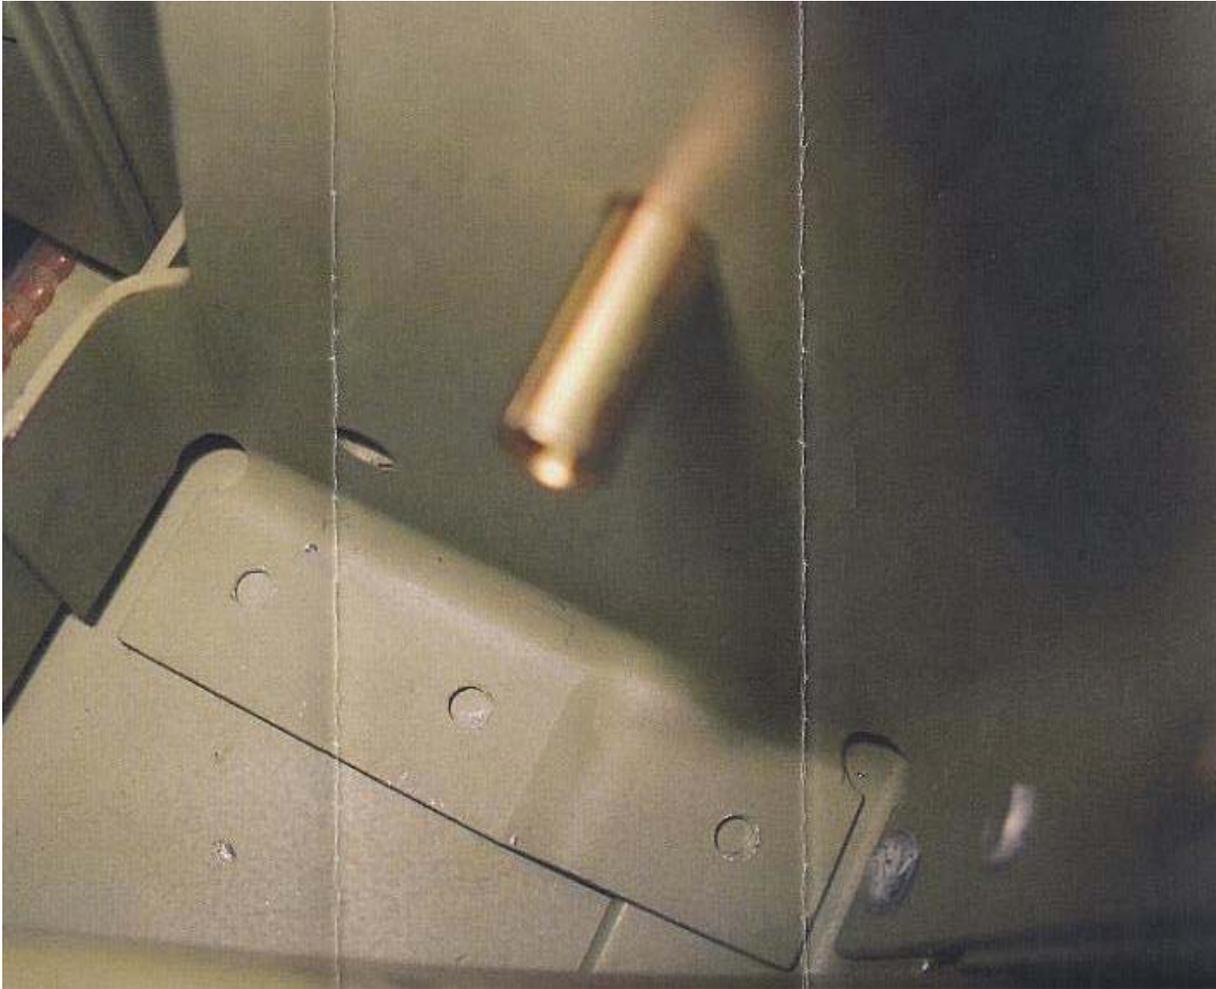
A repair station mechanic states, "Three each rivets were found missing from the upper and lower flap interconnect pulley brackets (P/N's 6565059-5 and 6565059-3) at fuselage station 354.00. *(These)* rivets were found missing while performing an under-floor inspection—presumably omitted during production."

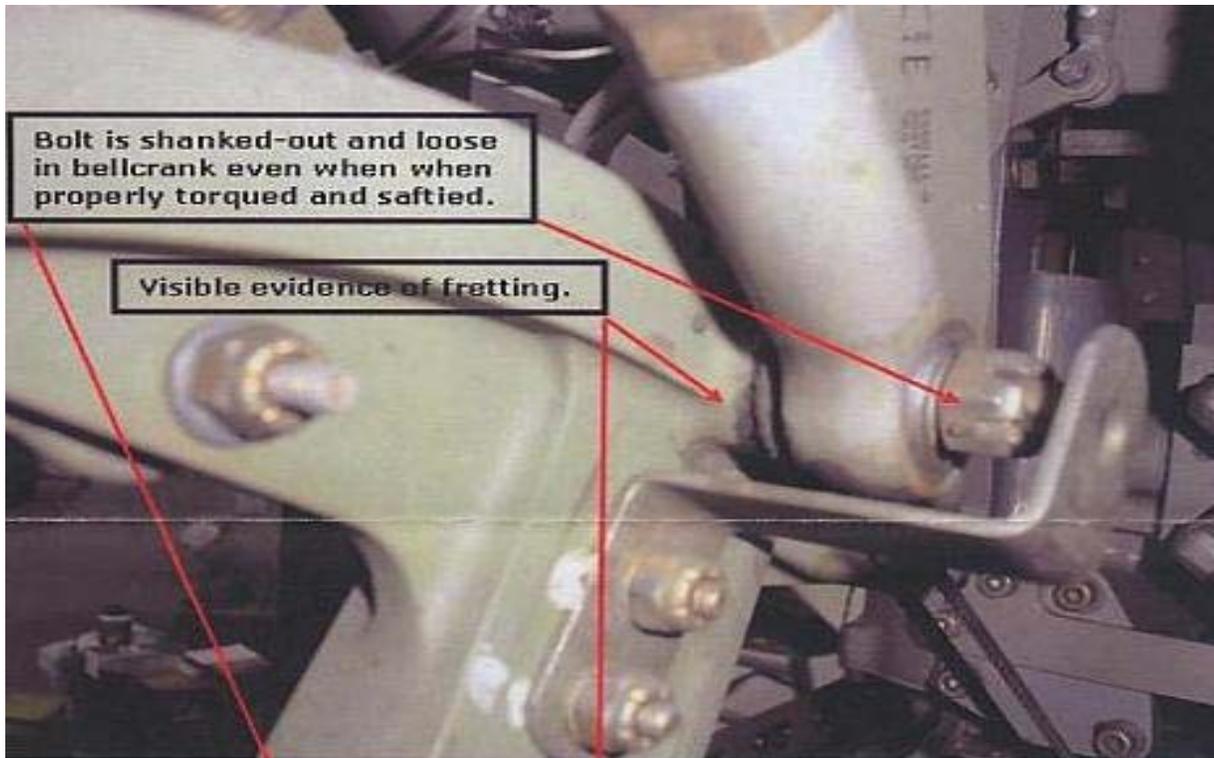
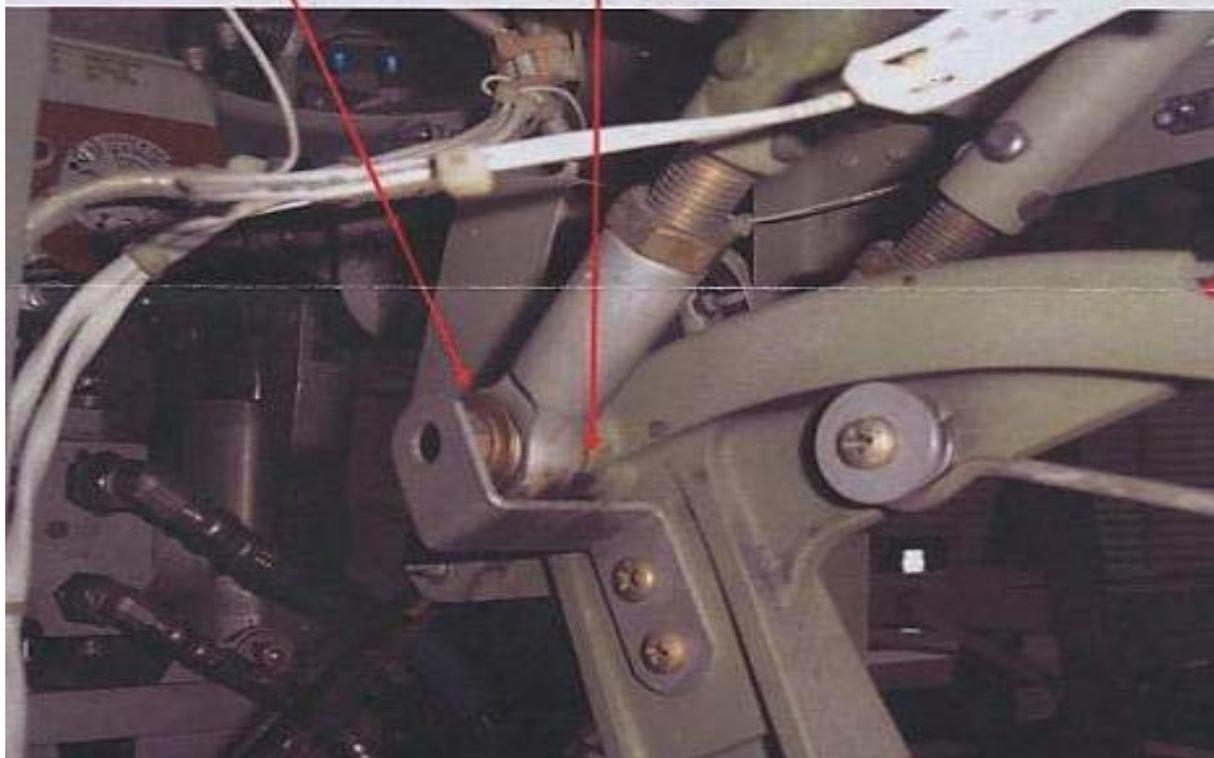
**Cessna 560XL SN 560-5805 @ 2347.0 Hrs TT LND 1802**

"(Note: *the location of this defect...*) is the rear of the aircraft in the compartment below the horizontal stabilizer attach point," says this repair station technician. "Two push-pull tubes that attach to the aft elevator bell crank (*have nuts*) that shank-out on the bolt. This allows the bolts to be rotated by hand, causing wear in the bell crank attach hole." "(Now) the bolt begins to rock back and forth in the hole, resulting in chafing between the attached parts."

"Recommendation: When installing hardware, assure the nut does not shank-out on the bolt. Replace the bolt if worn, and add washers as required to prevent the nut from (*bottoming on the bolt's shank*)."

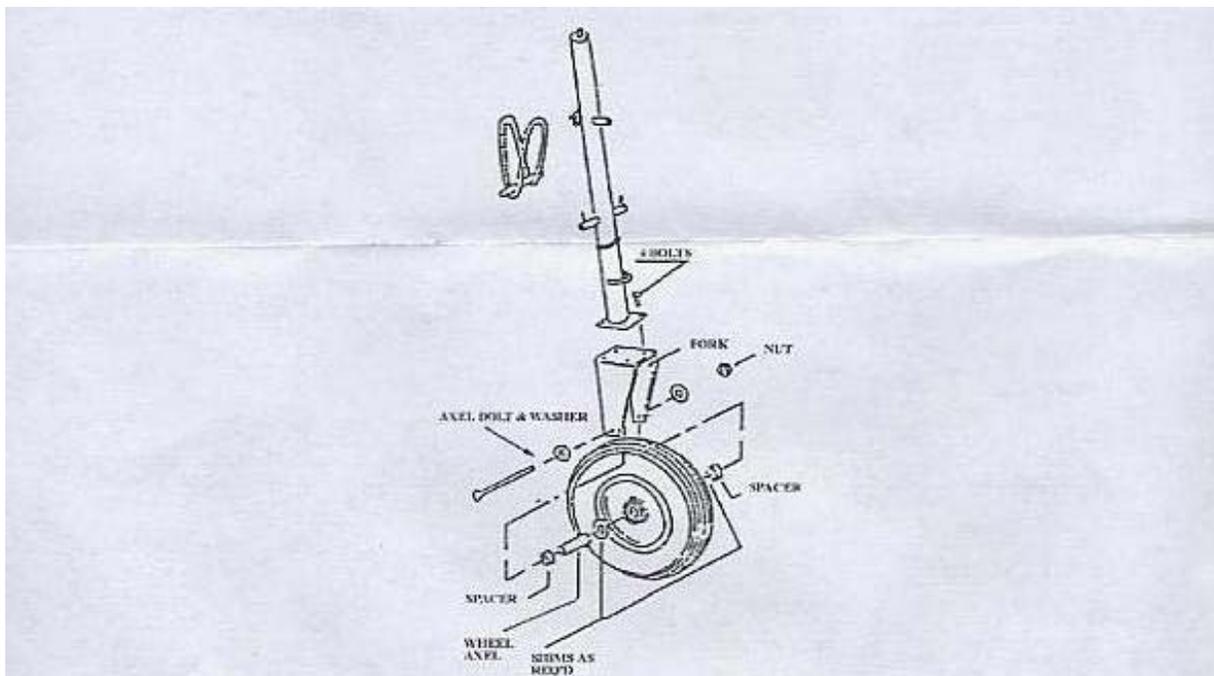
**Photo 1: Nose Landing Gear Assembly**

<b>BACKGROUND:</b> The Federal Aviation Administration (FAA) informed Transport Canada Civil Aviation (TCCA) of a NLG weld failure and crack findings of another NLG weld of a CH2000 aeroplane.  The incident report states that the first landing by a flight instructor and student was smooth and uneventful. While the second landing was also smooth, when the nose touched down, the instructor noticed the nose gear fork exit on the left side of the aeroplane and shot past the nose of the aeroplane. The remaining nose gear leg contacted the runway surface and supported the nose but the reduced clearance allowed the propeller blades to contact the runway.  Inspection of the aeroplane showed that the plate welded onto the bottom of the nose gear leg (Photo 1) failed, causing the nose gear fork to separate from the nose gear leg.		<b>CONTEXTE :</b> La Federal Aviation Administration (FAA) a fait part à Transports Canada, Aviation civile (TCAC) de la défaillance d'une soudure et de la présence de fissures sur une autre soudure du train avant d'un CH2000.  Le rapport d'incident stipule que le premier atterrissage effectué par un instructeur de vol et son élève s'est fait en douceur et sans encombre. Bien que le deuxième atterrissage a été fait également en douceur, au moment où le nez de l'aéronef se posait au sol, l'instructeur a vu la fourche du train avant filer du côté gauche de l'aéronef et se diriger au-delà du nez de l'appareil. La partie restante de la jambe du train avant a touché la surface de la piste et a continué à supporter le nez, mais la garde au sol étant devenue insuffisante, a permis les pales de l'hélice à heurté la piste.  L'inspection de l'aéronef a révélé que la plaque soudée à la base de la jambe du train avant (photo 1) avait cédé, entraînant la séparation de la fourche par rapport au reste de la jambe du train avant.

TCCA strongly recommends all affected owners and operators pay close attention to the NLG weld area both during scheduled maintenance activities and following every hard landing per Zenair Ltd. Service Manual instructions.

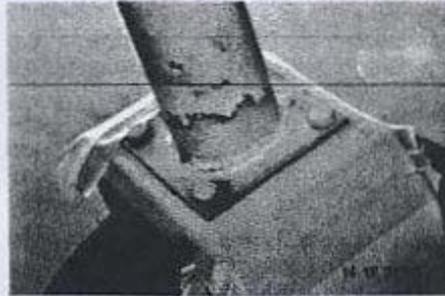
Additionally, the operator found cracks developing in the weld of another CH2000 aeroplane's NLG (Photo 2).

**Photo 2: Cracking on the NLG leg and plate weld**

A review of Service Difficulty Reports did not find additional occurrences. An investigation by Zenair did not reveal a root cause. It is believed that the weld cracking is due to "excessive hard NLG landing, exceeding the design limits. The nose wheel fork may flex and bend the square steel plate welded to the structure resulting in possible metal fatigue and eventual cracking."

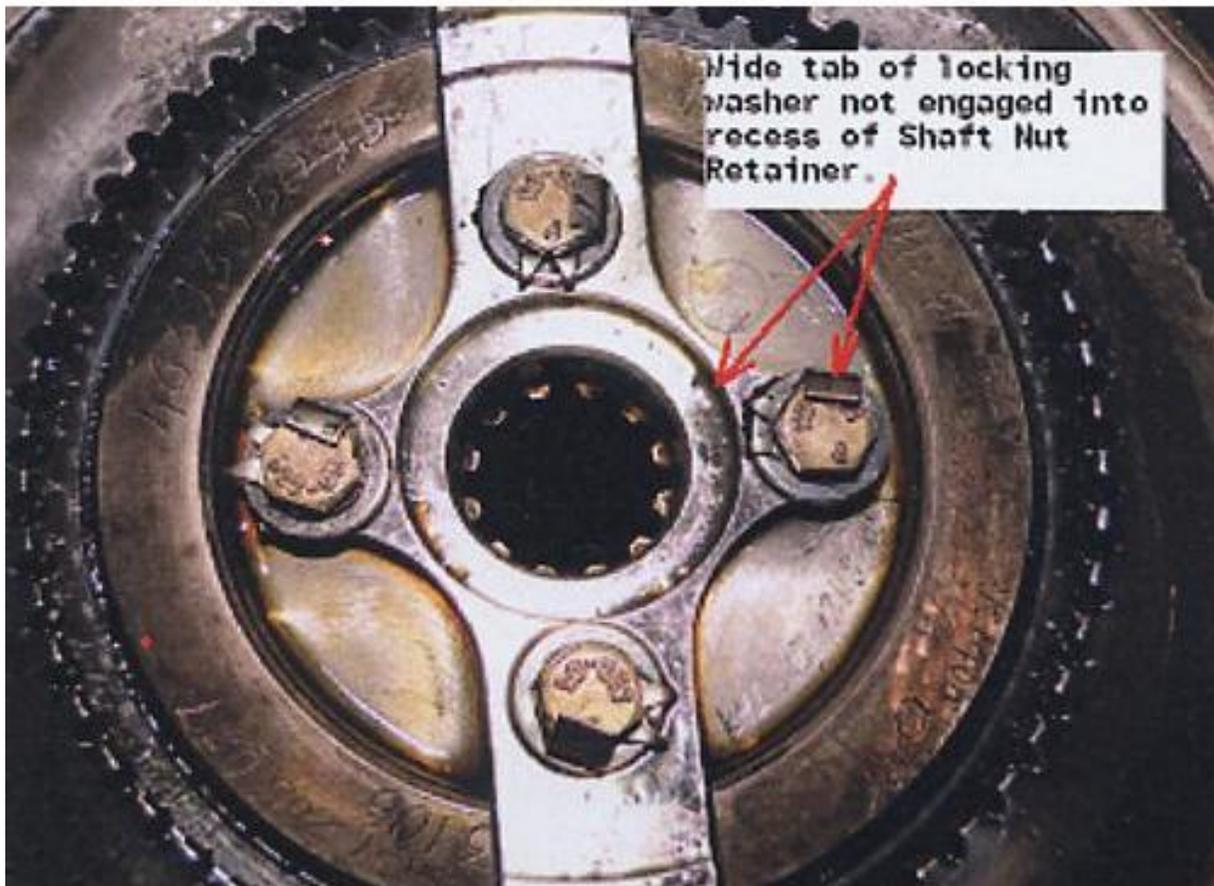
IMPROPER

"The incorrect application of locking washers on the Rotor Shaft Nut retainer lock (P/N 117-12118-01) occurred during installation of the replacement Rotor Shaft," says this technician. It was discovered while performing Main Gearbox lower casing repair (removal of the rotor shaft is required)." (*Lock washer P/N: LN9023B5-145449.*)

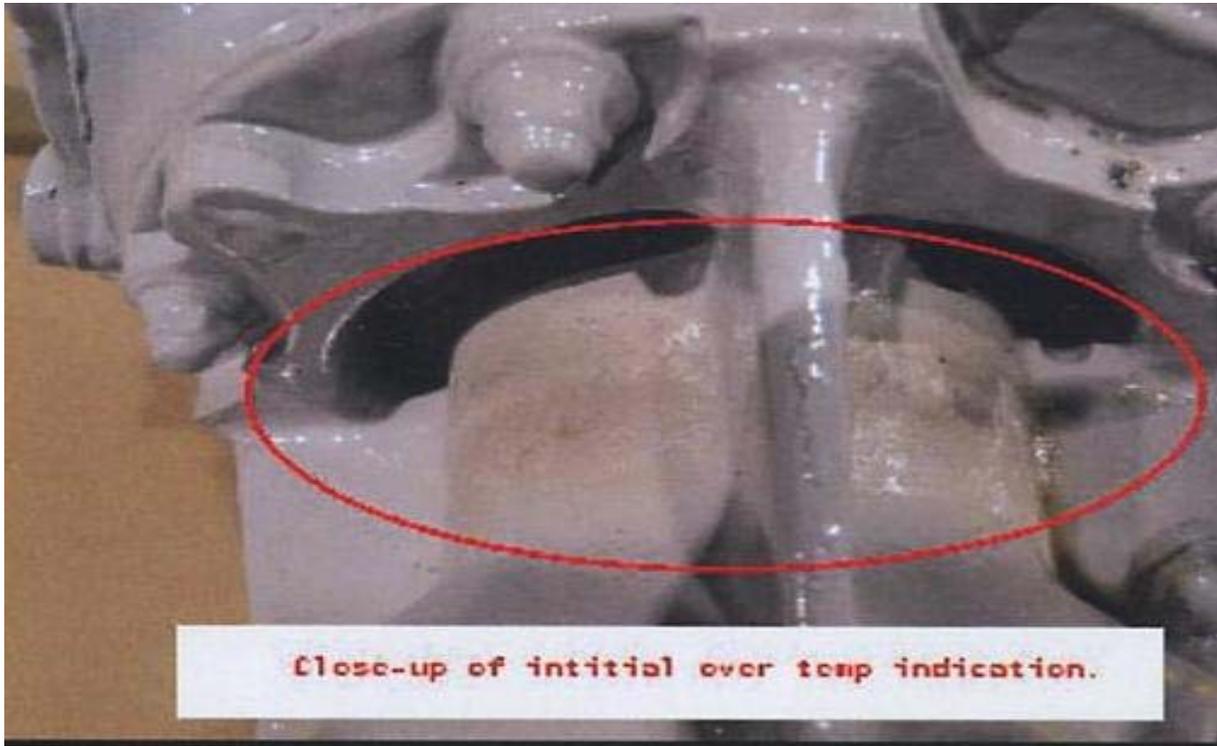
A mechanic states, "Failure of the Input Pinion Tapered Roller bearing (in the Tail Rotor Gearbox) occurred during ground run after maintenance. This gearbox is discolored due to overheating of the failed (seized) bearing." (*Bearing P/N: 704A33-652-044; Gearbox P/N: 365A33-6005-08.*)

Close-up of initial over temp indication.

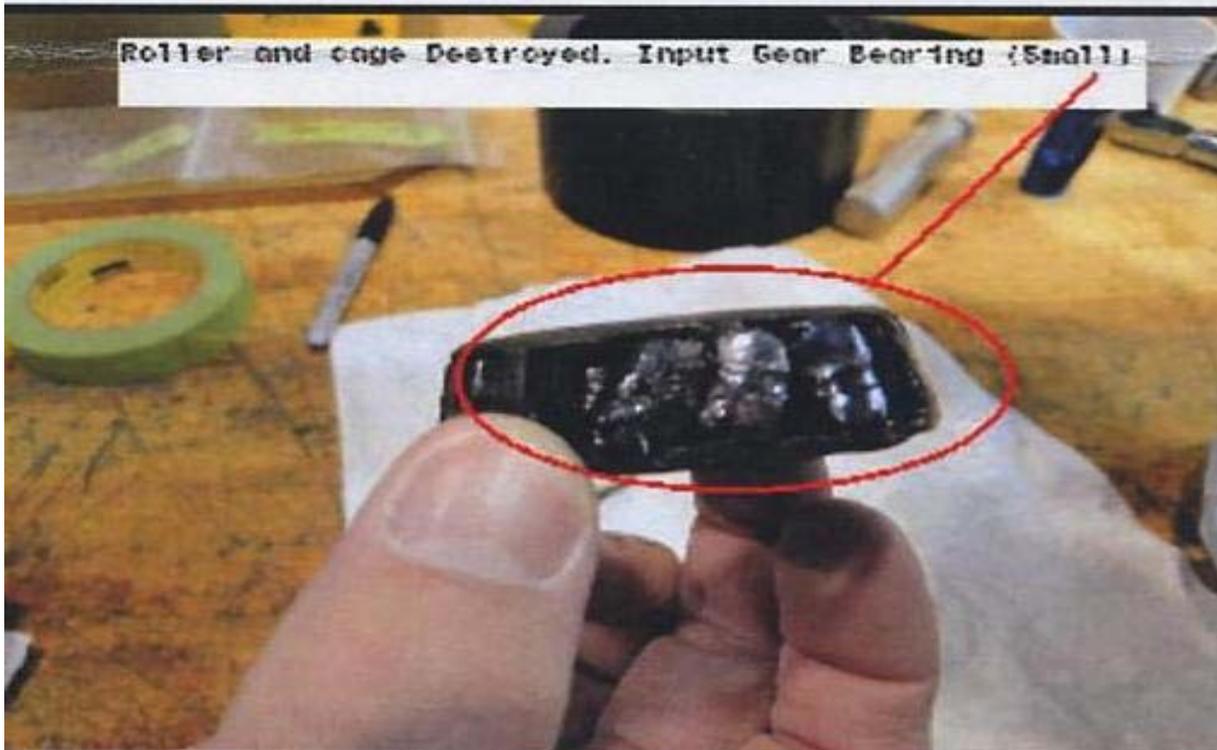
Roller and cage Destroyed. Input Gear Bearing (Small)

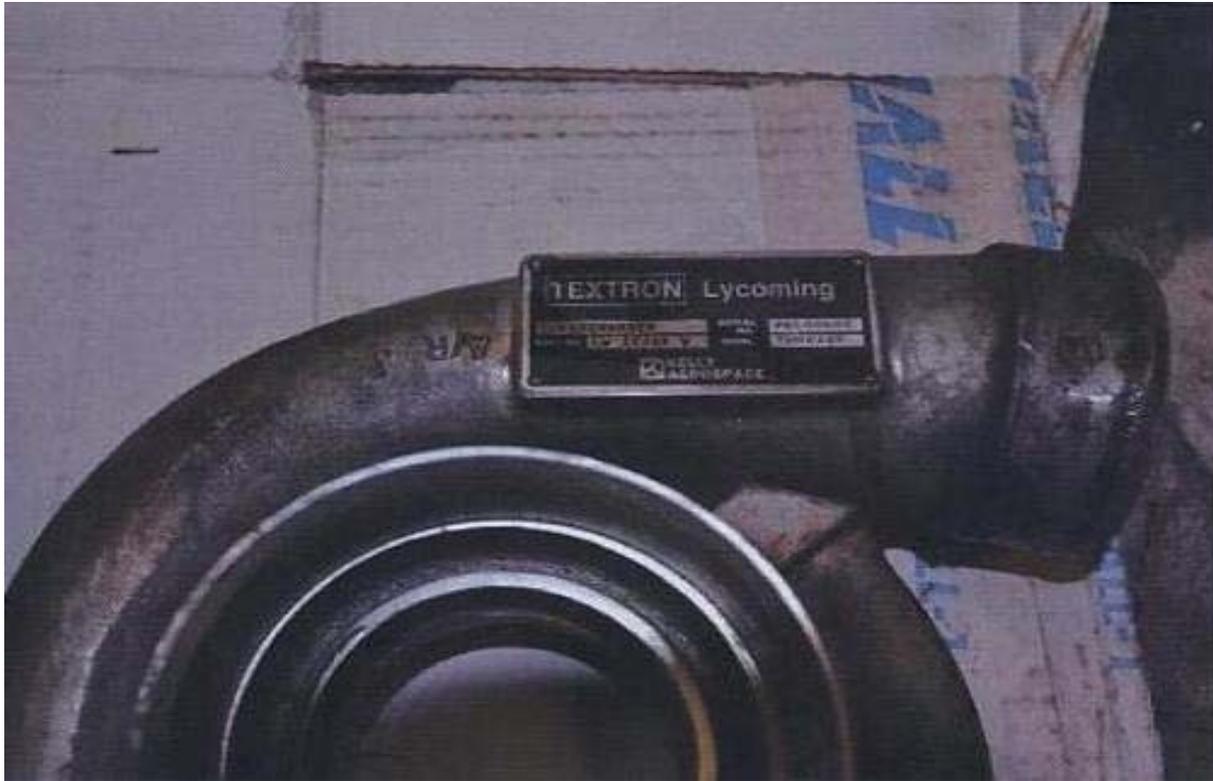
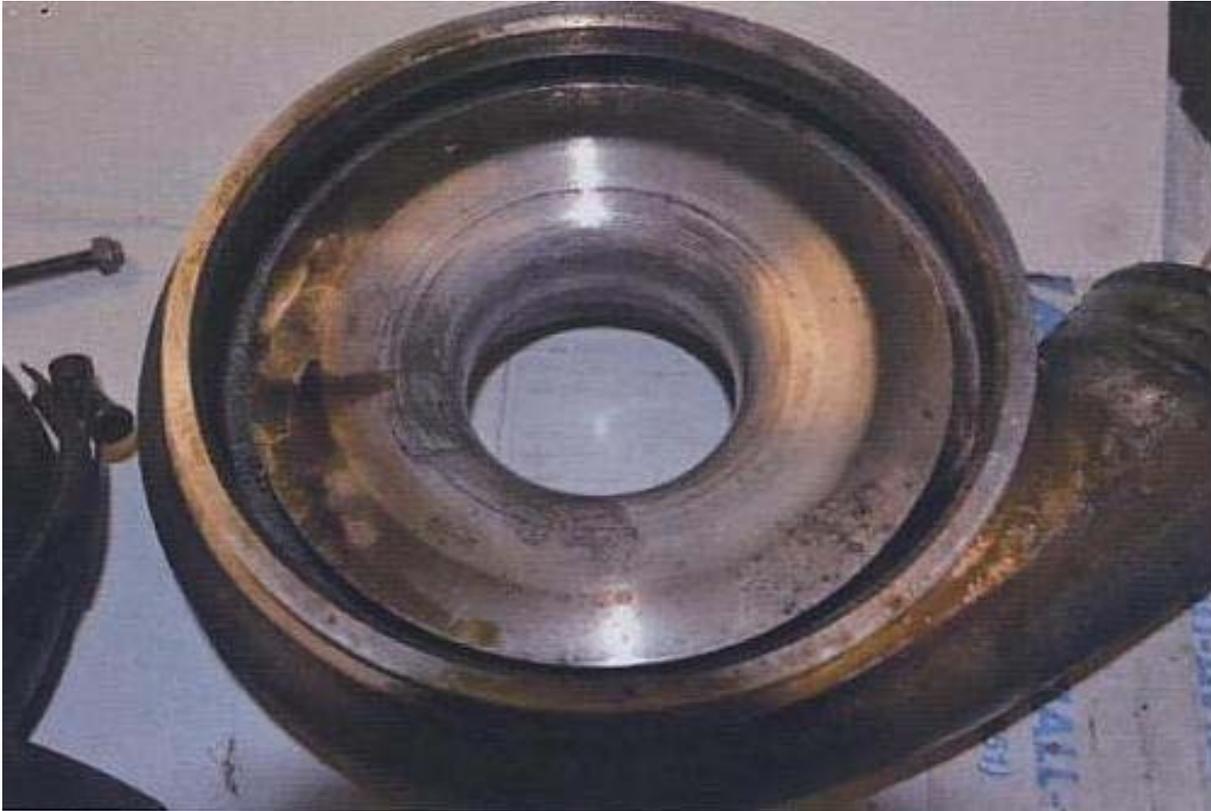
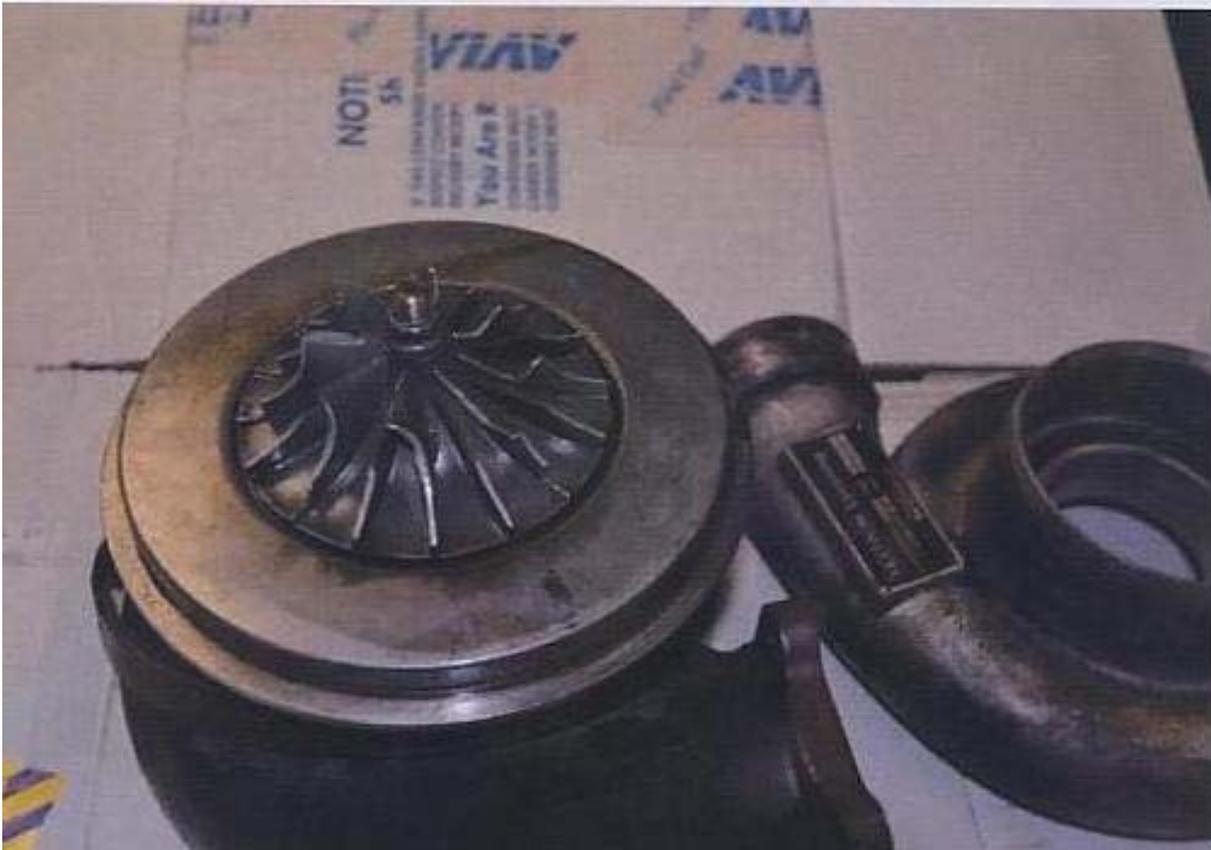
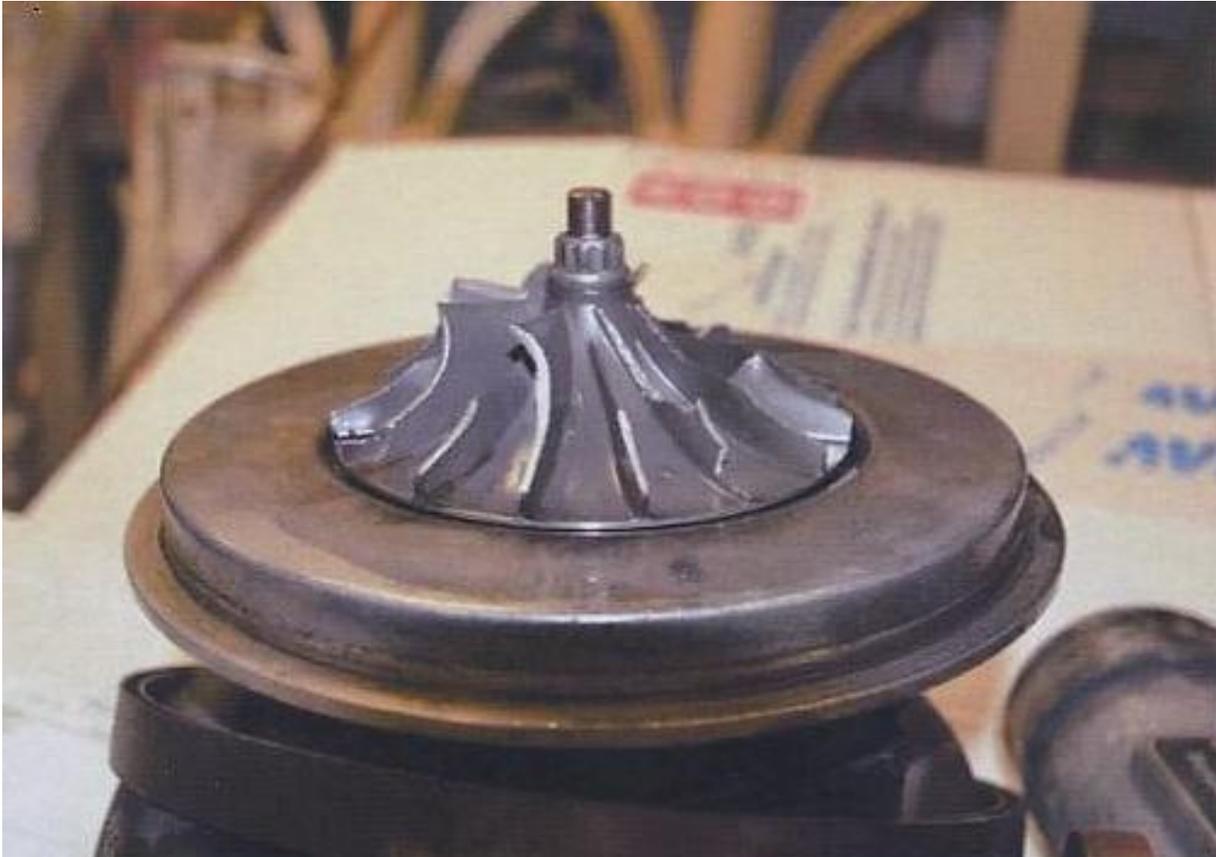
An air carrier submission says, "After landing touch-down, smoke was noticed exiting the rear of the R/H engine." "The turbocharger's main bearing (*had failed*), allowing the impeller to hit the housing, causing it to loose blades. Oil was able to get through the seals on the compressor (extremely hot turbine side), causing the fire and smoke. There was no external fire in the engine compartment. (*Existing*) fire was contained within the exhaust system, (*allowing for*) no visible fire damage...when the engine was inspected." (*Turbocharger P/N: LW12463W.*)

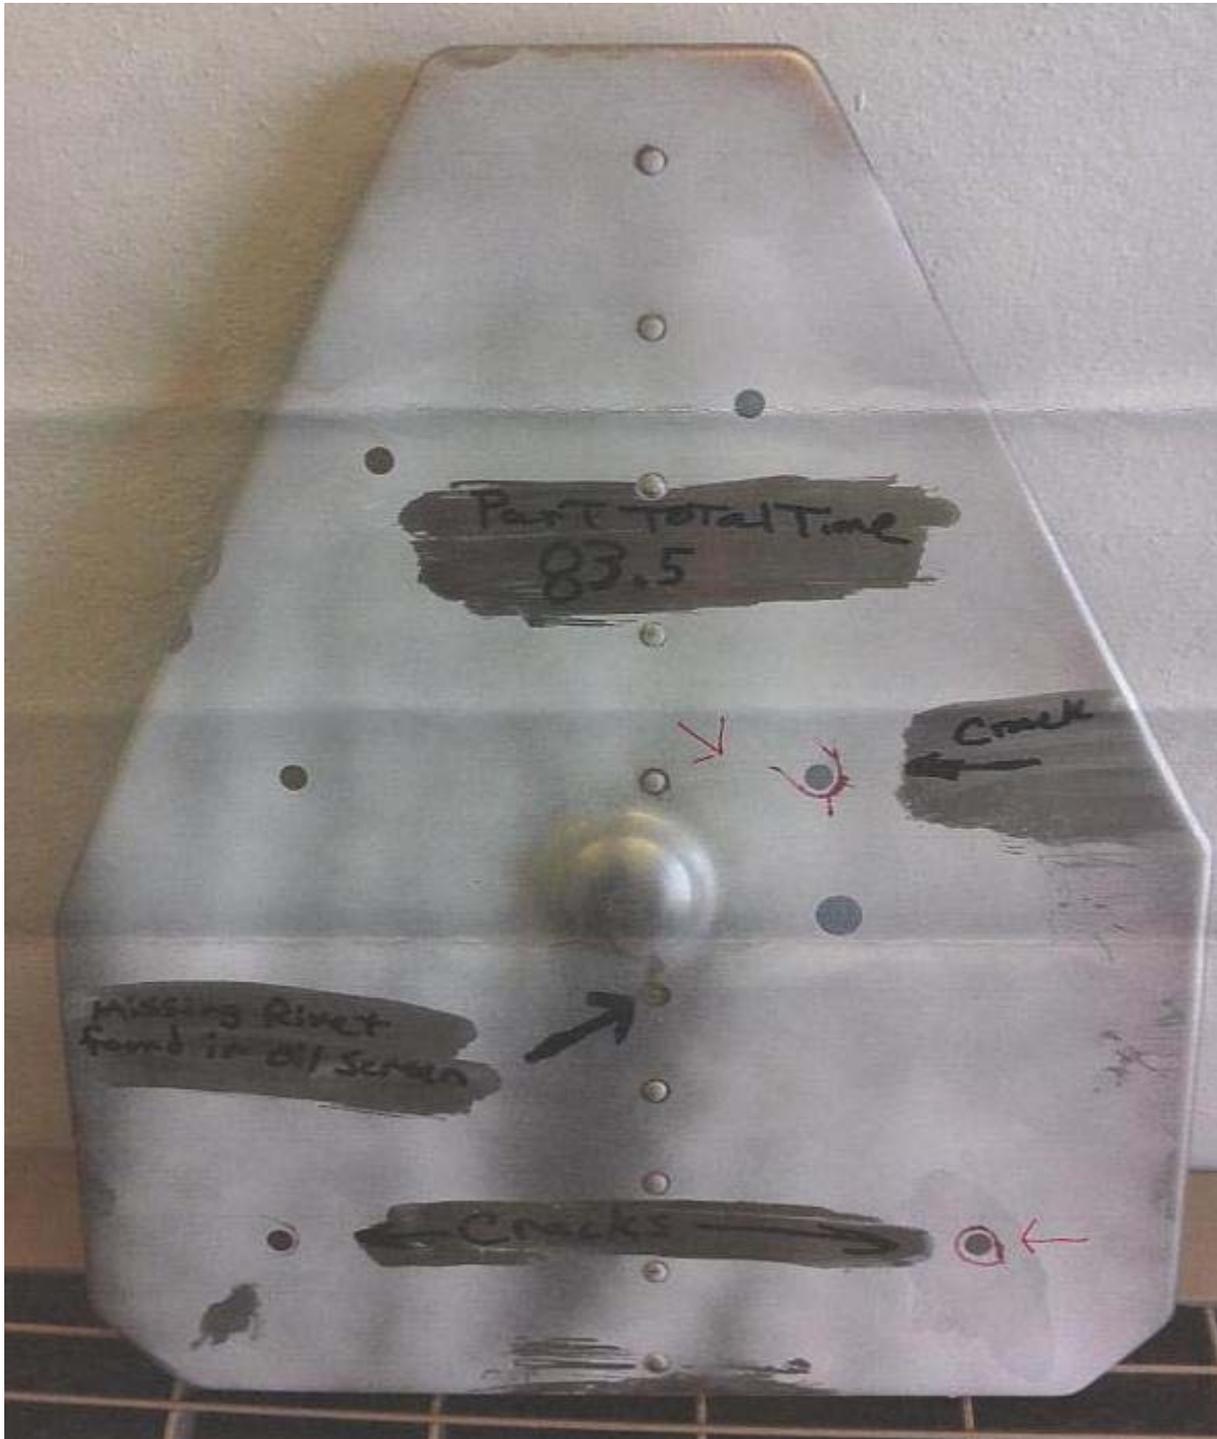
"This baffle (P/N LW-13383) has been replaced by a second (P/N 56G23399) and a third (P/N 56G26069)," states this mechanic. "During the first 50 hour inspection, the suction oil screen was removed for condition inspection. (I) found the head of a steel rivet in the screen. I consulted the parts catalogue figure 23 (*for the broken rivet's possible original location*) and found baffle (item 1) to have a rivet assembly. I then removed the oil sump and induction housing." "The oil baffle had one rivet head missing, and I noted three of the six attaching holes had circular cracks emanating from under the washers. After removal of all the attaching bolts and washers, it was noted all (*housing*) attaching (*points*) had been (*scored*) by the sharp edges of the washers."
