## ADVISORY CIRCULAR

43-16A

# AVIATION MAINTENANCE ALERTS

**ALERT  
NUMBER  
400**

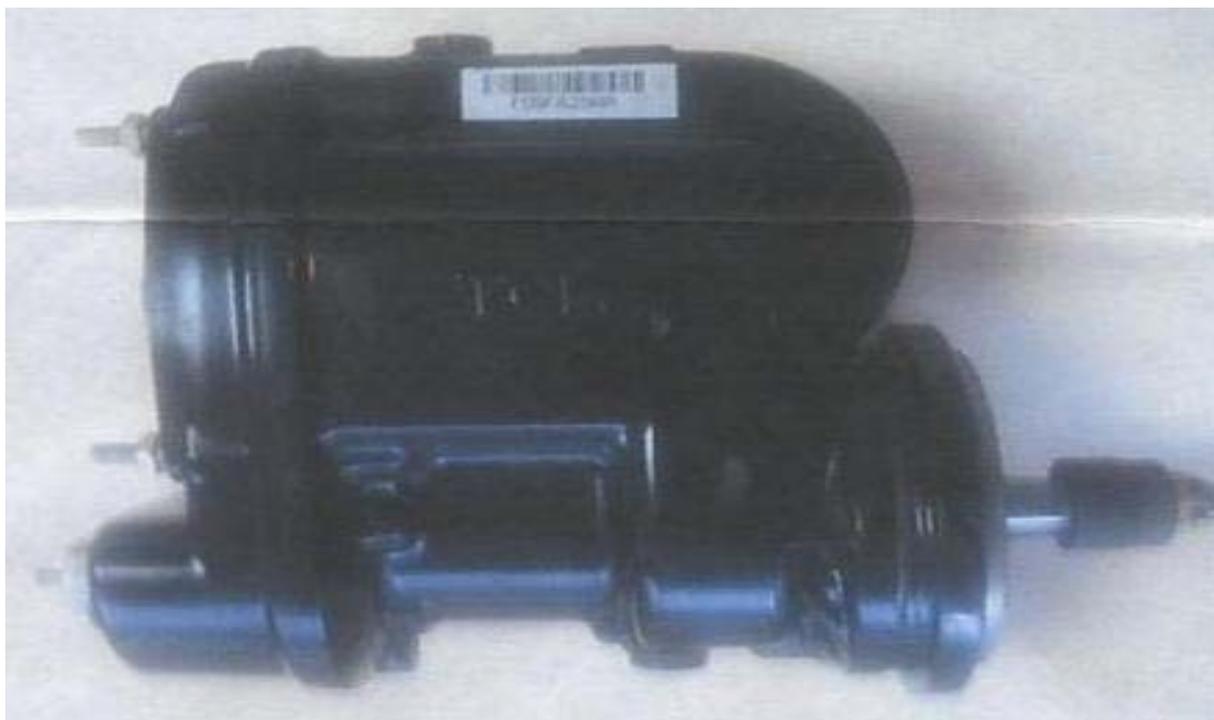
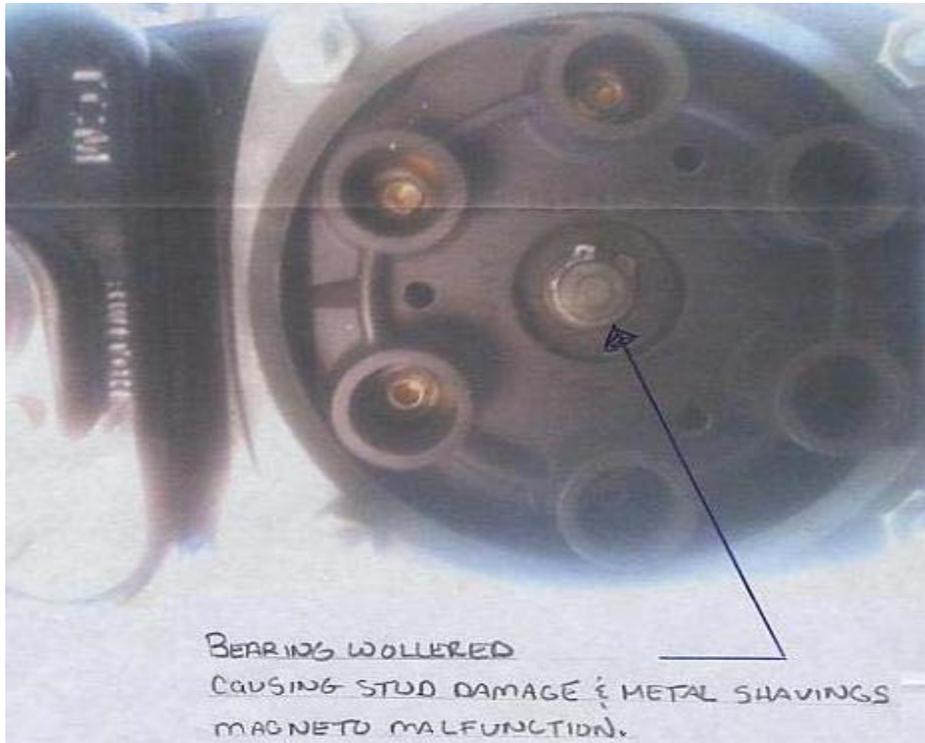
A mechanic says, "The pilot reported the R/H magneto failure. (*This unit*) was inspected for security of attachment and correct timing to the engine." "The magneto (*P/N BL-349310-1*) was removed and disassembled. Upon inspection, the brass (or brass appearing...) metal shavings (*were observed*) under the distributor cap and near the gear. The distributor gear was loose in the bearing— allowing the (*rotor*) to contact the ignition studs (four of six), wearing them down excessively. This caused the gaps to be excessive, (*resulting*) in the magneto failing to produce spark. We were informed only 60 hours (and 11 months) of service had (*accumulated*) on this magneto. This unit is a remanufactured magneto. No other damage was observed." "A replacement unit was installed and operationally tested without defect."
