## ADVISORY CIRCULAR

43-16A

# AVIATION MAINTENANCE ALERTS

**ALERT  
NUMBER  
401**

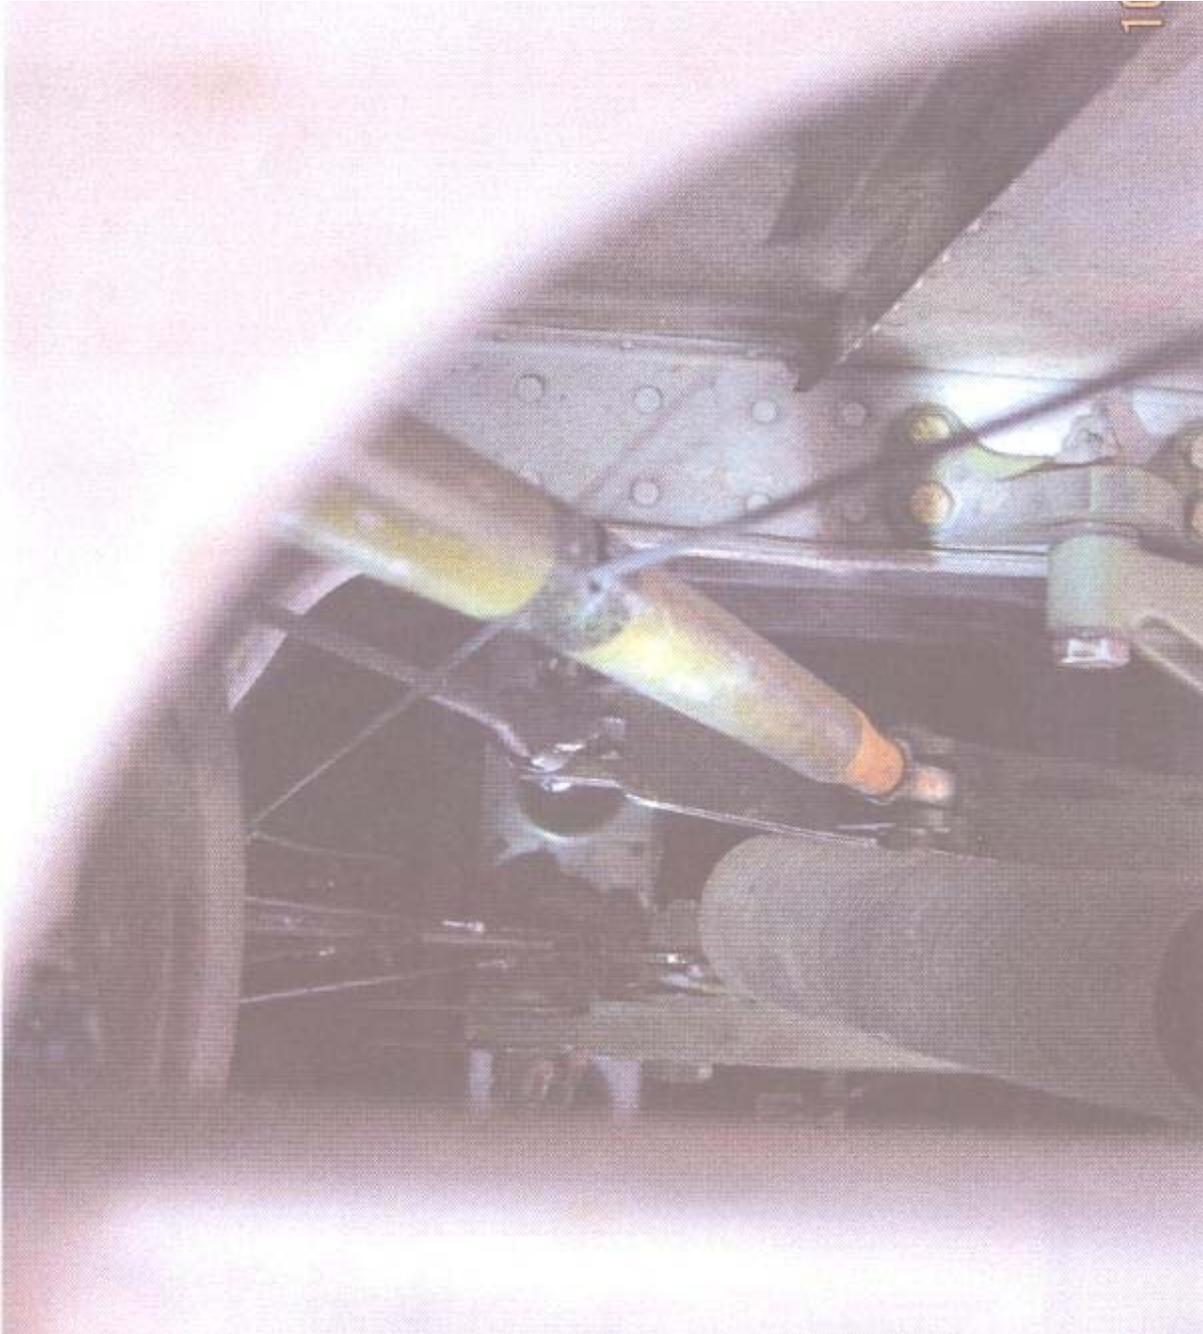
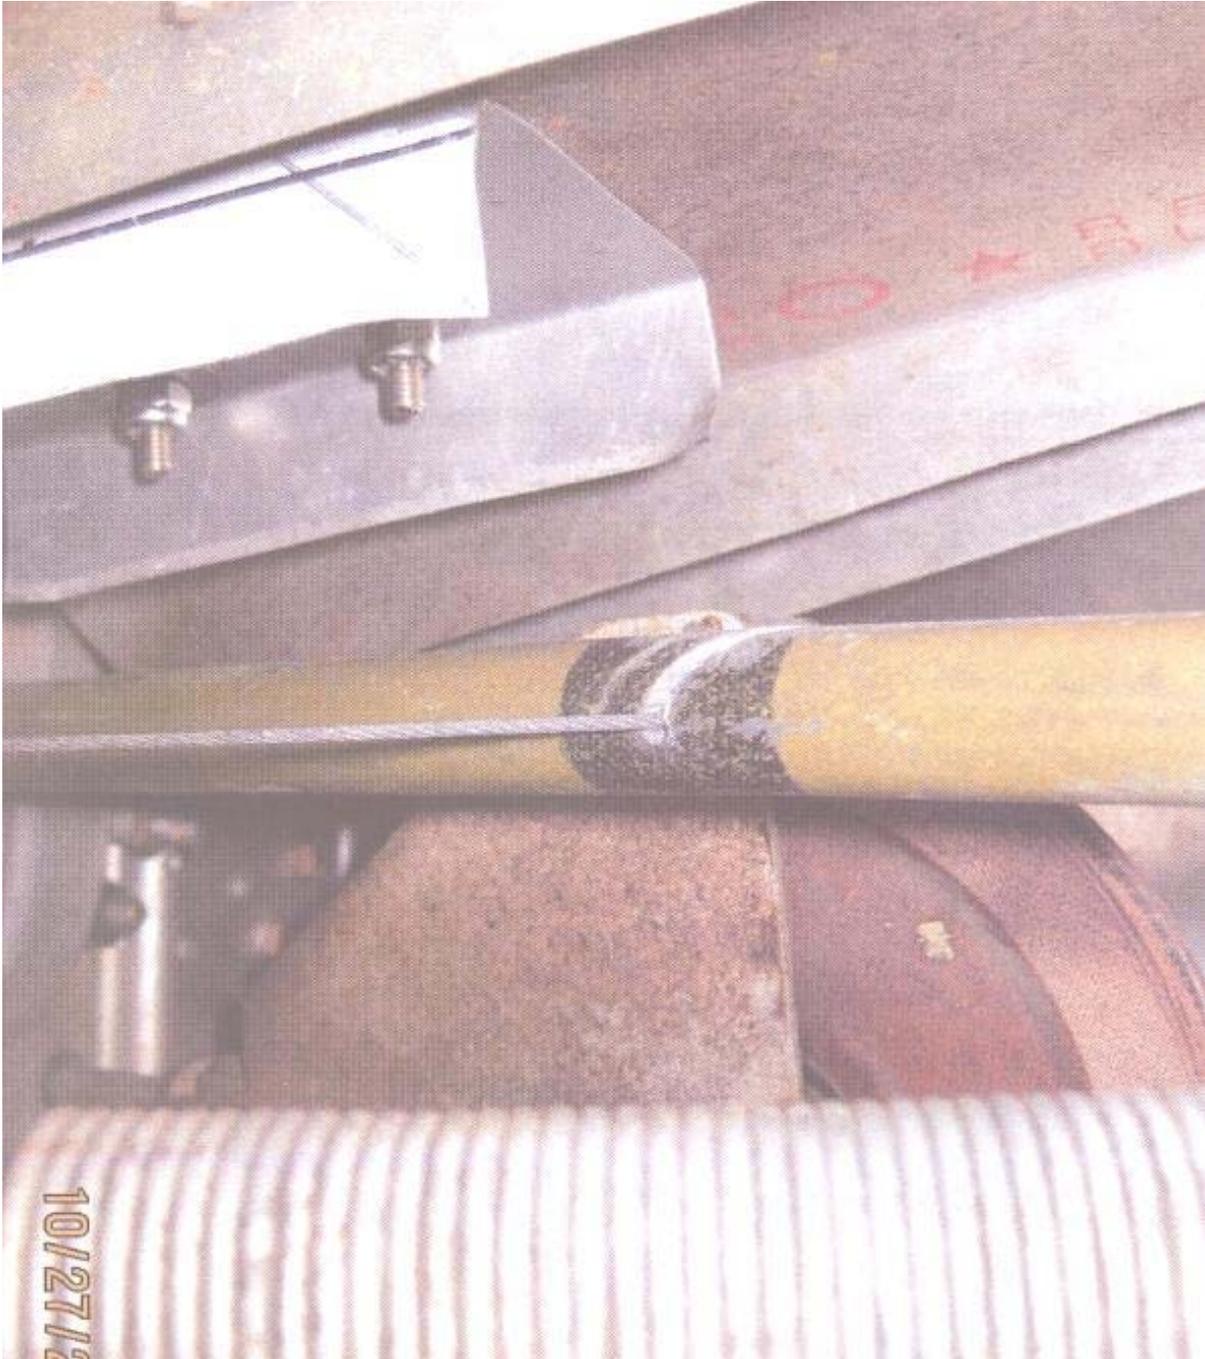
**Beechcraft: V35A; Cut Rudder Control Tube; ATA 2720**

A general aviation submitter says, "During the performance of an Annual Inspection, an IA (*inspection authorization*) found the right ruddervator trim control cable was routed incorrectly and had cut through the right ruddervator control tube (approximately 75%). The tube also had signs of a crack originating from the damaged section of the tube (cut area), and had begun to bend as a result of weakening of the tube as it was being cut. There were no maintenance entries noted in the log book to determine when this may have occurred." (*If this doesn't rate a steak dinner reward...nothing does!—Ed.*)

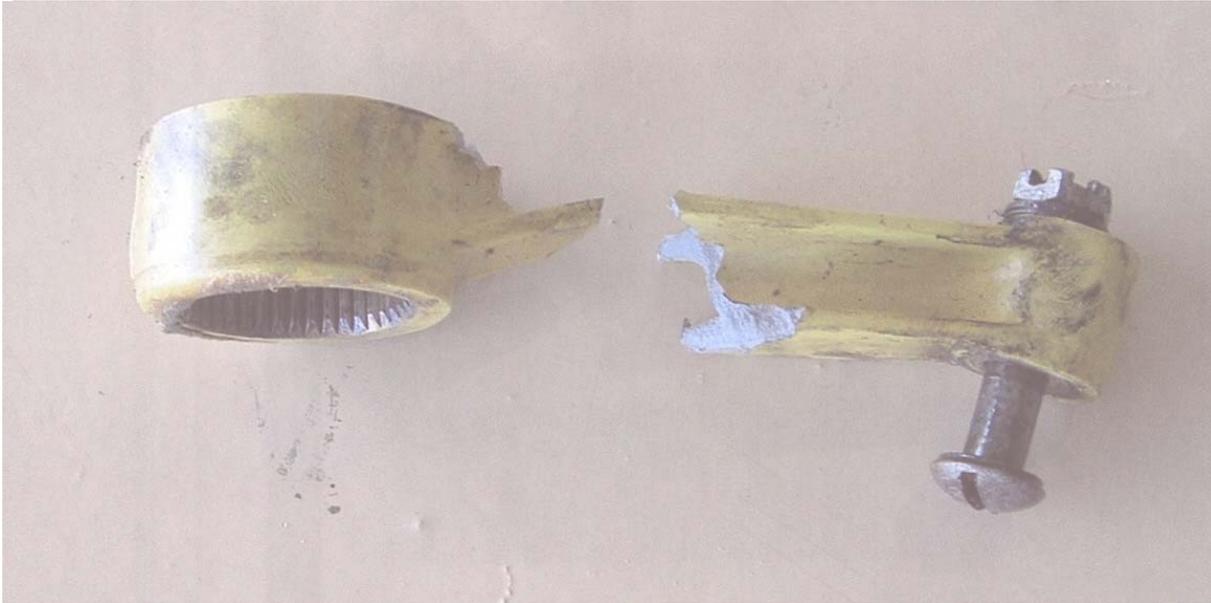
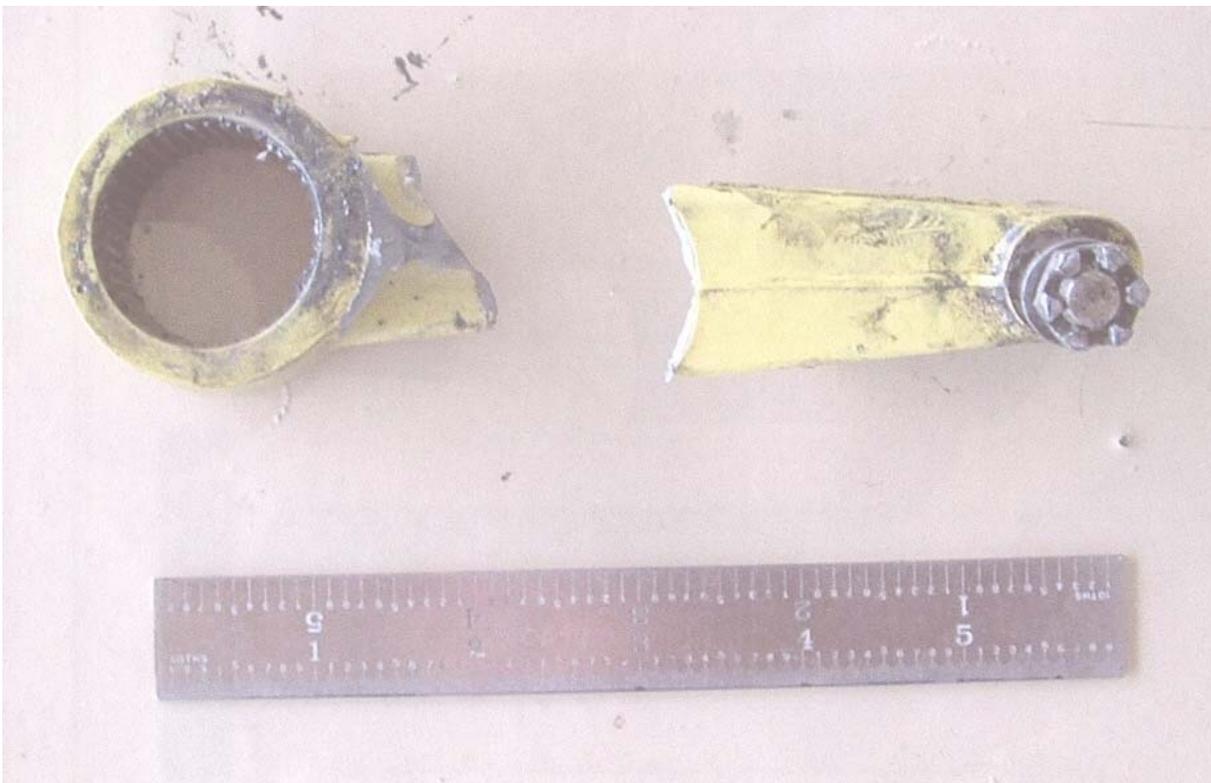
**Beechcraft: 58; Broken Nose Gear Retraction Arm; ATA 3233**

"The nose gear arm (P/N 35-825172-13) failed upon extension of the landing gear on approach...," writes this mechanic. "The pilot reported hearing a 'bang'—and could not get a nose gear 'down' indication. After a fly-by and attempts to extend the gear, it was determined the nose gear would not come down and lock. The pilot landed the aircraft—(and) the nose gear collapsed. (This) caused significant damage to the aircraft, including propeller strikes and sudden stoppages of both engines. Actual cause of the part failure has not been determined at this time."

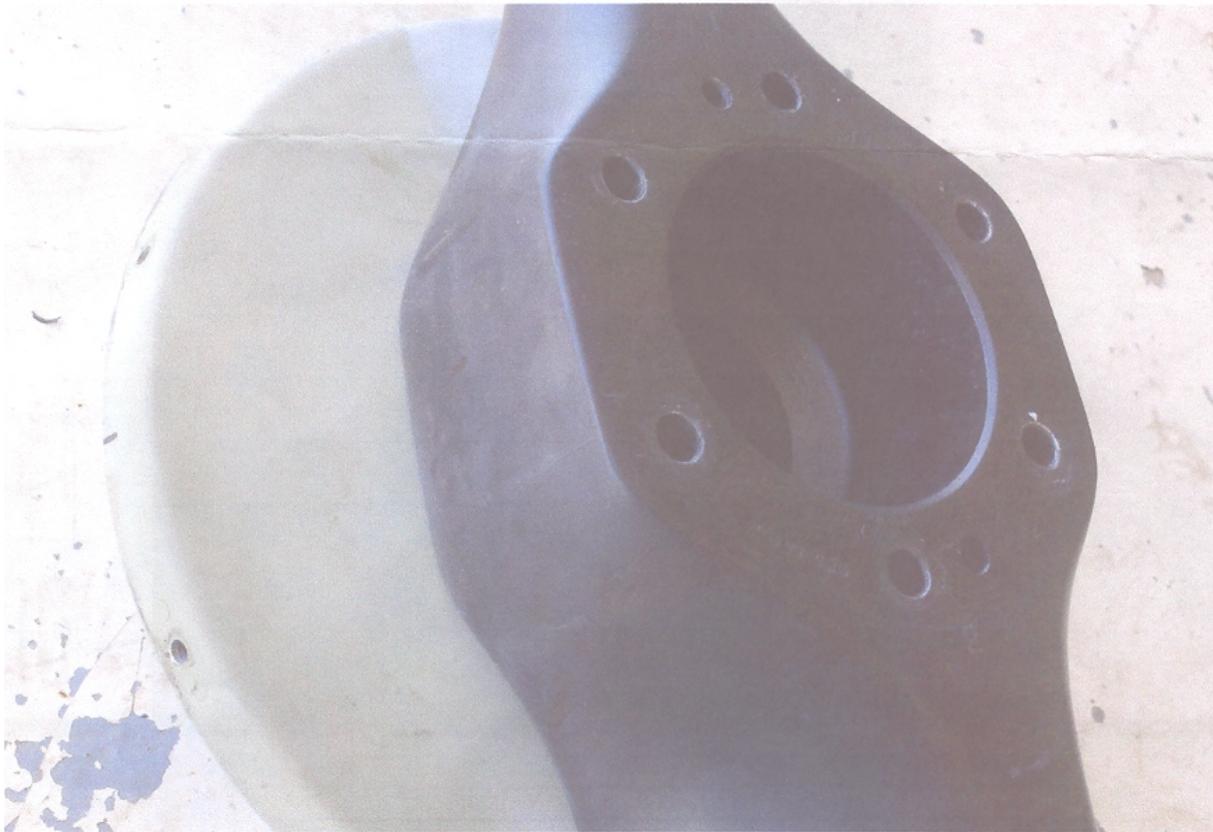
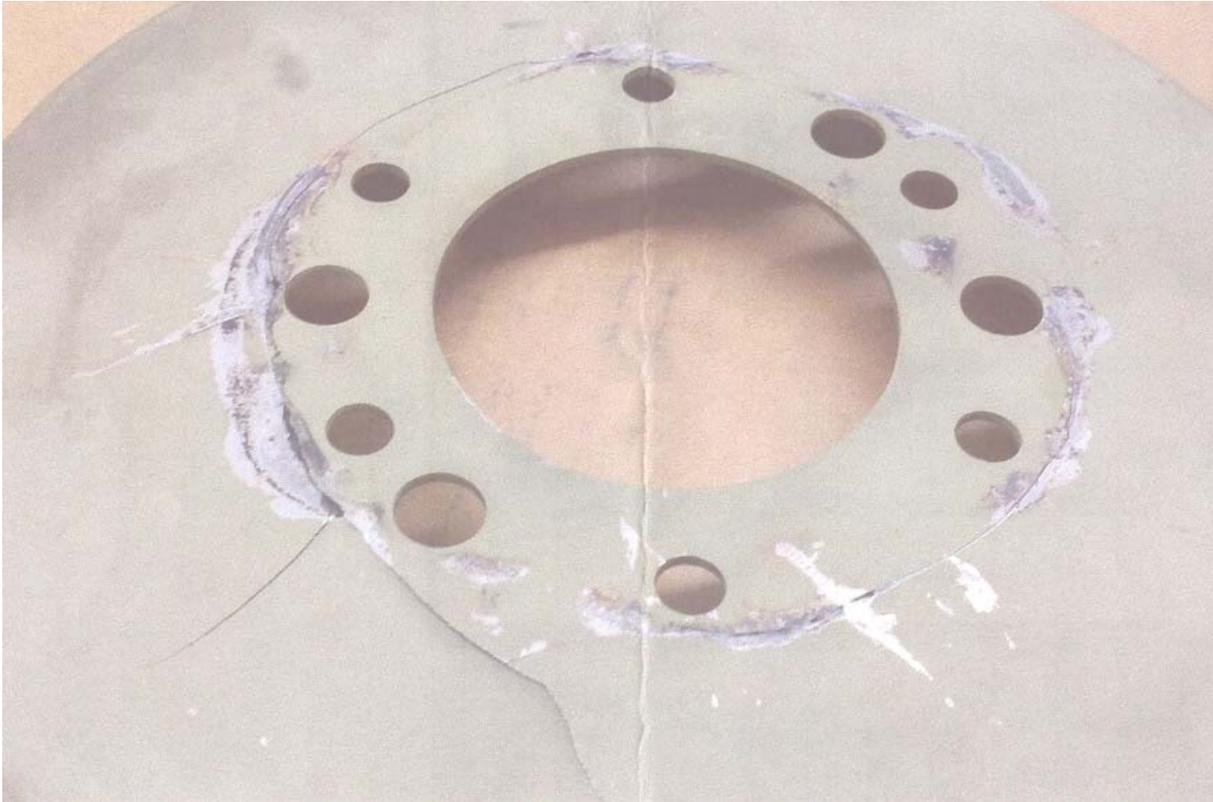
### **Cessna: 150L; Cracked Spinner Bulkhead; ATA 6113**

A repair station mechanic states, "This bulkhead (P/N 0450046-5) was installed in 2007 at 1,476.4 flight hours...." "The part has been inspected after every 100 hours of flight. Upon the latest inspection, a crack was discovered at the base of the propeller hub. (*The hub was removed*) and severe cracking was then (*found*), (*traveling*) 85% of the (*distance*) around the center of the bulkhead. The spinner and the propeller remain undamaged.

"The original bulkhead from the factory lasted 5,808.7 hours before a crack began to form. The replacement bulkhead was installed and inspected as per Cessna 150 service manual—(*and*) with the proper preload on the spinner." "In my opinion: to prevent catastrophic failure, mandatory propeller removal should take place at least every 200 hours of operation for a more thorough inspection of the bulkhead."

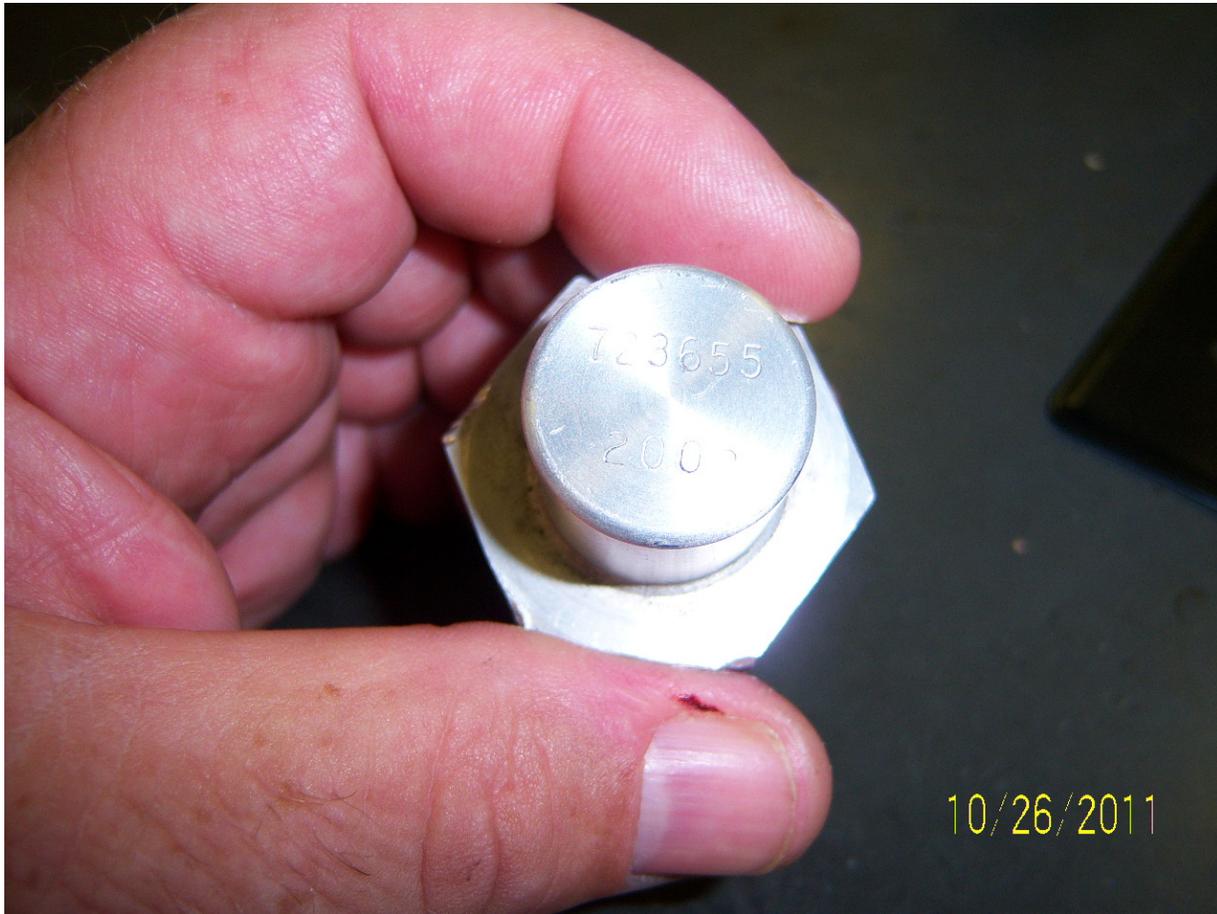
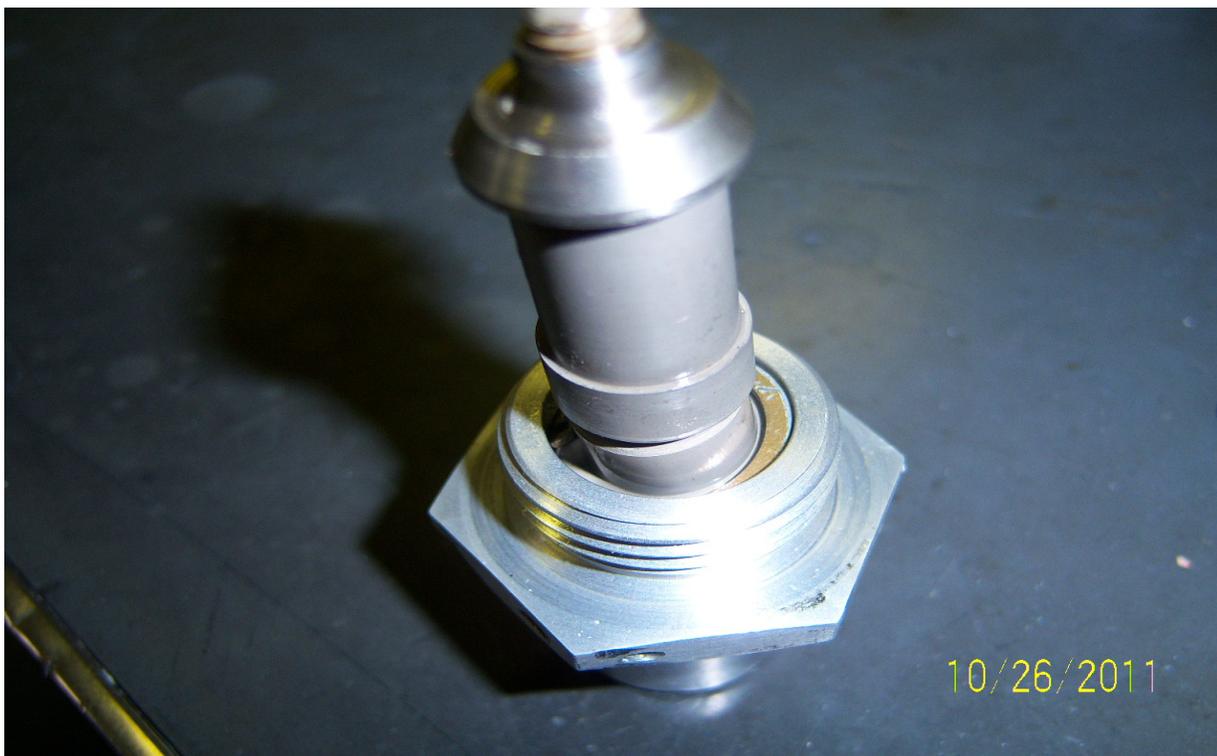
**Cessna: 208B; Failed Oil Cooler Vernatherm; ATA 7922**

"While in cruise flight," says this corporate submitter, "the pilot reported engine oil indicators showing oil pressure lower—and temperature higher than normal. Upon removal and inspection of the engine oil cooler Vernatherm (*P/N 723655*), it was noted (*this unit*) had started to come apart due to the failure of an internal snap ring. This caused a restriction of the engine oil cooling system, resulting in the abnormal readings. When this Vernatherm was replaced, the engine oil parameters returned to normal."

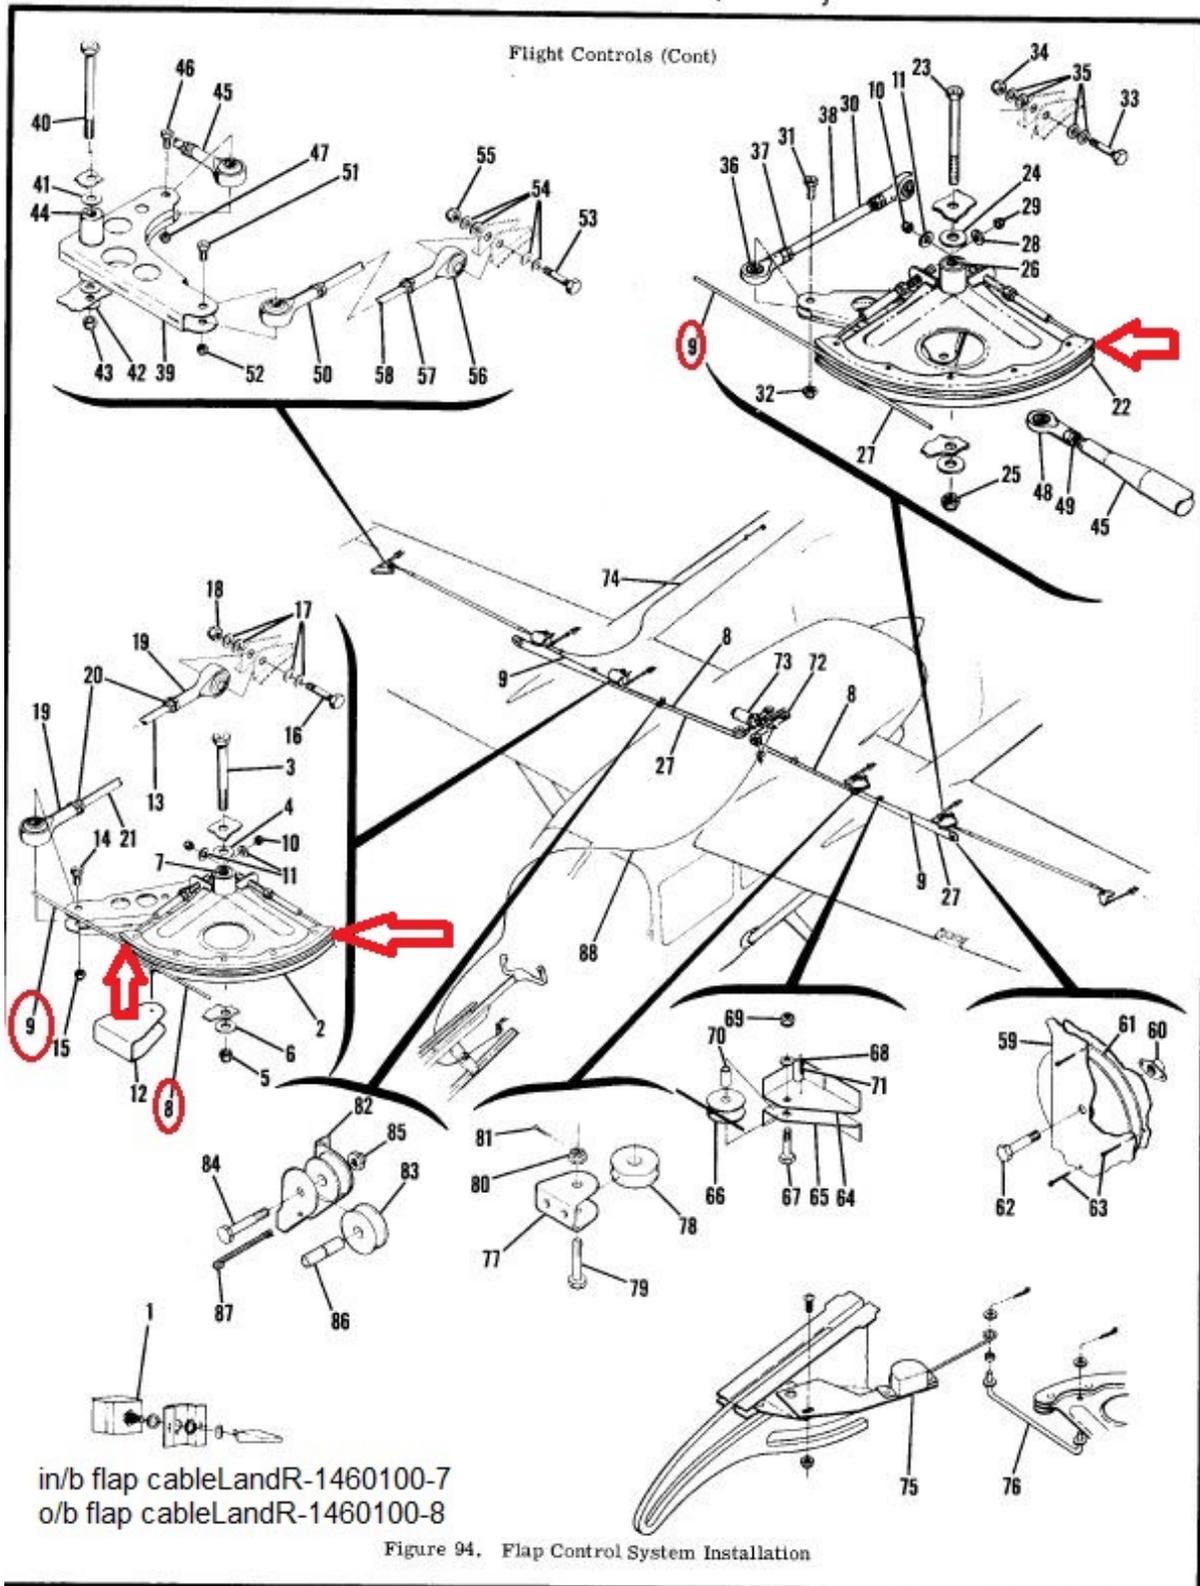
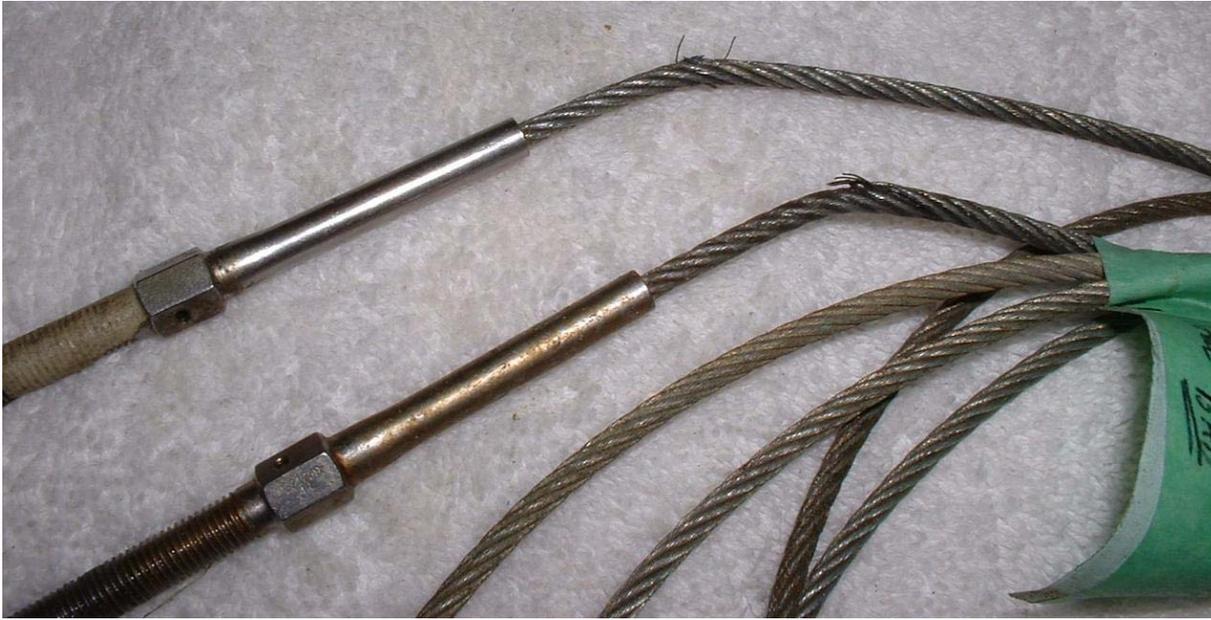
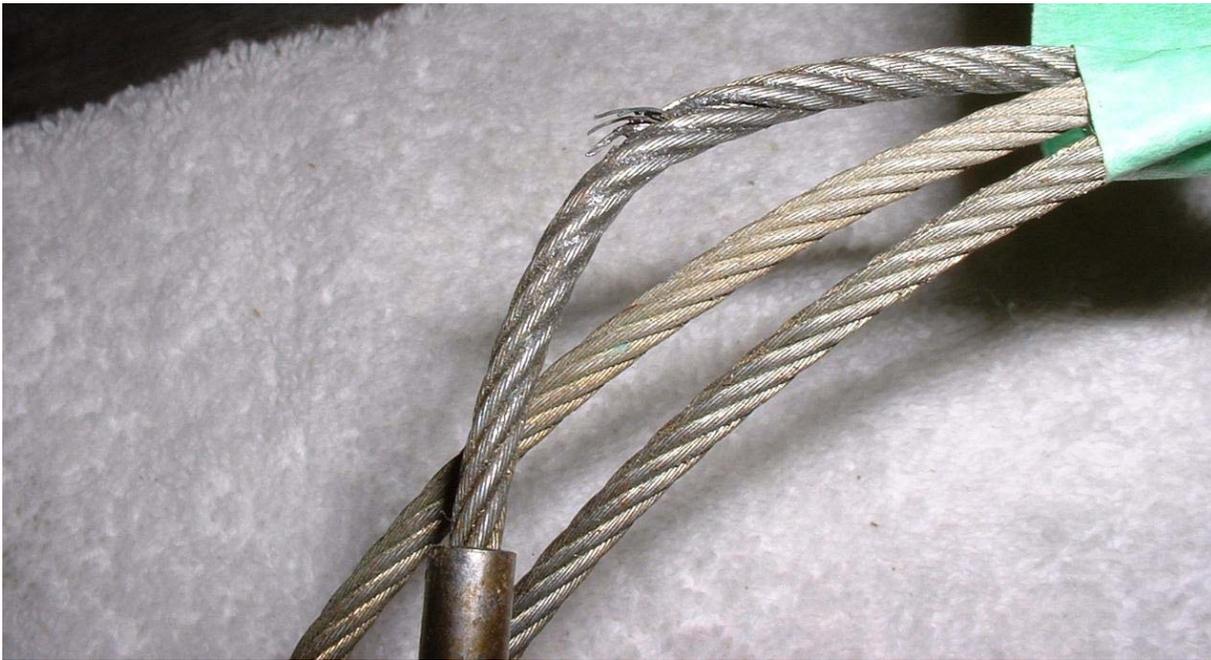
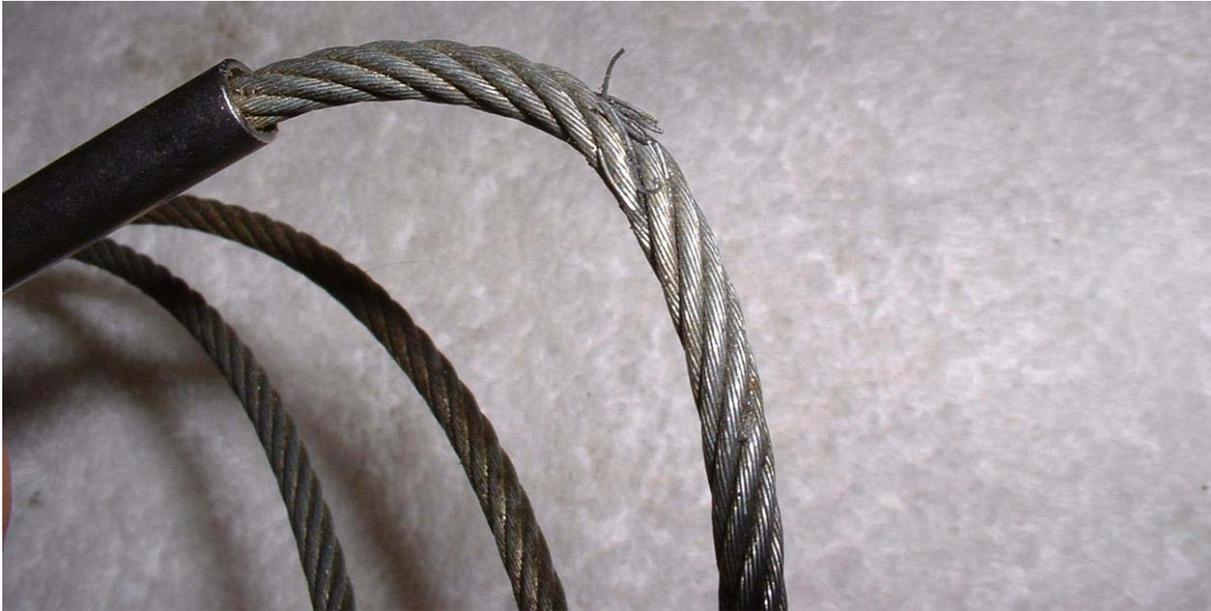
**Cessna: 337D; Frayed Flap Cables; ATA 2750**

A repair station technician says, "(I) removed the L/H and R/H inboard flap extend cables from both inboard flap bell cranks to inspect for wear and damage (per information from Cessna Pilot's Association and fellow type operators during 100 hour/Annual inspection processes). Approximately one inch behind the cable end threaded fittings on both cables I found significant broken wire strands/bundles. Undetected, these would have led to eventual failure. These cables were the steel type with 3,795.4 hours (original cables). All flap cables were replaced with new, and the flap system rigged from scratch per service manual. I suggest these cables be removed and inspected on a 500 hour minimum basis as this is becoming an issue on Skymasters fleet wide. These cables **MUST** be removed from the bell crank for proper inspection; they looked fine when installed, but were obviously not airworthy."

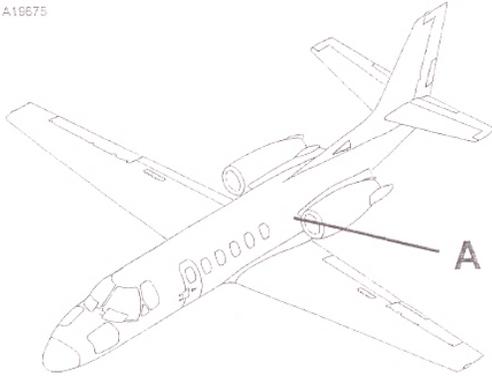
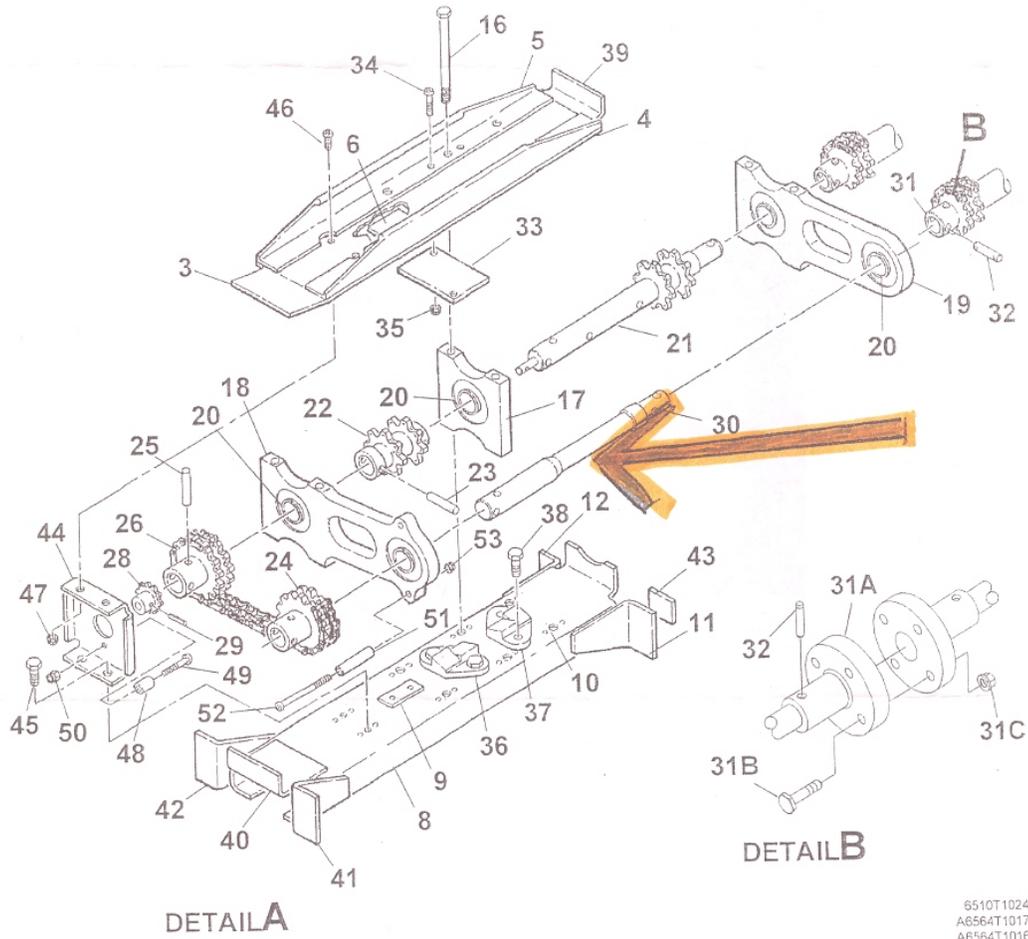
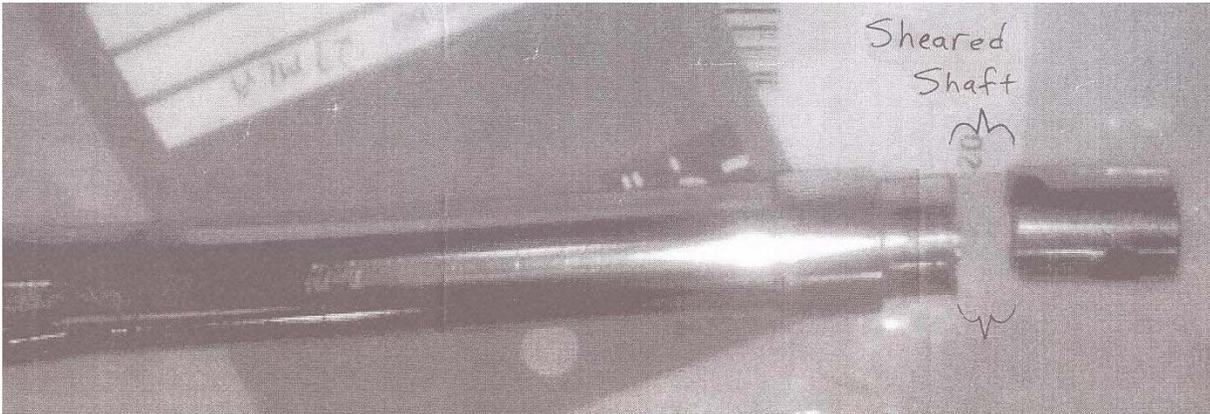
A repair station technician states, "The flap actuator shaft (55651915) was found sheared while performing Phase One inspection task 27-51-710—Flap Motor Operational Check. No obvious reason for this shaft to have sheared was found; no other defects were noted."

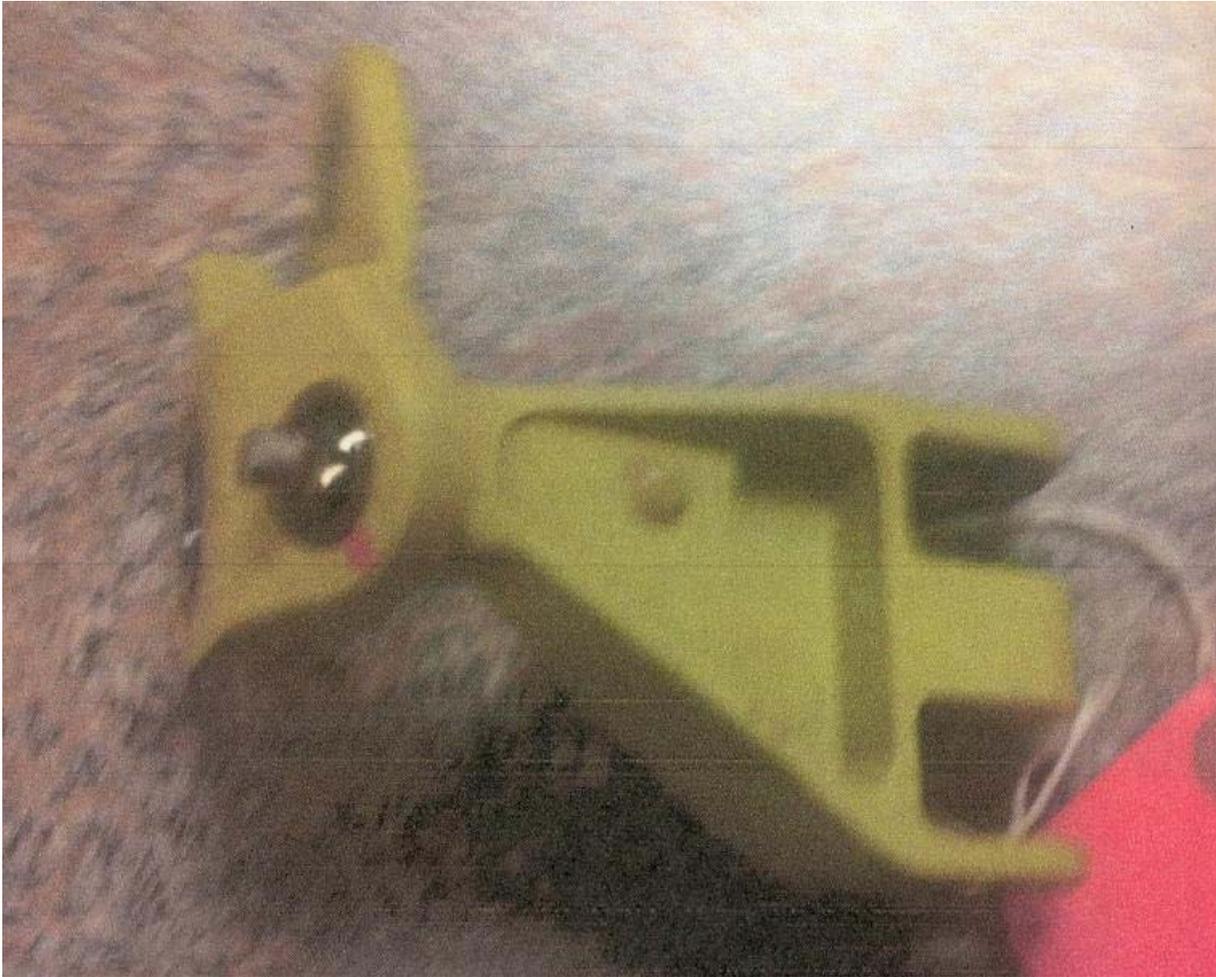
#### **Eclipse: EA500; Failed Aileron Joint Assembly; ATA 5751**

A mechanic for a repair station begins this report with a note, "Reference Eclipse Alert Service Bulletin number 500-27-004 Rev. B: 'Aileron Joint Assembly Inspection and Replacement'.

"This service bulletin has procedures for inspecting/testing both wing's aileron joint assemblies—and replacing the aileron joint assembly whenever the aileron fails a 'friction test.' The assembly fails testing when the bell crank is corroded and frozen in the bearing of the fitting assembly. The attached photo has this corroded/frozen condition. This corrosion is due to dissimilar metals.

"Since this (*reference*) is just a service bulletin, I suggest this inspection be upgraded to an Airworthiness Directive to prevent possible aileron malfunctions from (*those aircraft*) not complying with the service bulletin."

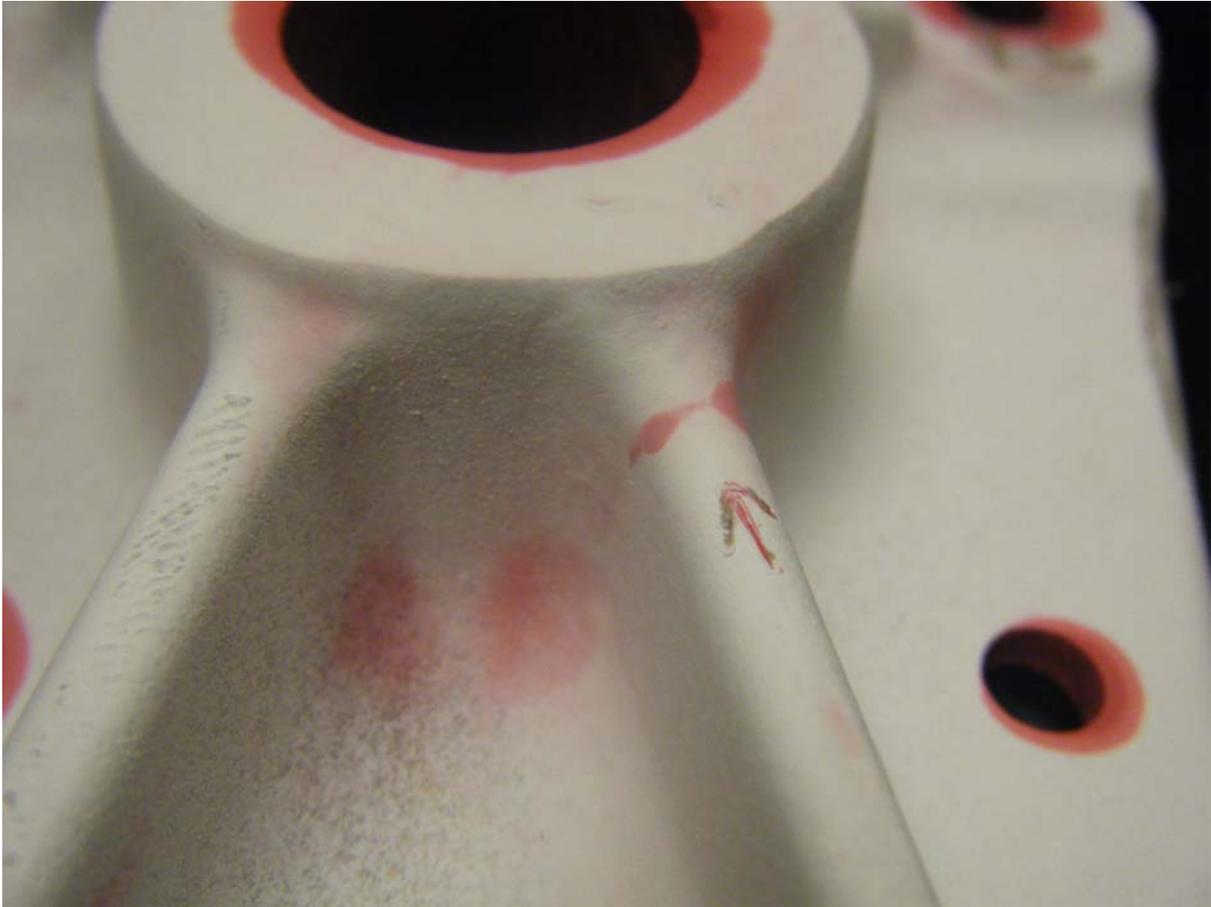
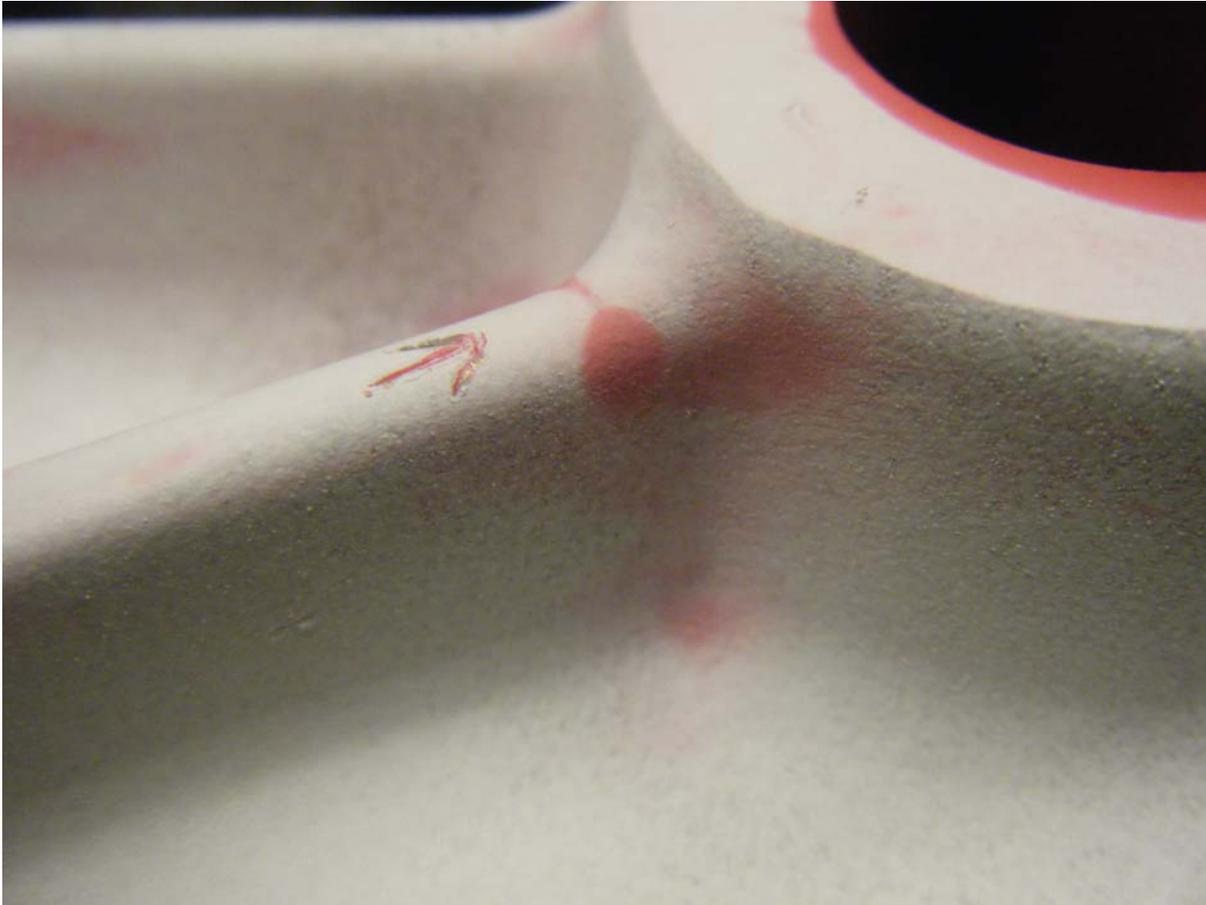
**Piper: PA31-350; Cracked Mail Landing Gear Trunnion; ATA 3210**

"Dye penetrant inspection revealed a small crack beginning to form on the trunnion—just below the bushing area along a casting ridge," states this mechanic. "This was the R/H aft MLG trunnion (P/N 40288000). The aft trunnion (L/H side) is identical and is not cracked. The forward trunnions (different P/N's) were found not to be cracked...." "Although total part time is not known, it is assumed these parts are original equipment. We have never replaced these on any of our other eight Navajo Chieftains."

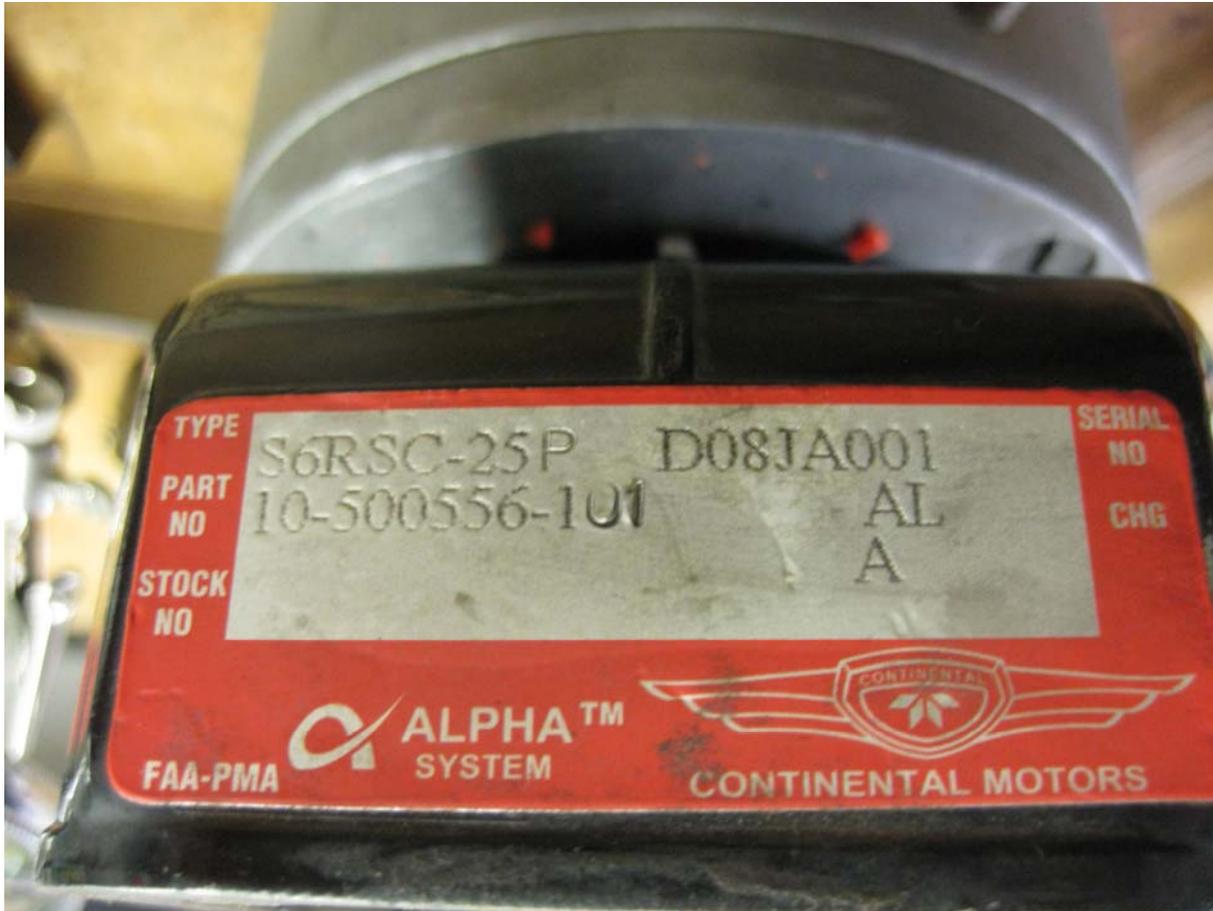
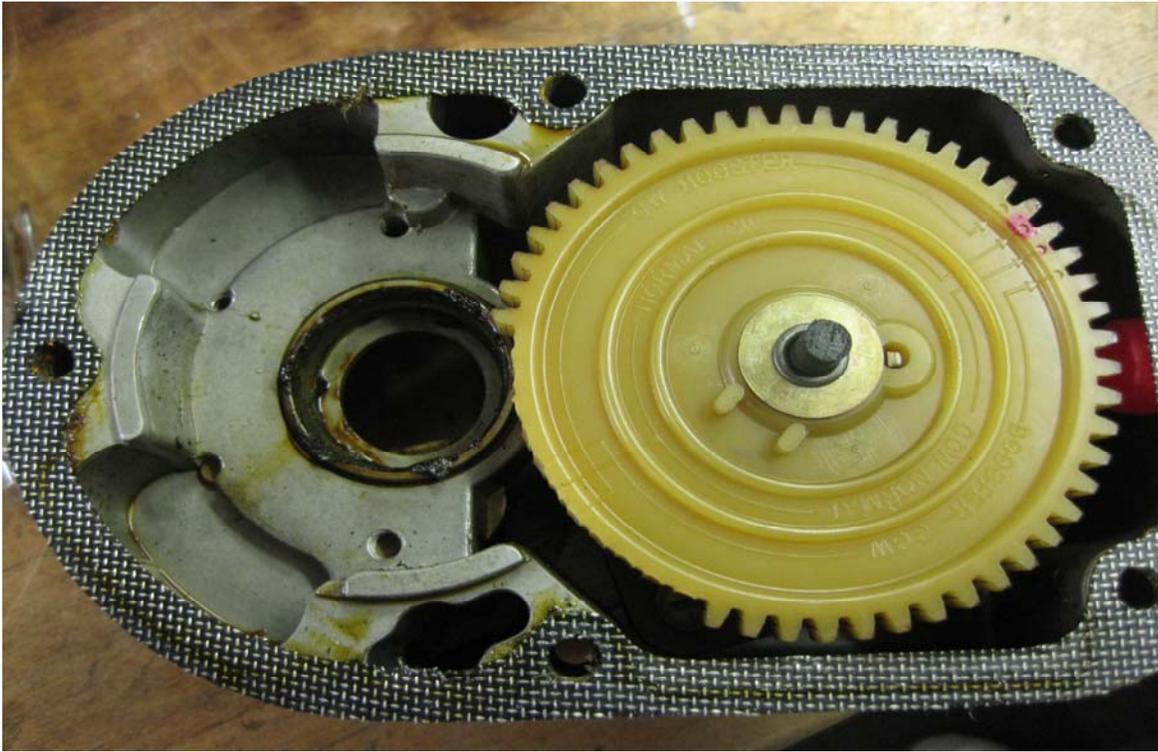
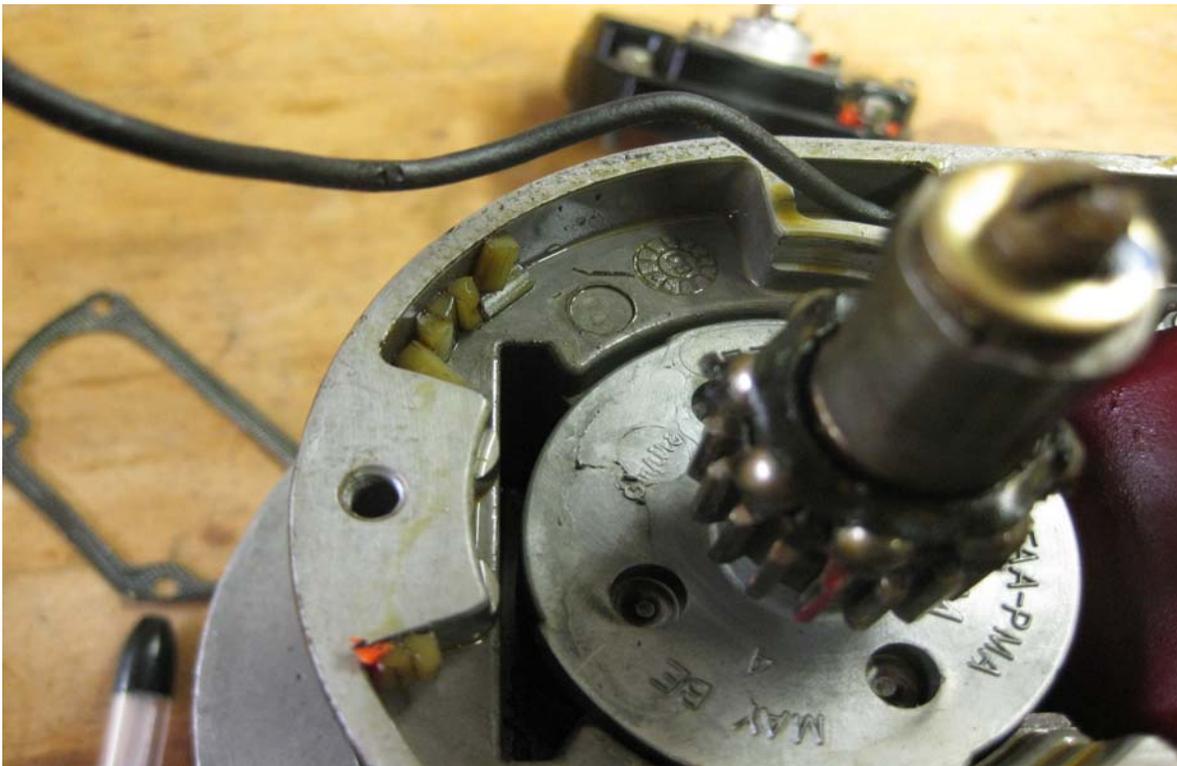
### TCM Magneto: S6RSC-25P; Broken Distributor Gear Teeth; ATA 7414

A repair station technician writes, "This magneto had undergone a 500 hour inspection prior to failure of the component (*approximately*) 100-150 hours after the inspection. The magneto was inspected in accordance with the TCM System Support Manual. The magneto was opened—and the distributor gear was found with several gear teeth broken away from the gear. The teeth were retained inside the magneto case. No other parts were found out of place inside the magneto case. This magneto was documented to have approximately 1000 hours total of operation."
