Federal Aviation Administration

National Part 139 CertAlert

Date: January 6, 2017 **No. 17-01**

Subject: Fueling Vehicle Fire Safety Notice

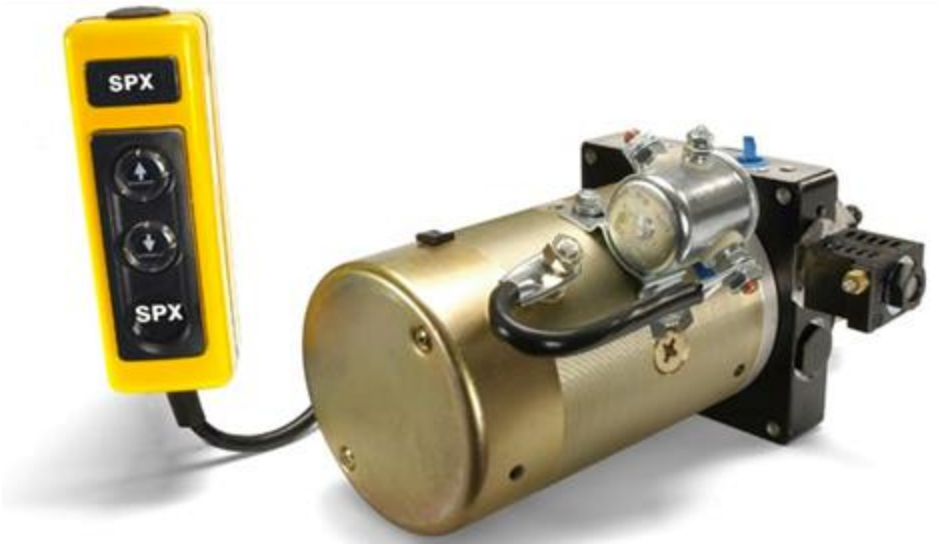
There was a 12V electrically driven hydraulic motor (SPX Fluid Power DC20 T-58), similar to the one shown below, installed near the source of the fire. The motor powered the hydraulic lift to raise the fueling truck cab and is installed near the scene of the fire.

Typical 12V DC solenoid operated - power up, hold, gravity down power unit

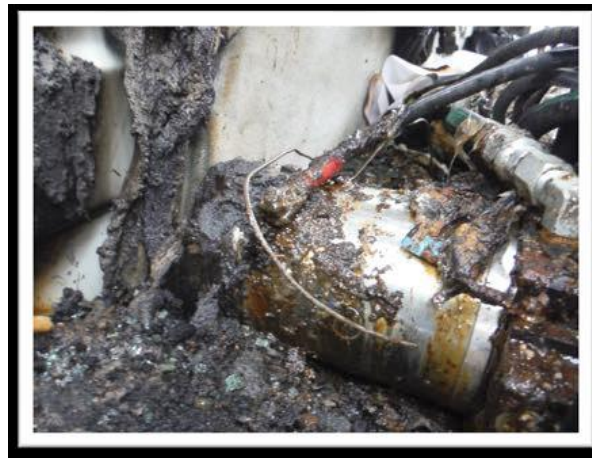
A metal coat hanger was located next to the electrical motor. Based on the location of the hanger, investigators concluded that it likely made contact with the positive connection of the motor and its housing. This could have created conditions for sparking and electrical overheating.

Aftermath of September 29, 2016, fire

The photograph above shows there was flammable material stored in direct proximity to the scene of the fire in the truck cab. The combination of sparks, electrical overheating, and flammable materials could have caused the fire to develop.

Contributing factors to the cause of this fire incident include:

- a. Installing the electric hydraulic motor without protective covers over electrical terminal connections.

- b. Installing the electric hydraulic motor without an enclosure shielding it from foreign objects and flammable debris.
- c. The presence of a foreign conductive object in the electrical system.
- d. Flammable debris present in direct proximity to the electrical system.

The Federal Aviation Administration (FAA) recommends all airports and FBOs inspect their fuel service vehicles to:

- a. Ensure fuel servicing vehicle cabs are clean and free from flammable debris.
- b. Ensure there are terminal boots on electrical connections.

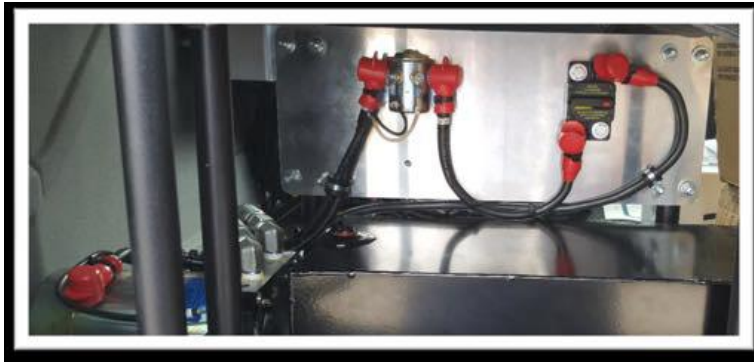
Terminal boots on electrical connections

The above changes will obscure the electrical motor connections from view. This will require written instruction for safe and periodic removal of the aluminum enclosure and terminal boots to inspect for positive and tight electrical connections.

NFPA 407 (2017) 6.1.6.3 states “Spark plugs and other exposed terminal connections shall be insulated to prevent sparking in the event of contact with conductive materials.”

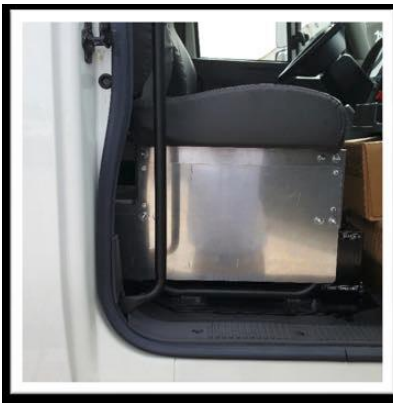
Installed aluminum safety enclosure

- c. Determine if improvements to the motor installation procedure are necessary and need to include installation of an aluminum safety enclosure.
