# **Aviation Maintenance Alerts**

**AC No. 43-16A**

**ALERT NO. 254  
SEPTEMBER 1999**

**Improve Reliability-  
Interchange Service  
Experience**

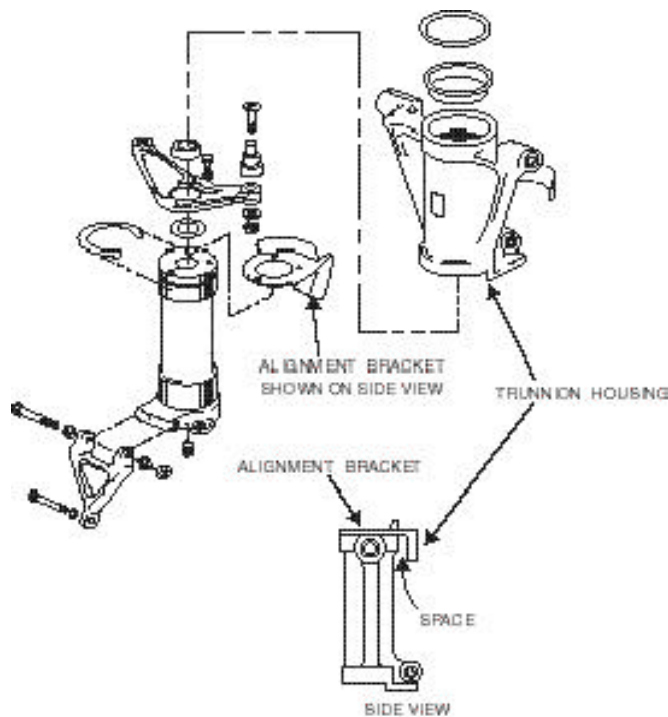
The technician discovered that the steering alignment cam was outside and to the left of its guide bracket (P/N 67107-00). This caused the cam to hit the bracket's ear, thus, not allowing the landing gear to fully extend. Also, because the tire was not aligned it would not fully retract into the cowling. (Refer to the following illustration.)

The submitter stated that because of normally high torque throughout the takeoff roll, the pilot's excessive right rudder application may cause the alignment cam to strike the ear on the alignment bracket during gear retraction. The resulting bracket flex caused it to strike the trunnion housing, and the cam assembly came out of its track.

assembly. However, he recommends that the manufacturer make the base plate thicker to avoid the excessive flexing caused by right rudder application throughout the gear retraction.

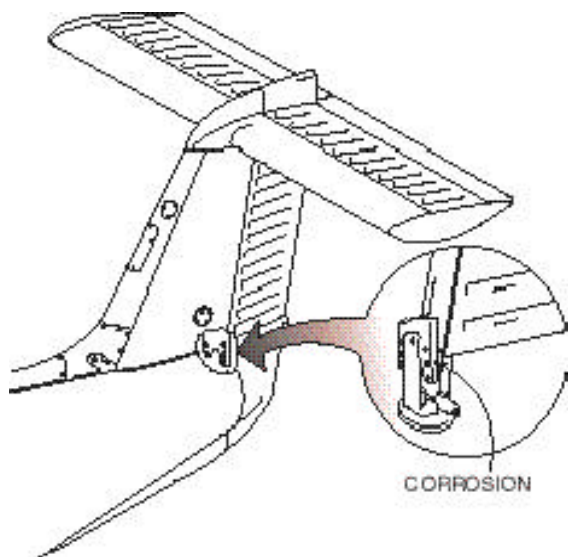
lower rudder fitting (P/N 38394-02) were approximately 40 percent corroded. Water standing in the rudder's lower attach tube may have caused the corrosion. (Refer to the following illustration.)

The submitter stated that if the tube had adequate drain holes, water would not stand in the rudder's lower attach tube.

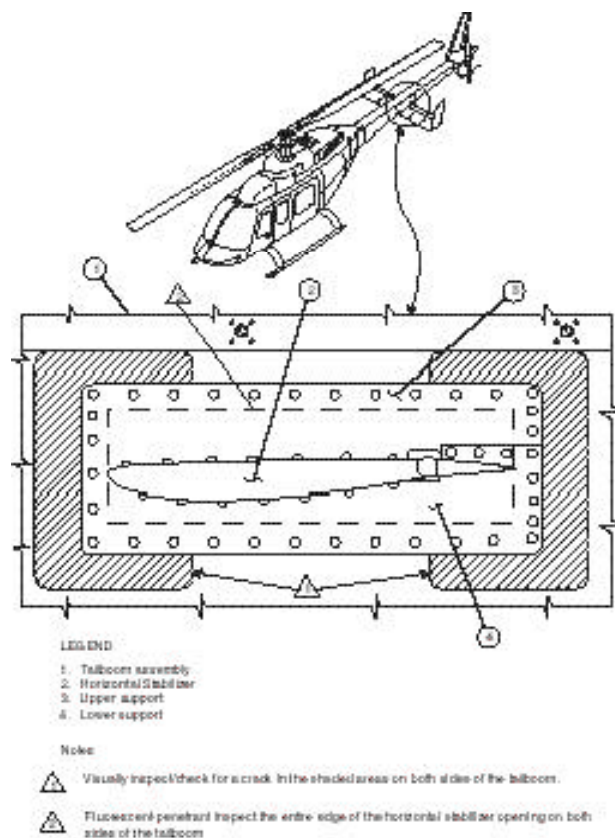
The FAA continues to receive reports of cracks developing in the tail boom structure. The similarity of the reported defects led to the issuance of FAA Airworthiness Directive (AD) 99-02-01, dated January 6, 1999. AD 99-02-01 is referenced in Bell Alert Service Bulletin 206L-98-114, dated November 25, 1998.

Several articles have been written in this publication and other aviation publications concerning this subject. Compliance with AD 99-02-01 is critical to flight safety. If cracks are discovered, the tail boom must be replaced. Refer to AD 99-02-01 for specific serial number applicability, requirements, and instructions for compliance. (The following illustration shows the area where cracks are typically found.)

All owners, operators, or maintenance entities are strongly urged to comply with AD 99-02-01 as soon as possible.
