May 4, 2005

The Fairbanks Flight Standards District Office (FSDO) has, on occasion, found problems with aircraft that appear to warrant dissemination of the findings to the general public, due in part to the impact the information may have on safety.

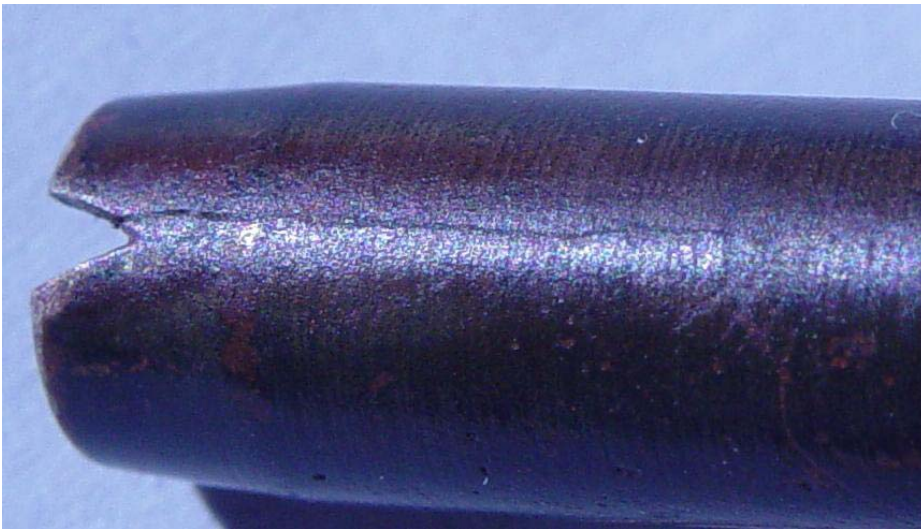
Currently, we have found three instances of turnbuckles on small Piper aircraft that have had cracks originating around the "V" notch at the location where a safety clip may be installed. The cracks run lengthwise on the buckle from the "V." The cracks are about 5/8 to 3/4 of an inch long. The cracks have all been on NAS-649 series turnbuckles. The latest turnbuckle has a manufacturer stamp date on it of 1973. A photograph of the typical crack is attached for your convenience.

As additional information, the NAS series turnbuckle has been superseded by the MS21251M series turnbuckle. A copy of the Data Specification Sheet MS21251M has been included. Of special note, look at the reference in the specification (item seven). It specifically states, "A turnbuckle with a manufacturing date of 1978 or older shall not be used for replacement repairs since stress relieving was not required prior to this date." This may be part of the problem with the older turnbuckles and associated cracking from the "V" notch cutouts for the safety clips.
