Problem Report Briefing

**FANS Interoperability Team Meeting
(FIT/24)**

Honolulu HI, USA

7 March 2017

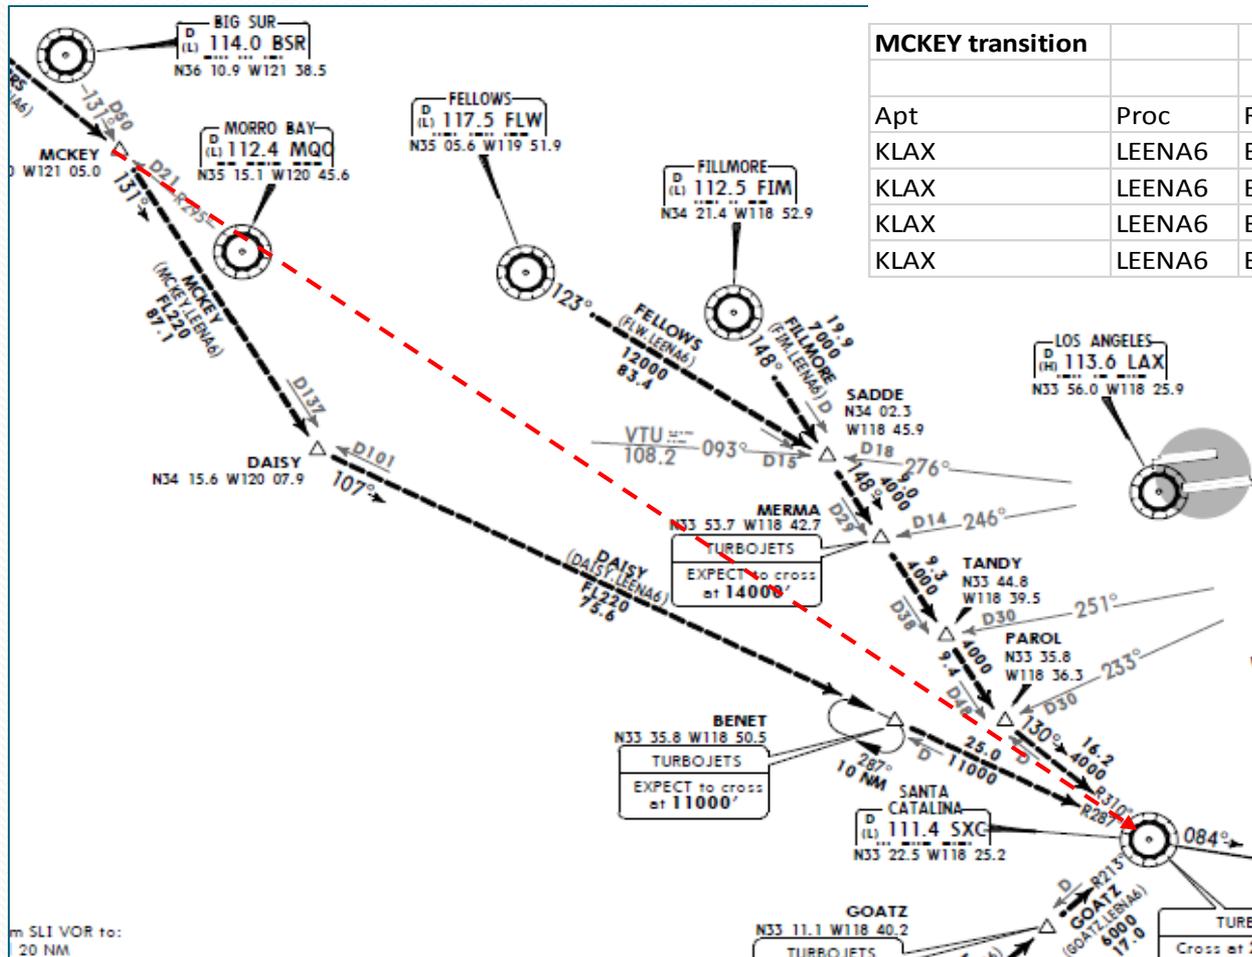
FMC Nav Database record for MCKEY Transition to LEENA6

- Description:
 - An operator reported receiving a letter from FAA regarding Pilot Deviation at LAX arrival.
 - According to FAA and ATC authority, “Pilot deviation occurred while on the LEENA SIX ARRIVAL to the Los Angeles International Airport. The flight was cleared for the LEENA SIX ARRIVAL via MCKEY, DAISY and Santa Catalina VORTAC. After passing MCKEY, the route continues to DAISY and then to the Santa Catalina VORTAC. The Controller observed the flight deviating from the route after MCKEY.
- Analysis results:
 - ATC was expecting the route to be flown with MCKEY transition; however, ATC center did not include the MCKEY transition in the uplink message.

MCKEY transition					
Apt	Proc	R	Via	Fix	Type
KLAX	LEENA6	B	STARET	MCKEY	WPT
KLAX	LEENA6	B	STARET	DAISY	WPT
KLAX	LEENA6	B	STARET	BENET	WPT
KLAX	LEENA6	B	STARET	SXC	NAV

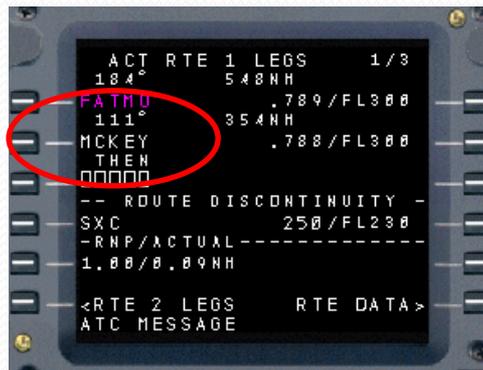
Uplinked route did not contain MCKEY transition

ATC DL Uplink Message

5,,20:55:17

0(80) CLEARED [routeclr]

arr procname(): ARR, LEENA6

route info(): 2

(pub): FATMO

(pub): MCKEY

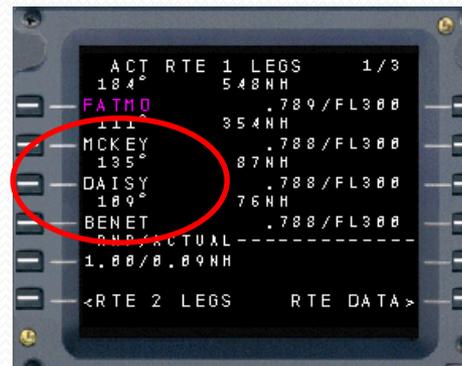
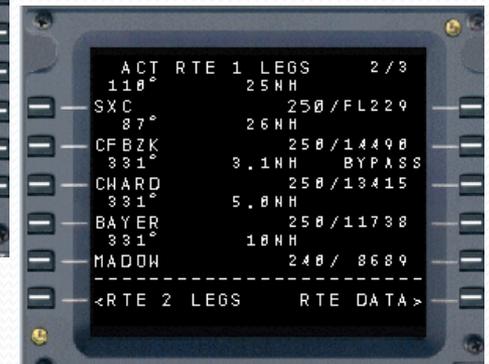
This uplink would have resulted in intended flight path.
