Problem Report Briefing

FANS Interoperability Team Meeting (FIT/20)

Auckland, New Zealand, 26-27 February 2013

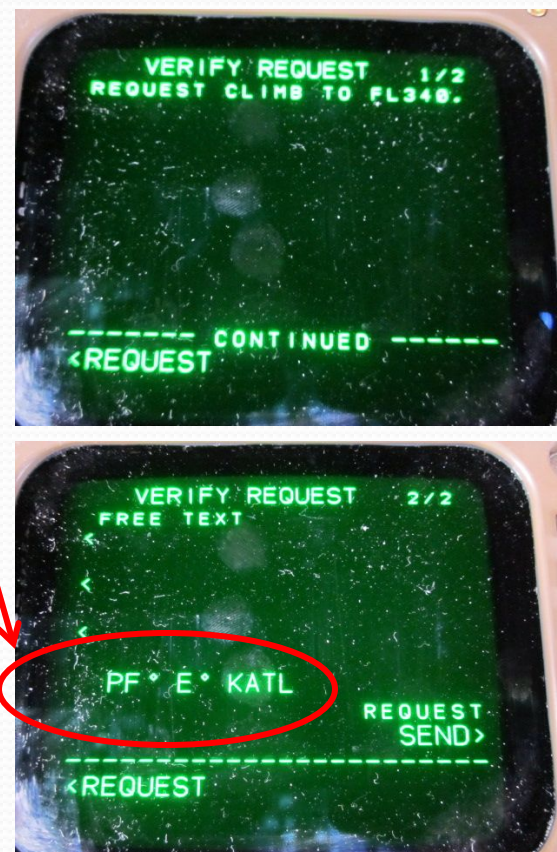
1155-GS - CPDLC Downlink message unreadable from B763

- Downlink request contained freetext element with random characters and destination airport identifier
- Random free text also displayed on VERIFY REQUEST page prior to sending
- Also reported in PRs 1179-MM and 1200-SN.
- Problem has been duplicated in Boeing lab and will be a candidate for the next 757/767 FMC block point
