SAFO 15007
DATE: 6/19/15

Subject: Pratt & Whitney R-985-AN-14B Flyweight Hardware Failures

Purpose: This SAFO advises aircraft owners, operators and mechanics about potential engine failures due to fatigued flyweight screws and associated expanders that are incorrectly modified and/or under-torqued during installation.

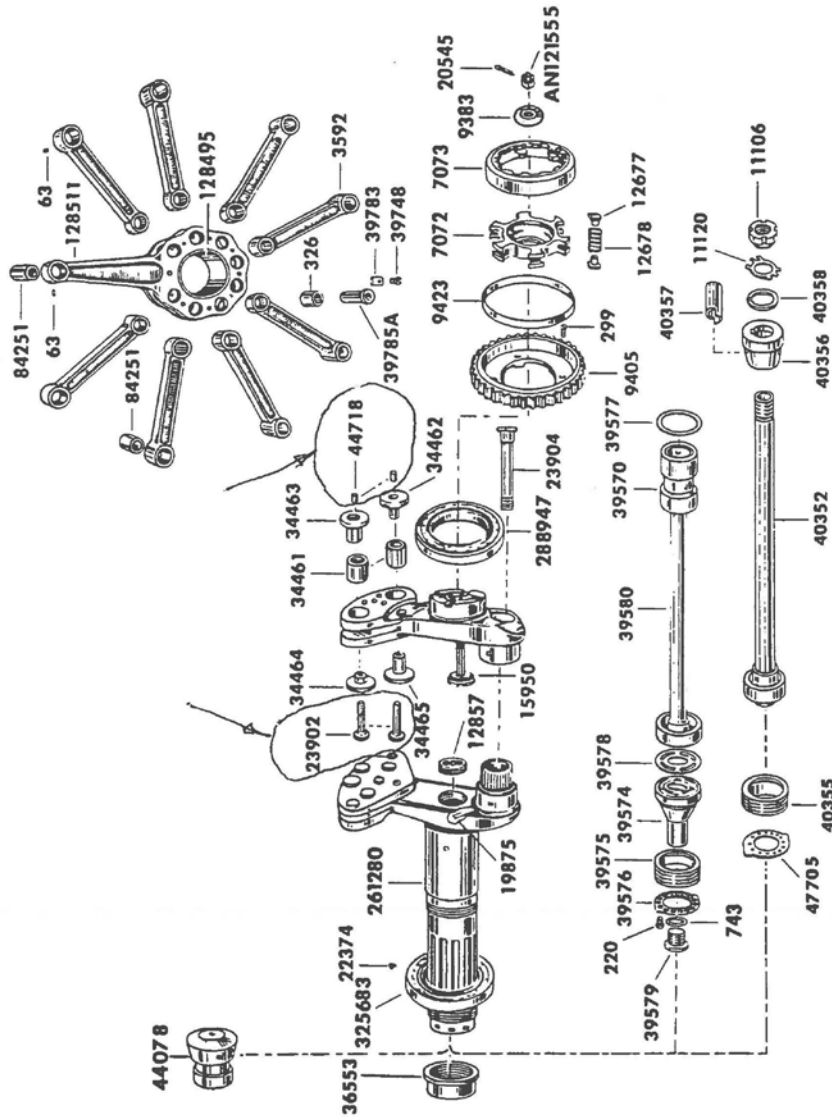
Figure 4. Crankshaft and Connecting Rods

Additional engine models that could be affected by this issue due to similar design include all Pratt & Whitney Wasp Jr (R-985 Series) and Wasp (R-1340 Series) engines, reference image on pg 3.

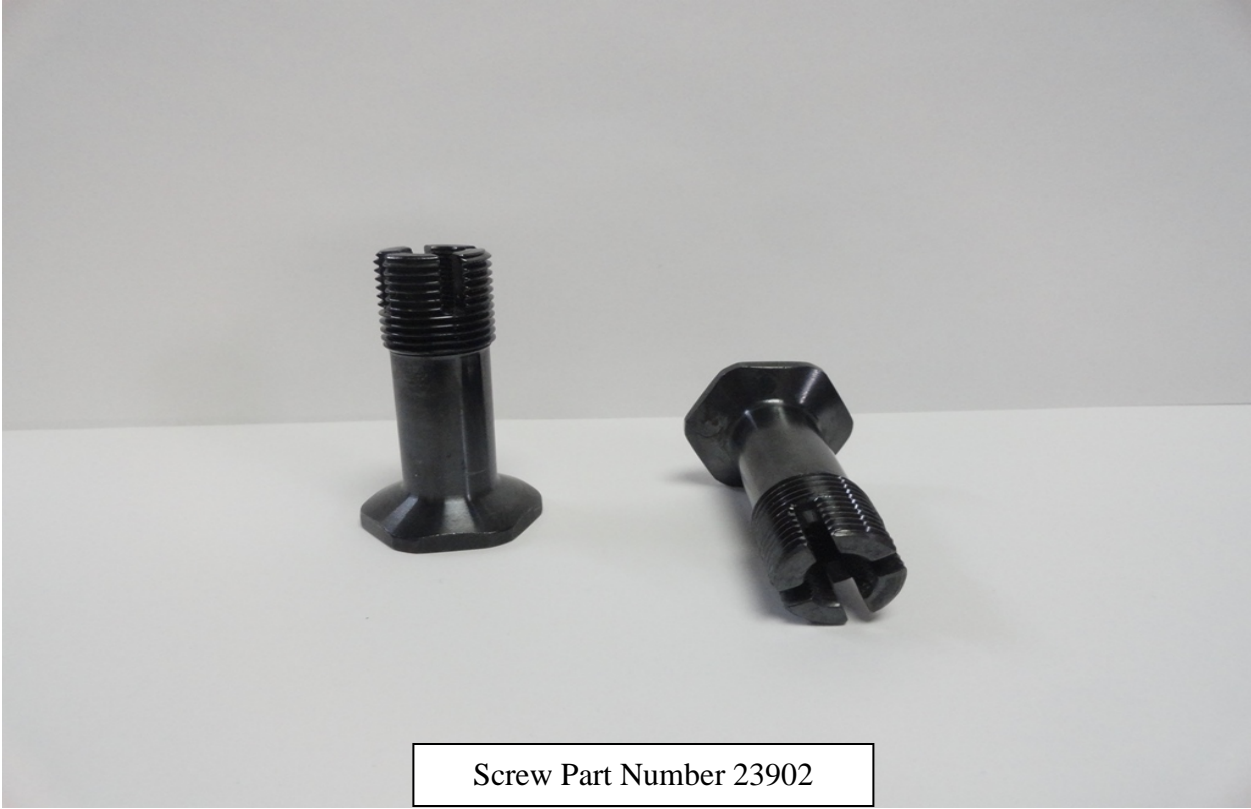
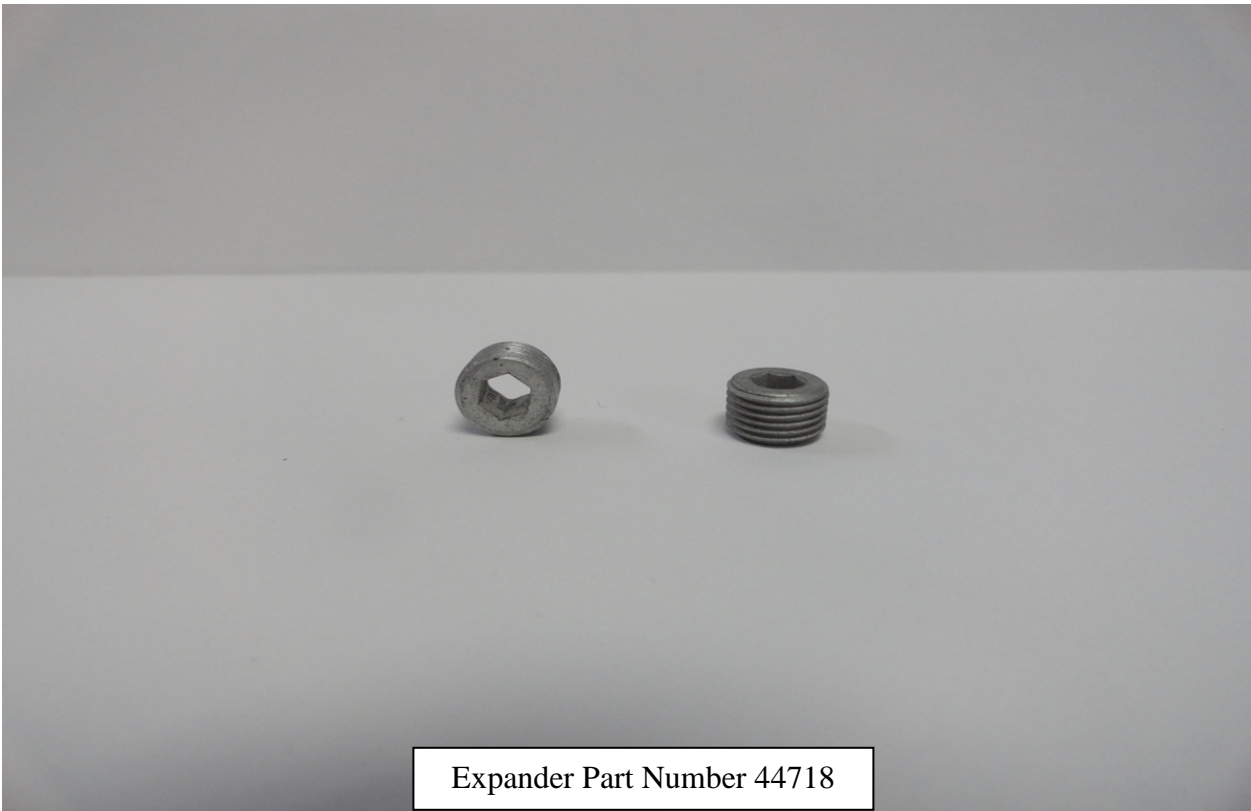
Background: Since June of 2013, there have been three documented engine failures caused by failed flyweight screws. These failures occurred during flight, resulting in forced landings. At the time of the failures, engine time since overhaul ranged from 2.5 hours to 671.6 hours. The engine crankshaft assemblies were overhauled by three different repair facilities. Additionally, inspections of at least four other engines have found cracked screws (P/N 23902, reference image on pg 4) and under torqued and/or improperly modified expanders (P/N 44718, reference image on pg 4) used to secure the screws in the flyweights.

After torquing the flyweight screw, the overhaul manual requires the expander plug be threaded into the screw and torqued 200 to 225 inch-pounds. The manual then provides a maximum measurement of 0.060 inch for the expander to protrude beyond the end of the screw. During engine inspections, multiple expanders have been found that have been modified by removal of up to half of the height of the expander. The FAA is currently not aware of any document, process or guidance that authorize removing material from the expander to meet the projection measurements. If, during inspection of an engine, an expander is found to have been modified in any way, the expander should be replaced. Continued use of an altered expander plug, which may not engage the proper amount of threads in the screw, could result in improper torque and subsequent fatigue failure of the screw.

- Certain maintenance actions accomplished between overhauls may provide visual access to the engine flyweights, i.e. cylinder replacement, etc. Owners, operators and repair facilities are urged to inspect the assemblies at those times for any signs of displacement of the screws, expanders, or flyweights. If any abnormalities are observed, the engine should be immediately removed from service and disassembled for further inspection, and the owner/operator should ensure that any affected flyweight screws and expanders are replaced.
- During overhaul these screws and expanders should be replaced with serviceable parts.
