AIA Project Report

**High Bypass Ratio Turbine Engine
Uncontained Rotor Events**

Small Fragment Threat Characterization

Volume 1

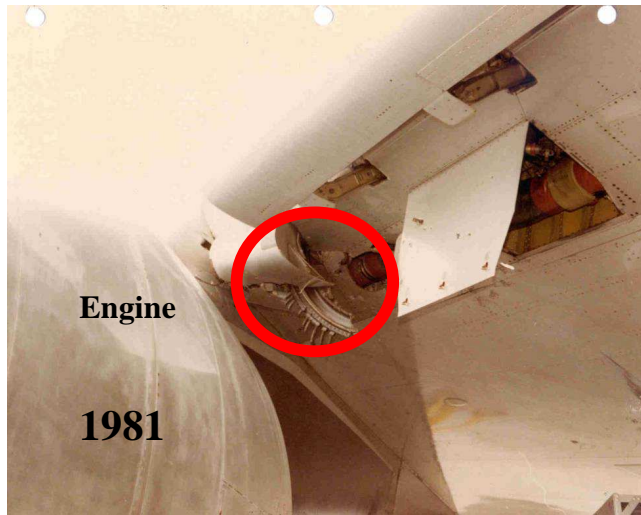
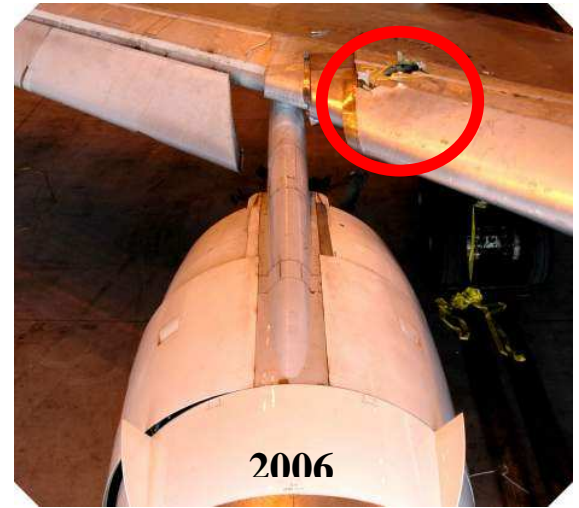
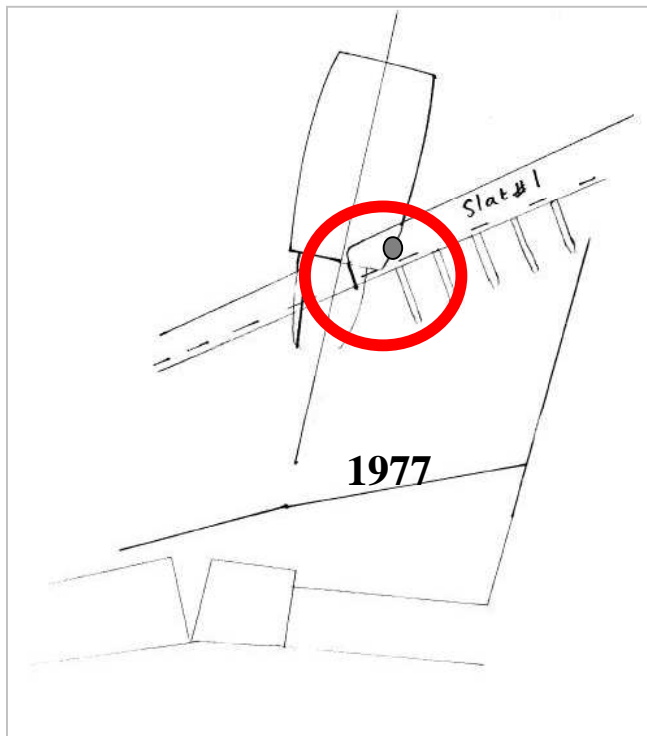
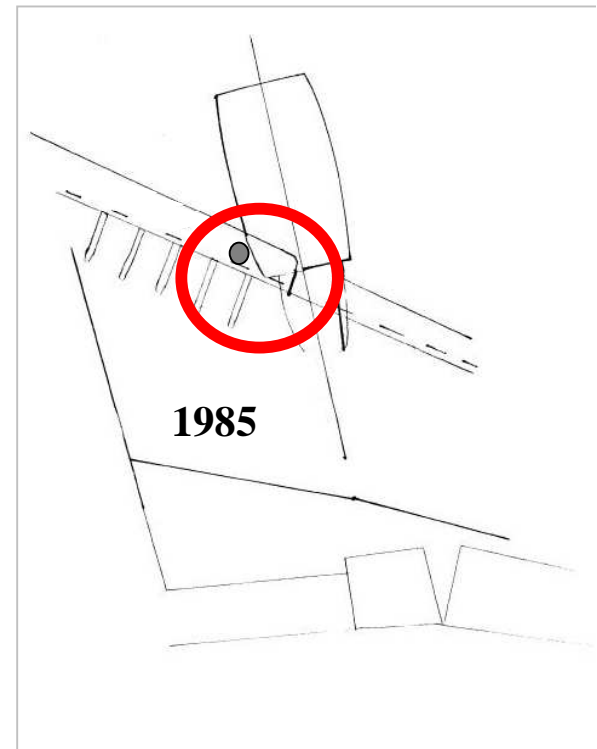
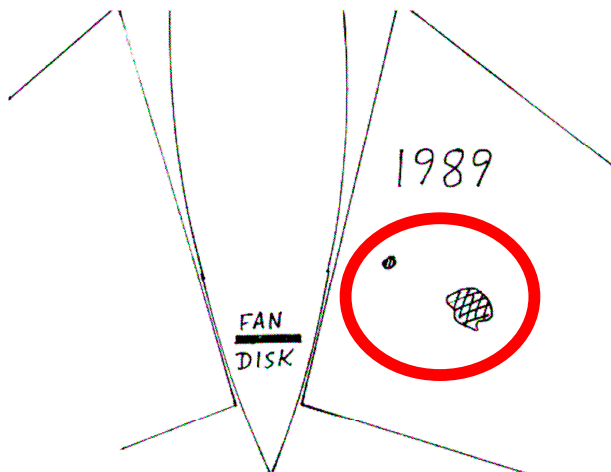
Figure 4.13 Examples of events where disk burst resulted in systems damage which reduced airplane controllability

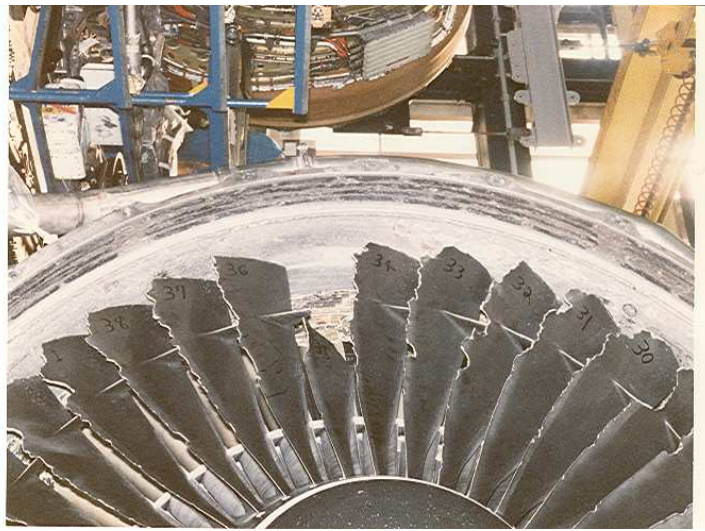
Figure A3.2.4 Conventional fan blade with mid-span shroud; 18 oz pigeon ingestion

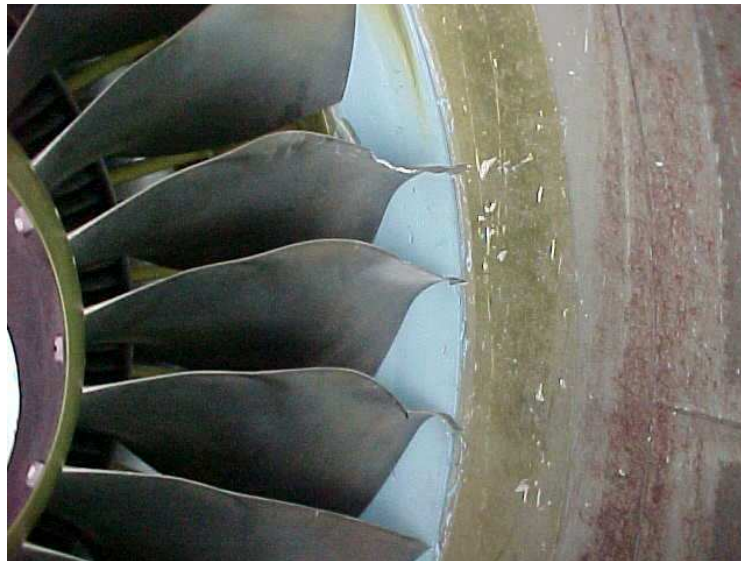
Figure A3.2.5 Wide-chord blade; 8 lb pelican ingestion

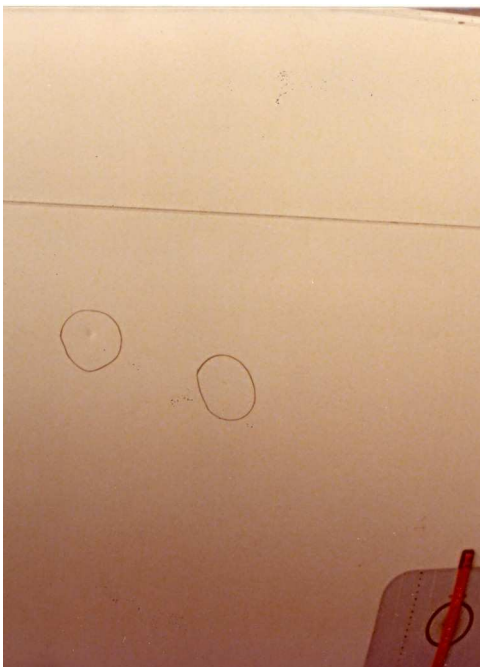
Figure A3.2.8 Fuselage dents (forward arc)

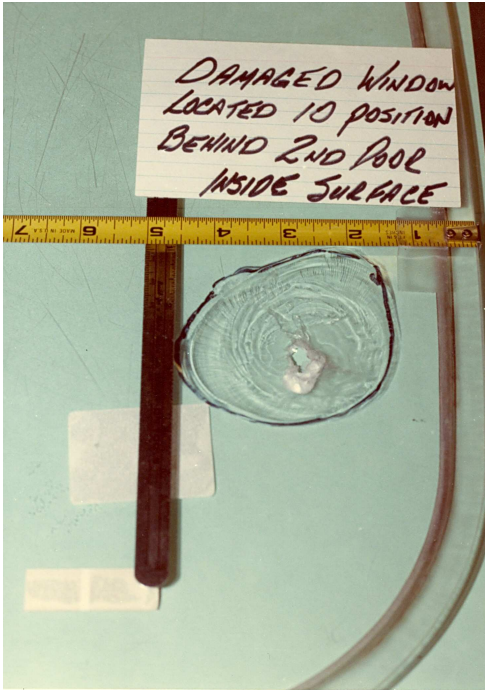
Figure A3.2.9 Hole in outer window pane (forward arc)

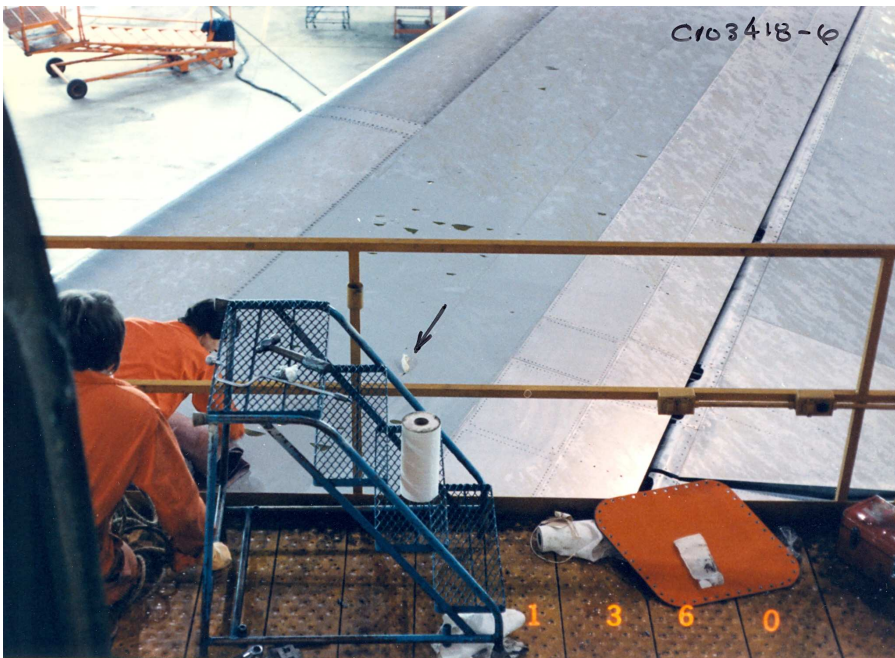
Figure A3.2.10 2" puncture in stabilizer skin (forward arc)

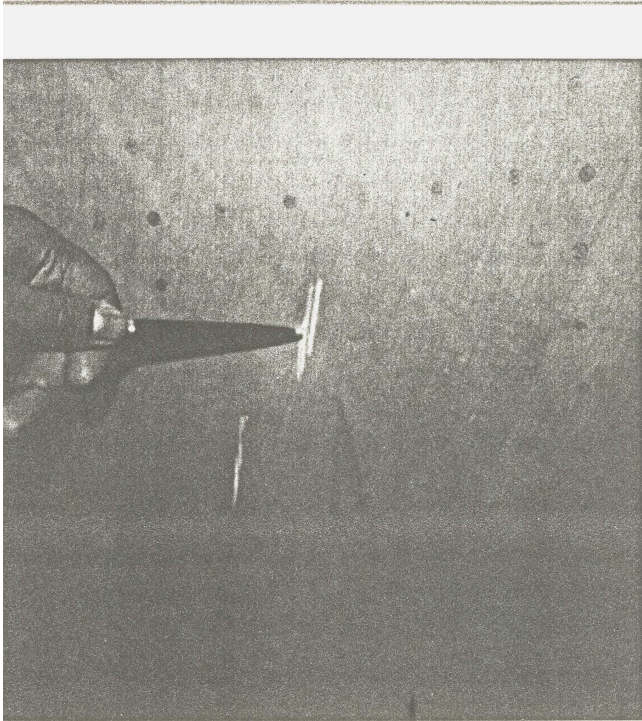
Figure A3.2.11 Scratches on horizontal stabilizer (forward arc)

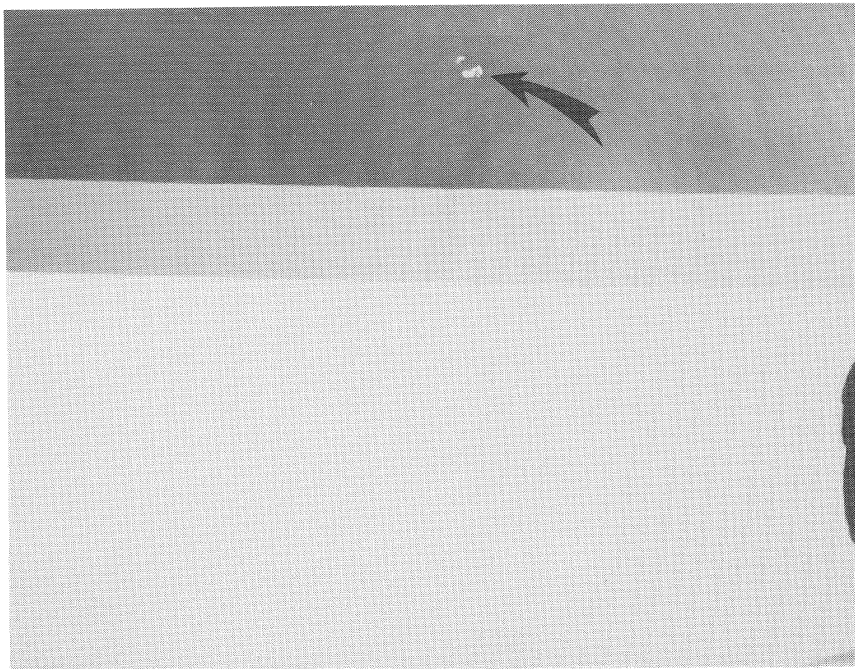
Figure A3.2.13 Fuselage skin puncture (forward arc)

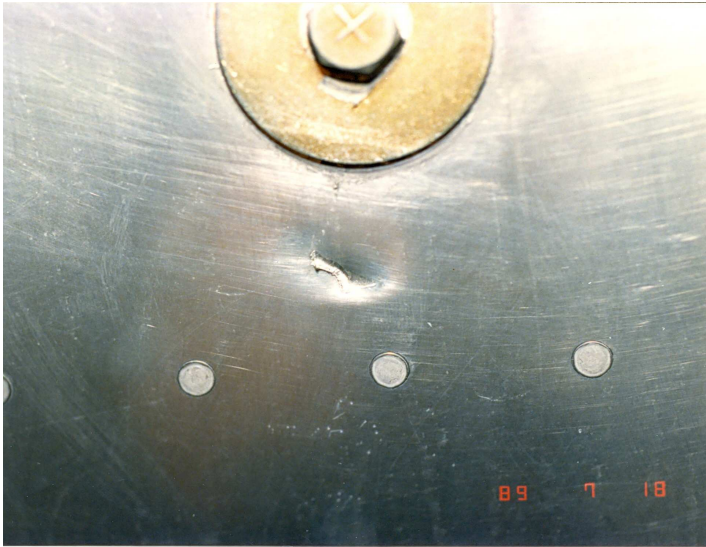
Figure A3.2.15 3" gouge in fuselage skin (plugged); (forward arc)

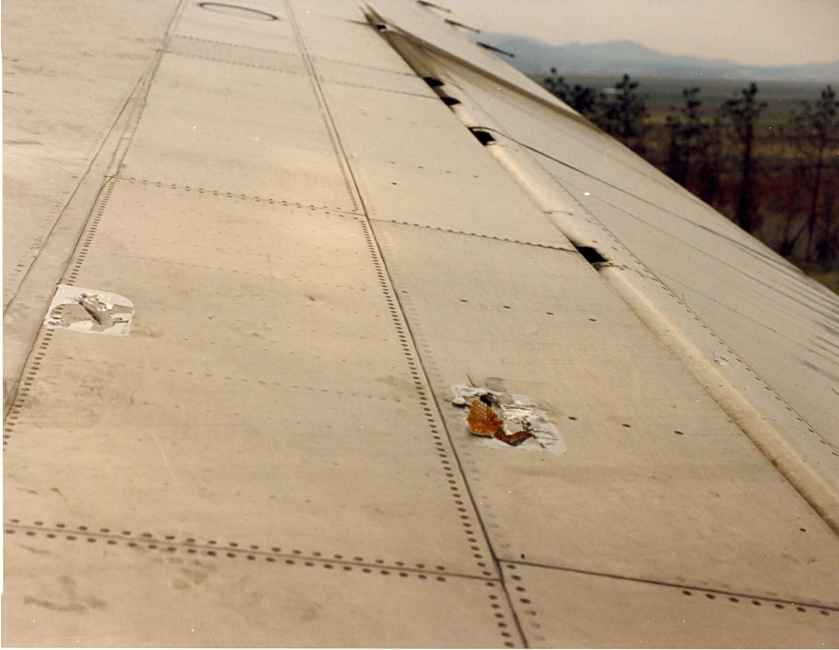
Figure A3.2.17 Right horizontal stabilizer holes (forward arc)

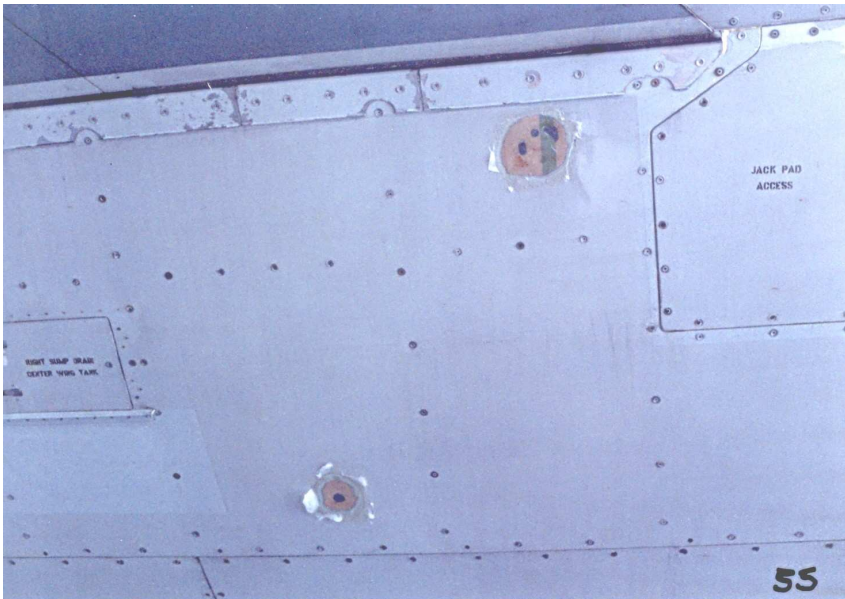
Figure A3.2.18 Plugged holes in fuselage (forward arc)

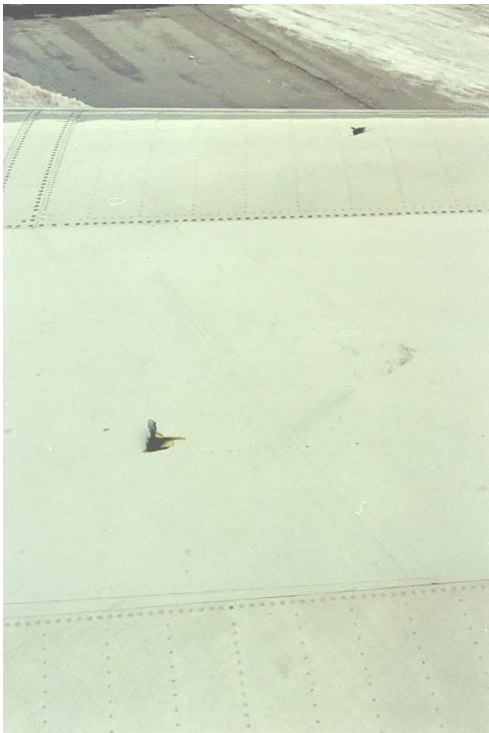
Figure A3.2.20 Elevator puncture (forward arc)

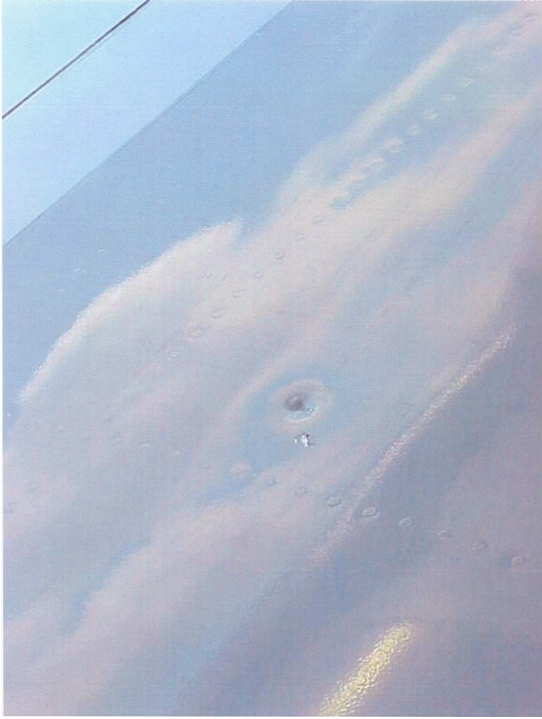
Figure A3.2.21 Fuselage dent (forward arc)

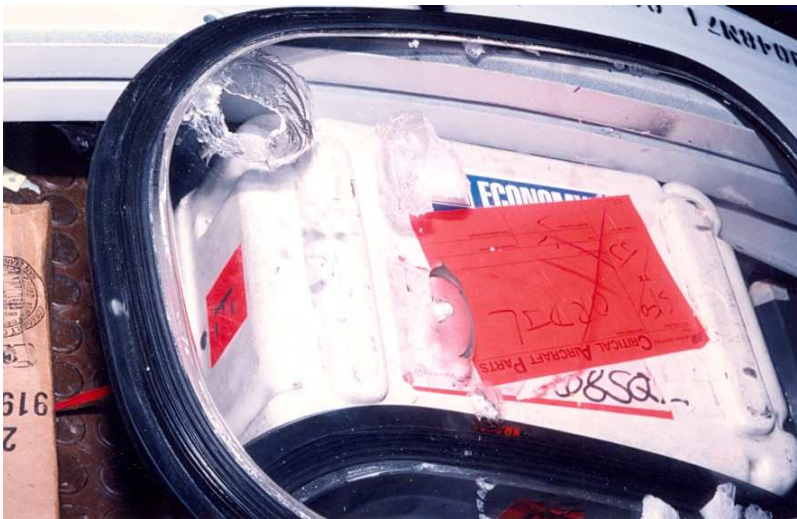
Figure A3.3.5 Cabin window outer pane (case uncontained)

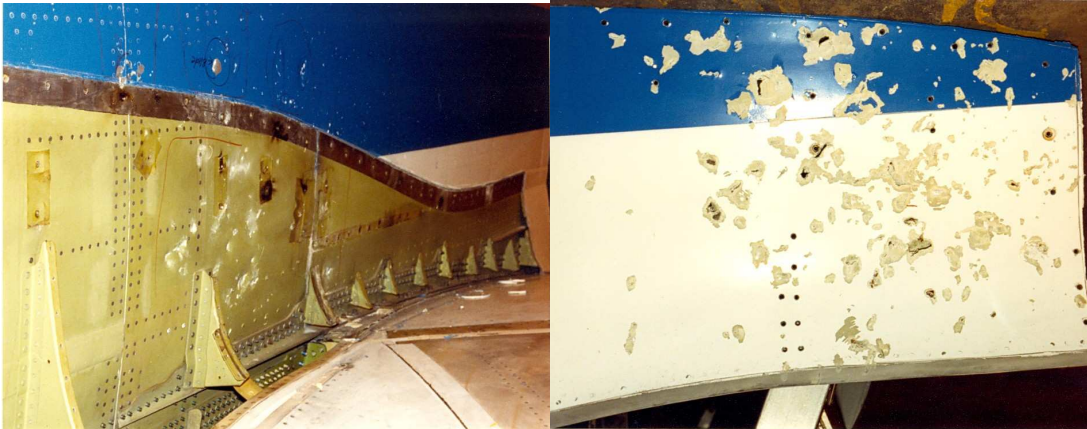
Figure A3.3.6 Wing/body fairing and matching fuselage (case uncontained)

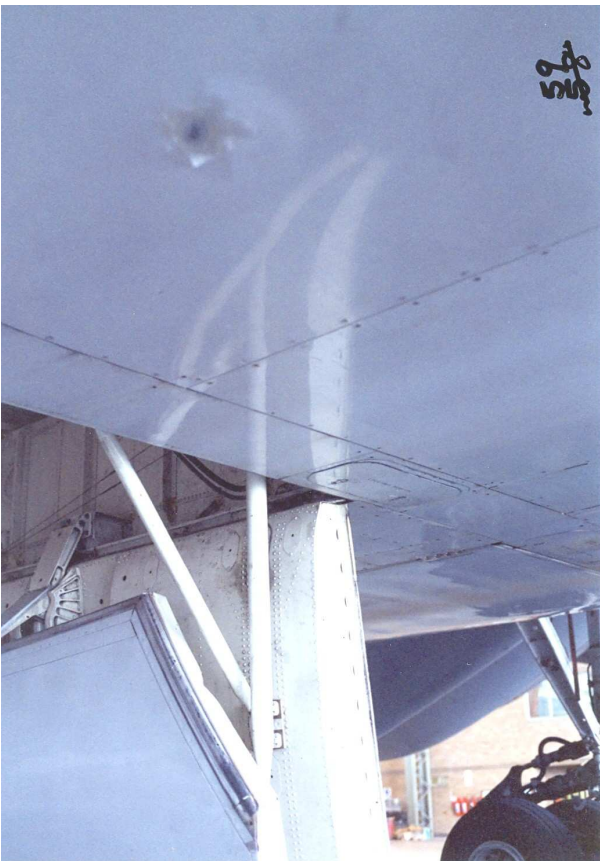
Figure A3.3.7 3" hole in slat (casing uncontained)

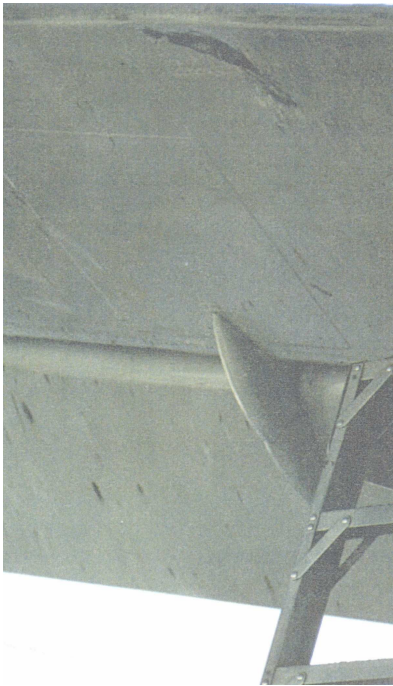
Figure A3.5.1 Cut in aileron (tailpipe debris)

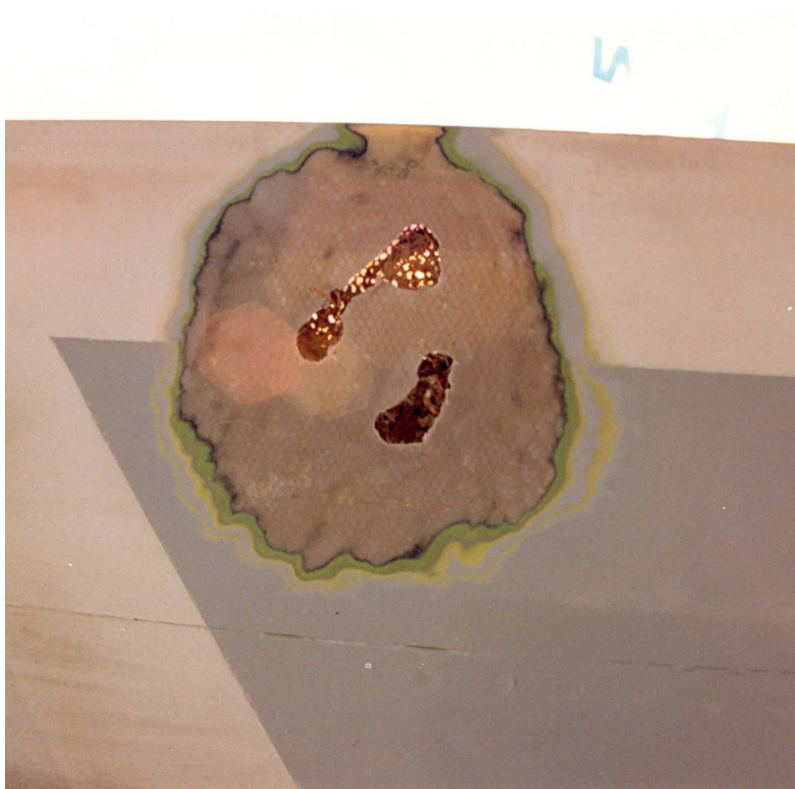
Figure A3.5.3 Trailing edge flap holes (tailpipe debris) (photo taken during repair process)

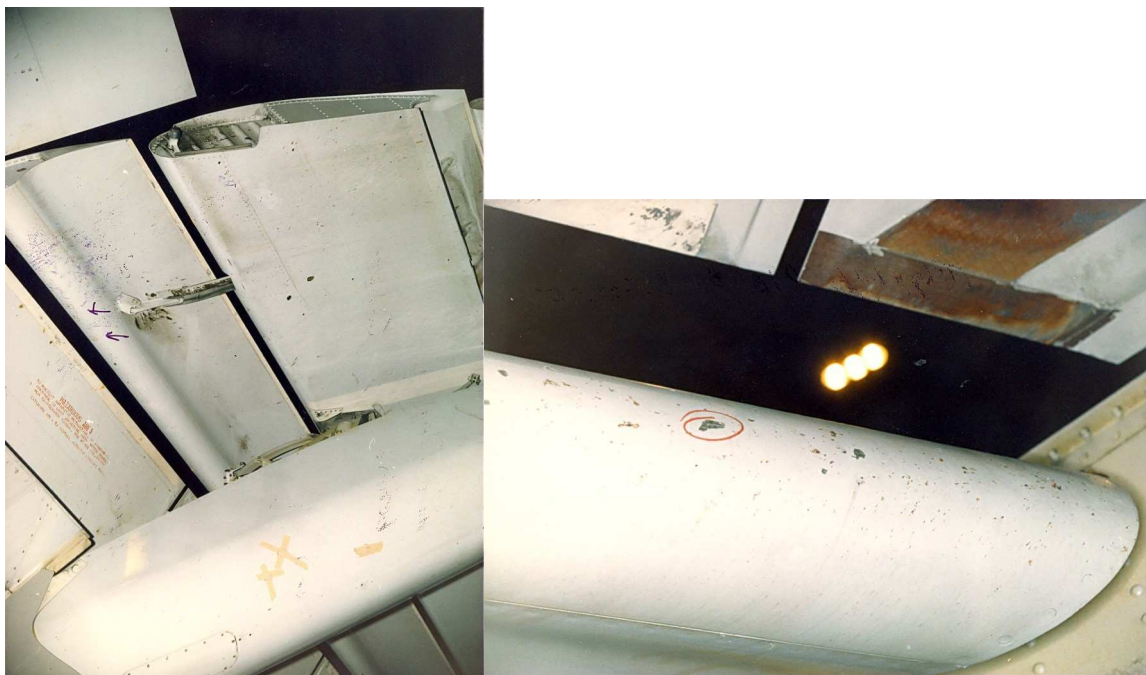
Figure A3.5.4 Nicks and dents to flaps, canoe fairings (tailpipe debris)
