COMMISSION OF  
INQUIRY INTO THE  
AIR ONTARIO CRASH  
AT DRYDEN, ONTARIO

Final Report

Volume I

The Honourable Virgil P. Moshansky  
Commissioner

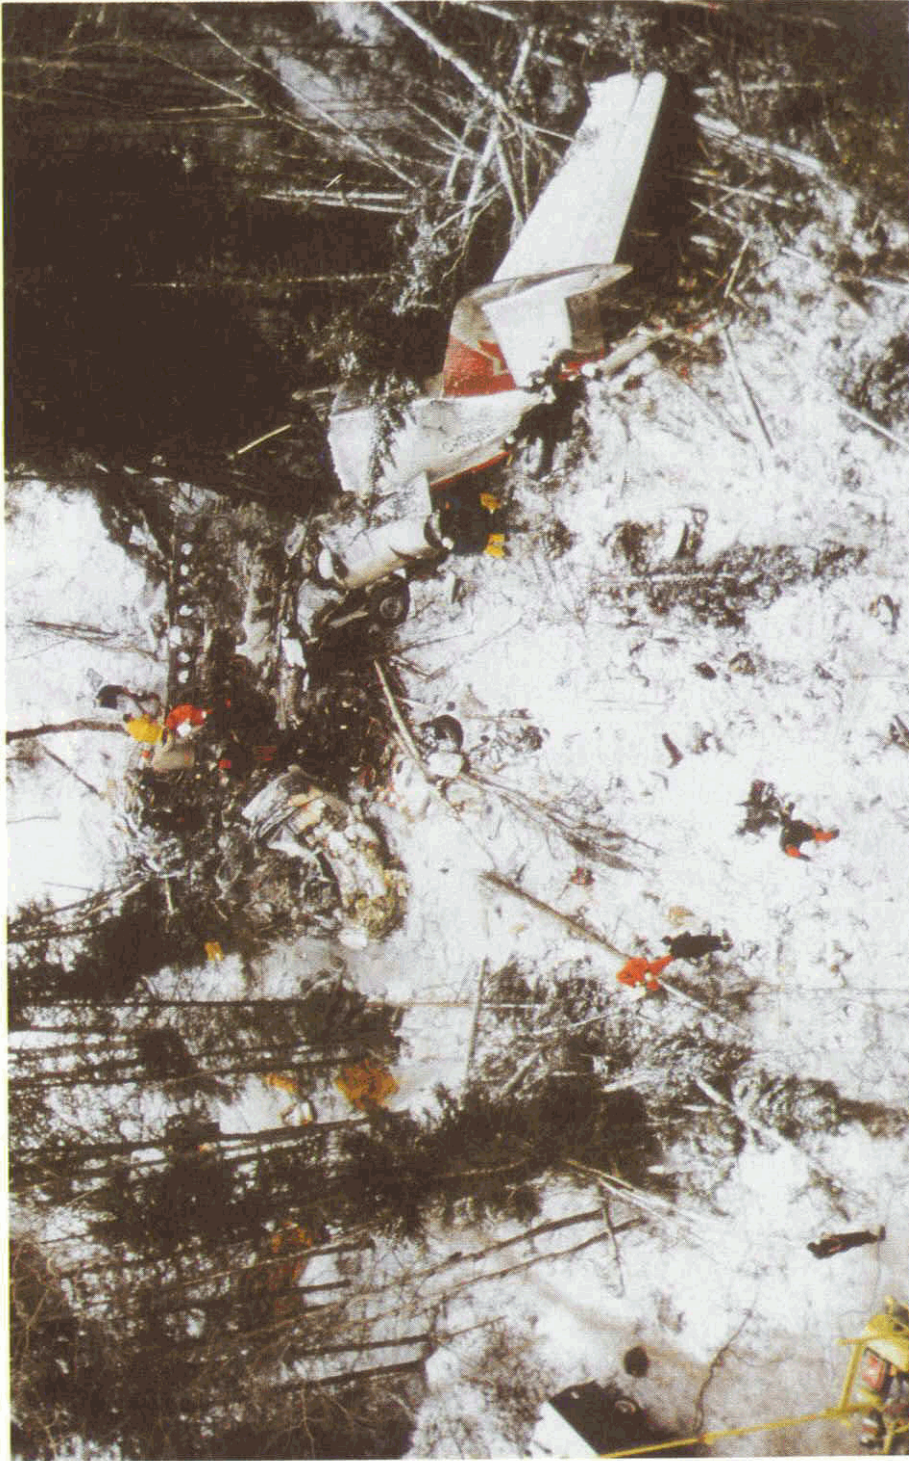
An aerial view of the wreckage of C-FONF, showing the aircraft in three pieces. The Air Ontario designator is clearly visible on the tail section.

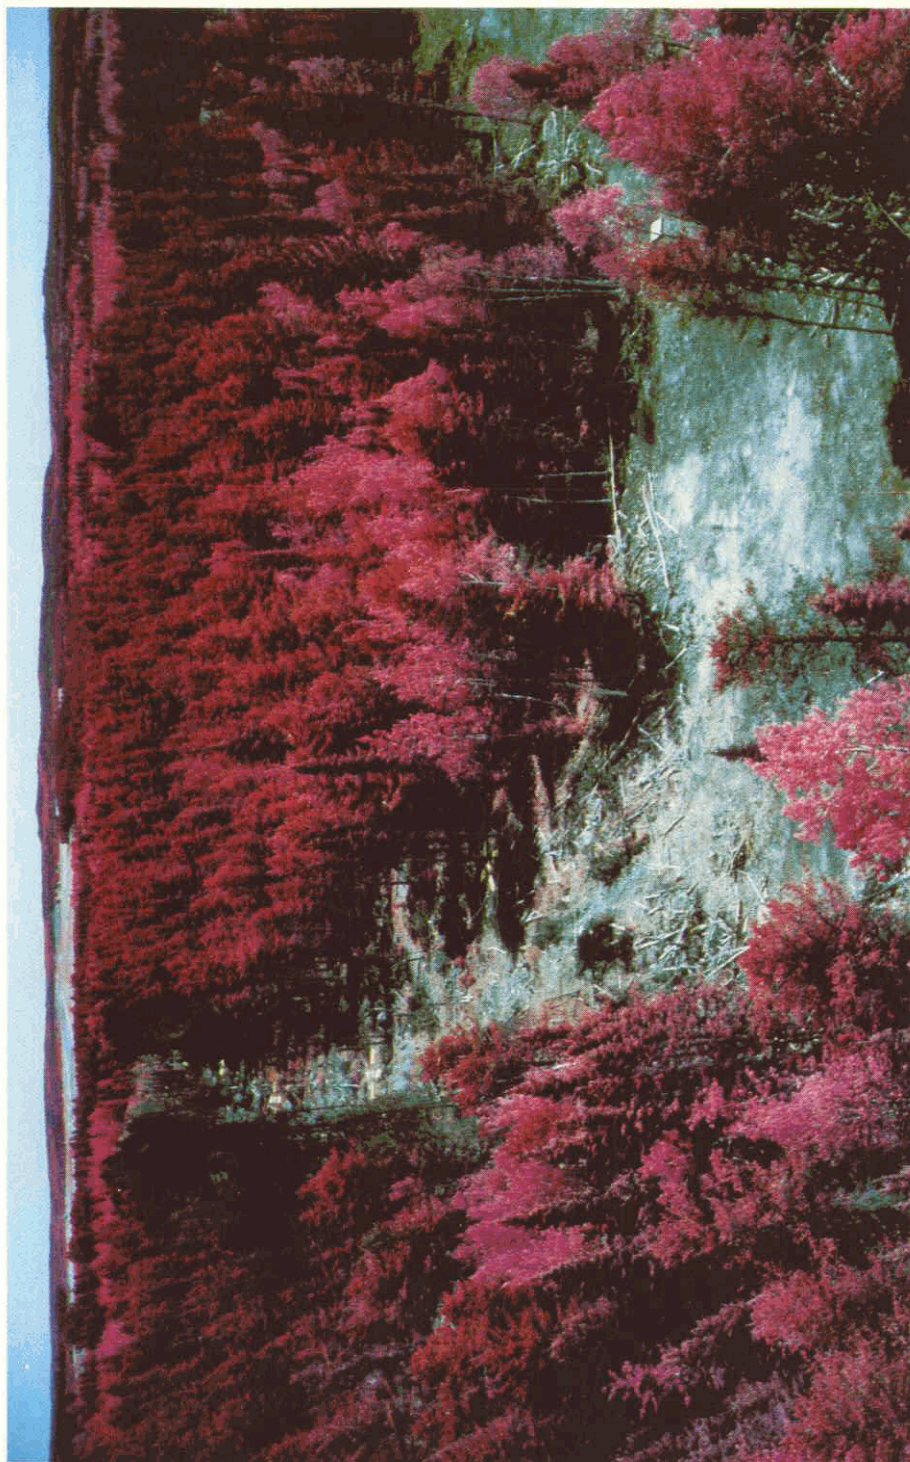
This infrared photograph shows the extent of the fire damage to trees along the flight path.

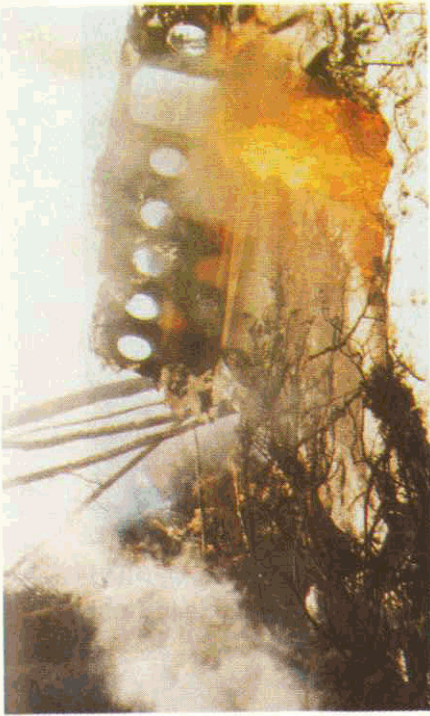
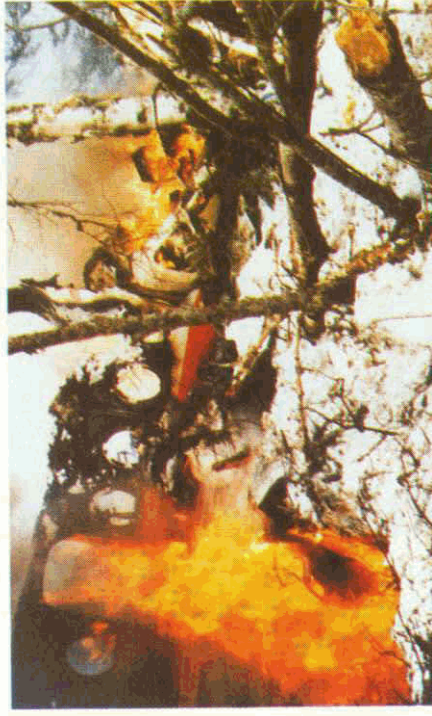
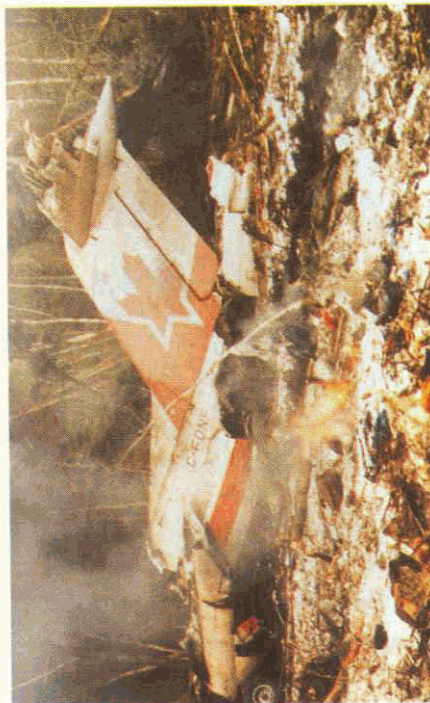
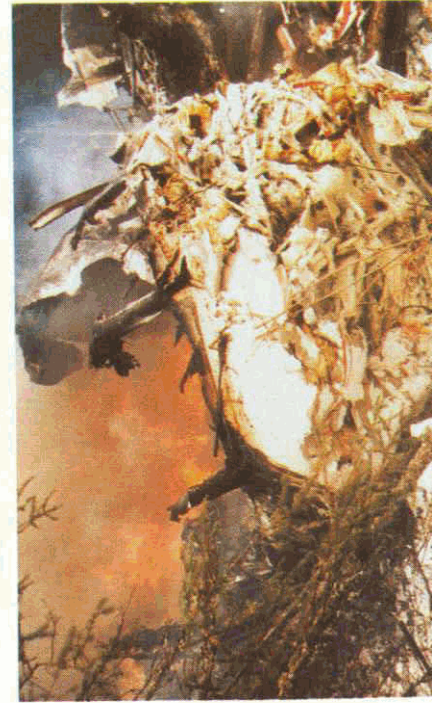
These photographs, taken by one of the fire-fighters in mid-afternoon March 10, 1989, convey the intensity of the fire which, by this time, is nearly extinguished.

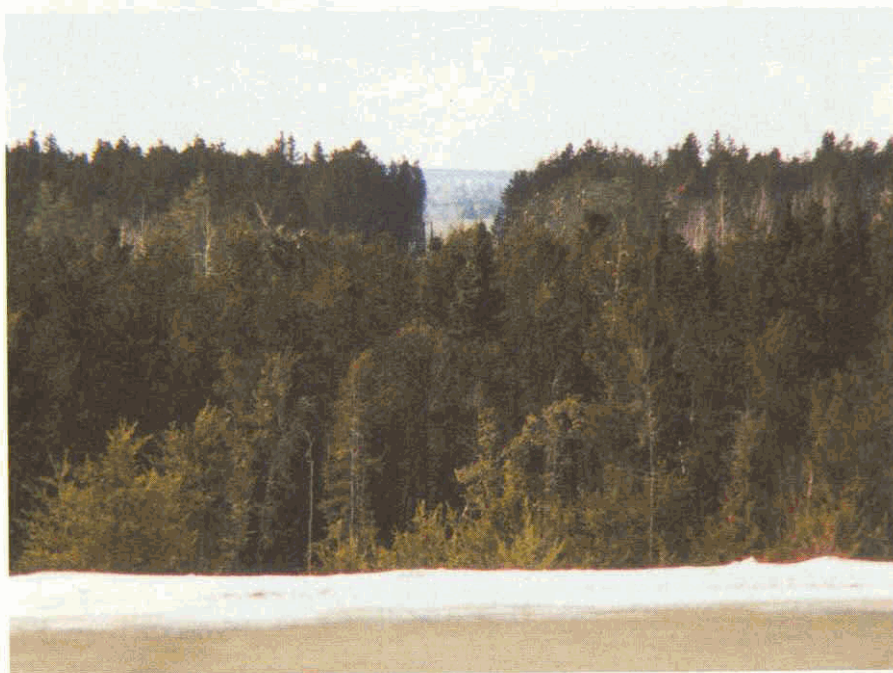
The path of flight 1363 is clear in this photograph taken by CASB investigators, looking west from runway 29 of Dryden airport.

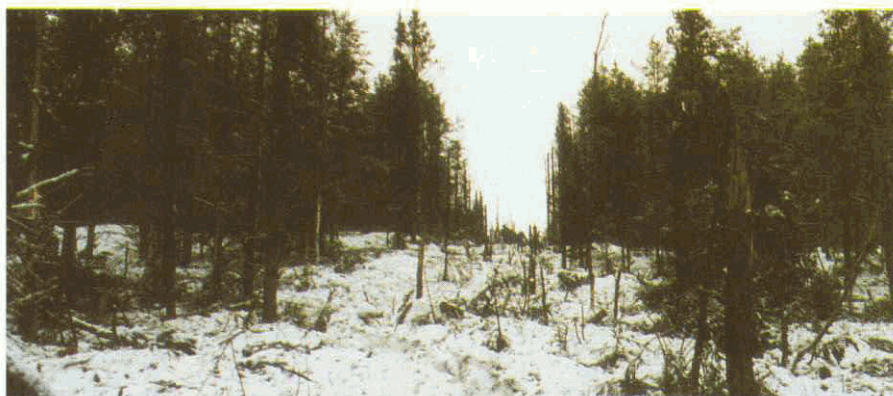
The wreckage trail looking east from the site of the crash

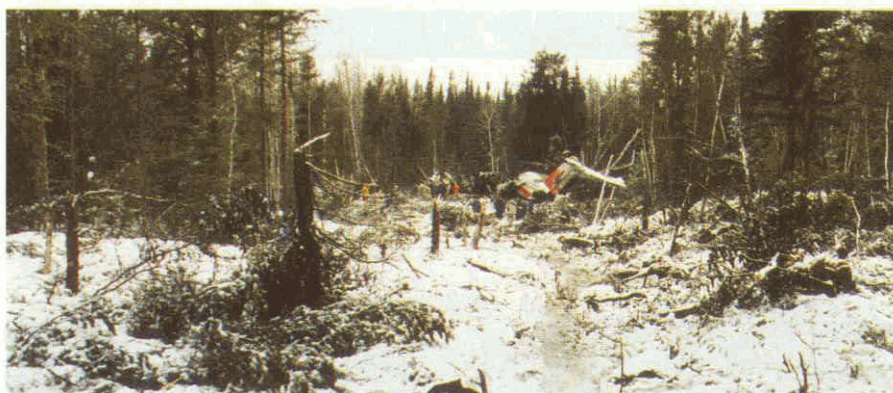
The wreckage trail looking west towards the wreckage from part way along the trail

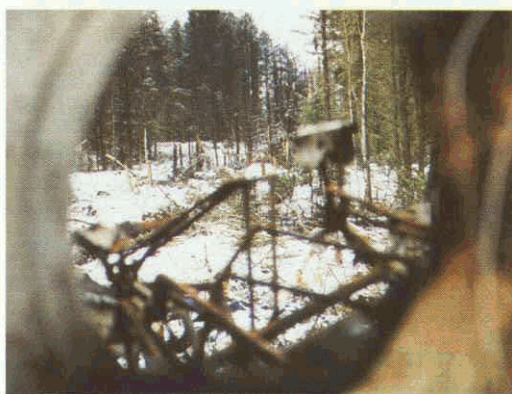
The wreckage trail shot through the fuselage of the aircraft

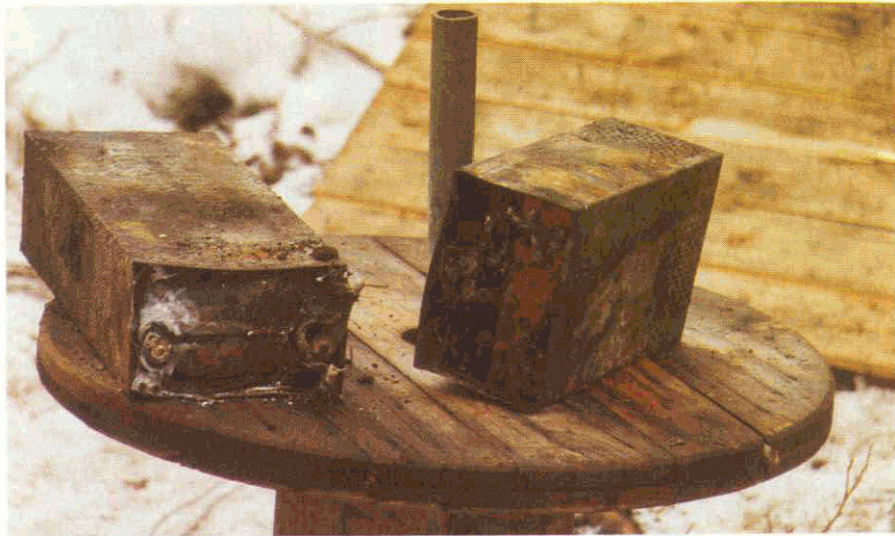
The cockpit voice recorder and flight data recorder were recovered, buried in debris, approximately 24 hours after the crash. On disassembly, it was discovered that the recording medium of both recorders had been destroyed by severe heat damage.

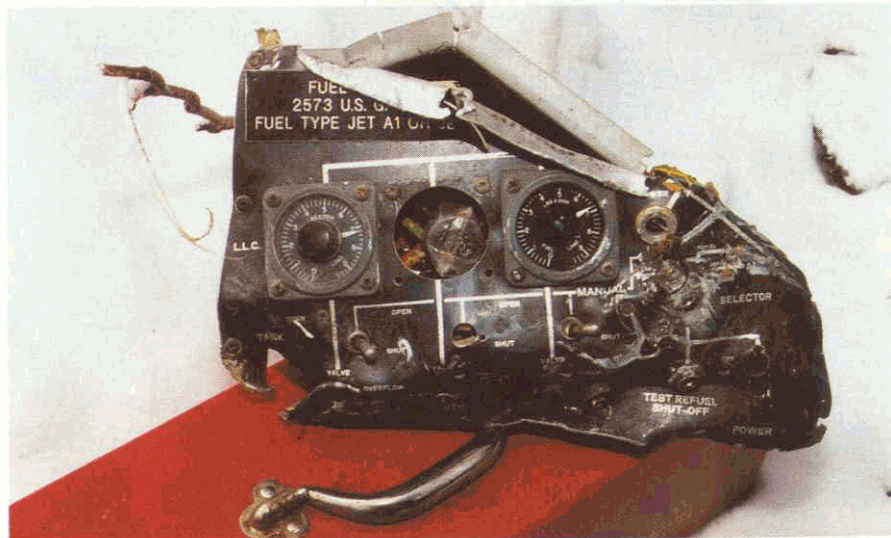
The refuelling panel, located in the wing, shows a fuel load of approximately 14,000 lbs.

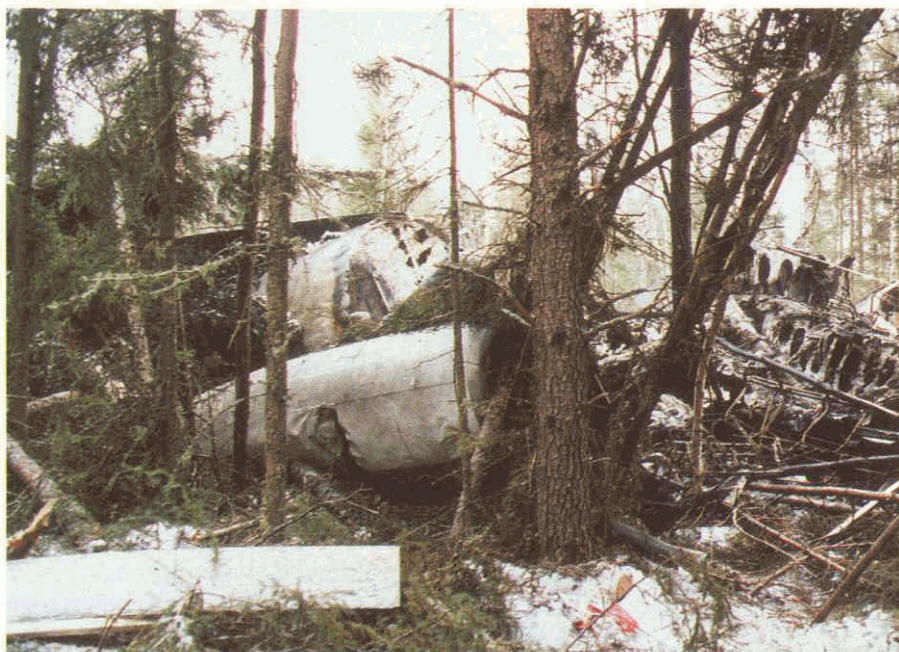
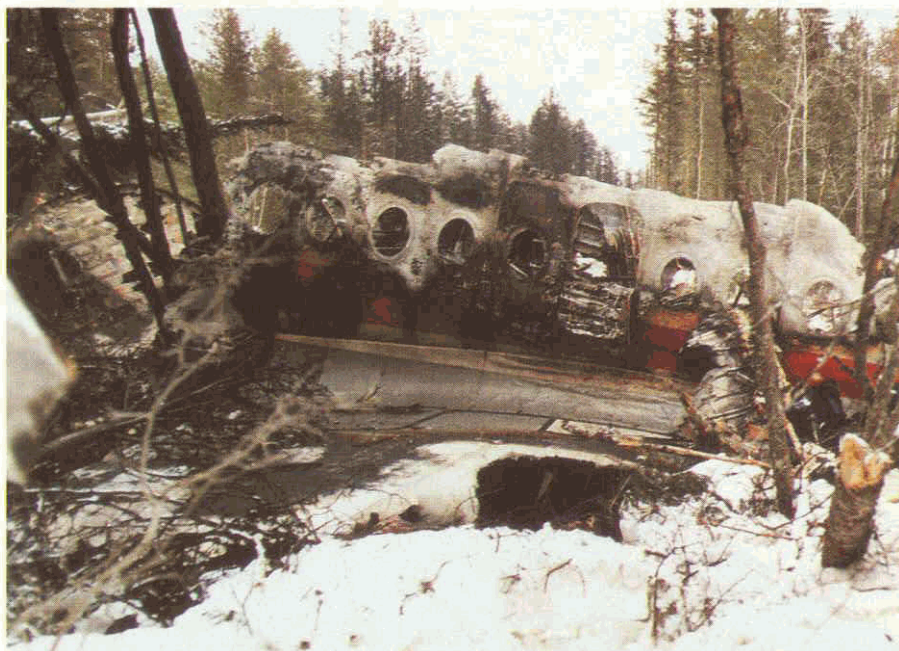
The wreckage was carefully photographed in situ at the crash site by the investigators: top, right engine; bottom, rear section of the right side of the fuselage.
