LYCOMING SPECIAL CERTIFICATION REVIEW TEAM (SCRT)

Final Report

September 30, 2004

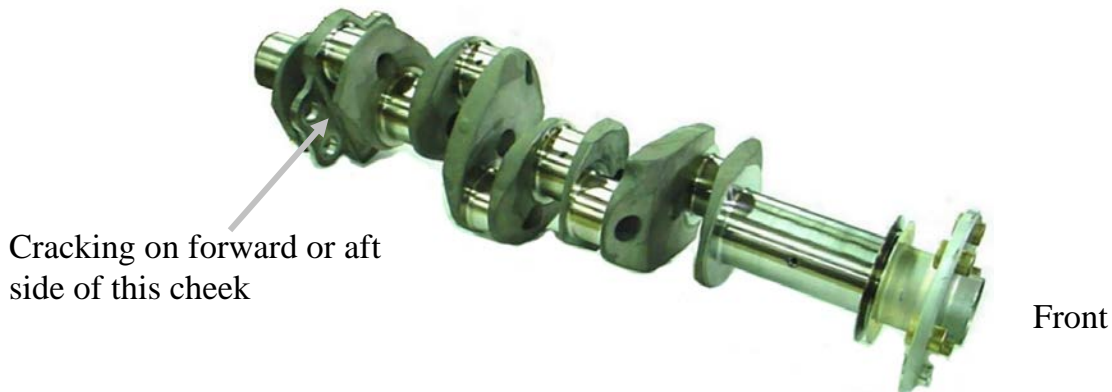
**Location of Crankshaft Cracking
(3-D View of Complete Crankshaft)**
Figure 3-1

Beginning in 2000, failures of crankshafts in the TIO-540 series turbocharged engines rated at 300 horsepower and higher began occurring. The failures all occurred in the area of the rear cross over cheek between the number five and six crankpin journals, and all were fatigue type in nature from subsurface origins (as observed when the origin was not mechanically damaged). Figures 3-1 through 3-4 graphically depict the location of the crack through the crankshaft geometry.

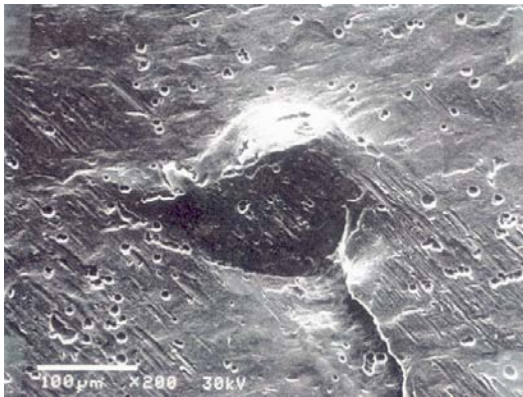
As the crankshafts fractured during engine operation, the parting surfaces experienced an amount of smearing. As a result, only one fracture surface was found to be undamaged at the origin allowing electron microscope examination. This inspection indicated the fracture origin appeared to be a planar, grain like structure approximately .005 X .010 inches in size (as shown in Figure 3-5).

**Planar Feature at Crack Initiation Site
Figure 3-5**

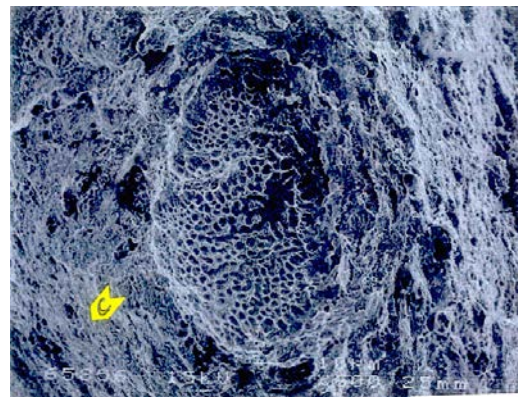
**Honeycomb Feature
Figure 3-6**

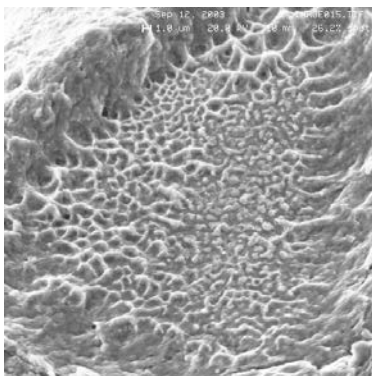
"Honeycomb Feature" is a term used first by Teledyne Continental Motors to describe a feature found on a fracture surface created by impact fracture of a Charpy Specimen. It is believed to be the result of alloying elements and contaminants segregating to the grain boundaries during forging when the crankshaft is forged at excessively high temperatures as the grain boundary begins to melt. In extreme cases, the honeycomb feature can have a planer appearance in the center and the feature size is larger (see Figure 7-1). This is believed to be an indication of more excessive overheating and/or tensile strain during forging. In the photographs below, the picture without the planer features is about 5 times the magnification of the photo with the planer areas. It is believed that as the degree of overheating increases, the honeycomb feature evident on the Charpy Specimen will be larger and will begin to form planer areas. The planer areas are basically cracks in the material.

**Honeycomb feature
Without Planer Areas**

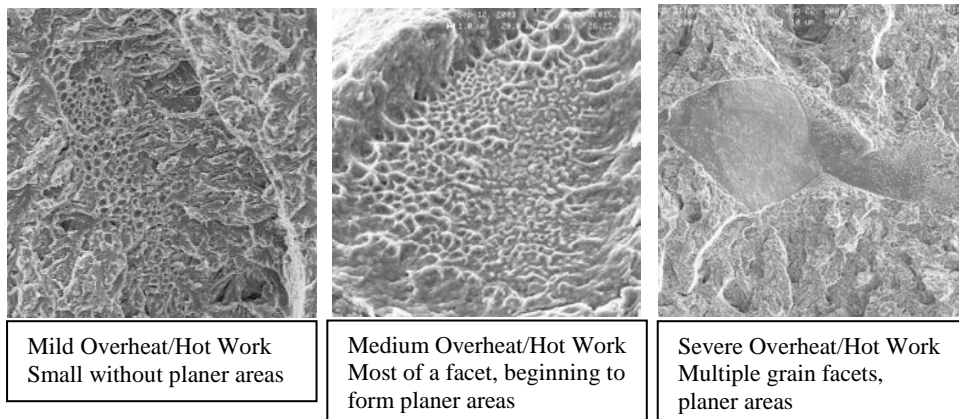
Figure 7-2

honeycomb feature can vary in degrees (see Figure 7-2). Mild overheating and/or small amounts of hot working producing tensile stresses during forging appear to produce small honeycomb features that do not have microcracks when only a portion of an occasional grain boundary was affected. Medium levels of overheat and/or tension stresses during hot working appear to cause most of one facet to form the cellular structure referred to as honeycomb and they tend to be larger. High degrees of overheat and tension stresses during overheat cause the honeycomb feature to disbond along the grain boundary and cause a microcrack.

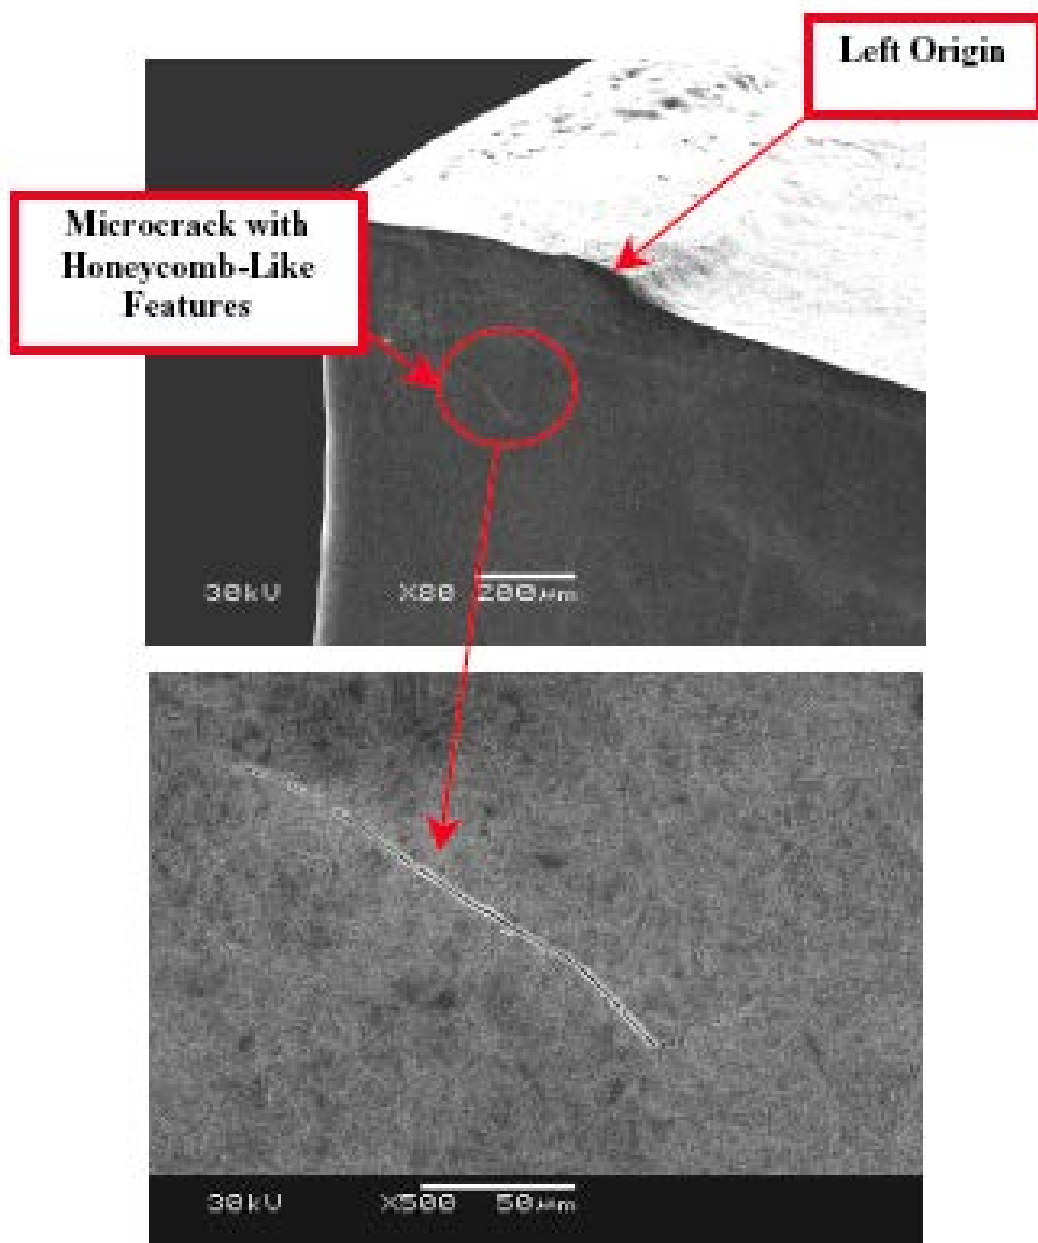
The microcrack is the result of the honeycomb feature maturing during the forging process to the point where the entire prior austenite grain boundary loses all its ability to sustain tension loads and becomes a crack. This is shown in the severe overheat/hot work picture of Figure 7-2. This can also be seen in metallographic sections examined during investigation of crankshaft service failures (see Figure 7-3). This failure is from a TIO 540 J2BD engine with the large journals. The crankshaft failed after 921.3 hours. The crack was found in the same area as the failure, but because it was a little smaller and not in as high stress an area of the crankshaft, it didn't grow. Figure 7-4 is a magnification of the crack shown in Figure 7-3 and shows how the crack develops out of the honeycomb feature. The length of this crack was measured to be .007 inches in this view, but because it is a section cut through the shaft, it is almost certainly larger in the body of the material.

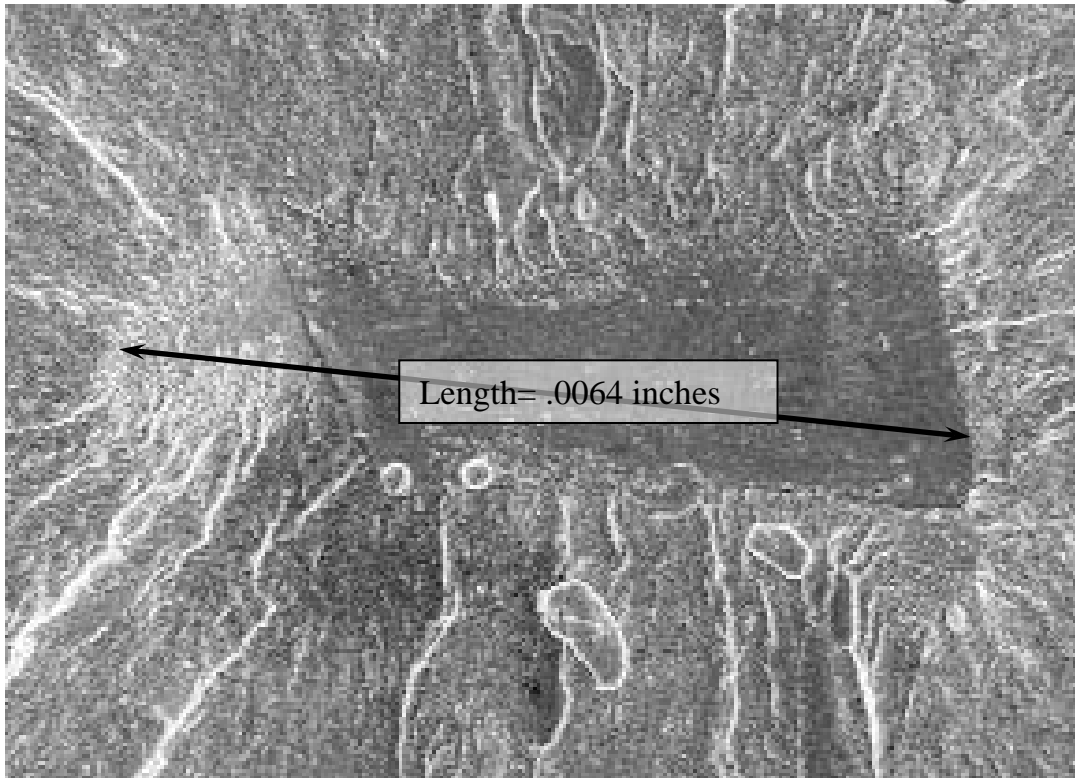
Figure 7-4b Aproximate 50% defect found by Dr. Barsom in a fatigue test specimen extracted from a crankshaft in the affected heat lot.

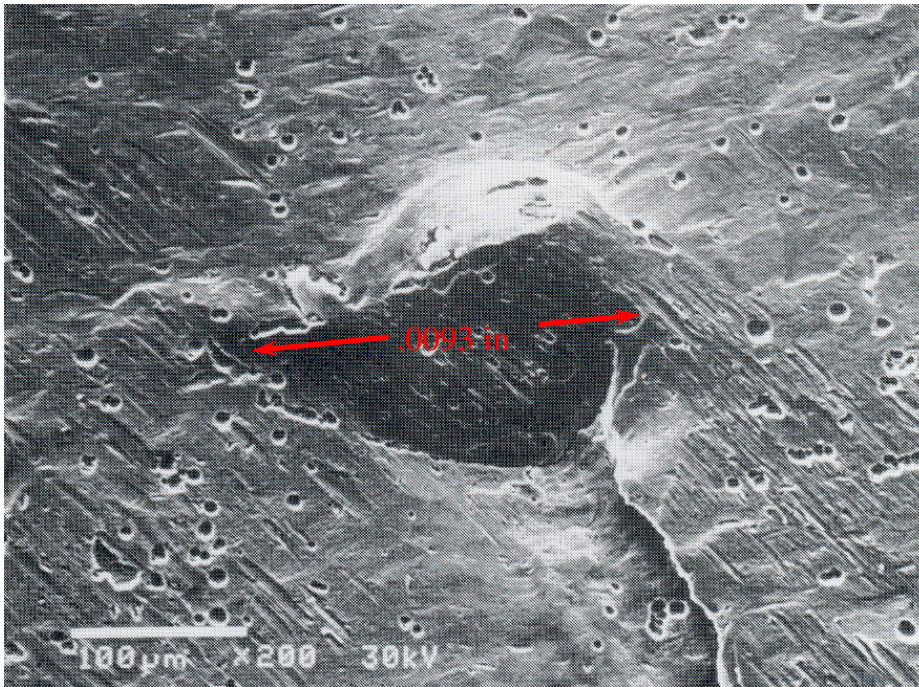
At the stress level indicated, the required flaw size for propagation in this engine at this location and at this power is .0070 in. Since this flaw obviously did propagate to failure in 887 hours, the conclusion that the SCRT Team reaches is that the fracture mechanics analysis is quite accurate in this case.

Figure 7-6. Flaw found in the number 6 journal in TIO 540J2BD, heat code SS-9T installed Piper Navajo. Failure was at 887 hours. Large Main Crank operating at 350 hp.

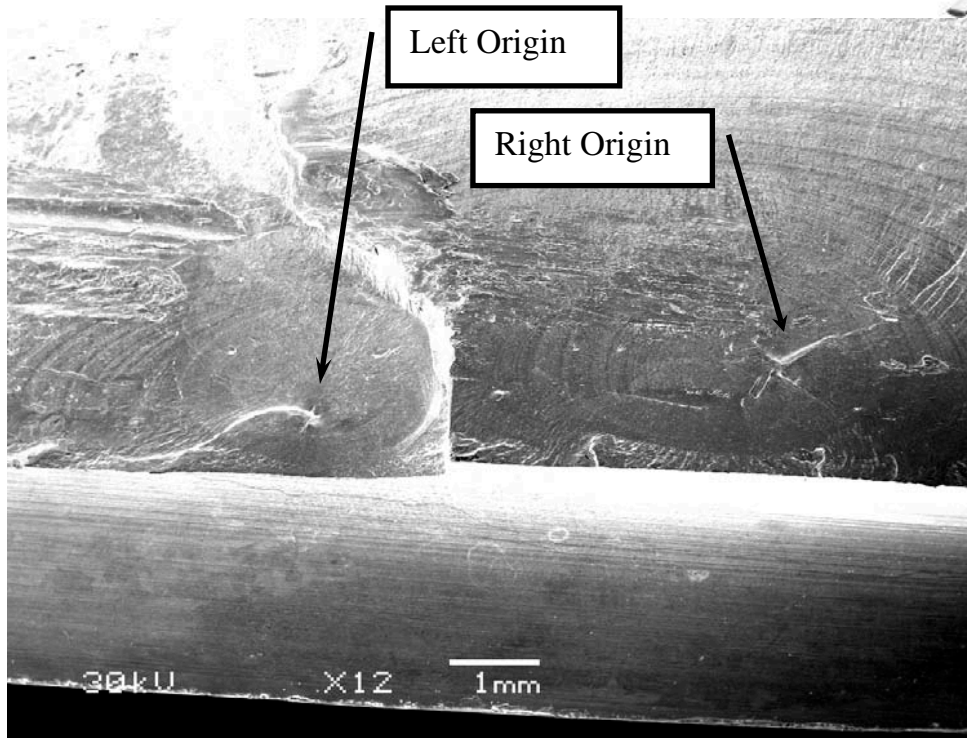
Figure 7-6a, Taken from the failure analysis of failed crankshaft showing multiple origins.

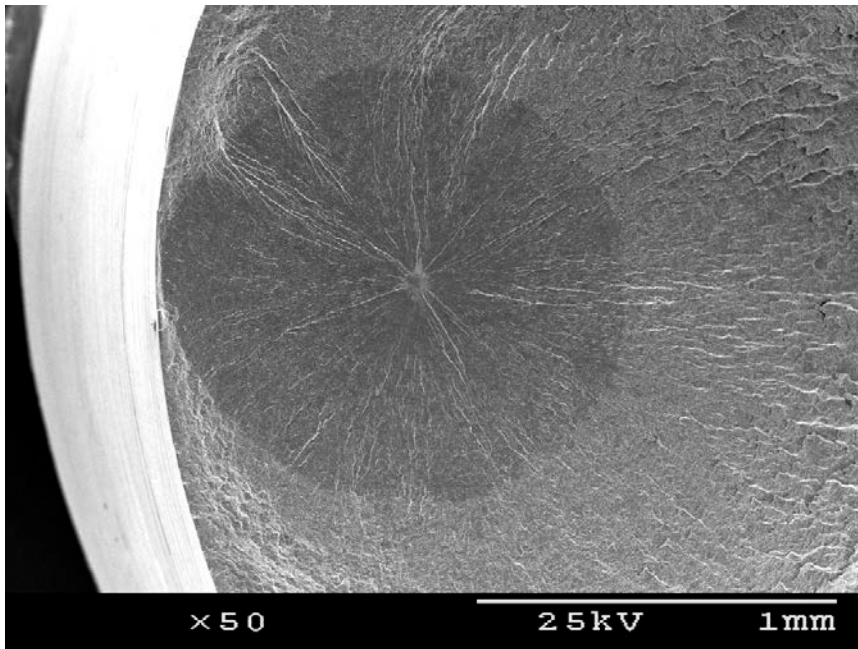
Figure 7-9 Photo taken from fatigue specimen IS-2. Specimen failed at 850,032 cycles. Specimen taken from the cross over cheek between the number 5 and 6 piston journals. Tested at 125 ksi alternating stress, $R=.05$, 10 Hz dry air. Note the subsurface origin at a microcrack

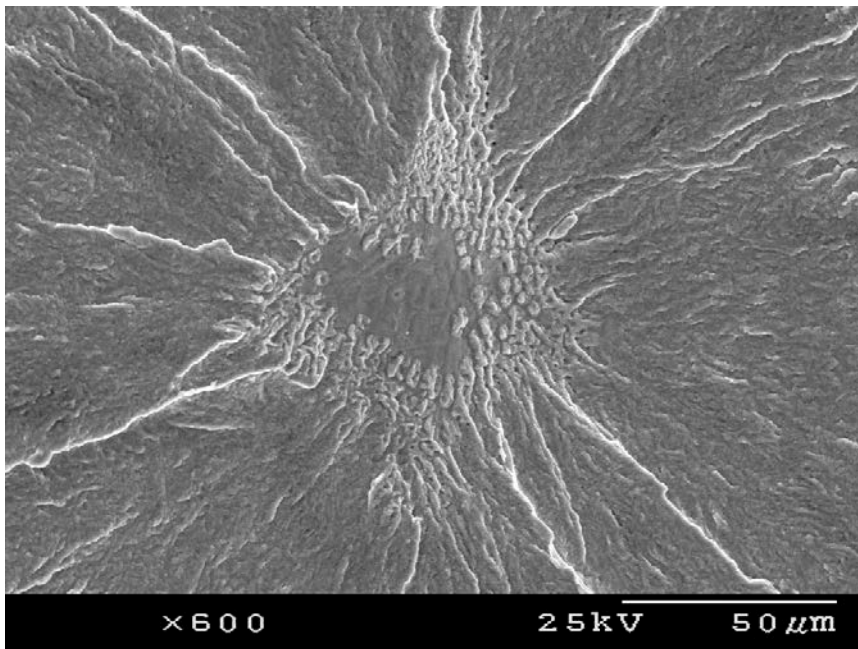
Figure 7-10 Photo taken from fatigue specimen IS-2 at the primary origin, higher magnification than figure 7-9. River marks indicate fatigue propagation from microcrack surrounded by honeycomb feature. Specimen failed at 850,032 cycles.

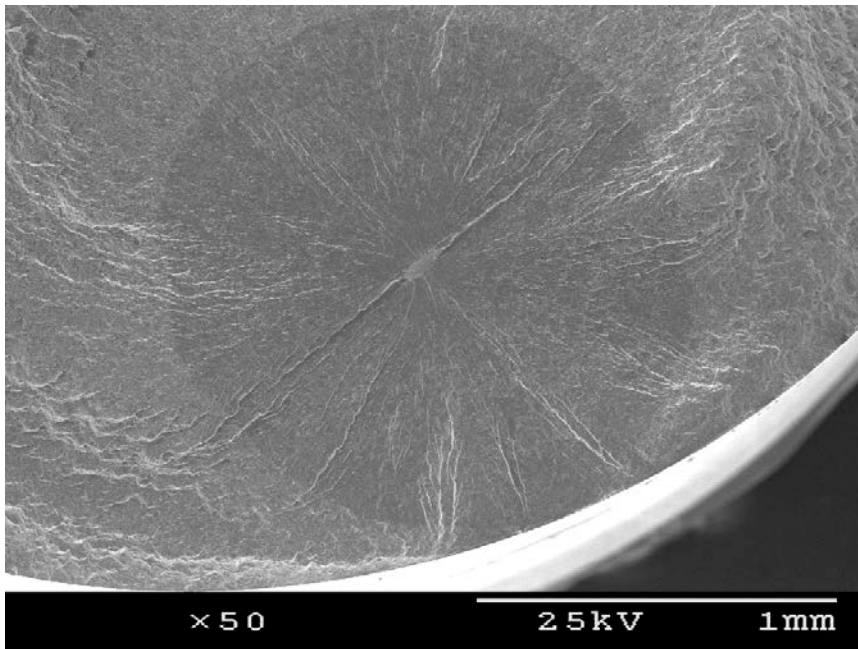
Figure 7-11 Photo taken of specimen IS6. Specimen removed from the number 5-6 cross over cheek. Specimen failed 2,190,571 cycles. Specimen tested at Tested at 125 ksi alternating stress, R=.05, 10 Hz dry air.

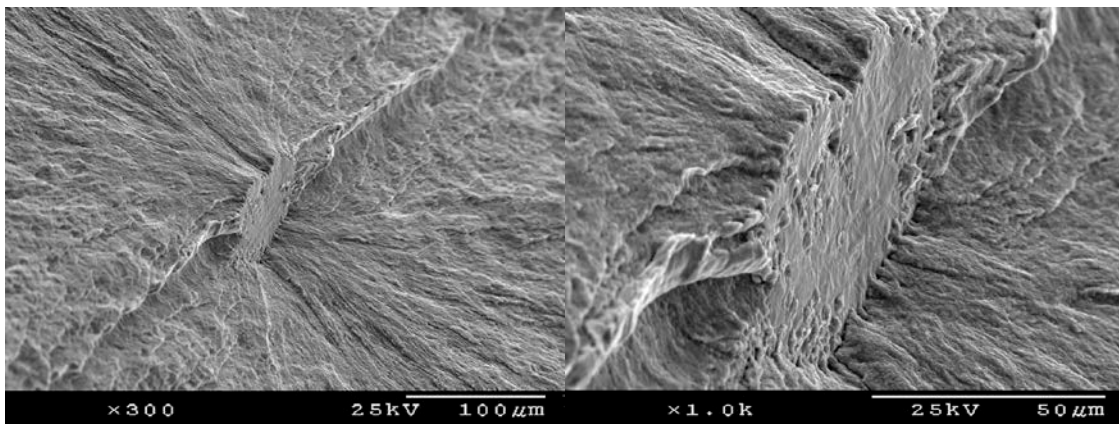
Figure 7-12 Increasing magnification pictures taken of specimen IS-6. This specimen was taken from the number 5-6 cross over cheek. The microcracks is inclined to the longitudinal axis of the specimen. Specimen failed at 2,190,571 cycles.

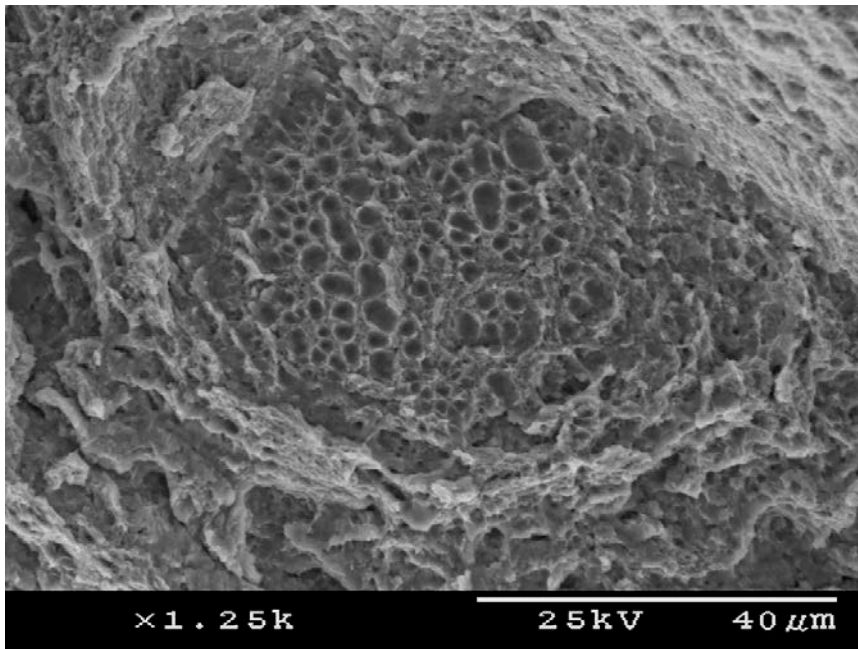
Figure 7-13 Honeycomb feature in specimen IS3 taken from a Charpy specimen taken from the number 5-6 crossover cheek.

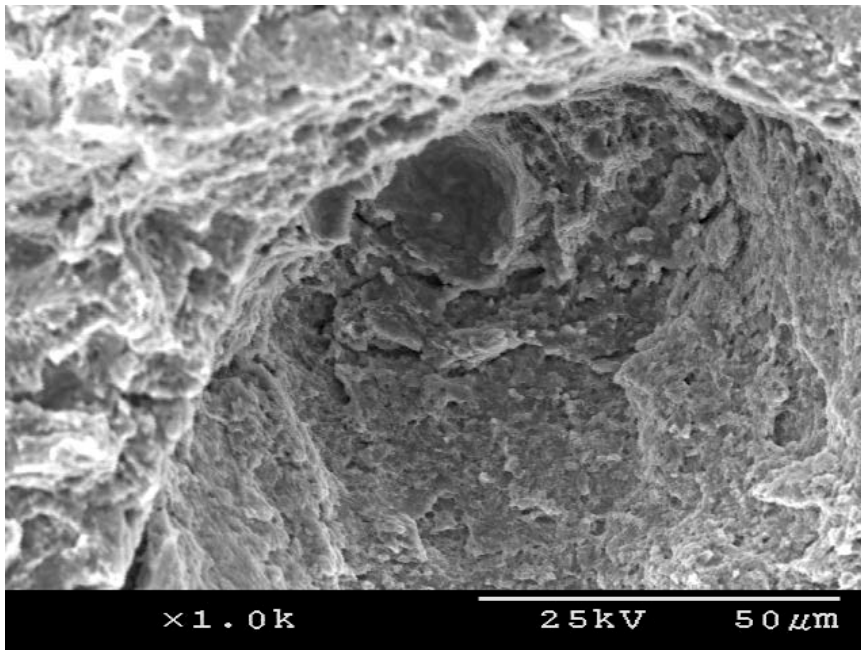
Figure 7-14 Pull out in Charpy specimen IS11 showing very small honeycomb feature at the bottom. Specimen taken from the interstate crankshaft under the forward main bearing. This was the largest feature found in this specimen.

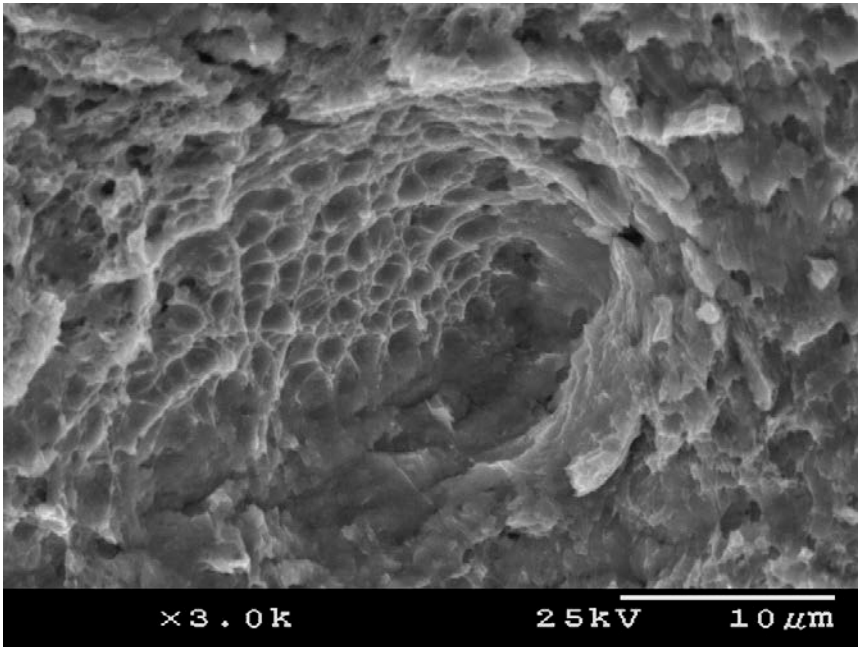
Figure 7-15 Small honeycomb feature found in Charpy specimen IS15 taken for an Interstate crankshaft in under the forward main bearing. This was the largest honeycomb feature found in this specimen.

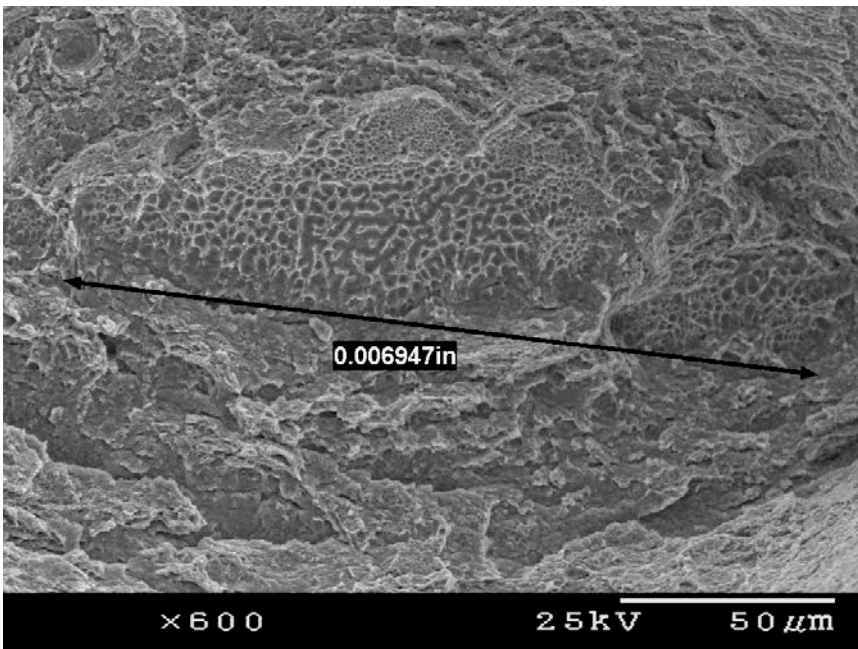
Figure 7-16 Largest honeycomb feature found is specimen IS7

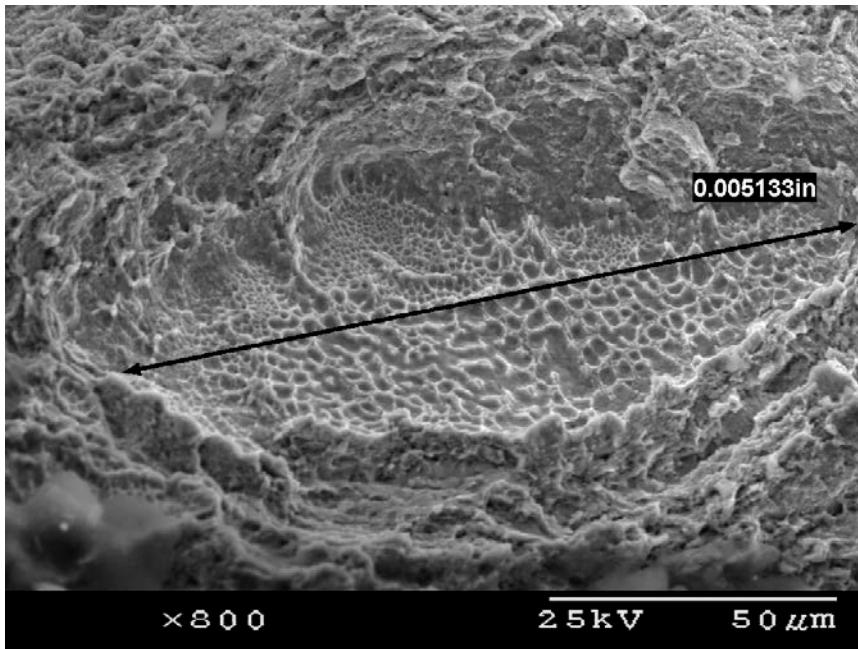
Figure 7-17 Picture from Charpy specimen IS 7 taken from to very close to the critical point in the number 5 crankshaft piston journal. Note the large size compared to those found under the forward main bearing where the grain flow is straight.

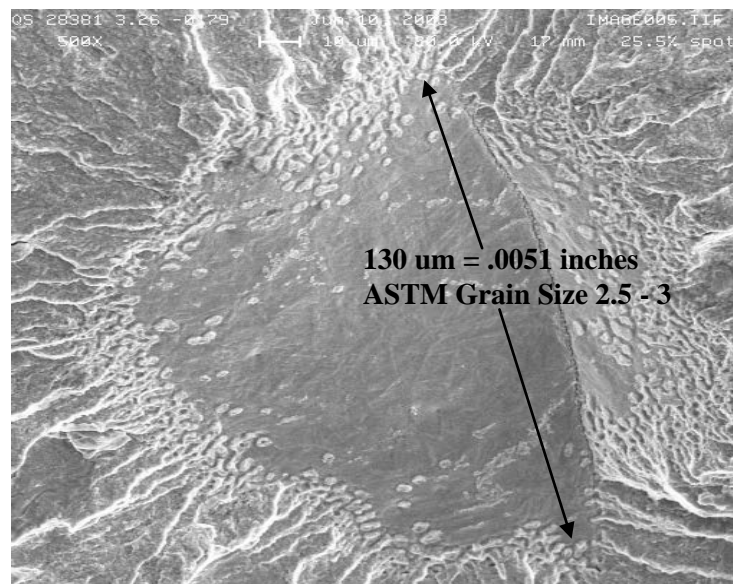
Figure 7-18 Grain size and microcrack from Barsom Fatigue test Specimen

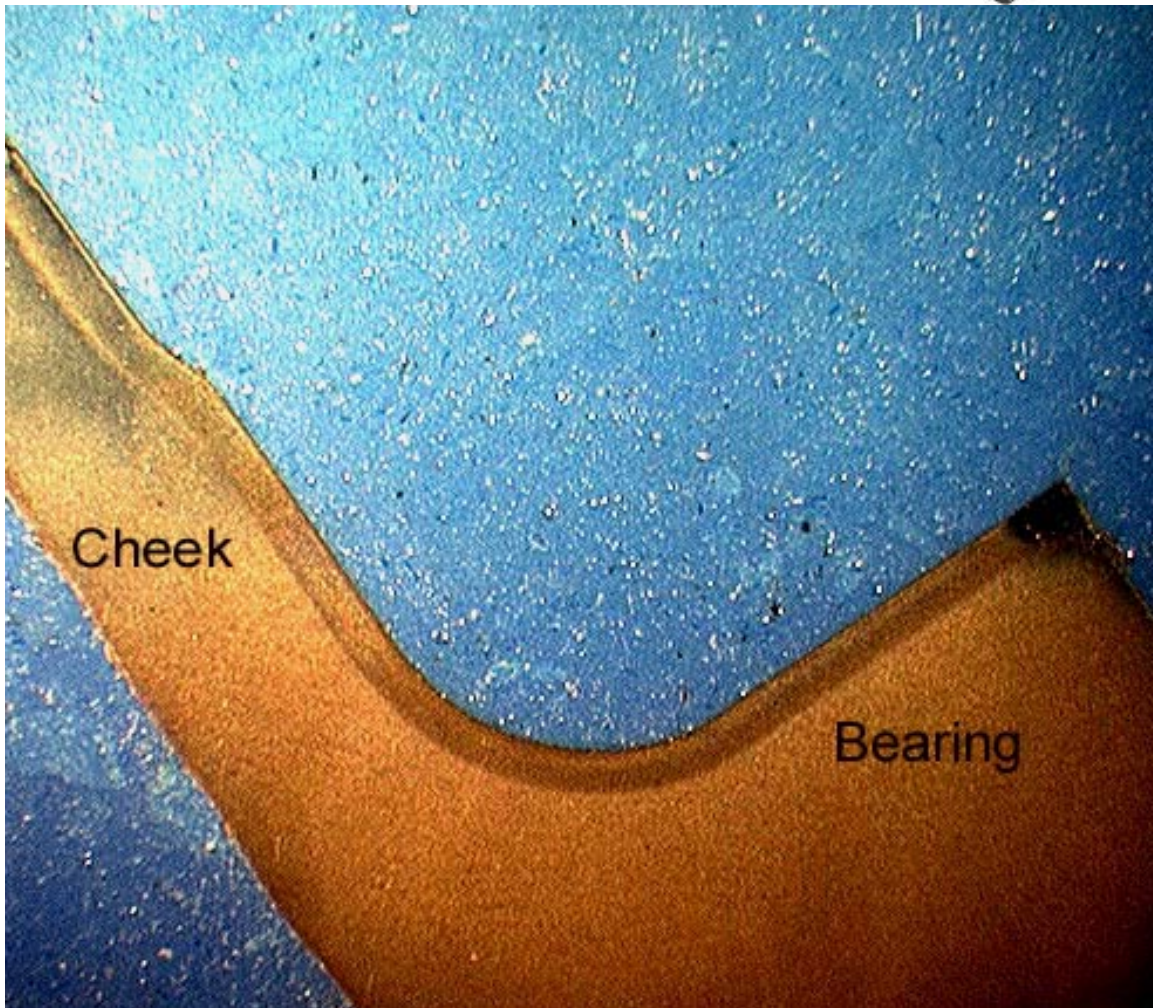
Figure 7-20 Metallographic section of the critical journal showing the nitride layer.

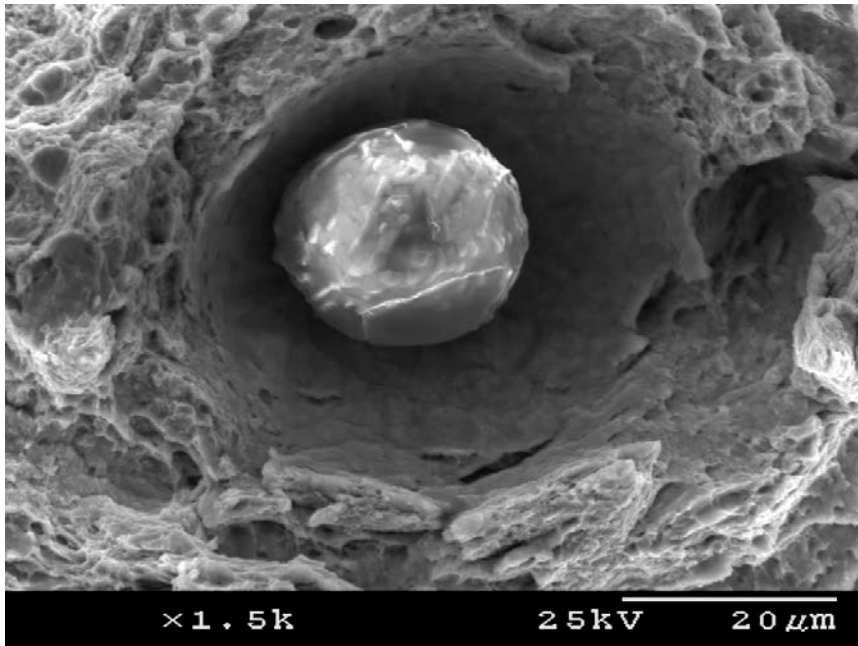
Figure 7-22 Photo taken from Krupp shaft showing small non-metallic inclusion.

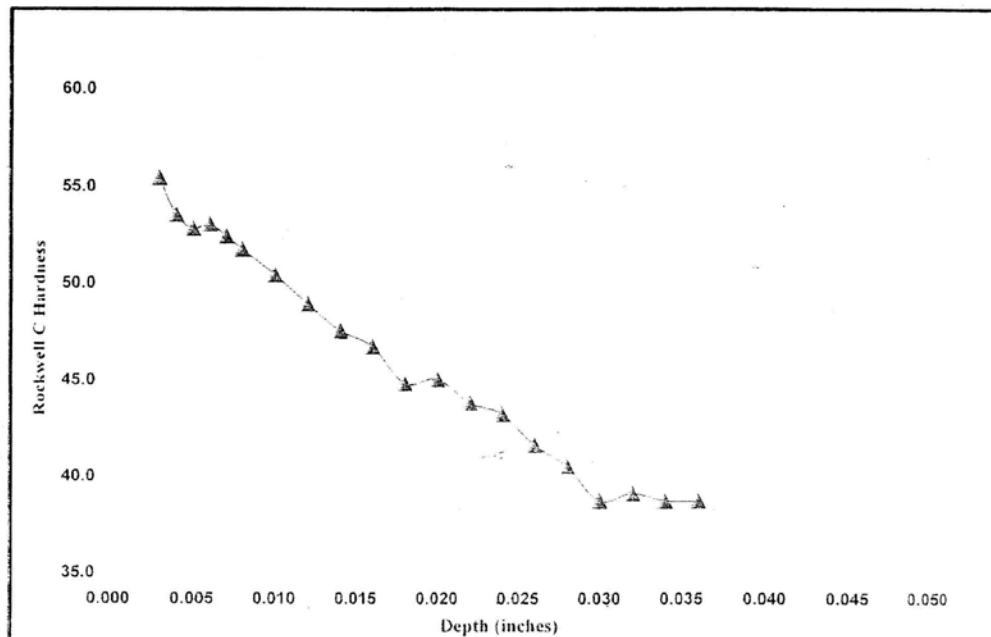
Figure 7-27, Variation of hardness with depth from Cessna Failure analysis. Normal nitride layer that met the specification requirements

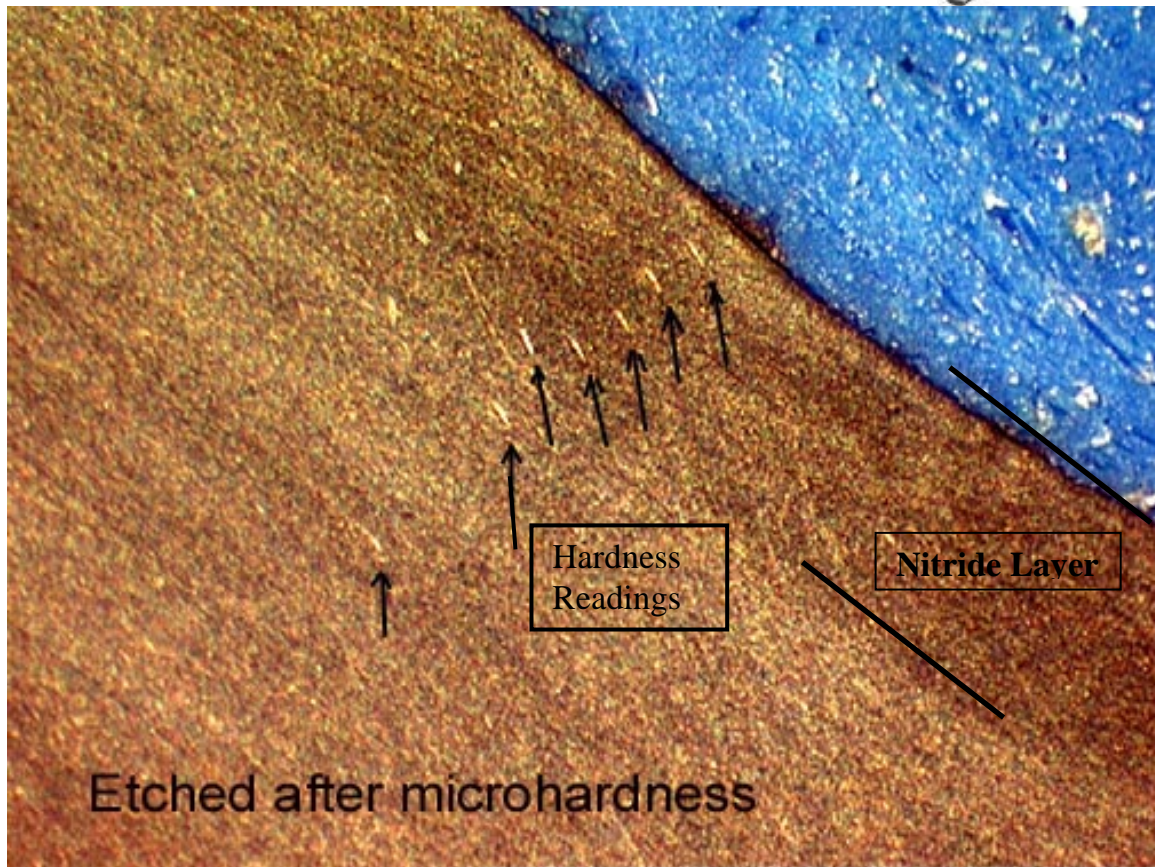
Figure 7-28 Locations for hardness readings showing the nitride layer on the number 5 Crankshaft piston pin journal. Photo taken during FAA investigation at Seal Beach Labs. (Results very similar to Cessna Study)
