# **AIRCRAFT ACCIDENT REPORT**

**NATIONAL AIRLINES, INC.**

**DC-10-10, N60NA**

**REPORT NUMBER: NTSB-AAR-75-2**

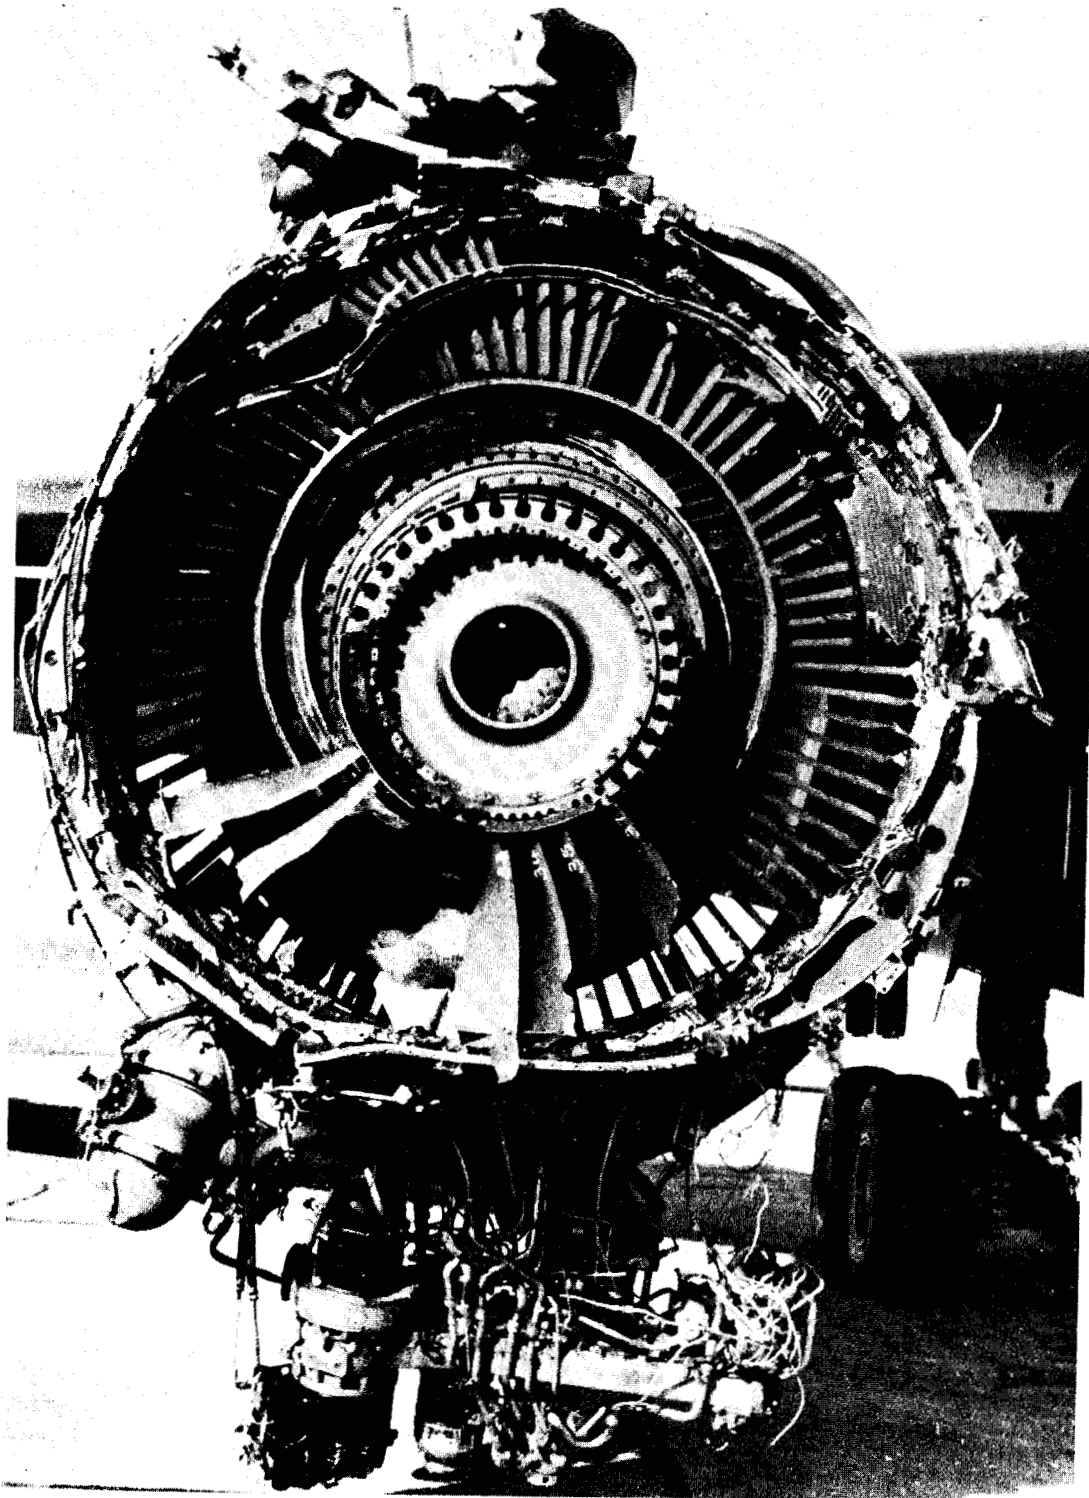
Front View No. 3 Engine

The nose cowl (inlet duct) was intact. It had broken away along the aft attach area, and the aft portion had been crushed on ground impact. Numerous blade fragments had penetrated through the inner barrel of the cowl. The outer barrel was punctured in eight locations.

The porous sheet from the first acoustic panel, extending from 12:00 3/ to 4:00, was missing from the nose cowl. It had been torn lengthwise at 12:30. A piece of this porous skin, about 230 square inches in area, was found resting against the fan outlet guide vanes.

The fan blade containment ring was recovered in an opened-up and twisted configuration. It separated at the 7:00 position, and the entire ring appeared torn and distorted, with considerable abrasion along the inner surface of the ring. Of the 12 bolts that attach the nose cowl to the containment ring, only portions of 5 bolts were recovered. The fracture surfaces of the bolts showed evidence of failure in shear. The 12 attachment bolt holes had deformed in various directions. The predominant forces, however, as shown on both the nose cowl and the containment ring, were in the direction of engine rotation.

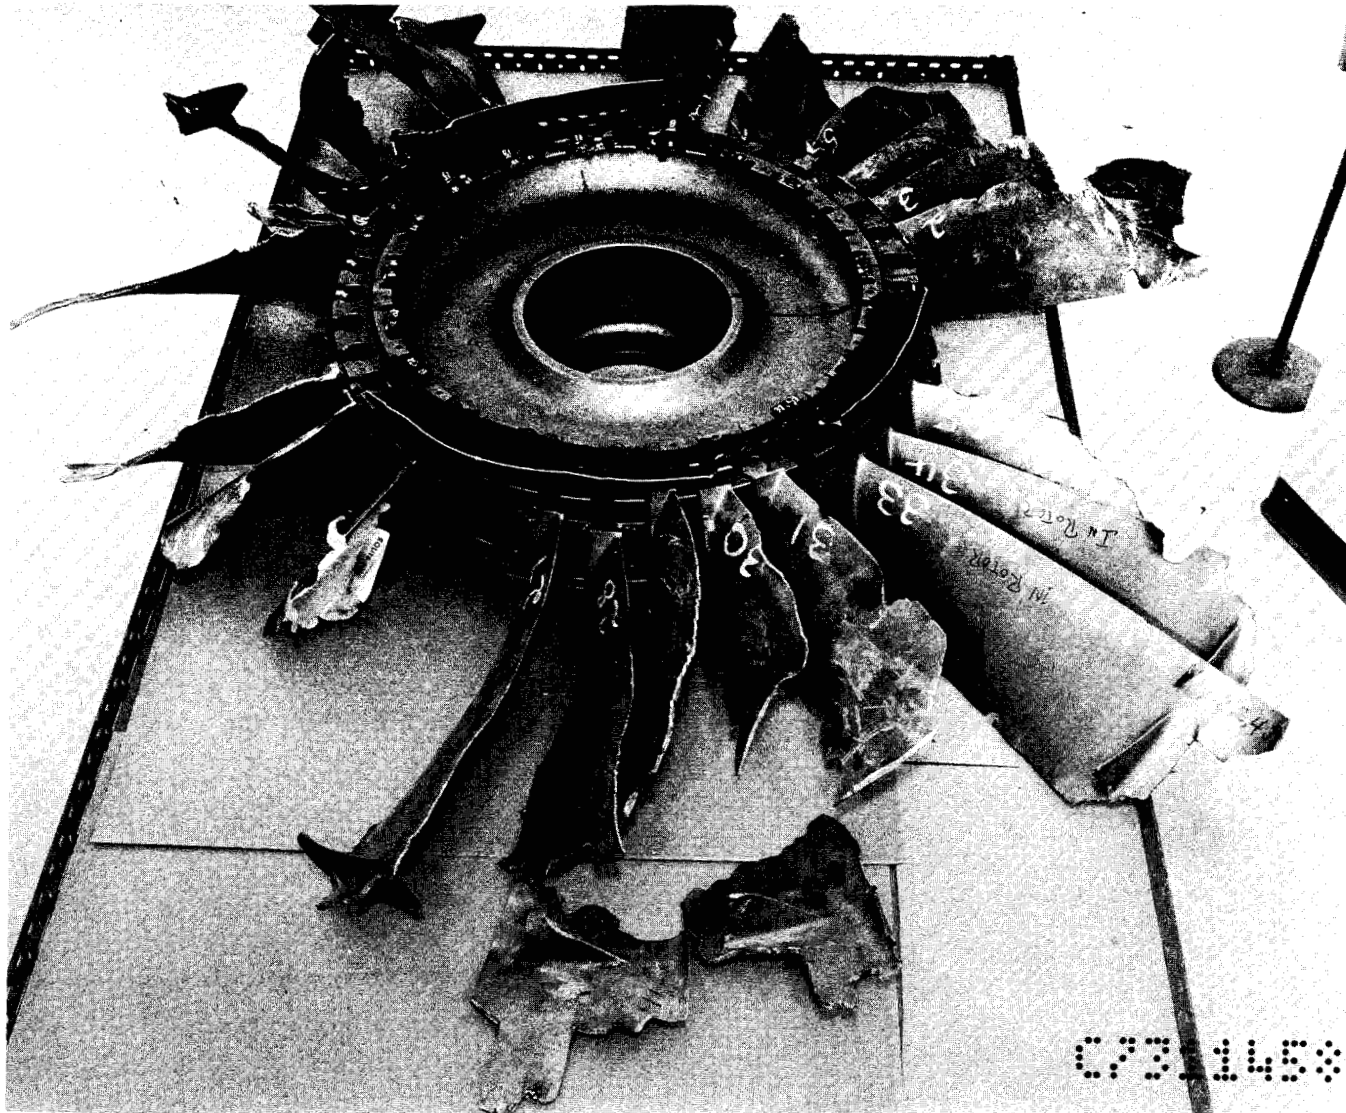
Twenty-four fan blade root sections, each with a different amount of blade remaining, including the six blades which remained in the fan disk, were recovered. Damage to the blade roots and fan disk showed forward movement past the blade restraining devices and out of the slot for each of the 18 blades which had departed the engine. For each of

the six blades that remained in the disk, the damage indicated some rearward movement in the slot.

Fan disk with recovered blade portions and spinner attachment flange segments.
