# CIVIL AIRCRAFT ACCIDENT

Report of the Court of Inquiry  
into the Accidents to  
Comet G—ALYP on 10th January, 1954  
and Comet G—ALYY on  
8th April, 1954

Report of the Public Inquiry into the causes and circumstances of the accident which occurred on the 10th January, 1954, to the Comet aircraft G-ALYP

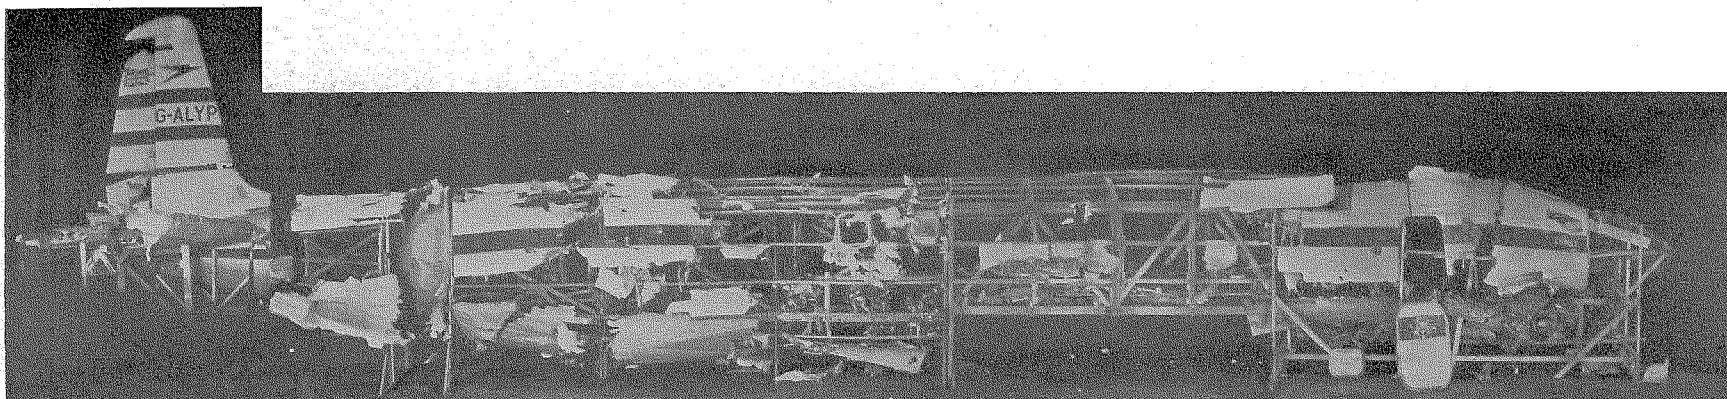
FIG. 4. RECONSTRUCTION OF FUSELAGE AND TAIL UNIT WRECKAGE—G-ALYP.

THIS PANEL  
(INCLUDING CREW  
ENTRY DOOR)  
RECOVERED  
SEPARATELY AND  
SHOWS WATER IMPACT  
DAMAGE ON OUTER  
FACE.

FORWARD EQUIPMENT  
BAY REAR BULKHEAD  
TORN FROM FRONT  
FUSELAGE AND  
REMAINED ATTACHED  
TO WING.

NOSE DOWN BENDING  
FAILURE OF PICK UP  
POINTS ON WING WITH  
FINALLY SOME BENDING  
TO STARBOARD.

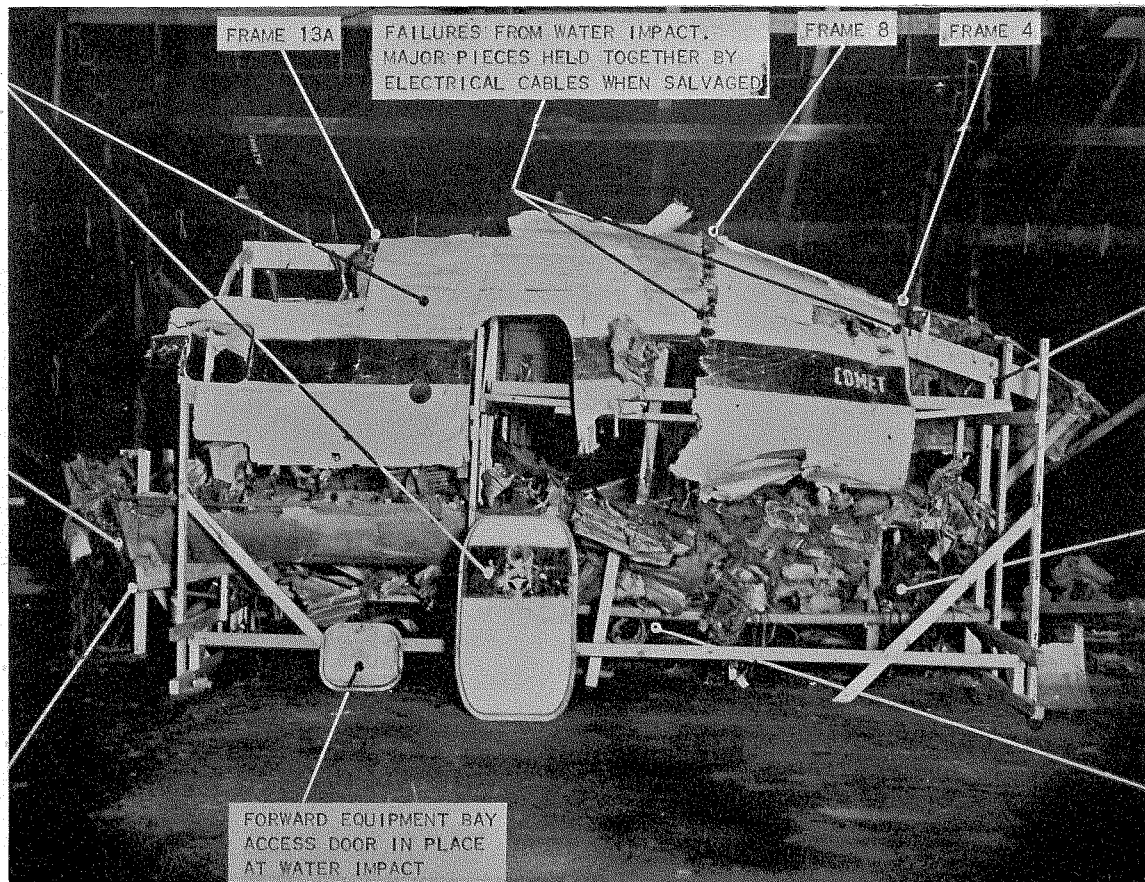
FIG. 5. FRONT FUSELAGE—VIEW ON STARBOARD SIDE—G-ALYP.

STARBOARD  
WINDSCREEN MISSING.

EXTENSIVE CRUSHING  
OF WHOLE UNDERSIDE  
OF FRONT FUSELAGE  
BY WATER.

NOSE WHEEL  
RETRACTED WHEN  
SALVAGED.

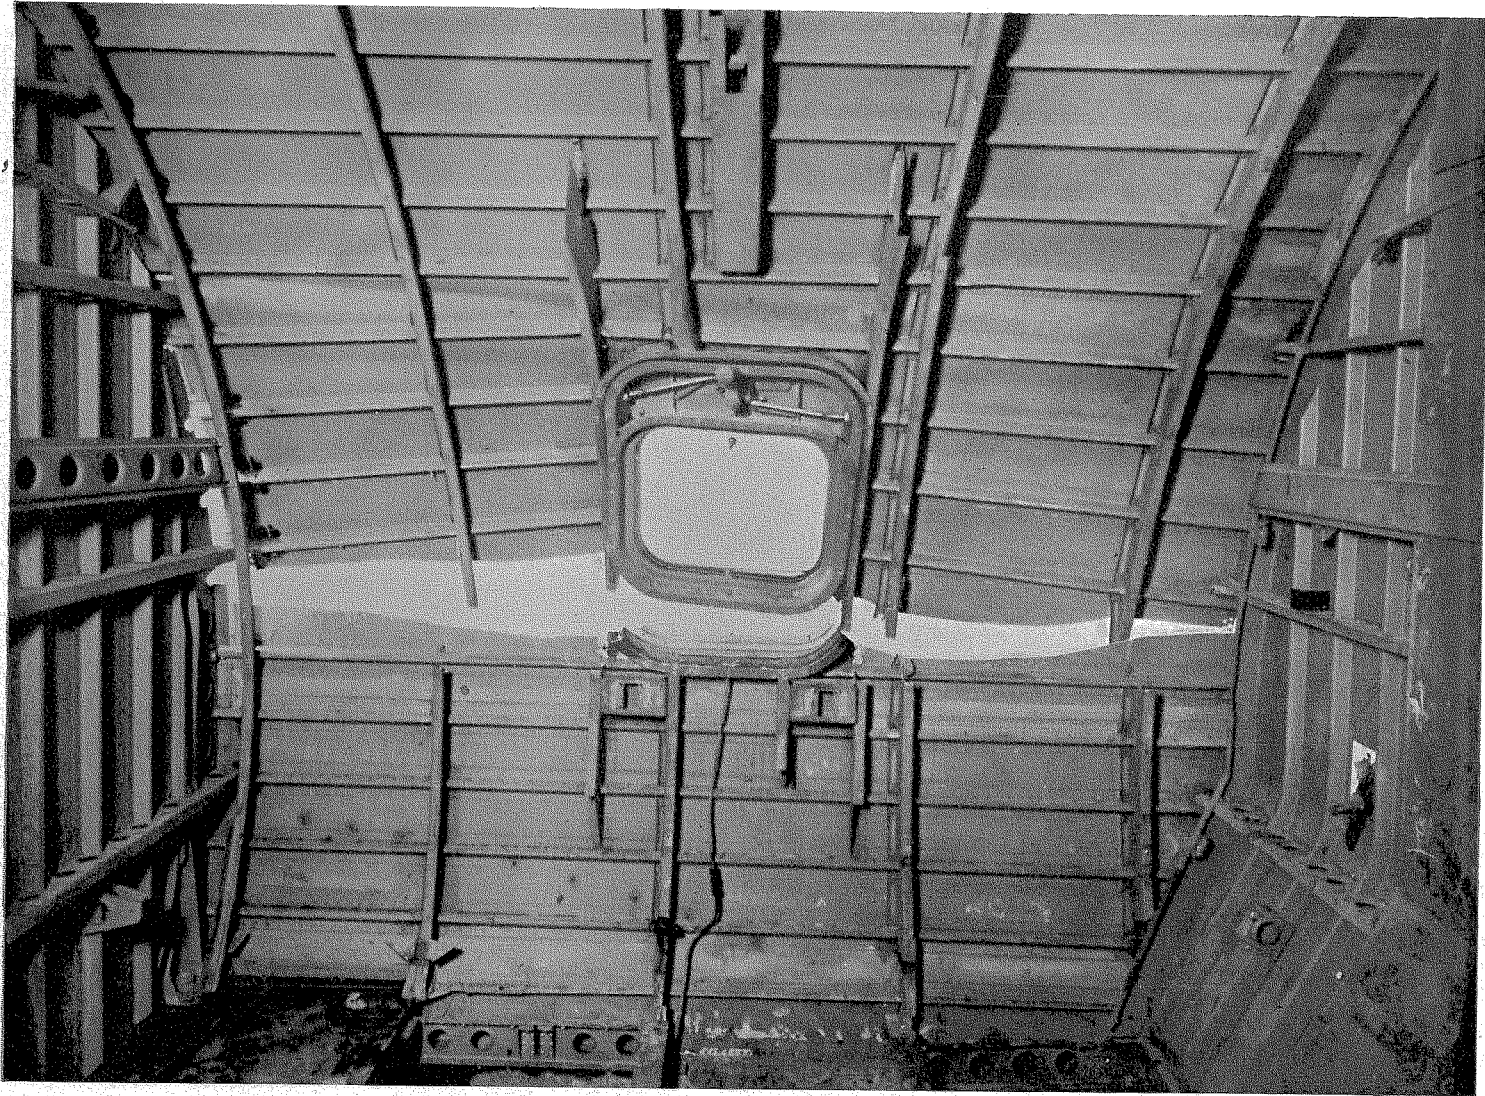
FIG. 7. VIEW FROM INSIDE OF FAILURE AT THE FORWARD ESCAPE HATCH ON THE PORT SIDE—COMET G-ALYU

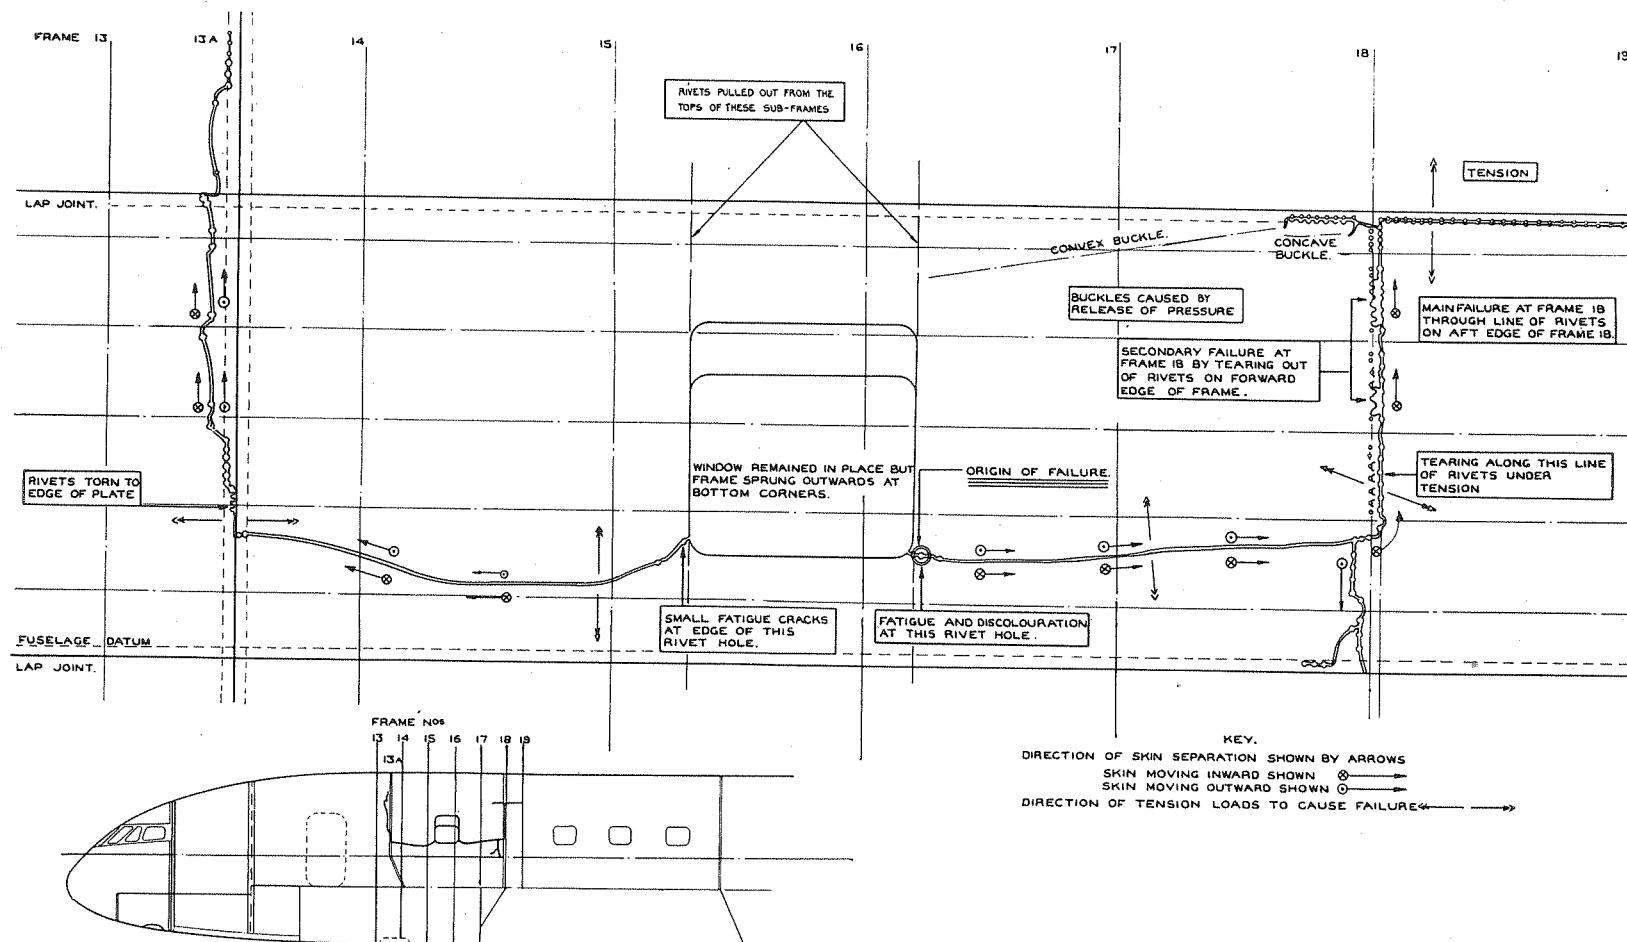
FIG. 8. THE PROGRESS OF THE FAILURE OF THE FORWARD ESCAPE HATCH ON THE PORT SIDE—COMET G-ALYU.

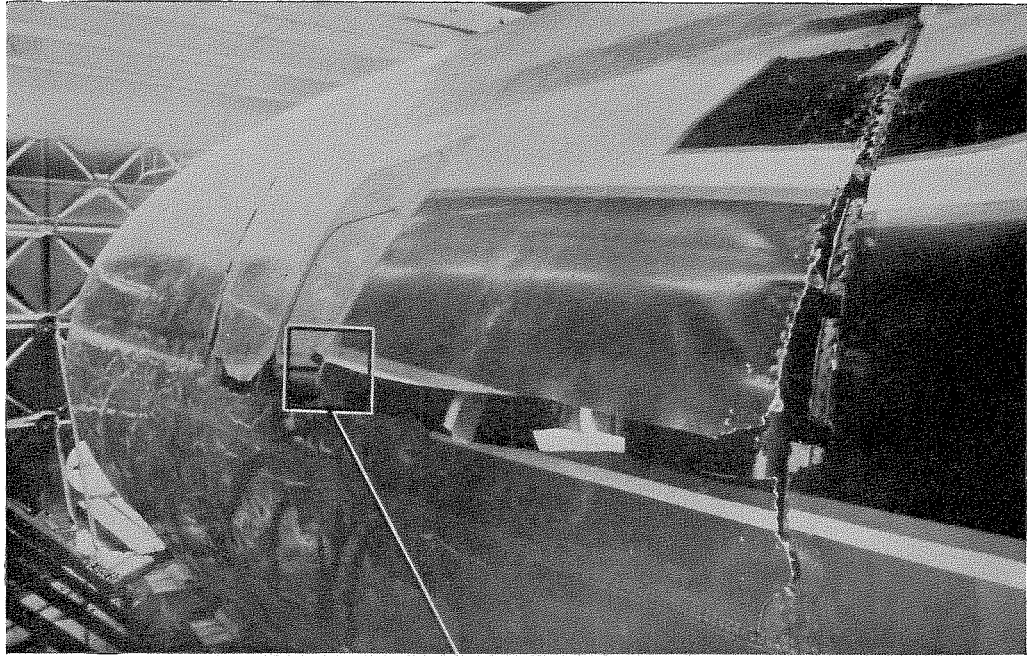
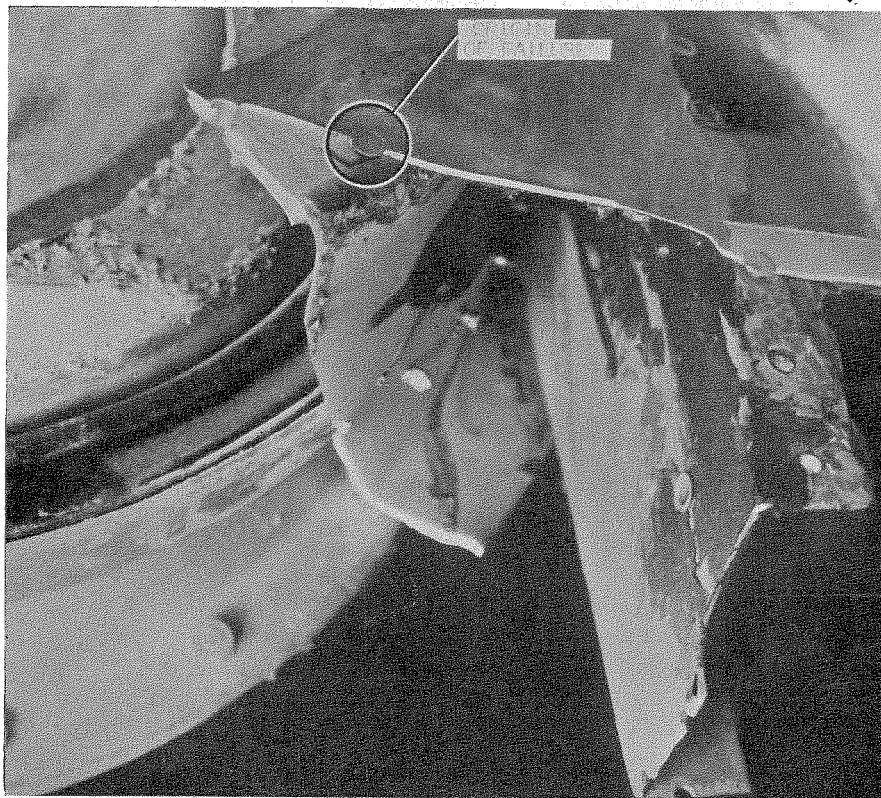
64. Yoke Uncle had made 1,230 pressurised flights before the test and after the equivalent of a further 1,830 such flights, making a total of 3,060, the cabin structure failed, the starting point of the failure being the corner of one of the cabin windows (see Figures 7 and 8). The fact that the failure occurred during one of the proving tests to 11 lb/sq. in. is not thought significant since the crack would have spread in very much the same way after a few more applications of the working pressure. Examination of the failure provided evidence of fatigue at the point where the crack would be most likely to start, namely near the edge of the skin at the corner of the window (see Figures 9 and 10). This was revealed

by the discolouration due to algae in the water which made it clear that the crack had endured several pressurisations before it spread catastrophically. It is important to note here that the sources of fatigue mentioned above, which were not reproduced in the tank test, all tend to increase the burden of fatigue and that, therefore, the life of a fuselage deduced from the test is longer than would be expected in service. It is not possible to do more than estimate the magnitude of this effect but it was suggested by Dr. Walker that a "life" of 3,060 flights in the test might be equivalent to about 2,500 in practice.

a. GENERAL VIEW LOOKING FORWARD.

b. CLOSE-UP OF SKIN AT BOTTOM REAR CORNER OF ESCAPE HATCH.

FIG. 9. FAILURE OF FRONT FUSELAGE AT 10.4 lb/in<sup>2</sup> (3057 TOTAL FLIGHTS)—G-ALYU.

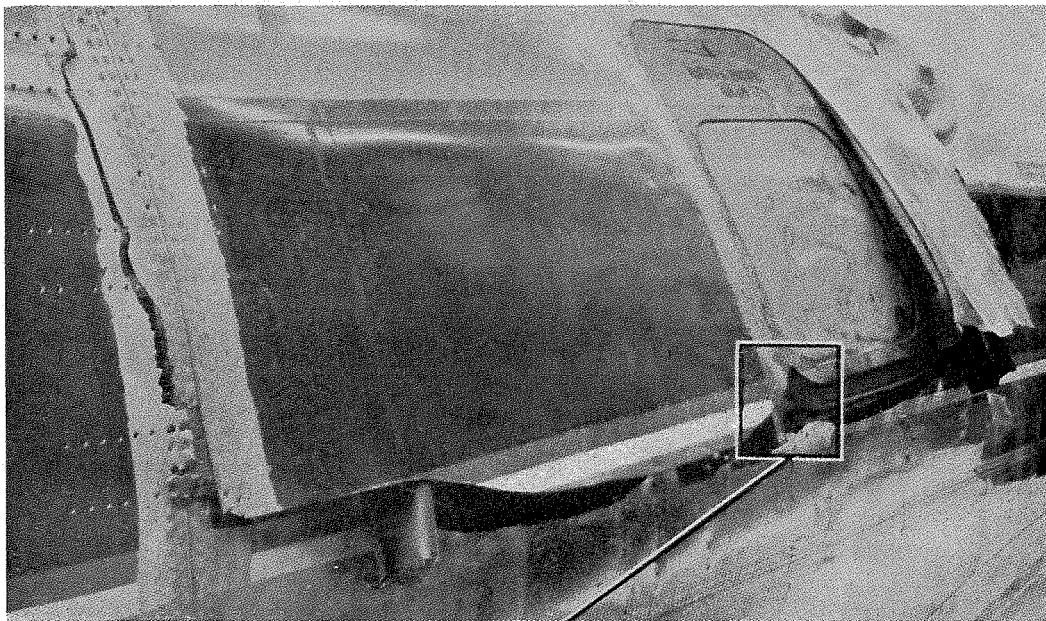
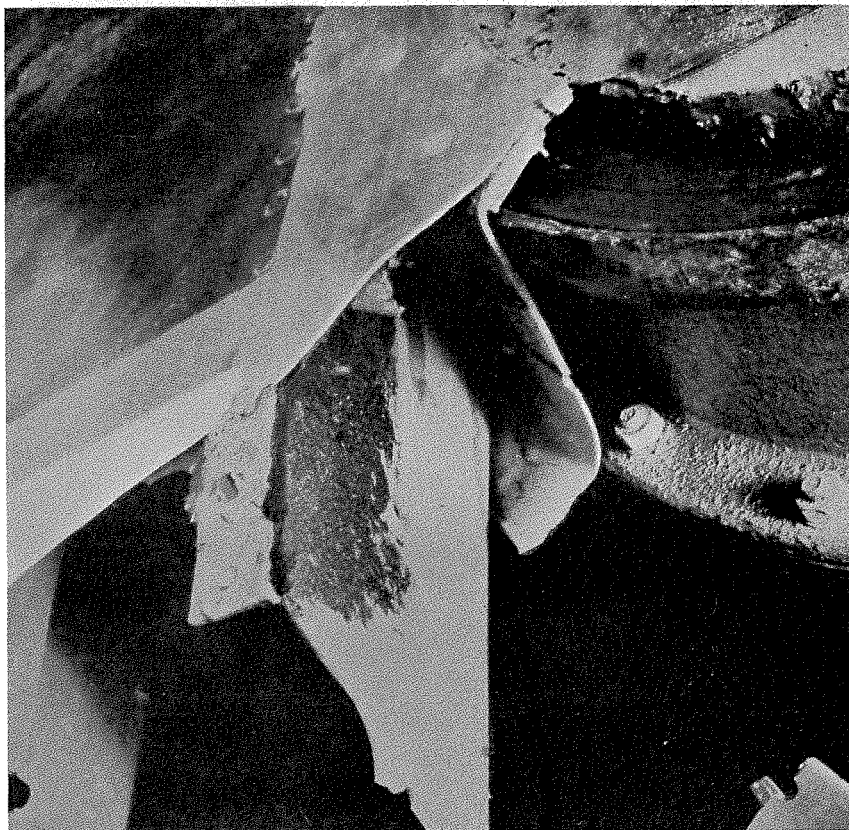
a. GENERAL VIEW LOOKING AFT.

b. CLOSE-UP OF SKIN AT BOTTOM FRONT CORNER OF ESCAPE HATCH.

FIG. 10. FAILURE OF FRONT FUSELAGE AT  $10.4 \text{ lb/in}^2$  (3057 TOTAL FLIGHTS)—G-ALYU.

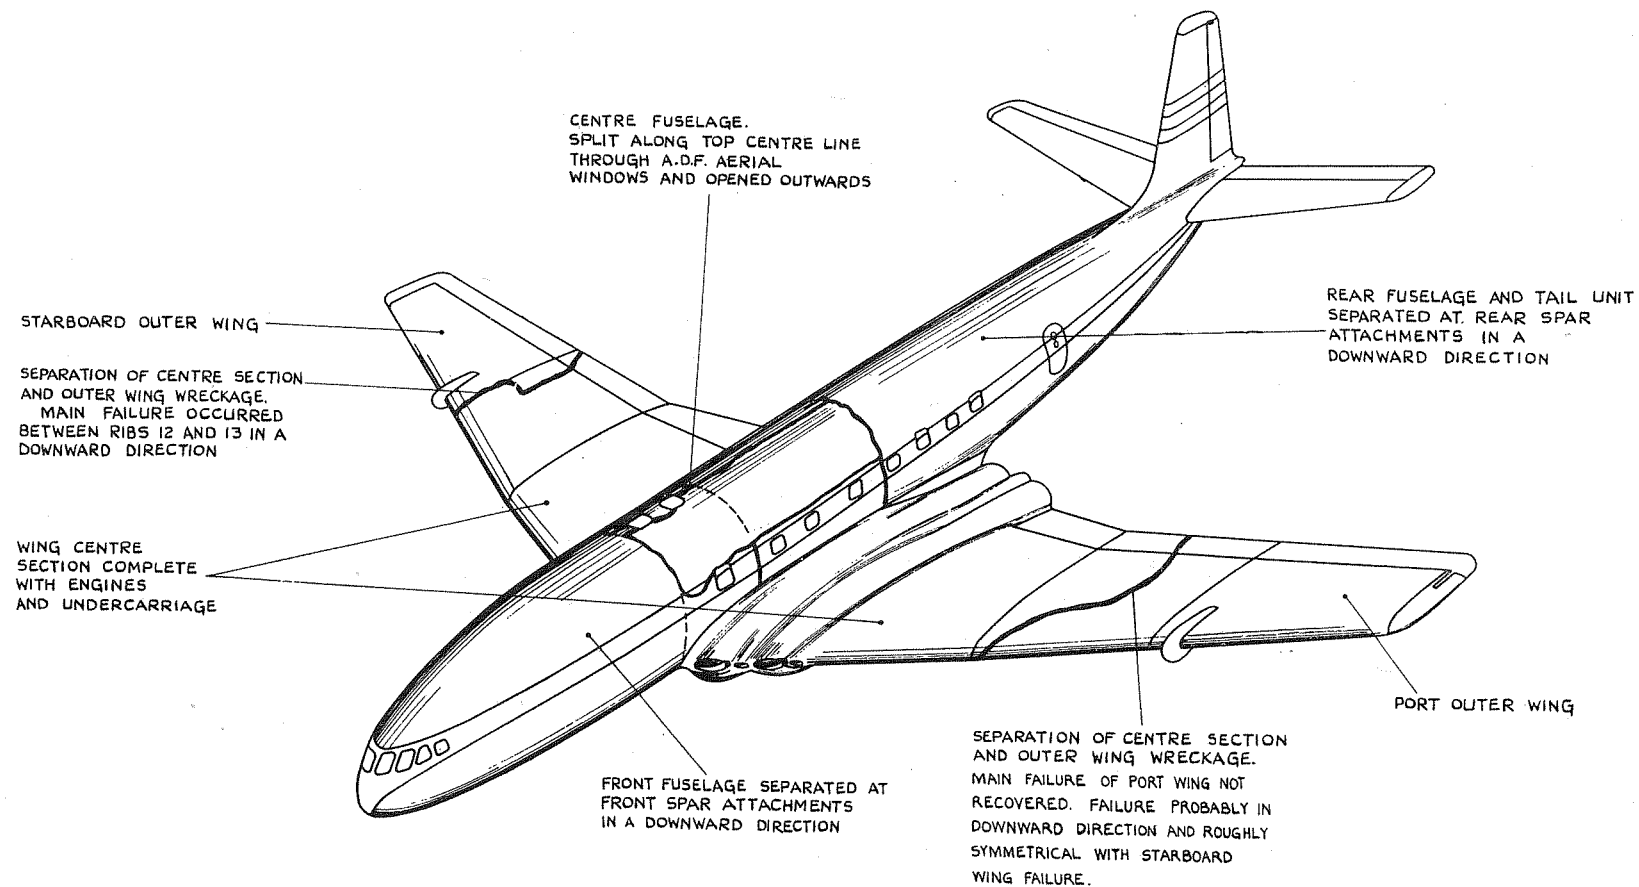
FIG. II. LOCATION AND DIRECTION OF MAIN FAILURES—G-ALYP.

DIRECTION OF  
PROPAGATION  
OF MAIN  
FAILURES

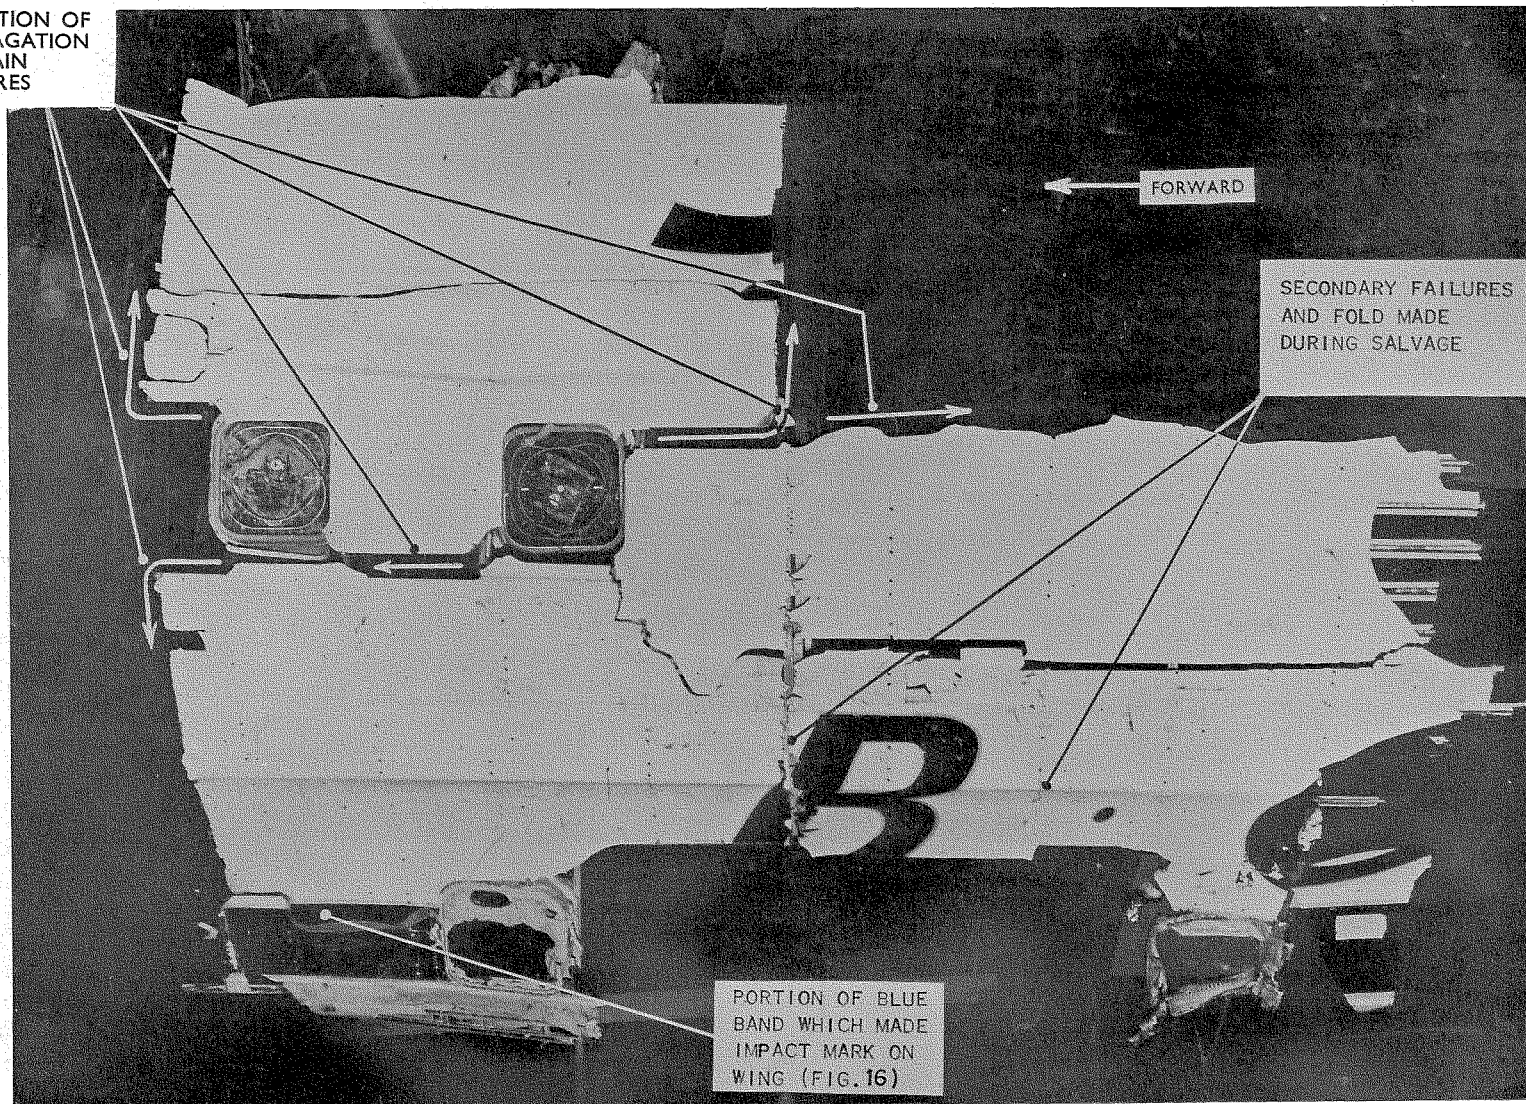
FIG. 12. PHOTOGRAPH OF WRECKAGE AROUND ADF AERIAL WINDOWS—G-ALYP.

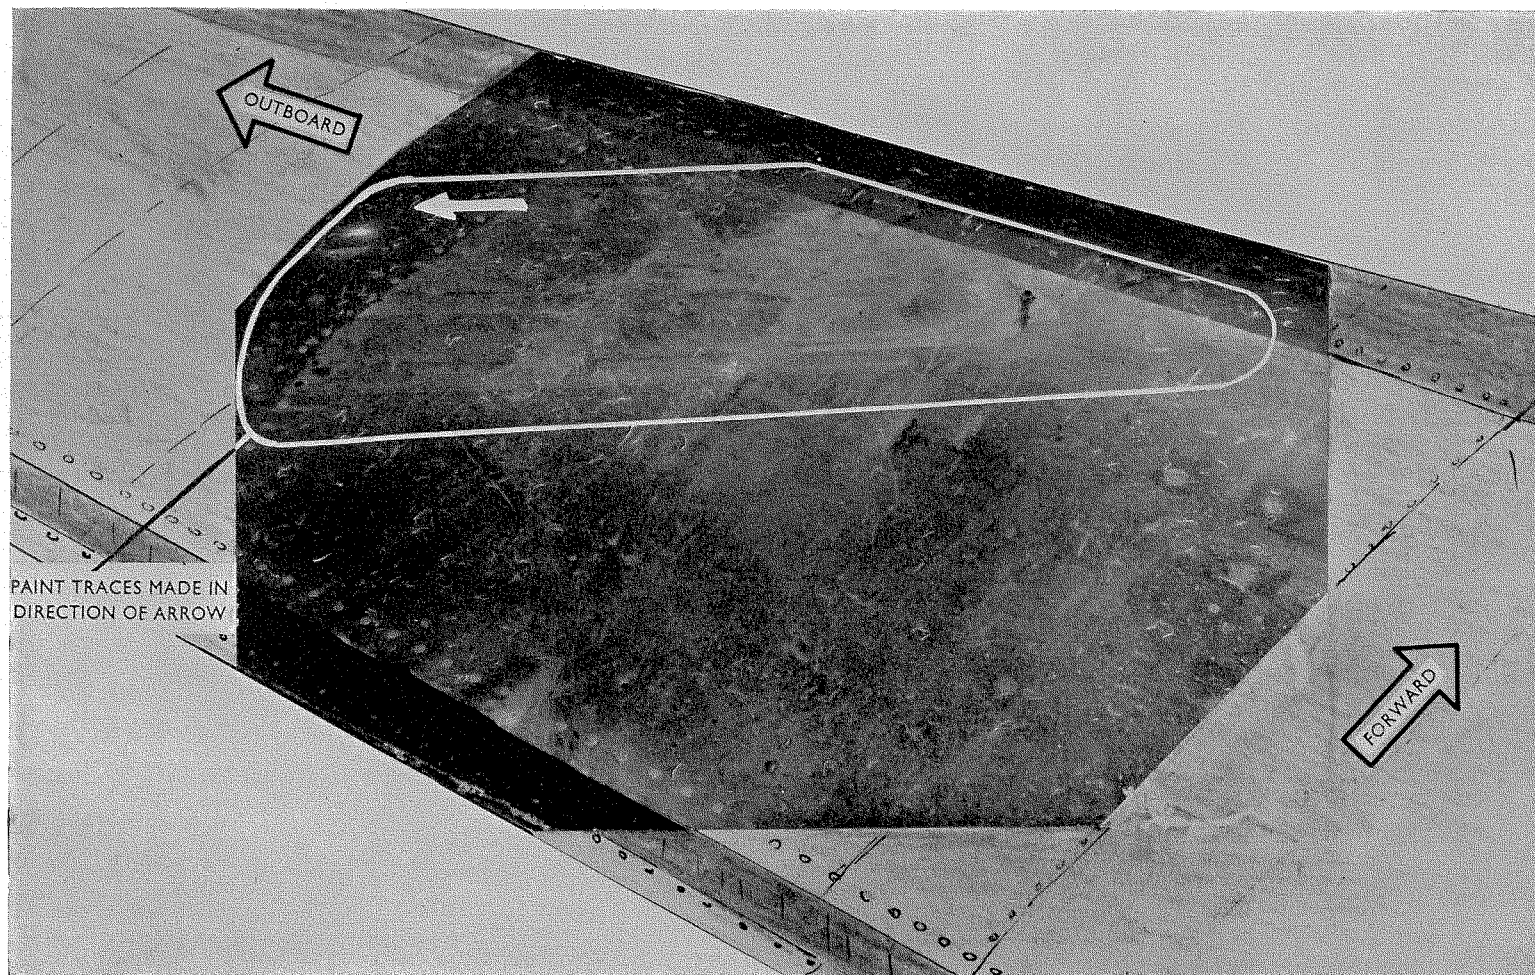
FIG. 13. PAINT TRACES OVER PORT AILERON UPPER SURFACE—G-ALYP.

PARTICLES OF FIBREGLASS AND WOOD JAMMED INTO SKIN AND  
UNDER LAP JOINT PROBABLY FROM FUSELAGE CABIN FLOORING

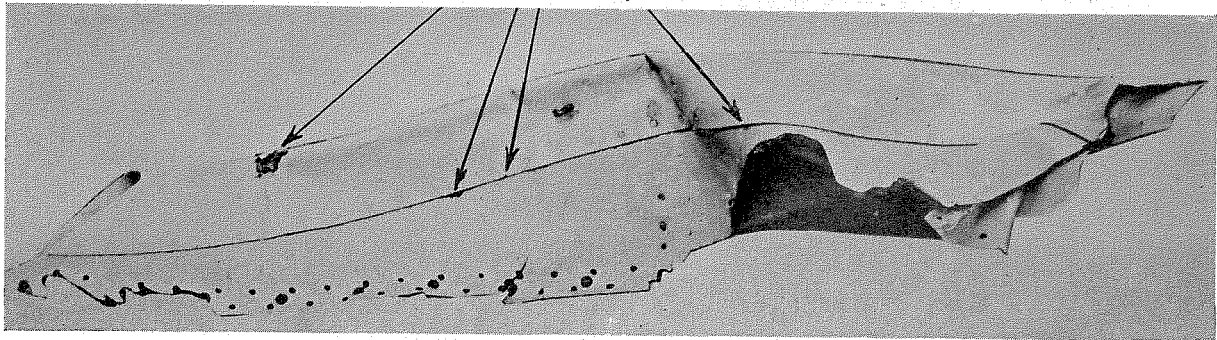
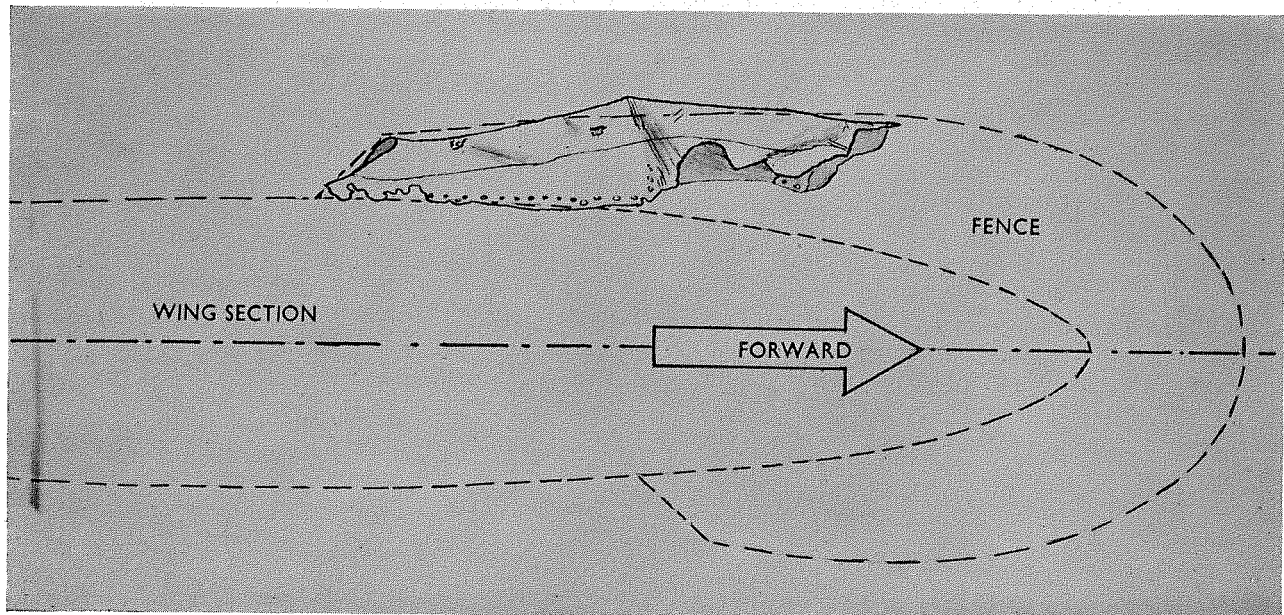
GENERAL PATTERN OF METALLIC SCORES AND PAINT TRACES OVER  
INBOARD FACE PROGRESSING FROM WING SKIN TO UPPER EDGE OF FENCE

NO COMPARABLE DAMAGE ON OUTBOARD FACE OF FENCE

FIG. 14. PORT BOUNDARY LAYER FENCE, IMPACT DAMAGE TO INBOARD FACE—G-ALYP.

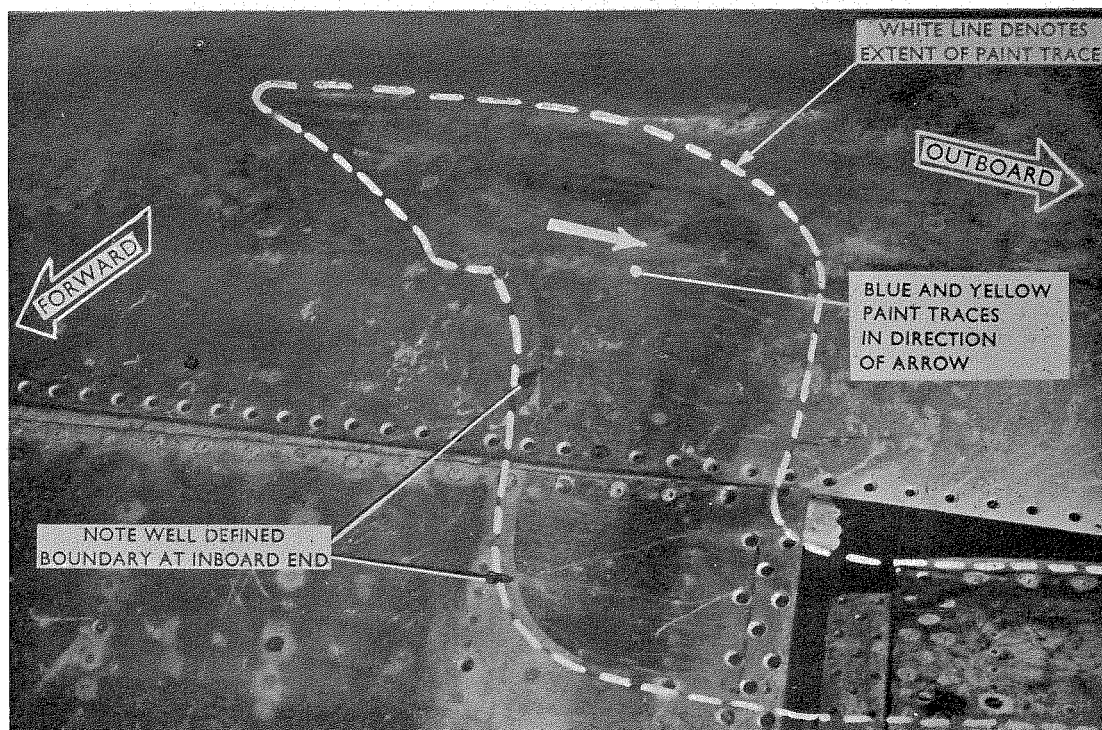
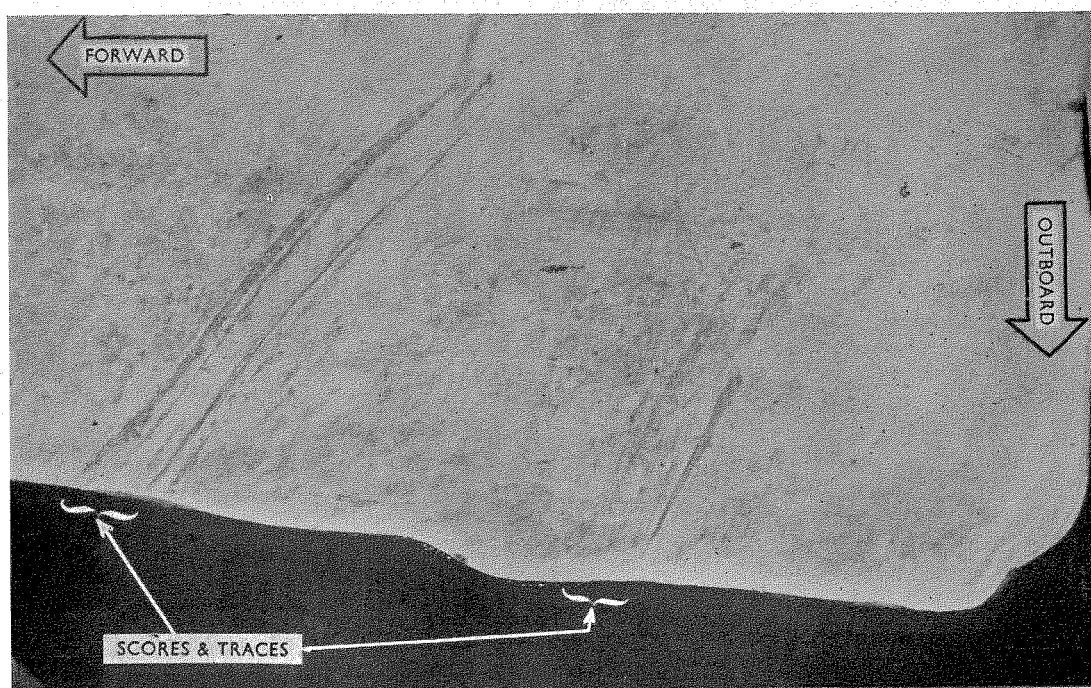
PAINT TRACES MADE BY PORTION OF CABIN WALL  
(FOR LOCATION SEE FIG. 16).

HEAVY METALLIC SCORING WITH BLUE PAINT TRACES CONTINUOUS OVER FRACTURE EDGE  
(FOR LOCATION SEE FIG. 16).

FIG. 15. PAINT TRACES ON PORT WING UPPER SURFACE—G-ALYP.

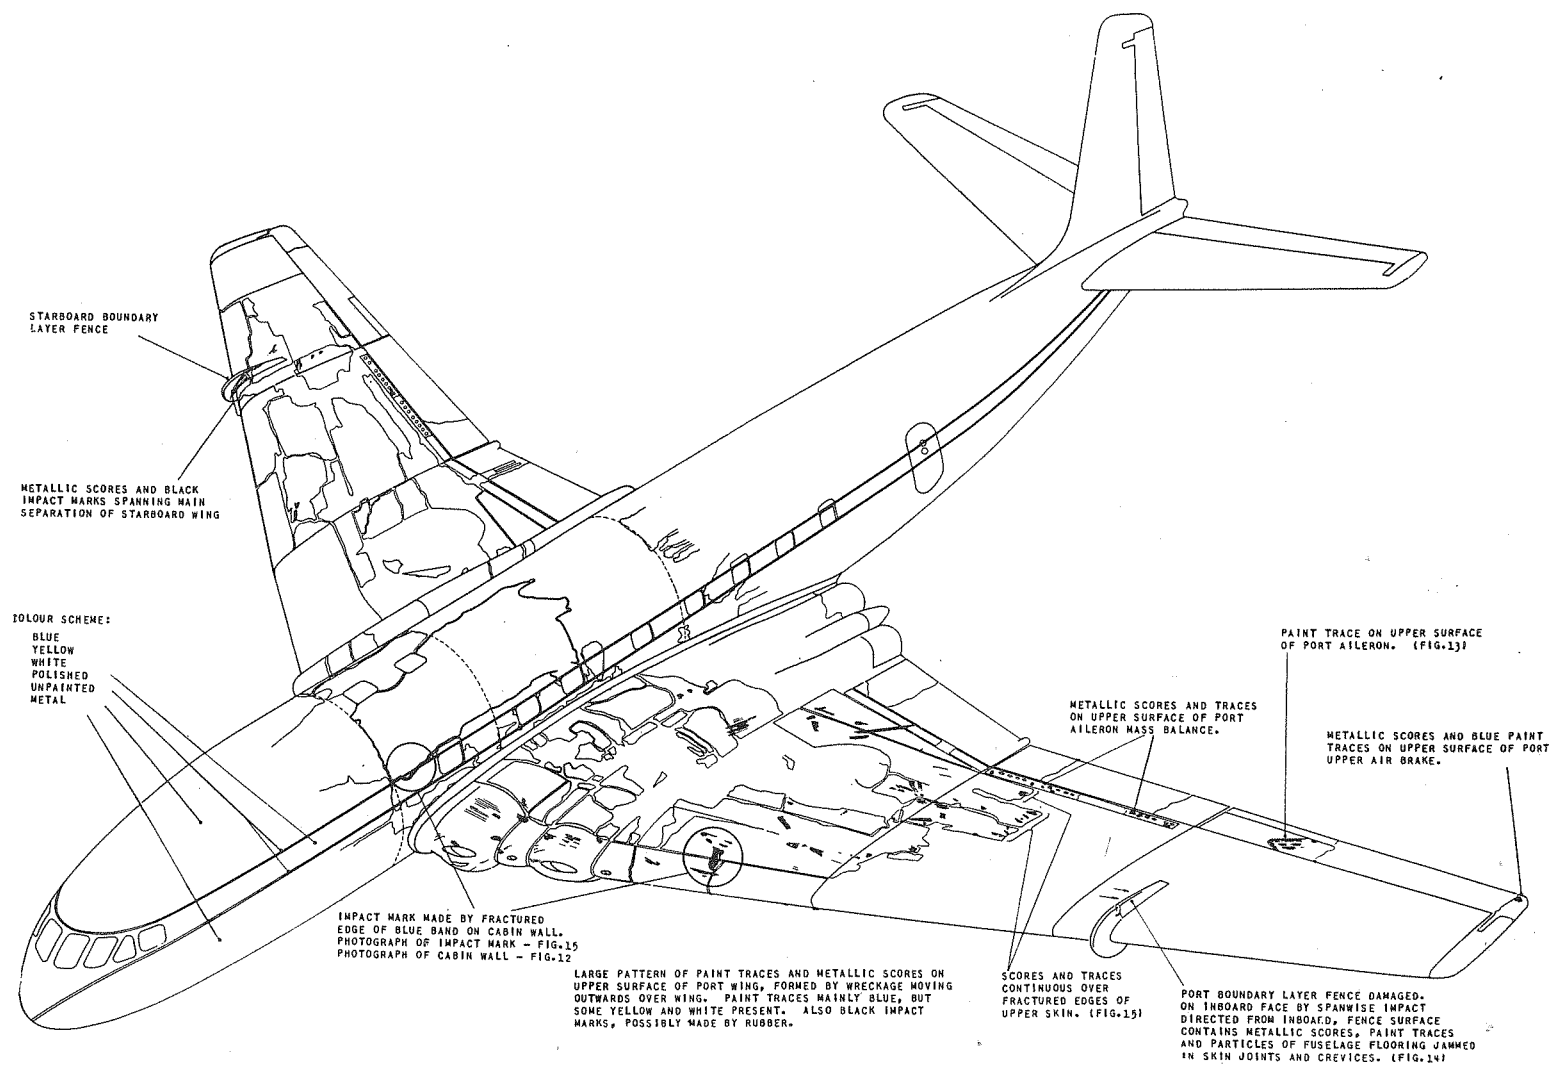
FIG. 16. IMPACT DAMAGE TO UPPER SURFACES OF WINGS—G-ALYP.

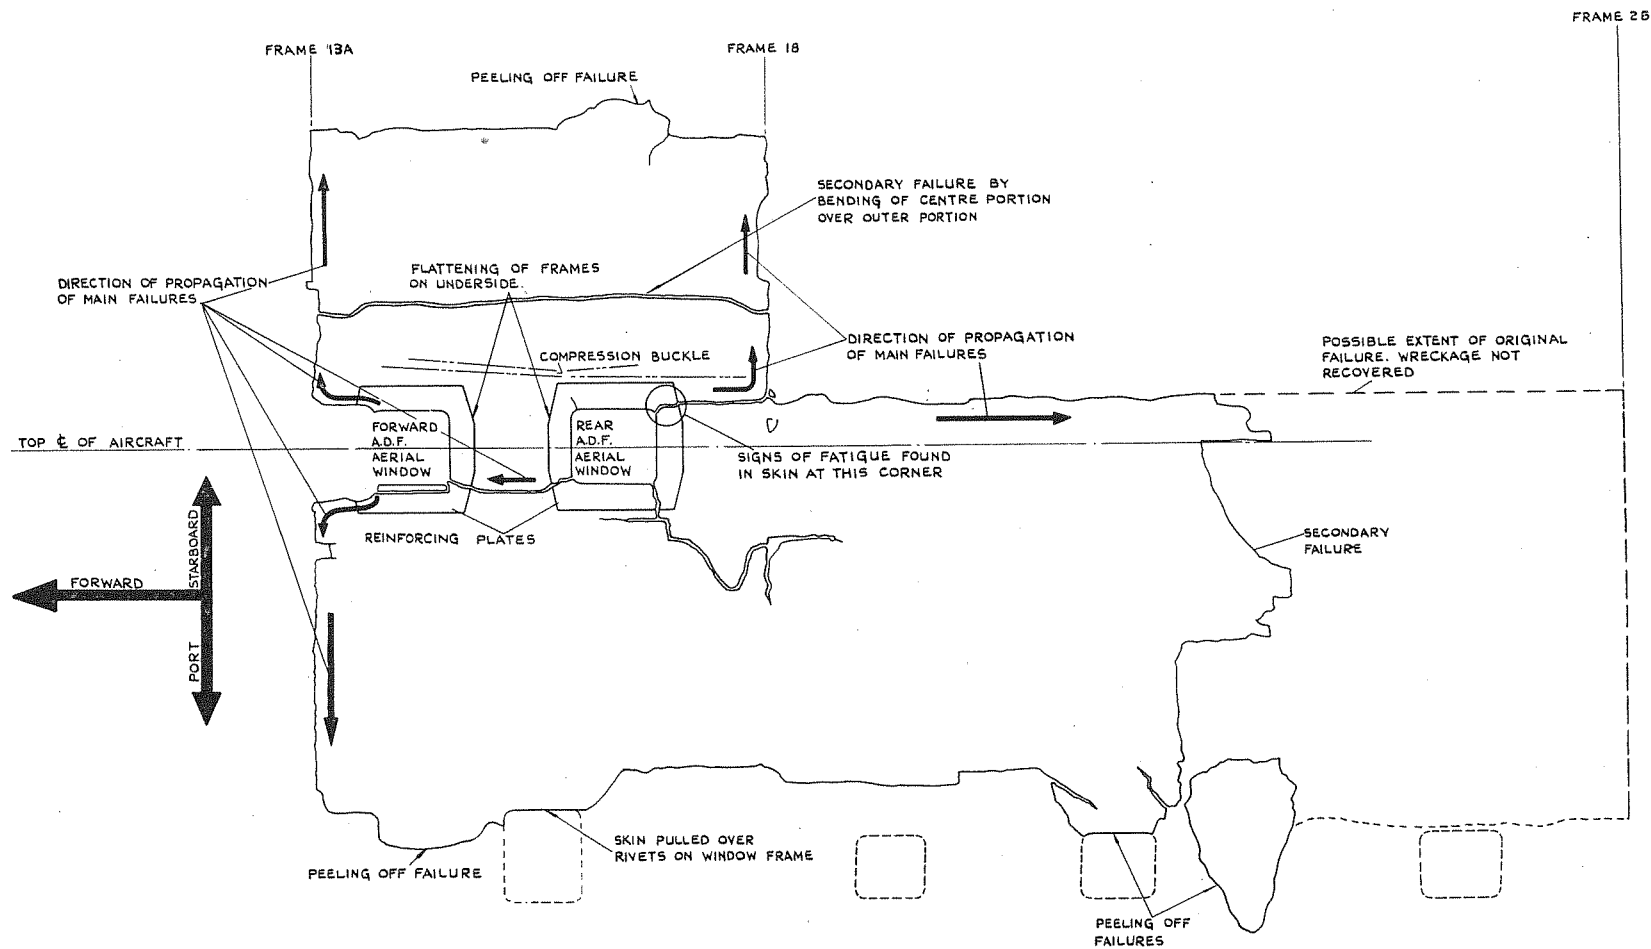
FIG. 17. SALIENT FEATURES OF DISRUPTION OF PRESSURE CABIN—G-ALYP.

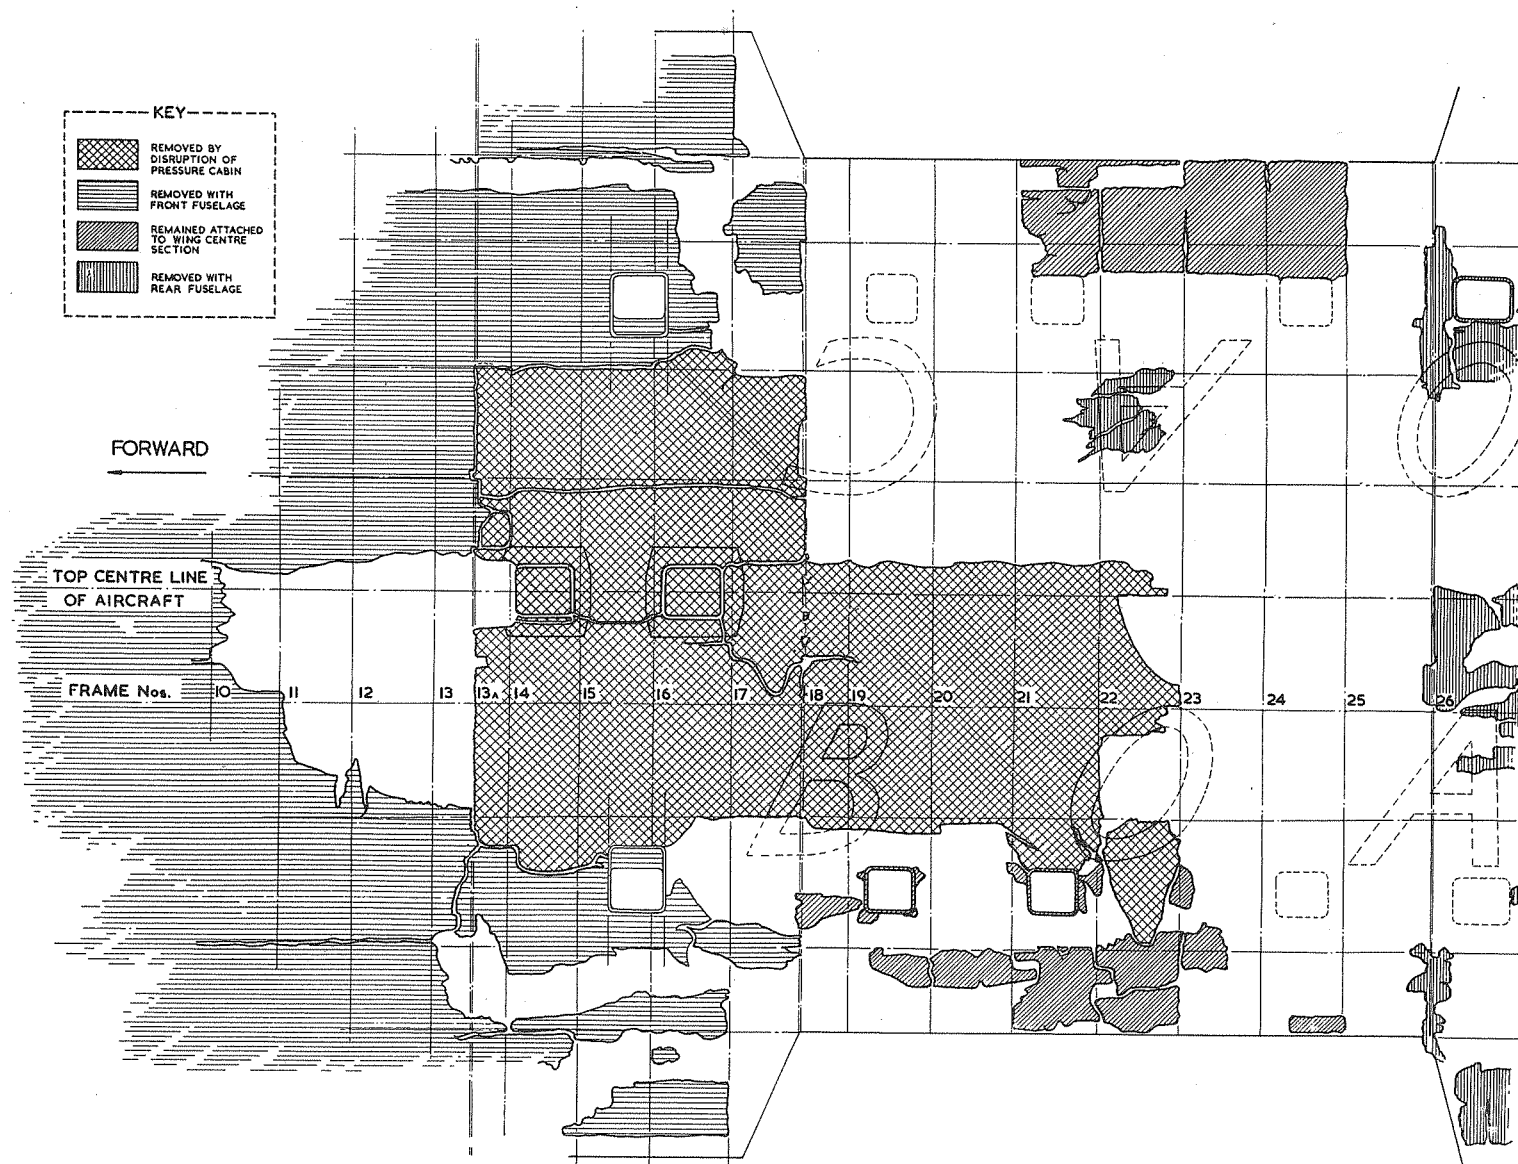
FIG. 18. DEVELOPMENT DRAWING OF WRECKAGE AROUND ADF AERIAL WINDOWS—G-ALYP.

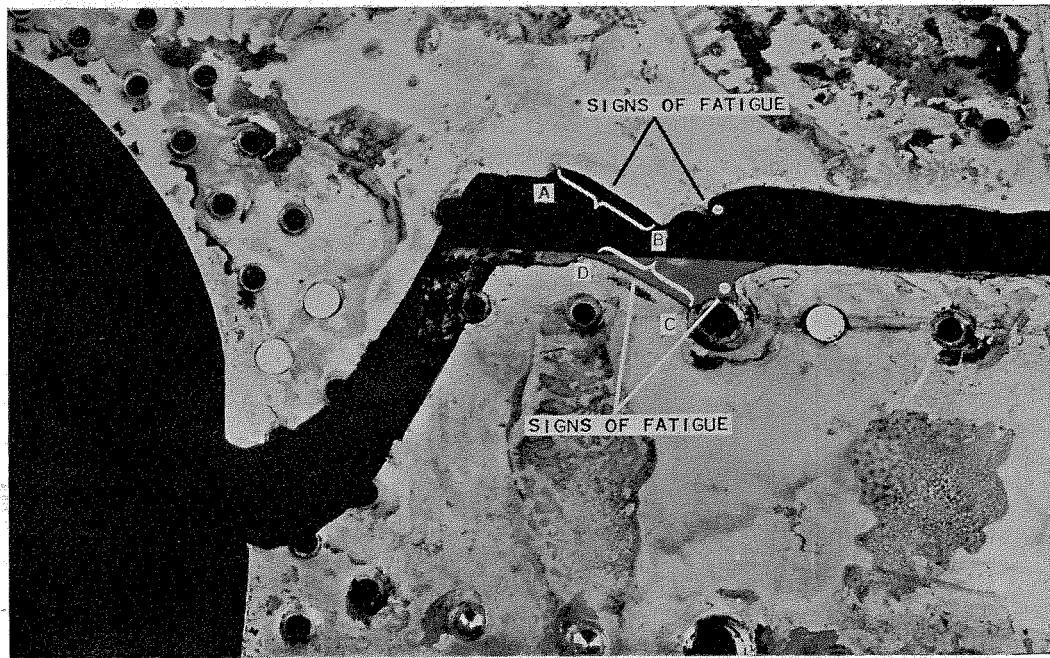
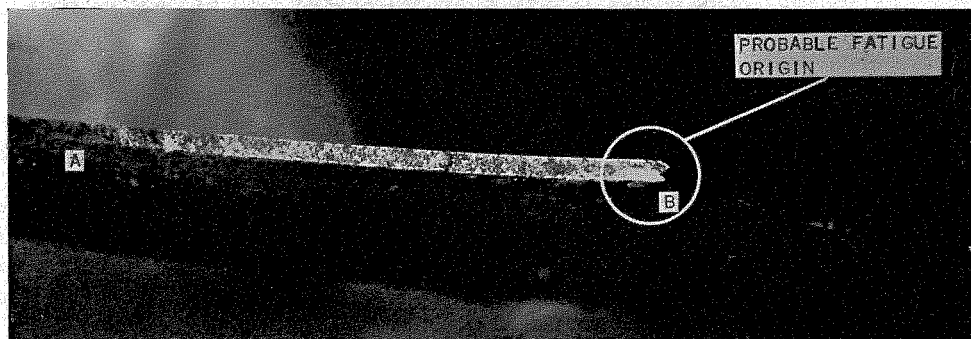
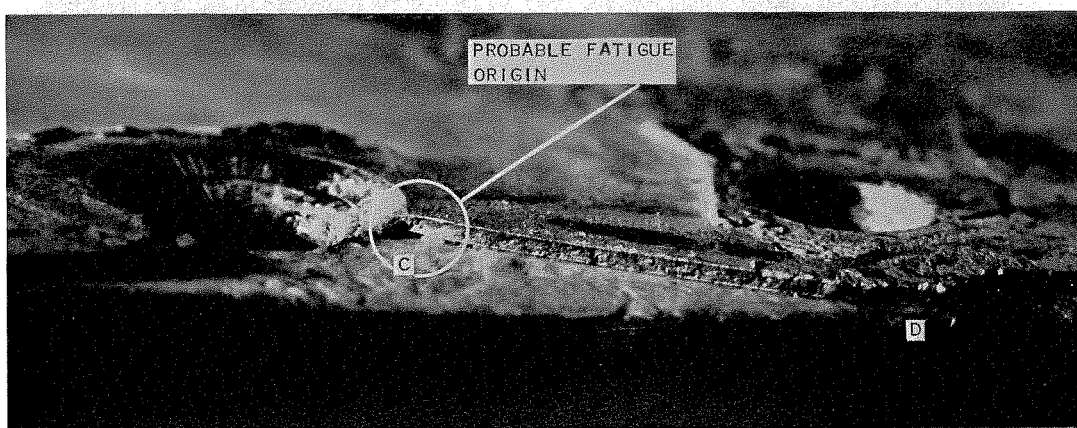
(a) PLAN VIEW OF FAILURE IN SKIN.

(b) VIEW OF EDGE A B.

(c) VIEW OF EDGE C D.

FIG. 19. SIGNS OF FATIGUE IN SKIN AT STARBOARD REAR CORNER OF REAR ADF AERIAL WINDOW—G-ALYP.
