| 1. Report No.<br>NTSB-AVR-75-16 | 2. Government Accession No. | 3. Recipient's Catalog No. |
| 4. Title and Subtitle<br>Aircraft Accident Report - Trans World Airlines, Inc.,<br>Boeing 727-231, N54328, Berryville, Virginia<br>December 1, 1974 | 5. Report Date<br>November 26, 1975 | 6. Performing Organization<br>Code |

At 1110 e.s.t., December 1, 1974, Trans World Airlines, Inc., Flight 514, a Boeing 727-231, N54328, crashed about 25 nautical miles northwest of Dulles International Airport, Washington, D. C. The accident occurred while the flight was descending for a VOR/DME approach to runway 12 at Dulles in instrument meteorological conditions. The 92 occupants -- 85 passengers and 7 crewmembers were killed, and the aircraft was destroyed.

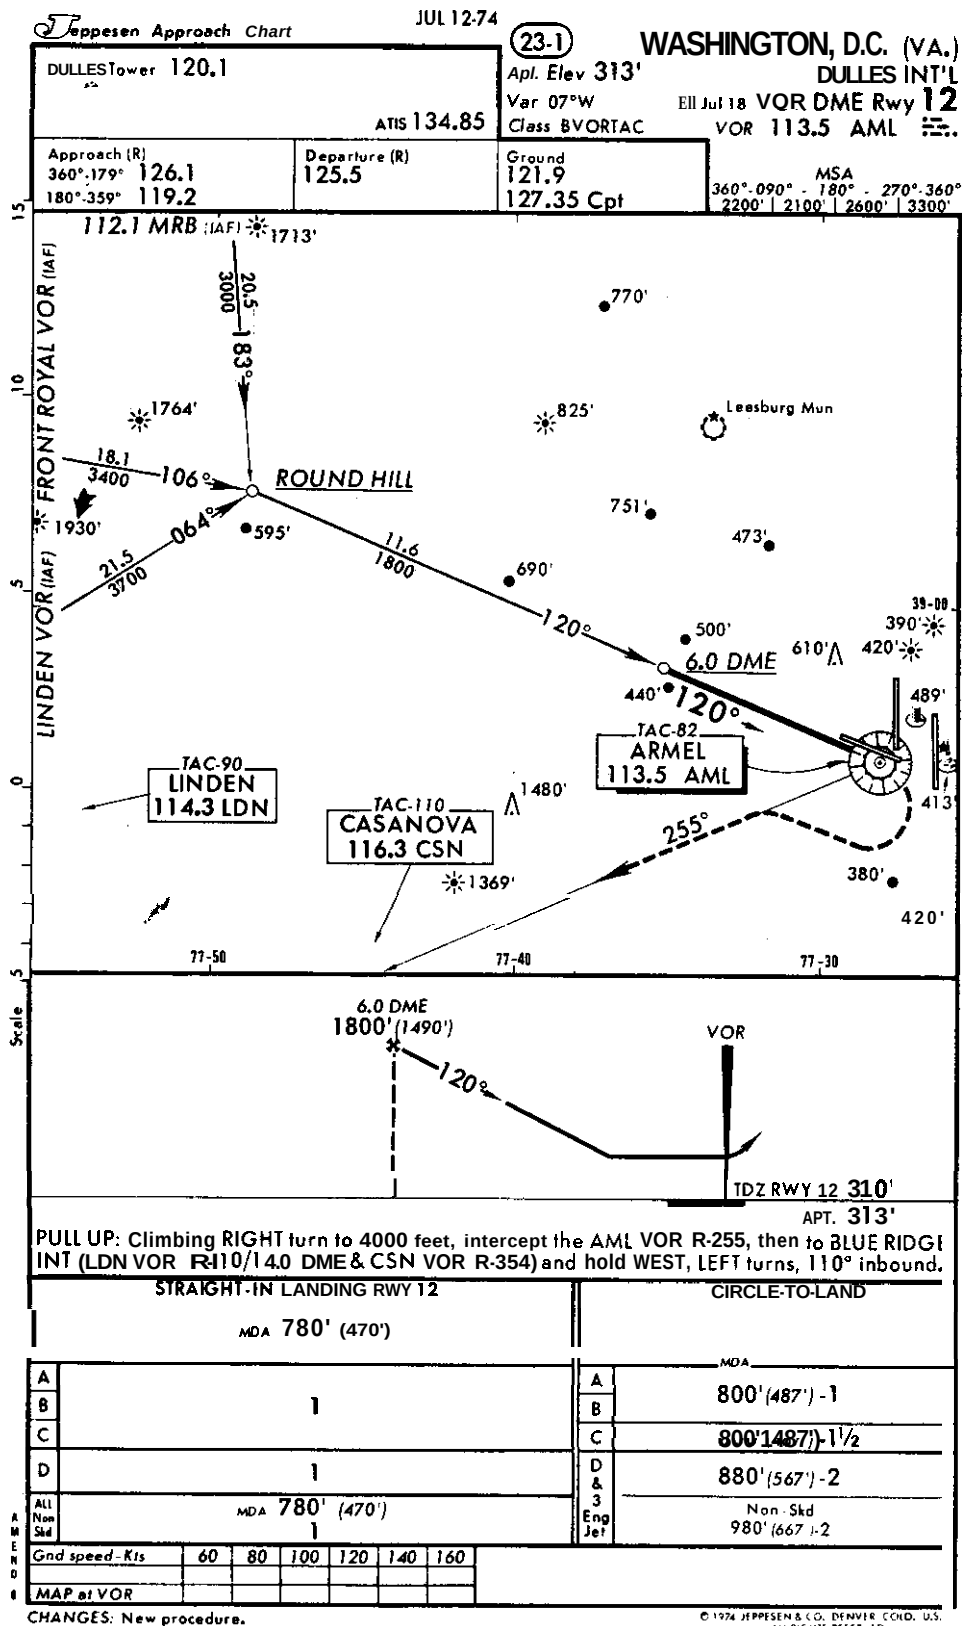
# APPENDIX D

The information available to the pilot, including the approach chart, should have alerted the crew that an unrestricted descent would be unsafe. It does appear to the Board that there was a deficiency in the chart. This particular approach chart depicted the profile view from the final approach fix to the airport. It did not depict the intermediate fix, Round Hill, with its associated minimum altitudes. This information was available from the plan view of the chart, but it appears that the crew gave their primary attention to the profile. If this was the

(3) Inadequate depiction of altitude restrictions on the profile view of the approach chart for the VOR/DME approach to runway 12 at Dulles International Airport.
